WRONG-WAY CRASH STUDY

INTERSTATES AND FREEWAYS | CALENDAR YEAR 2018

June 2020

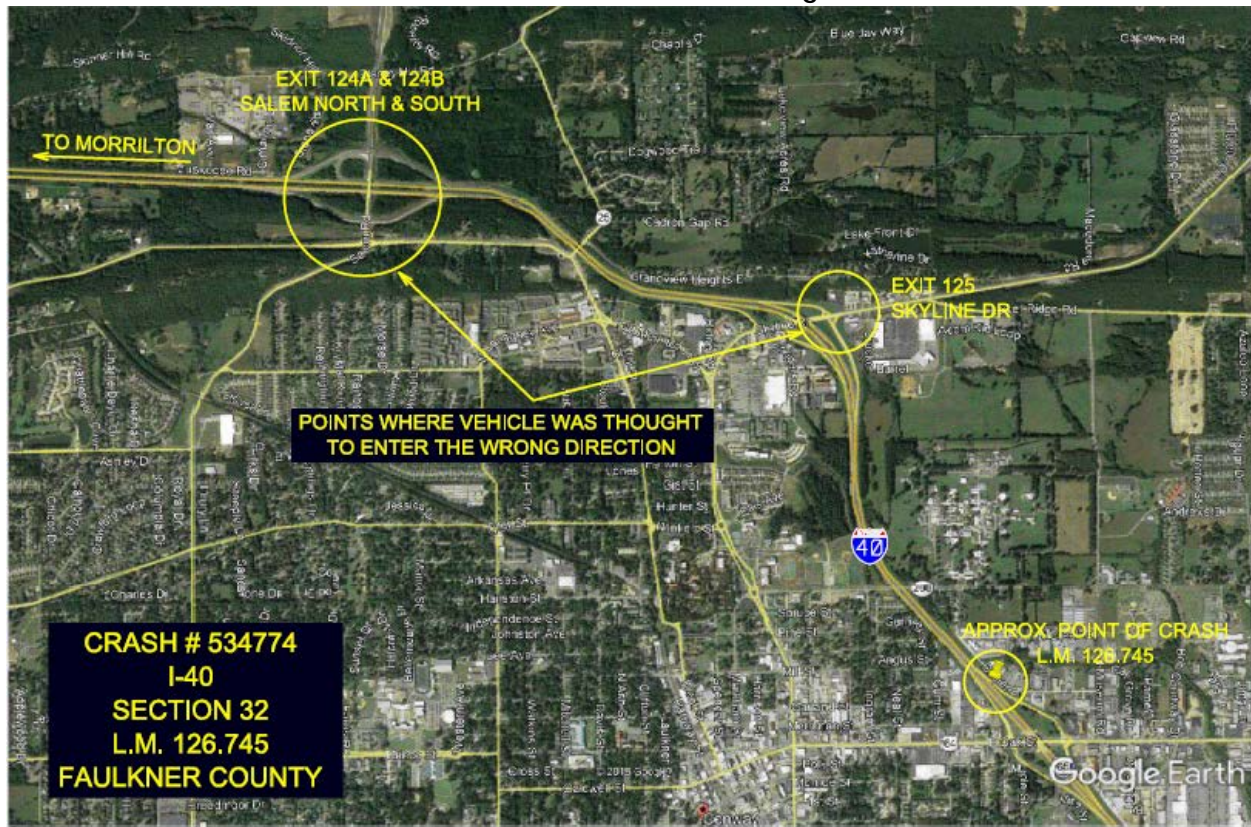
Crash # 2018534774 I-40, Section 32, Log Mile 126.745

The driver accessed I-40 possibly at Exit 124A (Salem-North), Exit 124B (Salem-South) or Exit 125 (Skyline Drive), and travelled east in the westbound lanes of traffic. The driver was involved in a head on collision at log mile 126.745 which resulted in a fatality.

The interchange at Exit 124B was reviewed. Pavement markings and signs were in place and in conformance with MUTCD and ARDOT standards.

The interchange at Exit 125 was reviewed. Pavement markings and signs were in place and in conformance with MUTCD and ARDOT standards.

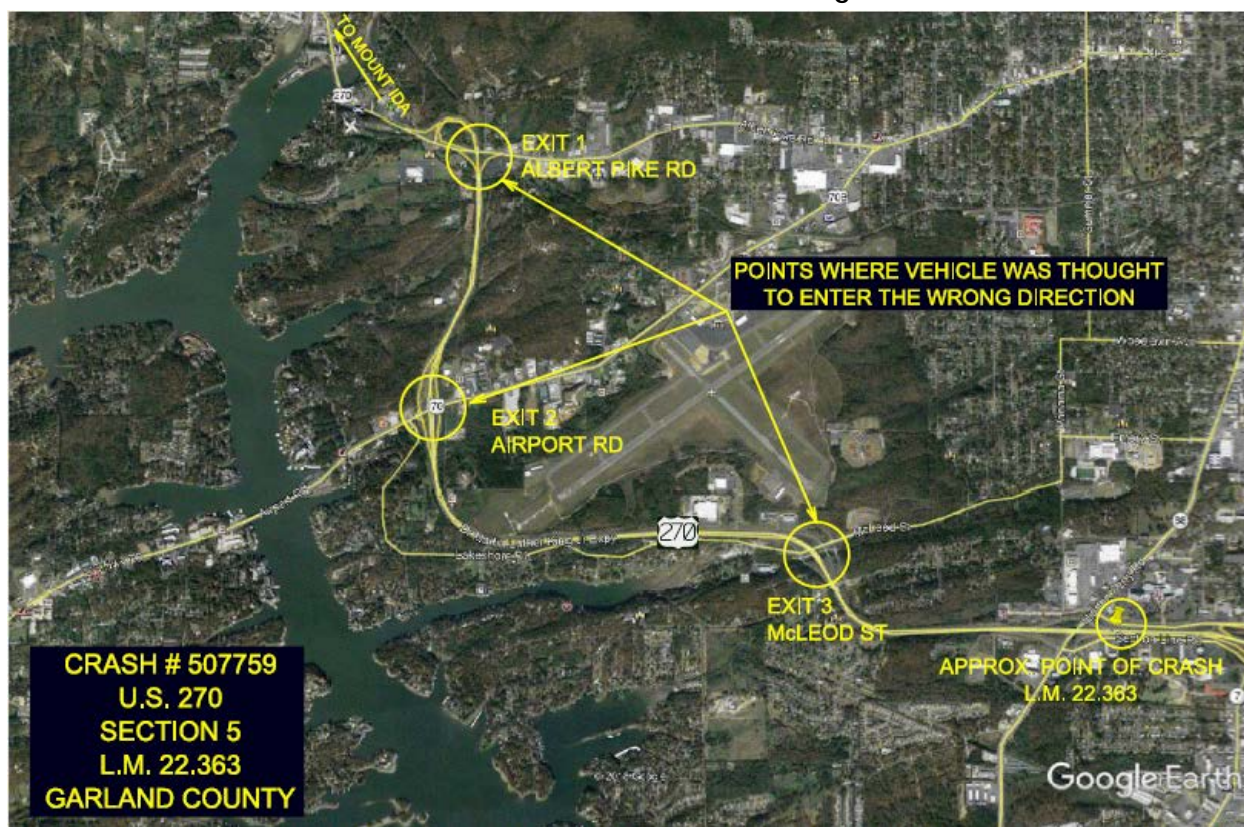
Crash # 2018507759 U.S. 270, Section 5, Log Mile 22.363

The driver accessed U.S. 270 possibly at Exit 1 (Albert Pike Rd.), Exit 2 (Airport Rd.) or Exit 3 (McLeod St.) and travelled east in the westbound lanes of traffic. The driver was in a near head on collision with a vehicle travelling westbound. The westbound driver attempted to change lanes to avoid head on collision. The wrong-way vehicle front driver side collided with westbound vehicle driver side at log mile 22.363.

The interchange at Exit 2 was reviewed. Pavement markings and signs were in place and in conformance with MUTCD and ARDOT standards.

The interchange at Exit 3 was reviewed. Signs were in place and in conformance with MUTCD and ARDOT standards. However, pavement markings will need to be moved up to be consistent with current ARDOT standards. These modifications will be implemented by district forces as soon as their schedule permits.

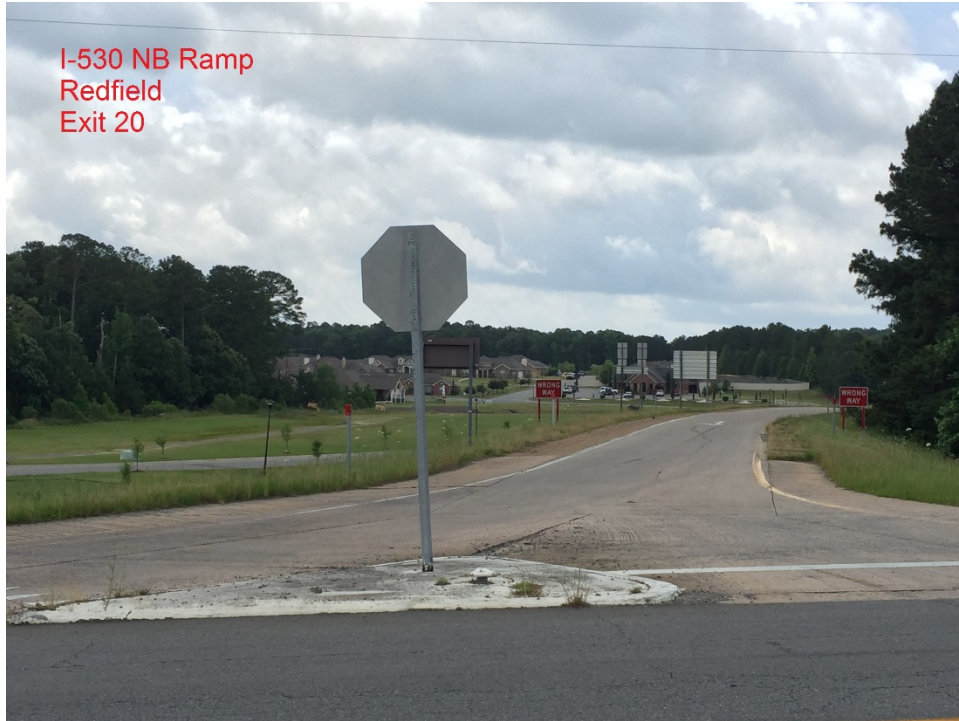
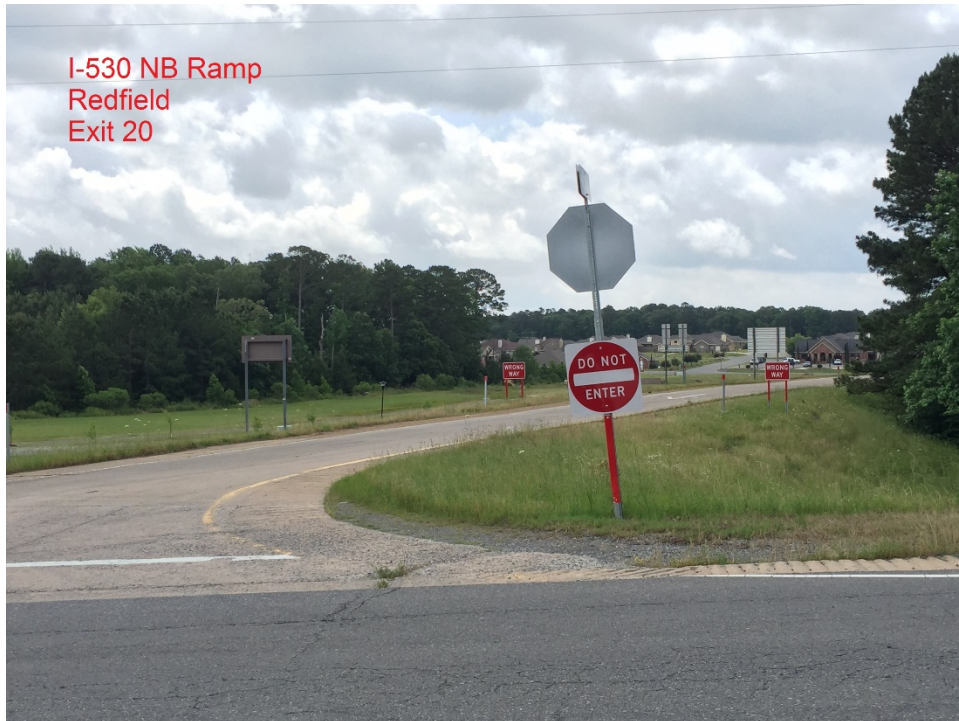
I-530 NB Ramp
Redfield
Exit 20

The interchange at Exit 20 was reviewed. Pavement markings and signs were in place and in conformance with MUTCD standards. However, the 30"x30" "DO NOT ENTER" sign along with two 12"x36" "ONE WAY" signs are missing and will be installed to be consistent with current ARDOT standards. These modifications will be implemented by statewide forces as soon as their schedule permits.

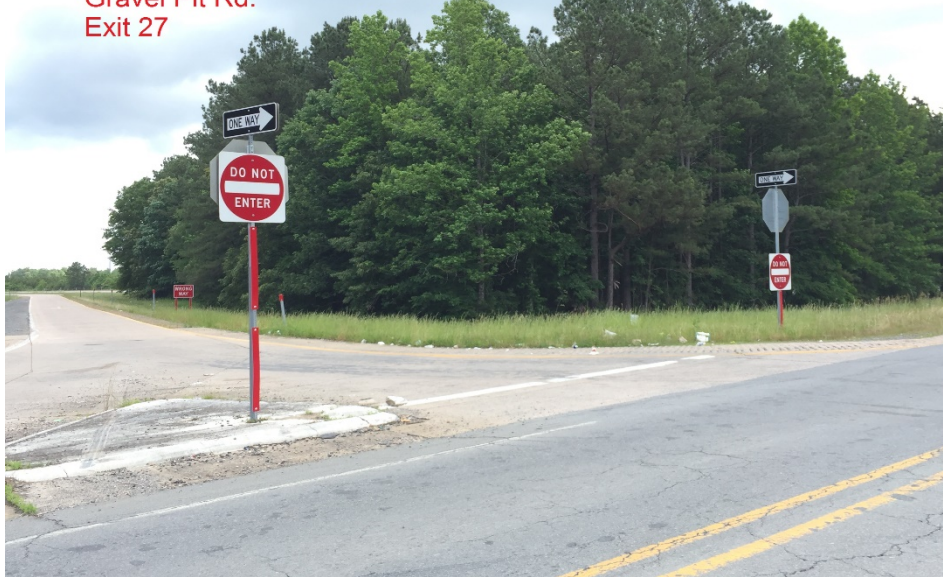
I-530 SB Ramp
Gravel Pit Rd.
Exit 27

The interchange at Exit 27 was reviewed. Pavement markings and signs were in place and in conformance with MUTCD and ARDOT standards.

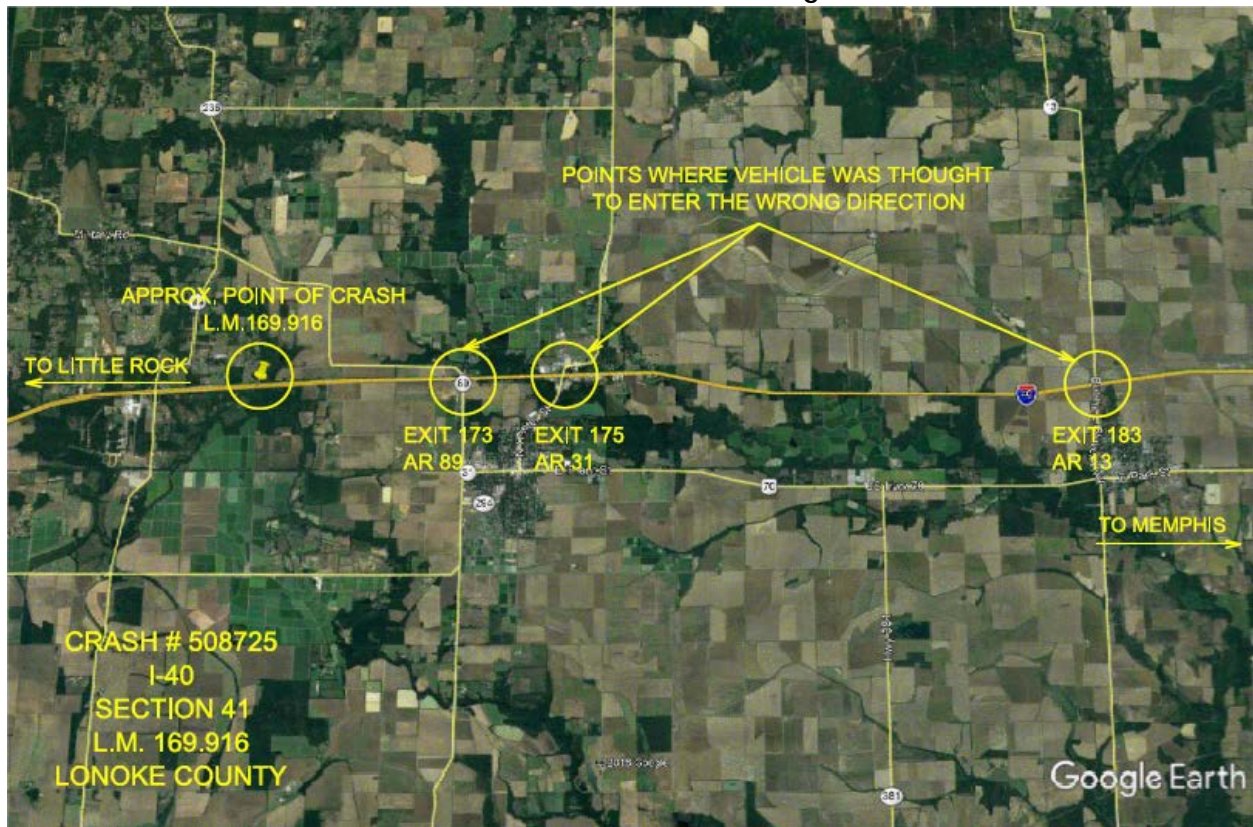
Crash # 2018508725 I-40, Section 41, Log Mile 169.916

The driver accessed I-40 possibly at Exit 173 (AR 89), Exit 175 (AR 31) or Exit 183 (AR 13) and travelled west in the eastbound lanes of traffic. The driver was involved in a head on collision at log mile 169.916 which resulted in a fatality.

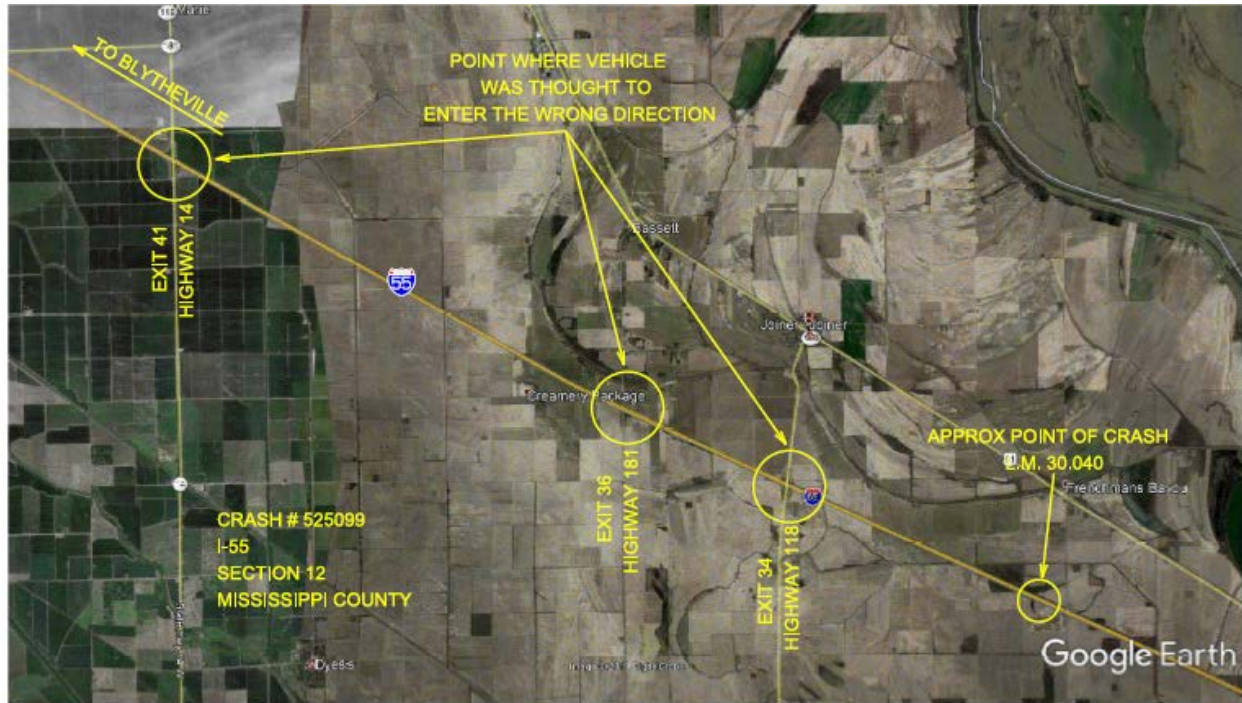
Crash # 2018525099 I-55, Section 12, Log Mile 30.040

The driver accessed I-55 possibly at Exit 34 (Highway 118), Exit 36 (Highway 181) or Exit 41 (Highway 14) and travelled southbound in the northbound traffic lane on Interstate 55. The driver was in a head on collision with a truck who was traveling north on Interstate 55.

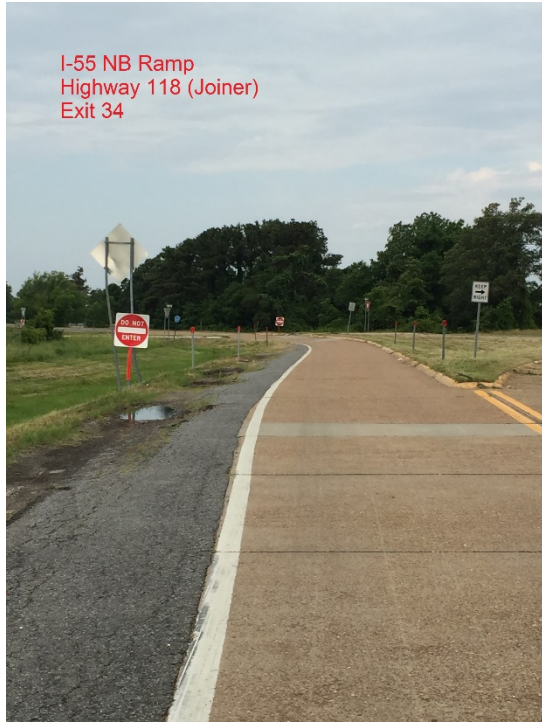
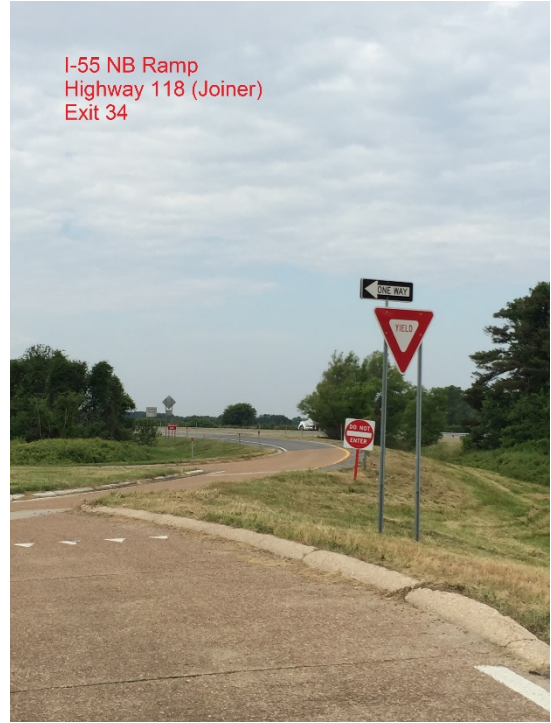
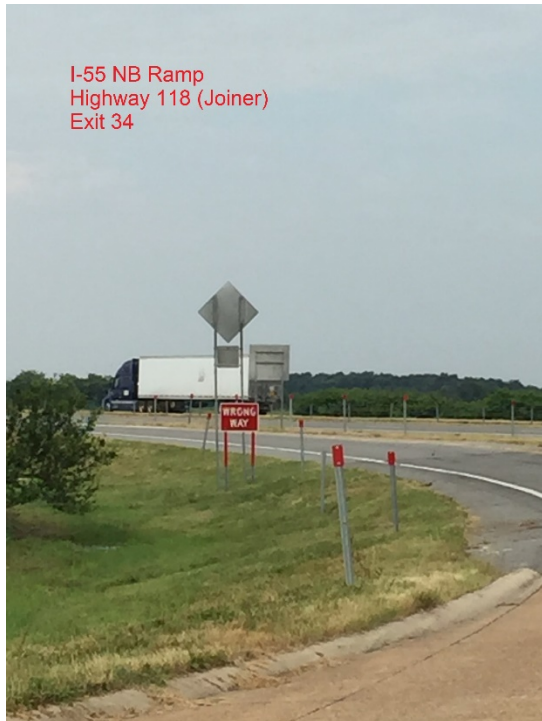
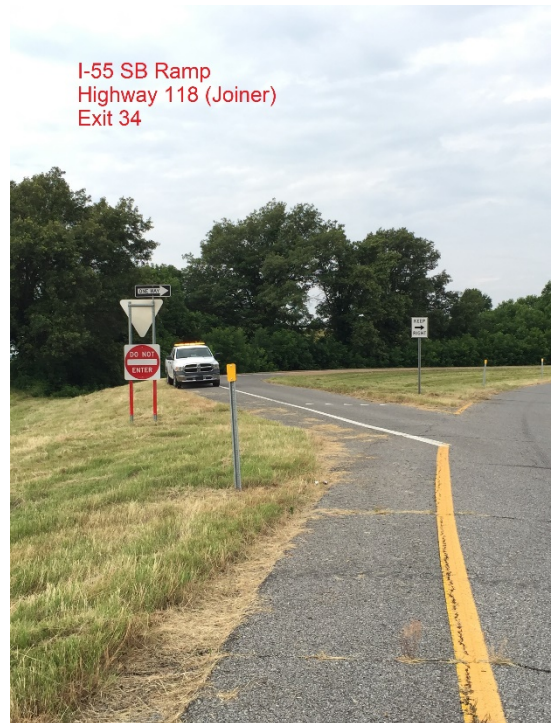
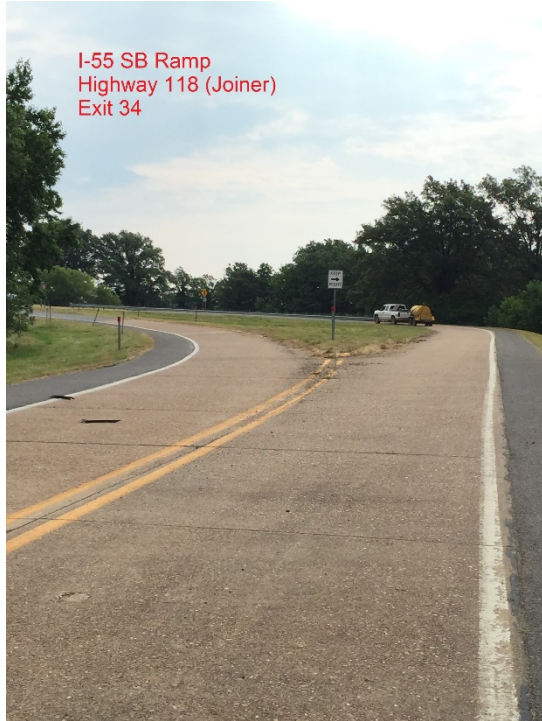
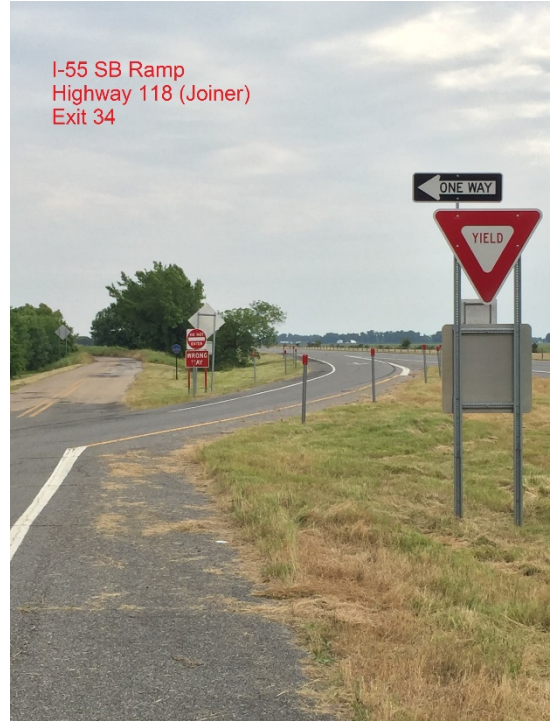
The interchange at Exit 34 was reviewed. Pavement markings and signs were in place and in conformance with MUTCD standards. However, two 30"x 42" "WRONG WAY" signs, a 36"x36" "DO NOT ENTER" sign and a 30"x30" "DO NOT ENTER" sign are missing and will be installed to be consistent with current ARDOT standards. These modifications will be implemented by statewide forces as soon as their schedule permits.

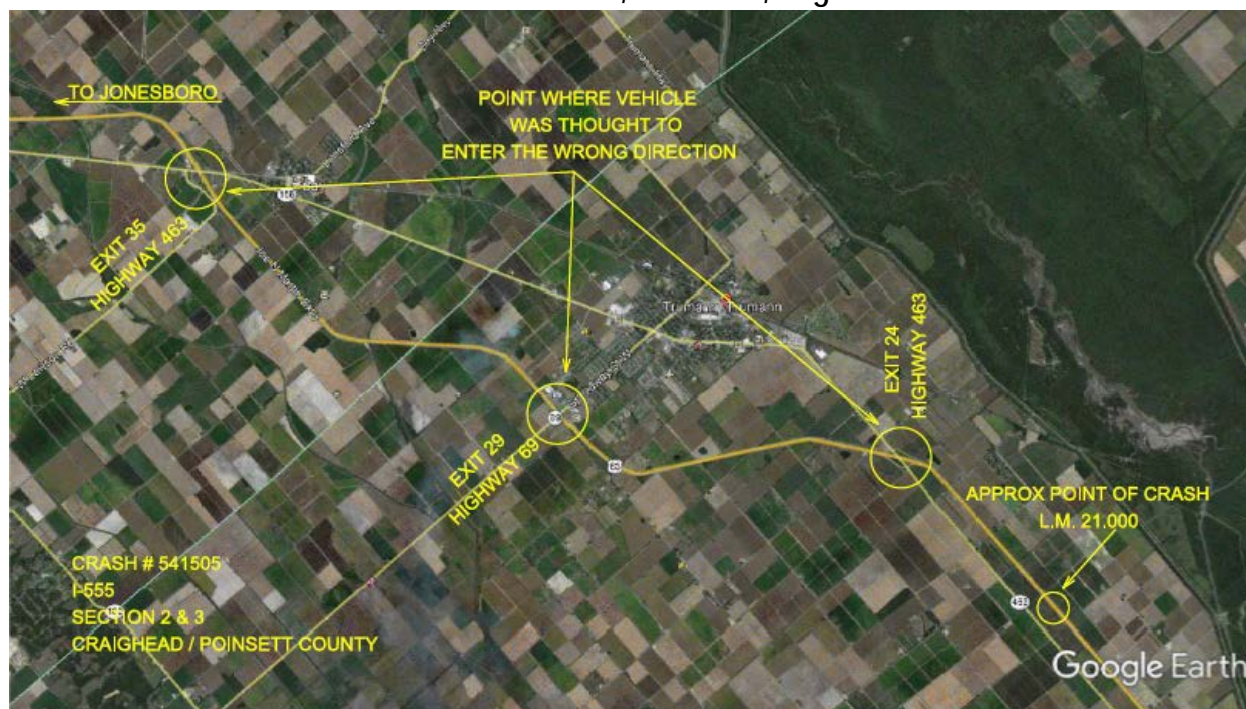
Crash # 2018541505 I-555, Section 2, Log Mile 21.000

The Driver accessed I-555 possibly at Exit 24 (Highway 463), Exit 29 (Highway 69) or Exit 35 (Highway 463) and travelled southbound in the northbound traffic lane on Interstate 555. The driver was in a collision with another vehicle who was traveling north.

The interchange at Exit 24 was reviewed. Pavement markings and signs were in place and in conformance with MUTCD standards. However, the 30"x30" "DO NOT ENTER" sign is missing and will be installed to be consistent with current ARDOT standards. These modifications will be implemented by statewide forces as soon as their schedule permits.

The interchange at Exit 29 was reviewed. Pavement markings and signs were in place and in conformance with MUTCD and ARDOT standards.

The interchange at Exit 35 was reviewed. Pavement markings and signs were in place and in conformance with MUTCD standards. However, the 18"x54" "ONE WAY" signs are missing and will be installed to be consistent with current ARDOT standards. These modifications will be implemented by statewide forces as soon as their schedule permits.

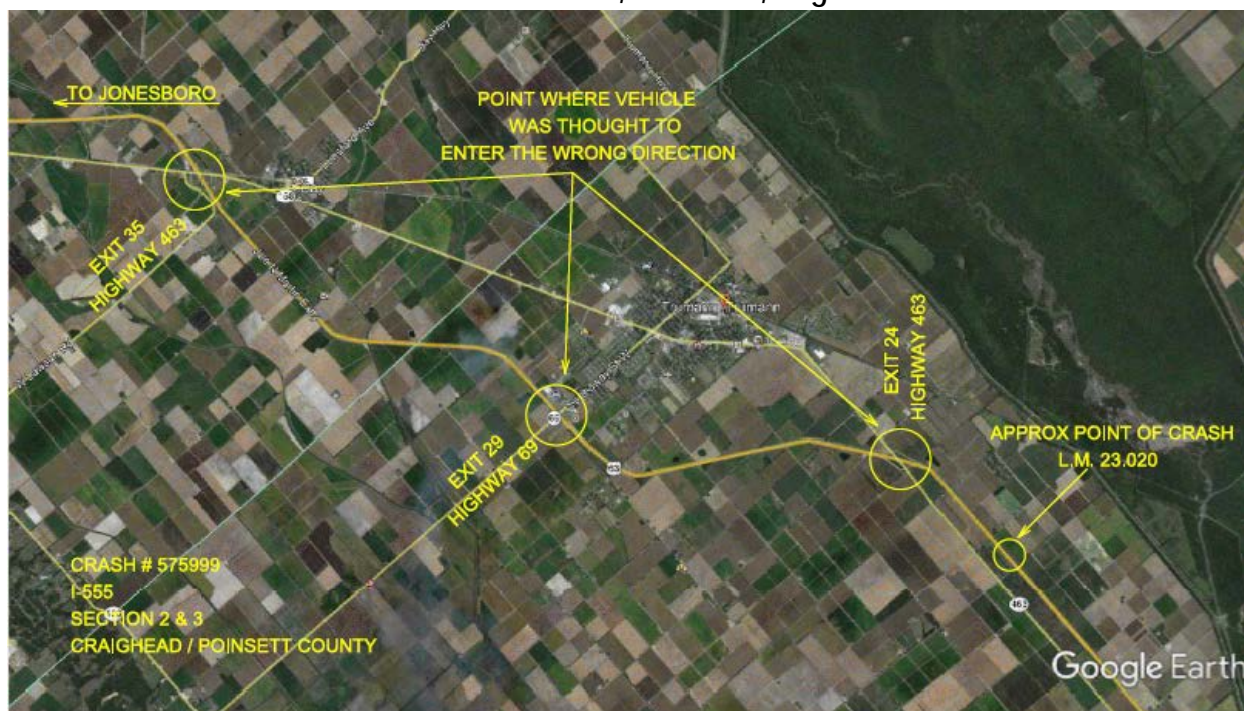
Crash # 2018575999 I-555, Section 2, Log Mile 23.020

The driver accessed I-555 possibly at Exit 24 (Highway 463), Exit 29 (Highway 69) or Exit 35 (Highway 463) and travelled southbound in the northbound traffic lane on Interstate 555. The driver was in a head on crash with another vehicle traveling north which caused both vehicles to catch on fire. The occupants of both vehicles were unable to get out of the vehicles.

The interchange at Exit 24 was reviewed. Pavement markings and signs were in place and in conformance with MUTCD standards. However, the 30"x30" "DO NOT ENTER" sign is missing and will be installed to be consistent with current ARDOT standards. These modifications will be implemented by statewide forces as soon as their schedule permits.

The interchange at Exit 29 was reviewed. Pavement markings and signs were in place and in conformance with MUTCD and ARDOT standards.

The interchange at Exit 35 was reviewed. Pavement markings and signs were in place and in conformance with MUTCD standards. However, the 18"x54" "ONE WAY" signs are missing and will be installed to be consistent with current ARDOT standards. These modifications will be implemented by statewide forces as soon as their schedule permits.

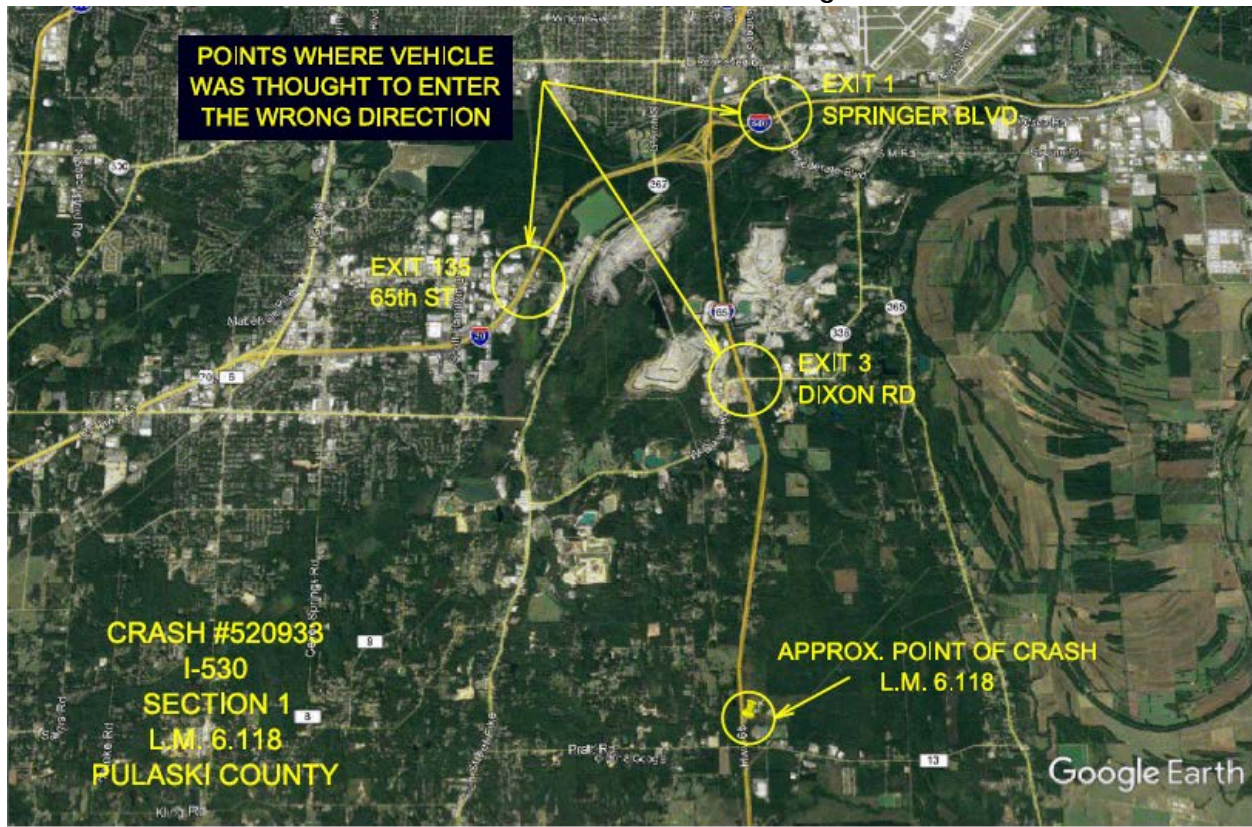
Crash # 2018520933 I-530, Section 1, Log Mile 6.118

The driver accessed I-530 possibly at Exit 1 (Springer Blvd.), Exit 3 (Dixon Rd.), or Exit 135 (65th St.) and travelled south in the northbound lanes of traffic. The driver was in a near head on collision with a vehicle travelling northbound. The northbound driver swerved to avoid the collision. The wrong-way driver sideswiped the northbound driver and continued for approximately one half mile before being stopped by law enforcement.

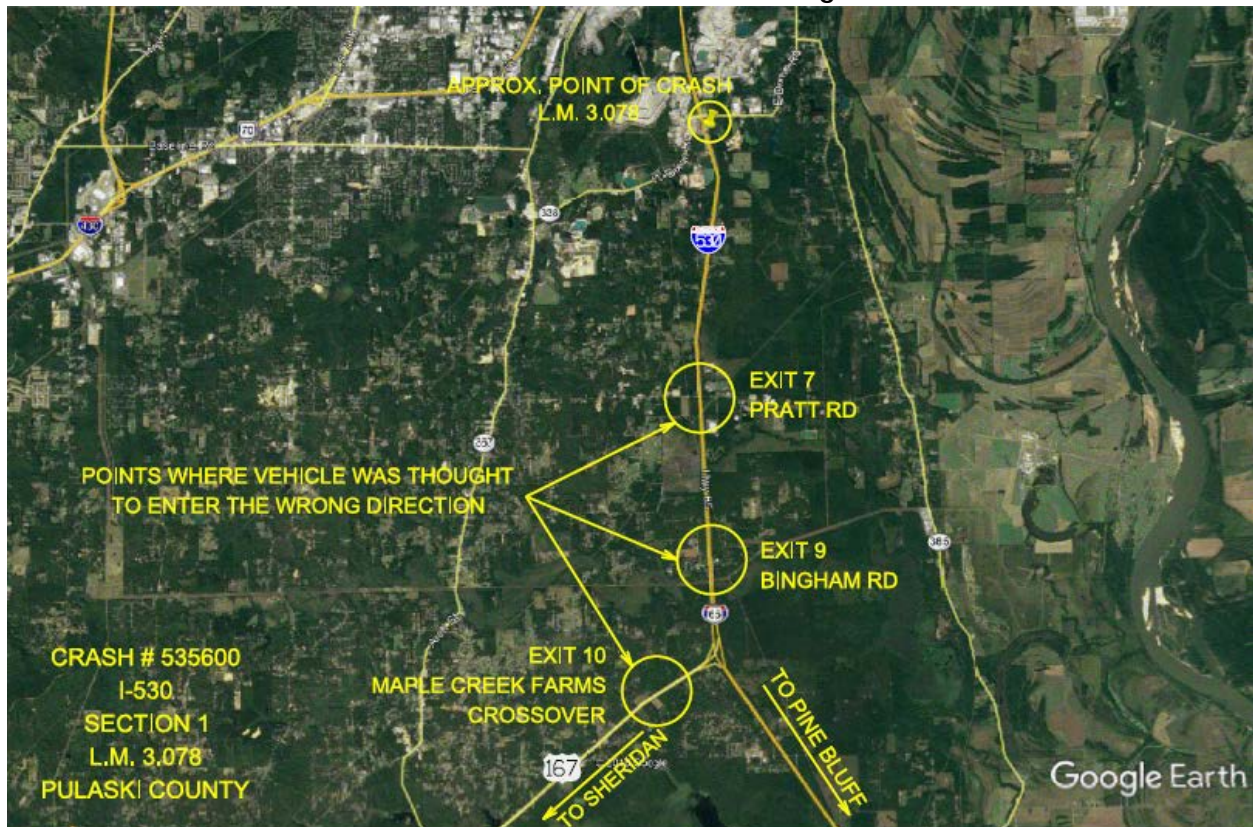
Crash # 2018535600 I-530, Section 1, Log Mile 3.078

The driver accessed I-530 possibly at Exit 7 (Pratt Rd.), Exit 9 (Bingham Rd.) or Exit 10 (Maple Creek Farms Crossover) and travelled north in the southbound lanes of traffic. The driver was in a near head on collision with a vehicle travelling southbound. The southbound driver noticed the northbound vehicle and turned toward the left before its right front side was struck by the right front side of the wrong-way vehicle. The impact caused the vehicle to rotate counter-clockwise leaving the roadway and struck the cable barrier. The wrong-way vehicle came to rest with its front in the inside traffic lane.

The interchange at Exit 7 was reviewed. Pavement markings and signs were in place and in conformance with MUTCD standards. However, the pavement marking arrow and 42"x30" "WRONG WAY" sign was missing and will be installed to be consistent with current ARDOT standards. These modifications will be implemented by statewide forces as soon as their schedule permits.

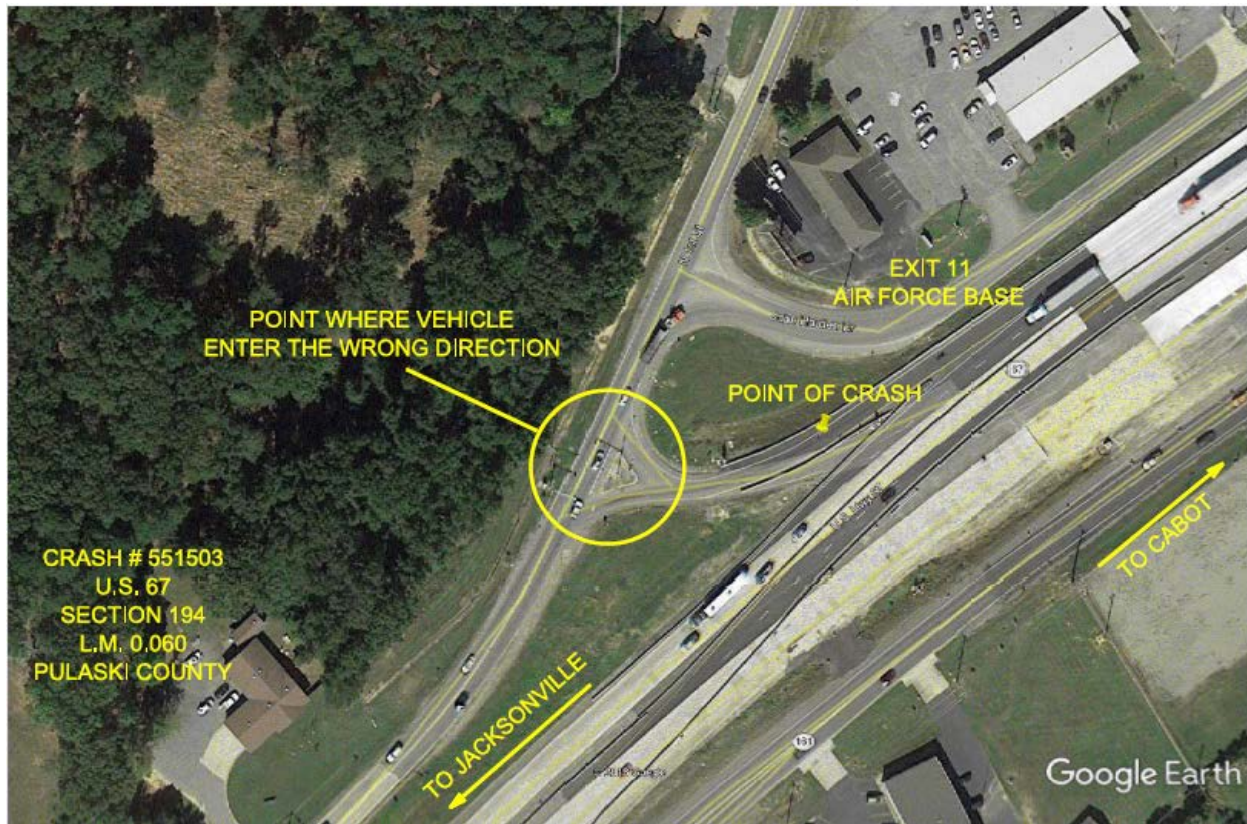
Crash # 2018551503 U.S. 67, Section 194, Log Mile 0.060

The driver accessed the southbound ramp of U.S. 67 at Exit 11 (Air Force Base) and was traveling northbound. The driver was in a near head on crash with another vehicle traveling southbound on the exit ramp. The vehicle traveling on the southbound ramp slowed to avoid the wrong-way driver, which caused him to be struck in the rear and spin. The wrong-way driver struck the left side of the vehicle traveling southbound.

The interchange at Exit 11 was reviewed. Pavement markings and signs were in place and in conformance with MUTCD standards. However, the 36"x12" "ONE WAY" signs are missing and will be installed to be consistent with current ARDOT standards. These modifications will be implemented by statewide forces as soon as their schedule permits.

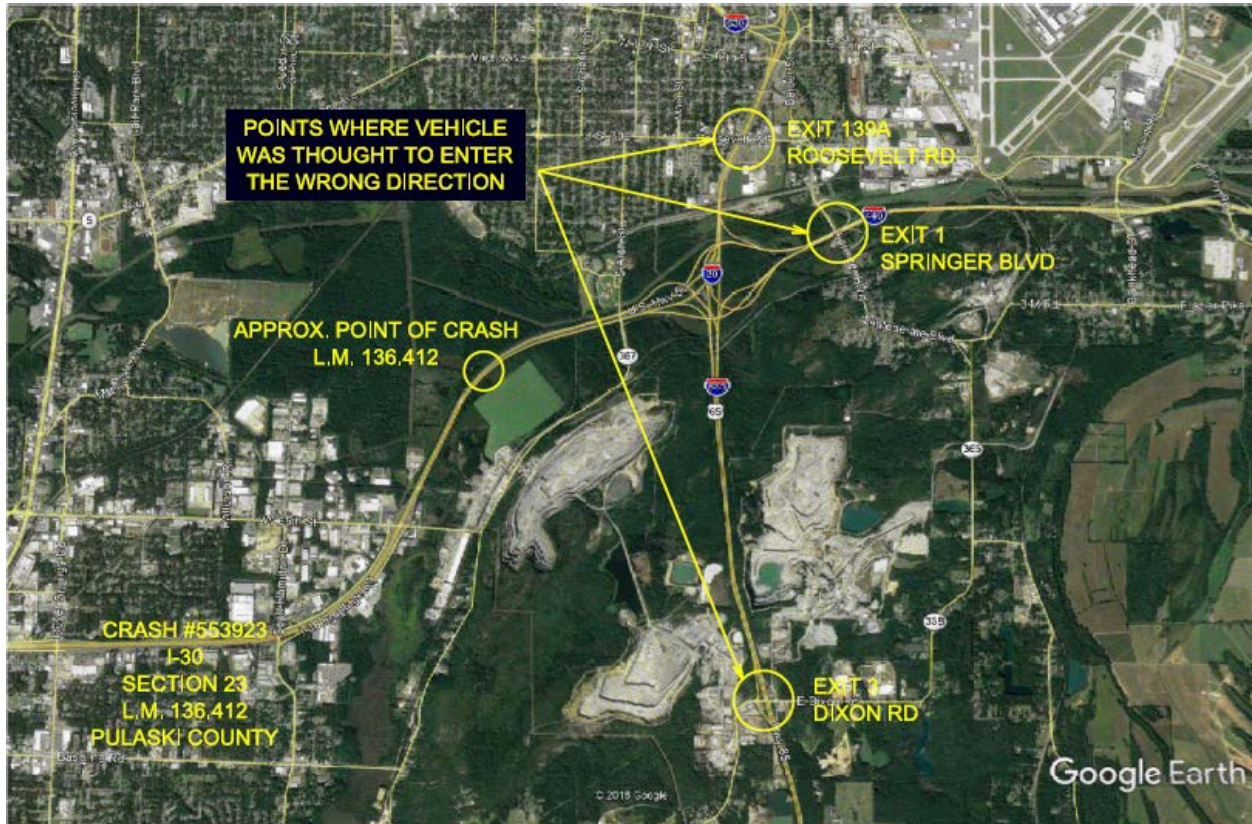
Crash # 2018553923 I-30, Section 23, Log Mile 136.412

The driver accessed I-30 possibly at Exit 1 (Springer Blvd.), Exit 3 (Dixon Rd.) or Exit 139A (Roosevelt Rd.) and travelled west in the eastbound lanes of traffic. The driver was involved in a head on collision at log mile 136.412 which resulted in two fatalities.

The interchange at Exit 139A was reviewed. Pavement markings and signs were in place and in conformance with MUTCD standards. However, to be consistent with current ARDOT standards and sizes, the 36"x12" "ONE WAY" signs at the ramp will be replaced with 54"x18" signs. The 30"x30" "DO NOT ENTER" signs will be replaced with 36"x36" signs and the 36"x24" "WRONG WAY" sign will be replaced with a 42"x30" sign. These modifications will be implemented by statewide forces as soon as their schedule permits.

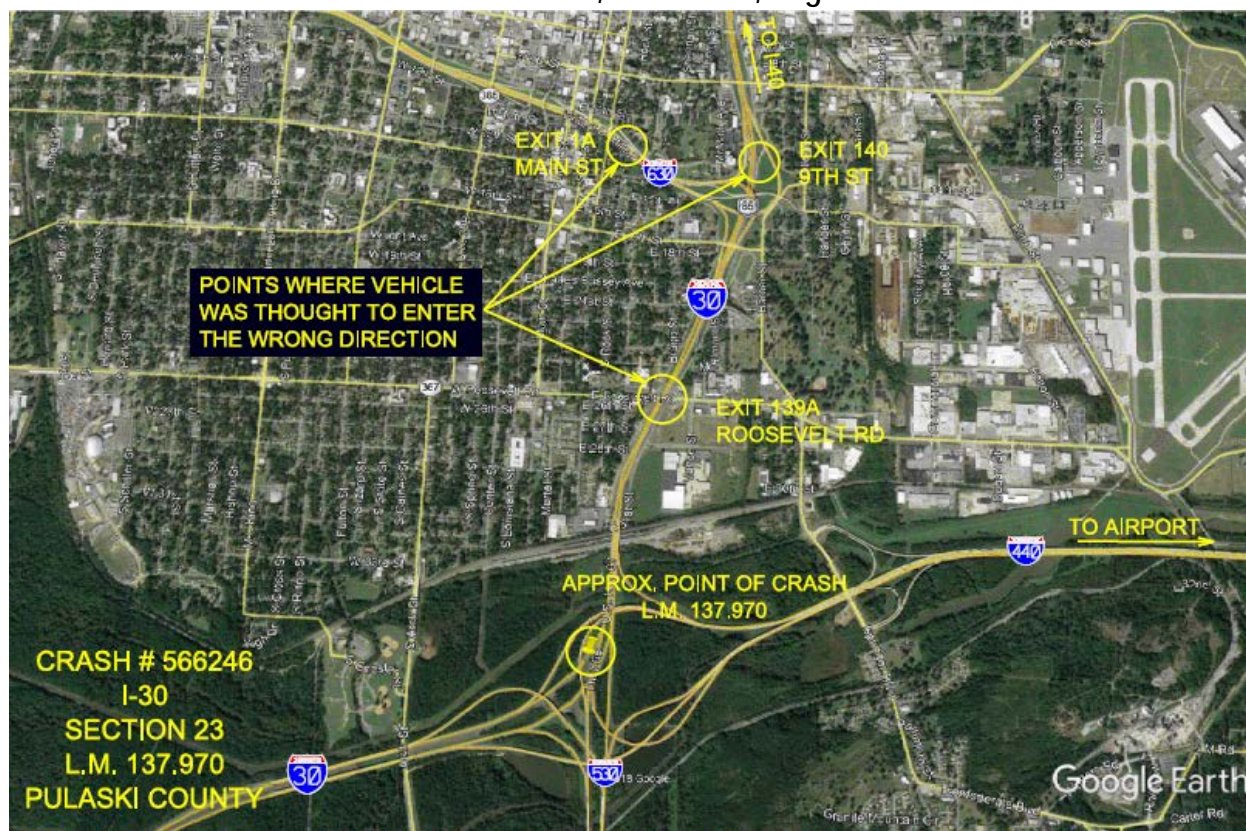
Crash # 2018566246 I-30, Section 23, Log Mile 137.970

The driver accessed I-30 possibly at Exit 1A (Main St.), Exit 139A (Roosevelt Rd.) or Exit 140 (9th St.) and travelled west in the eastbound lanes of traffic. The driver attempted to avoid colliding into the wrong-way vehicle by steered slightly to the left but was involved in a head on collision at log mile 137.970.
