WRONG-WAY CRASH STUDY

INTERSTATES AND FREEWAYS | CALENDAR YEAR 2018

June 2020

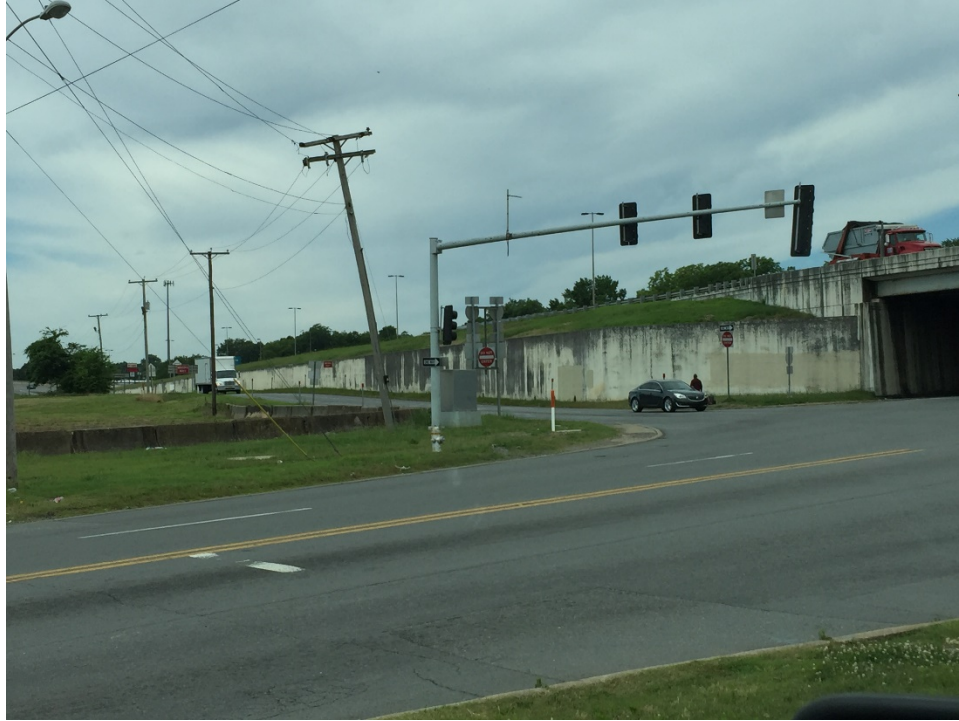
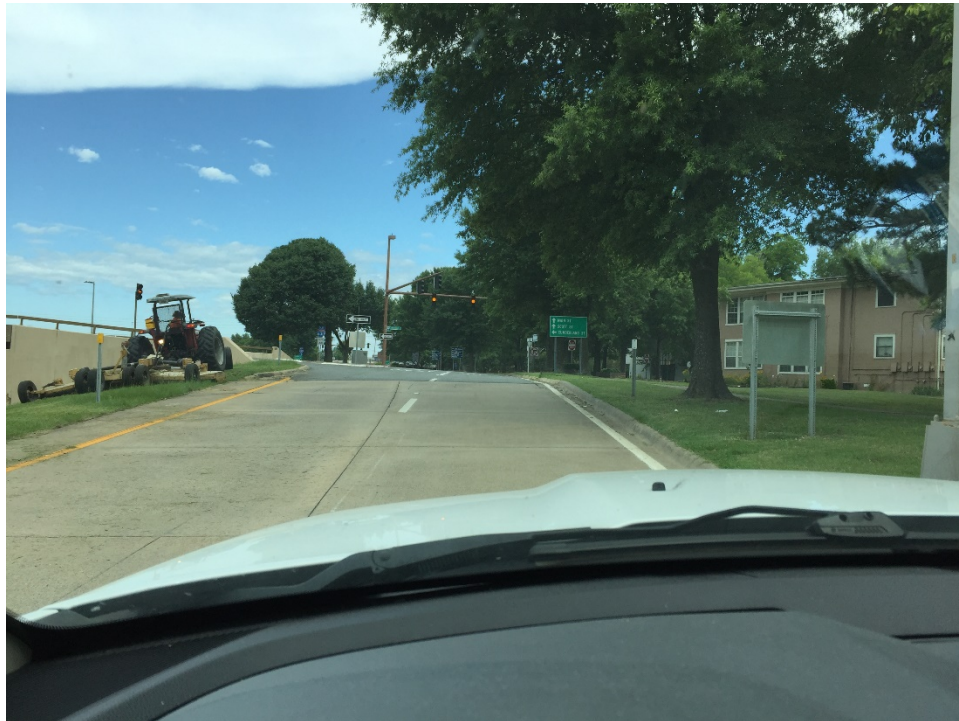
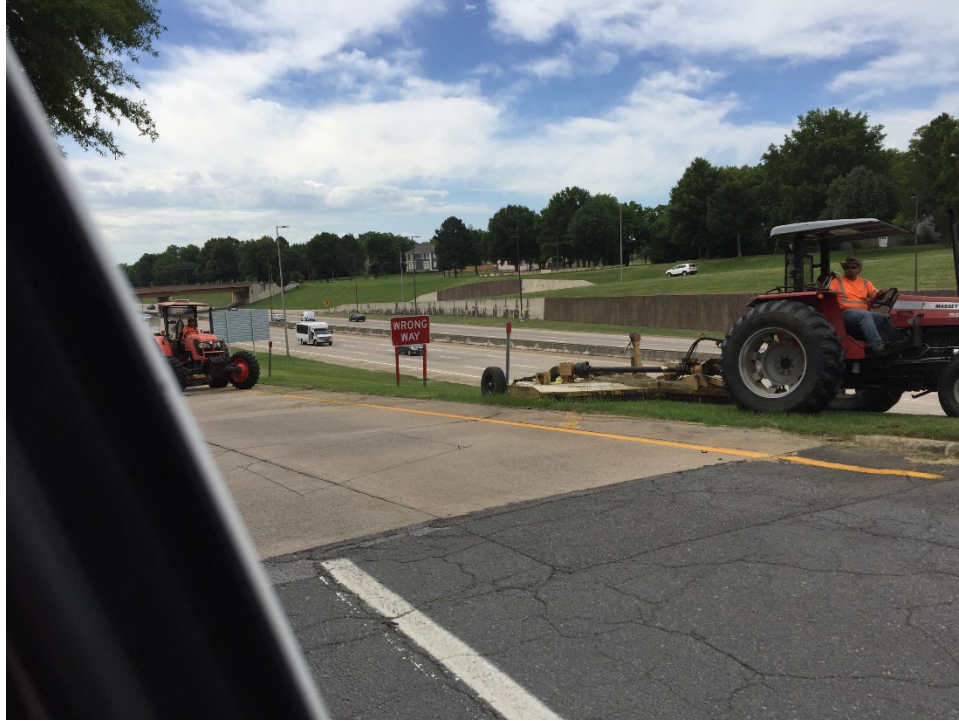
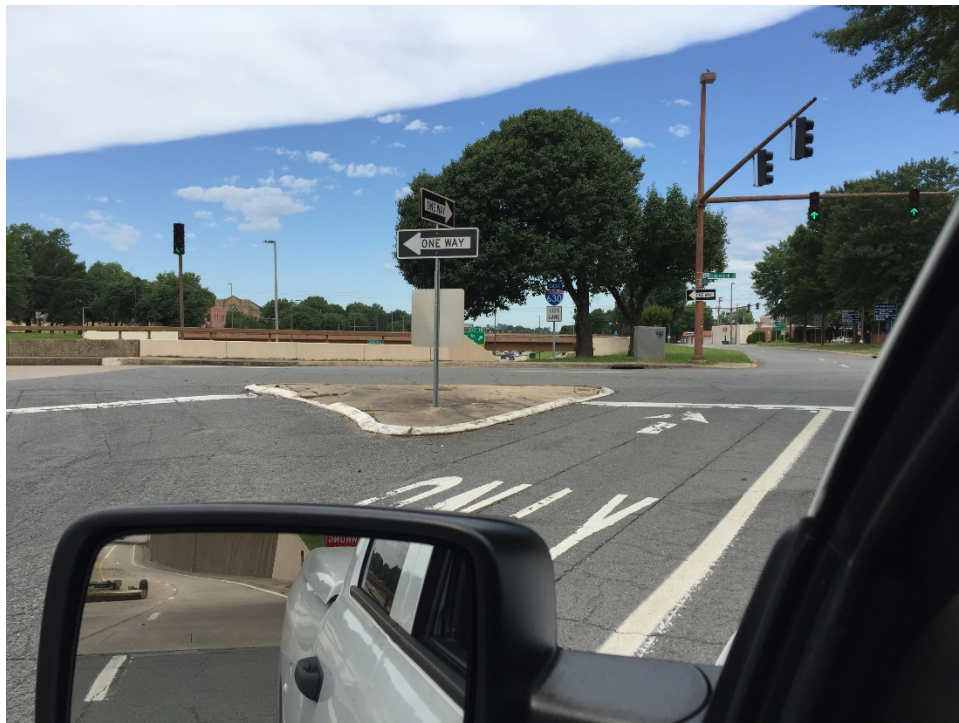
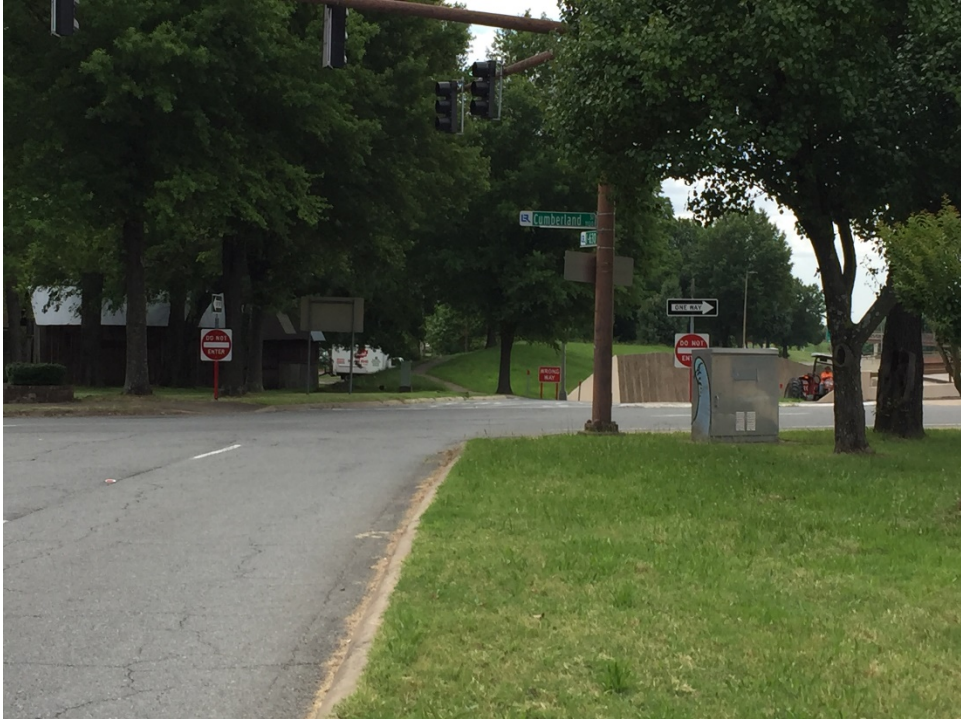
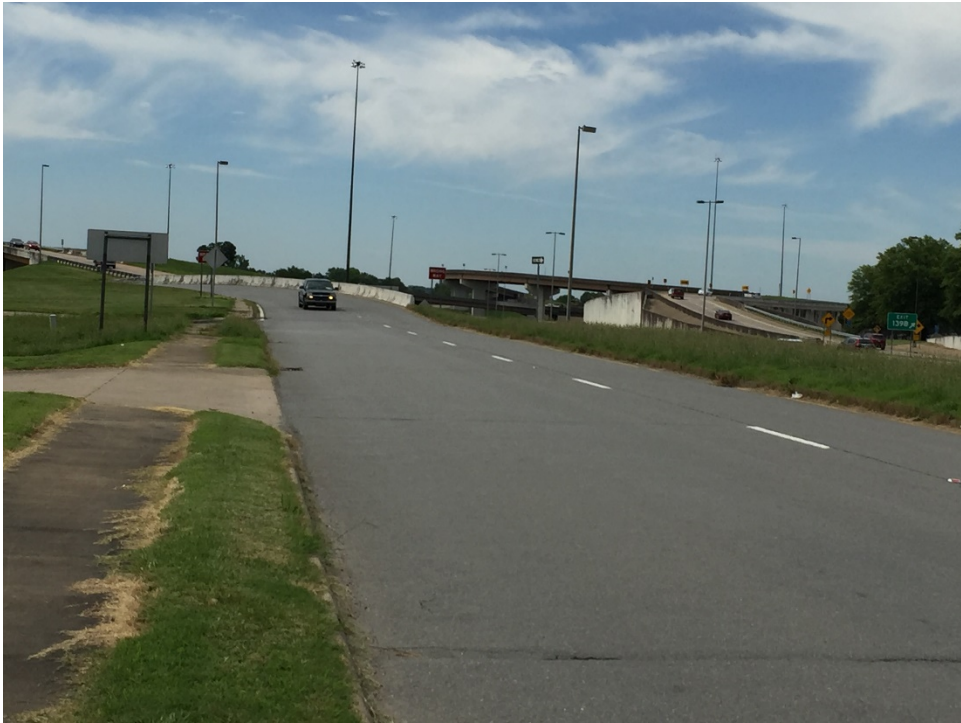
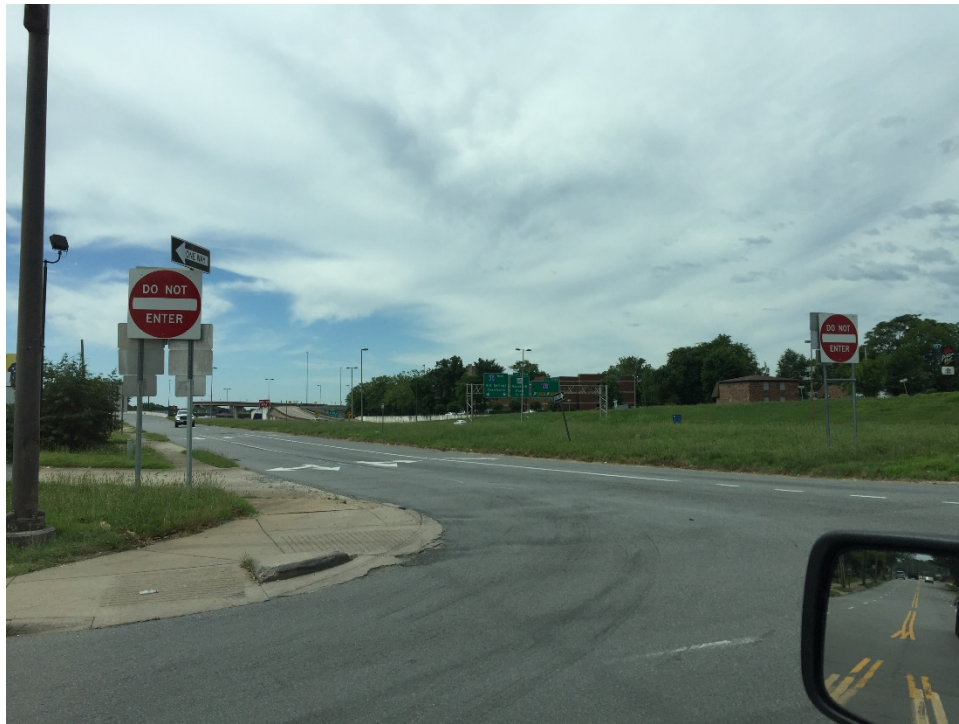
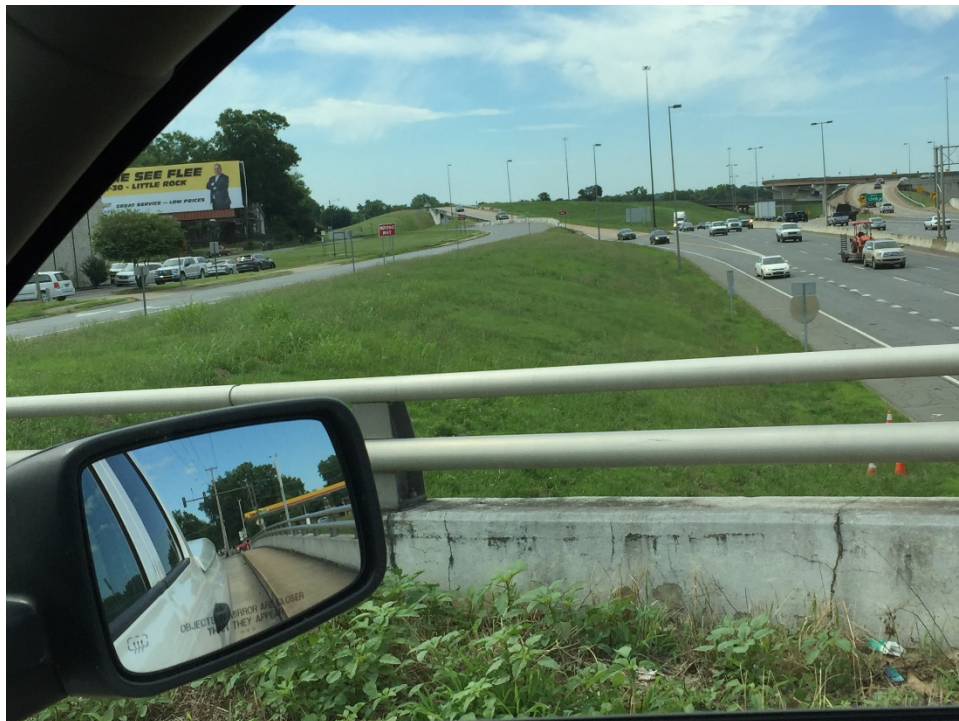
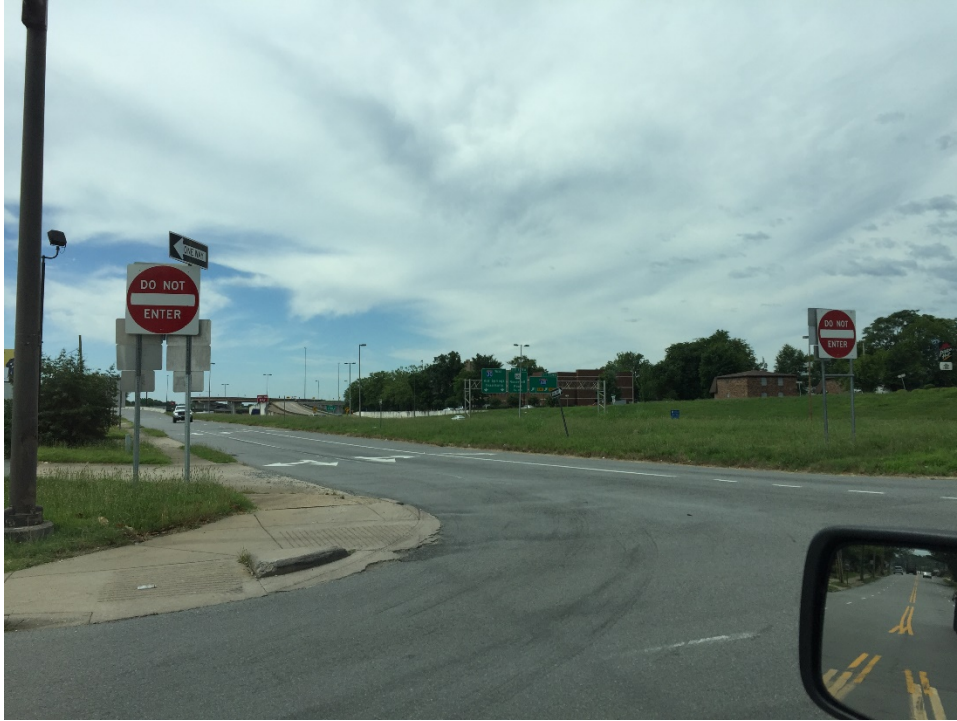
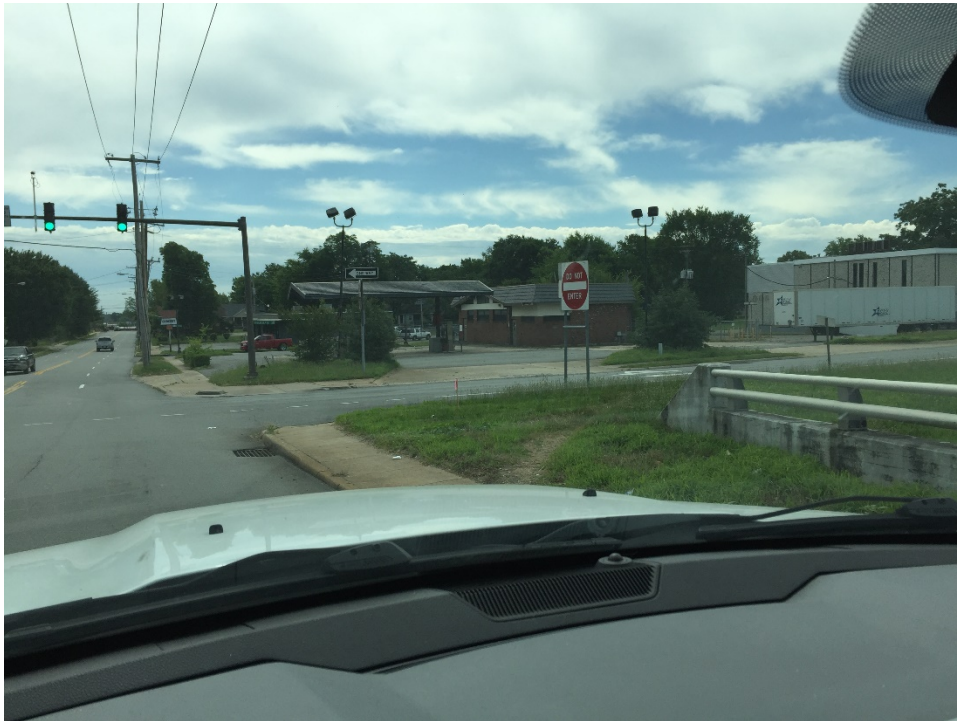
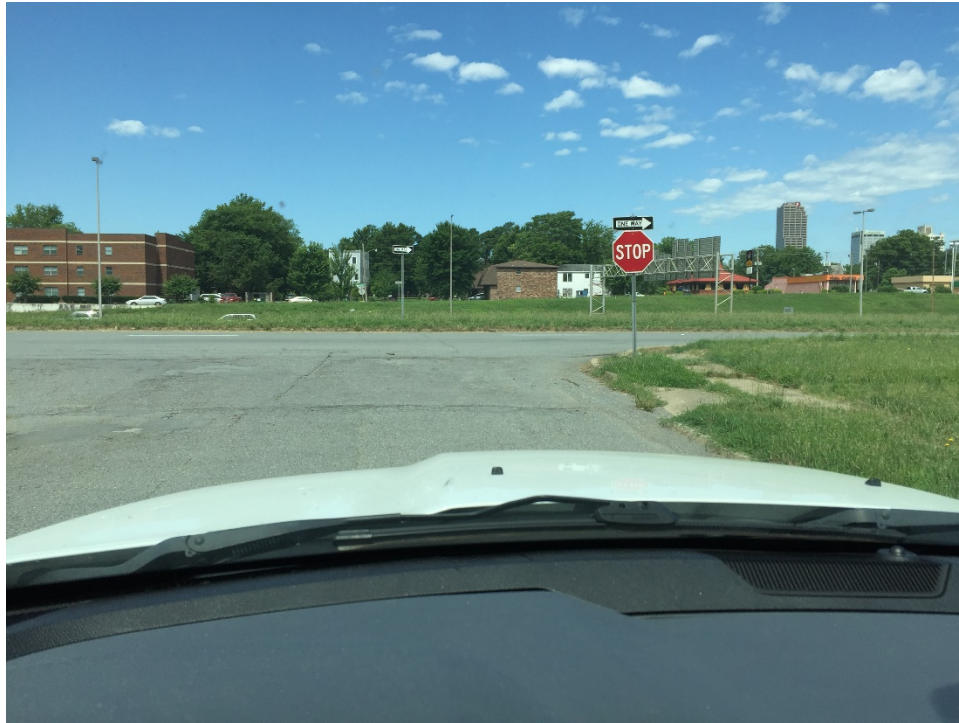
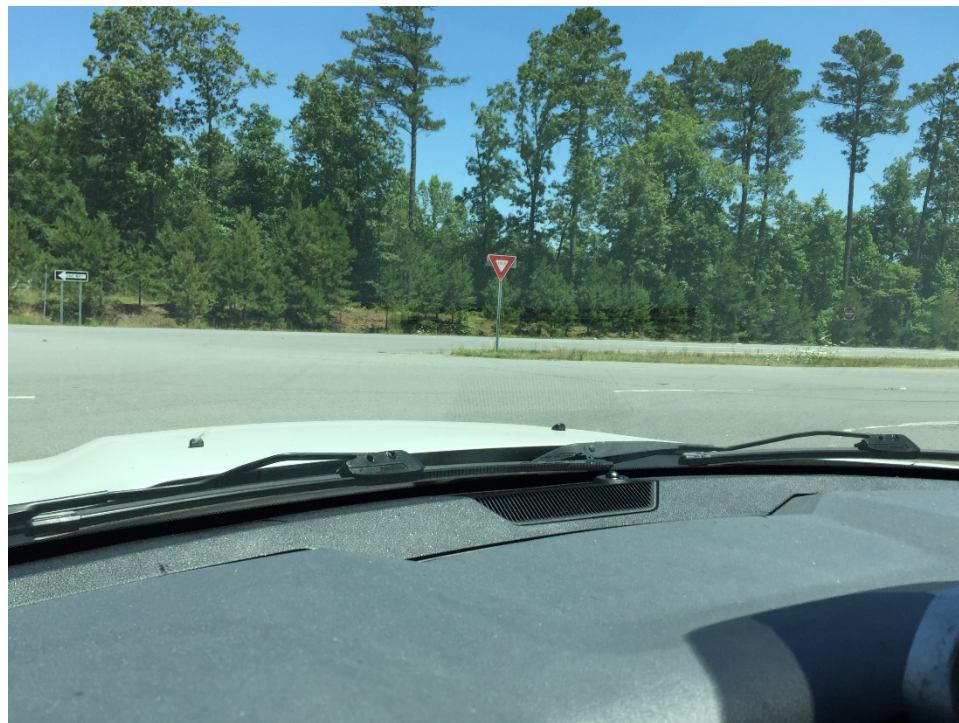
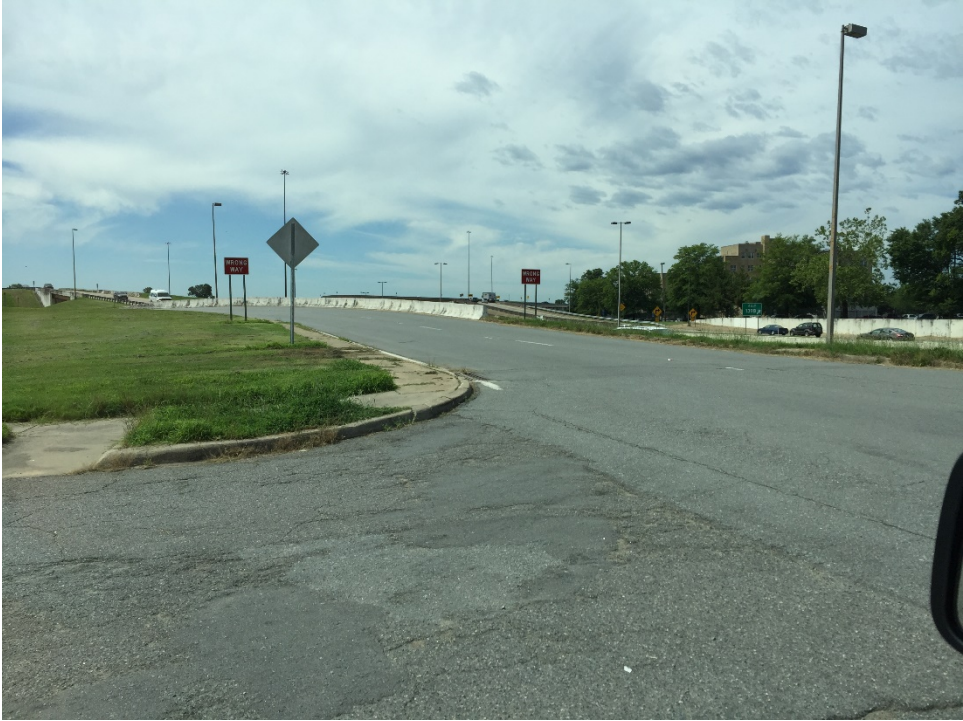
The interchange at Exit 139A was reviewed. Pavement markings and signs were in place and in conformance with MUTCD standards. However, to be consistent with current ARDOT standards and sizes, the 36"x12" "ONE WAY" signs at the ramp will be replaced with 54"x18" signs. The 30"x30" "DO NOT ENTER" signs will be replaced with 36"x36" signs and the 36"x24" "WRONG WAY" sign will be replaced with a 42"x30" sign. These modifications will be implemented by statewide forces as soon as their schedule permits.

The interchange at Exit 140 was reviewed. Pavement markings and signs were in place and in conformance with MUTCD standards. However, the 54"x18" "ONE WAY" signs are missing and will be installed to be consistent with current ARDOT standards. These modifications will be implemented by statewide forces as soon as their schedule permits.

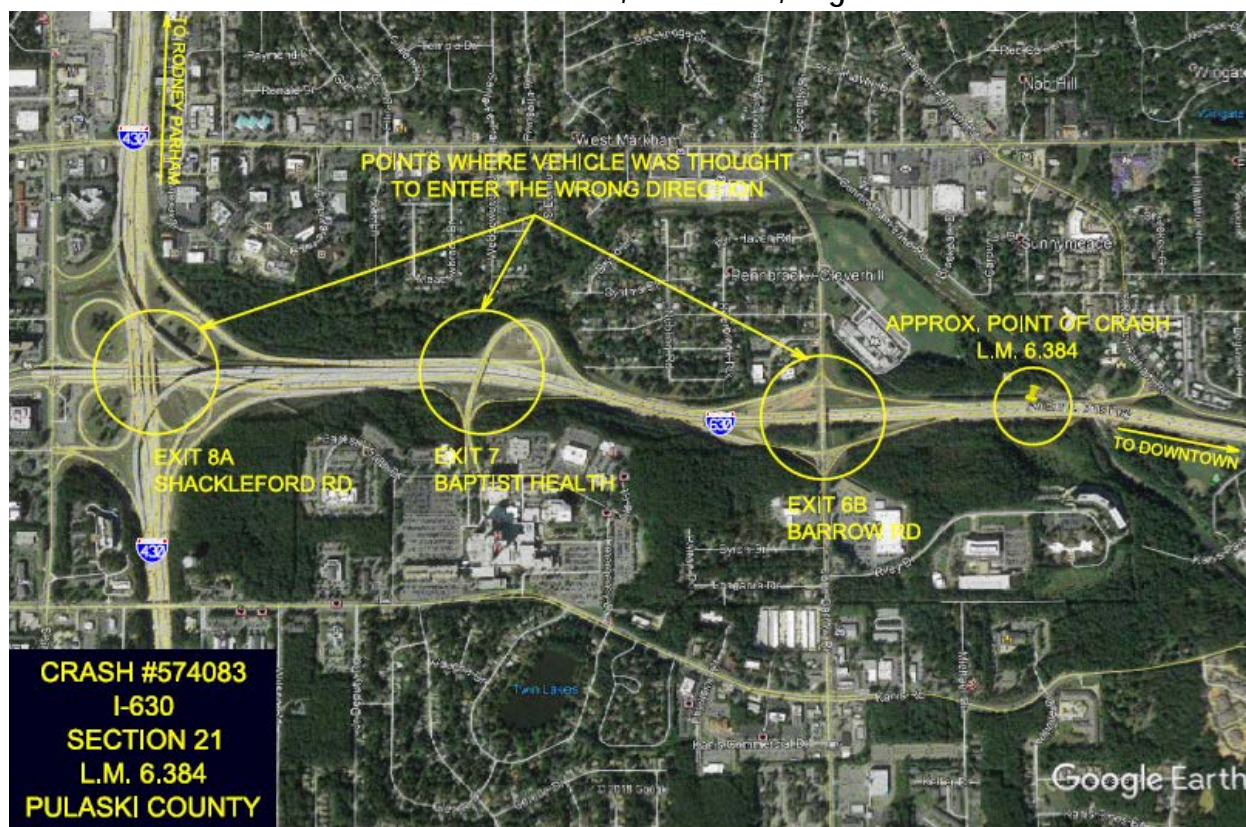
Crash # 2018574083 I-630, Section 21, Log Mile 6.384

The driver accessed I-630 possibly at Exit 6B (Barrow Rd.), Exit 7 (Baptist Health) or Exit 8A (Shackleford Rd.) and travelled east in the westbound lanes of traffic. The driver was in a near head on collision with vehicles travelling westbound. The westbound drivers swerved to avoid the collision. The wrong-way driver struck the left side of the westbound vehicle causing it to rotate and come to final rest facing eastbound. After that impact, the wrong-way vehicle struck left rear of another vehicle who continued traveling west. The wrong-way vehicle struck another vehicle head on which came to final rest facing northwest at log mile 6.384.

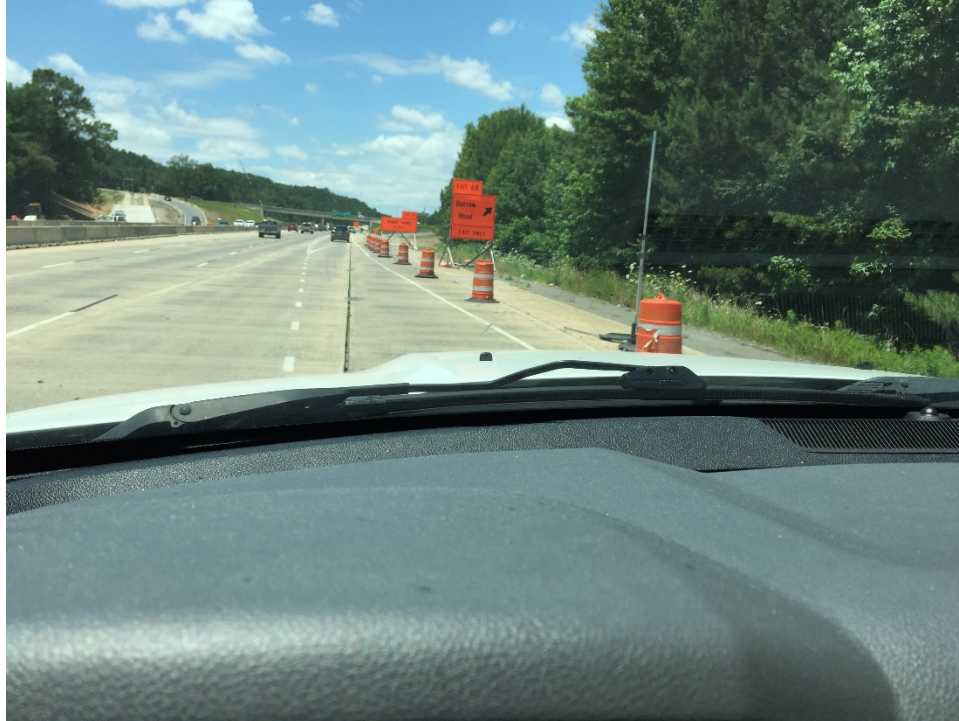
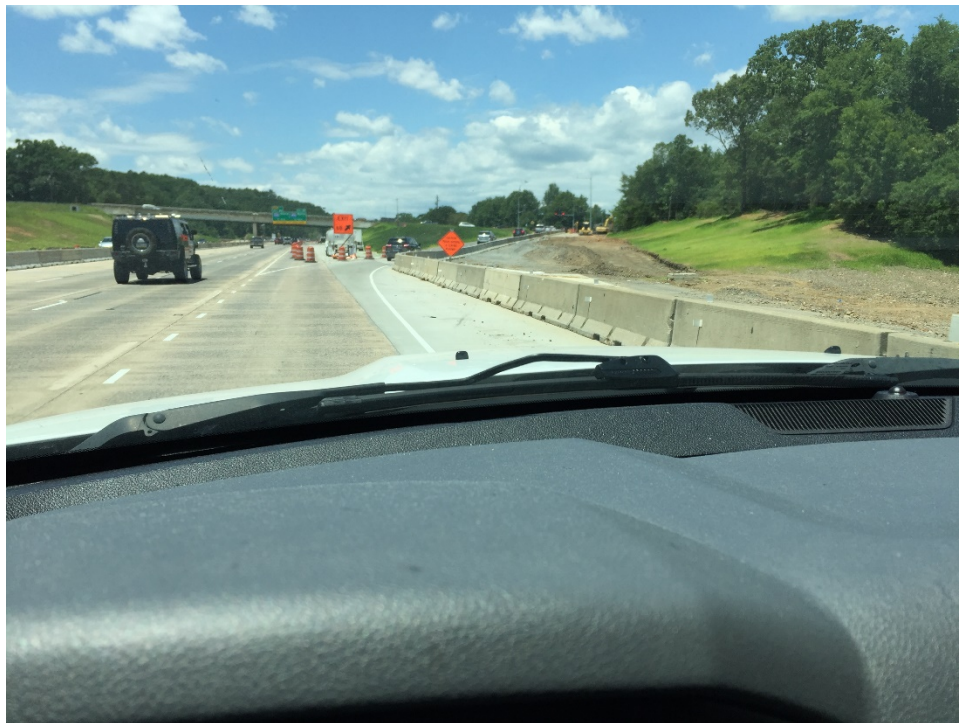
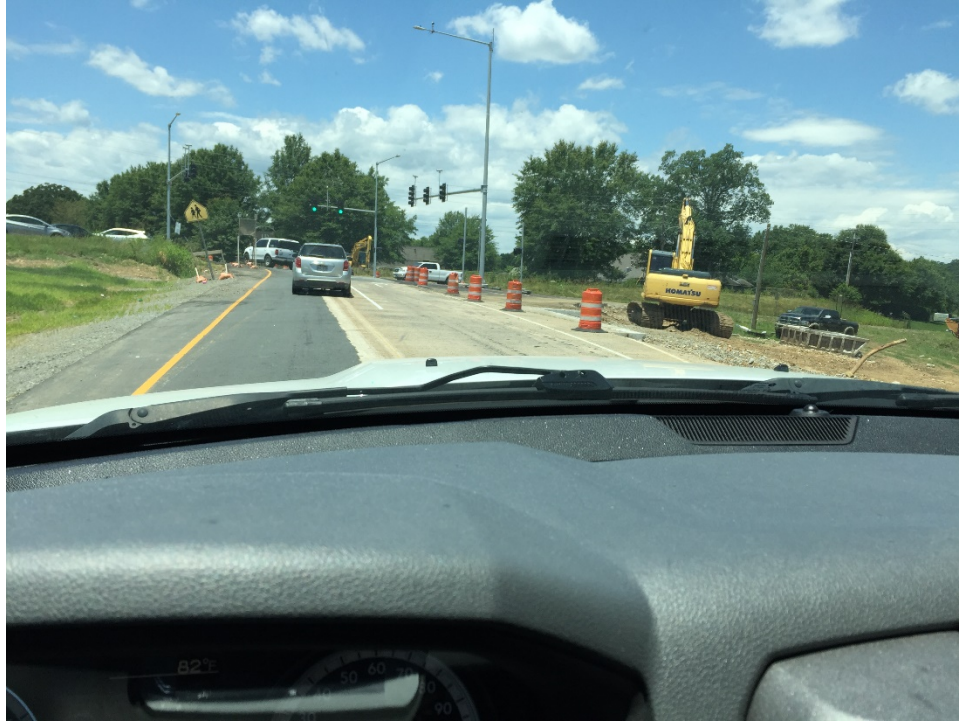
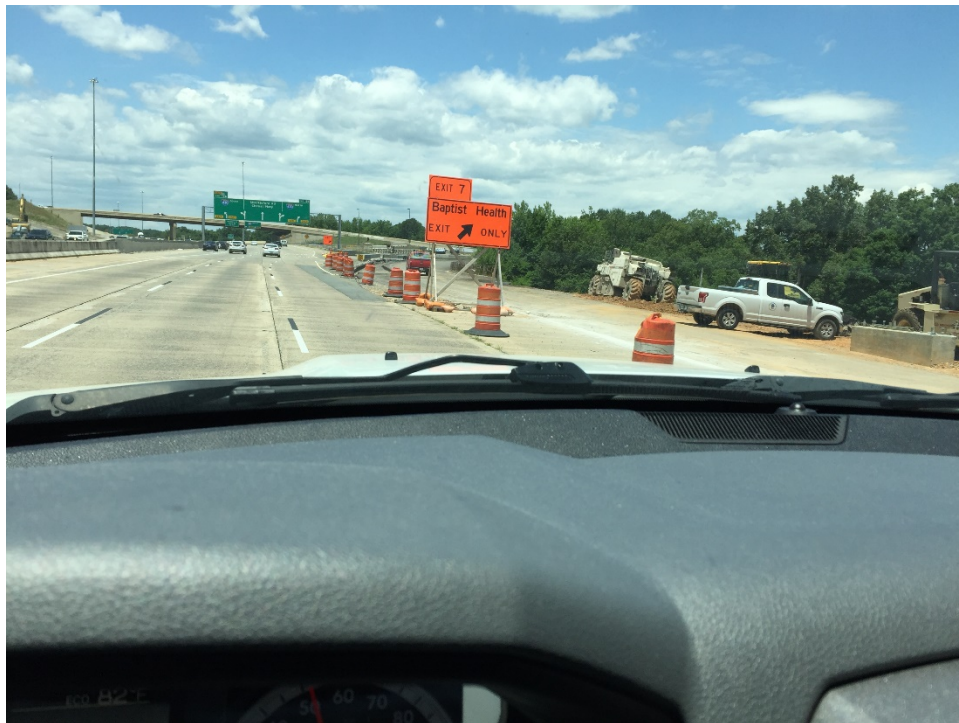
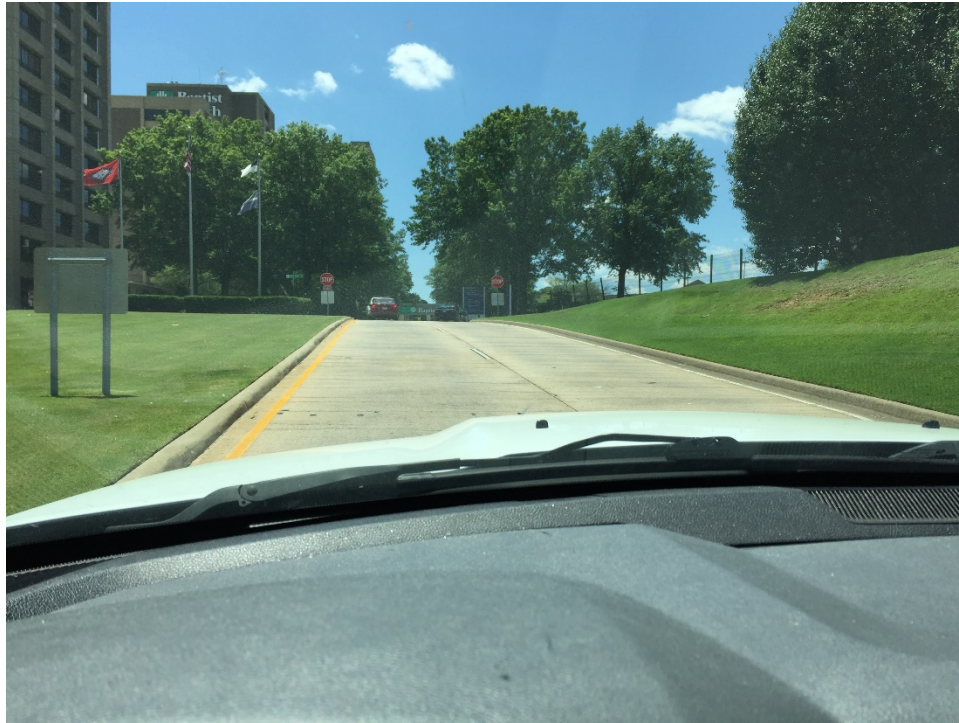
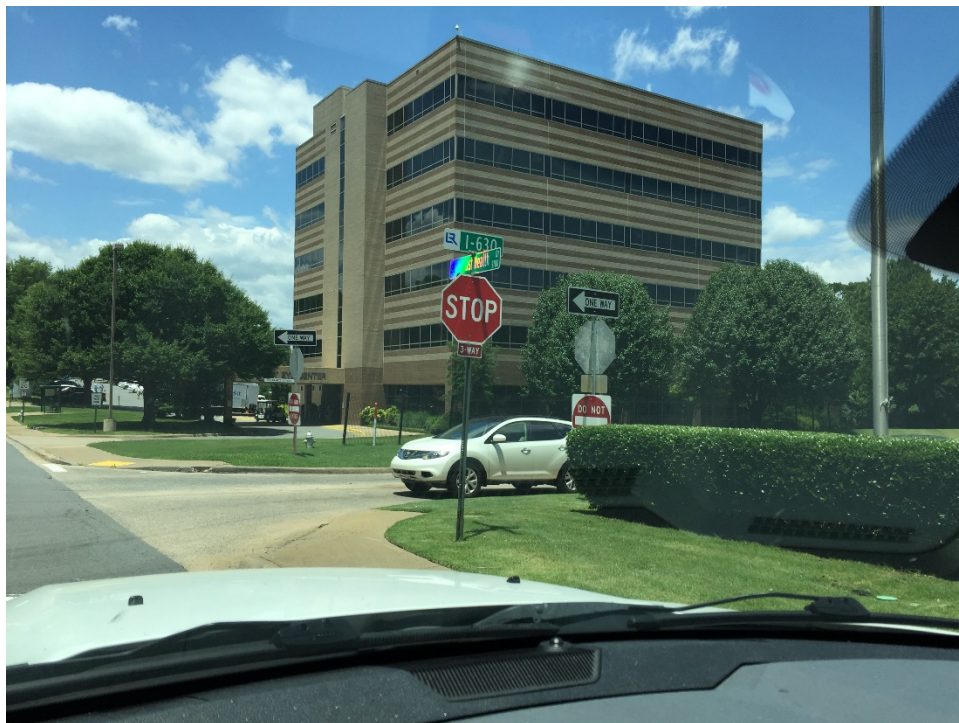
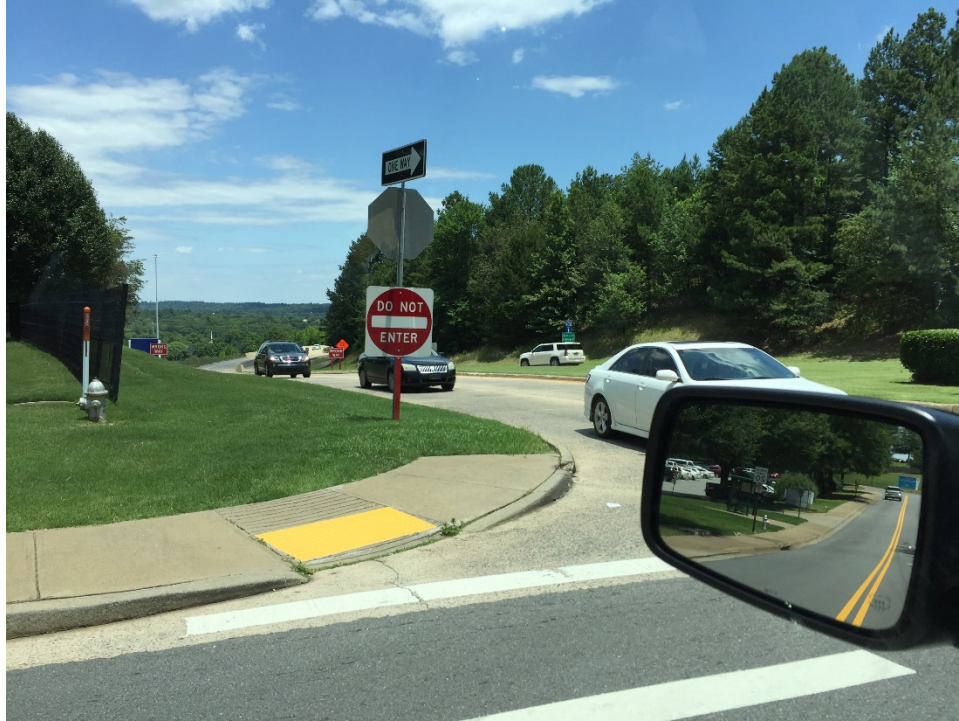
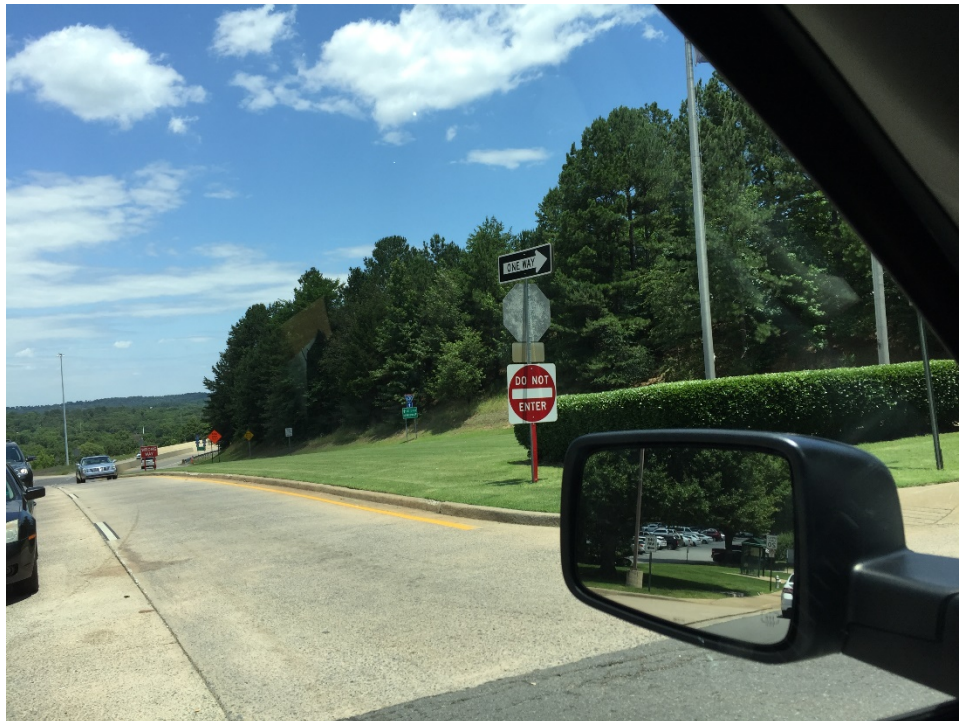
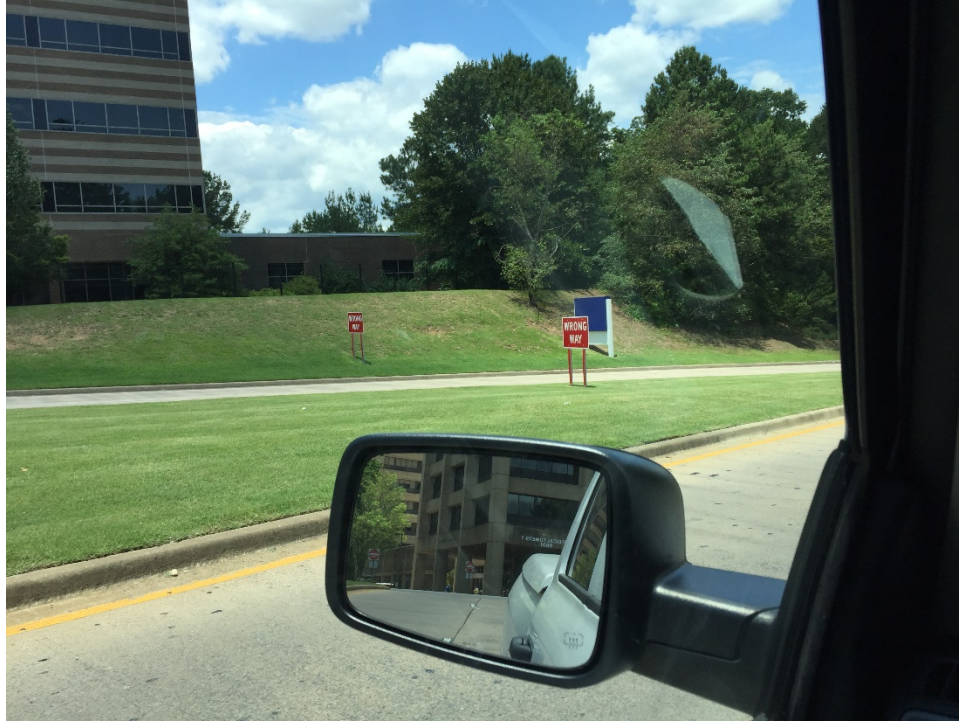
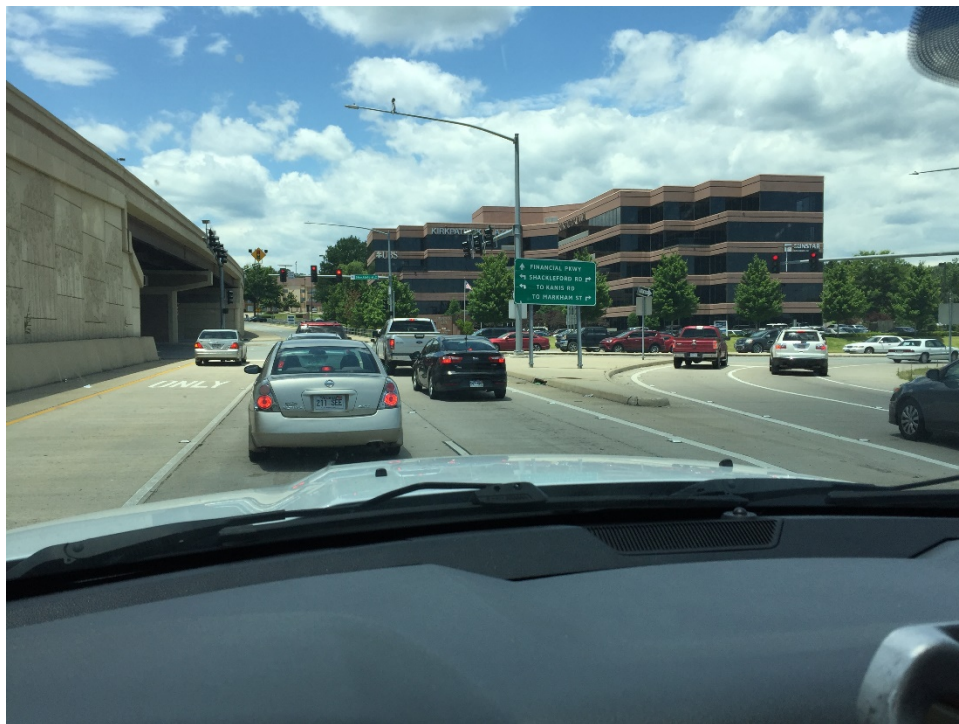
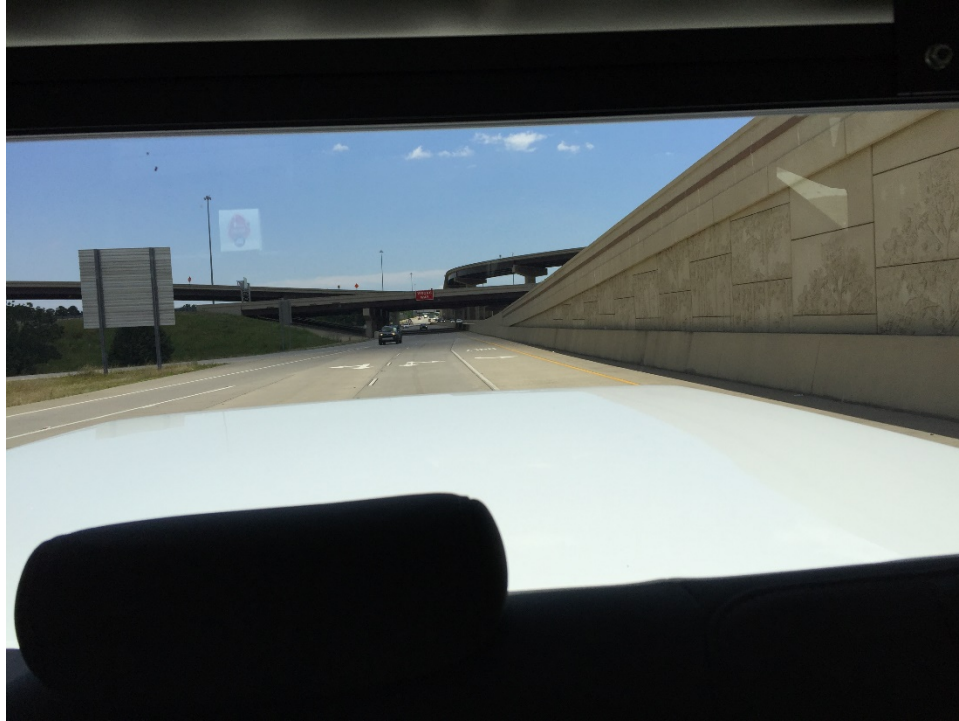
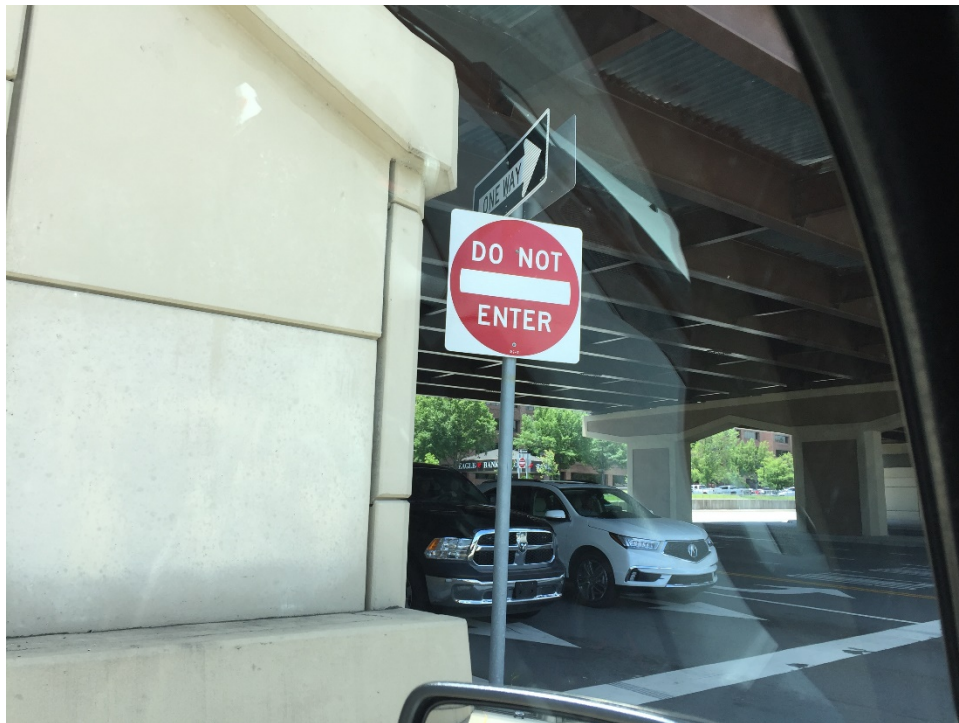
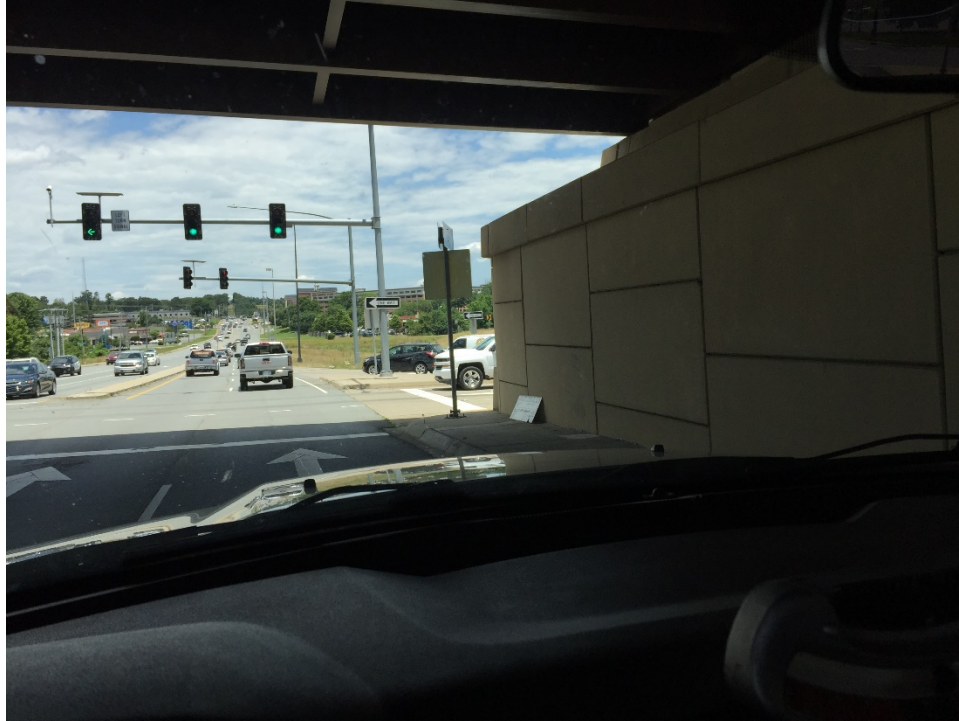
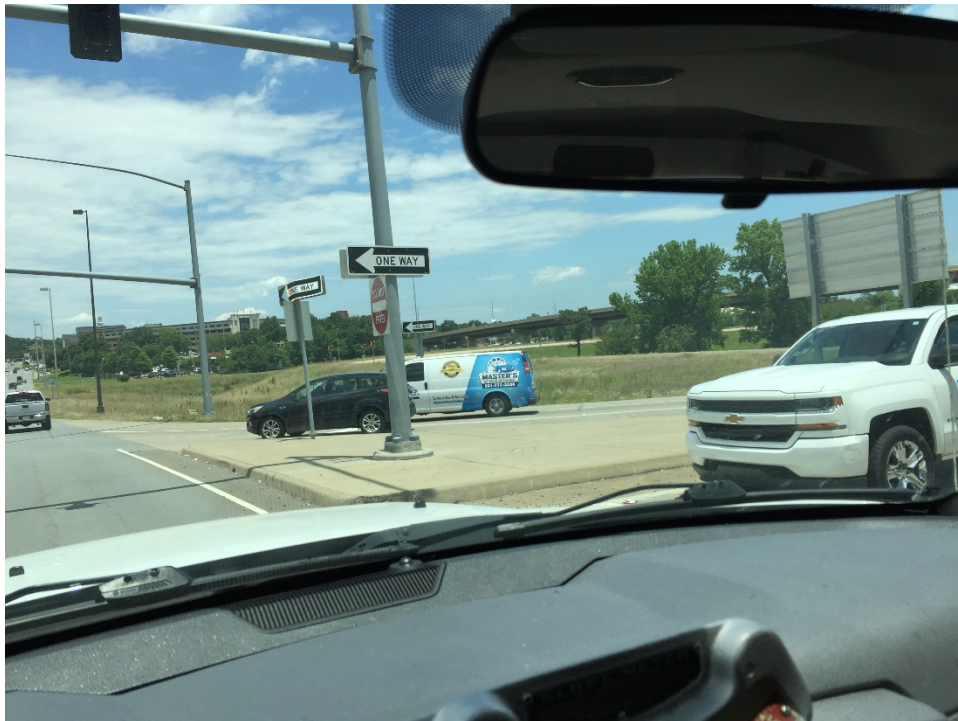
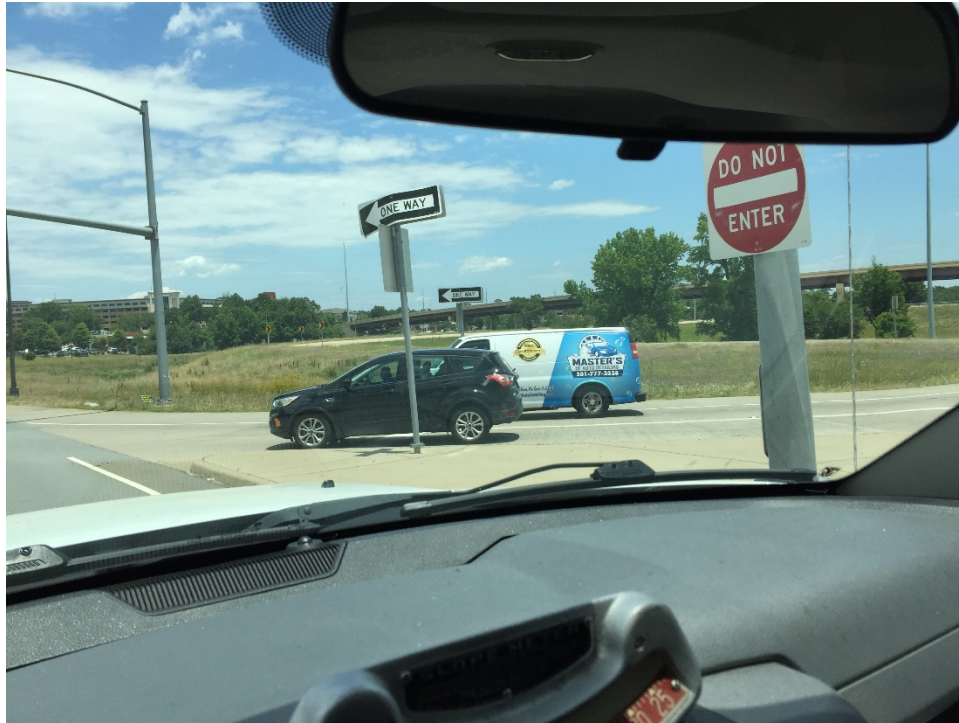
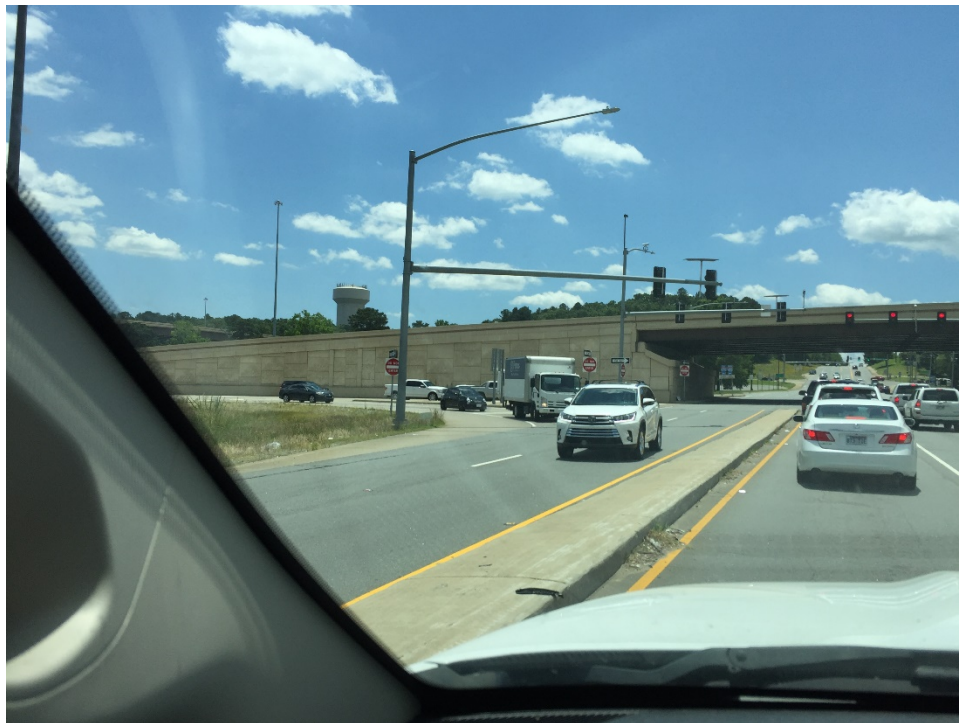
The interchange at Exit 7 was reviewed. Pavement markings and signs were in place and in conformance with MUTCD and ARDOT standards.

The interchange at Exit 8A was reviewed. Pavement markings and signs were in place and in conformance with MUTCD and ARDOT standards.

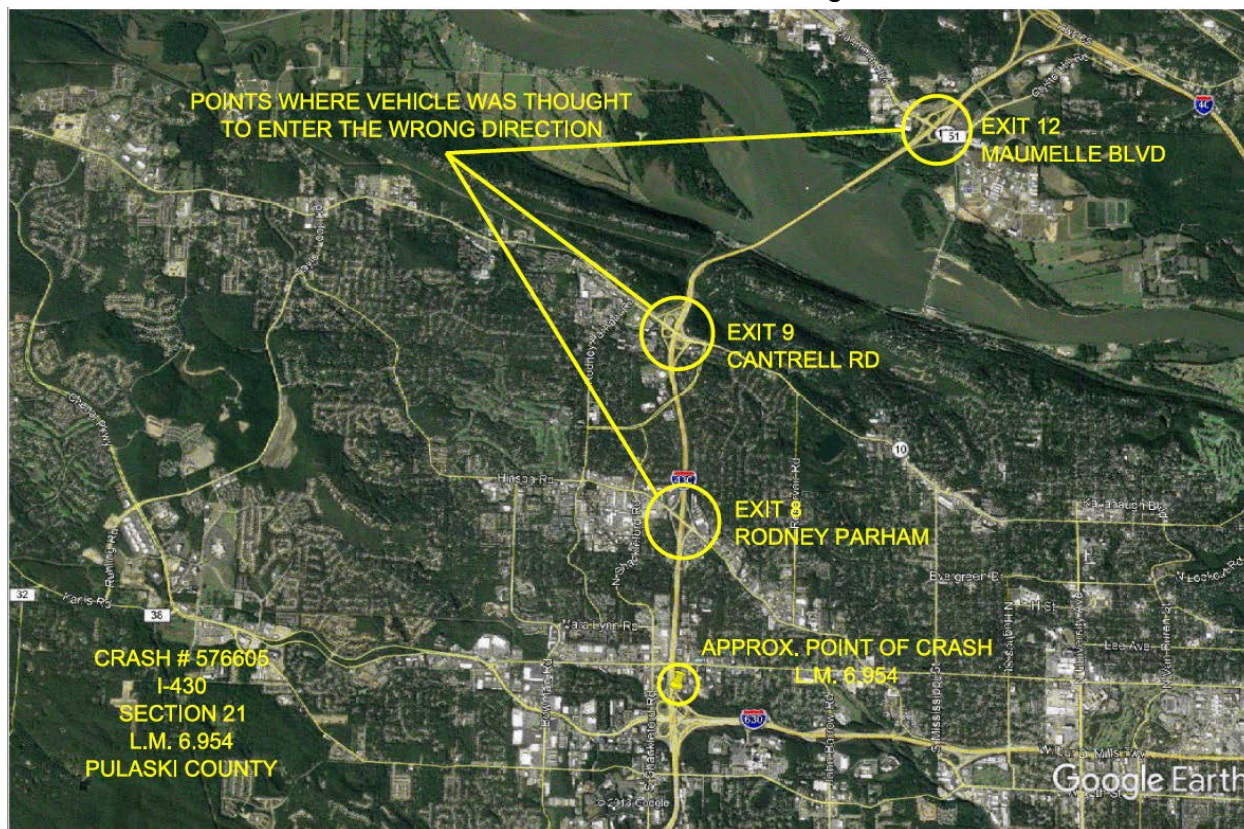
Crash # 2018576605 I-430, Section 21, Log Mile 6.954

The driver accessed I-430 possibly at Exit 8 (Rodney Parham Rd.), Exit 9 (Cantrell Rd.) or Exit 12 (Maumelle Blvd.) and travelled south in the northbound lanes of traffic. The driver veered to the median and struck the concrete barrier with the front bumper. The vehicle began to spin clockwise and re-entered the roadway and coming to rest at log mile 6.954.

The interchange at Exit 8 was reviewed. Pavement markings and signs were in place and in conformance with MUTCD standards. However, the 48"x48" "DO NOT ENTER" and 54"x18" "ONE WAY" signs will need to be remounted at the exit ramp. The 36"x36" "DO NOT ENTER" signs are missing and will be installed to be consistent with current ARDOT standards. These modifications will be implemented by statewide forces as soon as their schedule permits.

The interchange at Exit 9 was reviewed. Pavement markings and signs were in place and in conformance with MUTCD standards. However, the 36"x12" "ONE WAY" signs at the ramp will be replaced with 54"x18" signs to be consistent with current ARDOT standards and sizes. These modifications will be implemented by statewide forces as soon as their schedule permits.

The interchange at Exit 12 was reviewed. Pavement markings and signs were in place and in conformance with MUTCD and ARDOT standards.
