WRONG-WAY CRASH STUDY

INTERSTATES AND FREEWAYS | CALENDAR YEAR 2018

June 2020

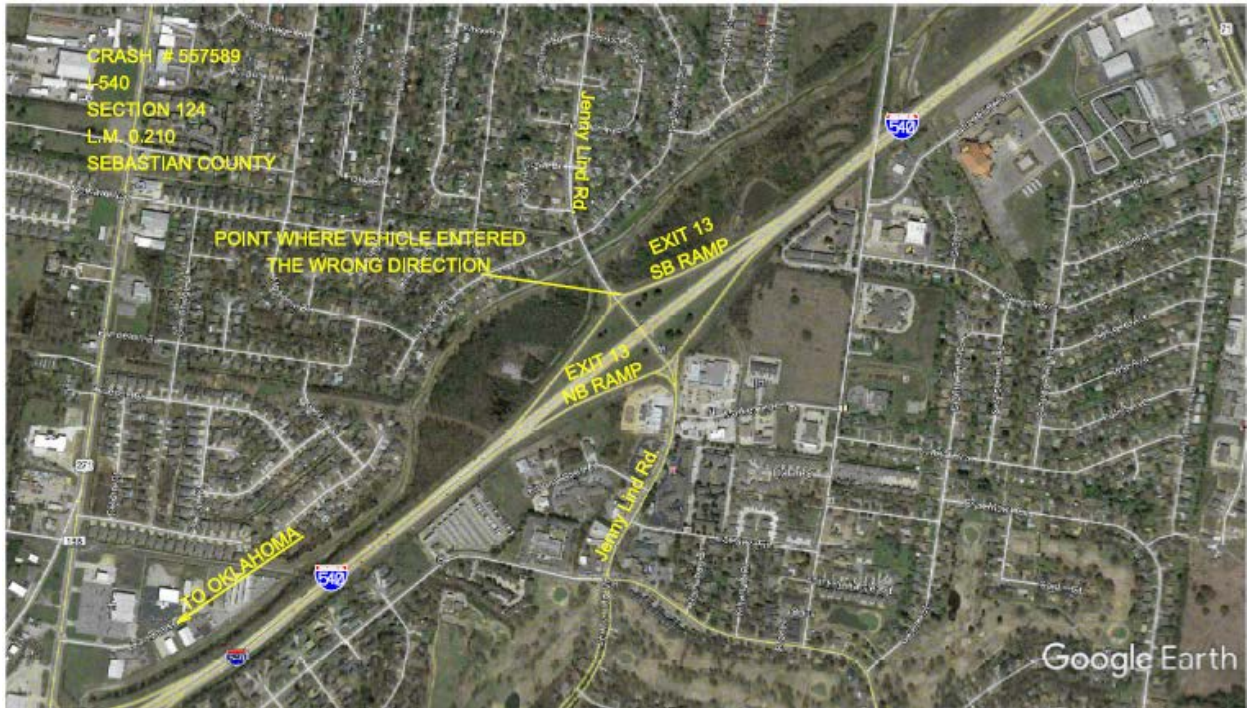
Crash # 2018557589 I-540, Section 124, Log Mile 0.210

The driver attempted to turn left at the traffic light from Jenny Lind Road onto I-540 south exit ramp. This action caused the driver to strike the rear driver side door of a stationary vehicle who was waiting to make a left turn from the I-540 exit ramp onto Jenny Lind Road at the traffic signal. The wrong-way driver came to a final rest at the I-540 southbound ramp exit ramp facing south.
