Bridge Inspection Report

A5038
I 40, WB LNS
over
Dirty Creek

Structure Number: A5038

Facility Carried: I 40, WB LNS

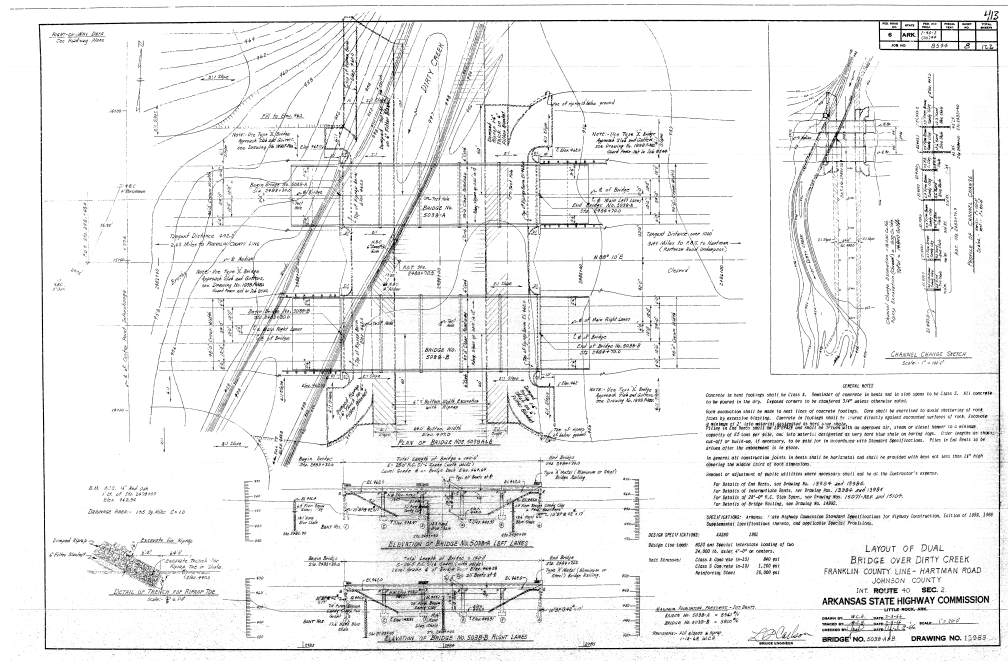
Bridge deck, All spans
Major unsealed longitudinal crack.
Picture included.

PHOTO 1 Description Typ Long Cracking in all .Spans
