Bridge Inspection Report

A5040
I 40-SEC 21-WB LN
over
CR 440, Horsehead Creek

Structure Number: A5040

Facility Carried: I 40-SEC 21-WB LN

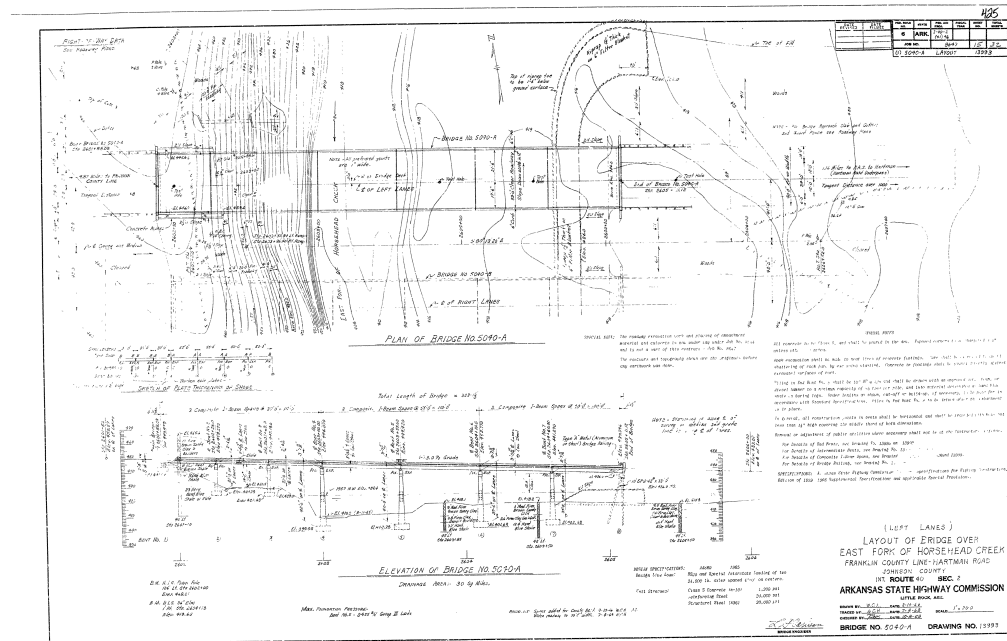
Deck joint #s 1, 4, 6, 7 & 8. Seals at Joints 1, 7 & 8 have several failed Areas. Seals at Joints 4 & 6 have failed & fallen out of Joints.

PHOTO 1 Description Seal missing at Joints.
