## Bridge 14772 Inspection Report

**Richie Road over Ashley Creek Logan Co.**

**Location: 0.54 MI S SH 10**

**Team Lead: Rhett Franks Inspection Date: 09/26/2024**

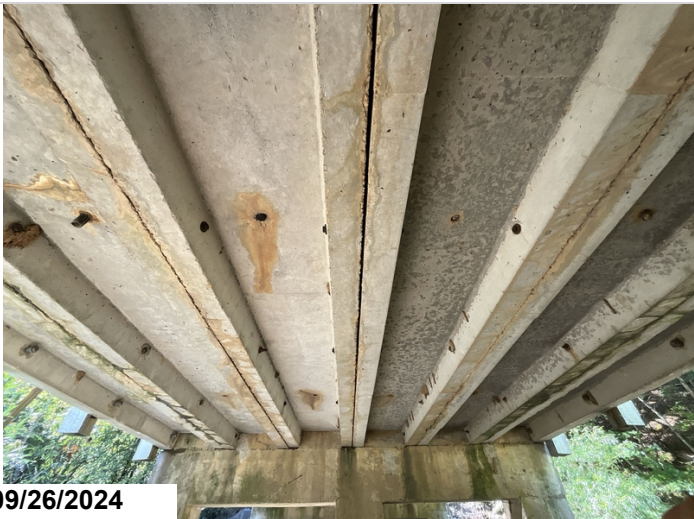
Pre-Cast concrete channels with vertical hairline flexure cracking in the stems of the units at approximately 6" to 8" centers.

Several channel beams in all spans have diagonal shear type cracks adjacent to the bents.

Isolated areas of shallow concrete spalls with no exposed reinforcing steel.

Typical undersurface.

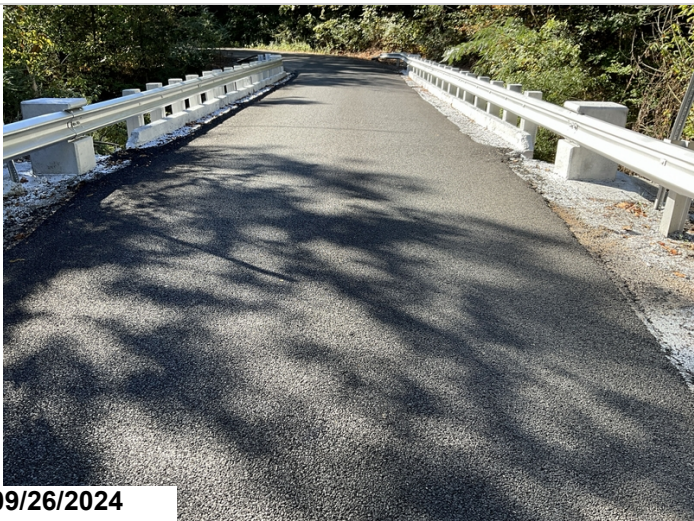
Asphalt wearing surface has longitudinal reflective cracks in the asphalt over the longitudinal joints between the channel units and transverse cracks over the intermediate bents. Isolated areas of map cracking.

Visible portion of deck has light abrasion / wear visible in the gutters.

Typical deck
