WRONG-WAY CRASH STUDY

INTERSTATES AND FREEWAYS | CALENDAR YEAR 2021

Wrong-Way Crash Report

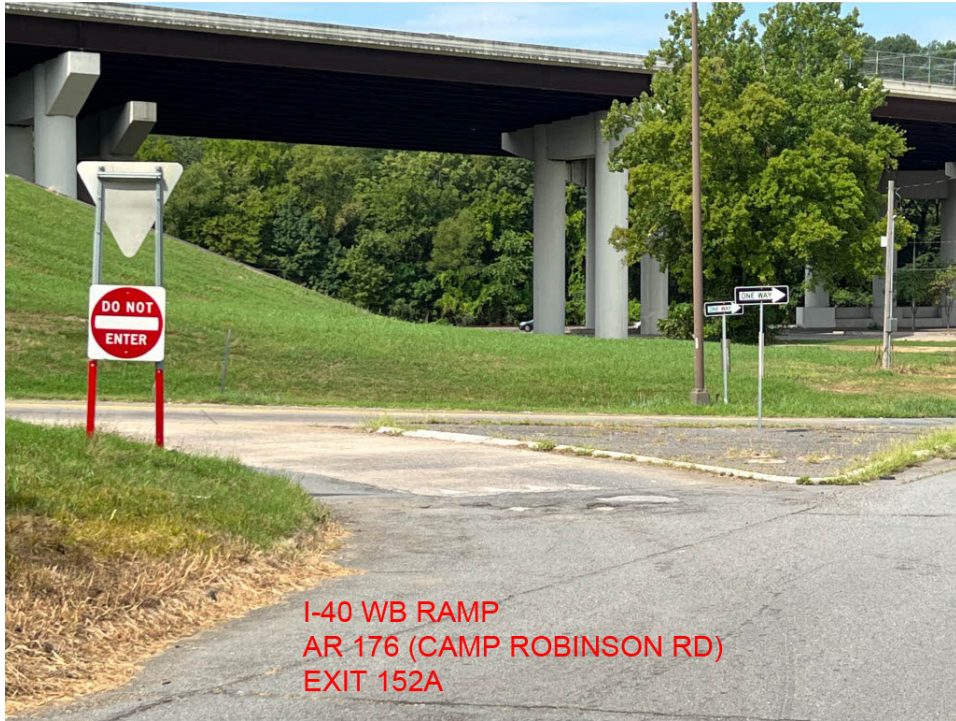
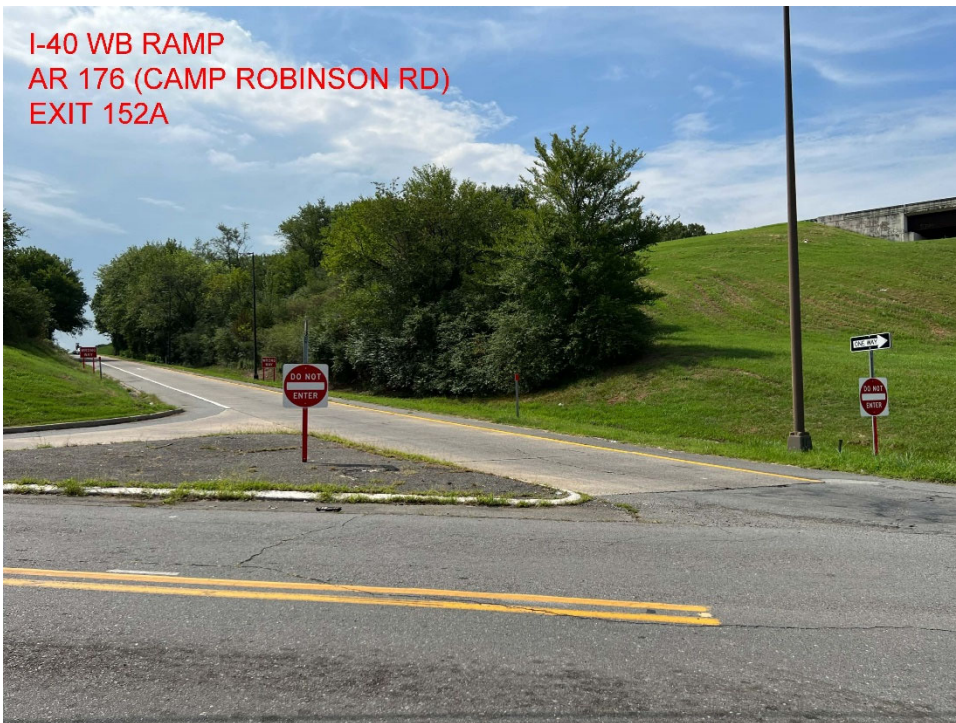
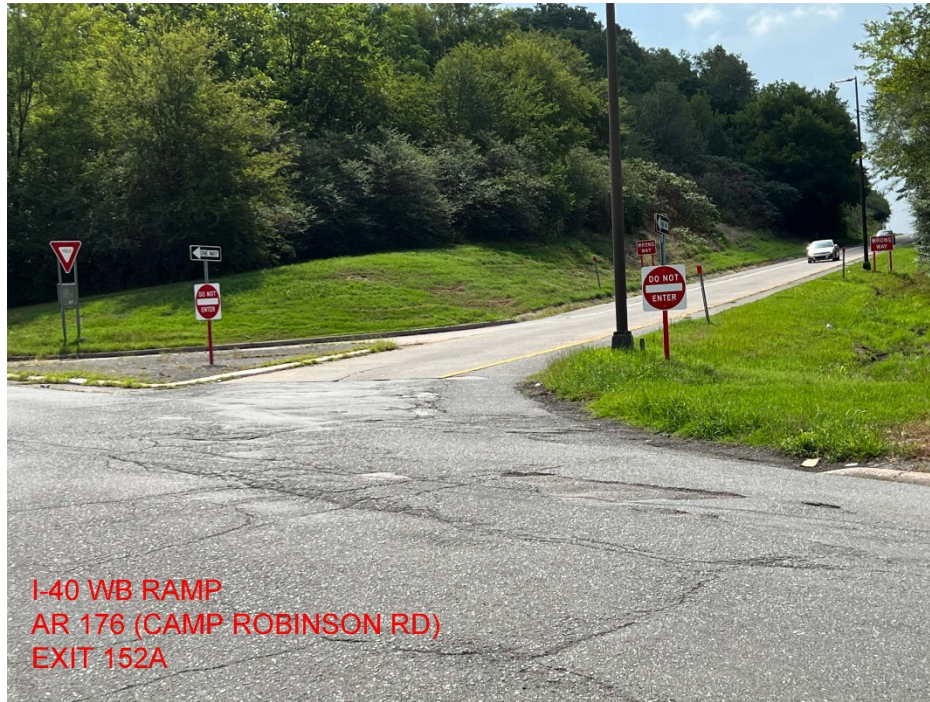
The driver attempted to access I-40 at Exit 152A (AR 176, Camp Robinson Rd.) and traveled eastbound in the westbound traffic lane of the Exit 152A off-ramp. The wrong-way driver was involved in a head-on collision.

The interchange at Exit 152A was reviewed. Pavement markings and signs were in place and in conformance with MUTCD and ARDOT requirements.

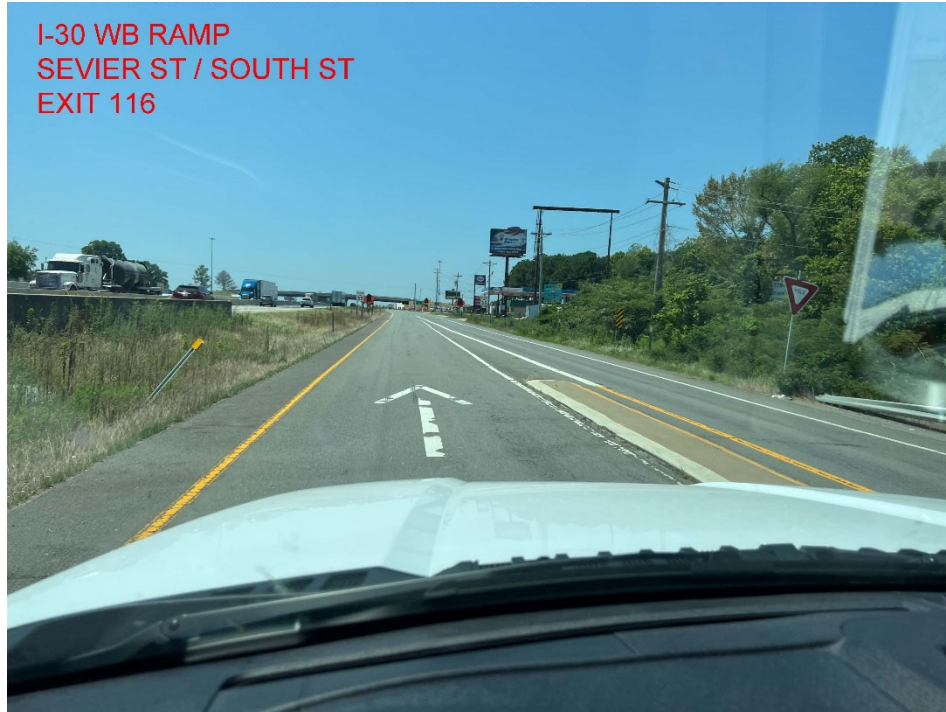
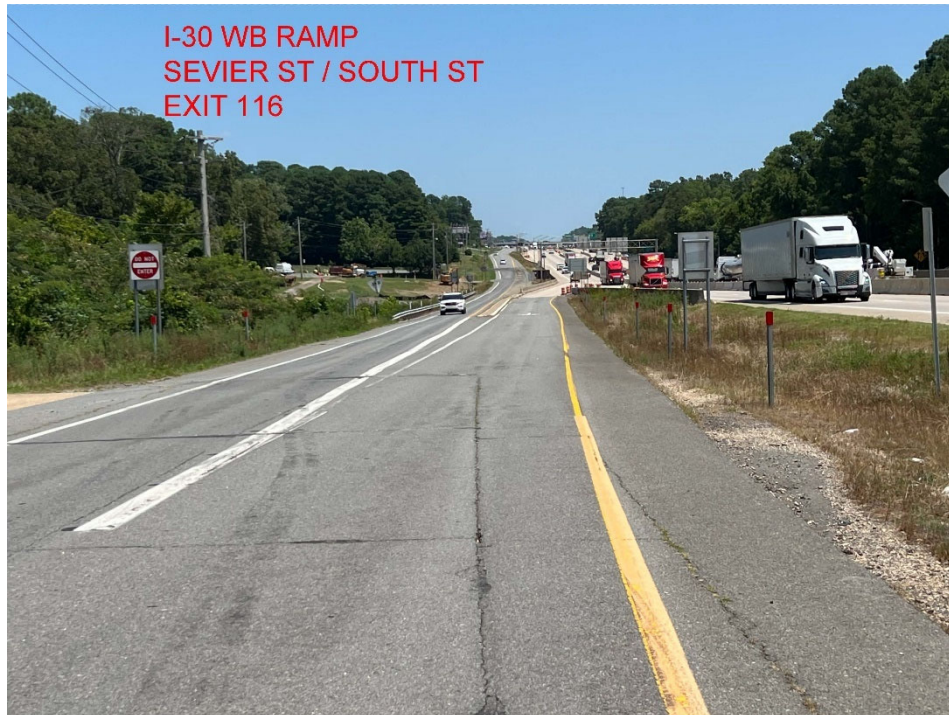
The driver accessed I-30 at Exit 116 (Sevier St. & South St.) and traveled eastbound in the westbound traffic lane of the Exit 116 westbound off ramp. The driver realized his mistake and attempted to complete a U-turn onto westbound I-30 from the exit ramp striking an oncoming vehicle.

The interchange at Exit 116 was reviewed. Pavement markings were in place and in conformance with MUTCD and ARDOT requirements. However, an additional “Do Not Enter” sign needs to be installed at the ramp, and the existing “Do Not Enter” signs need to be upsized with red vertical reflective strips installed on the signposts to conform with ARDOT requirements.

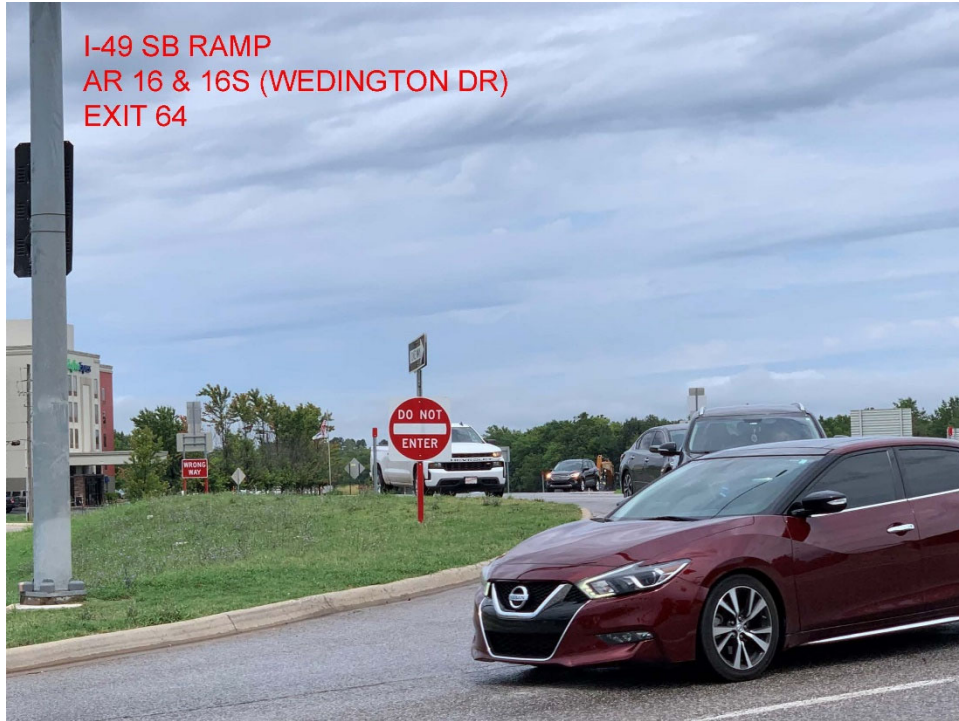
The driver attempted to access I-49 at Exit 64 (AR 16 & 16S, Wedington Dr.), and traveled northbound in the southbound off ramp. The wrong-way vehicle was involved in a head-on collision on the southbound exit ramp.

The interchange at Exit 64 was reviewed. Pavement markings and signs were in place and in conformance with MUTCD and ARDOT requirements.

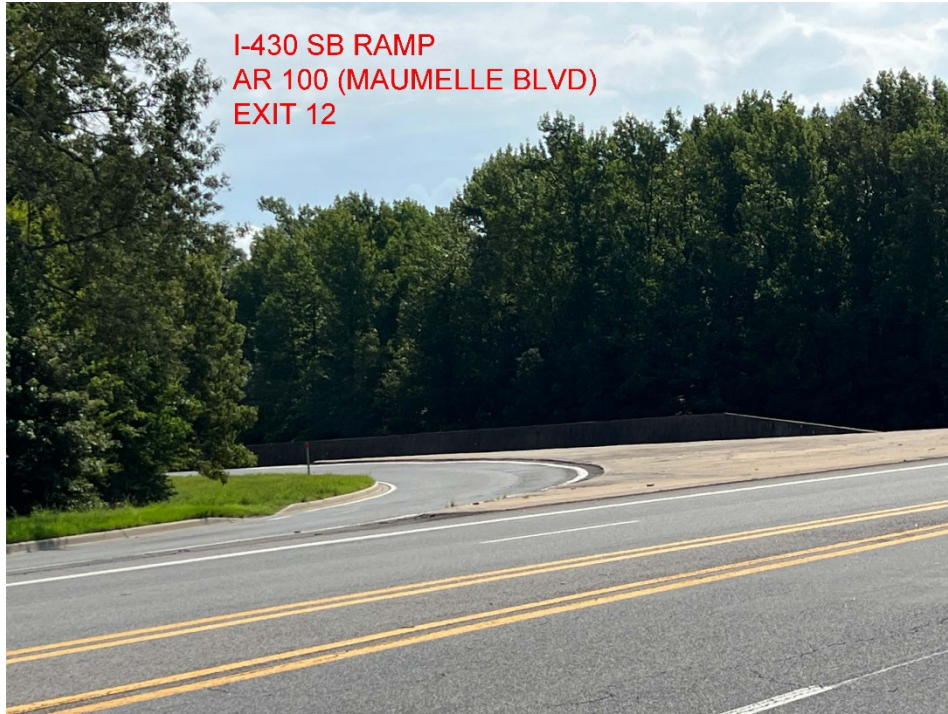
I-430 SB RAMP
AR 100 (MAUMELLE BLVD)
EXIT 12

The interchange at Exit 12 via Exit 147 was reviewed. Signs were in place and in conformance with MUTCD. However, the “Do Not Enter” and “Wrong Way” signs need to be installed with red vertical reflective strips on the signposts to conform with current ARDOT requirements. Also, pavement markings (arrow) have faded and need to be replaced to conform with current ARDOT requirements. The sign modifications have been implemented.

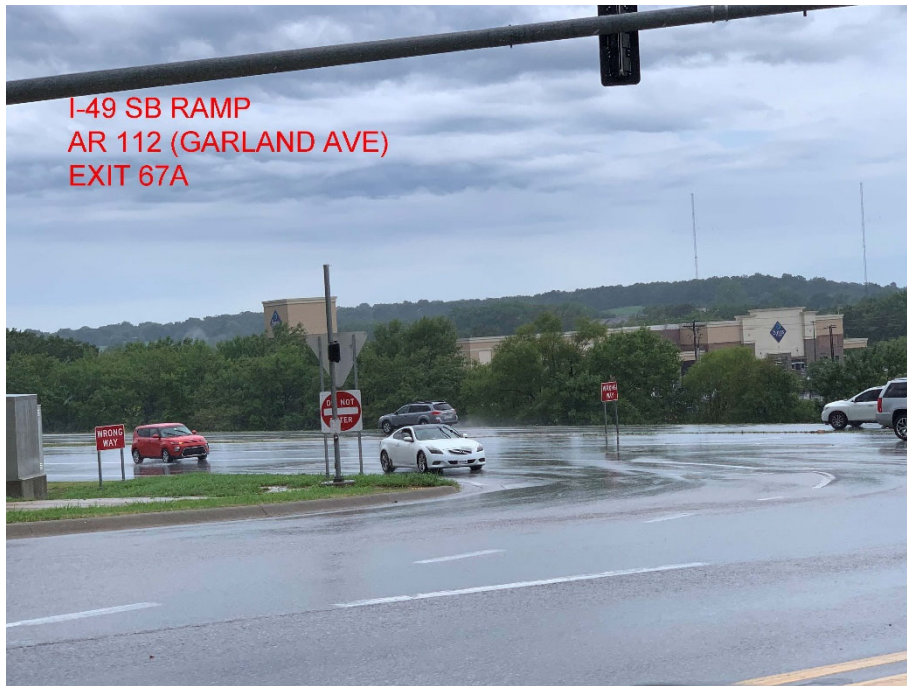
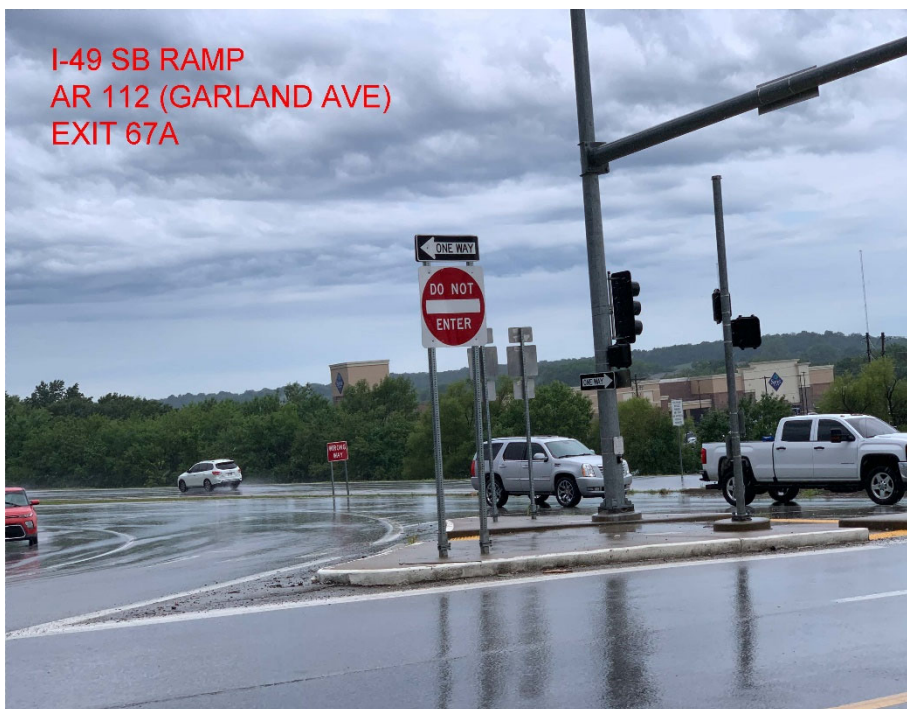
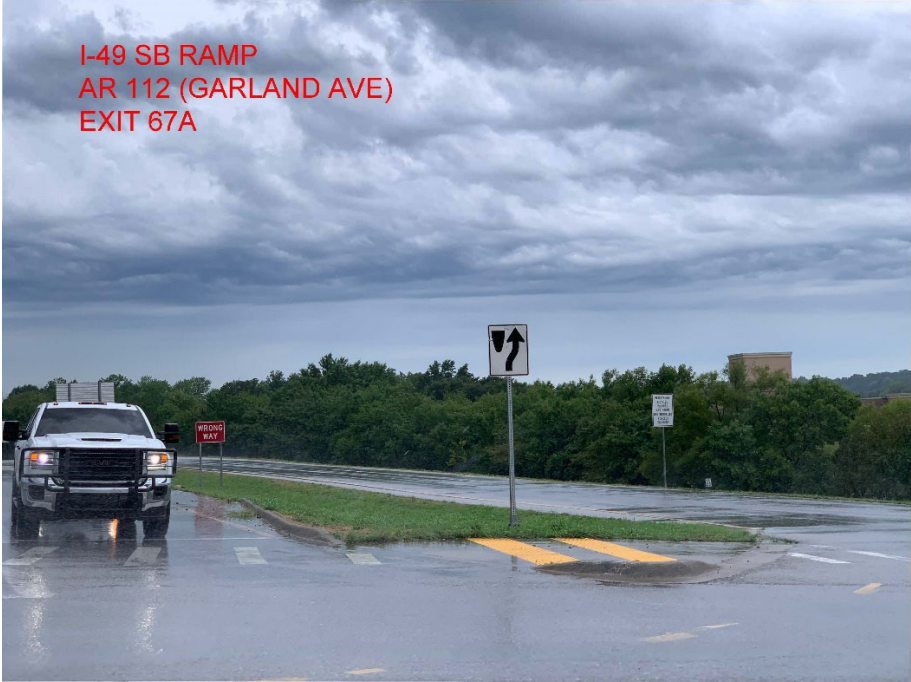
The driver attempted to access I-49 at AR 112 (Garland Ave.) by making a left turn onto the southbound traffic lane of the Exit 67A off ramp. The wrong-way vehicle was involved in a head-on collision on the southbound exit ramp. The wrong-way driver was suspected of being under the influence of alcohol at the time.

The interchange at Exit 67A was reviewed. Pavement markings and signs were in place and in conformance with MUTCD. However, the "One Way" signs at the ramp need to be upsized, and red vertical reflective strips need to be installed on the "Wrong Way" and "Do Not Enter" signposts to conform with current ARDOT. These modifications have been implemented.

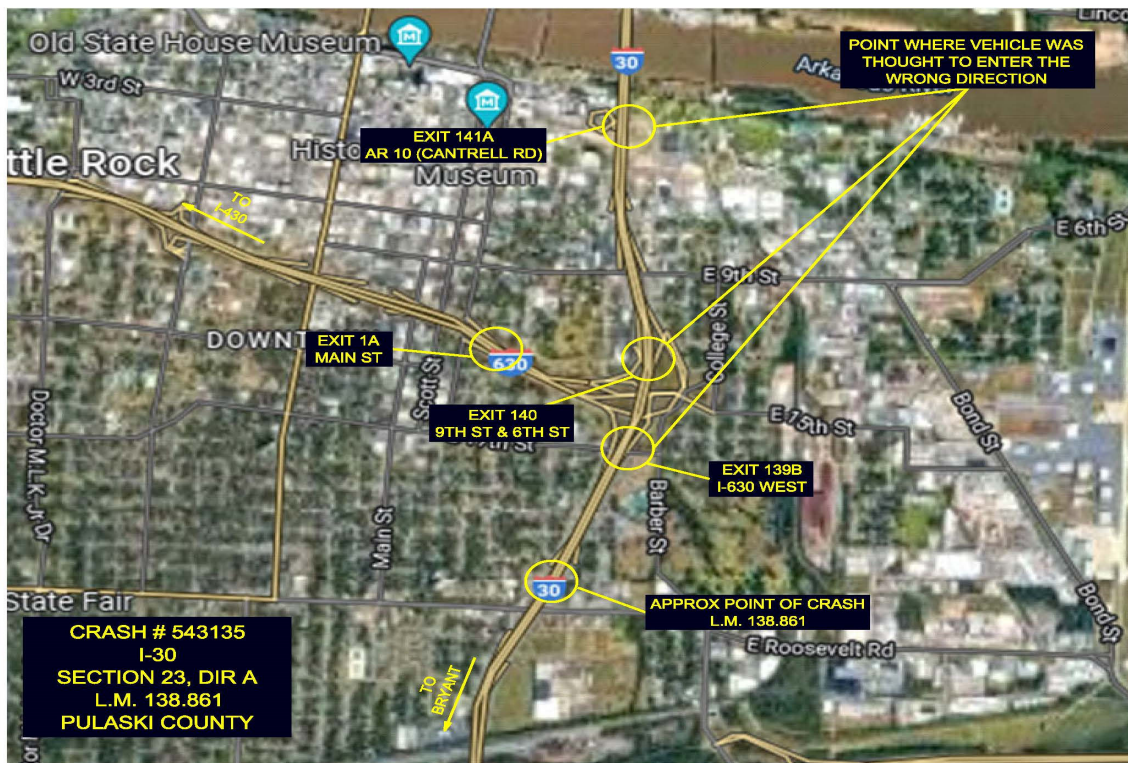
Crash # 2021543135 I-30, Section 23, Direction A, Log Mile 138.861

The driver accessed I-30 possibly at Exit 139B (I-630 West), Exit 140 (9th St. & 6th St.), or Exit 141A (AR 10, Cantrell Rd.) and traveled westbound in the eastbound traffic lane on I-30. The driver struck a digital control sign, which is used to direct traffic. The wrong-way driver was suspected of being under the influence of alcohol at the time of crash.

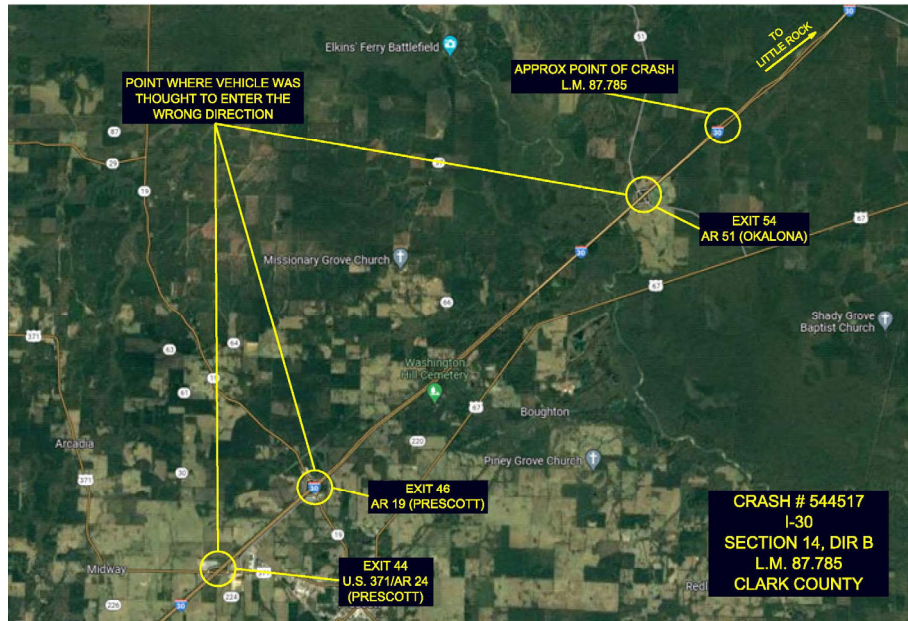
Crash # 2021544517 I-30, Section 14, Direction B, Log Mile 87.785

The driver accessed I-30 possibly at Exit 44 (U.S. 371/AR 24, Prescott), Exit 46 (AR 19, Prescott), or Exit 54 (AR 51, Okalona), and traveled eastbound in the westbound traffic lane on I-30. The driver struck a vehicle head-on, then went into a clockwise spin and struck another vehicle nearly head-on.

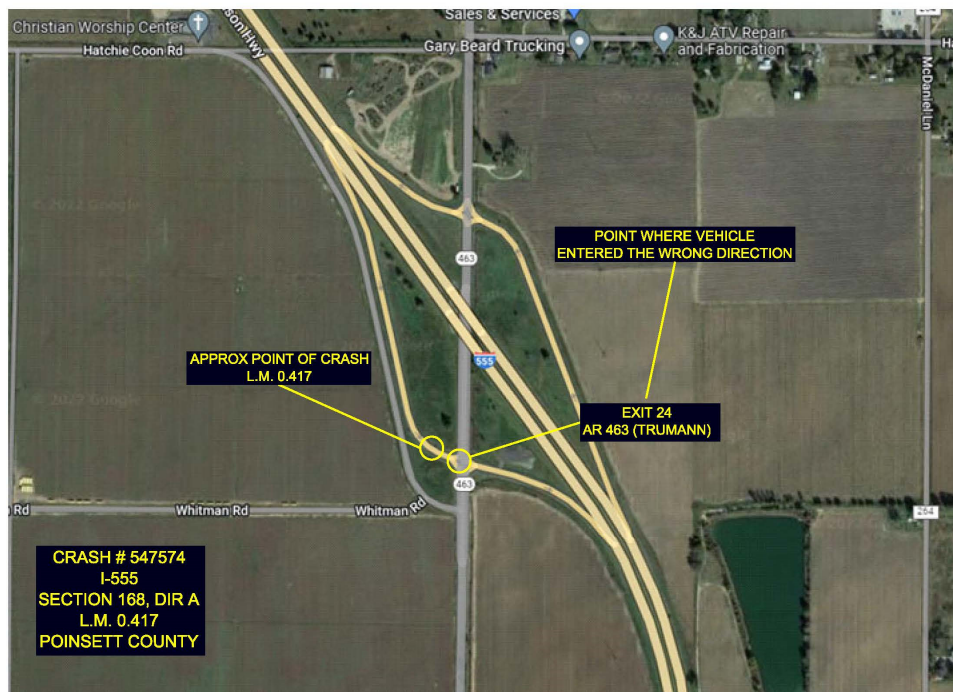
Crash # 2021547574 I-555, Section 168, Direction A, Log Mile 0.417

The driver accessed I-555 at Exit 24 (AR 463, Trumann) and traveled northbound in the southbound traffic lane of Exit 24 southbound off ramp. The driver realized his mistake and tried to turn around but backed off the roadway and struck a sign.

The interchange at Exit 24 was reviewed. Signs were in place and in conformance with MUTCD. The “Stop”, “Do Not Enter”, “One Way” and “Wrong Way” signs need to have red vertical reflective strips installed on the signposts to conform with current ARDOT requirements. Also, the pavement marking arrow needs to be moved up 426’ to conform with current ARDOT requirements. These modifications have been implemented.

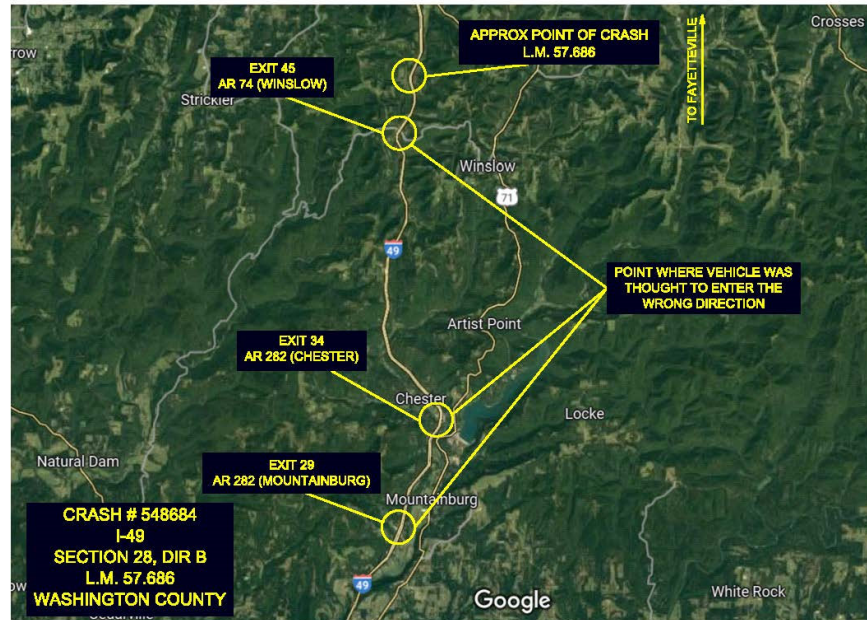
Crash # 2021548684 I-49, Section 28, Direction B, Log Mile 57.686

The driver accessed I-49 possibly at Exit 29 (AR 282, Mountainburg), Exit 34 (AR 282, Chester) or Exit 45 (AR 74, Winslow) and traveled northbound in the southbound traffic lane on I-49. A southbound vehicle swerved to avoid a head-on collision with the driver and struck a concrete barrier. The wrong-way vehicle continued traveling northbound in the southbound lane and struck another vehicle head-on. The wrong-way driver was suspected of alcohol usage.

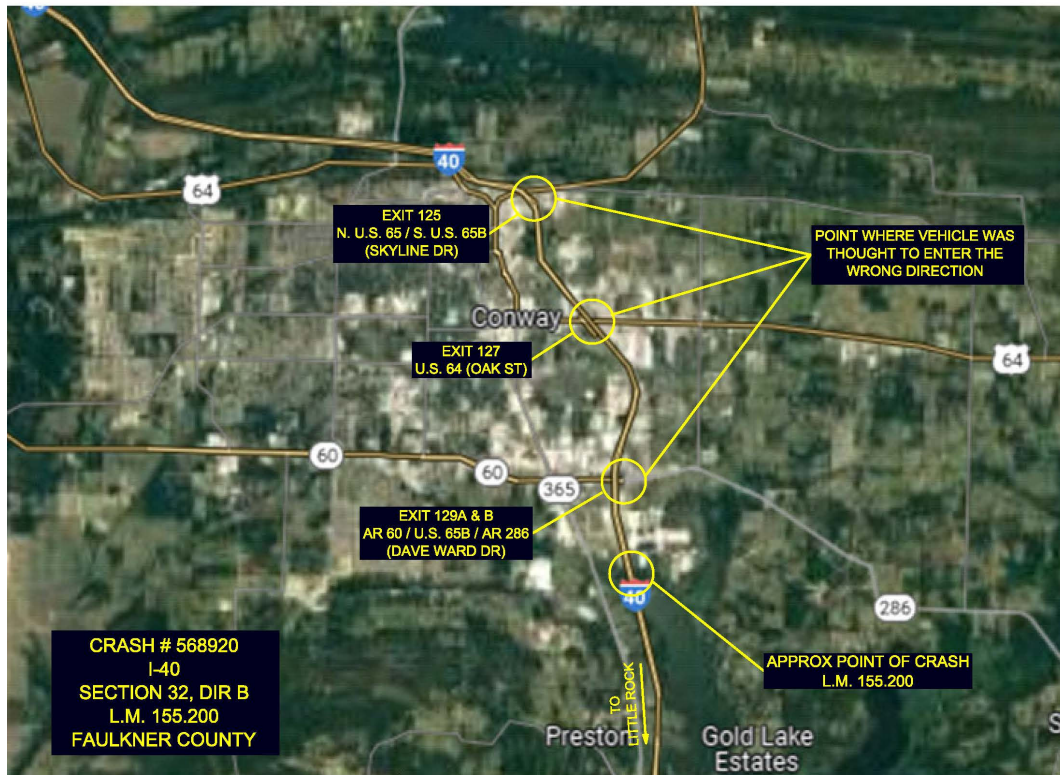
Crash # 2021568920 I-40, Section 32, Direction B, Log Mile 155.200

The driver accessed I-40 possibly at Exit 125 (North U.S. 65/South U.S. 65B, Skyline Dr.), Exit 127 (U.S. 64, Oak St.), Exit 129A (AR 286, E. Dave Ward Dr.), or Exit 129B (AR 60/U.S. 65B, W. Dave Ward Dr.), and traveled eastbound in the westbound traffic lane on I-40. The wrong-way vehicle was involved in a head-on collision at log mile 155.200. Another westbound vehicle attempted to avoid the collision but sideswiped the westbound vehicle, before hitting the wrong-way vehicle head-on. Both the wrong-way driver and the other driver in the initial crash suffered fatal injuries.

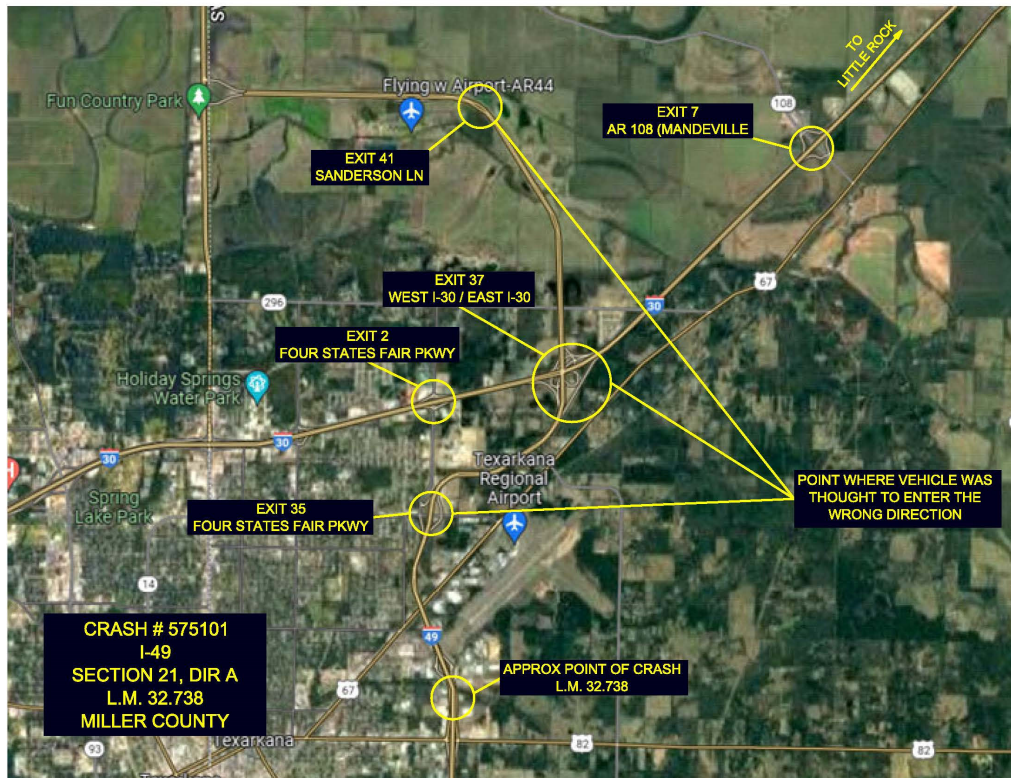
Crash # 2021575101 I-49, Section 21, Direction A, Log Mile 32.738

The driver accessed I-49 possibly at Exit 35 (Four States Fair Pkwy.), Exit 37 (West I-30, East I-30), or Exit 41 (Sanderson Ln.), and traveled southbound in the northbound traffic lane on I-49. The Texarkana Police Department received multiple calls of a white SUV driving recklessly and going the wrong way. A northbound vehicle was attempting to pass another vehicle when they noticed the wrong-way vehicle, and moved back to avoid a head-on collision, but the wrong-way vehicle hit their driver's side mirror. The wrong-way driver left the scene before police arrived.

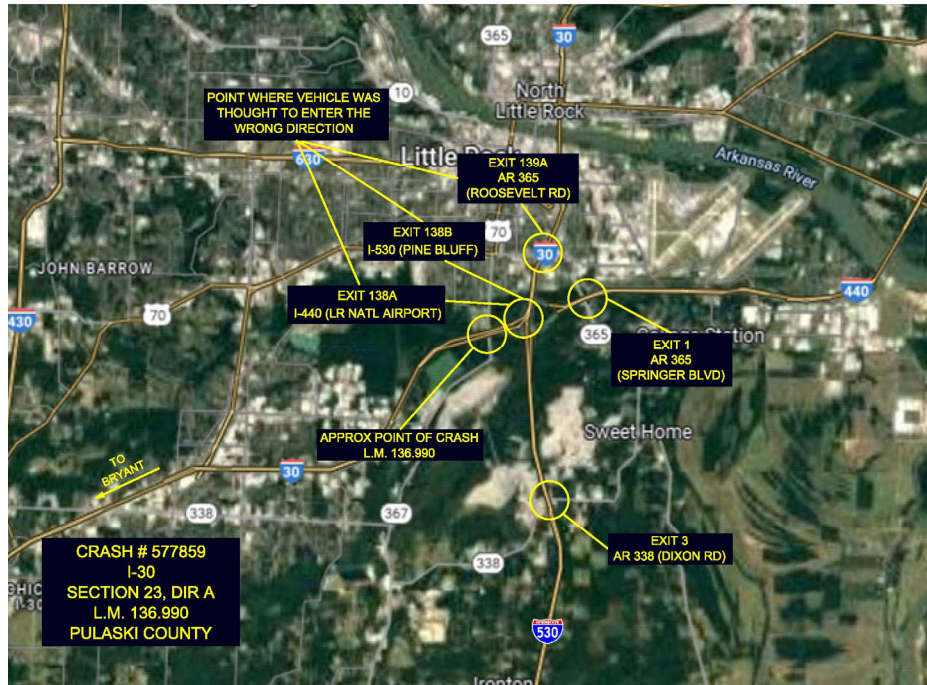
Crash # 2021577859 I-30, Section 23, Direction A, Log Mile 136.990

The driver accessed I-30 possibly at Exit 138A (I-440, LR National Airport), Exit 138B (I-530, Pine Bluff), or Exit 139A (AR 365, Roosevelt Rd.) and traveled westbound in the eastbound traffic lane on I-30. The driver collided with a concrete barrier on the left shoulder. The wrong-way driver was suspected to be under the influence of alcohol.

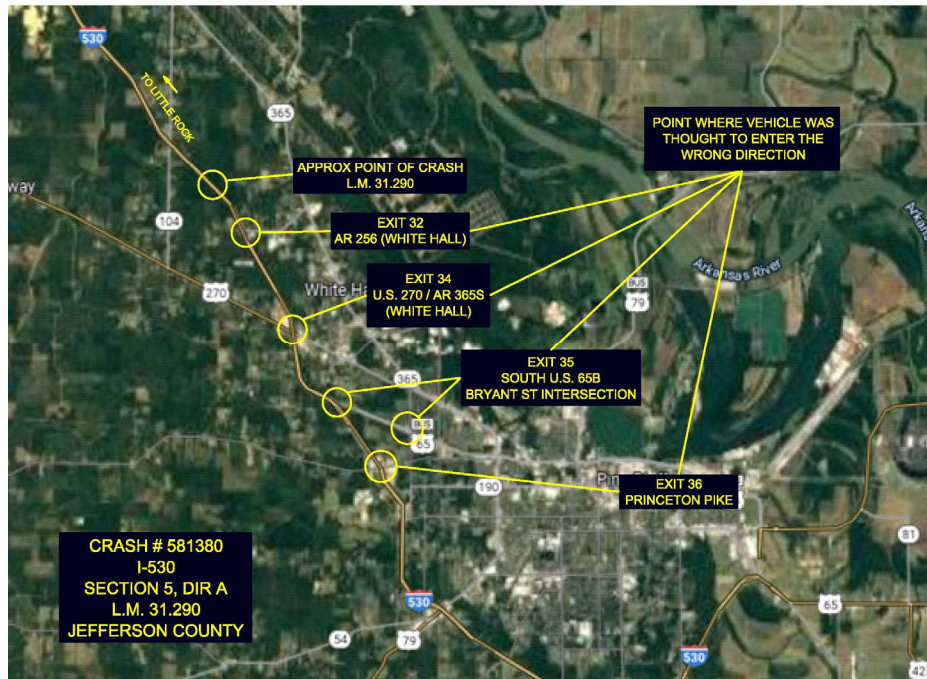
Crash # 2021581380 I-530, Section 5, Direction A, Log Mile 31.290

The driver accessed I-530 possibly at Exit 32 (AR 256, White Hall), Exit 34 (U.S. 270/AR 365S, White Hall), Exit 35 (South U.S. 65B), or Exit 36 (Princeton Pike) and traveled northbound in the southbound traffic lane on I-530. A southbound vehicle attempted to swerve to avoid a head-on impact but was unable to completely avoid him and the vehicles hit nearly head-on. The wrong-way driver was under the influence of alcohol.

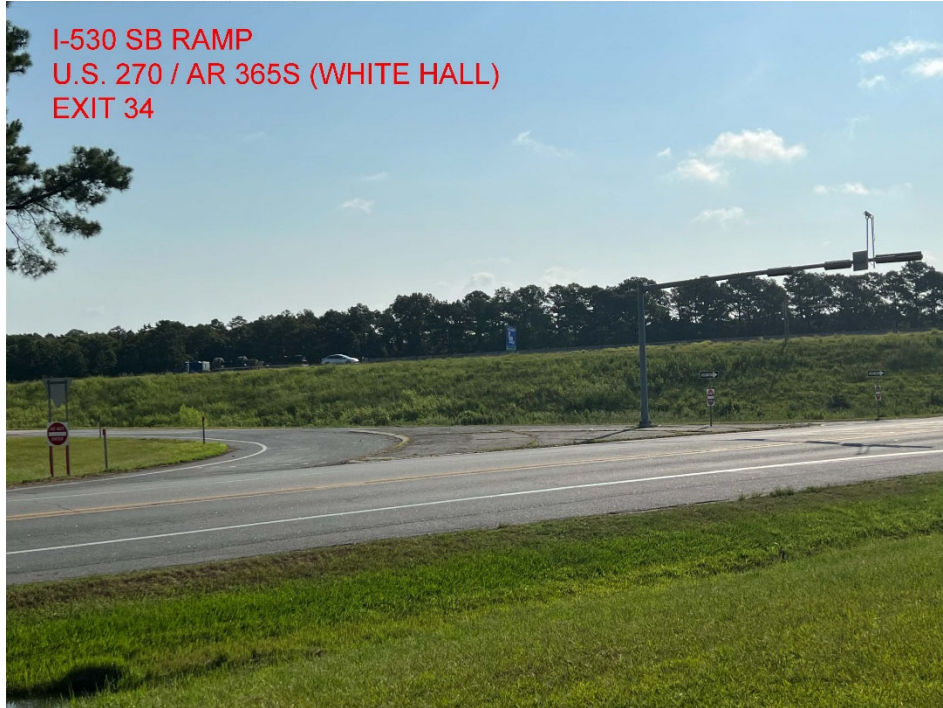
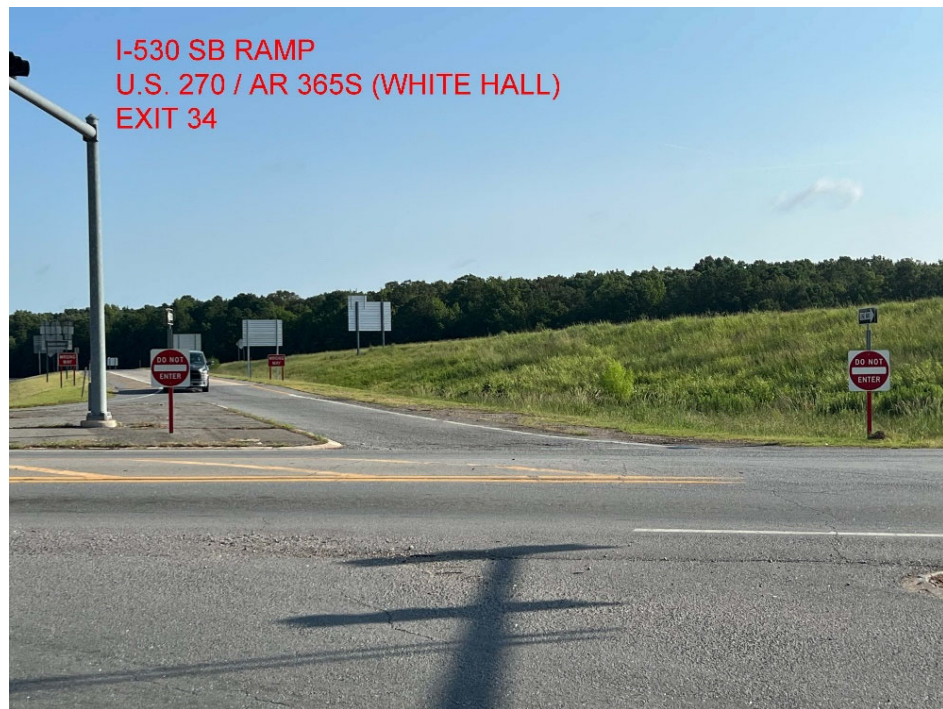
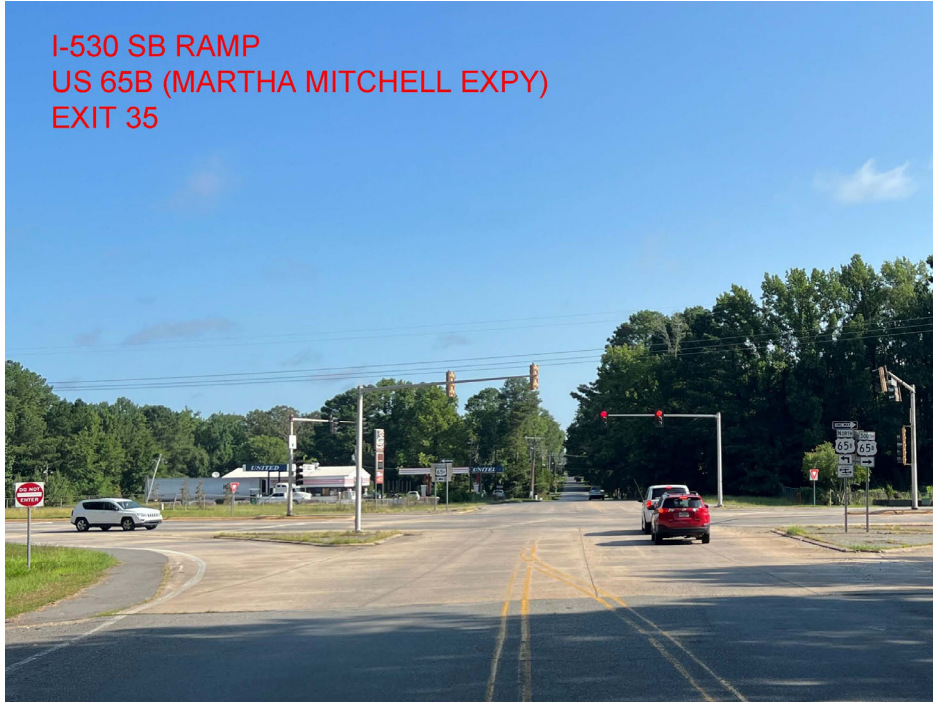
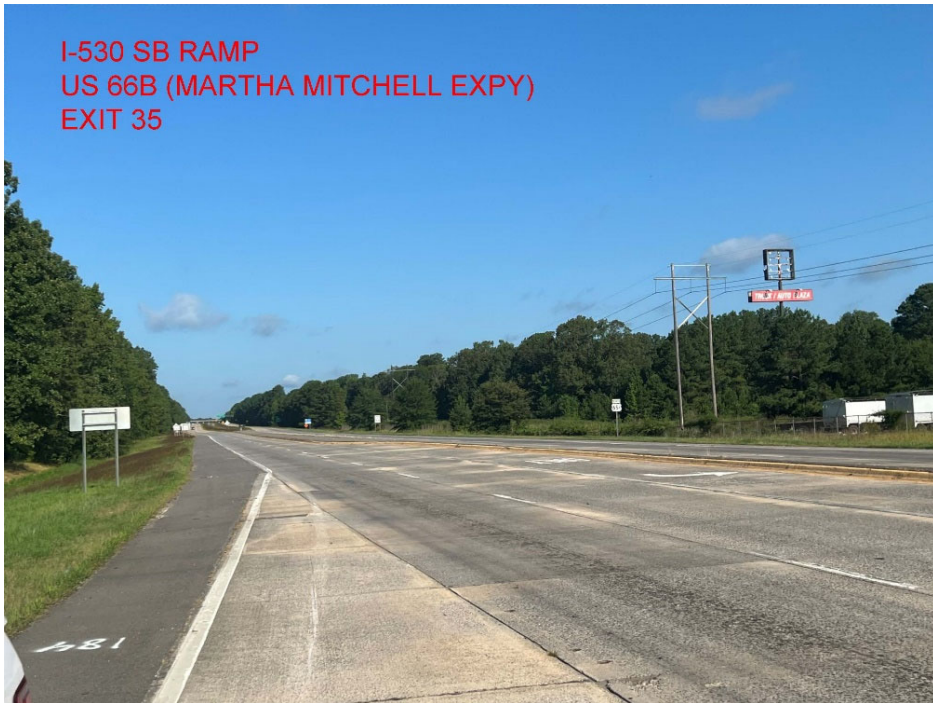
The interchange at Exit 32 was reviewed. Pavement markings and signs were in place and in conformance with MUTCD. However, the “Do Not Enter” sign needs to be replaced to conform with current ARDOT requirements. This modification has been implemented.

The interchange at Exit 34 was reviewed. Signs were in conformance with MUTCD and ARDOT requirements. However, pavement markings (stop bar and arrow) have faded and need to be replaced to conform with current ARDOT requirements. These modifications have been implemented.

The interchange at Exit 36 was reviewed. Pavement markings and signs were in place and in conformance with MUTCD and ARDOT requirements.

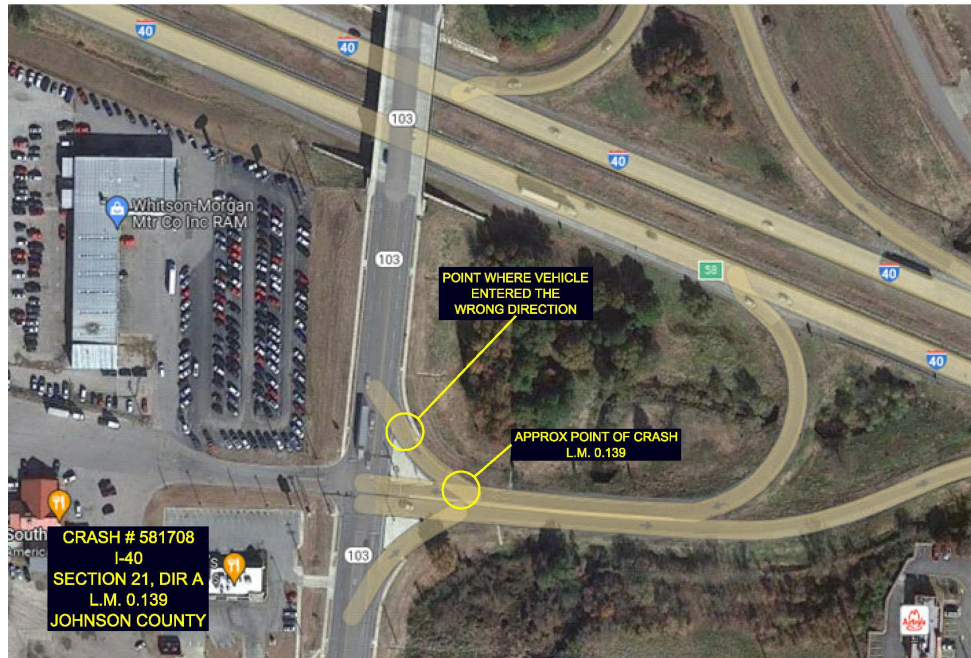
Crash # 2021581708 I-40, Section 259, Direction A, Log Mile 0.139

The driver attempted to access I-40 at Exit 58 (AR 103, AR 21, Rogers Ave.) and traveled westbound in the eastbound traffic lane of Exit 58 eastbound off ramp. The wrong-way driver was traveling south on Rogers Ave approaching the eastbound off ramp. The wrong-way driver then veered left across all lanes of traffic and entered the Exit 58 off ramp where he struck an eastbound vehicle head on. Following the impact, the wrong-way vehicle struck a raised divider and came to rest facing north in the eastbound entrance lane. After the crash, the driver of the wrong-way vehicle fled the scene on foot.

The interchange at Exit 58 was reviewed. Signs were in conformance with MUTCD. However, the “Keep Right” sign needs to be upsized to conform with current ARDOT requirements. Also, pavement markings (arrow and cat tracks) have faded and need to be replaced to conform with current ARDOT requirements. The sign modifications have been implemented.
