# WRONG-WAY CRASH STUDY

INTERSTATES AND FREEWAYS | CALENDAR YEAR 2022

## Wrong-Way Crash Report

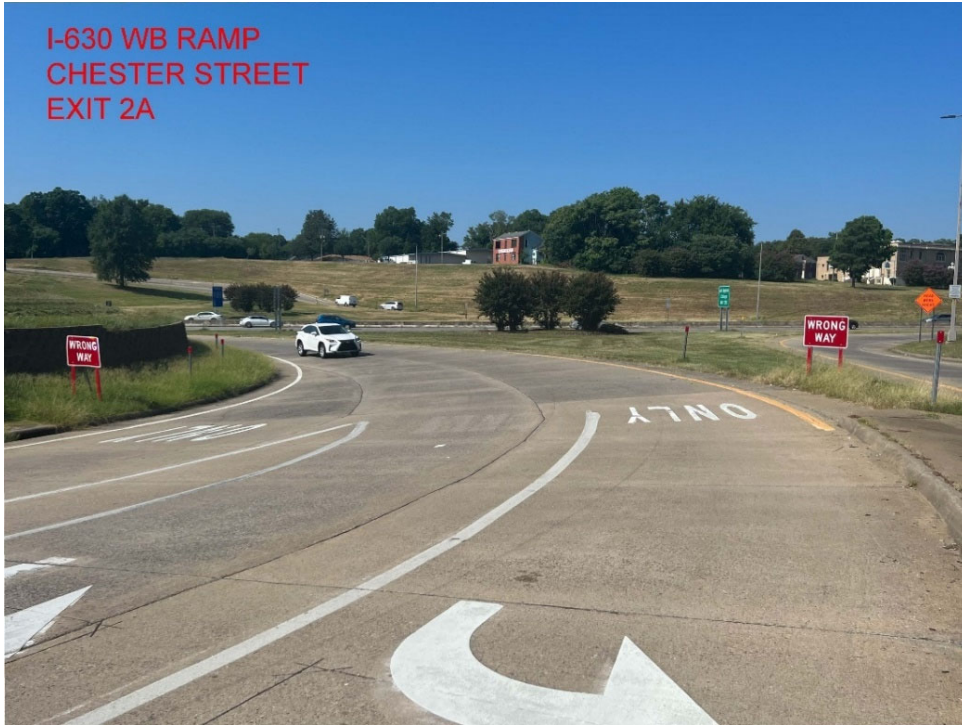
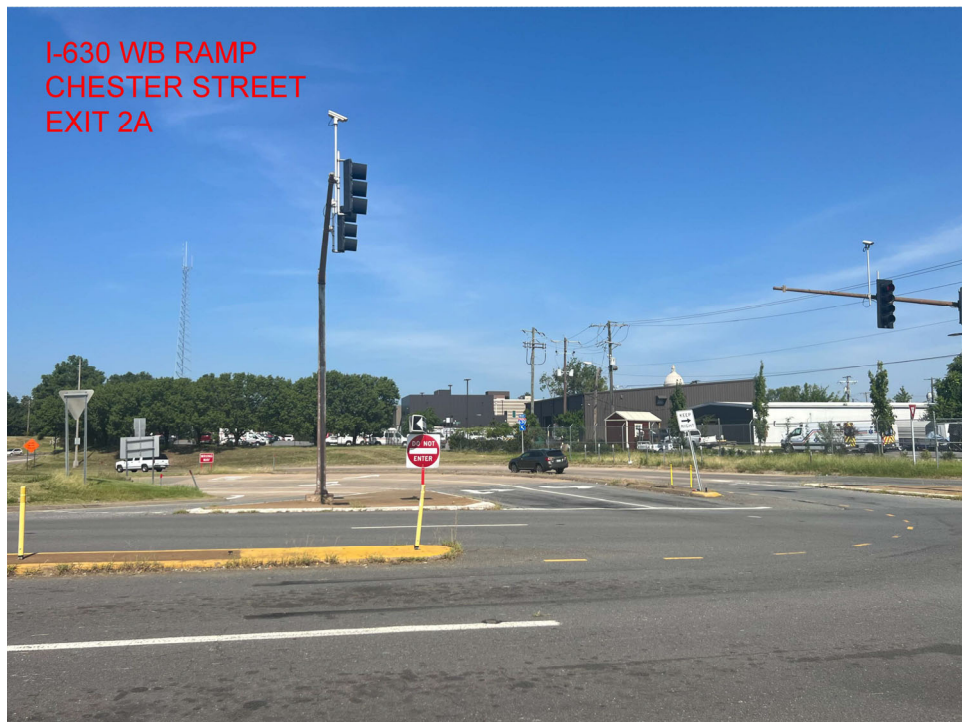
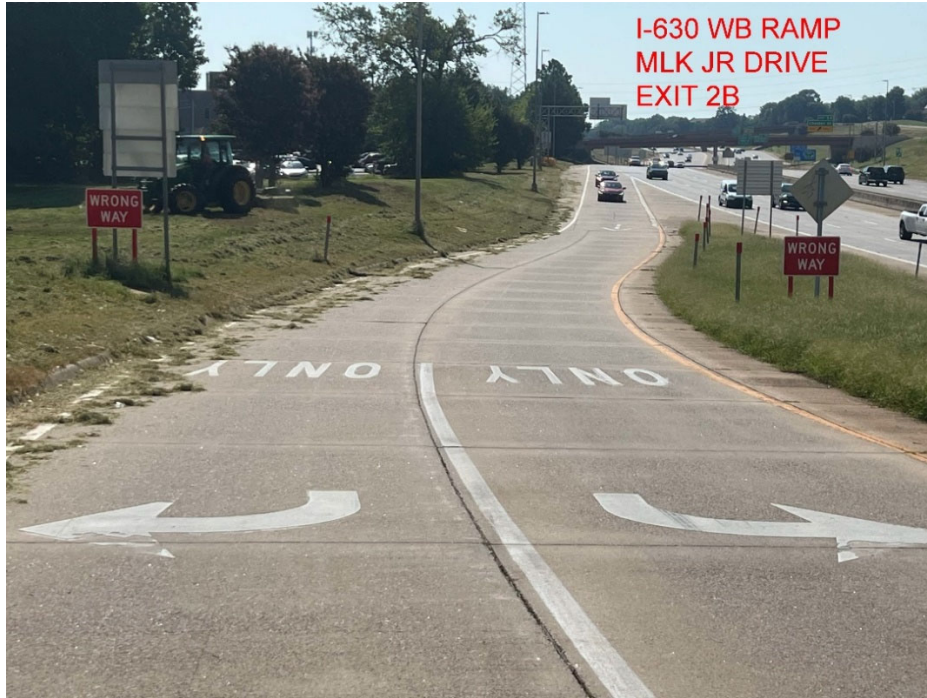
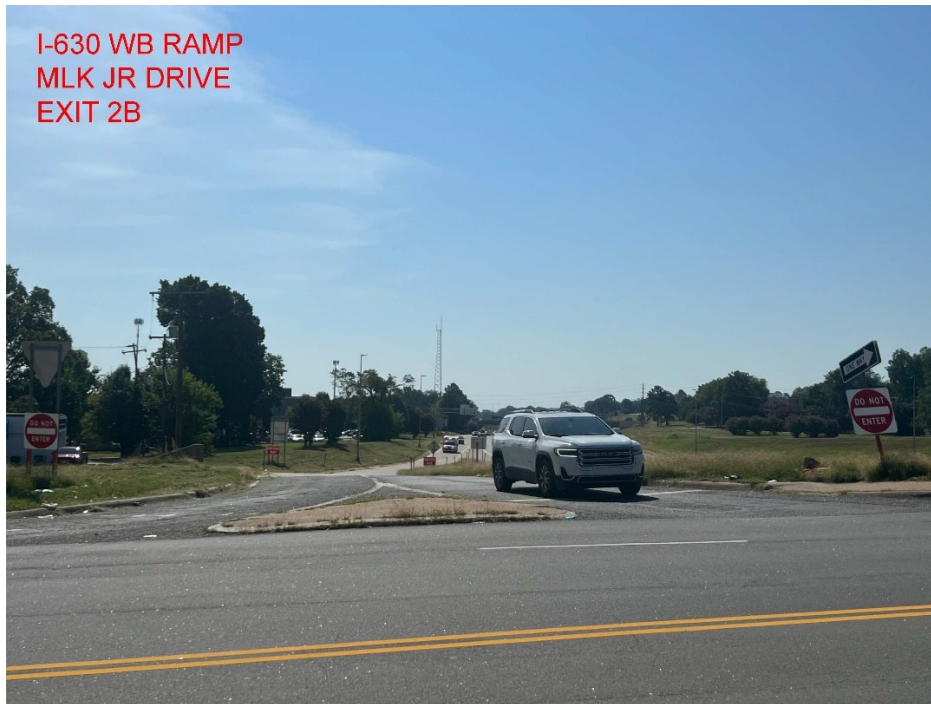
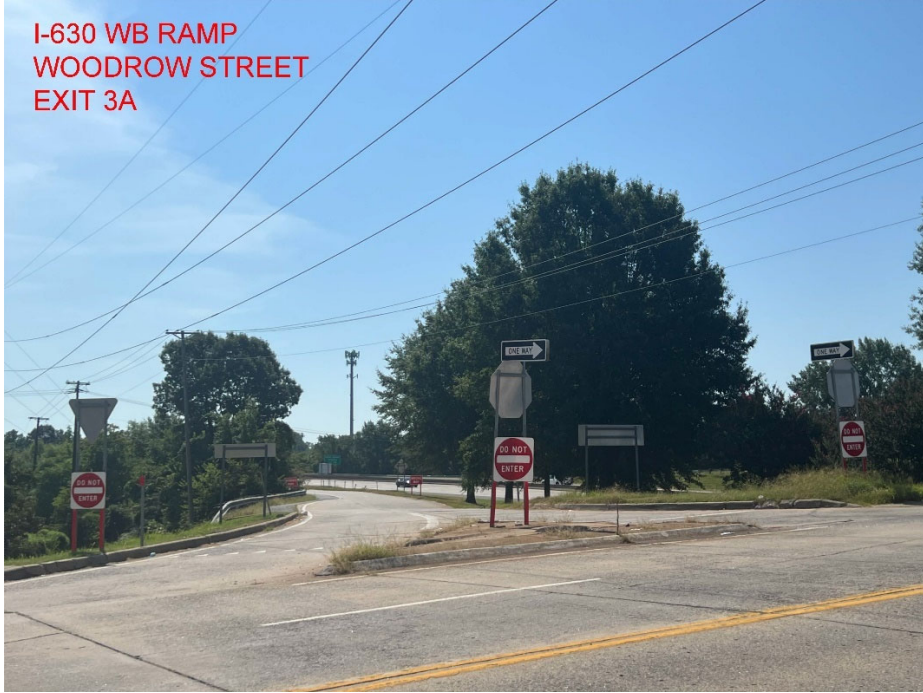
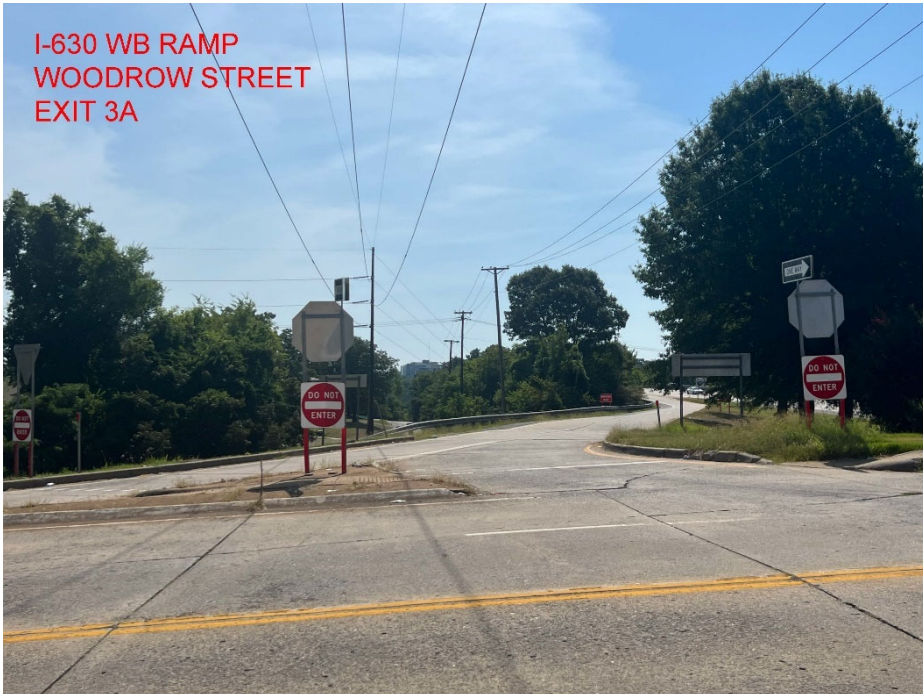
**Crash # 2022504996 I-630, Section 21, Direction A, Log Mile 1.060**

The driver accessed I-630 at either Exit 2A (Chester St.), Exit 2B (MLK Jr. Dr.) or Exit 3A (Woodrow St.) and traveled eastbound in the westbound traffic lane. The wrong-way vehicle struck the front of a westbound vehicle. The westbound vehicle spun 90 degrees counterclockwise before striking a concrete traffic barrier and coming to a final rest. The wrong-way driver was under the influence of alcohol.

The interchange at Exit 2B was reviewed. Pavement markings and signs were in place and in conformance with MUTCD. However, additional “Do Not Enter” and “One Way” signs need to be installed and red vertical reflective strips installed on the signposts to conform with current ARDOT requirements. These modifications have been implemented.

The interchange at Exit 3A was reviewed. Pavement markings and signs were in place and in conformance with MUTCD and ARDOT requirements.

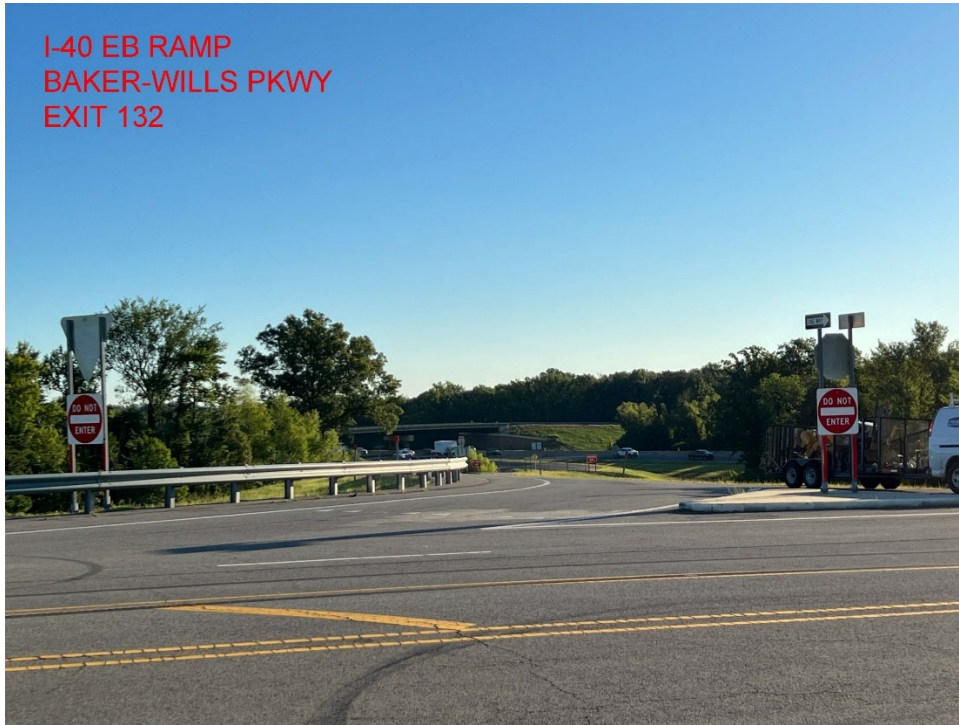
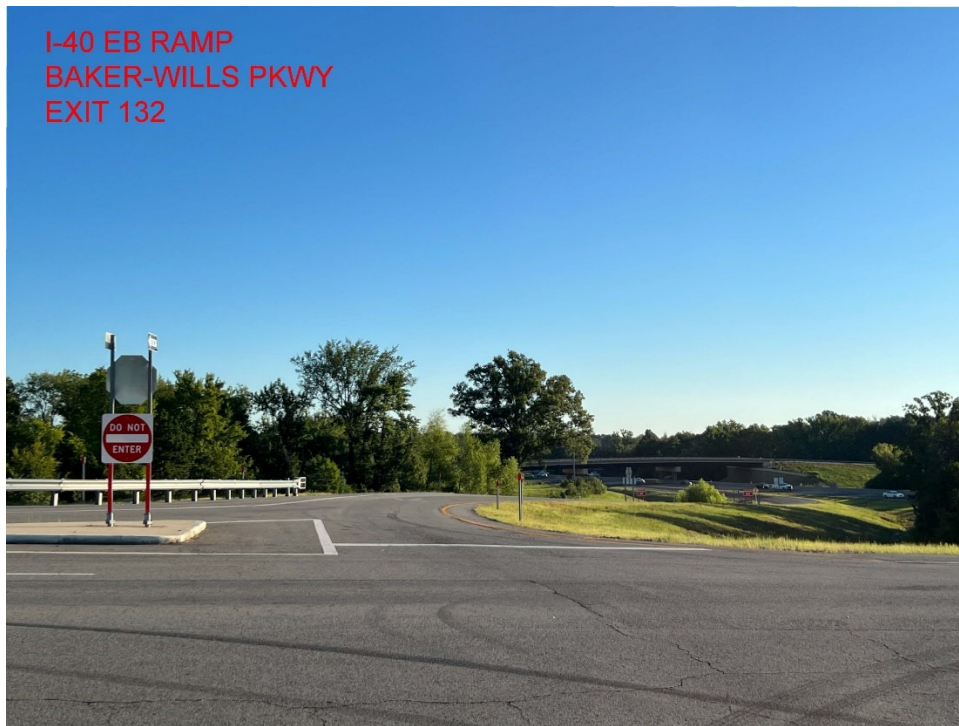
**Crash # 2022509395 I-40, Section 32, Direction A, Log Mile 131.886**

The driver accessed I-40 at Exit 132 (Baker-Wills Pkwy.) and traveled westbound in the eastbound traffic lane. The front of the wrong-way vehicle struck the front passenger side of an eastbound vehicle, causing the vehicle to rotate counter-clockwise before coming to a final rest in the right-hand lane facing west. The wrong-way driver was under the influence of alcohol at the time of the accident.

The interchange at Exit 132 was reviewed. Pavement markings and signs were in place and in conformance with MUTCD. However, the “Stop”, “Do Not Enter” and “One Way” signs need to be installed with red vertical reflective strips on the signposts to conform with current ARDOT requirements. These modifications have been implemented.

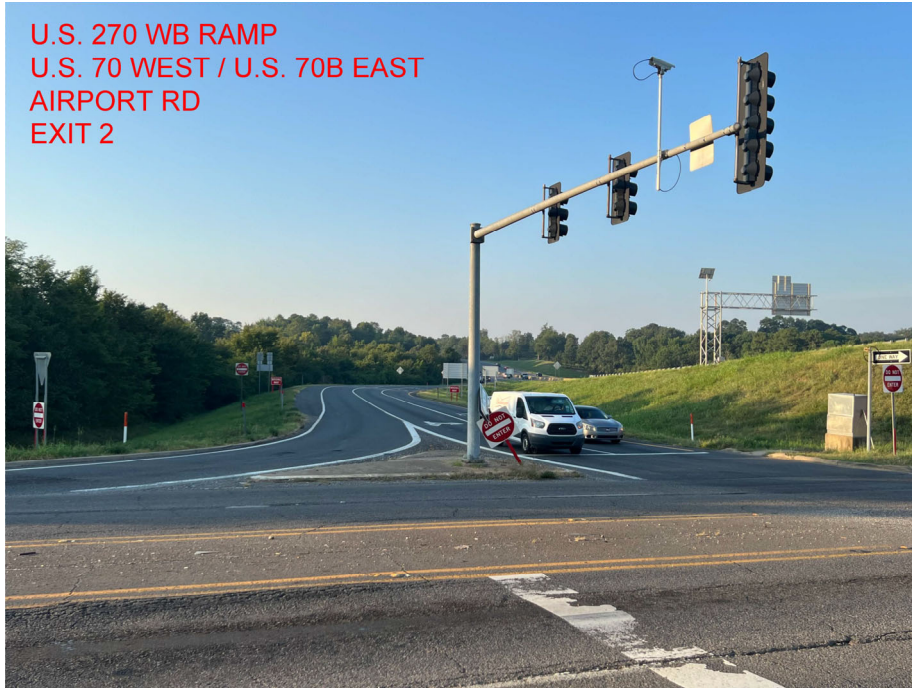
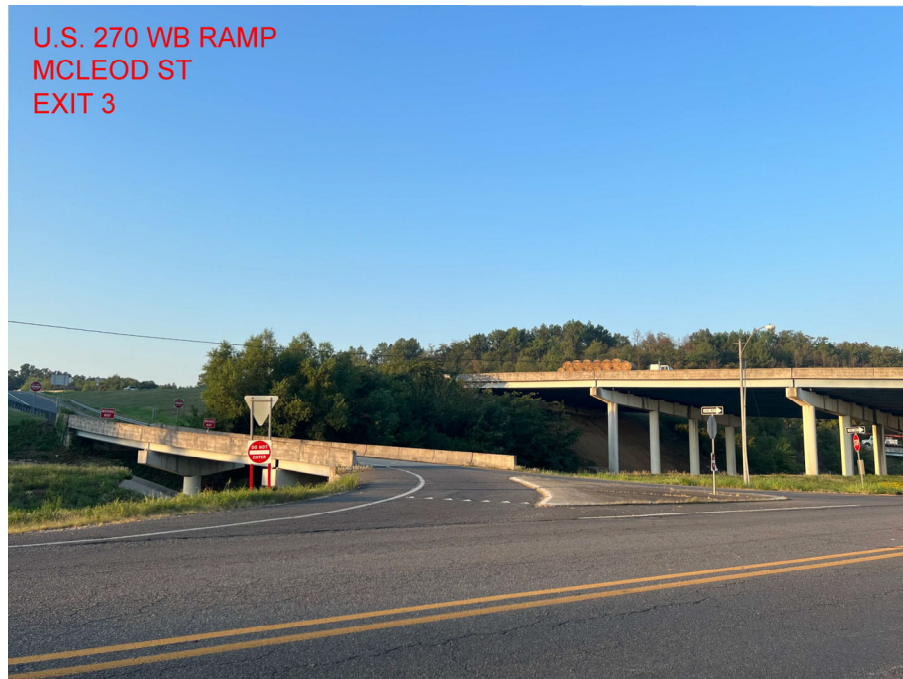
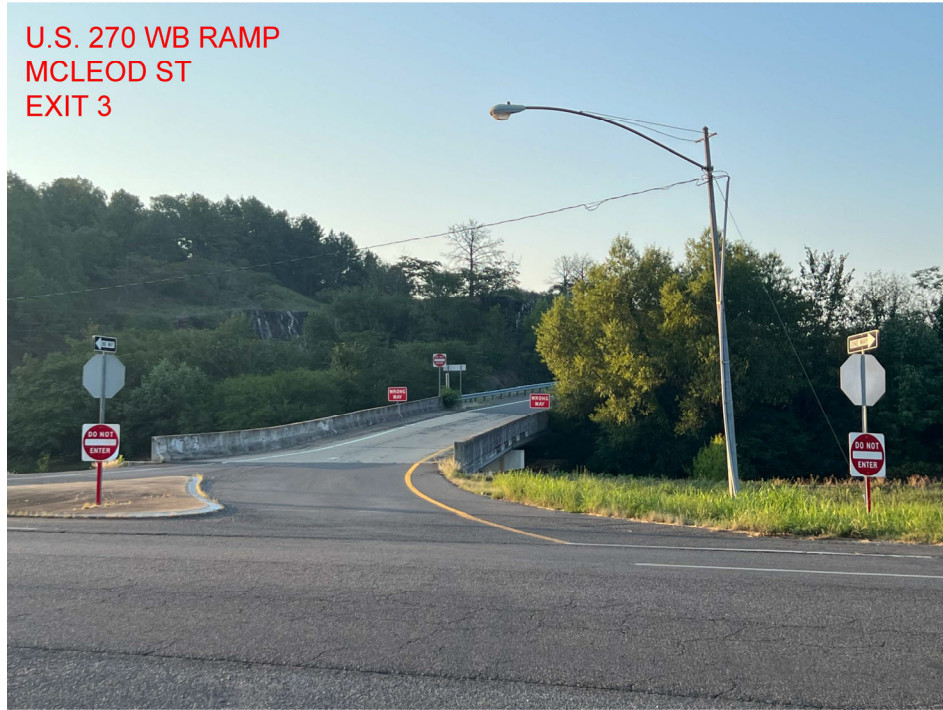
**Crash # 2022510105 U.S. 270, Section 5, Direction B, Log Mile 1.412**

The driver accessed U.S. 270 possibly at Exit 1 (U.S. 270 West, Mt Ida, U.S. 270B East, Hot Springs), Exit 2 (U.S. 70 West, U.S. 70B East, Airport Rd.) or Exit 3 (McLeod St.) and traveled eastbound in the westbound traffic lane. The wrong-way driver was involved in a head-on collision with both drivers being pronounced dead at the scene.

The interchange at Exit 2 was reviewed. Pavement markings and signs were in place and in conformance with MUTCD. However, pavement markings (yield bar) have faded and need to be replaced. Also, sign assemblies need to be straightened to conform with ARDOT requirements. These modifications have been implemented.

The interchange at Exit 3 was reviewed. Signs were in place and in conformance with MUTCD and ARDOT requirements. However, pavement markings (stop bar) have faded and need to be replaced. Also, the pavement marking arrow needs to be moved up 400’ to conform with ARDOT requirements. These modifications have been implemented.

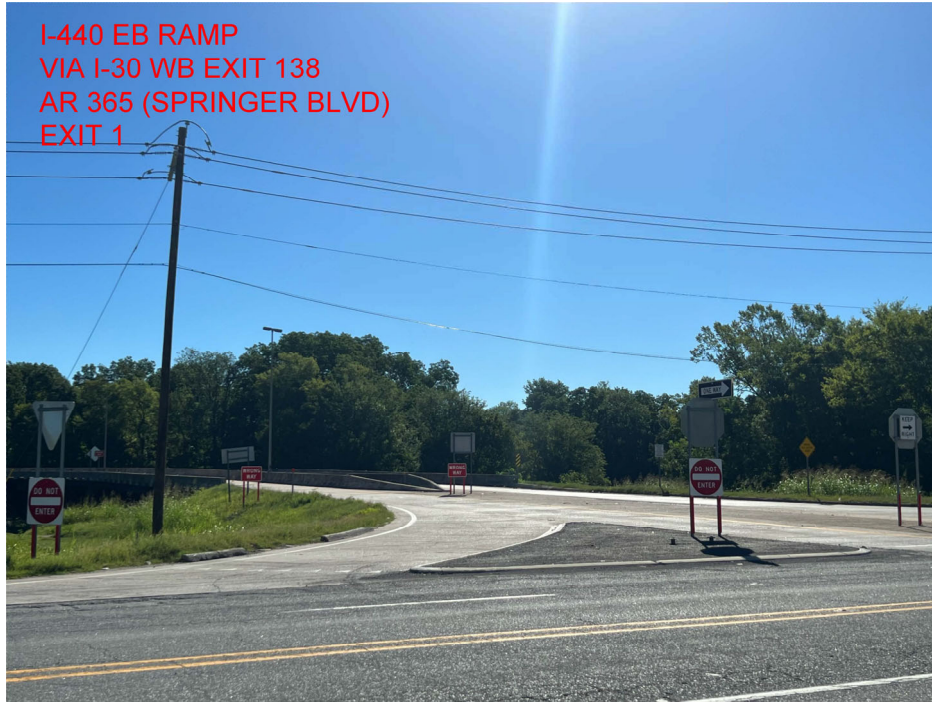
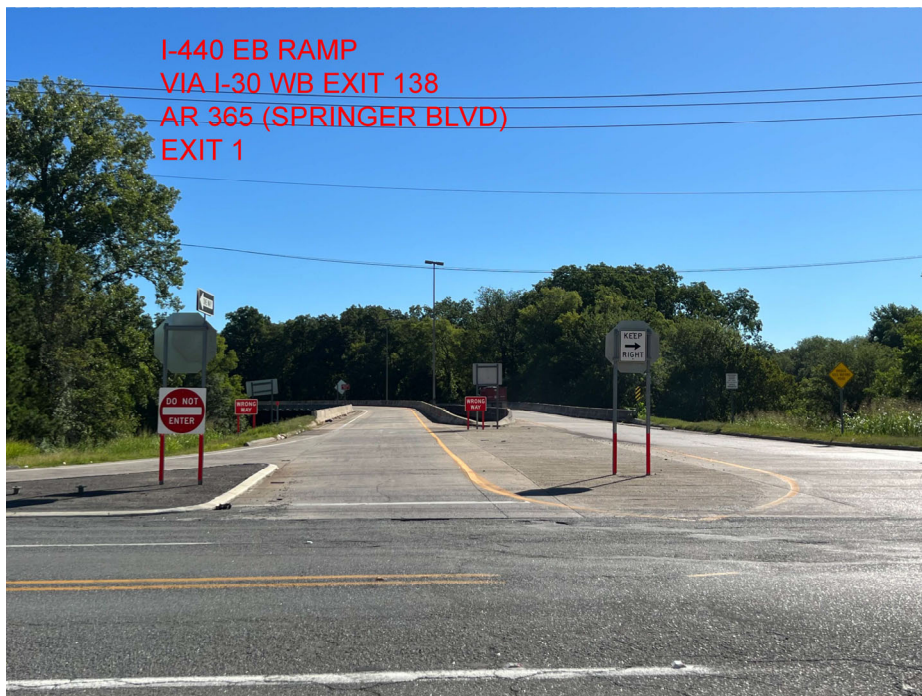
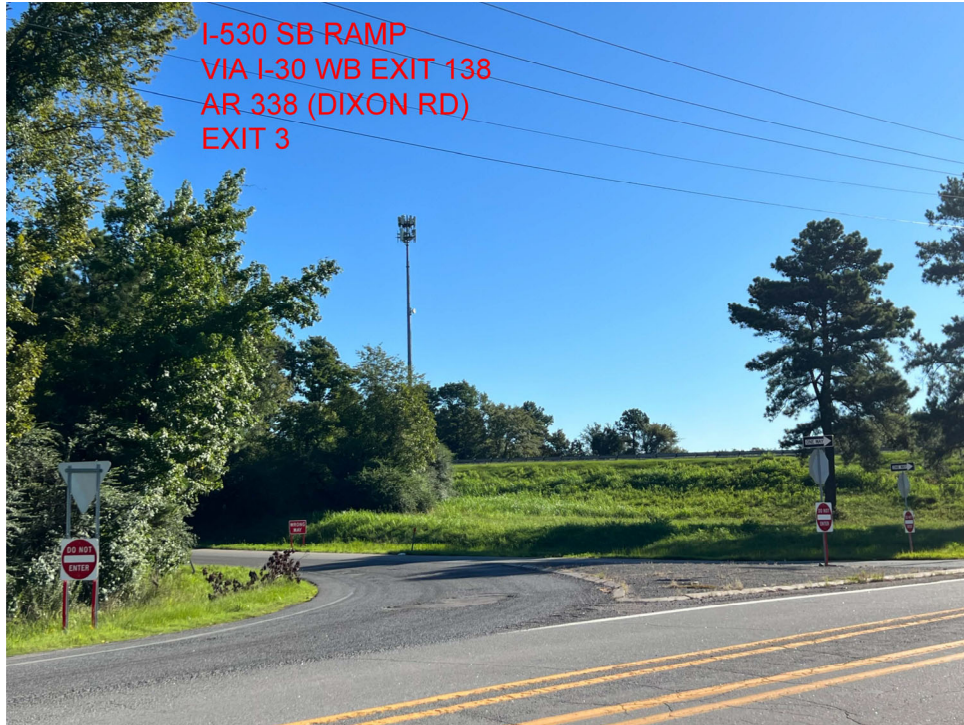
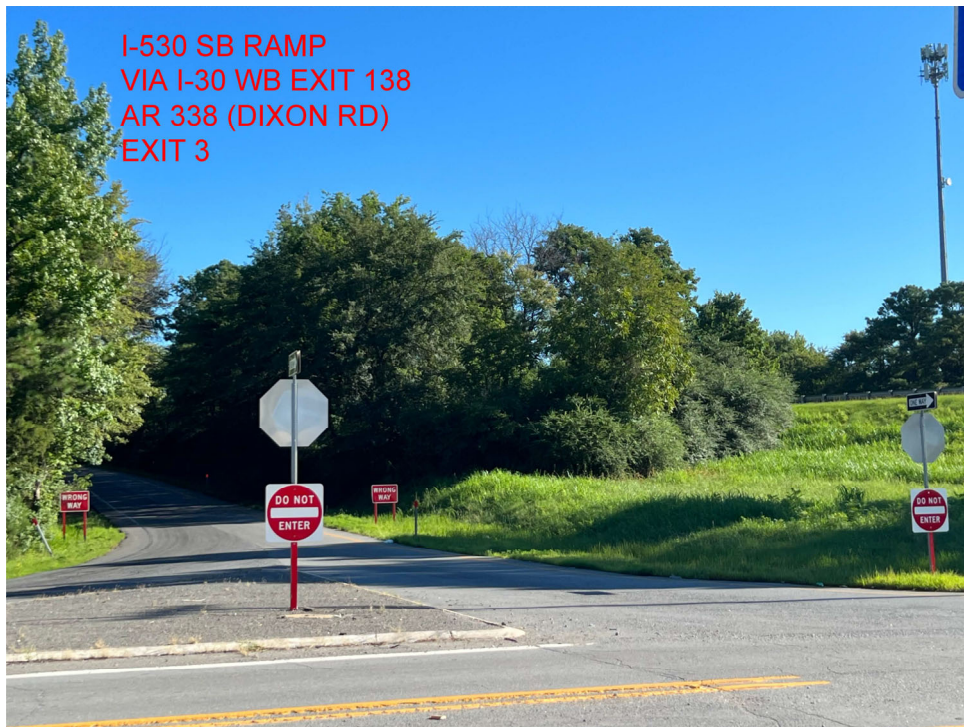
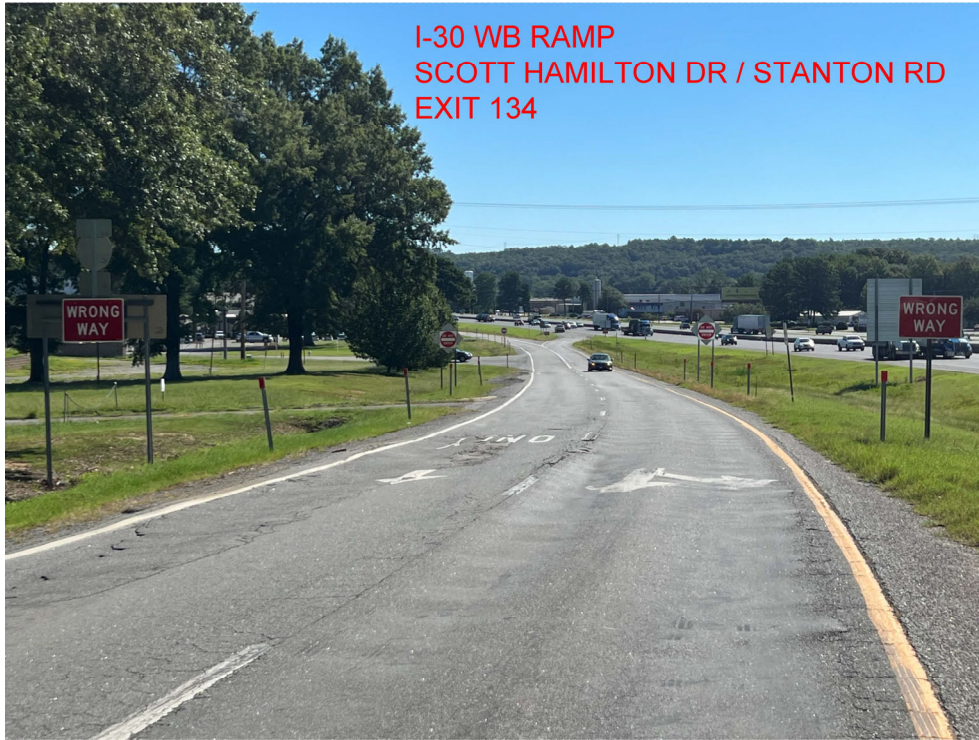
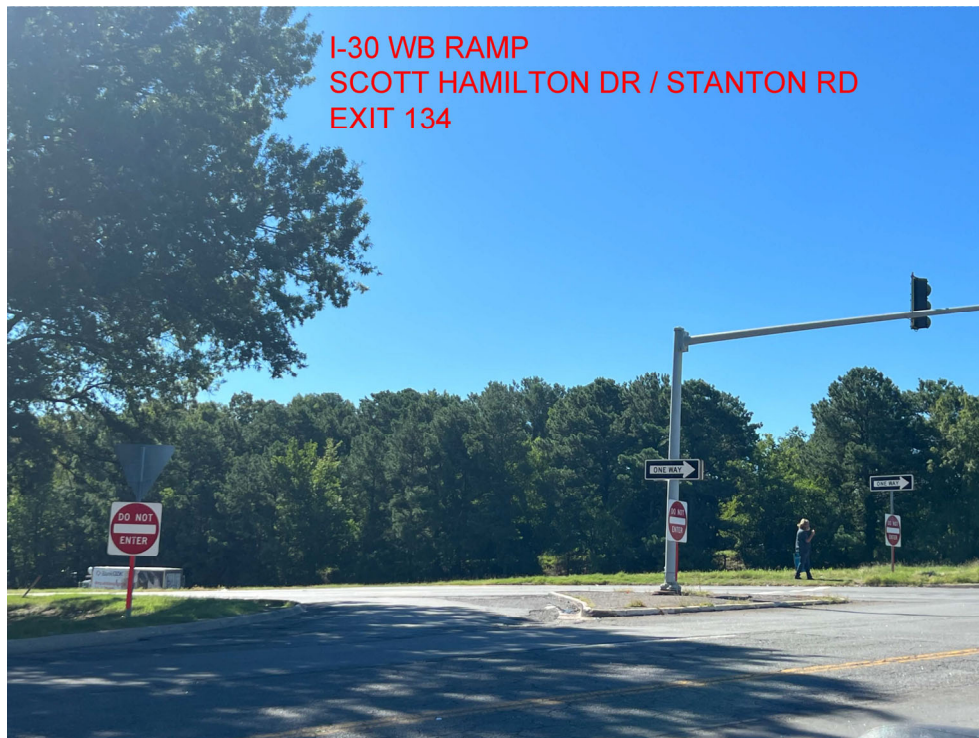
**Crash # 2022513409 I-30, Section 23, Direction B, Log Mile 4.401**

The driver accessed I-30 possibly at Exit 1 via Exit 138 (AR 365, Springer Blvd.), Exit 3 via Exit 138 (AR 338, Dixon Rd.), Exit 134 (Scott Hamilton Dr., Stanton Rd.) or Exit 135 (65<sup>th</sup> St.) and traveled eastbound in the westbound traffic lane. The wrong-way driver was involved in a head-on collision with a westbound vehicle. After impact, the wrong-way vehicle struck the middle concrete barrier before coming to a final rest. The wrong-way driver was suspected of being under the influence of alcohol at the time of the crash.

The interchange at Exit 134 was reviewed. Pavement markings and signs were in place and in conformance with MUTCD. However, red vertical reflective strips need to be installed on all "Wrong Way" signposts to conform with current ARDOT requirements. These modifications have been implemented.

The interchange at Exit 135 was reviewed. Signs were in place and in conformance with MUTCD and ARDOT requirements. However, pavement markings (stop & yield bars, arrow) need to be installed to conform with current ARDOT requirements. These modifications have been implemented.

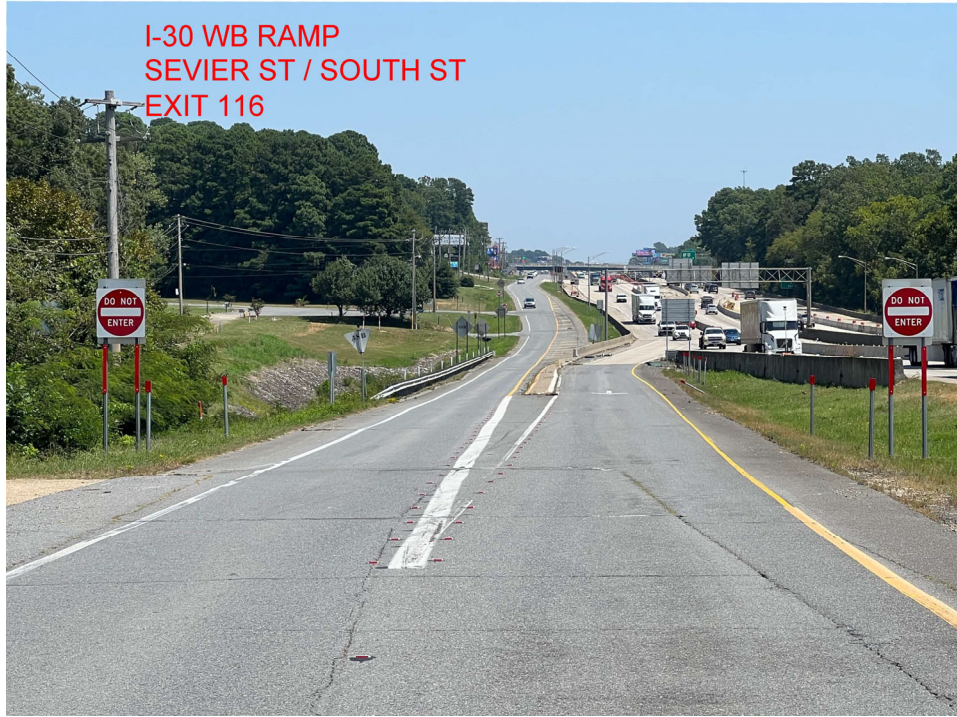
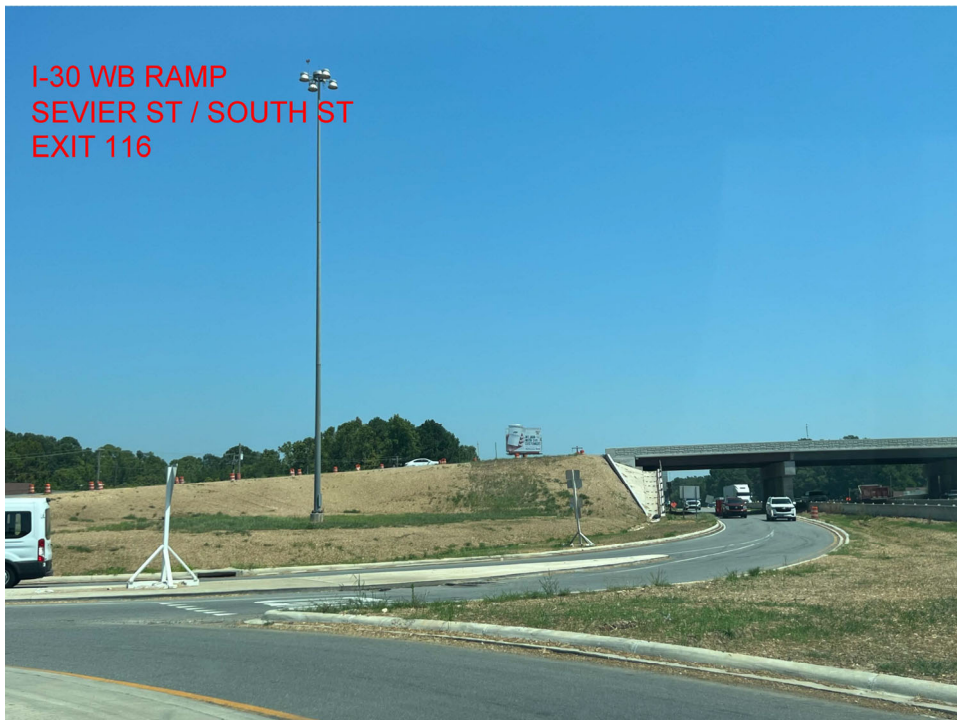
**Crash # 2022514905 I-30, Section 22, Direction B, Log Mile 26.683**

The driver accessed I-30 at Exit 116 (Sevier St., South St.) and traveled eastbound in the westbound traffic lane. The wrong-way driver was involved in a head-on collision. This area of highway was under construction at the time of the crash. The wrong-way driver was suspected of having Alzheimer's or dementia at the time of the crash.

The interchange at Exit 116 was reviewed and is currently under construction under the I-30 Hwy. 70 – Sevier St. (widening) Project CA0601. However, an additional “Wrong Way” sign needs to be installed to conform with current ARDOT requirements. This modification has been implemented.

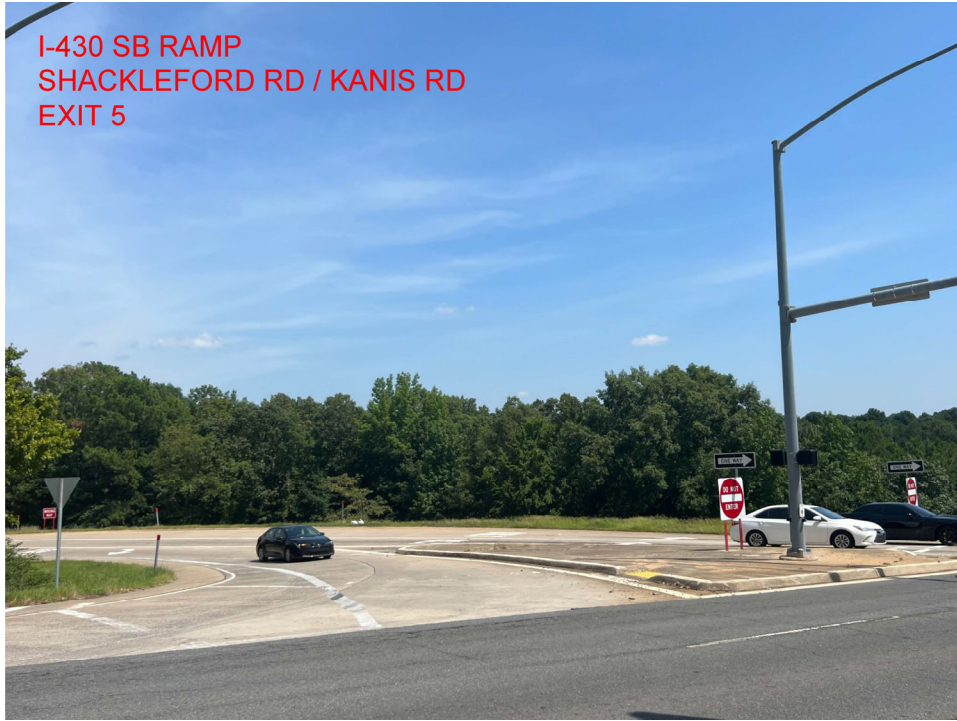
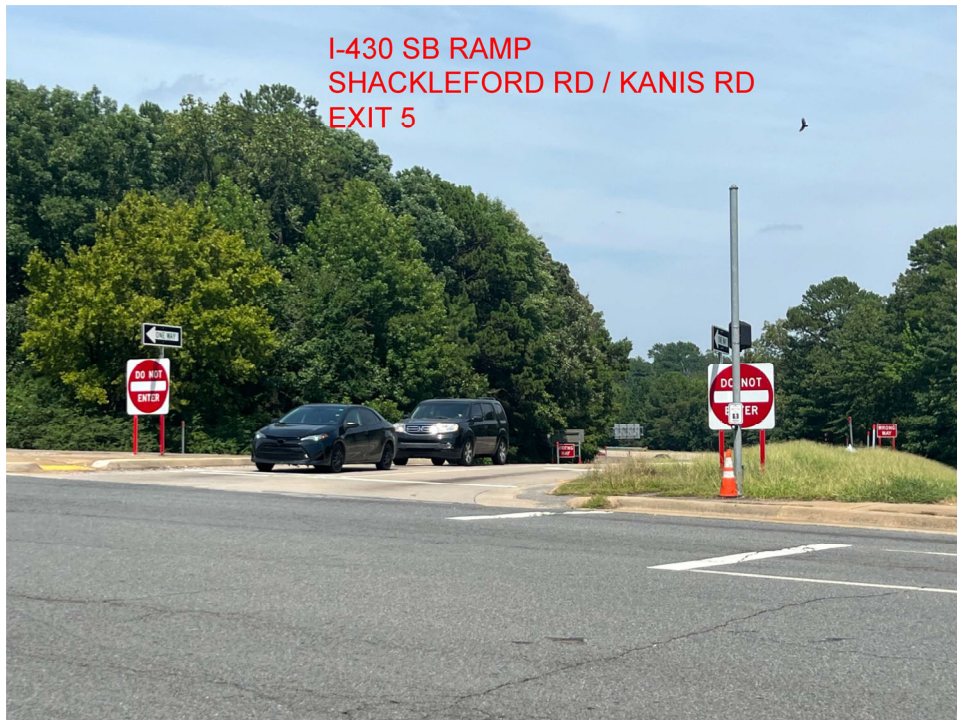
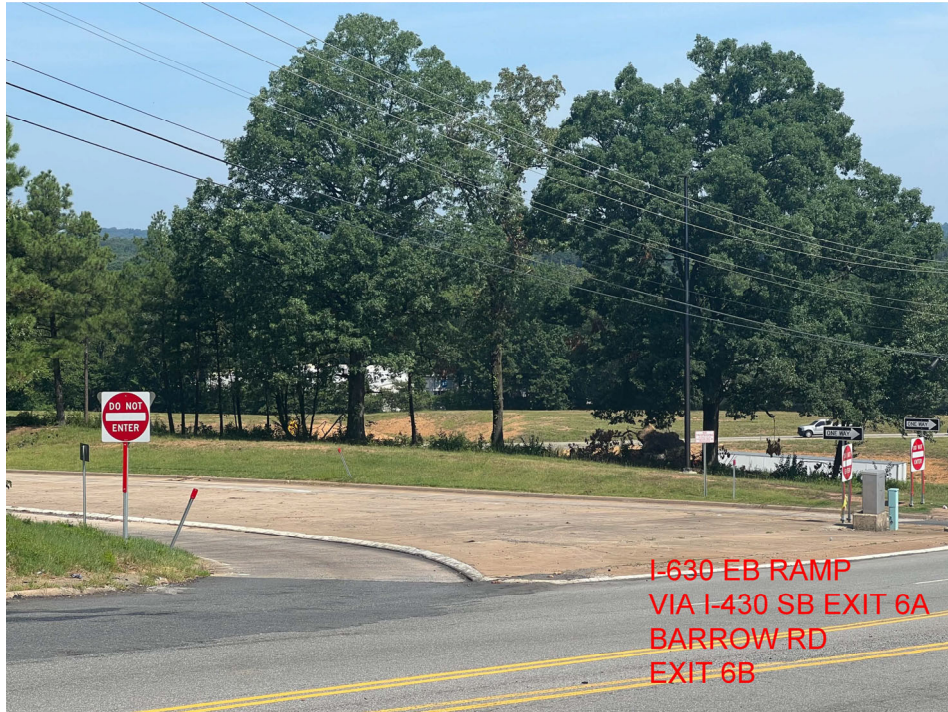
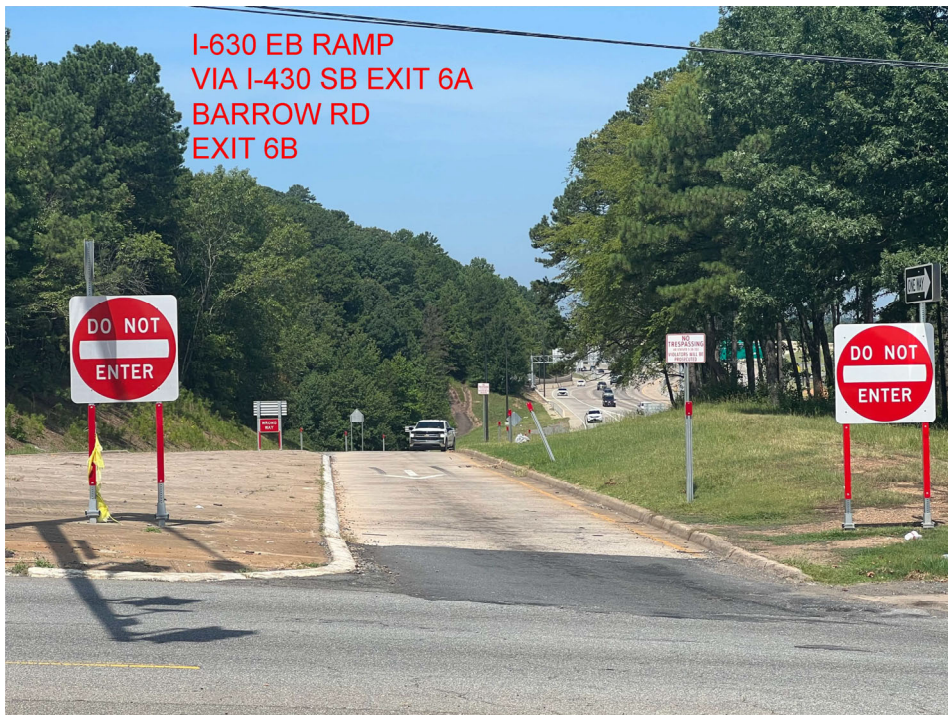
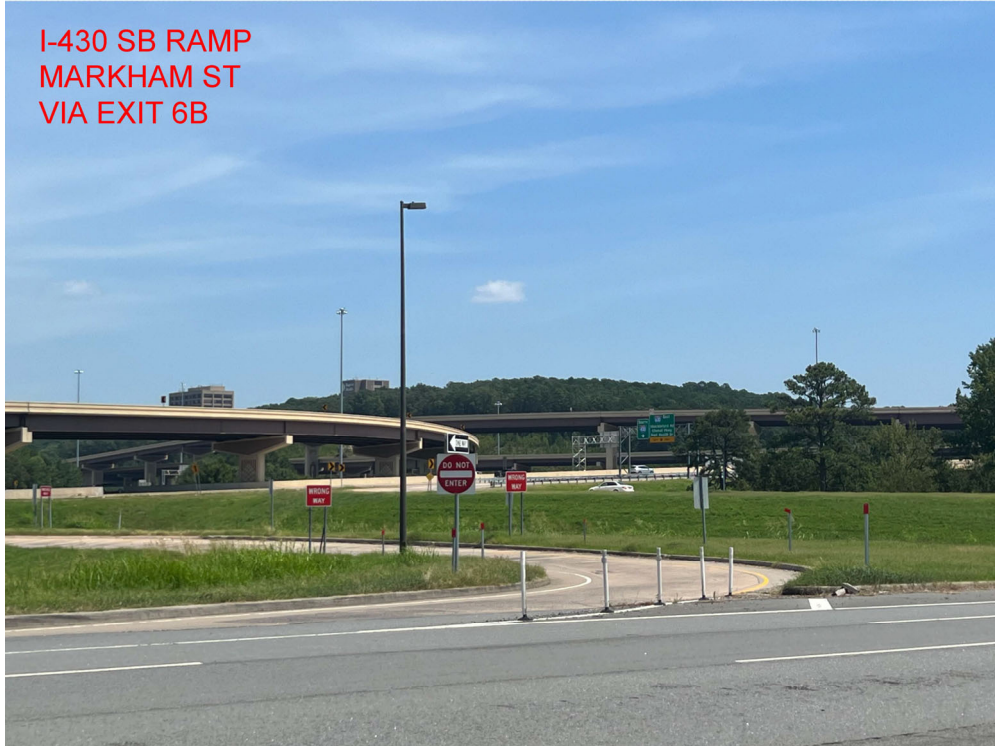
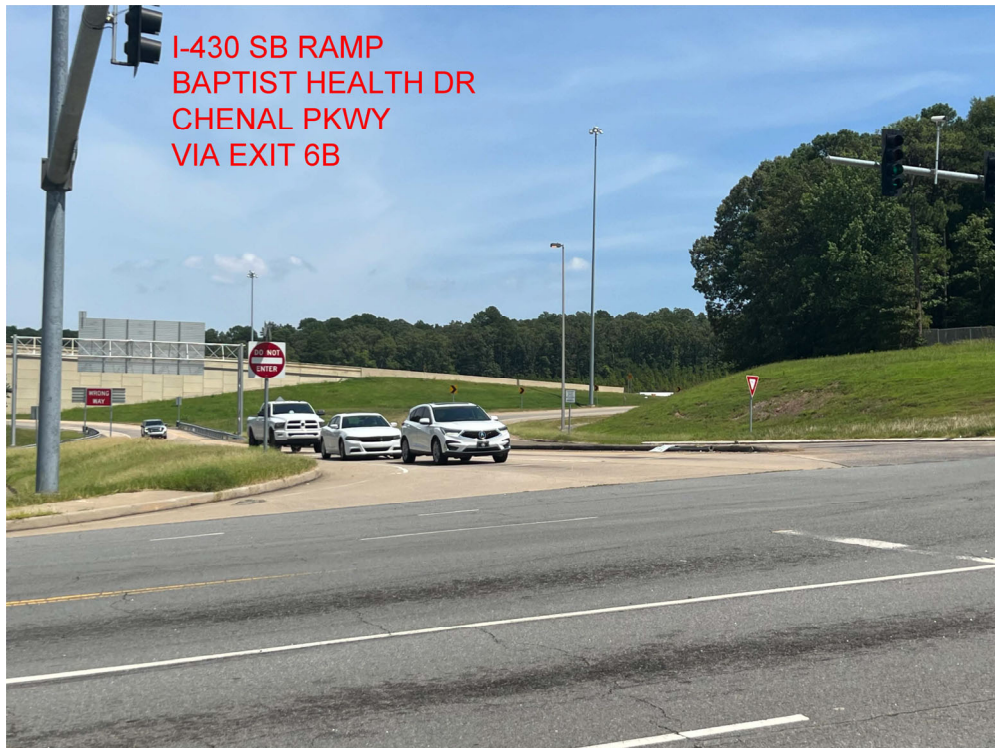
**Crash # 2022521663 I-430, Section 21, Direction B, Log Mile 3.893**

The driver accessed I-430 possibly at Exit 5 (Shackleford Rd., Kanis Rd.), Exit 6B via Exit 6A (Barrow Rd.), Exit 6B (Markham St., Baptist Health Dr., Chenal Pkwy.) or Exit 8 (Rodney Parham Rd.) and traveled northbound in the southbound traffic lane on I-430. This area of Interstate was under construction at the time of the accident. The wrong-way driver was involved in a head-on collision with an active construction machine which resulted in a fatality.

The interchange at Exit 6B was reviewed. Signs were in place and in conformance with MUTCD. However, an additional “Wrong Way” sign needs to be installed with the red vertical reflective strips on the signpost to conform with current ARDOT requirements. Also, pavement markings (stop & yield bars) need to be installed to conform with current ARDOT requirements. These modifications have been implemented.

The interchange at Exit 8 was reviewed. Signs were in place and in conformance with MUTCD. However, additional “Do Not Enter” and “Yield” signs need to be installed with red vertical reflective strips on the signposts to conform with current ARDOT requirements. Also, pavement marking (yield bar) need to be installed to conform with current ARDOT requirements. These modifications have been implemented.

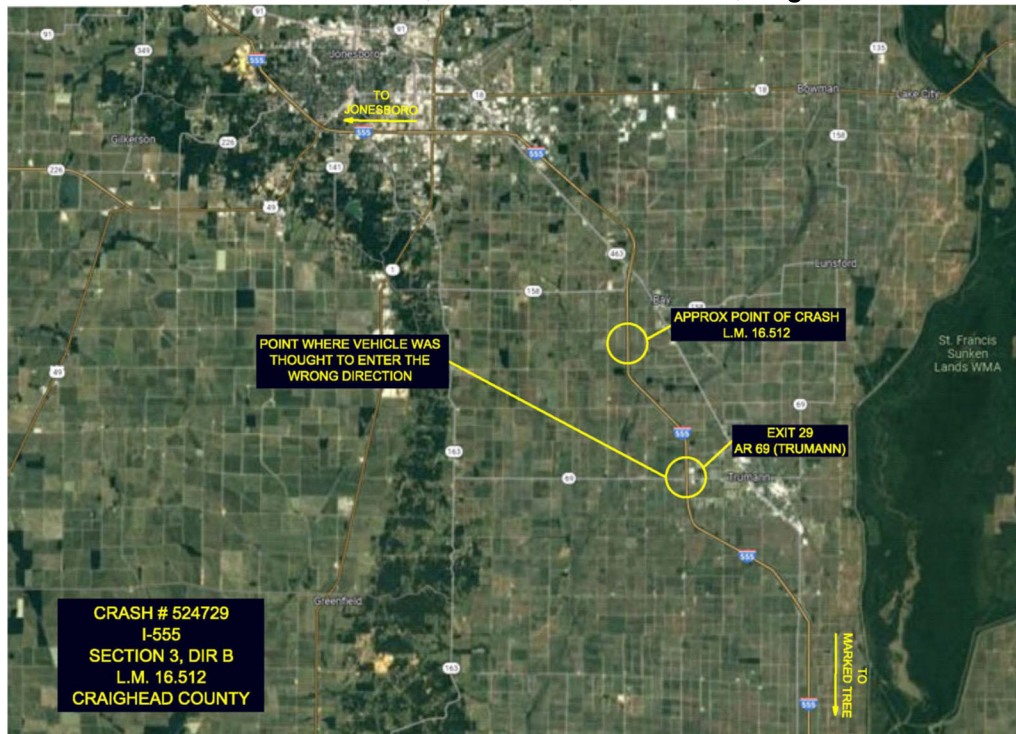
**Crash # 2022524729 I-555, Section 3, Direction B, Log Mile 16.512**

The driver accessed I-555 at Exit 29 (AR 69, Trumann) and traveled northbound in the southbound traffic lane on I-555 while fleeing from the Trumann Police Department. The wrong-way vehicle forced an oncoming vehicle to swerve to their right to avoid being hit head-on, causing that vehicle to strike a ditch embankment, near log mile 19.731 in Poinsett County. The wrong-way vehicle traveled into Craighead County where it left the roadway and struck the cable median barrier.

The interchange at Exit 29 was reviewed. Pavement markings and signs were in place and in conformance with MUTCD. However, red vertical strips need to be installed on one of the “Wrong Way” signposts to conform with current ARDOT requirements. This modification has been implemented.

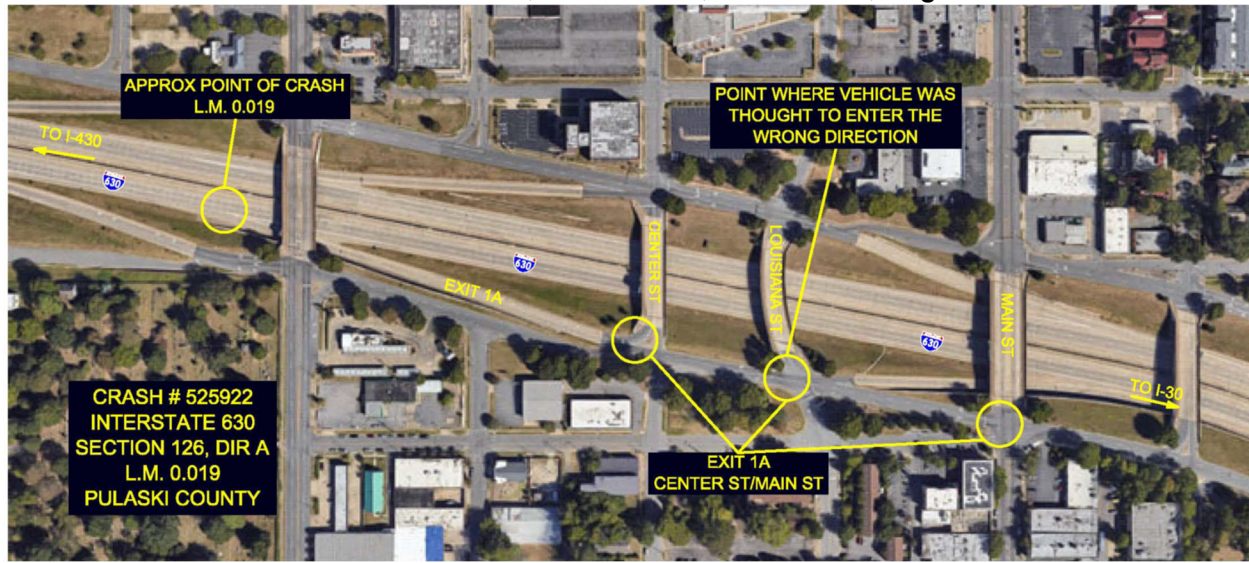
**Crash # 2022525922 I-630, Section 126, Direction A, Log Mile 0.019**

The driver attempted to access I-630 at Center St./Main St. and traveled westbound on the eastbound traffic lane of Exit 1A off ramp. The wrong-way vehicle struck the right front bumper of the eastbound vehicle. The wrong-way driver was under the influence of alcohol at the time of the accident.

The interchange at Exit 1A was reviewed. Pavement markings and signs were in place and in conformance with MUTCD and ARDOT requirements.

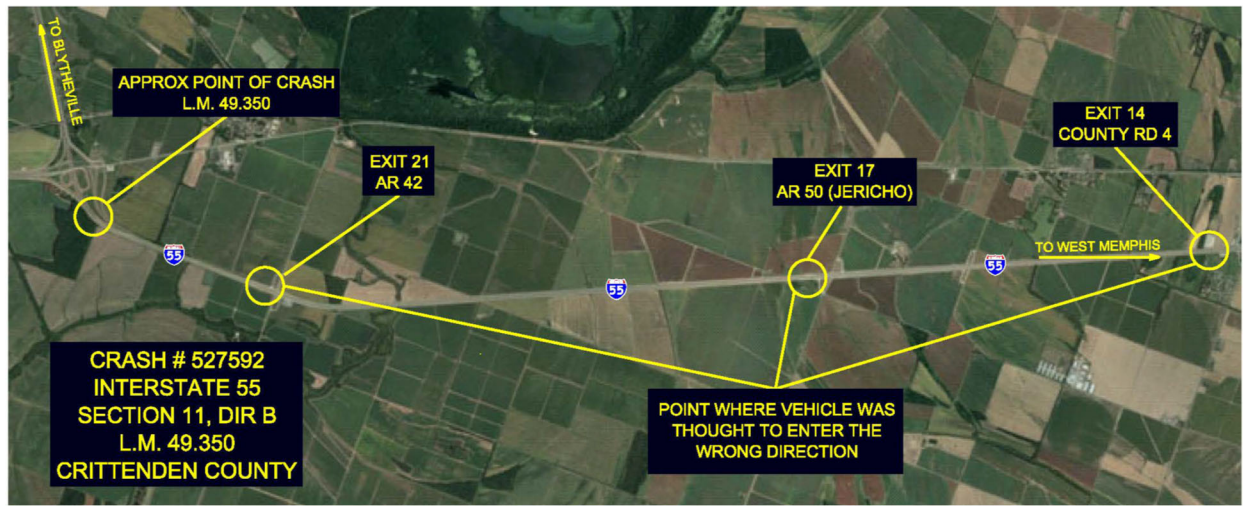
**Crash # 2022527592 I-55, Section 11, Direction B, Log Mile 49.350**

The driver accessed I-55 possibly at Exit 14 (County Rd. 4), Exit 17 (AR 50, Jericho) or Exit 21 (AR 42) and traveled northbound in the southbound traffic lane. The wrong-way vehicle was in the southbound outside (right) lane and veered left off the roadway, colliding with the ditch, where it came to a final rest. The wrong-way driver was under the influence of alcohol at the time of the accident.

The interchange at Exit 14 was reviewed. Signs were in place and in conformance with MUTCD and ARDOT requirements. However, the arrow pavement marking needs to be installed to conform with current ARDOT requirements.

The interchange at Exit 17 was reviewed. Signs were in place and in conformance with MUTCD and ARDOT requirements. However, arrow pavement markings need be installed to conform with current ARDOT requirements.

The interchange at Exit 21 was reviewed. Signs were in place and in conformance with MUTCD and ARDOT requirements. However, pavement markings (arrows and yield bars) need to be installed to conform with ARDOT requirements.

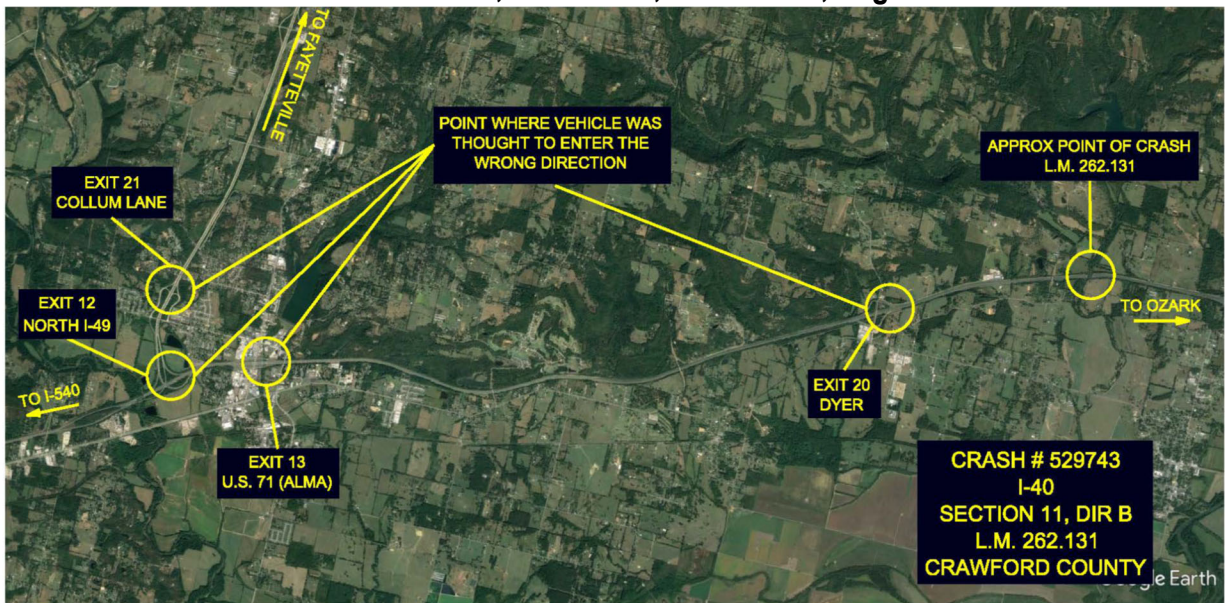
**Crash # 2022529743 I-40, Section 11, Direction B, Log Mile 262.131**

The driver accessed I-40 possibly at Exit 13 (U.S. 71, Alma), Exit 20 (Dyer) or Exit 21 via Exit 12 (Collum Lane) and traveled eastbound in the westbound traffic lane on I-40. The wrong-way driver was involved in a head-on collision with several motorcycles which resulted in multiple fatalities. The wrong-way driver tested positive for drugs at the time of the crash.

The interchange at Exit 13 was reviewed. Pavement markings and signs were in place and in conformance with MUTCD and ARDOT requirements.

The interchange at Exit 20 was reviewed. Pavement markings and signs were in place and in conformance with MUTCD and ARDOT requirements.

The interchange at Exit 21 via Exit 12 was reviewed. Pavement markings and signs were in place and in conformance with MUTCD and ARDOT requirements.
