# WRONG-WAY CRASH STUDY

INTERSTATES AND FREEWAYS | CALENDAR YEAR 2022

## Wrong-Way Crash Report

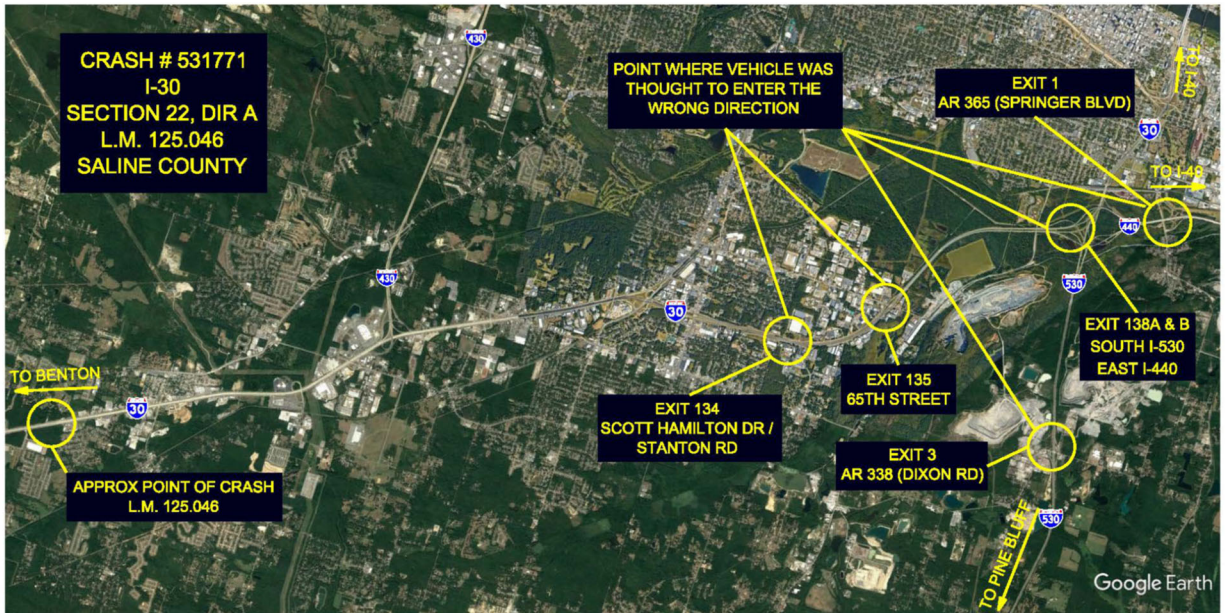
**Crash # 2022531771 I-30, Section 11, Direction A, Log Mile 125.046**

The driver accessed I-30 possibly at Exit 1 via Exit 138 (AR 365, Springer Blvd.), Exit 3 via Exit 138 (AR 338, Dixon Rd.), Exit 134 (Scott Hamilton Dr., Stanton Rd.) or Exit 135 (65th St.) and traveled westbound in the eastbound traffic lane. Communications received 911 calls regarding a wrong-way vehicle on I-30 around mile marker 133, then later advised they witnessed a head-on collision on ARDOT cameras near mile marker 124. The wrong-way driver was involved in a head-on collision in the inside eastbound travel lane which resulted in a fatality.

The interchange at Exit 1 via Exit 138 was reviewed. Signs were in place and in conformance with MUTCD and ARDOT requirements. However, pavement markings (arrow & cat tracks) have faded and need to be replaced to conform with current ARDOT requirements. These modifications have been implemented.

The interchange at Exit 3 via Exit 138 was reviewed. Signs were in place and in conformance with MUTCD and ARDOT requirements. However, pavement markings (stop & yield bars, arrow) need to be installed to conform with current ARDOT requirements. These modifications have been implemented.

The interchange at Exit 134 was reviewed. Pavement markings and signs were in place and in conformance with MUTCD. However, an additional "Wrong Way" sign needs to be installed with red vertical reflective strips on the signpost to conform with current ARDOT requirements. These modifications have been implemented.

The interchange at Exit 135 was reviewed. Pavement markings and signs were in place and in conformance with MUTCD and ARDOT requirements.

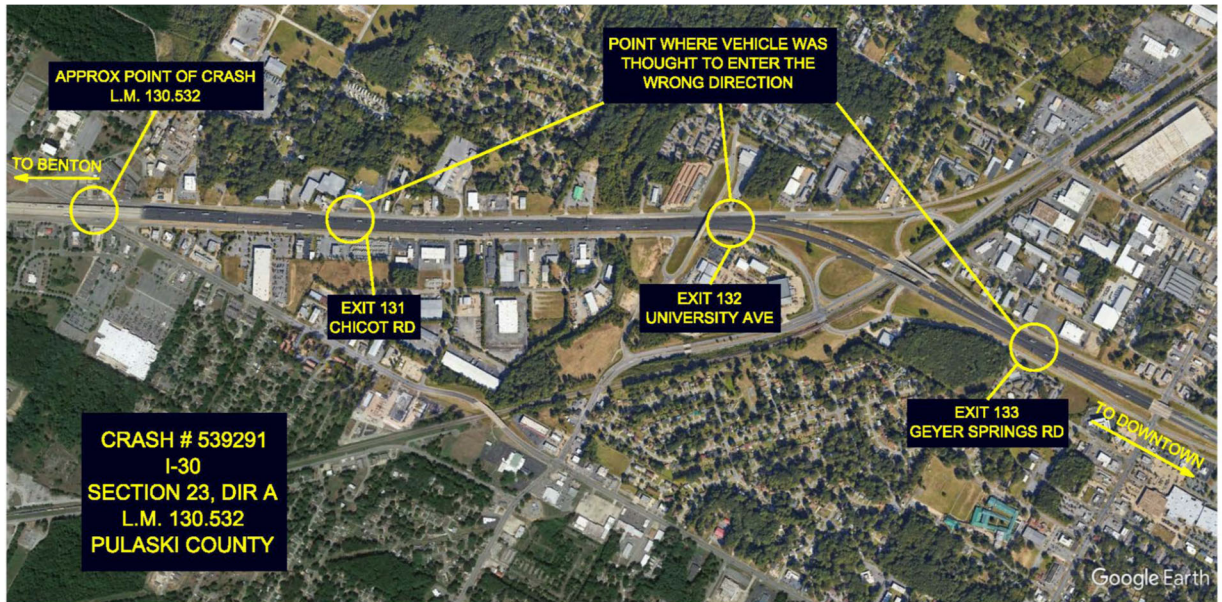
**Crash # 2022539291 I-30, Section 23, Direction A, Log Mile 130.532**

The driver accessed I-30 possibly at Exit 131 (Chicot Rd.), Exit 132 (University Ave.) or Exit 133 (Geyer Springs Rd.) and traveled westbound in the eastbound traffic lane. An eastbound vehicle observed the wrong-way vehicle going the wrong direction in the middle lane and attempted to avoid a head-on collision by swerving to the right. The front left fender of the wrong-way vehicle collided with the front left fender of the eastbound vehicle causing both vehicles to rotate counterclockwise before coming to a final rest. The wrong-way driver was under the influence of alcohol at the time of the crash.

The interchange at Exit 131 was reviewed. Pavement markings and signs were in place and in conformance with MUTCD. However, additional “Do Not Enter” and “Wrong Way” signs need to be installed. Existing “Do Not Enter” signs need to be upsized and red vertical reflective strips installed on the signposts to conform with ARDOT requirements. These modifications have been implemented.

The interchange at Exit 133 was reviewed. Pavement markings and signs were in place and in conformance with MUTCD and ARDOT requirements.

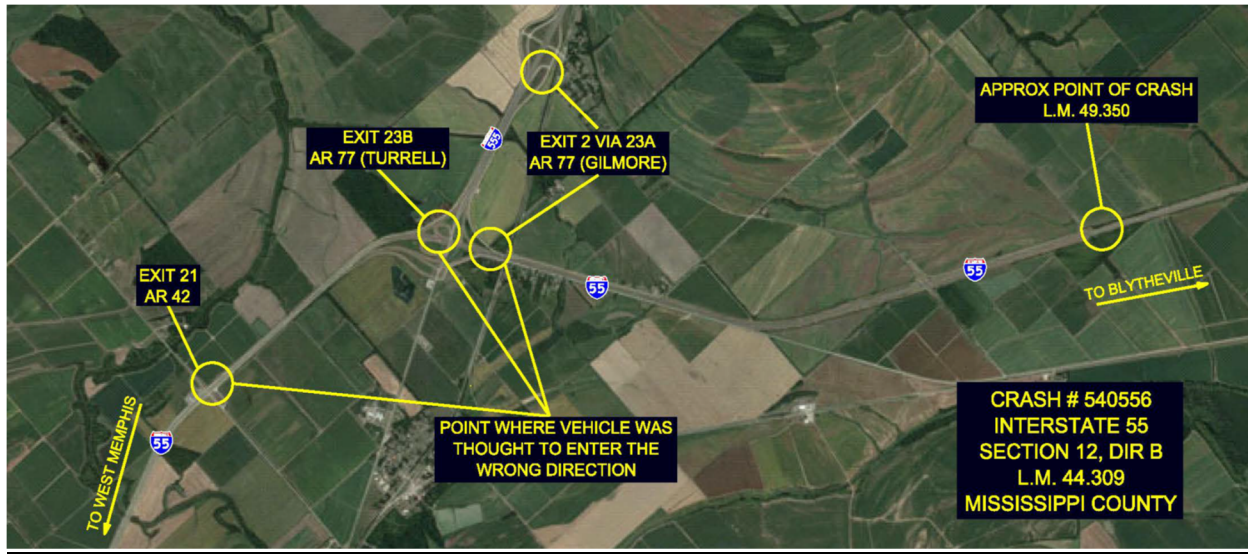
**Crash # 2022540556 I-55, Section 12, Direction B, Log Mile 44.309**

The driver accessed I-55 possibly at Exit 23A (I-555 North), Exit 23B (Hwy 77, Turrell), or Exit 21 (AR 42) and traveled northbound in the southbound traffic lane. The wrong-way vehicle was in the left-hand lane on the southbound side of the interstate, when they left the roadway and struck the cable median barrier. The wrong-way vehicle then re-entered the roadway, sideswiped a southbound vehicle, and came to rest in the middle of the southbound lanes. Another southbound vehicle was unable to avoid the wrong-way vehicle and struck it in the driver's side door causing the wrong-way vehicle to split in half behind the driver's side seat. The wrong-way driver was pronounced dead at the scene and tested positive for alcohol.

The interchange at Exit 23B was reviewed. Signs were in place and in conformance with MUTCD and ARDOT requirements. However, pavement markings (arrow & yield bar) need to be installed to conform with ARDOT requirements.

The interchange at Exit 2 via Exit 23A was reviewed. Signs were in place and in conformance with MUTCD. However, additional "Do Not Enter", "One Way" and "Stop" signs need to be installed with red vertical reflective strips on the signposts to conform with ARDOT requirements. Also, pavement markings (arrow, stop bar & yield bar) need to be installed to be consistent with ARDOT requirements. The sign modifications have been implemented.

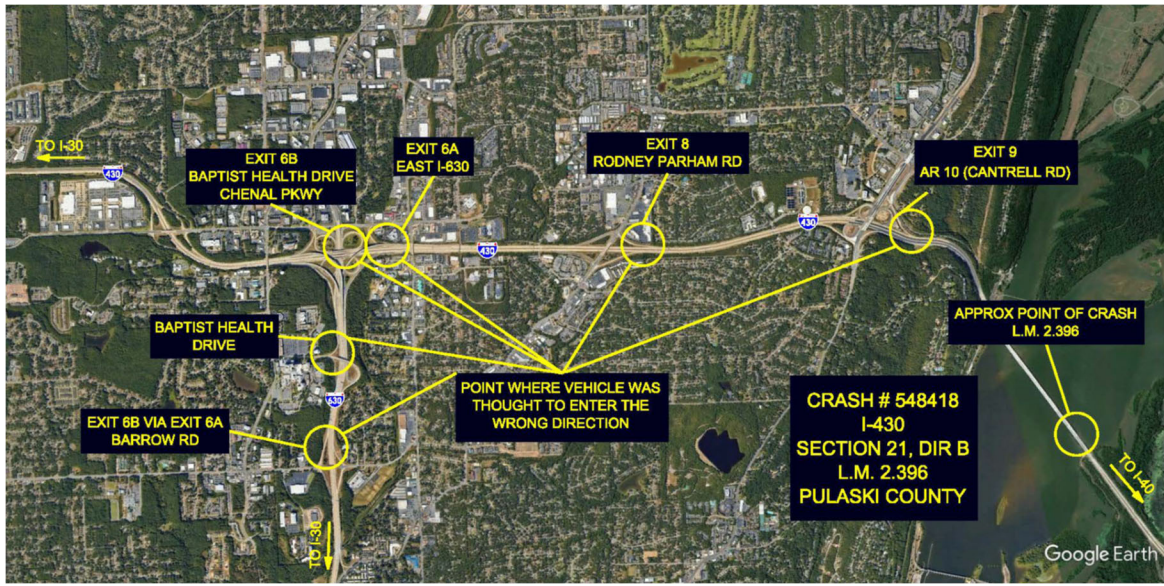
**Crash # 2022548418 I-430, Section 21, Direction B, Log Mile 2.396**

The driver accessed I-430 possibly at Exit 6B via Exit 6A (Barrow Rd.), Exit 6B (Markham St., Baptist Health Dr., Chenal Pkwy.), Exit 8 (Rodney Parham Rd.) or Exit 9 (AR 10, Cantrell Rd.) and traveled northbound in the southbound traffic lane. This area of interstate was under construction at the time of the crash. The wrong-way driver was involved in a head-on collision with a southbound vehicle in the inside lane. After impact the wrong-way vehicle crossed all three lanes, rotating clockwise, before coming to a final rest facing east in the outside lane. The wrong-way driver was suspected of being under the influence of alcohol at the time of the crash.

The interchange at Exit 8 was reviewed. Signs were in place and in conformance with MUTCD. However, additional “Do Not Enter” and “Yield” signs need to be installed and red vertical reflective strips need to be installed on the signposts to conform with current ARDOT requirements. Also, pavement marking (yield bar) need to be installed to conform with current ARDOT requirements. These modifications have been implemented.

The interchange at Exit 9 was reviewed. Pavement markings and signs were in place and in conformance with MUTCD. However, additional “One Way” and “Wrong Way” signs need to be installed. Existing “Wrong Way” signs need to be upsized and red vertical reflective strips need to be installed on all signposts to conform with current ARDOT requirements. These modifications have been implemented.

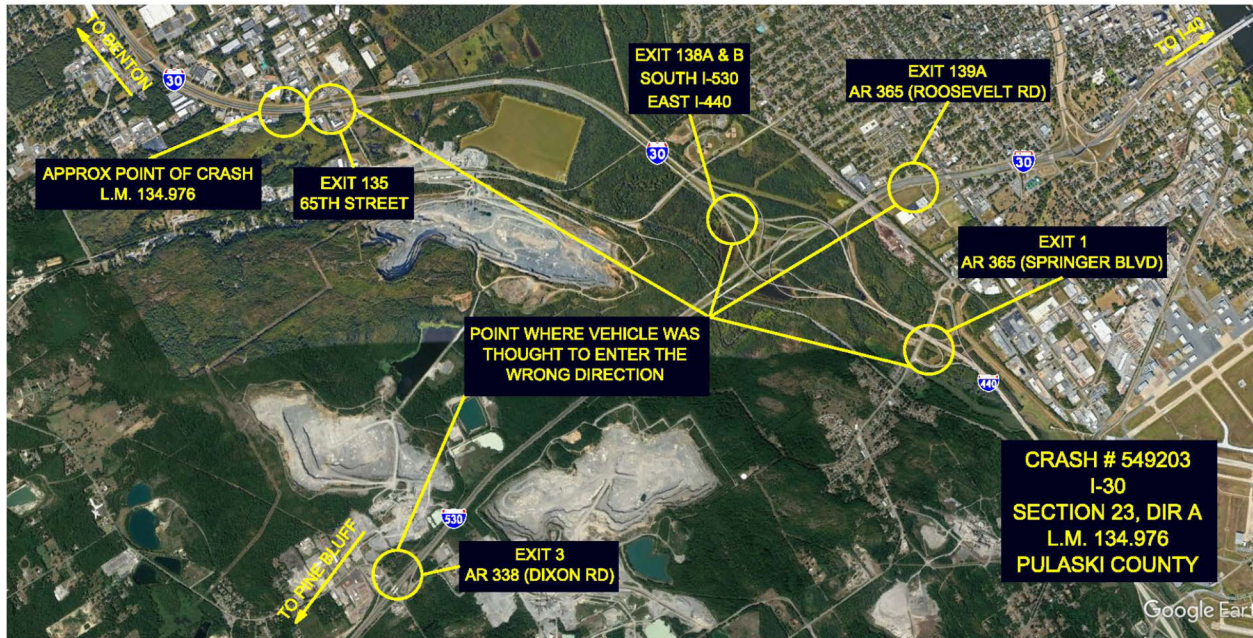
**Crash # 2022549203 I-30, Section 23, Direction A, Log Mile 134.976**

The driver accessed I-30 possibly at Exit 1 via Exit 138A (AR 365, Springer Blvd.), Exit 3 via Exit 138B (AR 338, Dixon Rd.), Exit 135 (65<sup>th</sup> St.) or Exit 139A (AR 365, Roosevelt Rd.) and traveled westbound in the eastbound traffic lane. The wrong-way vehicle side swiped a semi-truck and then fled the scene before being located on the eastbound frontage road near Scott Hamilton Drive. The wrong-way driver was under the influence of alcohol at the time of the crash.

The interchange at Exit 139A was reviewed. Signs were in place and in conformance with MUTCD and ARDOT requirements. However, one of the “Wrong Way” sign was damaged and needs to be replaced. Also, pavement marking (stop bar) needs to be installed to conform with current ARDOT requirements. These modifications have been implemented.

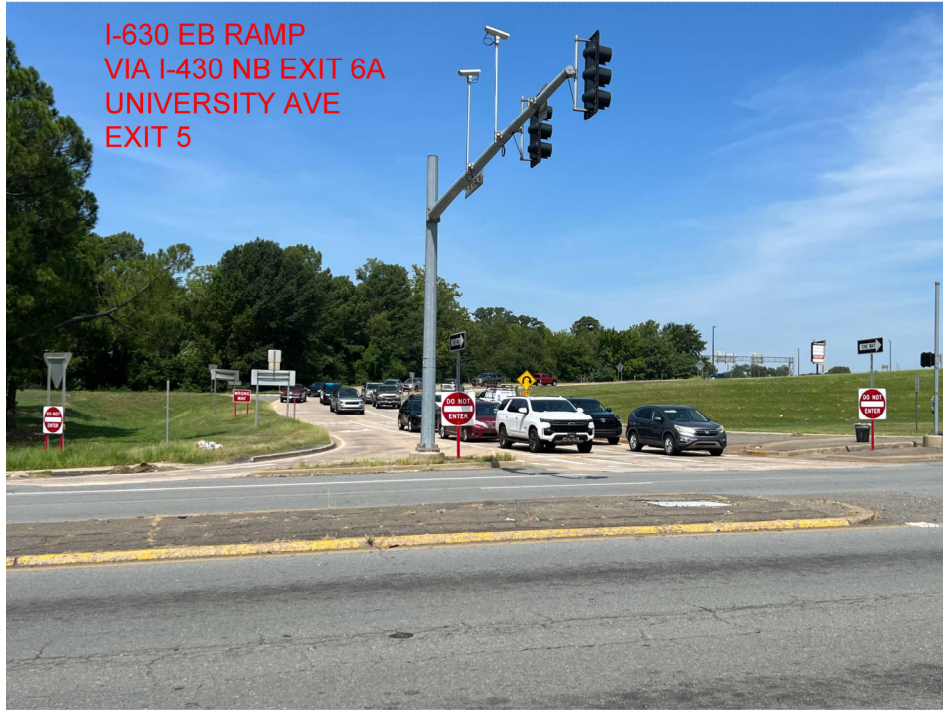
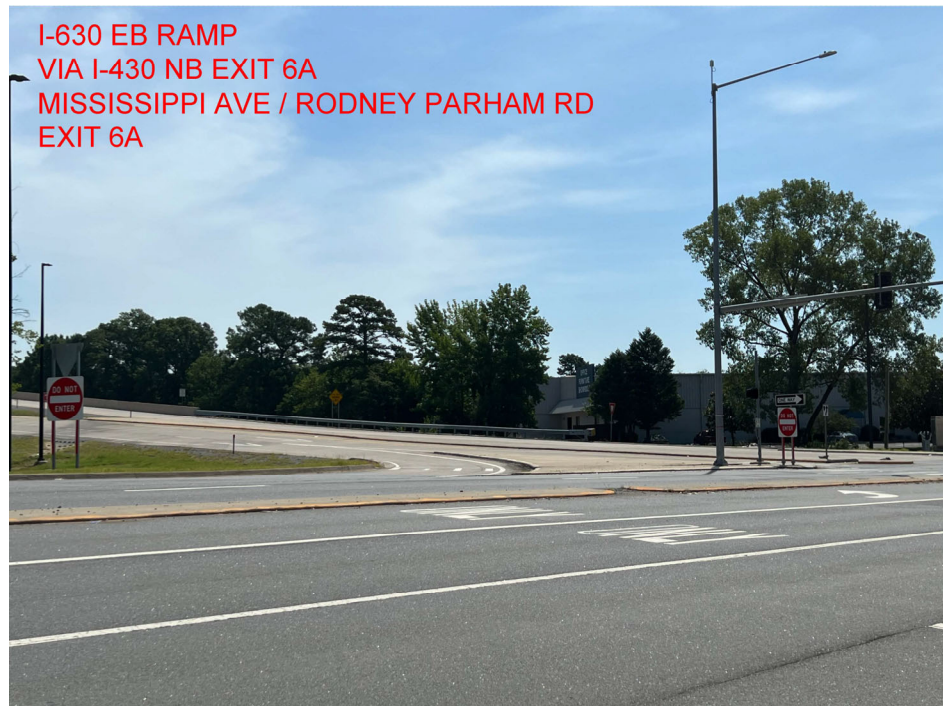
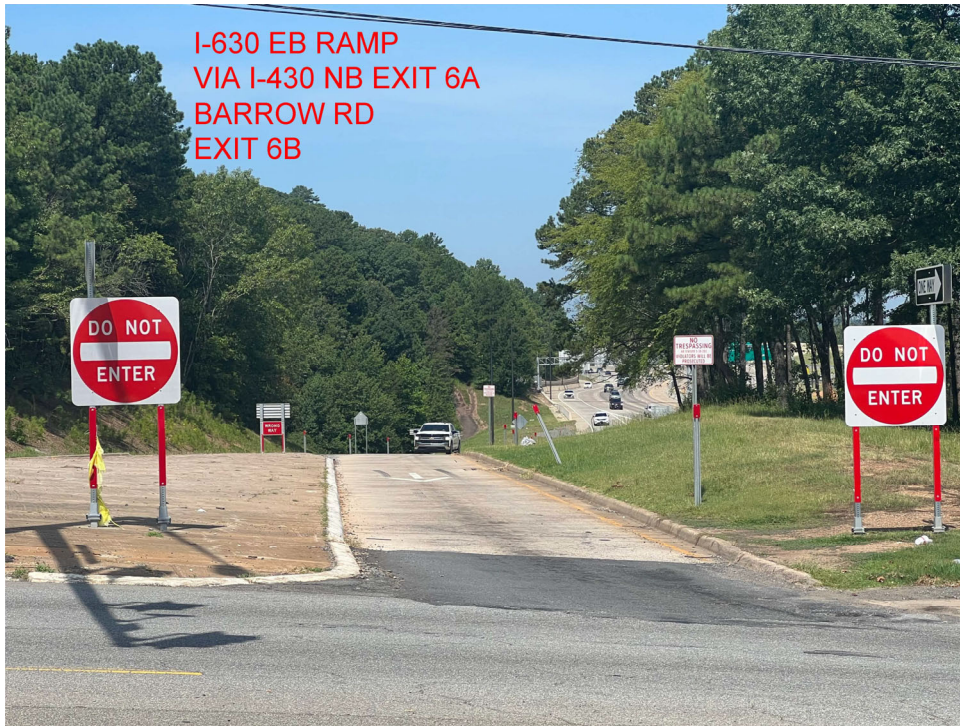
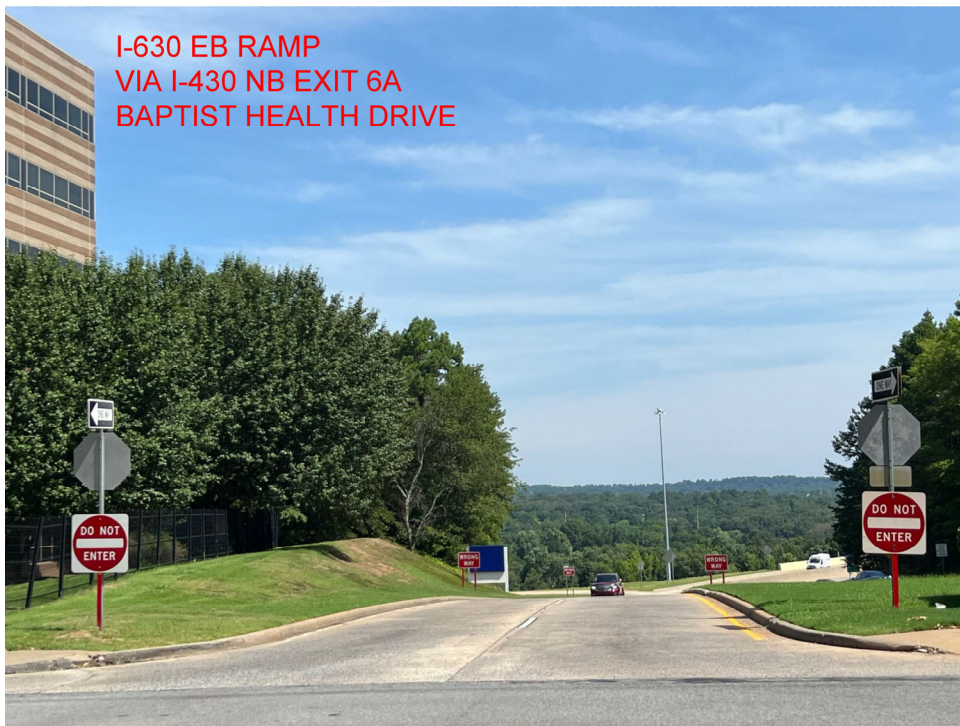
The interchange at Exit 6A was reviewed. Signs were in conformance with MUTCD. However, the “Keep Right” sign needs to be upsized. Also, pavement marking (cat tracks) have faded and need to be replaced to conform with current ARDOT requirements.

The interchange at Exit 6B was reviewed. Signs were in place and in conformance with MUTCD. However, an additional “Wrong Way” sign needs to be installed and red vertical reflective strips needs to be installed on the signpost to conform with current ARDOT requirements. Also, pavement markings (stop and yield bars) will need to be installed to be consistent with current ARDOT requirements. The sign modifications have been implemented.

The interchange at the Baptist Health Exit was reviewed. Pavement markings and Signs were in place and in conformance with MUTCD and ARDOT requirements.

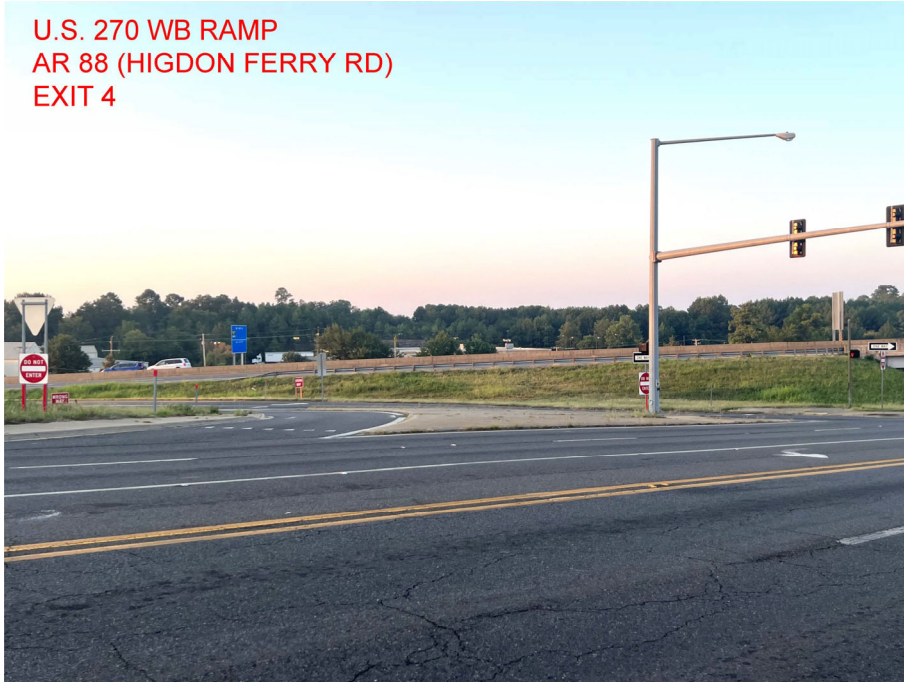
U.S. 270 WB RAMP  
AR 88 (HIGDON FERRY RD)  
EXIT 4

The interchange at Exit 4 was reviewed. Pavement markings and signs were in place and in conformance with MUTCD and ARDOT requirements.

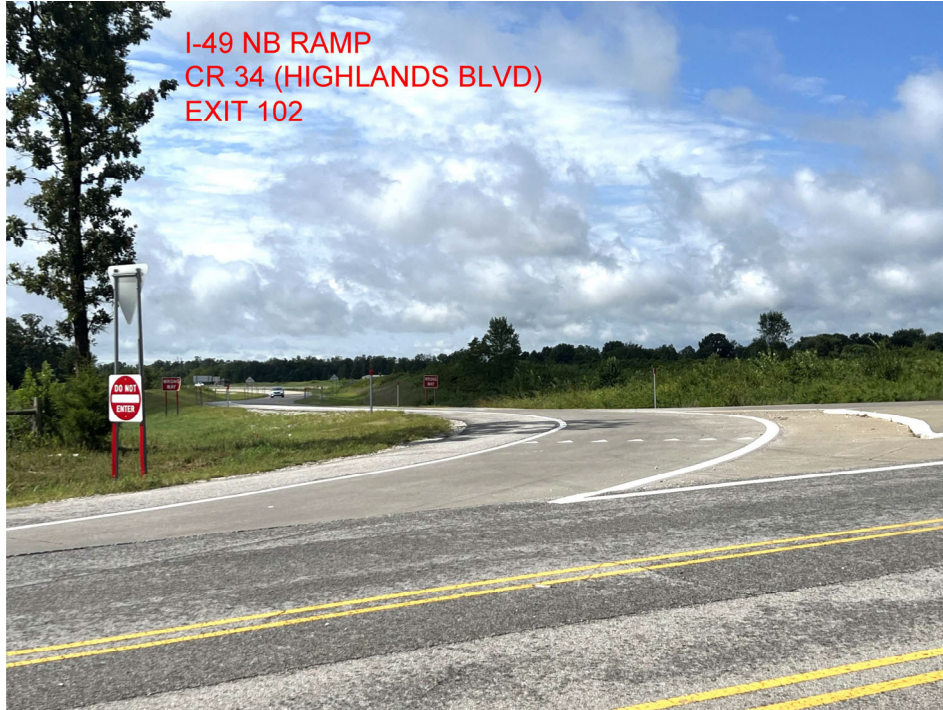
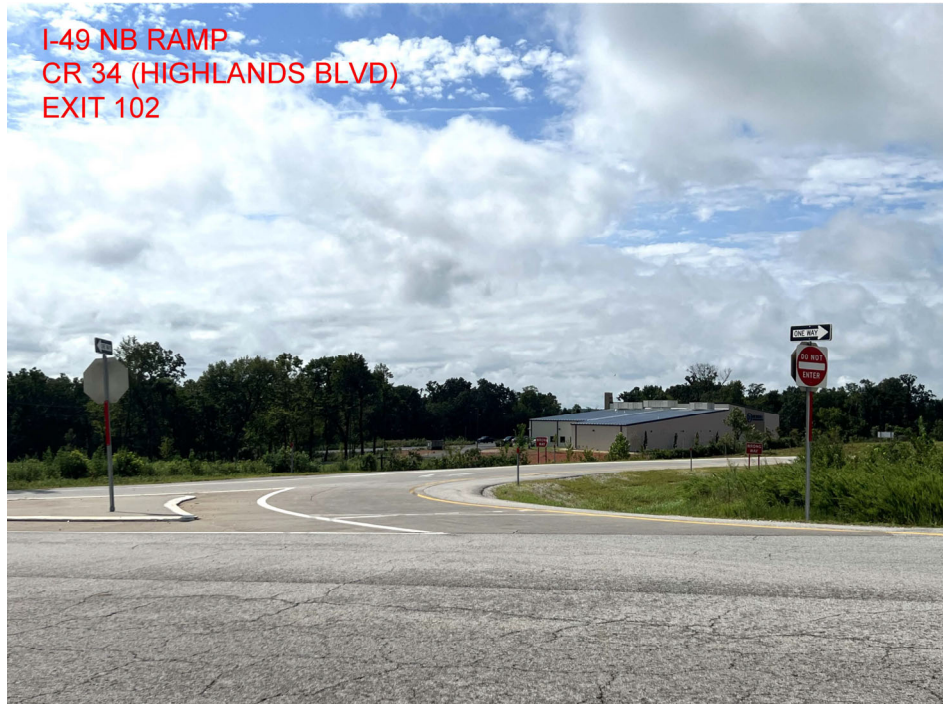
The interchange at Exit 102 was reviewed. Pavement markings and signs were in place and in conformance with MUTCD. However, an additional "Do Not Enter" sign needs to be installed to conform with current ARDOT requirements. This modification has been implemented.
