## Bridge 02899 Inspection Report

Arnold Road ID:54x49x11xA, Arnold Log mile:0.569

# National Bridge Inventory Data Sheet

| IDENTIFICATION | |
|---|---|
| (7) Facility Carried | US 49- Phillips Co |

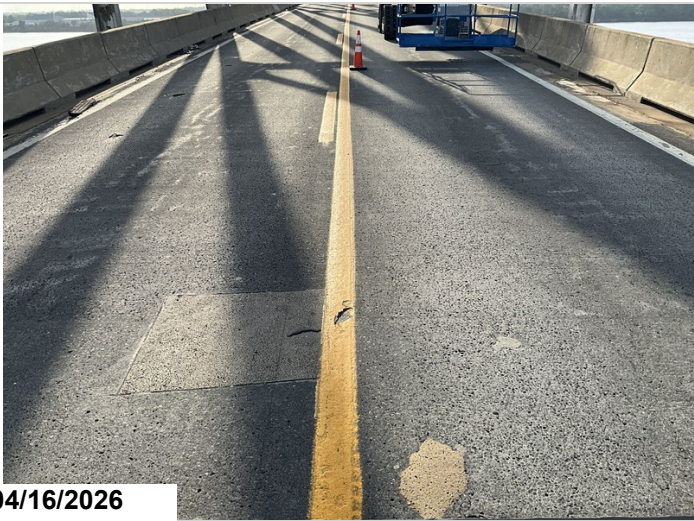
Overall, the Deck is in Poor condition throughout the structure. The Main Truss spans exhibit extensive deterioration, including large areas of spalling, numerous unsound patches, widespread exposed reinforcing steel, efflorescence, cracking, and abrasion. The underside of the deck also shows significant deterioration, with multiple areas of spalling and exposed reinforcing steel, particularly along the overhangs.

Typical deck, Truss Spans.

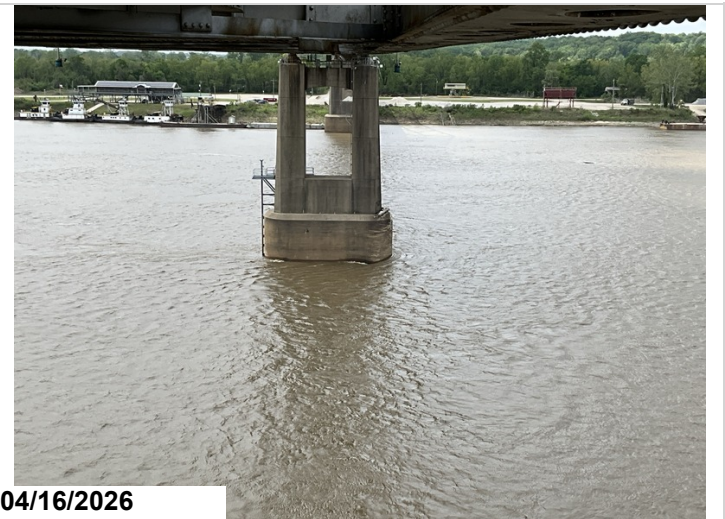
Pier 12, Left: impact damage.

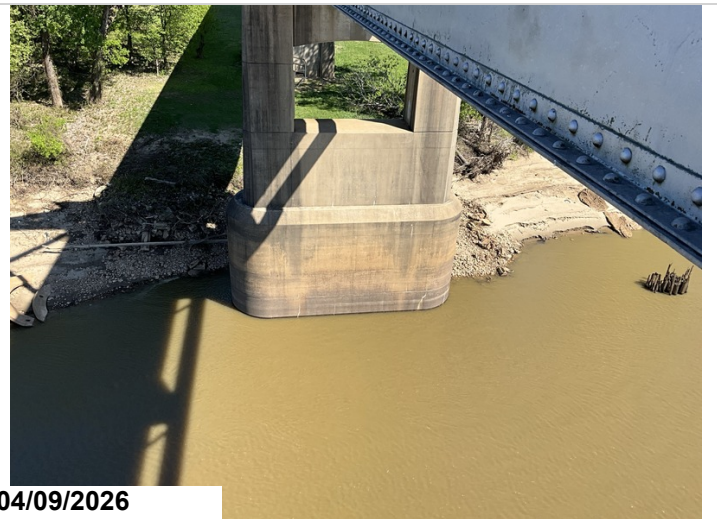
Pier 15, Back: Cracking with efflorescence.

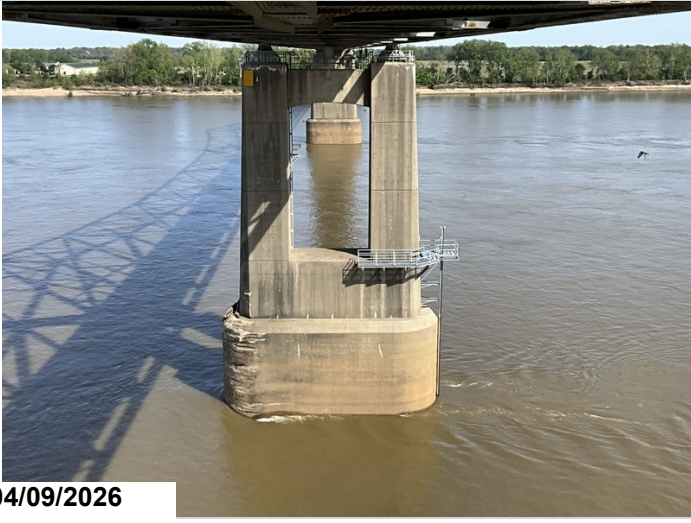
Pier 13 back, cracks with efflorescence, collision damage on the left side.

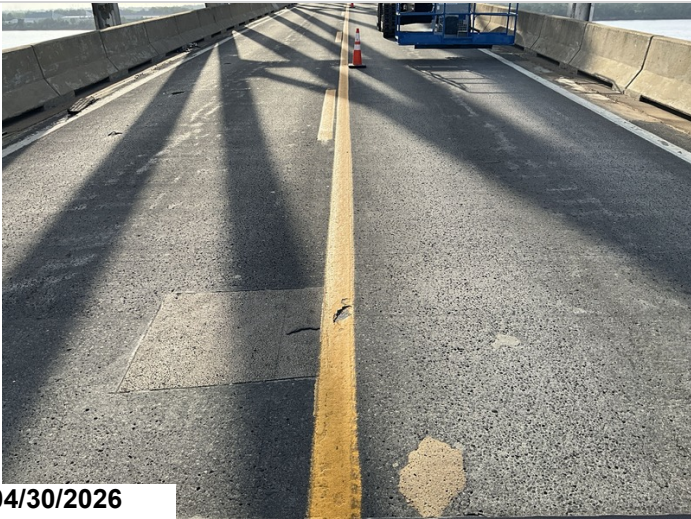
Deck washing could be used.

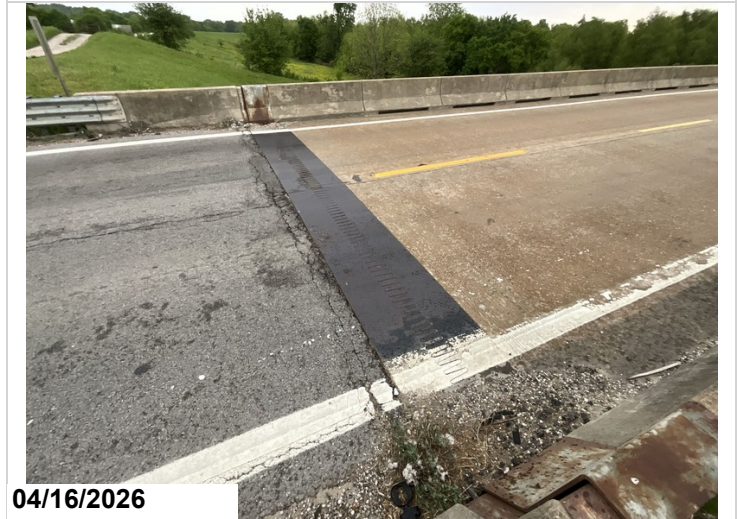
Abutment 1, Joint: Fingers closed due to rotation in abutment.

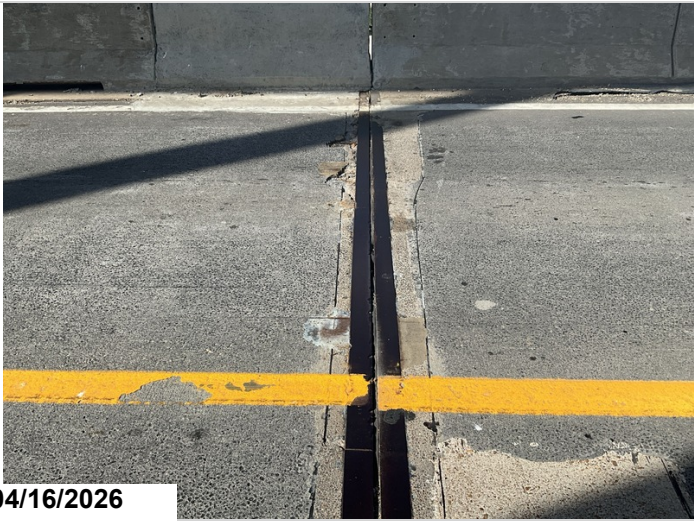
PP3: Joint loose in Arkansas bound lane 9'.

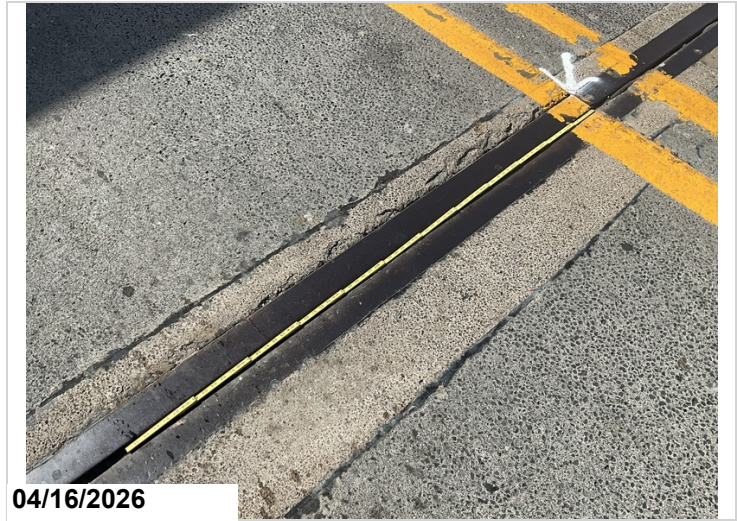
PP8, Joint: Cracked and loose for 56" on Mississippi bound lane.

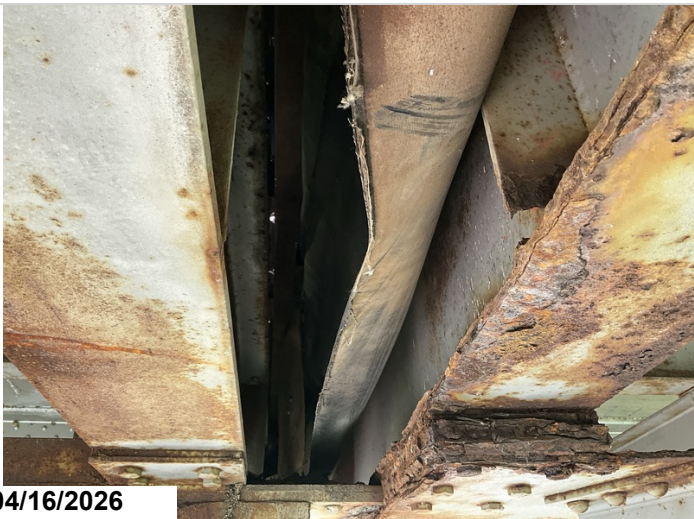
Span 19, pin and hanger joint: trough torn full length of joint.  
LF CS4

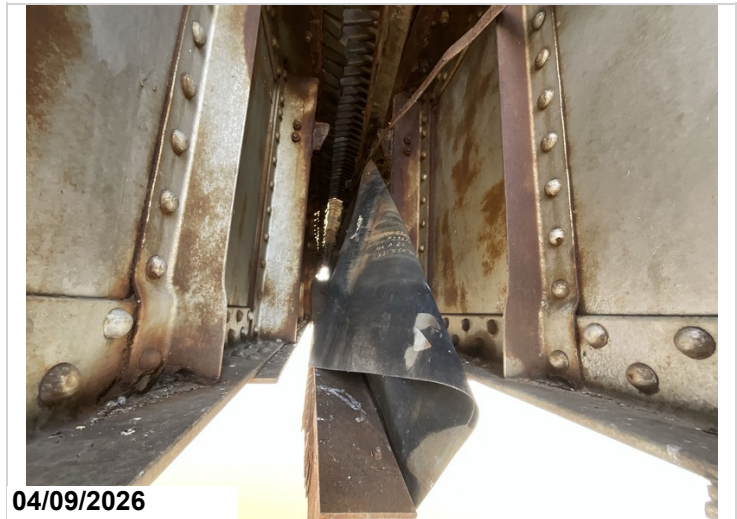
Span 14, PP59, Joint seal and angle connection plate:  
Corroded and broken away from the connection areas,  
causing the joint seal and angles to have little to no  
effectiveness.

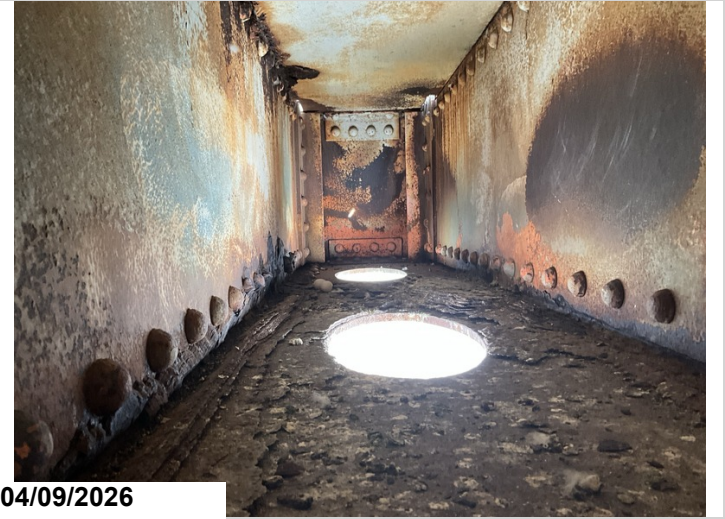
Span 13, Truss 2, Inside of the Lower Chord, PP45, Back: Heavy Active corrosion with heavy flaking rust along top of Bottom Flange and inside webs. 10LF CS3 corrosion.

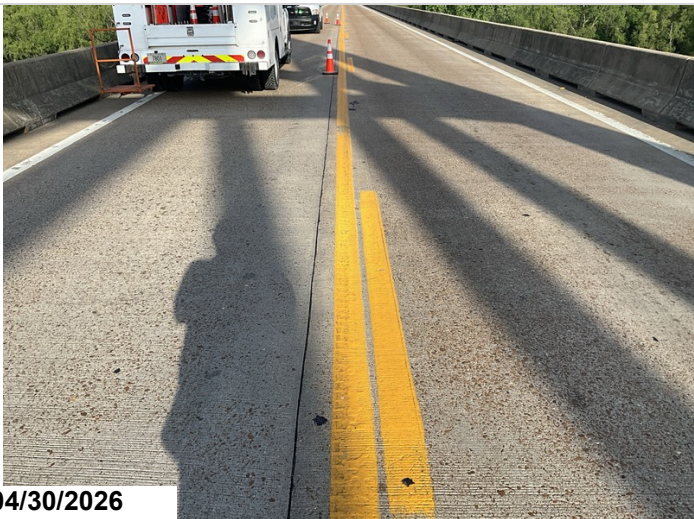
The approach spans, while not as deteriorated as the Main Truss spans, still display substantial distress. The driving surface contains widespread transverse cracking, and the underside exhibits cracking accompanied by notable efflorescence.

Approach Spans: Transverse cracking and abrasion.

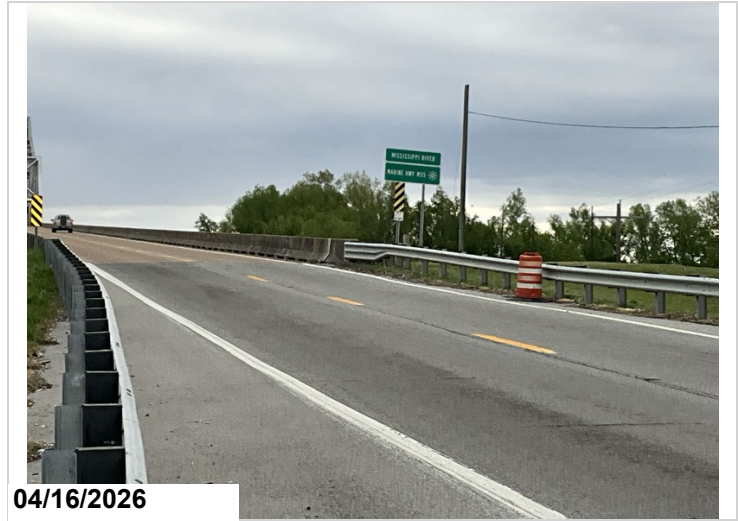
Typical Transition.

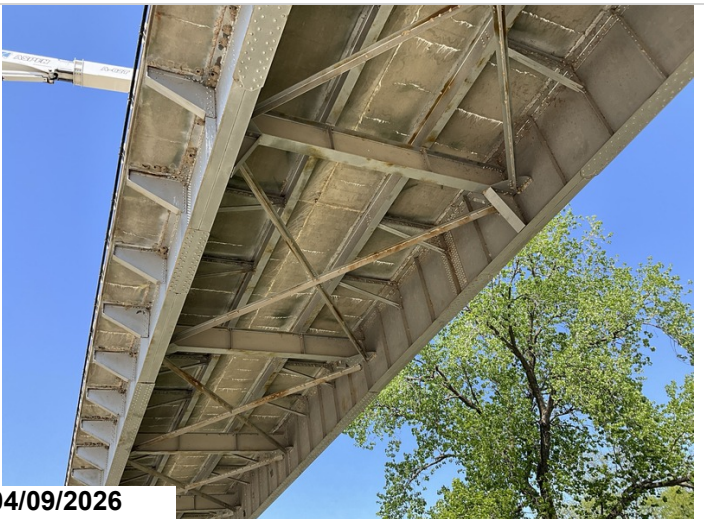
Span 8: Typical cracking with efflorescence along the Two-Girder Spans.

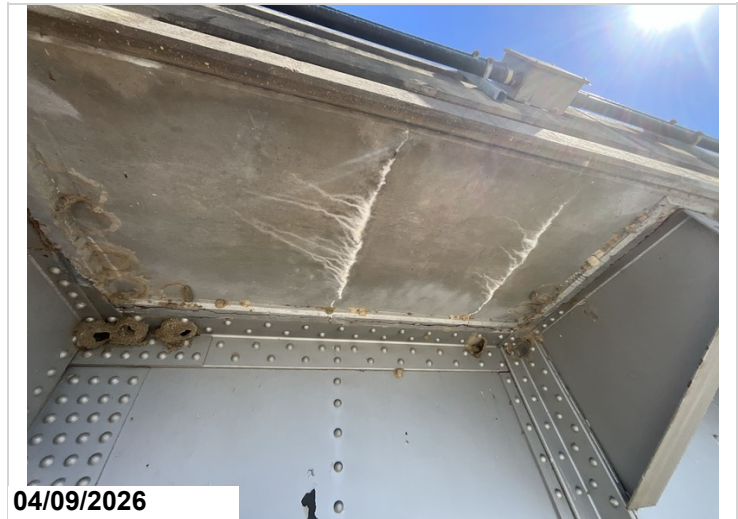
Span 9, Right overhang: Typical cracking with efflorescence.

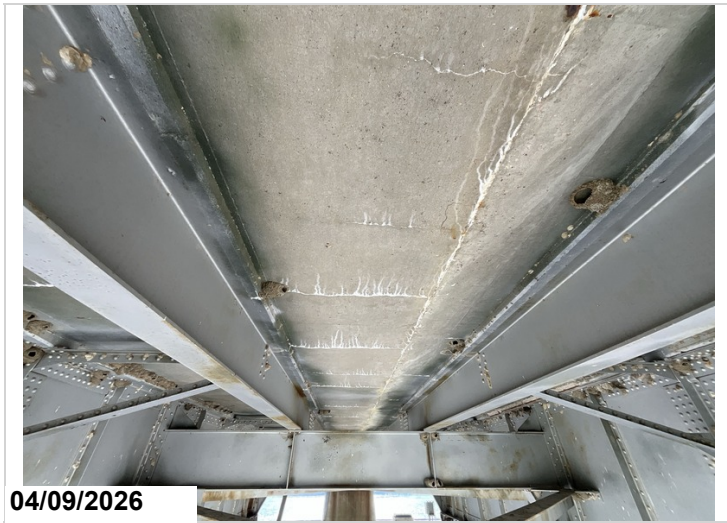
Span 10: Large amount of cracking with efflorescence.

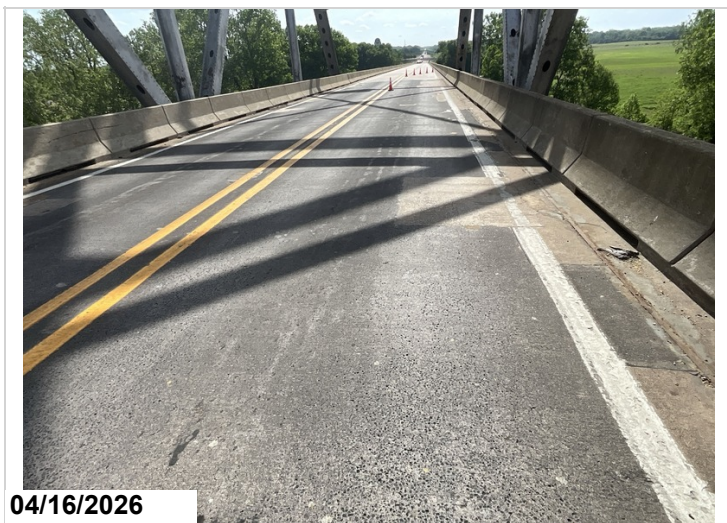
PP71 - PP74: 230SF of CS2 delam/patched areas and 5SF of CS3 exposed reinforcing steel.

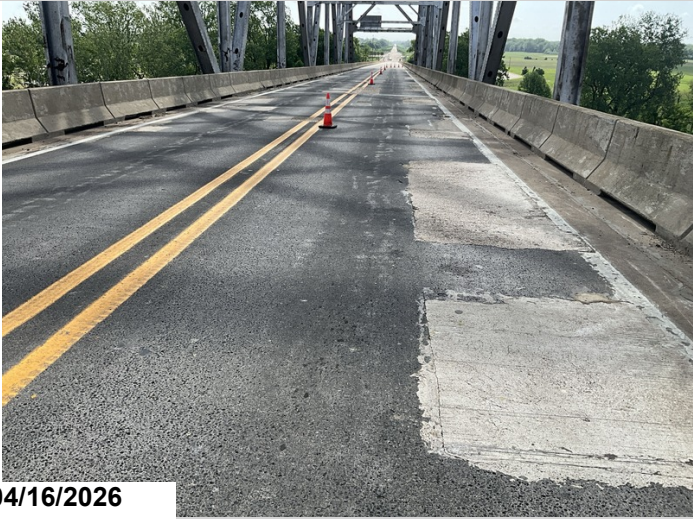
PP66 - PP68: 155SF of CS2 delam/patched areas and 61SF of CS3 spalling and unsound patched areas, along with 5SF of CS3 exposed reinforcing steel.

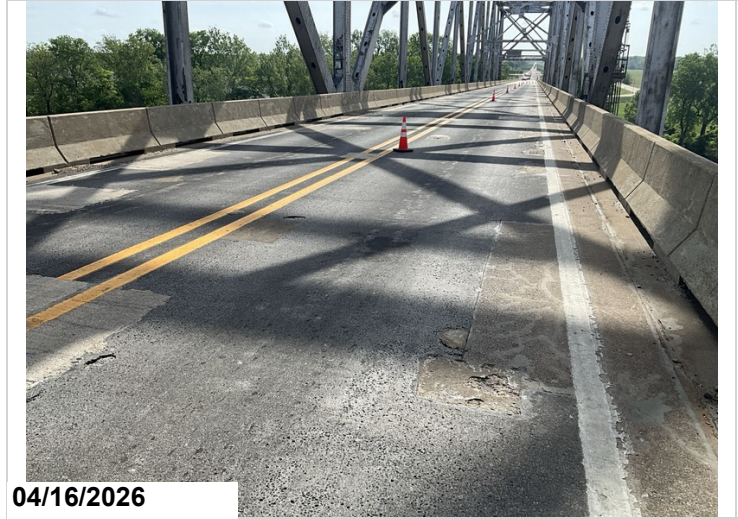
PP62 - PP66: 311SF of CS2 delam/patched areas and 90SF of CS3 spalling and unsound patched areas, along with 10SF CS3 of exposed reinforcing steel.

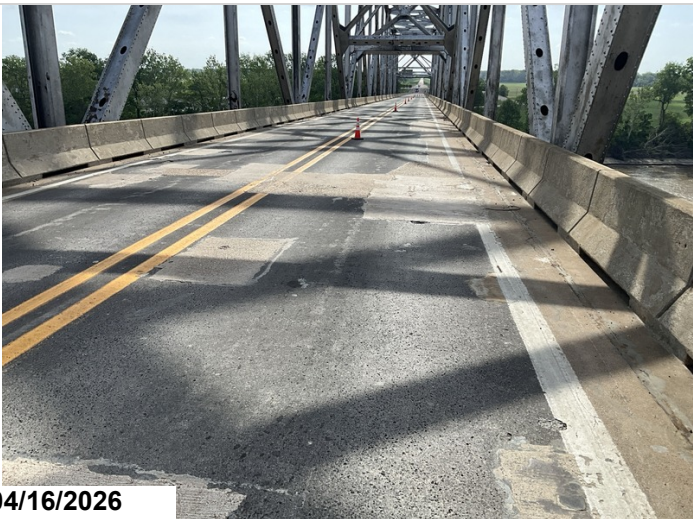
PP59 - PP62: 449SF of CS2 delam/patched areas and 111SF of CS3 spalling and unsound patched areas, along with 8SF of CS3 exposed reinforcing steel.

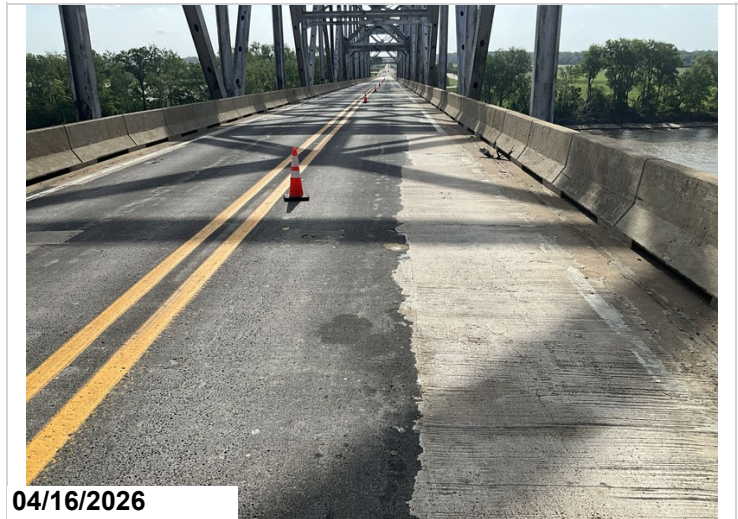
PP56 - PP59: 399SF of CS2 delam/patched areas and 67SF of CS3 spalling and unsound patched areas, along with 1SF of CS3 exposed reinforcing steel.

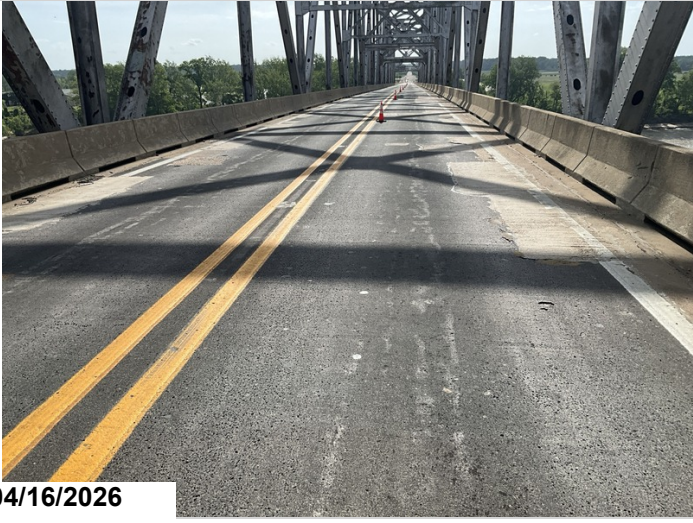
PP53 - PP56: 346SF of CS2 delam/patched areas and 81SF of CS3 spalling and unsound patched areas, along with 4SF of CS3 exposed reinforcing steel.

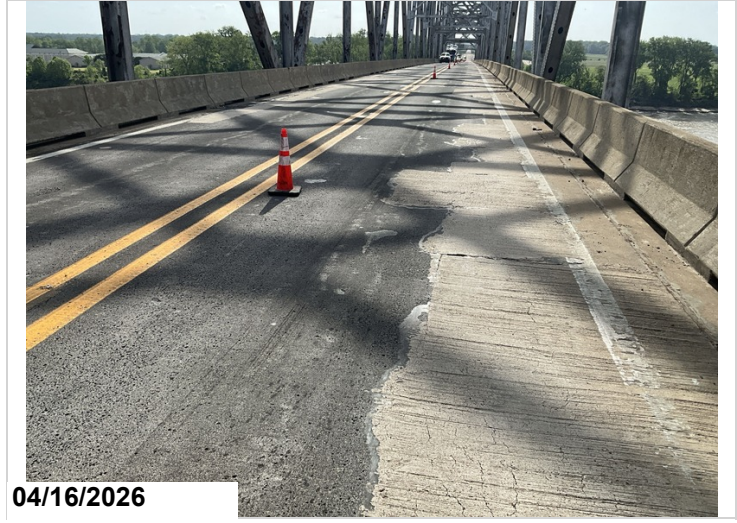
PP50 - PP53: 538SF of CS2 delam/patched areas and 110SF of CS3 spalling and unsound patched areas, along with 3SF of CS3 exposed reinforcing steel.

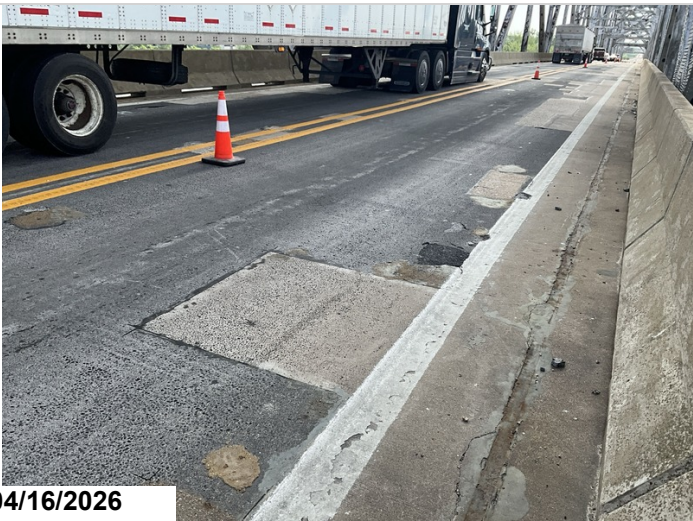
PP46 - PP50: 507SF of CS2 delam/patched areas and 95SF of CS3 spalling and unsound patched areas, along with 4SF of CS3 exposed reinforcing steel.

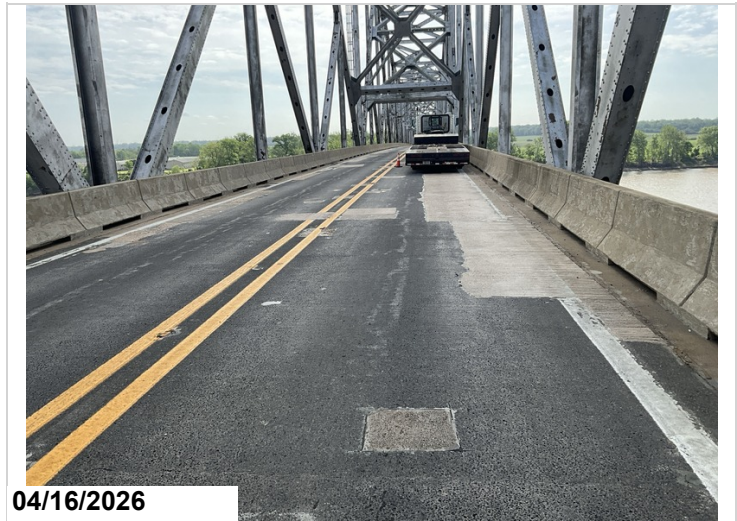
PP43 - PP46: 390SF of CS2 delam/patched areas and 46SF of CS3 spalling and unsound patched areas, along with 3SF of CS3 exposed reinforcing steel.

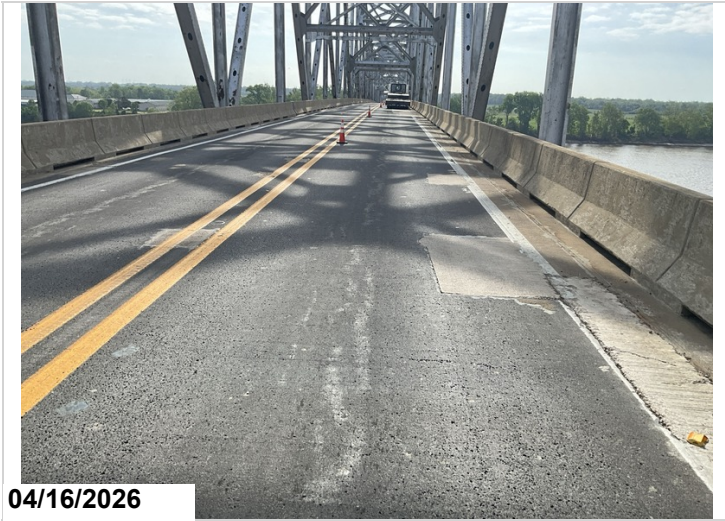
PP40 - PP43: 120SF of CS2 delam/patched areas and 41SF of CS3 spalling and unsound patched areas.

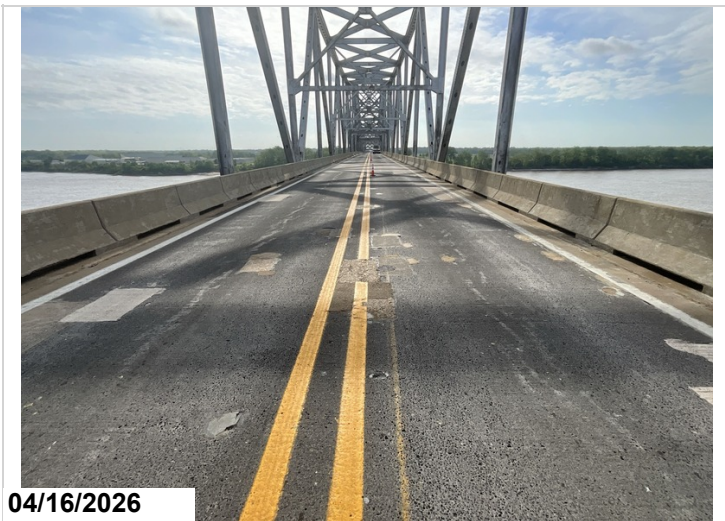
PP36 - PP40: 195SF of CS2 delam/patched areas and 56SF of CS3 spalling and unsound patched areas.

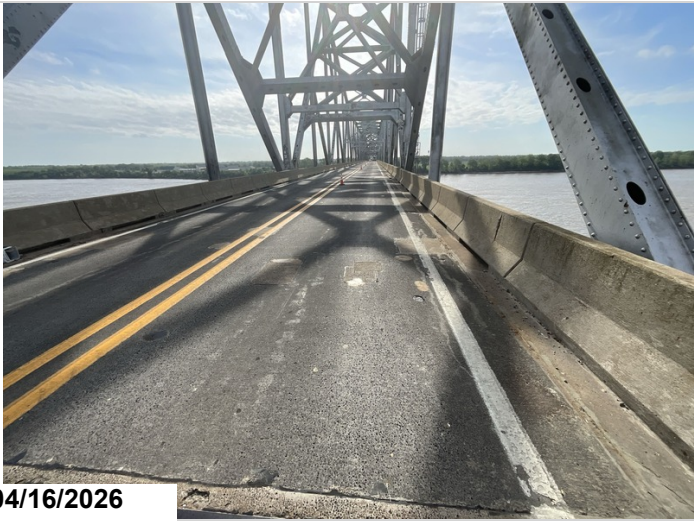
PP28 - PP32: 195SF of CS2 delam/patched areas and 93SF of CS3 spalling and unsound patched areas, along with 1SF of CS3 exposed reinforcing steel.

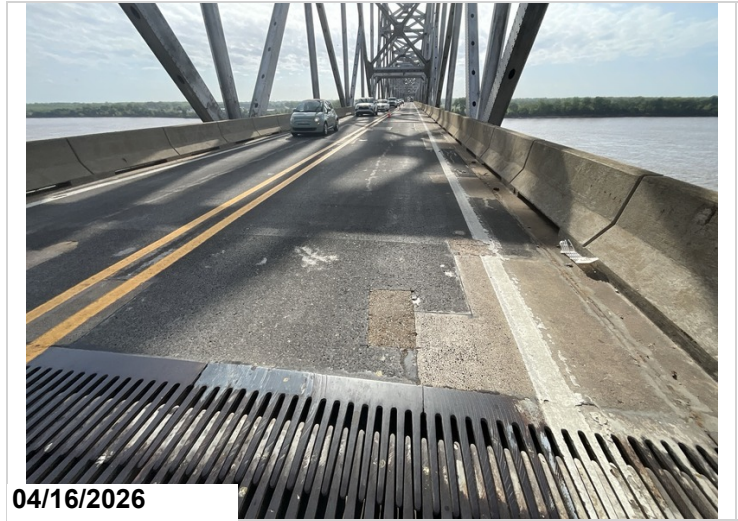
PP25 - PP28: 352SF of CS2 delam/patched areas and 94SF of CS3 spalling and unsound patched areas, along with 2SF of CS3 exposed reinforcing steel.

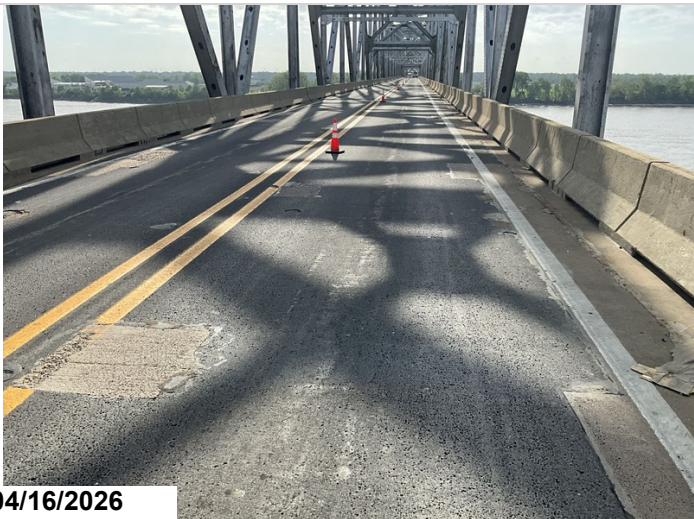
PP22 - PP25: 183SF of CS2 delam/patched areas and 61SF of CS3 spalling and unsound patched areas, along with 6SF of CS3 exposed reinforcing steel.

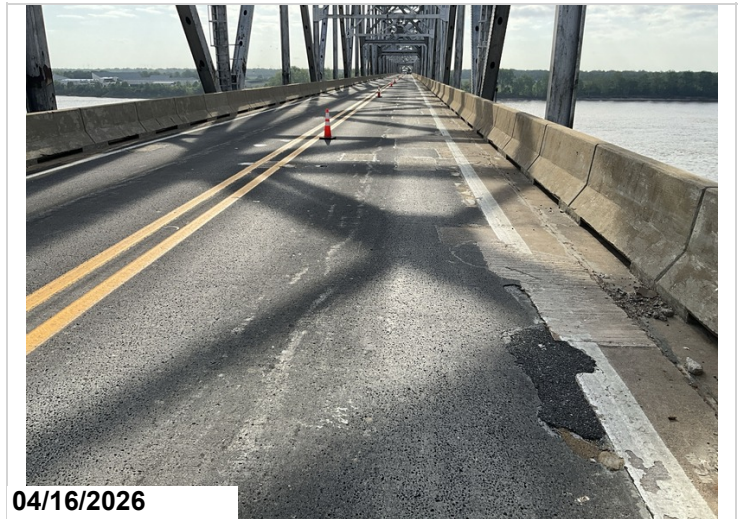
PP18 - PP22: 342SF of CS2 delam/patched areas and 104SF of CS3 spalling and unsound patched areas.

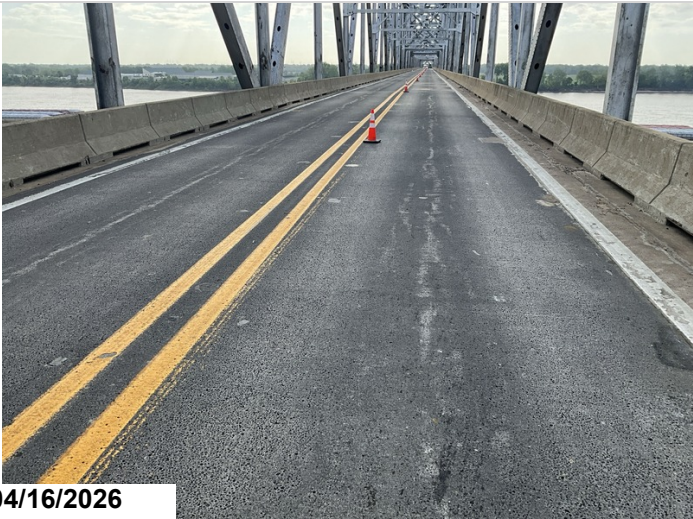
PP12 - PP15: 56SF of CS2 delam/patched areas and 28SF of CS3 spalling and unsound patched areas.

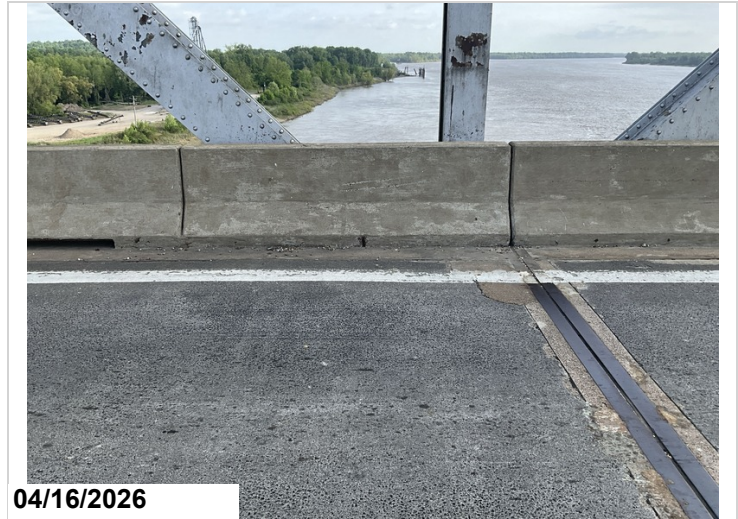
Typical minor exposed reinforcing steel in bridge railing.

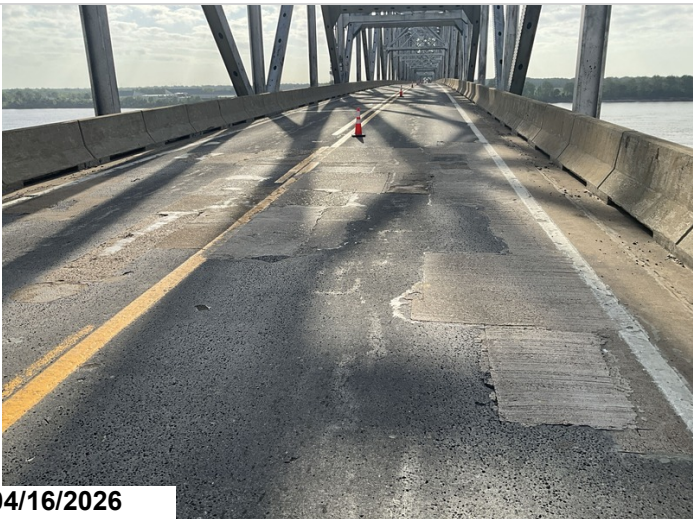
PP6 - PP8: 365SF of CS2 delam/patched areas and 59SF of CS3 spalling and unsound patched areas.

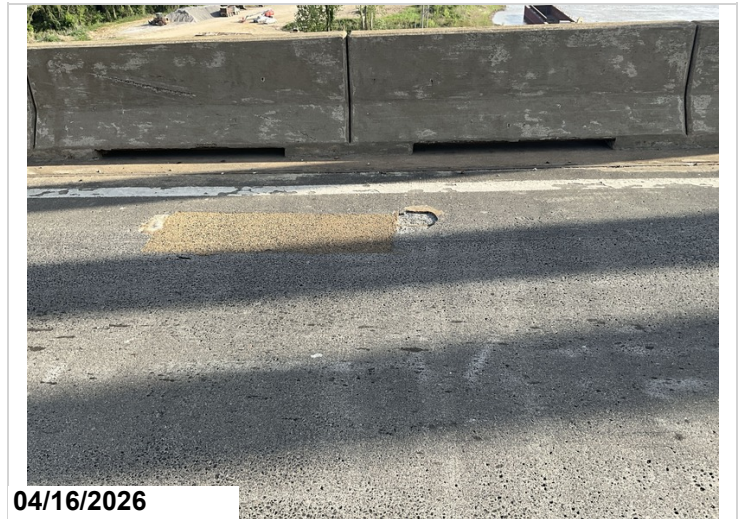
PP3 - PP6: 81SF of CS2 delam/patched areas and 38SF of CS3 spalling and unsound patched areas, along with 2SF of CS3 exposed reinforcing steel.

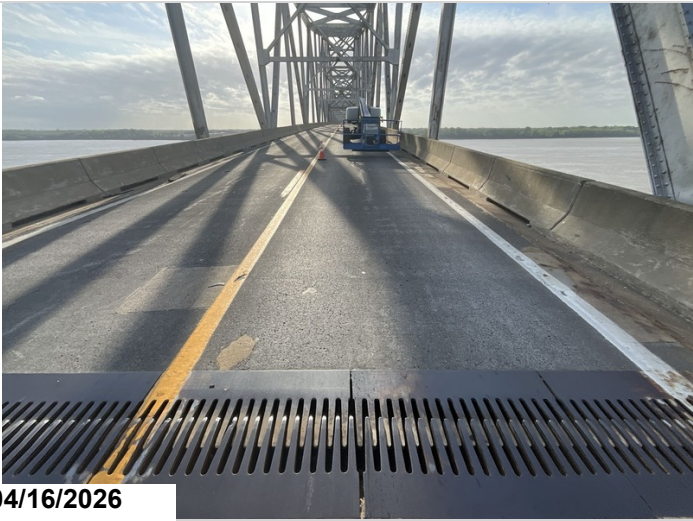
PP0 - PP3: 95SF of CS2 delam/patched areas and 21SF of CS3 spalling and unsound patched areas.

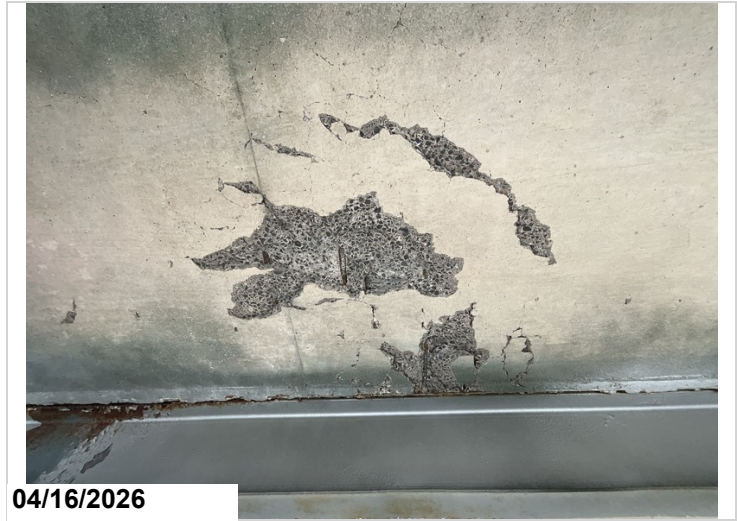
Typical spalling with exposed reinforcing steel along the undersurface.

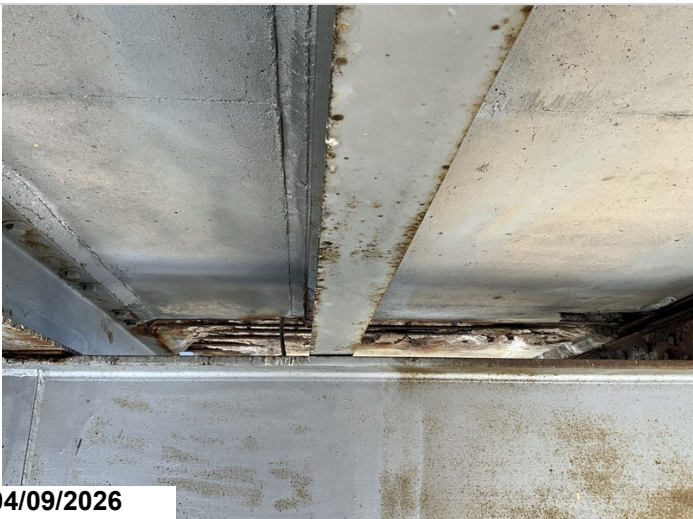
Span 14, Ahead of Floorbeam 56, Left: Heavy spalling with exposed reinforcing steel with loss of bond.

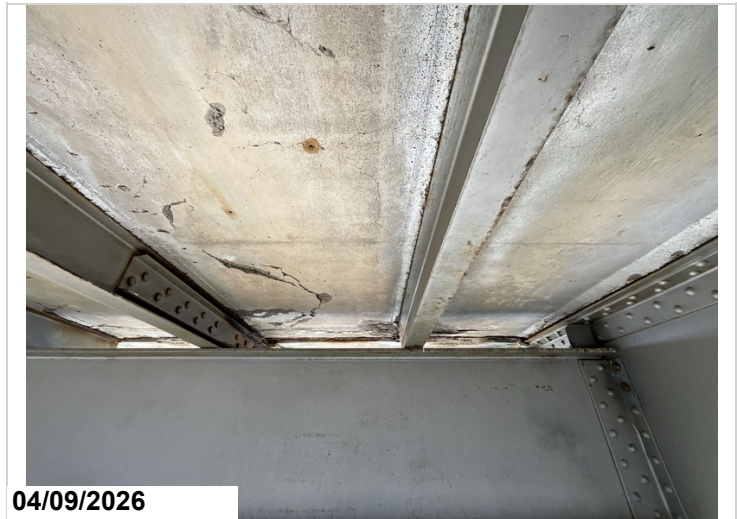
Typical undersurface condition on main truss spans.

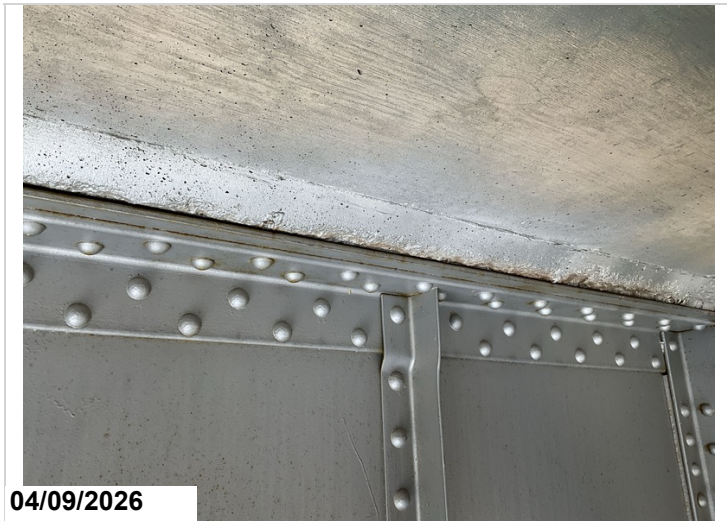
Typical floating deck.

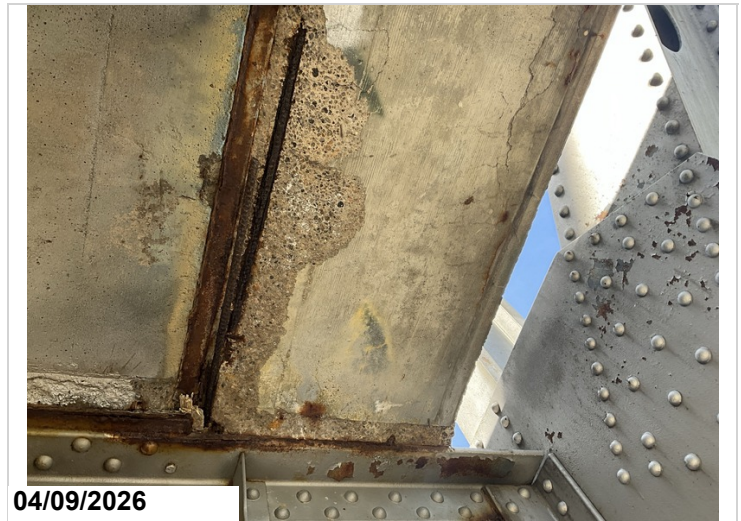
Span 14, Ahead of Floorbeam 54, left overhang: Unbonded exposed reinforcing steel.

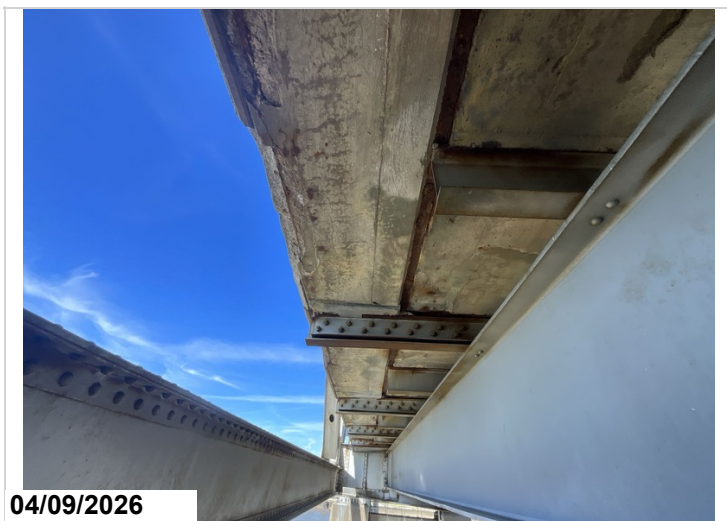
Typical overhang.

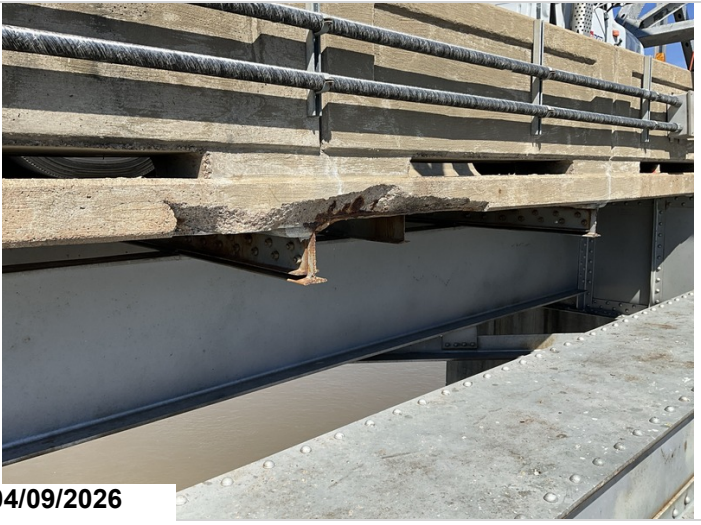
Span 11, Right Overhang, Near PP8: Large spalling, typical throughout the structure.

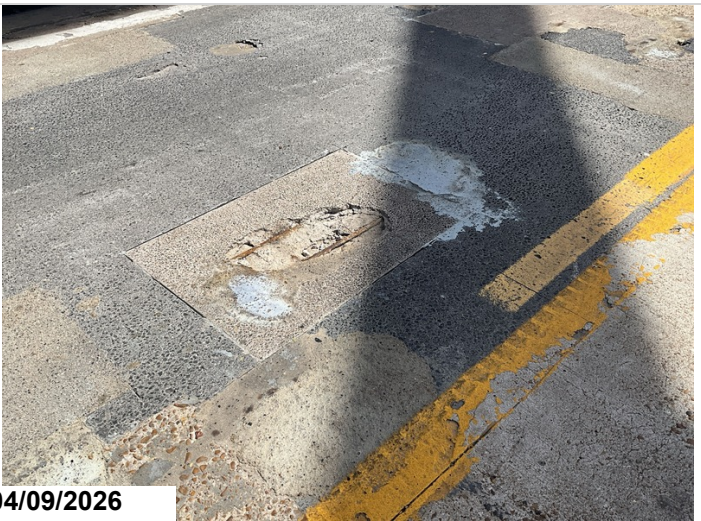
Between panel points 6 and 7, moderate spall with exposed rebar, 2SF, CS3.

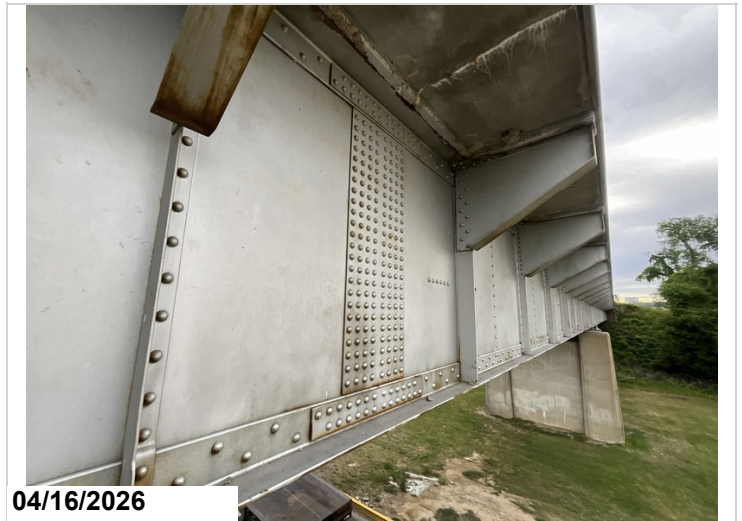
Span 20, Girder 2: Typical Field Splice Plate.

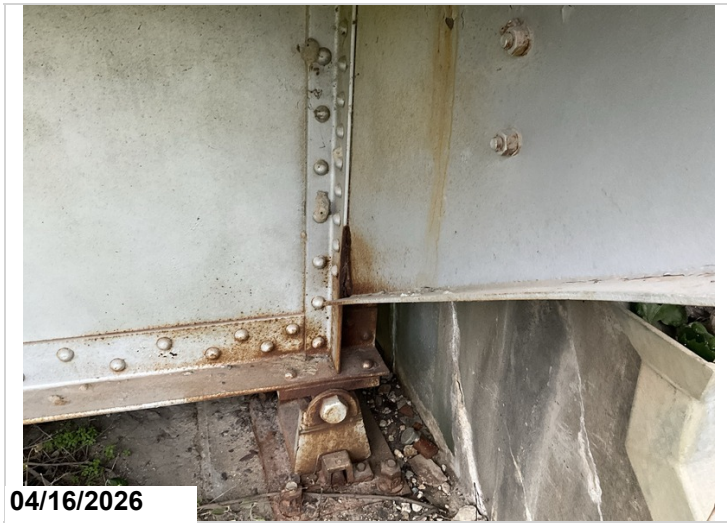
Span 1, Abutment 1, Girder 1, Left: Active corrosion with pack rust up to 1/2".

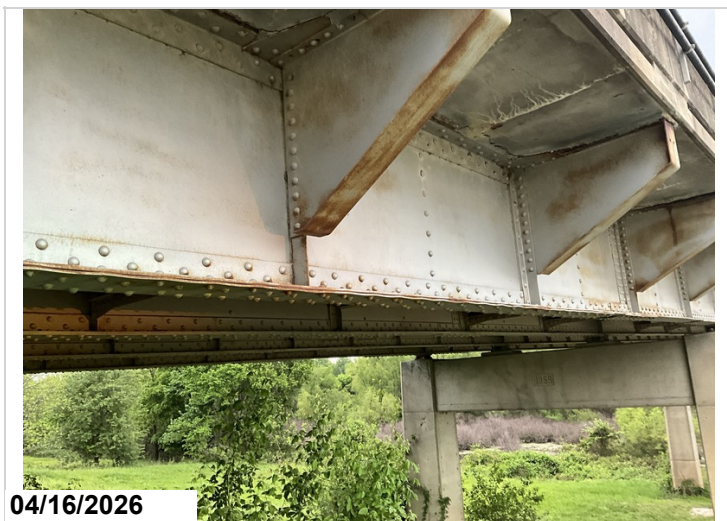
Typical Girder in Multi-Girder Spans.

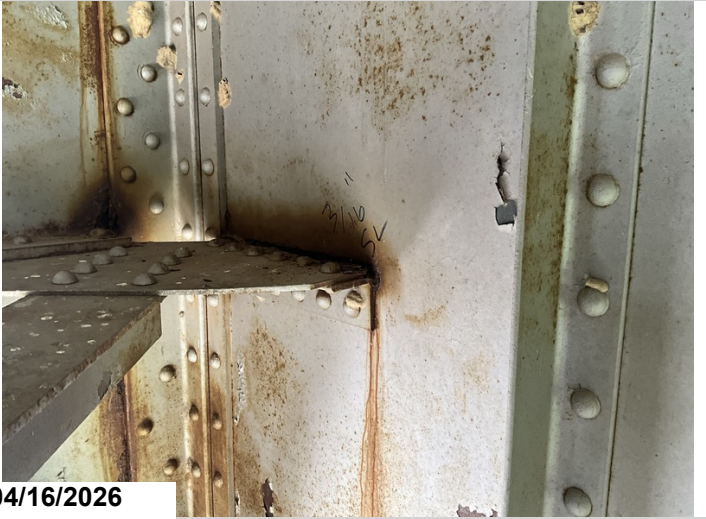
Span 16, Girder 1, Right, Adjacent to Floorbeam 0: Active corrosion with section loss up to 3/16". 2LF CS3 corrosion.

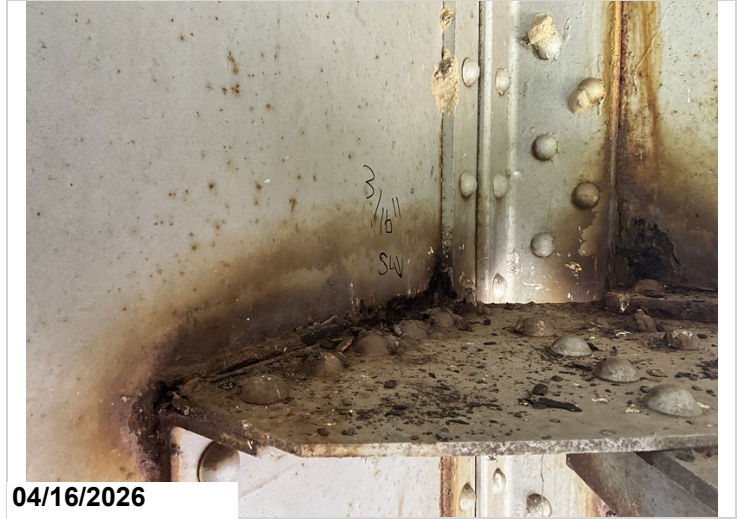
Span 16, Girder 2, Left, Adjacent to Floorbeam 0: Active corrosion with section loss up to 3/16". 2LF CS3 corrosion.

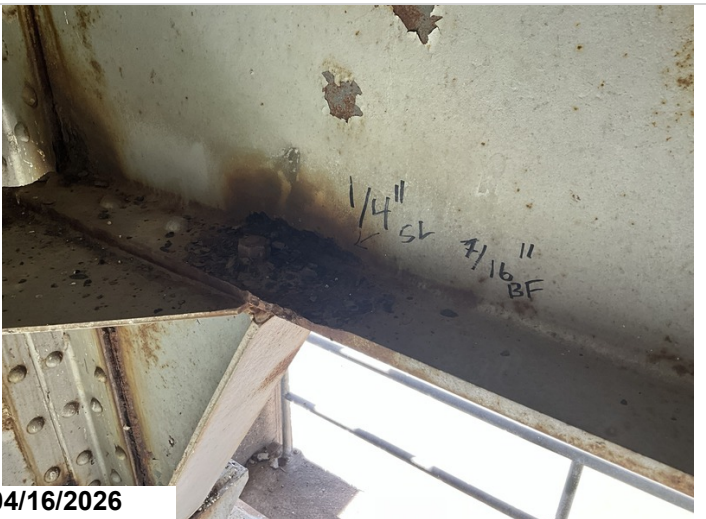
Span 16, Floorbeam 1, Ahead, Adjacent to Girder 2: Active corrosion with section loss up to 1/4" to the web and 7/16" to the Bottom Flange.

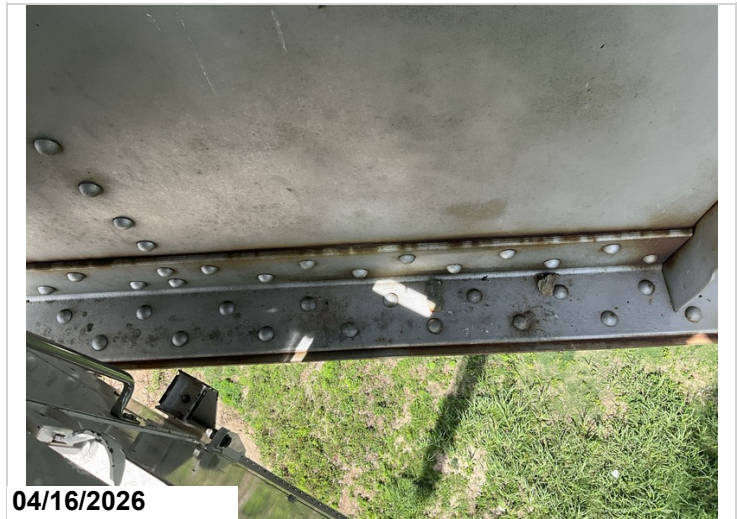
Span 16, Girder 2, Right. Minor pack rust between bottom flange angle vertical leg and girder web. Typical this span.

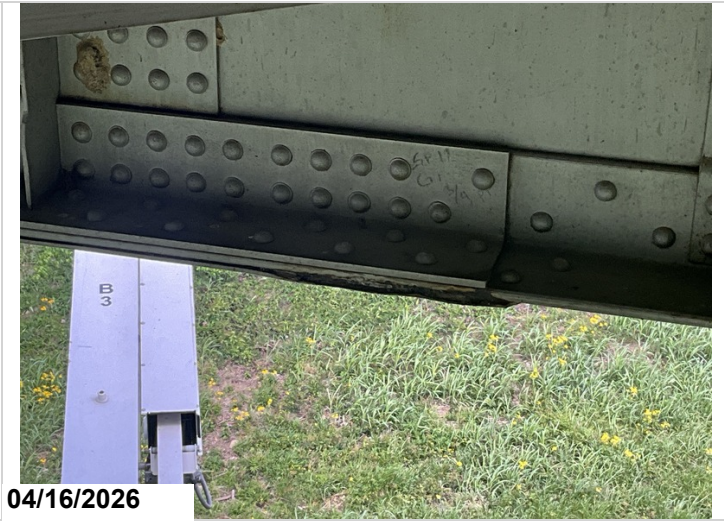
Span 17, Girder 1, Last field splice plate: Active corrosion with pack rust between bottom flange and cover plate approximately 3/4". 2LF CS3 corrosion.

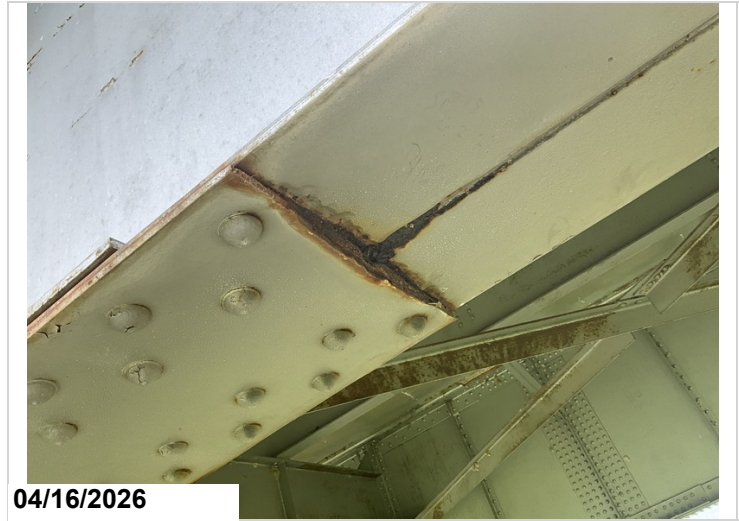
Span 18, Girder 2, ahead of second splice: corrosion with section loss up to 3/16". 1 LF CS3.

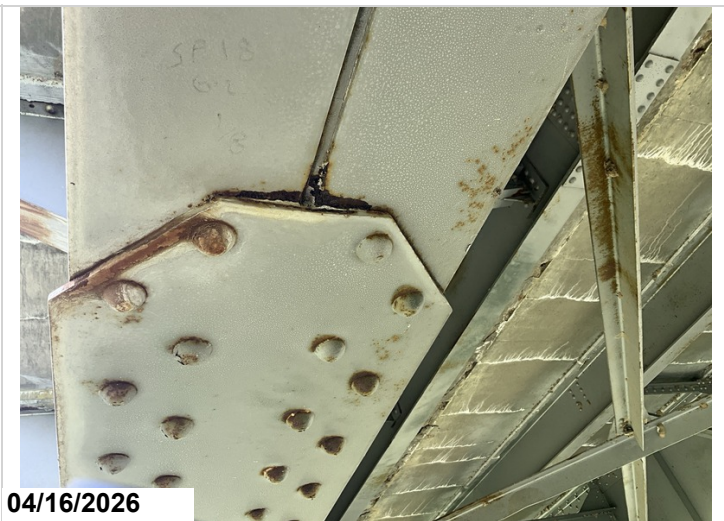
Span 18, Girder 2, ahead of cover plate: corrosion with up to 1/8" section loss. 1 LF CS3.

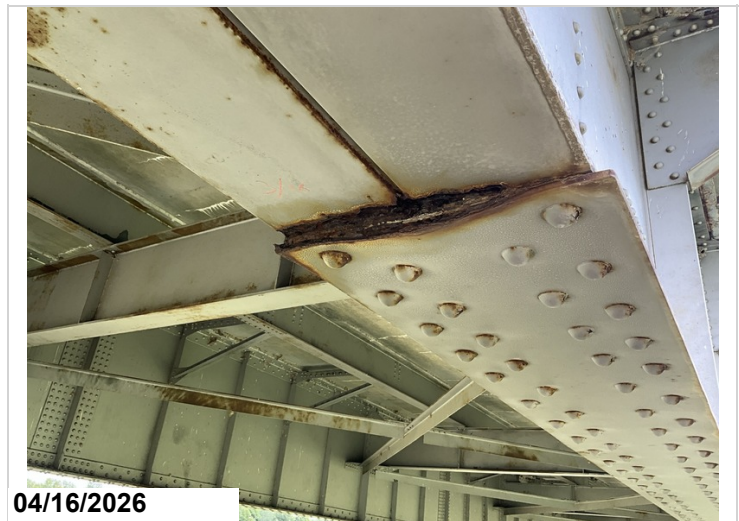
Span 19, Girder 2, Back end of cover plate back of Floorbeam 5: Corrosion with up to 3/16" section loss. 1 LF CS3.

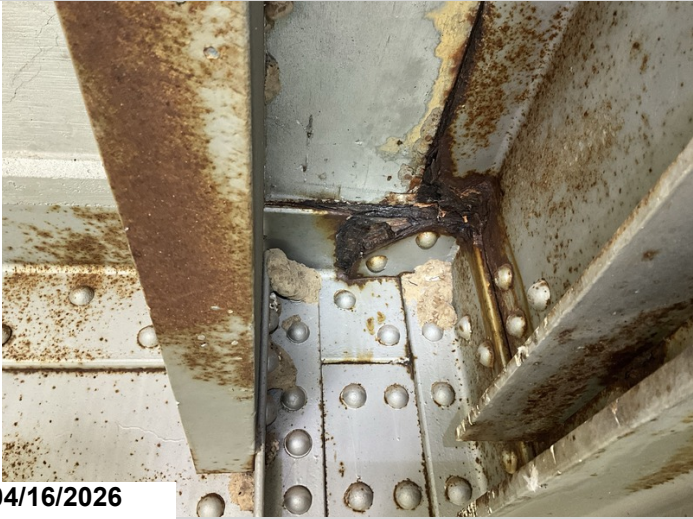
Span 19, Floorbeam 3, Ahead, Right: pack rust and section loss to top connection angle to Girder 2. Hole in diaphragm adjacent to connection.

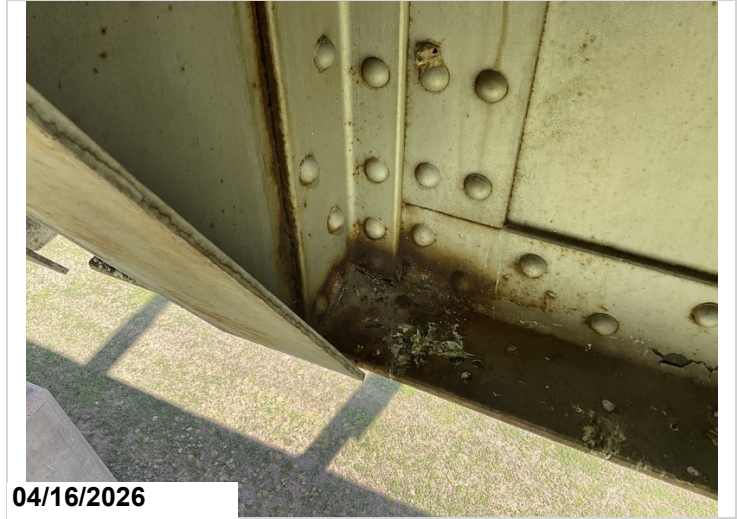
Span 19, Girder 1, ahead of Floorbeam 3. Corrosion with minor section loss to bottom flange angle. 2 LF CS3.
