## Bridge 02899 Inspection Report

Arnold Road ID:54x49x11xA, Arnold Log mile:0.569

# National Bridge Inventory Data Sheet

| IDENTIFICATION | |
|---|---|
| (7) Facility Carried | US 49- Phillips Co |

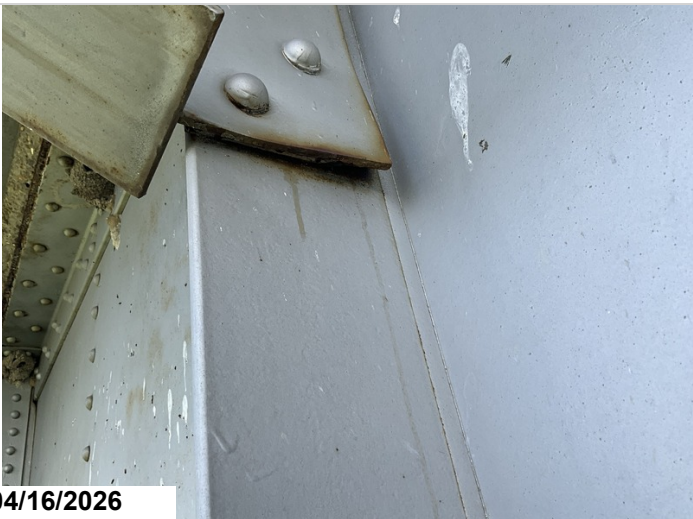
Span 19, Girder 2, Right, Floorbeam 7 cantilever: pack rust distorting lower cantilever web up to 1". Typ Floorbeam 6. 2 LF CS3

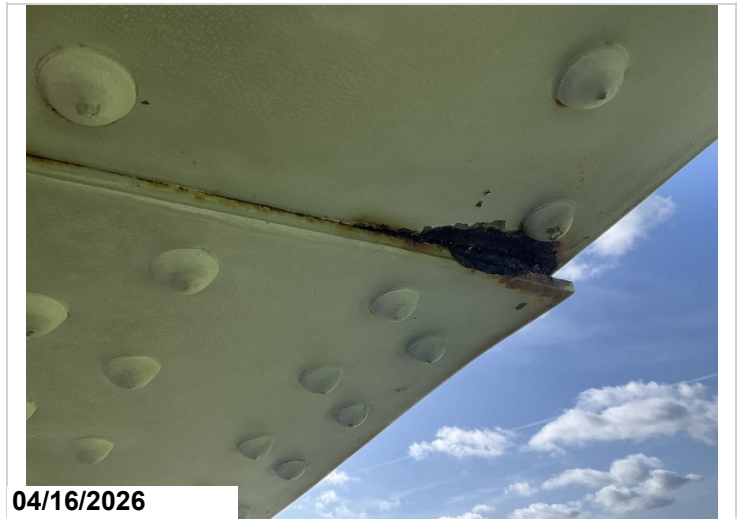
Span 19, Girder 2, 10' from Pier 19: Corrosion with section loss up to 1/4" to pier cover plate. 1 LF CS3.

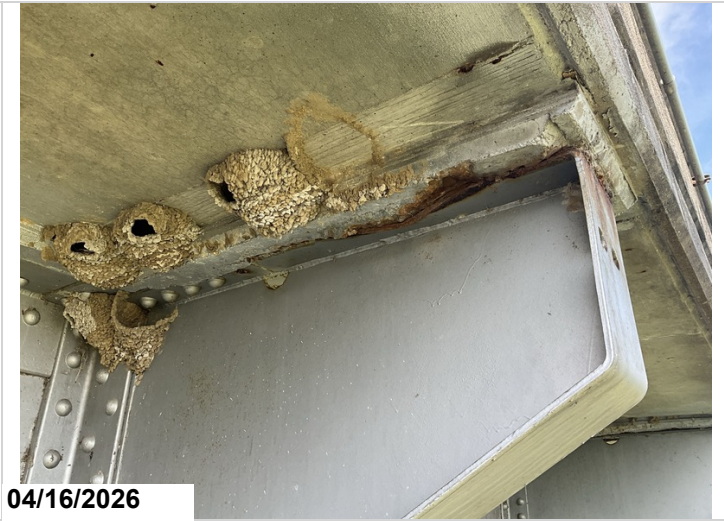
Span 19, Girder 1, Left, Floorbeam 3: Distortion to top flange of cantilever that appears to be present during construction. Typical Girder 2, right, ahead of Floorbeam 4.

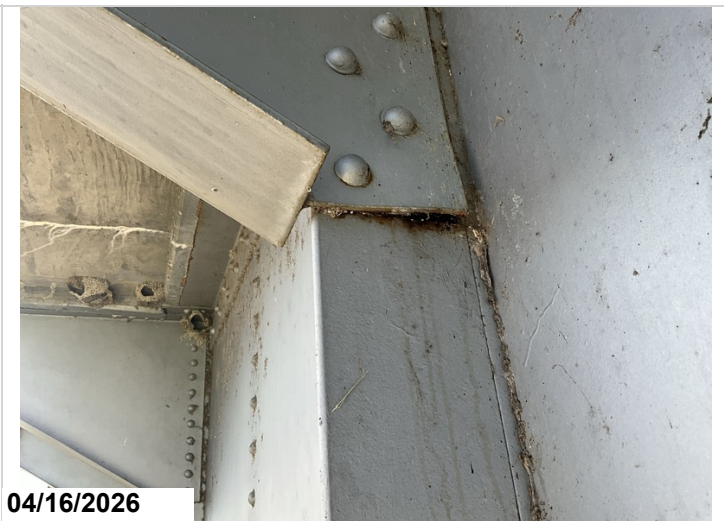
Span 20, Girder 1, Left, Floorbeam 3 cantilever: pack rust distorting lower cantilever web up to 7/8". 1 LF CS3

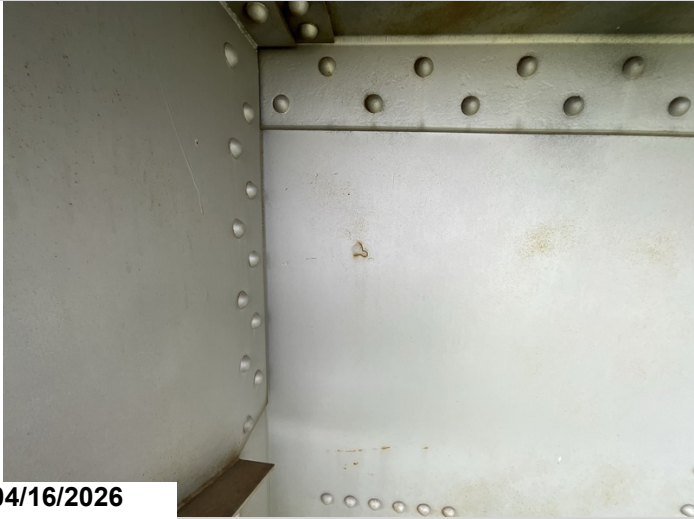
Span 20, Girder 2, Right, Ahead of Floorbeam 6: Rolling defect.

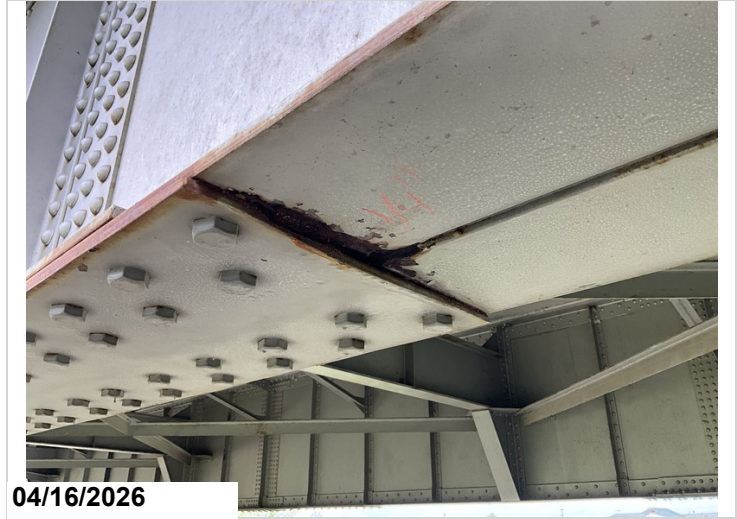
Span 21, Girder 2, Bottom Flange, Ahead of Floorbeam 2:  
Active corrosion with section loss up to 1/4". 1LF CS3 corrosion.

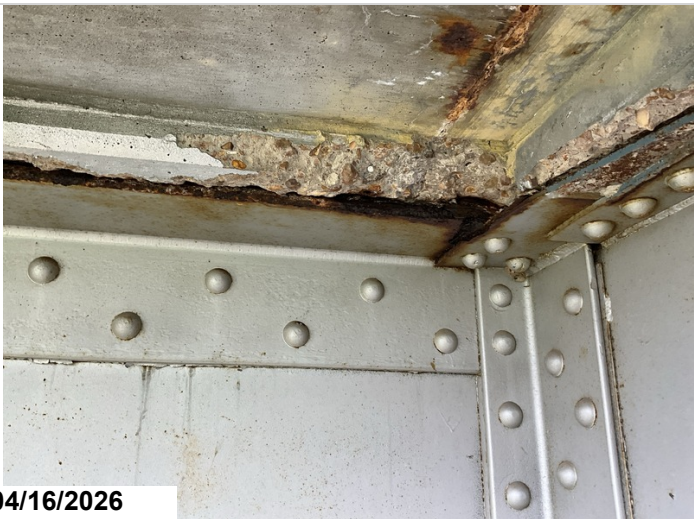
Span 21, Girder 2, Right, Back of Floorbeam 4: Active corrosion with flaking rust along the Top Flange. 6LF CS3 corrosion.

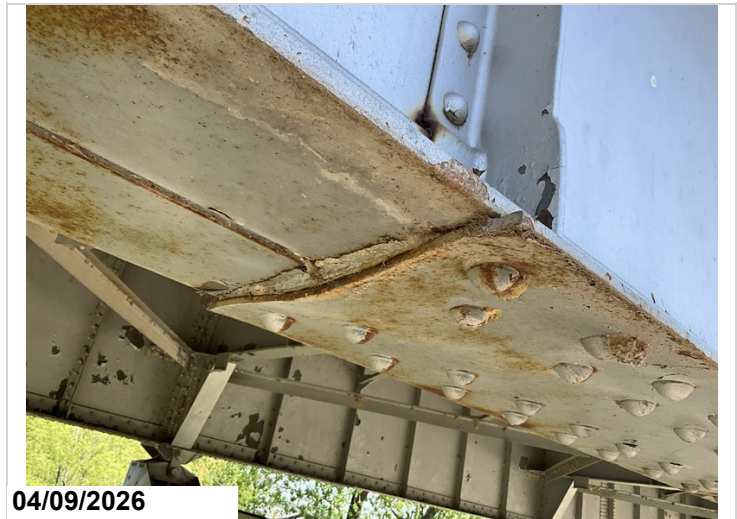
Span 7, Girder 2, Bottom Flange near Pier 7: Active corrosion with pack rust up to 3/4" between the bottom flange and the cover plate. 1LF CS3 corrosion.

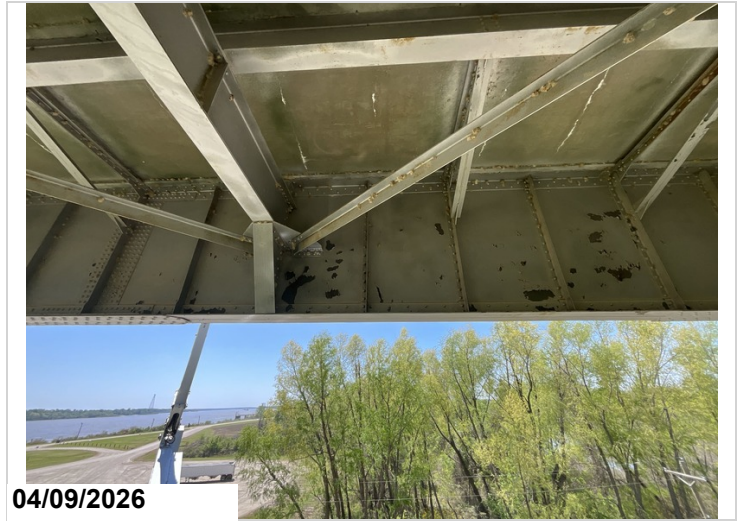
Span 8, Girder 2: Typical paint.

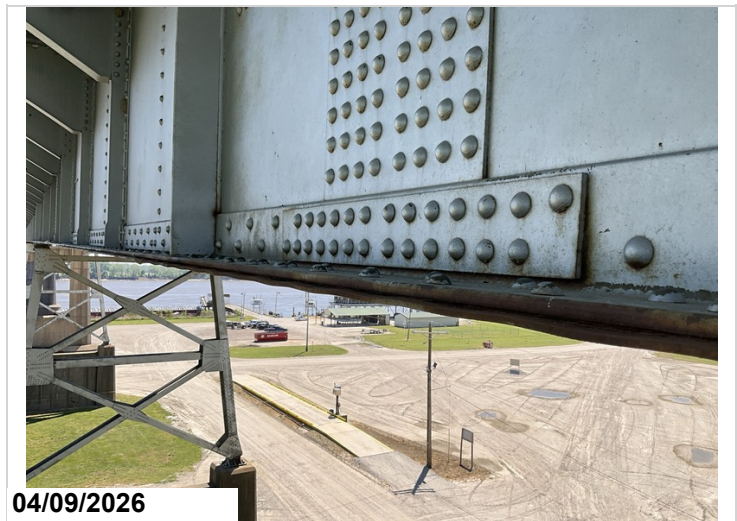
Span 8, Girder 1: Active corrosion with pack rust between the Bottom Flange and cover plate, 40LF CS3 corrosion.

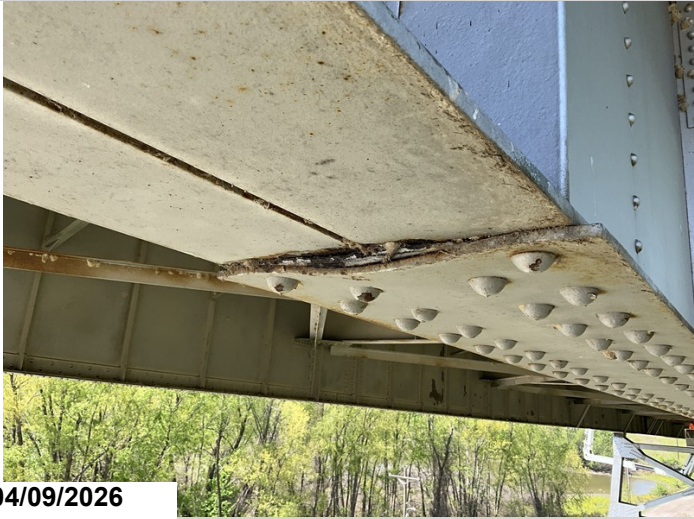
Span 8, Girder 1, adjacent to Floorbeam 5, Bottom Flange:  
Active corrosion with pack rust up to 3/4" between the  
Bottom Flange and cover plate.

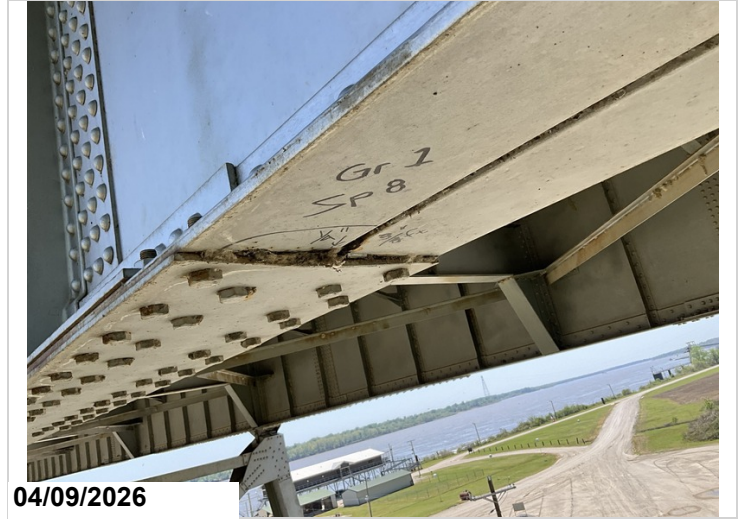
Span 8, Girder 1, Third field splice plate: Active corrosion  
with section loss up to 1/4" to the bottom flange and pack  
rust. 1LF CS3 corrosion.

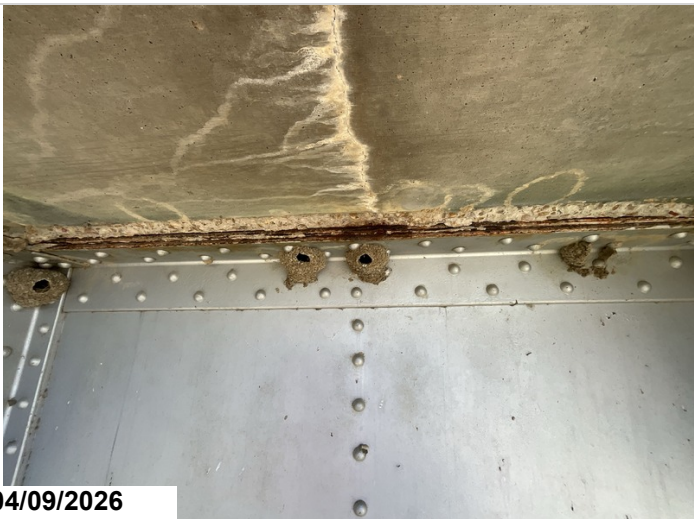
Span 8, Girder 2, Right, Ahead of Floorbeam 4: Active  
corrosion with flaking rust along the Top Flange. 10LF CS3  
corrosion.

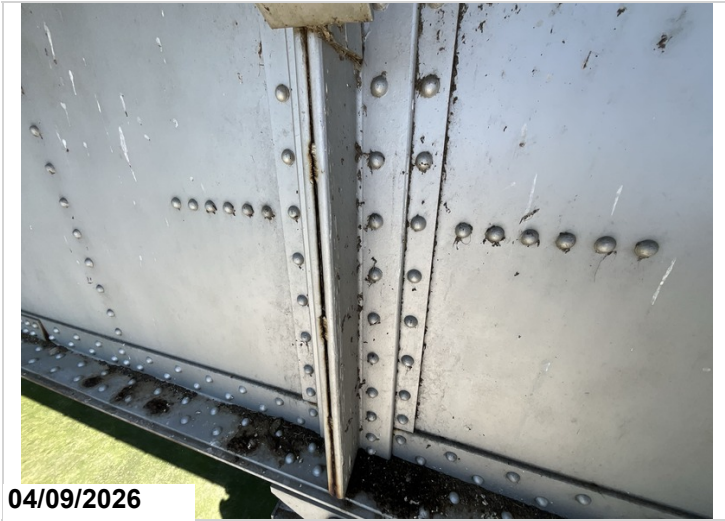
Pier 8, Girder 2, Right: Cracked tack welds at bearing stiffener due to pack rust at the stiffeners, fully arrested. 1LF CS3 corrosion.

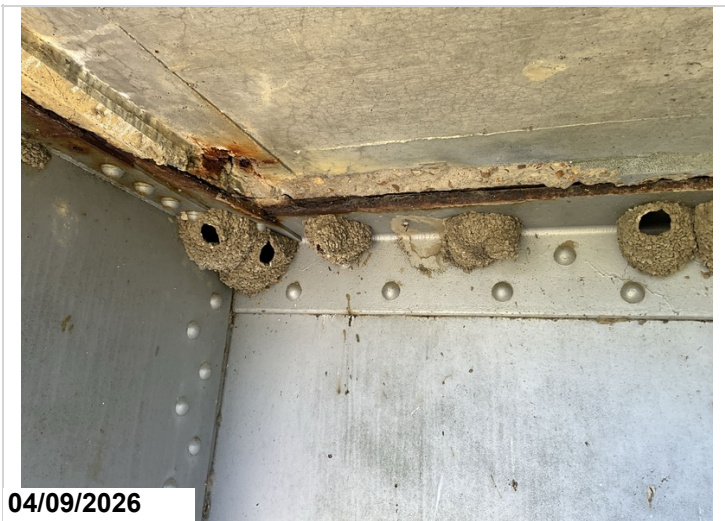
Span 9, Girder 1, Left, back of Floorbeam 3: Active corrosion with pack rust along the Top Flange. 3LF CS3 corrosion.

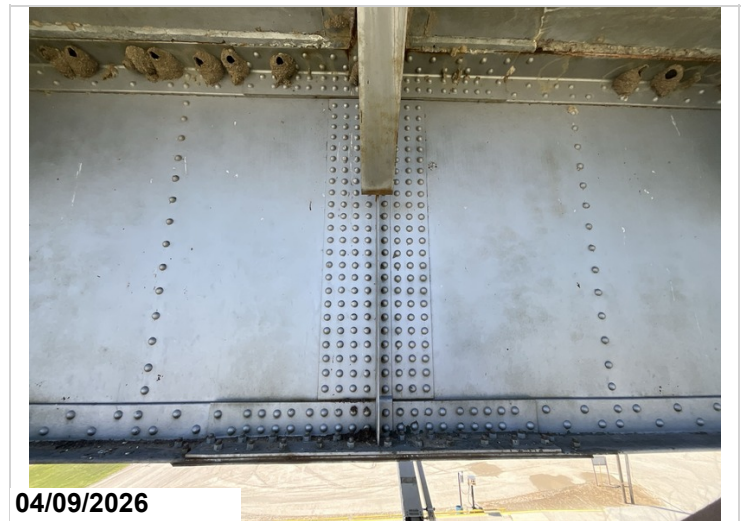
Typical Field Splice Plate in Two-Girder system.

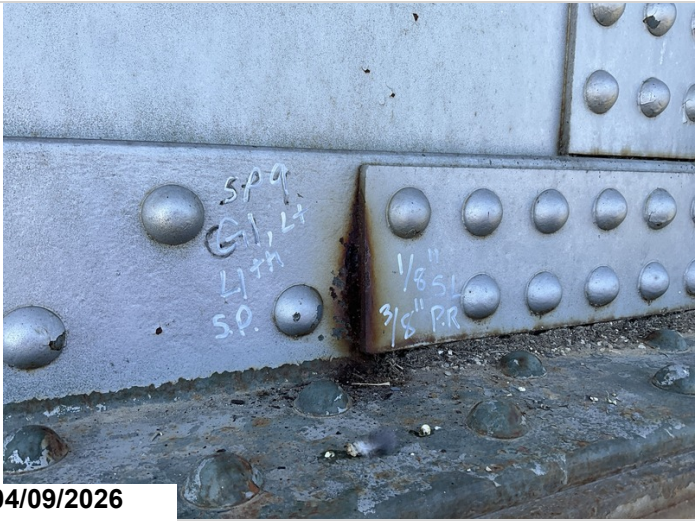
Span 9, Girder 1, Left, Fourth field splice plate: Active corrosion with section loss up to 1/8" and pack rust up to 3/8". 1LF CS3 corrosion.

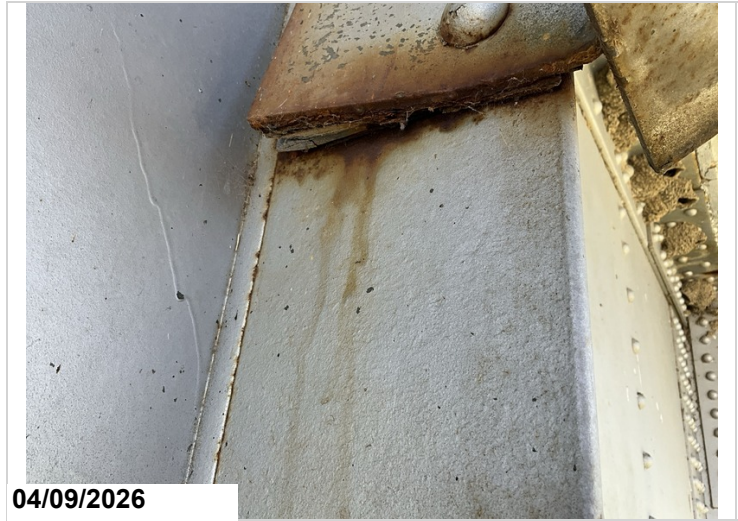
Span 9, Girder 1, Left, Floorbeam 6: Active corrosion with pack rust up to 1". 1LF CS3 corrosion.

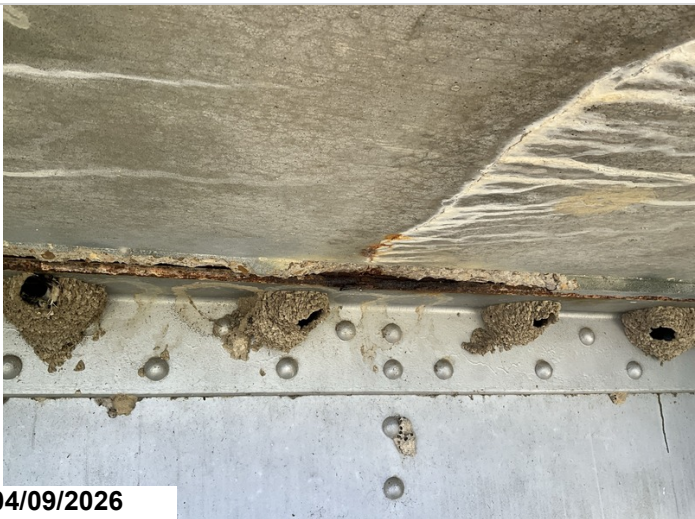
Span 9, Girder 1, Left, Ahead of Floorbeam 5: Active corrosion with pack rust up to 3/8" between the Top Flange of the Girder and the deck. 1LF CS3 corrosion.

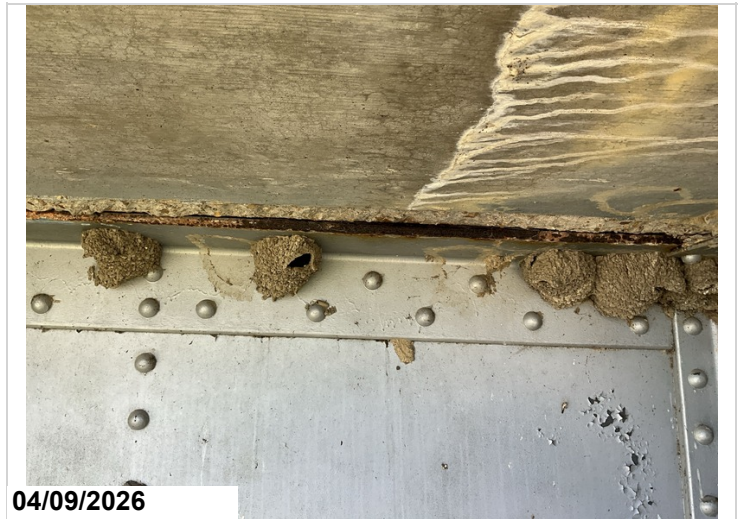
Span 9, Girder 1, Left, Ahead of Floorbeam 4: Active corrosion with flaking rust along the top flange. 4LF CS3 corrosion.

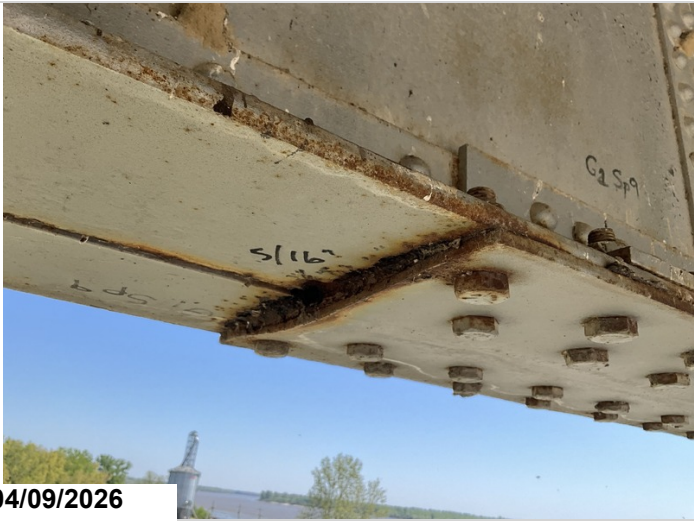
Span 9, Girder 1, Third Field Splice Plate: Active corrosion with section loss up to 5/16" to the Bottom Flange and pack rust up to 1/2". 1LF CS3 corrosion.

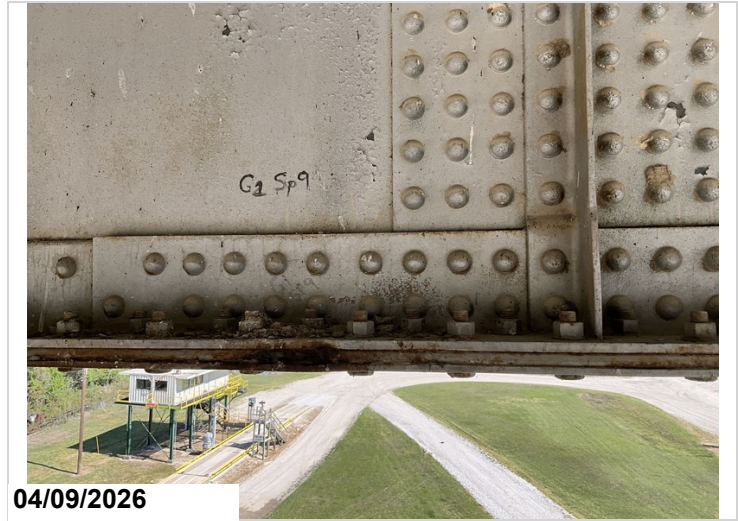
Span 9, Girder 1, third Field Splice Plate: Active corrosion with crevice corrosion at Bottom Flange connection. 1LF CS3 corrosion.

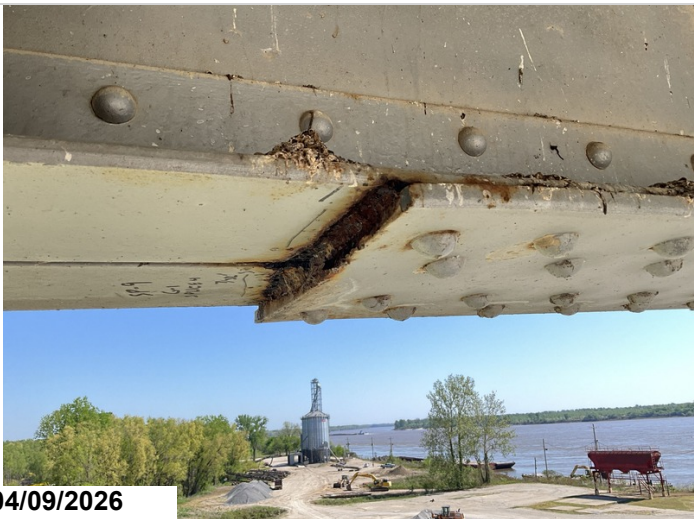
Span 9, Girder 1, Bottom Flange cover plate ahead of Floorbeam 6: Active corrosion with section loss to the Bottom Flange up to 3/16" and pack rust up to 1/2".

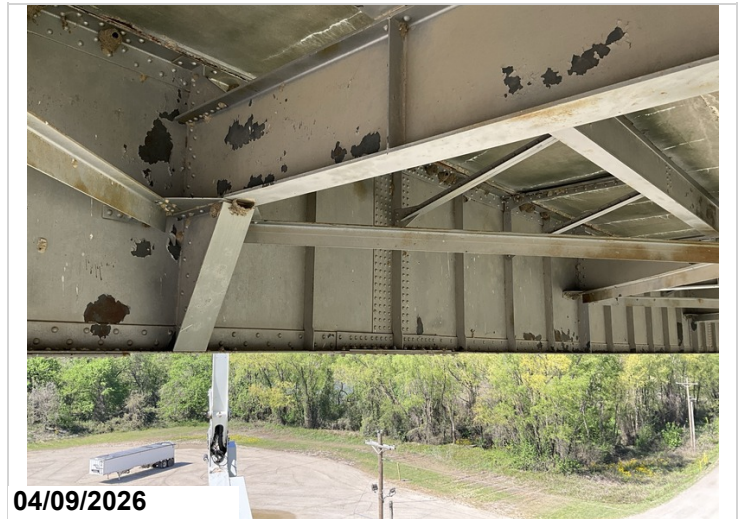
Span 9, Girder 2, Left: Typical flaking paint.

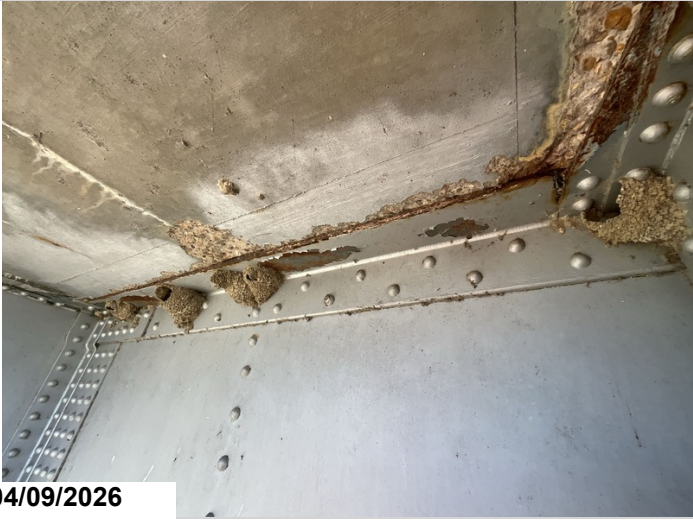
Span 9, Girder 2, Right, Back of Floorbeam 4: Active corrosion with flaking rust along the top flange. 6LF CS3 corrosion.

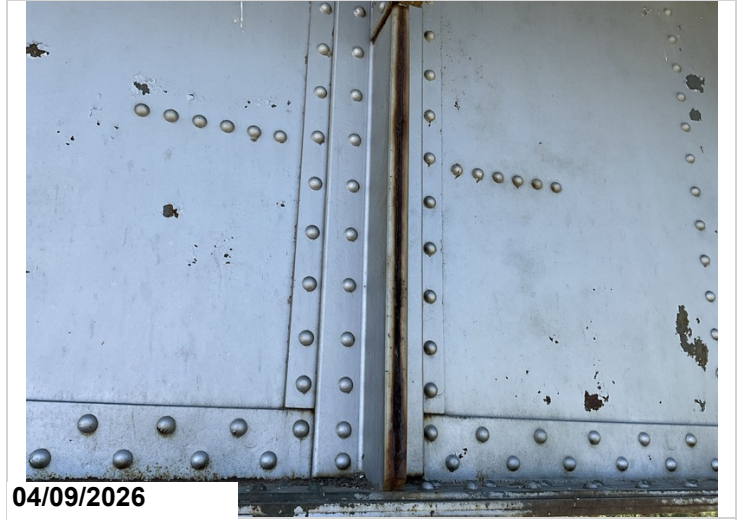
Pier 9, Girder 1, Left: Active corrosion with pack rust up to 1/4" between the bearing stiffener angle plates. CS3 corrosion.

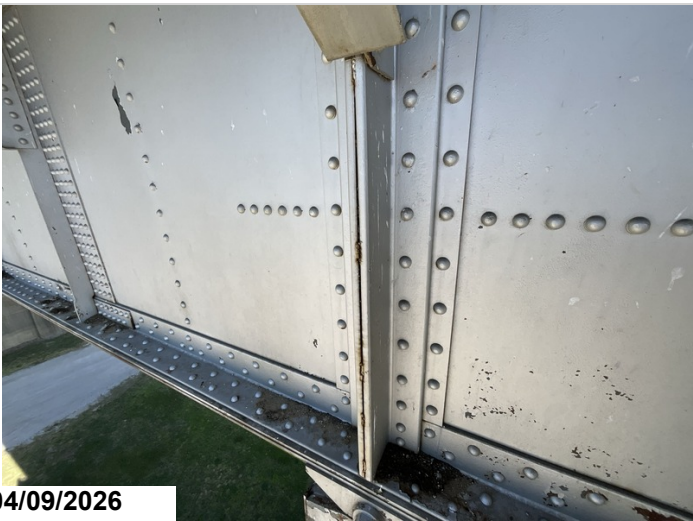
Pier 9, Girder 2, Right: Cracked tack welds at bearing stiffener due to pack rust at the stiffeners, fully arrested. 1LF CS3 corrosion.

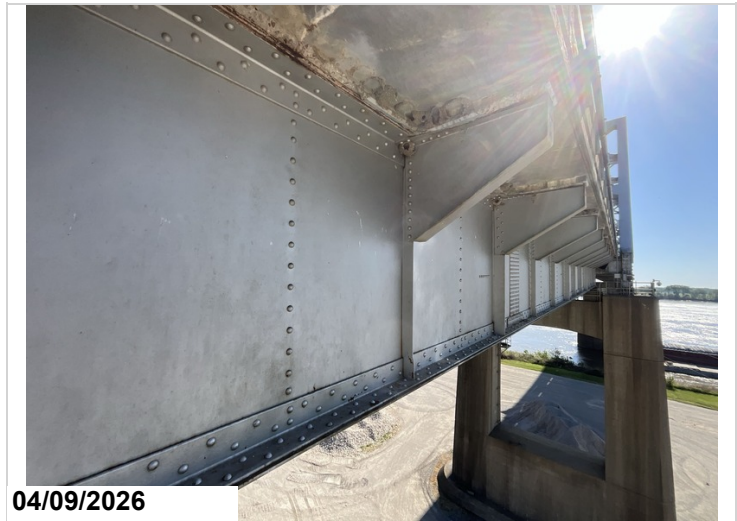
Typical Girder in Two-Girder system.

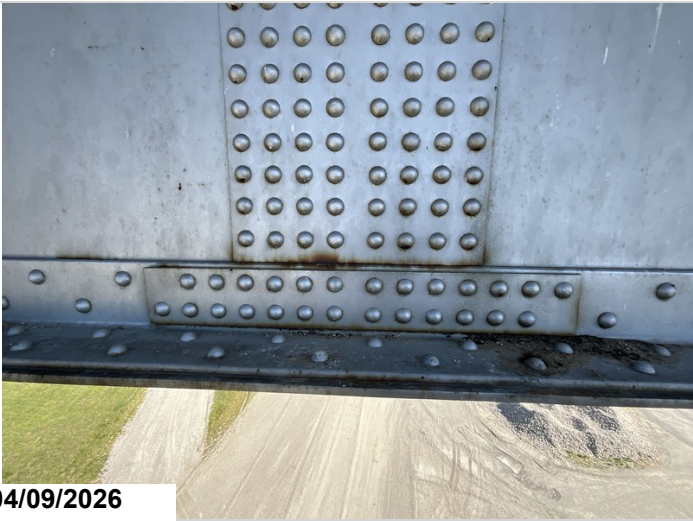
Span 10, Girder 2, Ahead of Floorbeam 4: Minor Active corrosion with crevice rust at the Field Splice Plate.

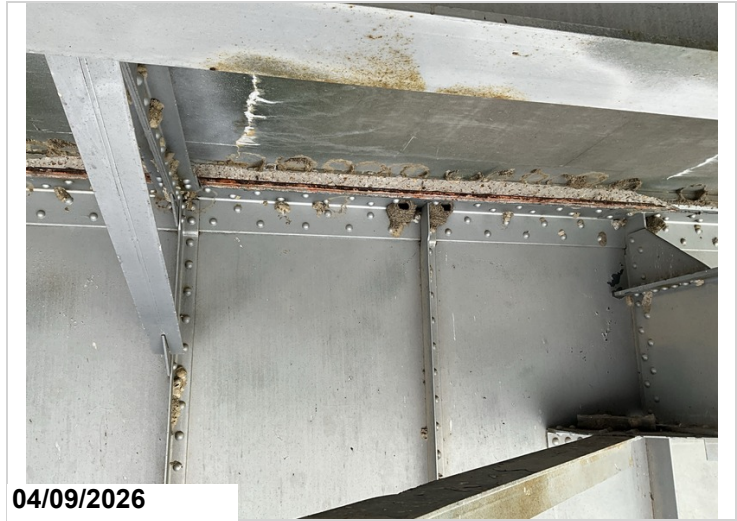
Span 10, Girder 2, Left, Top flange: Typical minor corrosion where deck haunch has spalled. CS2 corrosion.

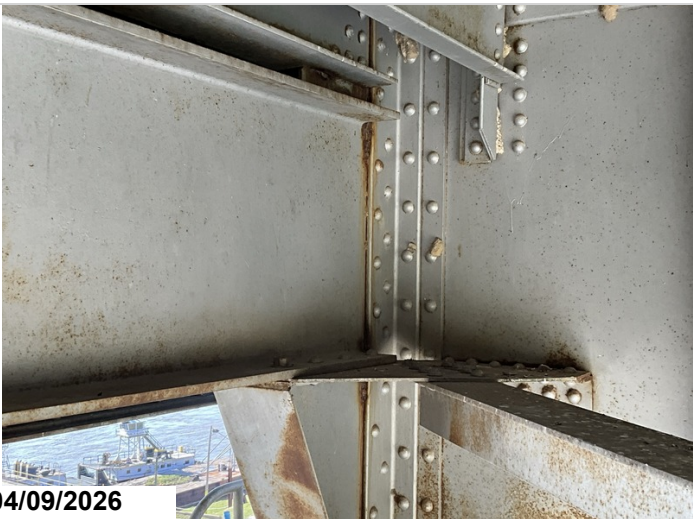
Span 10, Floorbeam 7, Adjacent to Girders 1 and 2: Active corrosion with pack rust and section loss up to 1/8" to the Floorbeam web near Girder connection.

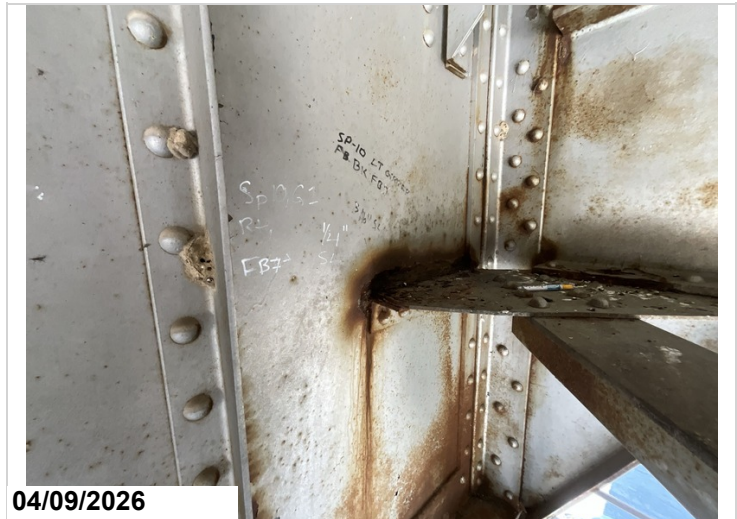
Span 10, Girder 1, Right, Adjacent to Floorbeam 7: Active corrosion with section loss up to 1/4" to the web. 2LF CS3 corrosion.

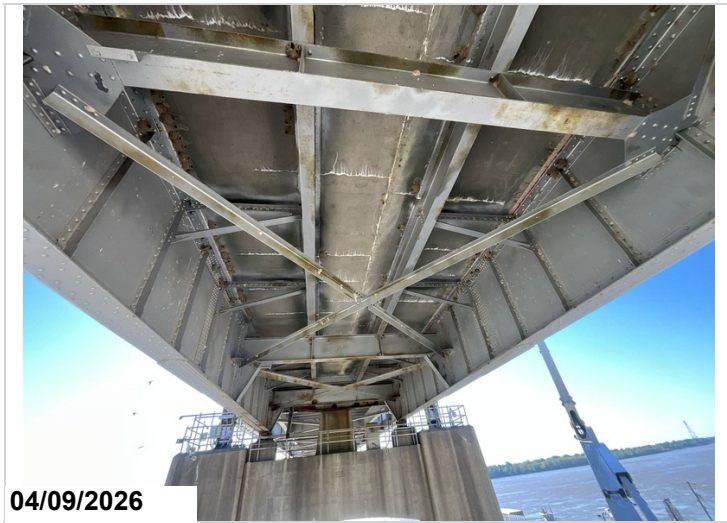
Typical undersurface of Two-Girder spans.

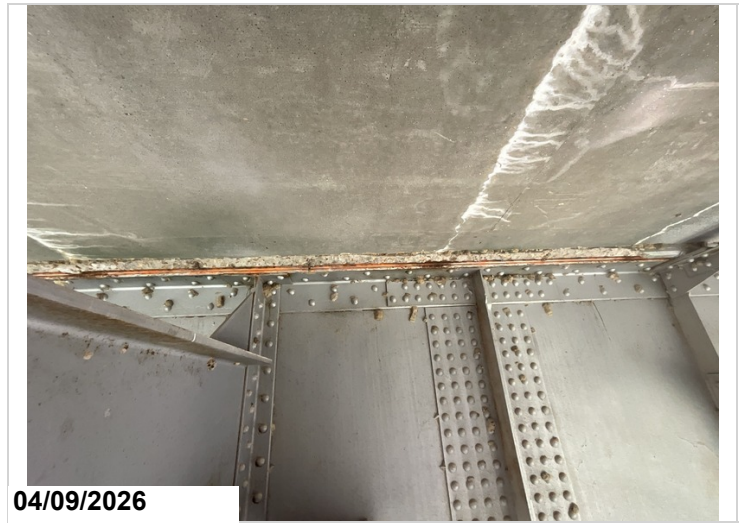
Span 2, Girder 2, Adjacent to Floorbeam 3: Deck haunch has spalled, causing the Top Flange of the Girder to be exposed while having surface corrosion. Typical throughout the Two-Girder Spans. CS2 corrosion.

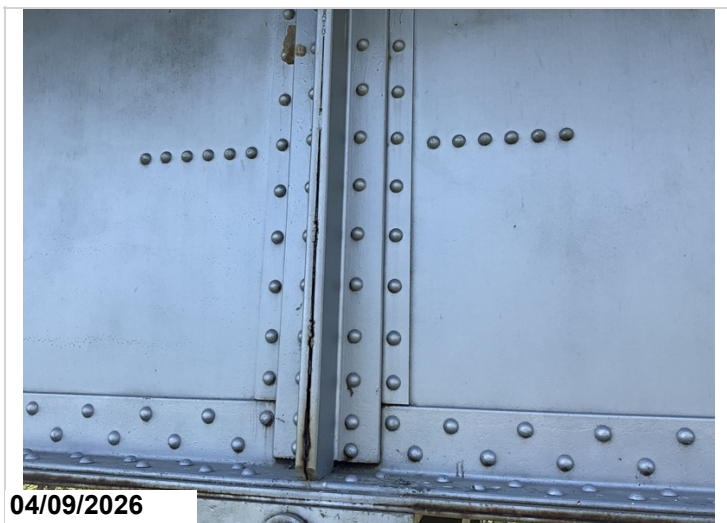
Pier 6, girder 1, pack rust between stiffener angles breaking welds. Typical

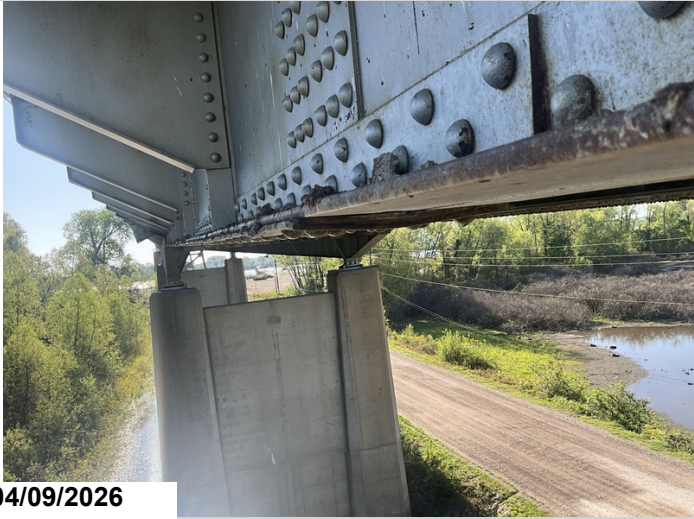
Span 4, girder 1, pack rust between the bottom flange, 25LF, CS3.

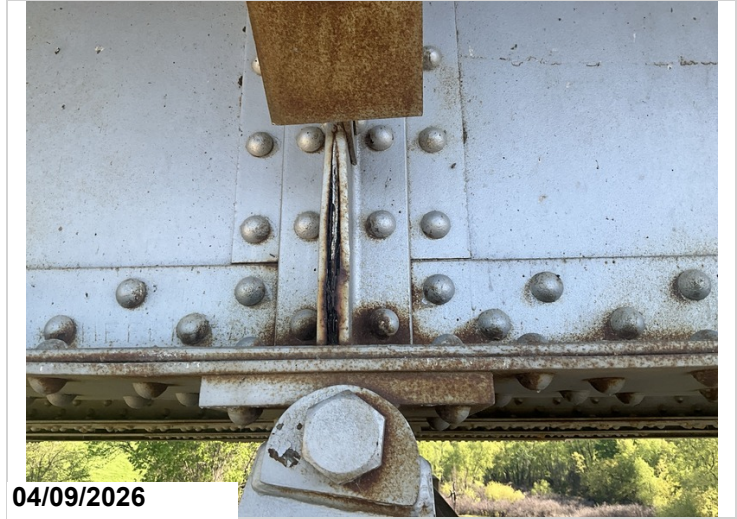
Pier 3, girder 4, pack rust between angles below cantilever, 1LF, CS3. Typical over piers.

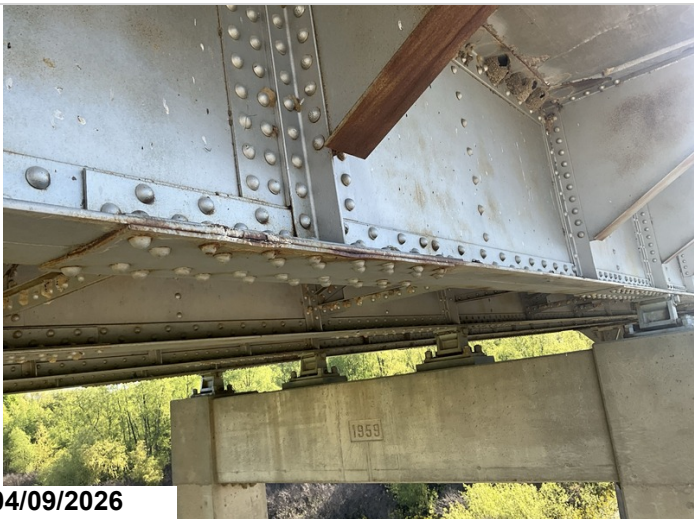
Span 3, girder 4, pack rust between splice plate and bottom flange. 3LF, CS3.

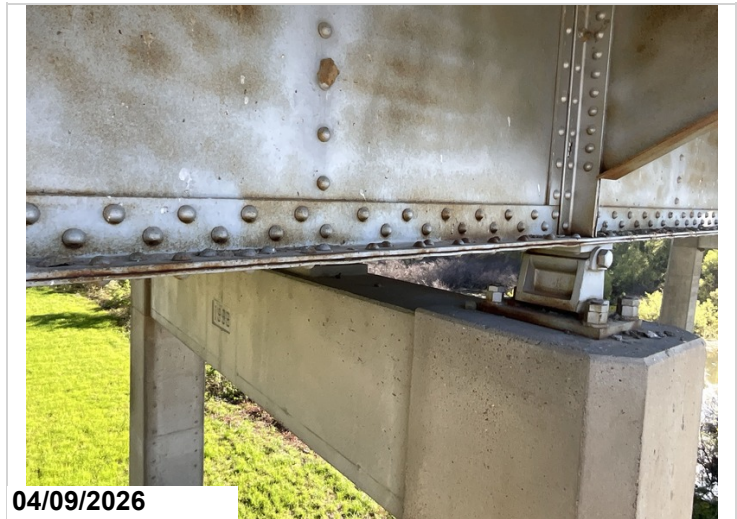
| ELEMENTS | DESCRIPTION | UNITS | TOTAL | CS1 | CS2 | CS3 | CS4 |
|---|---|---|---|---|---|---|---|
| Span 2, Girder 4, Back of Pier 2: Active corrosion with pack rust between the bottom flange and the cover plate. 8LF CS3 corrosion. | | | | | | | |

Span 2, Girder 4, Back of Pier 2: Active corrosion with pack rust between the bottom flange and the cover plate. 8LF CS3 corrosion.

| ELEMENTS | DESCRIPTION | UNITS | TOTAL | CS1 | CS2 | CS3 | CS4 |
|---|---|---|---|---|---|---|---|
| | Span 2, Girder 4, Back of Pier 2: Active corrosion with pack rust between the bottom flange and the cover plate. 8LF CS3 corrosion. | | | | | | |

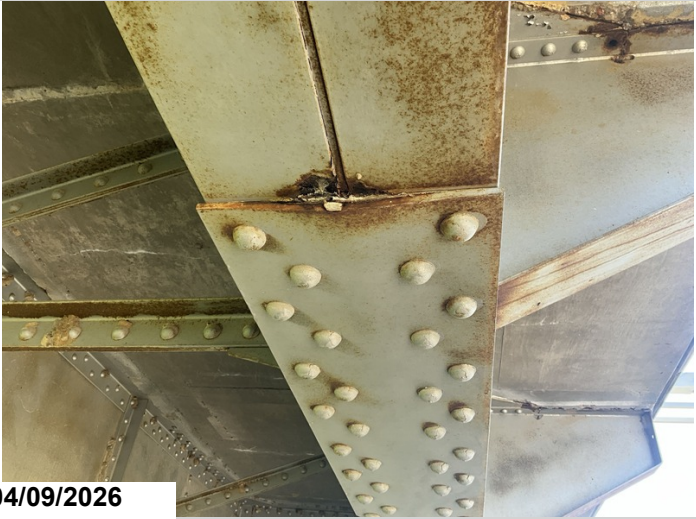
Span 2 girder 4, splice near pier 2, 1/8" section loss and pack rust, 1LF, CS3.

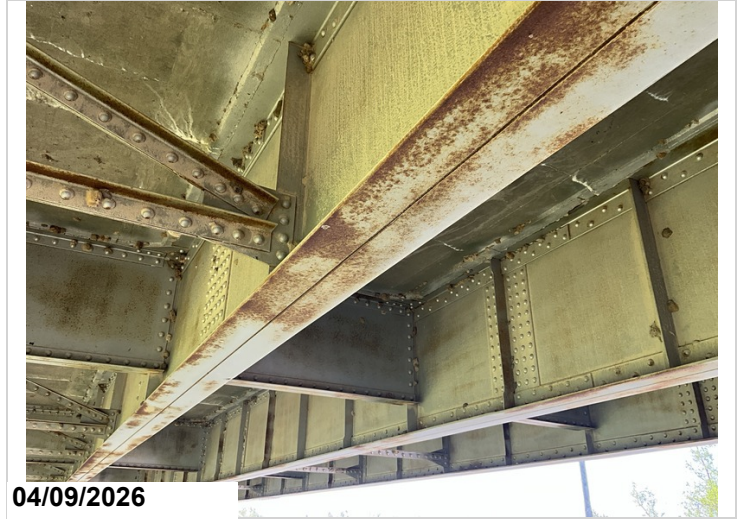
Span 2 , girder 2, typical minor corrosion.

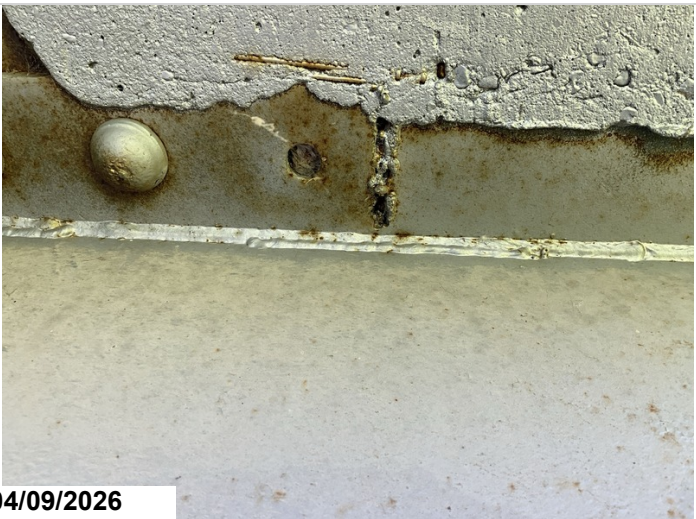
Span 2, girder 1, cantilever member 1, cut in top flange.

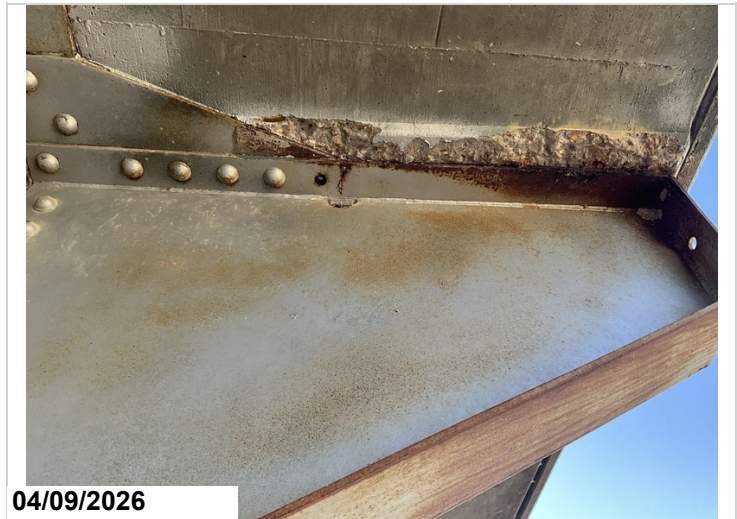
Span 2, girder 4 right, cantilever member, arrested crack in top flange, typical.

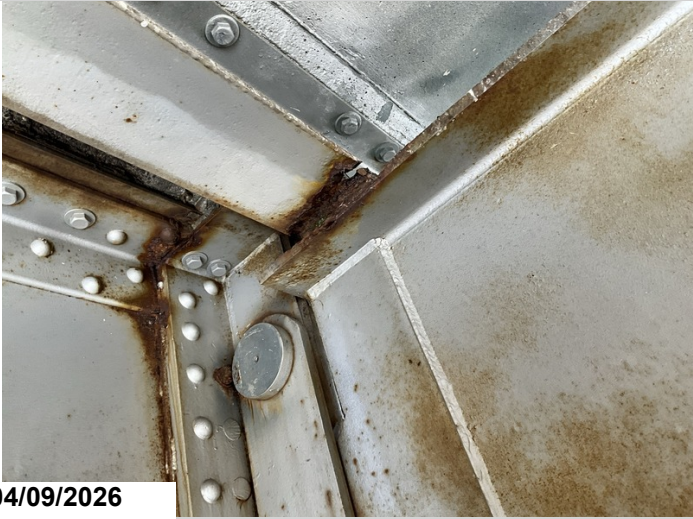
Span 15, First Deck Joist ahead of Floorbeam 66, Above Stringer 1: Active corrosion with a hole in the bottom flange of the deck joist. 1LF CS4 corrosion.

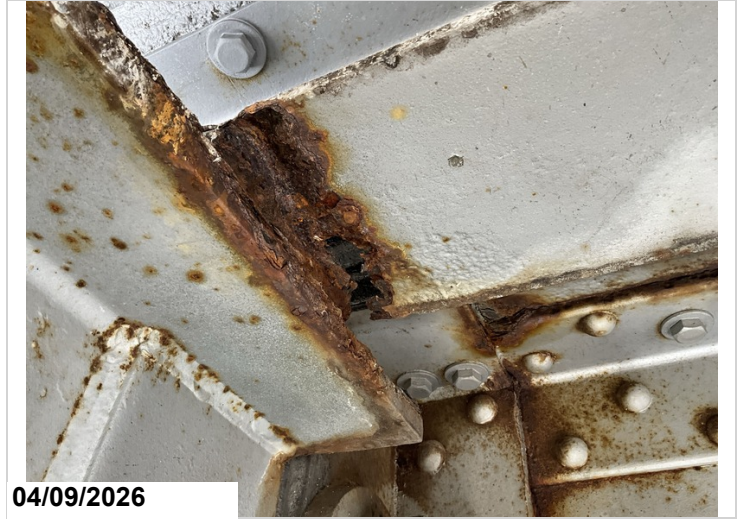
Span 15, First Deck Joist ahead of Floorbeam 66, Above Stringer 2: Active corrosion with a hole in the bottom flange of the deck joist. 1LF CS4 corrosion.

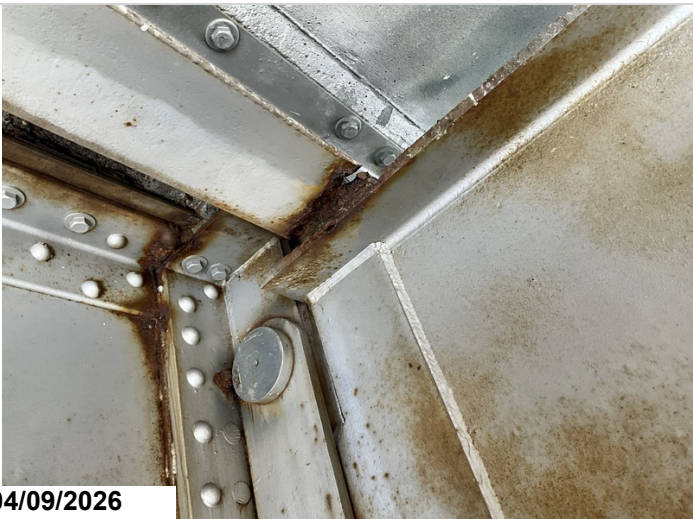
Span 15, First Deck Joist ahead of Floorbeam 66, Above Stringer 1: Active corrosion with a hole in the bottom flange of the deck joist. 1LF CS4 corrosion.

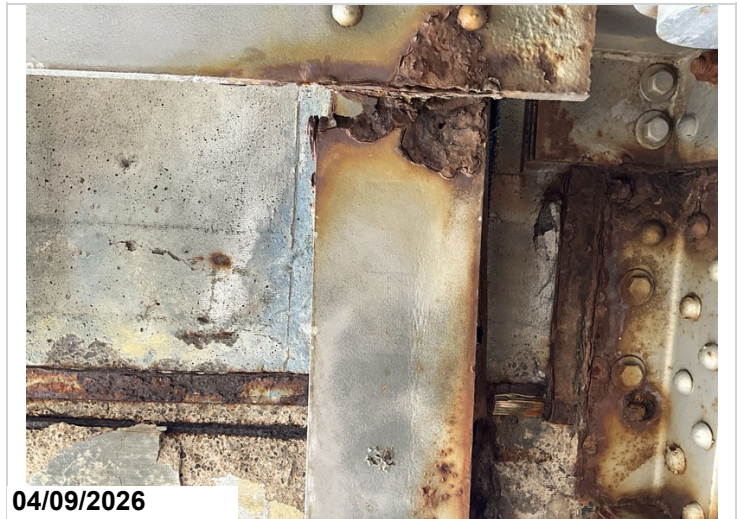
Span 14, Last deck joist before Floorbeam 62, Stringer 1: Active corrosion with a hole in the bottom flange of the deck joist. 1LF CS4 corrosion.

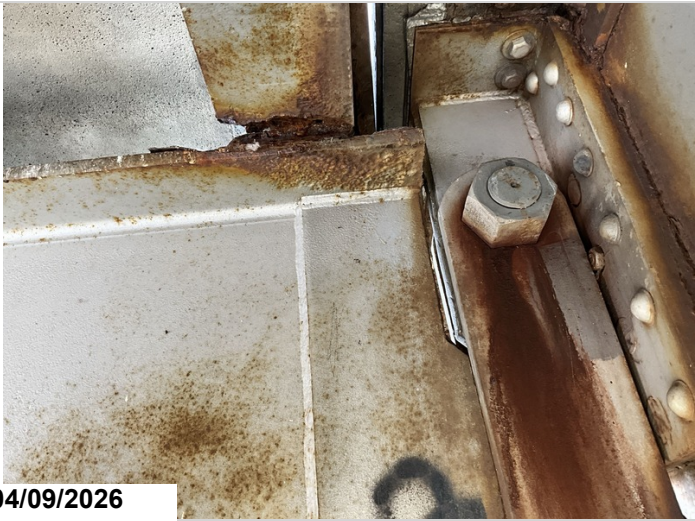
Span 14, Last deck joist before Floorbeam 62: Hole in Bottom Flange at stringer 1.

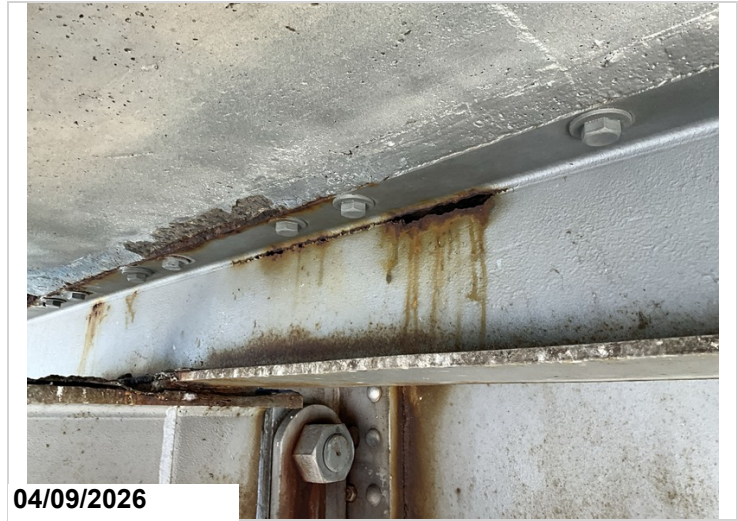
Span 14, Last deck joist before Floorbeam 62: Active corrosion with a 22" X 1 1/2" Hole in the web along the top web juncture. 2LF CS4 corrosion.

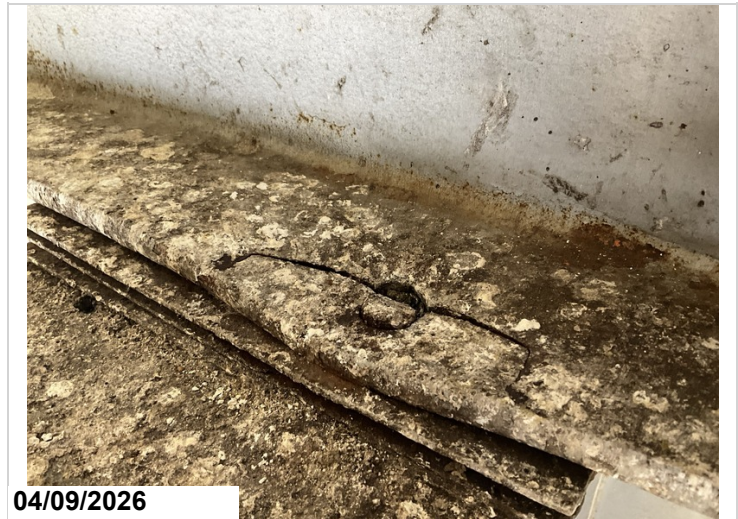
Span 14, Last deck joist before PP59, Stringer 2: Active corrosion with pack rust, causing a fracture in the bottom flange of the deck joist on both the ahead and back side, making a "Half-Moon" shape around the stringer connection bolts. 1LF CS3 crack.

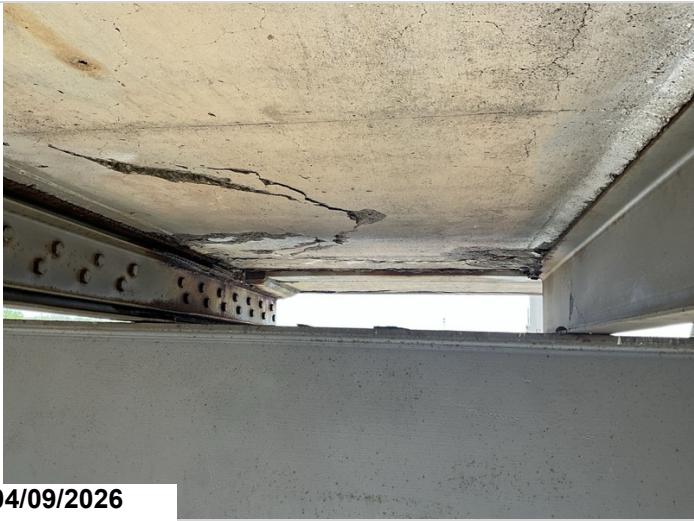
Typical condition of Deck Joist.

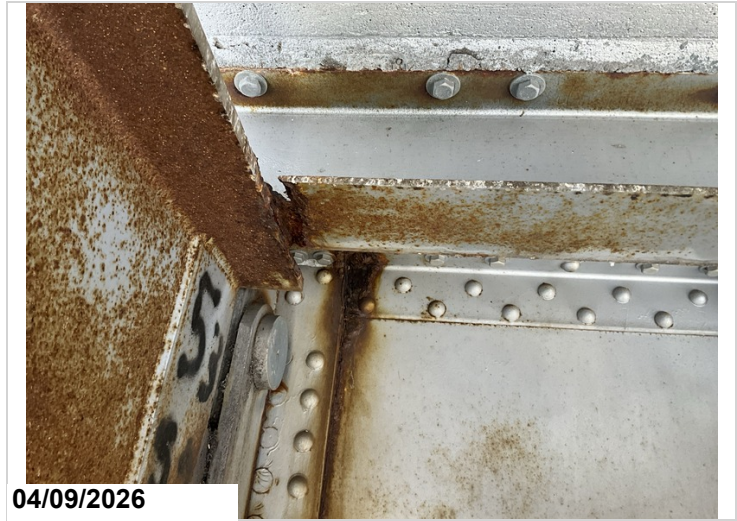
Span 14, Floorbeam 53, Stringer 2, Ahead, Deck joist: 2 3/4" X 1" hole and severe section loss with knife's edge section remaining.  
2" X 1" hole on Right side of Stringer 2.

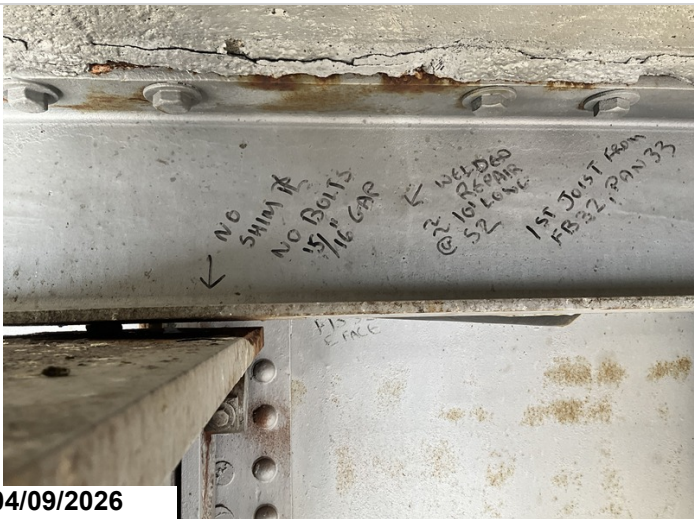
Span 13, first joist ahead of floor beam 32 at stringer 2, bolts and shim plate missing.

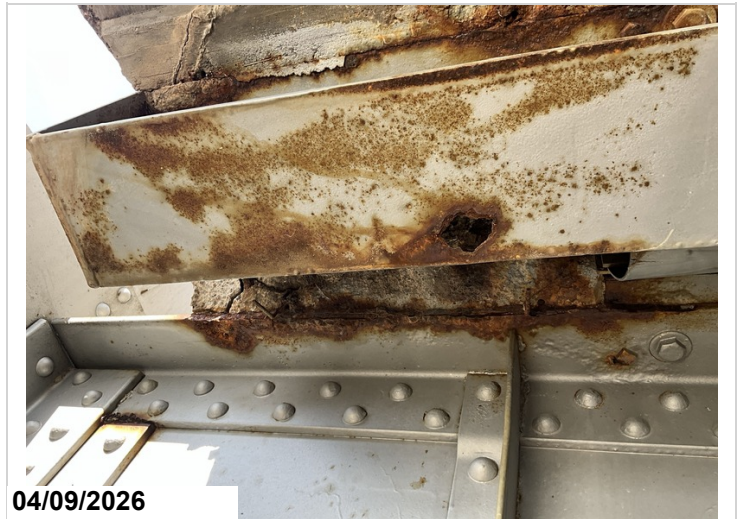
Span 13, panel point 32, first deck joist ahead of floor beam, 2" hole in bottom flange of floor joist.

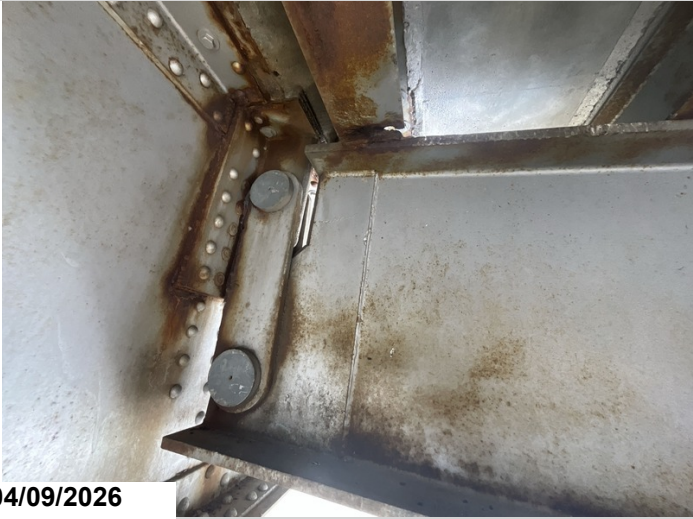
Span 12, Deck Joist, Back of Floorbeam 22, above Stringer 2: Active corrosion with a 2 1/2" X 1" Hole in the bottom flange of the Deck Joist. 1LF CS4 corrosion.

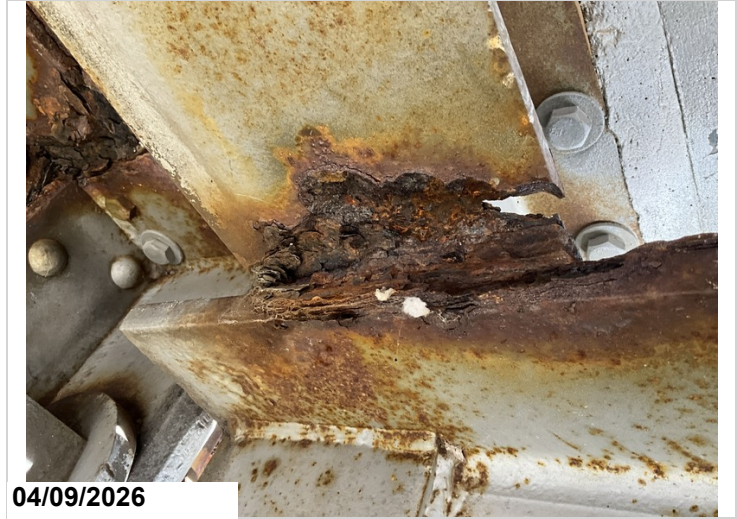
Span 12, Deck Joist, Back of Floorbeam 22, above Stringer 3: Active corrosion with a 1 1/2" X 1/2" Hole in the bottom flange of the Deck Joist. 1LF CS4 corrosion.
