## Bridge 02899 Inspection Report

Arnold Road ID:54x49x11xA, Arnold Log mile:0.569

# National Bridge Inventory Data Sheet

| IDENTIFICATION | |
|---|---|
| (7) Facility Carried | US 49- Phillips Co |

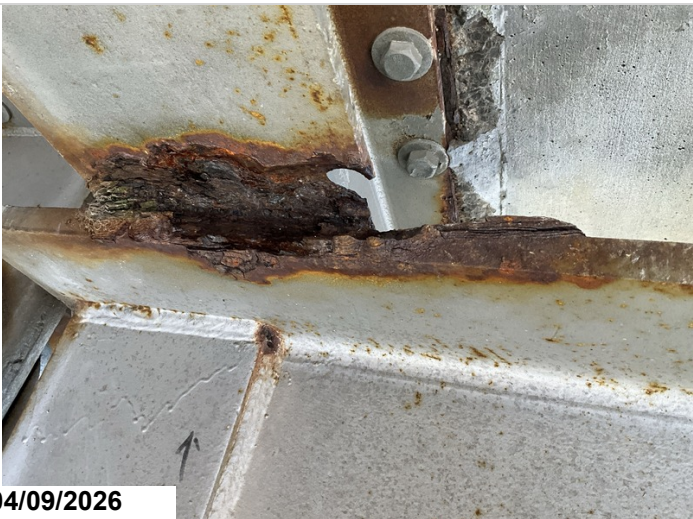
Span 12, floor beam 18, stringer 1, deck joists causing 1, hole in bottom flange above stringer. Move to Deck joist.

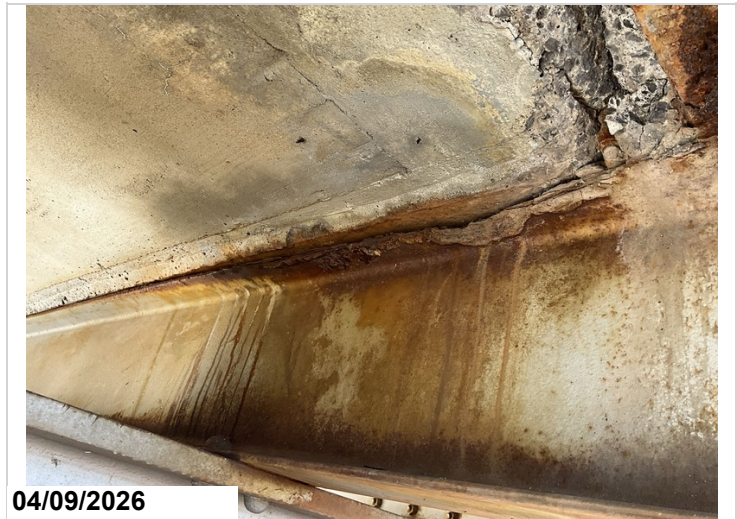
Typical Deck Joist.

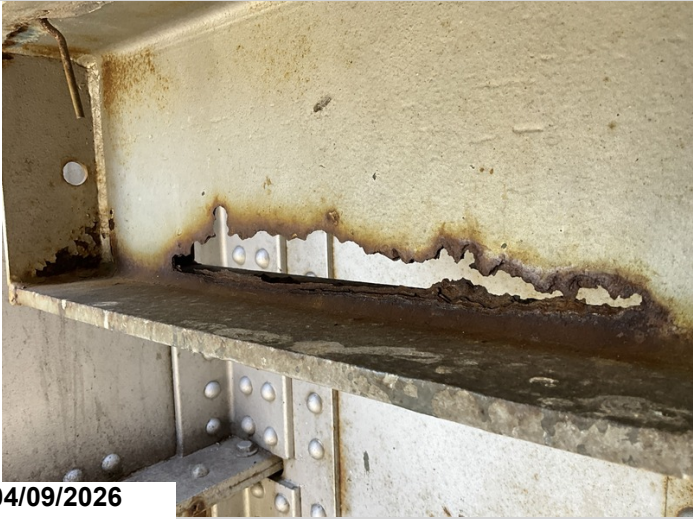
Span 11, Deck Joist, Floorbeam 8, Back, Adjacent to Stringer 1: Active corrosion with a 16" X 2 1/2" Holes in the deck joist, causing distortion at Stringer 1. 2LF CS4 corrosion.

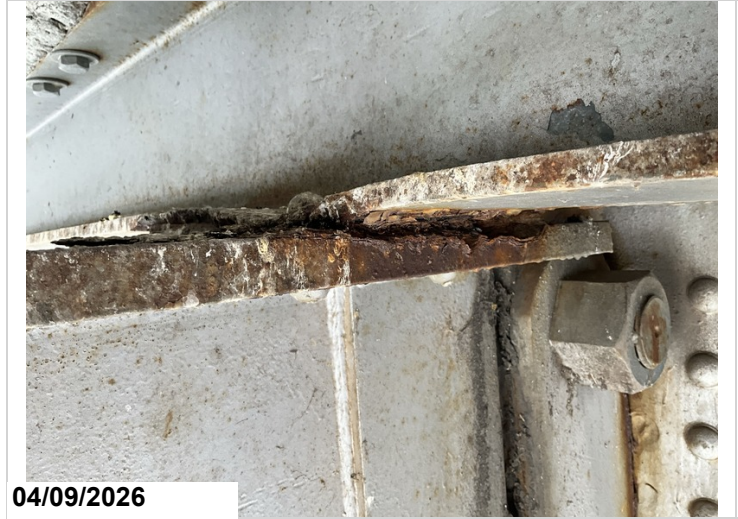
Span 11, Deck Joist, Floorbeam 8, Back, Adjacent to Stringer 1: Active corrosion with a 16" X 2 1/2" Holes in the deck joist, causing distortion at Stringer 1. 2LF CS4 corrosion.

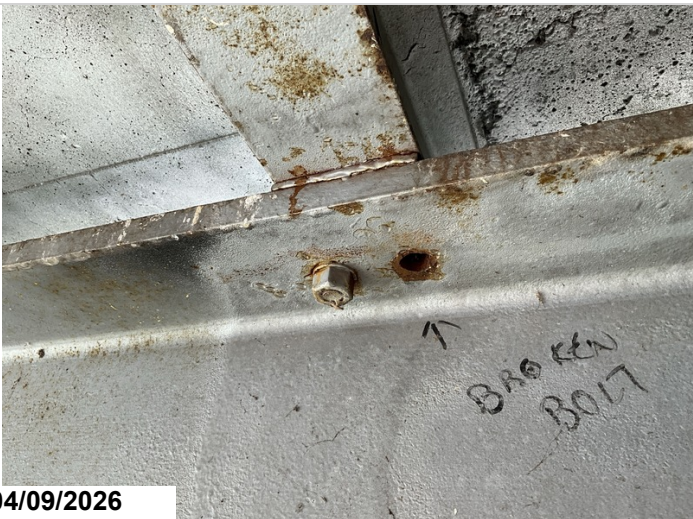
Span 11, Two Deck Joist back from Floorbeam 6: Sheared bolt. 1LF CS3 connection.

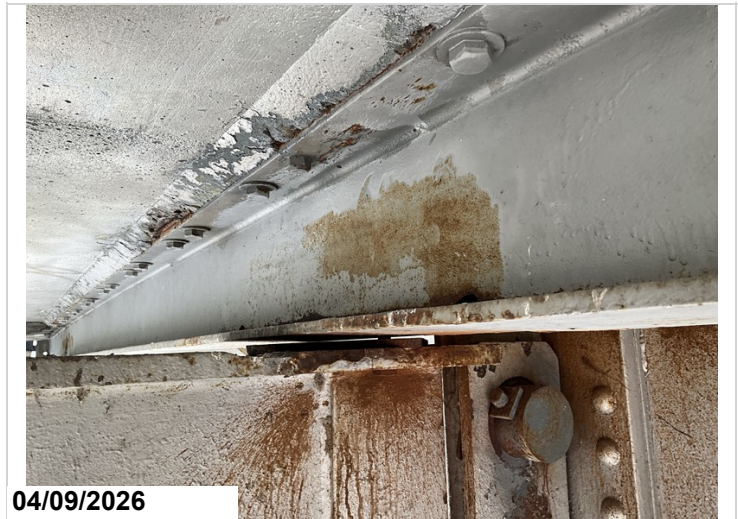
Span 11, Deck Joist, Floorbeam 3, Back, Adjacent to Stringer 2: Deck joist is floating, no bolts in place. 1LF CS3 connection.

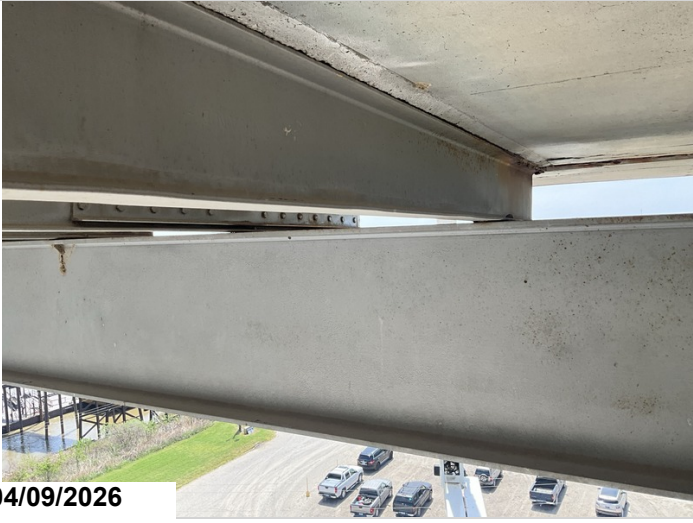
Span 11, Deck Joist to Stringer 3 connection: Typical active corrosion with pack rust. CS3 corrosion.

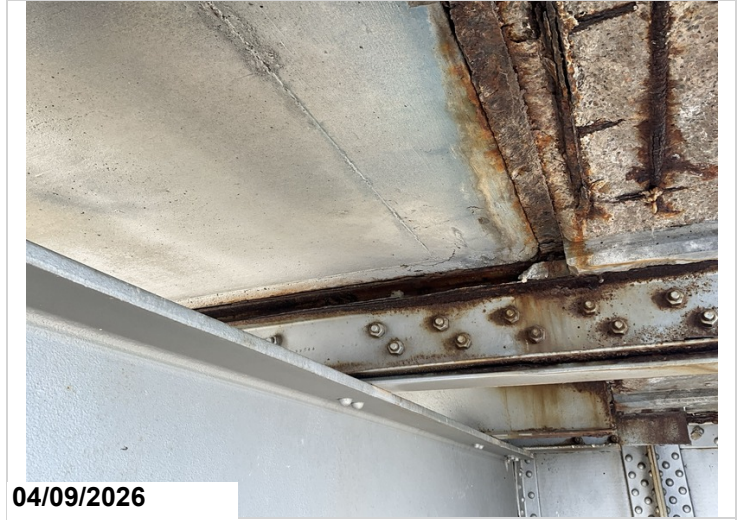
Span 11, Deck Joist, Adjacent to Stringer 1: Typical active corrosion with flaking rust and section loss to the deck joist. 3LF CS3 corrosion.

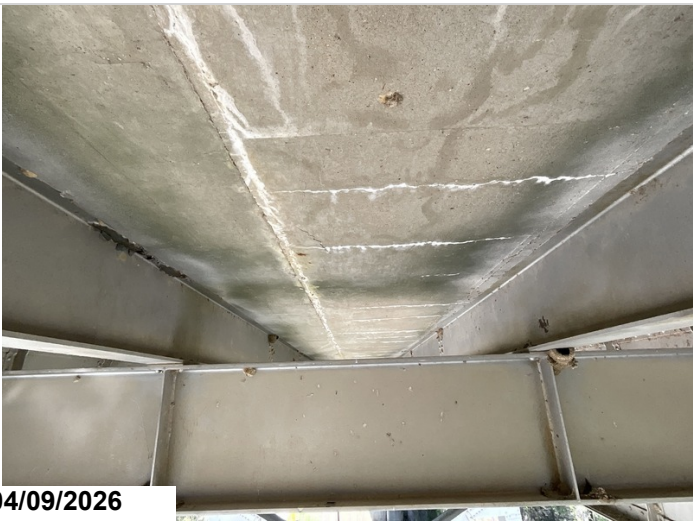
Span 9, Stringers: Flaking paint, typical throughout the structure.

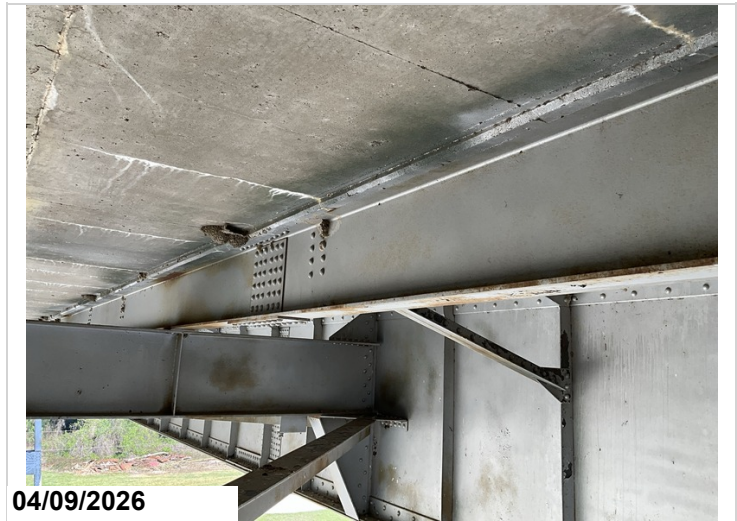
Span 10, Stringer 1: Typical Active corrosion with surface rust. 325LF CS2 corrosion throughout the structure.

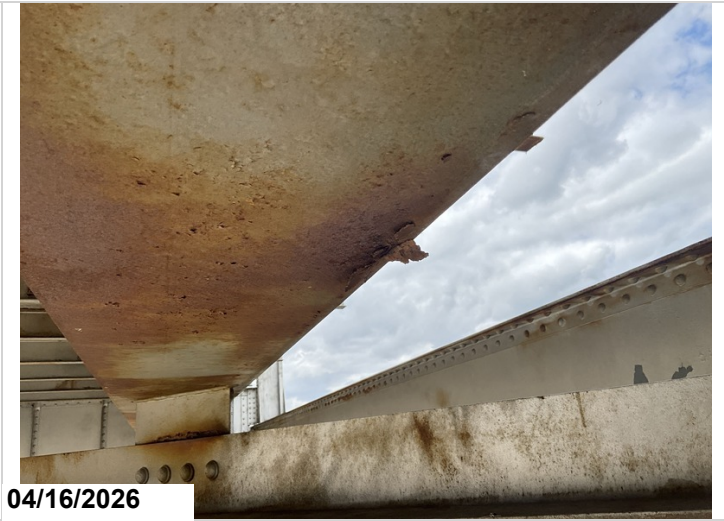
Span 13, Stringer 1, between PP41 and 42: Rolling defect.

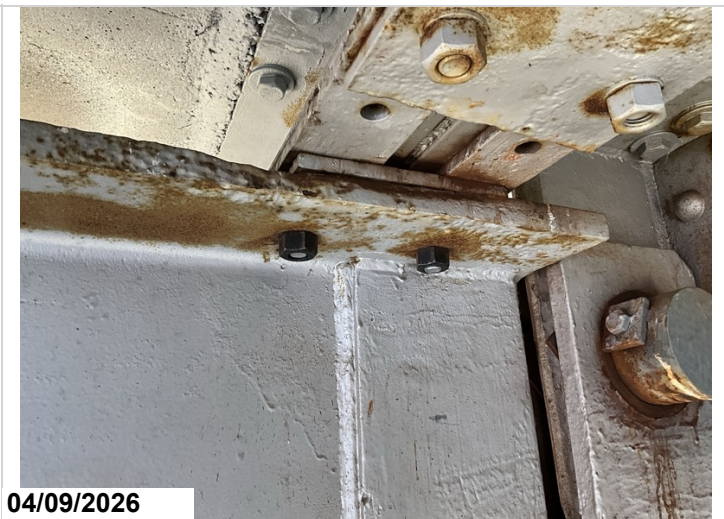
Span 13, Stringer 2 to last Deck Joist connection before Floorbeam 36: Bolts put in place by inspection personnel.

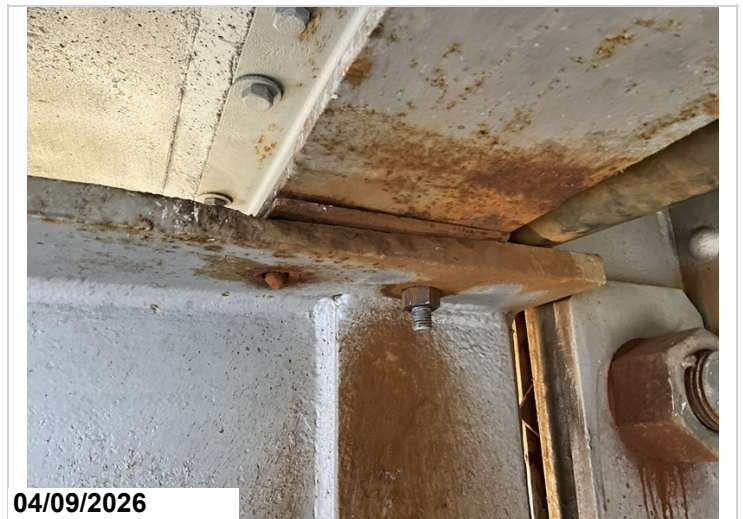
Span 13, Stringer 2 to last Deck Joist connection before Floorbeam 40: Bolt put in place by inspection personnel.

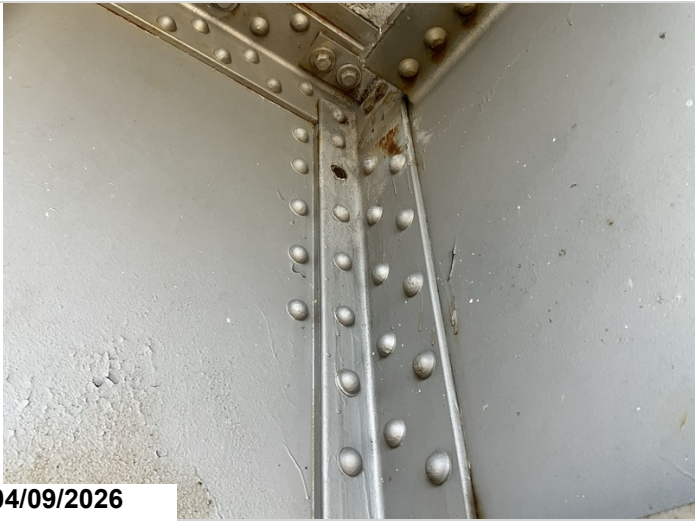
Span 13, Stringer 3, Floorbeam 46, Ahead: One sheared rivet heads. 1LF CS3 connection.

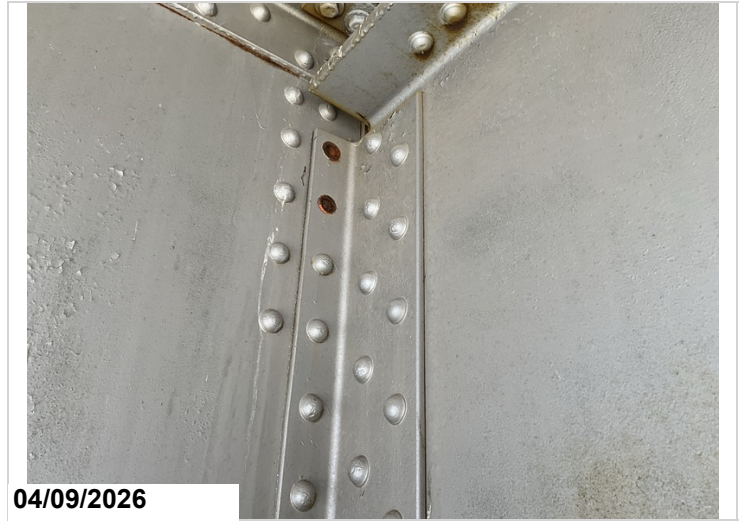
Span 13, Stringer 1, Floorbeam 46, Ahead: Two sheared rivet heads. 1LF CS3 connection.

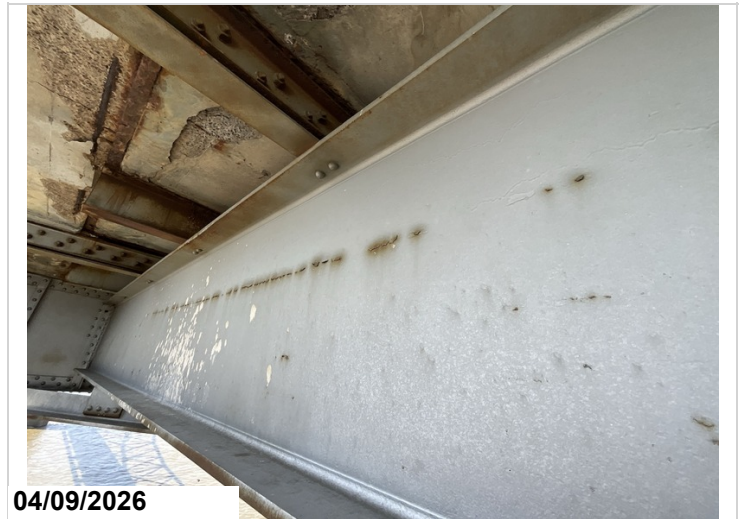
Span 13, Stringer 1, Right, Adjacent to Floorbeam 48: Rolling defect.

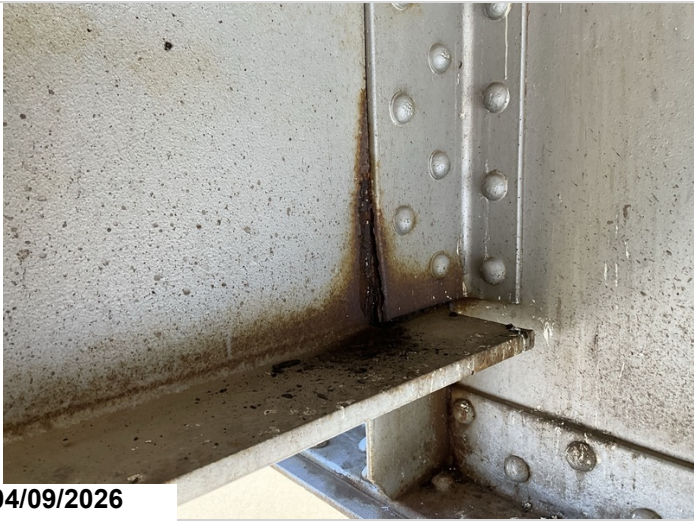
Span 13, Stringer 3, Right, between Floorbeams 46 and 47: Rolling defect.

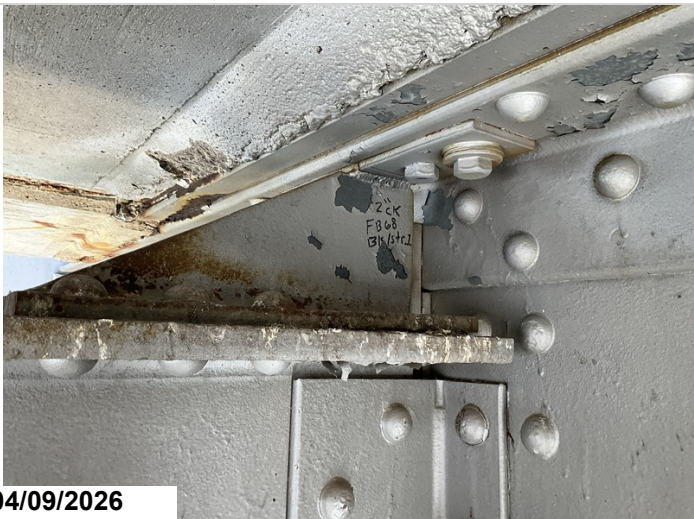
Span 15, Stringer 1, Floorbeam 69: Two missing rivets and one sheared rivet head. 1LF CS3 connection.

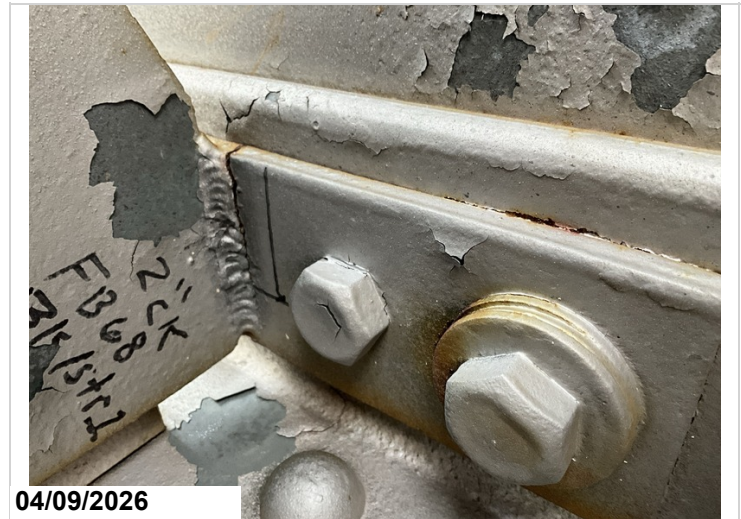
Span 15, Stringer 1, Floorbeam 68, Back, Kicker plate: 2" crack in weld in stringer kicker plate. 1LF CS3 crack.

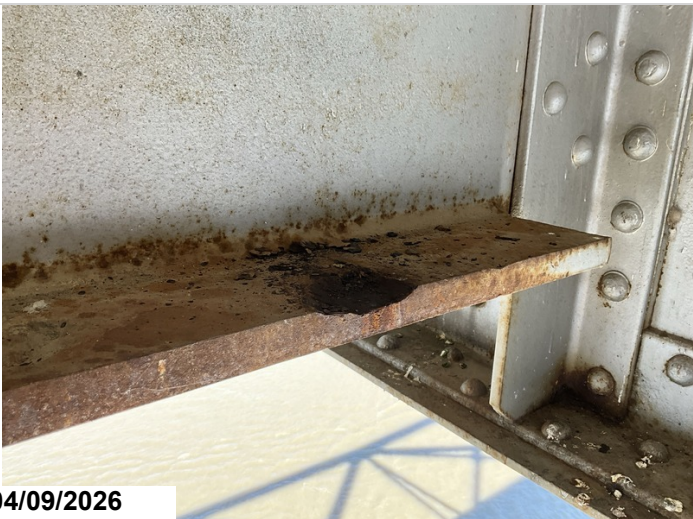
Span 15, Stringer 2, Floorbeam 68, Back, Kicker plate: 1 3/4" crack in weld in stringer kicker plate. 1LF CS3 crack.

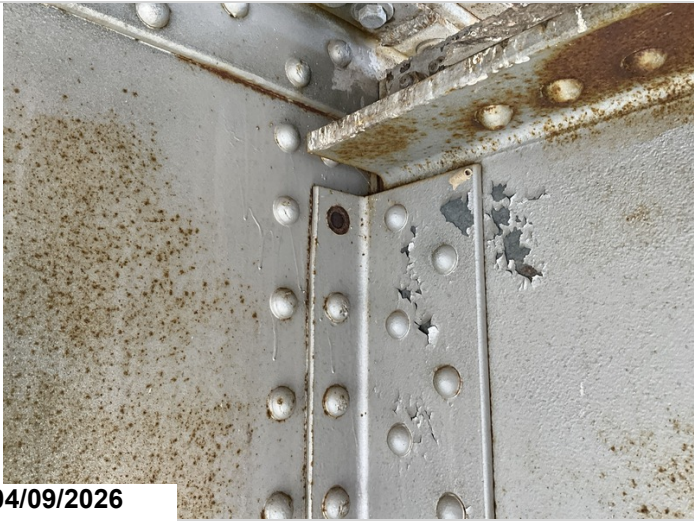
Span 15, Stringers 1 - 3, Ahead of Floorbeam 66: Active corrosion with section loss to Top Flange approximately 3/8". 3LF CS3 corrosion.

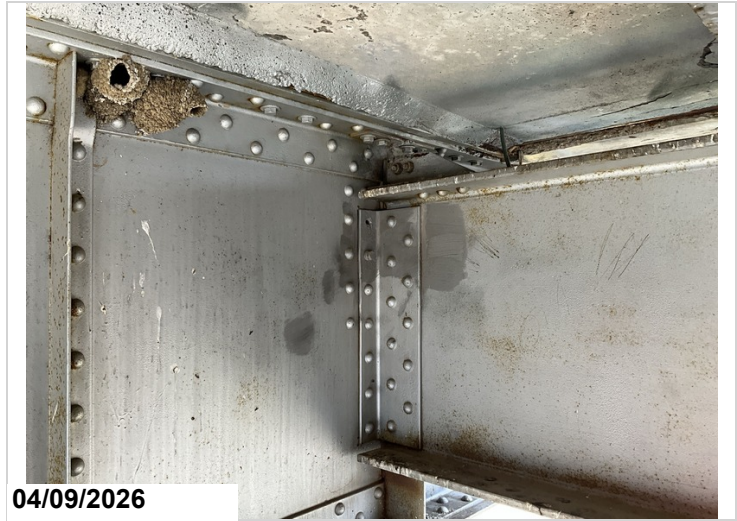
Span 15, Stringers 1 and 2, Floorbeam 66: Sheared rivet head. 2LF CS3 connection.

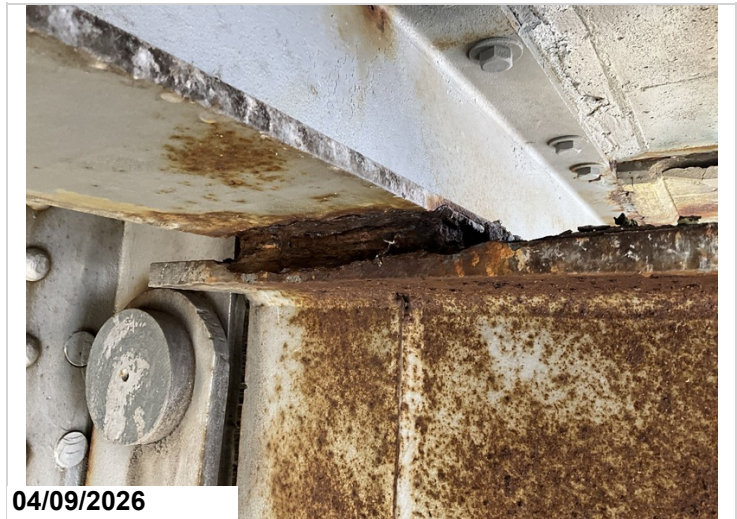
Span 14, Stringer 2, Back of Floorbeam 62: Active corrosion with pack rust up to 1" between stringer and deck joist. 1LF CS3 corrosion.

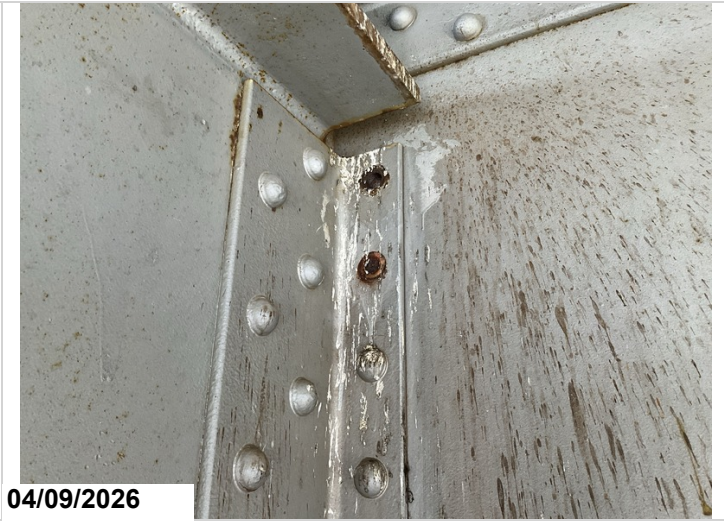
Span 14, Stringer 3 to Deck joist connection, Floorbeam 62: 1/4" section loss to Top Flange of stringer and 1" pack rust. 1LF CS3 corrosion.

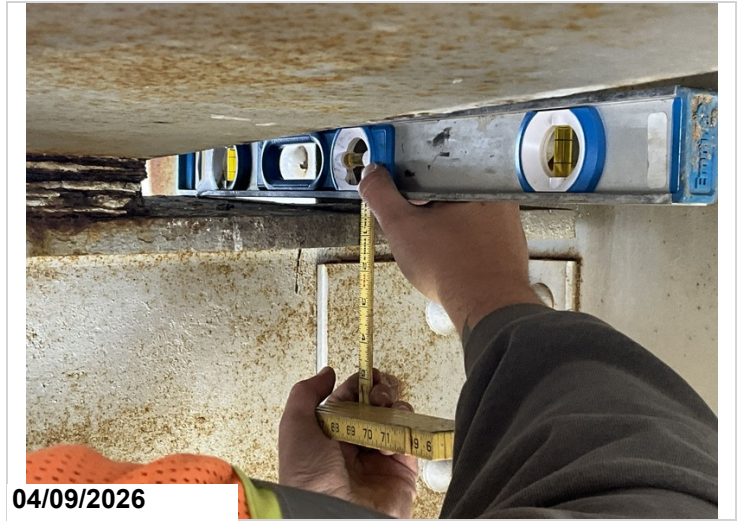
Span 14, Stringer 1, Floorbeam 61: Missing and sheared rivets. 1LF CS3 connection.

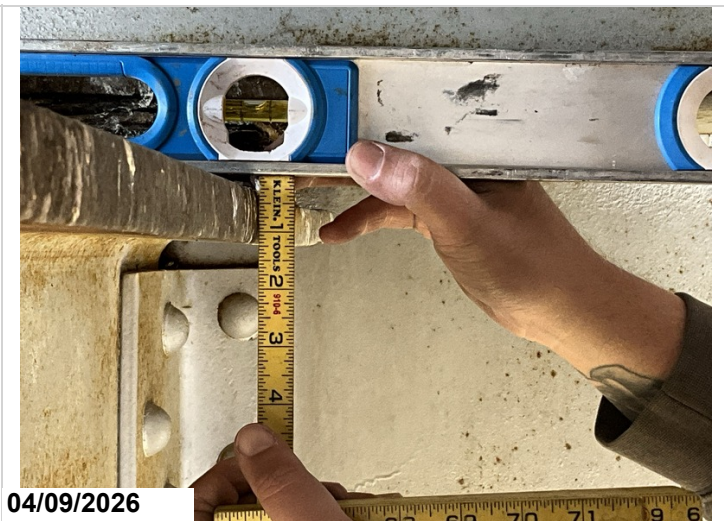
Span 14, Stringer 1, Back of PP59: Top Flange twisted 5/16 - 3/8" per width of Top Flange (1'), towards stringer 2. 5LF CS2 distortion.

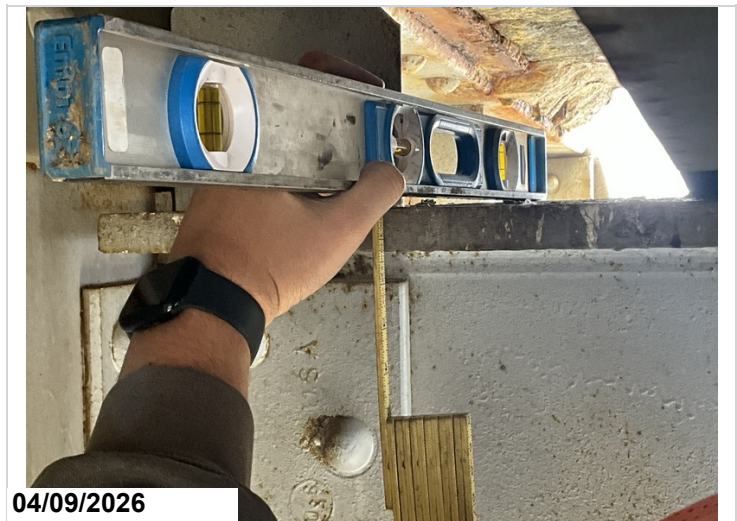
Span 14, Stringer 1, Back of PP59: Top Flange twisted 5/16 - 3/8" per width of Top Flange (1'), towards stringer 2. 5LF CS2 distortion.

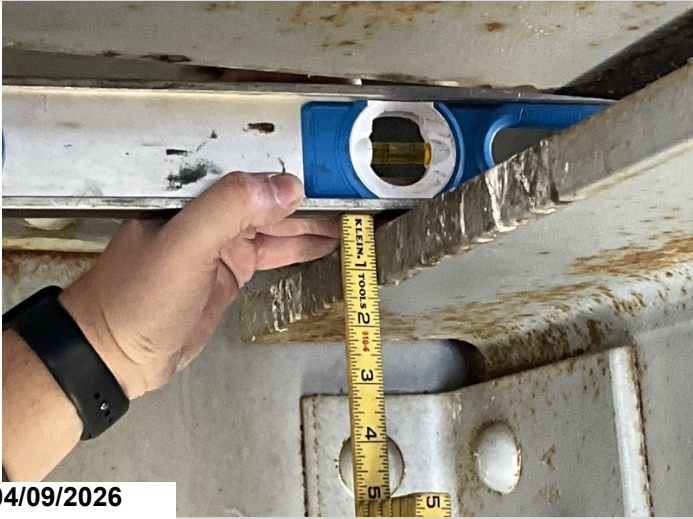
Span 14, Stringer 3, Back of PP59: Top Flange twisted 5/16" per width of Top Flange (1'), towards stringer 2. 5LF CS2 distortion.

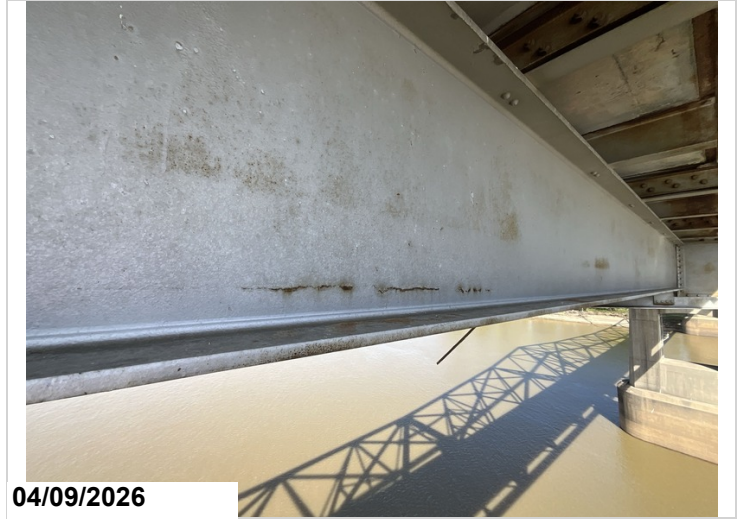
Span 14, Stringer 3, Back of PP59: Top Flange twisted 5/16" per width of Top Flange (1'), towards stringer 2. 5LF CS2 distortion.

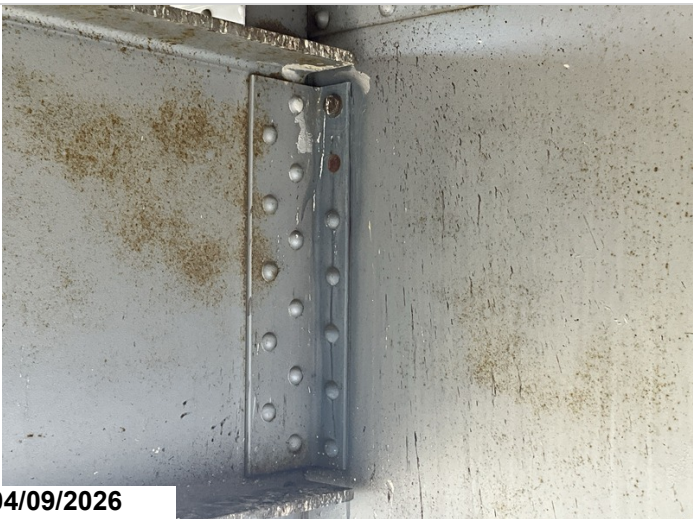
Span 14, Stringer 3, Between PP58 and 59: Mill scale along the web.

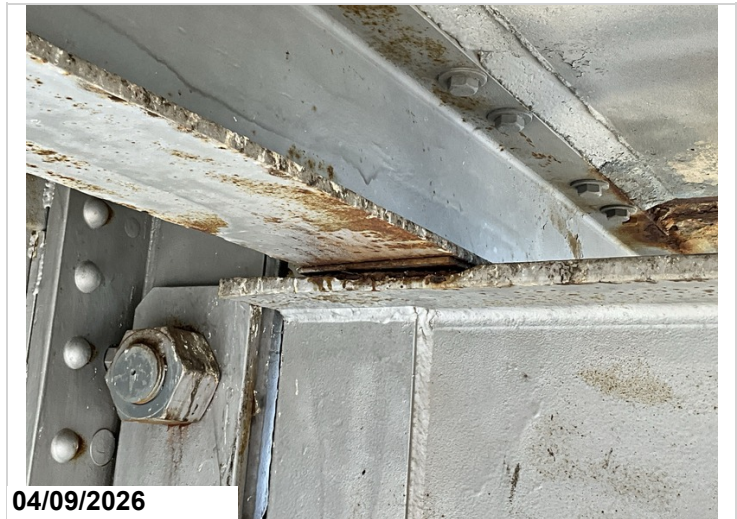
Span 14, Stringer 3, Floorbeam 57: Sheared rivet head. 1LF CS3 connection.

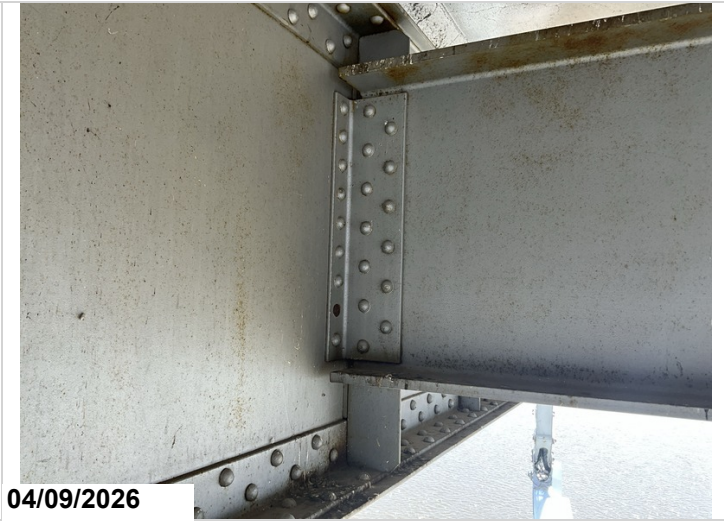
Span 14, Stringers 1 - 3, Ahead of Floorbeam 56, Stringers 1 - 3: Active corrosion with section loss up to 1/2" at the first deck joist connection. 3LF CS3 corrosion.

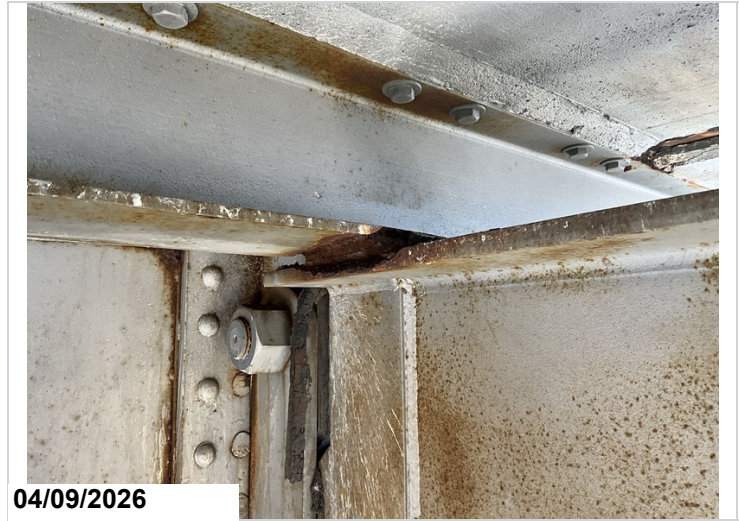
Span 14, Stringer 2, Floorbeam 55: Sheared rivet head. 1LF CS3 corrosion.

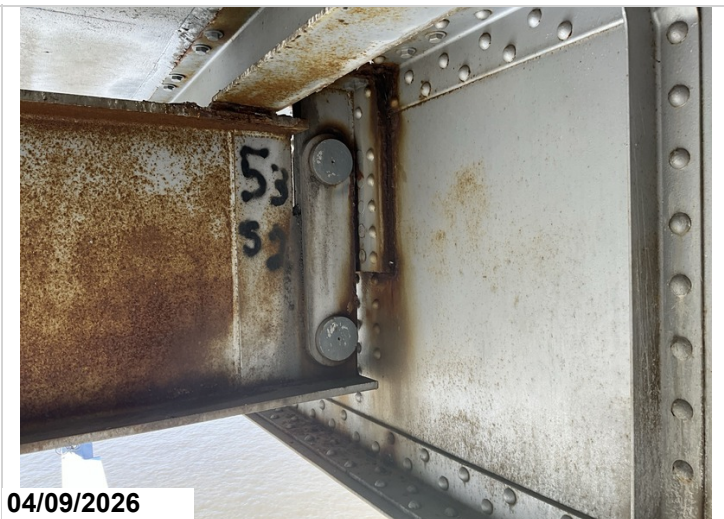
Span 14, Stringer 1, Floorbeam 53, Ahead: 1/2" section loss to the Top Flange, heavy section loss to deck joist. 1LF CS3 corrosion.

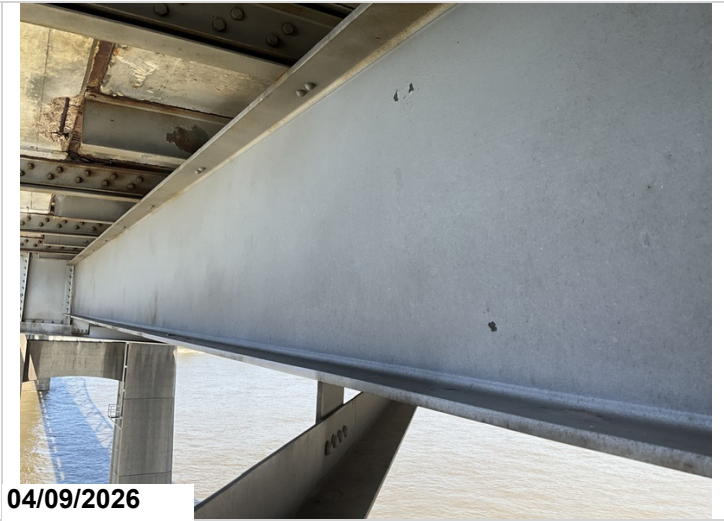
Span 14, Stringer 1, Floorbeam 52: Missing rivets. 1LF CS3 connection.

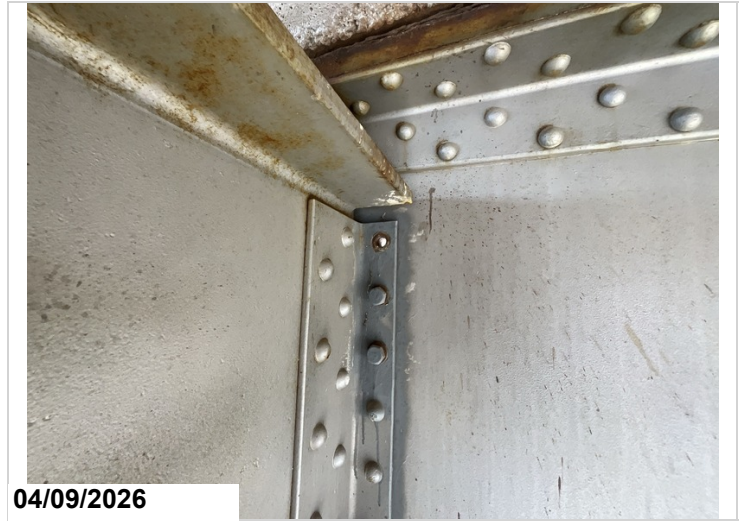
Typical stringer.

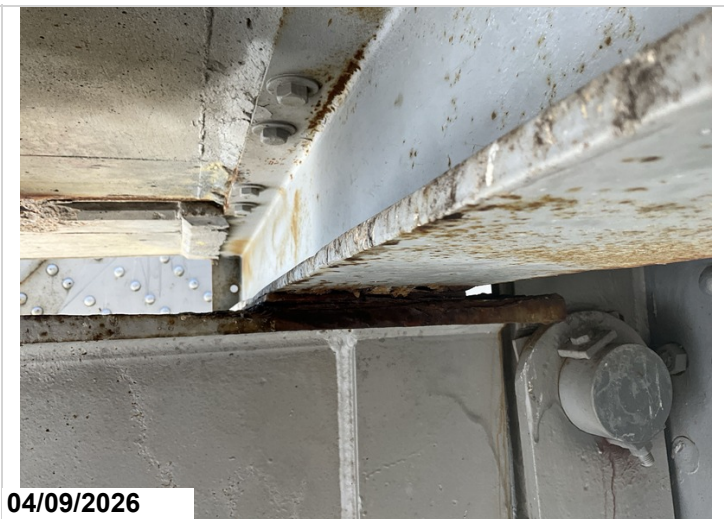
Span 14, Stringer 1, Floorbeam 51: Missing rivet. 1LF CS3 connection.

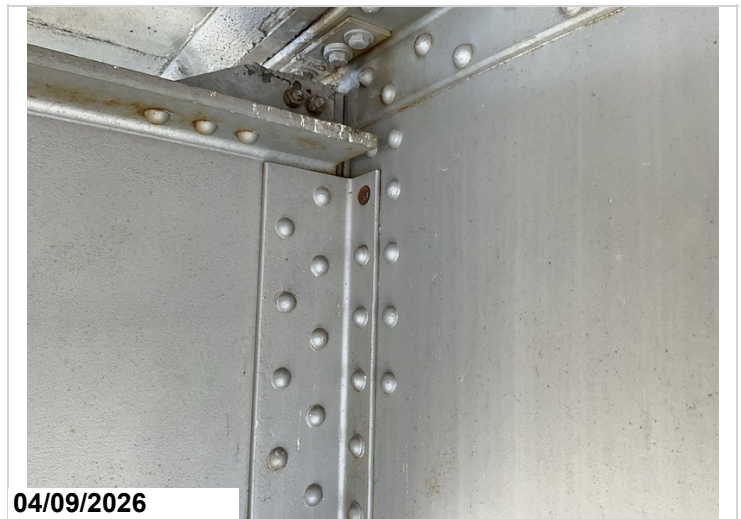
Span 14, Stringers 2 and 3, Floorbeam 50, Back: Active corrosion with section loss up to 1/2" to the top flange. 2LF CS3 corrosion.

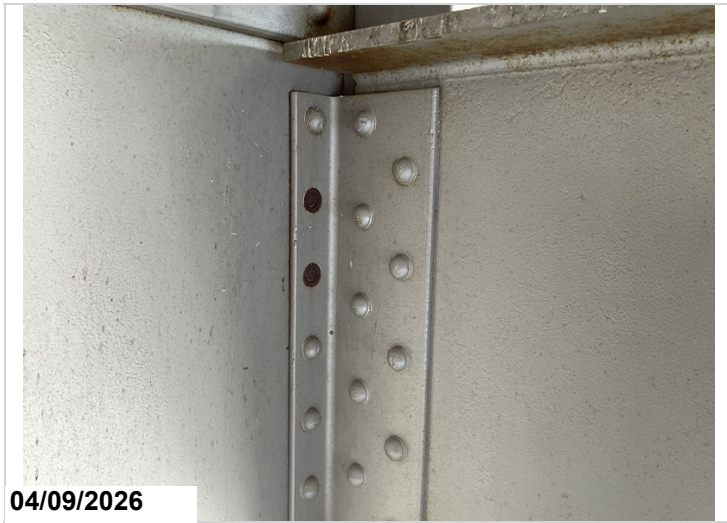
Span 14, Stringer 1, Floorbeam 50, Back: One sheared rivet head. 1LF CS3 connection.

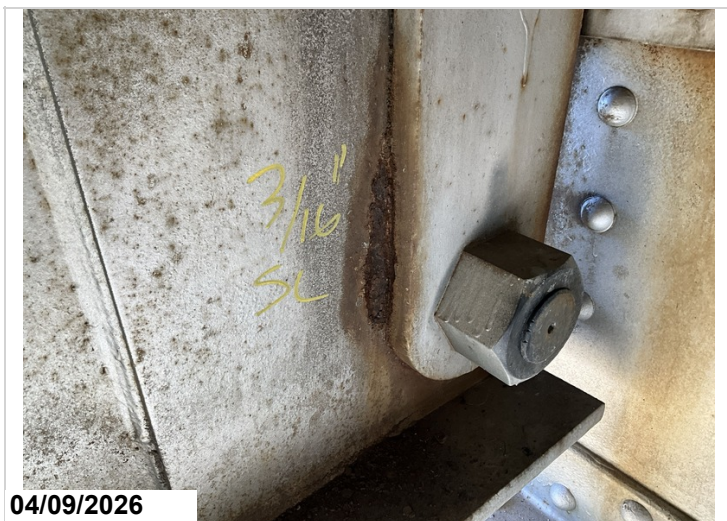
Span 15, Stringer 3, Floorbeam 71: Active corrosion with section loss up to 1/8" to the built-up stringer web plate. 1LF CS3 corrosion.

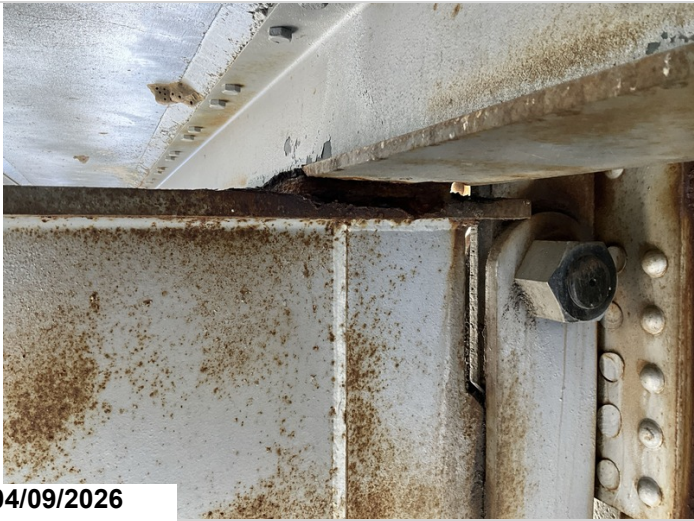
Span 15, Stringer 2, Floorbeam 71: Active corrosion with section loss up to 1/8" to the built-up stringer web plate. 1LF CS3 corrosion.

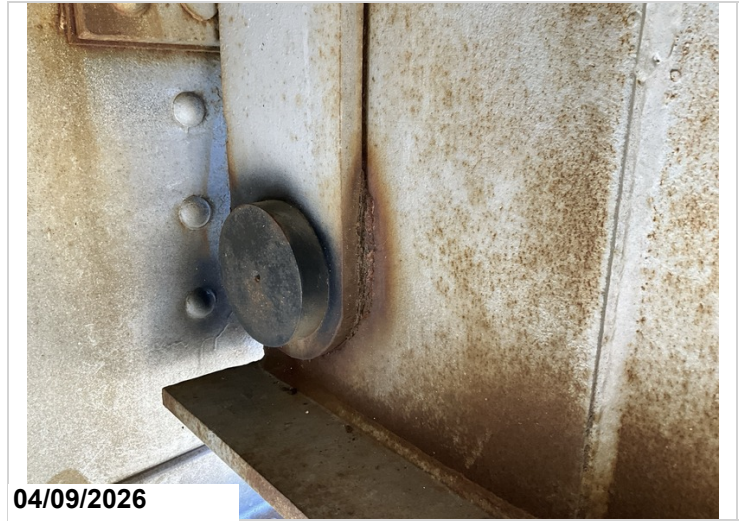
Span 15, Stringers 1 and 2, Floorbeam 71, Ahead: Active corrosion with pack rust up to 3/4" between the stringer and deck joist. 2LF CS3 corrosion.

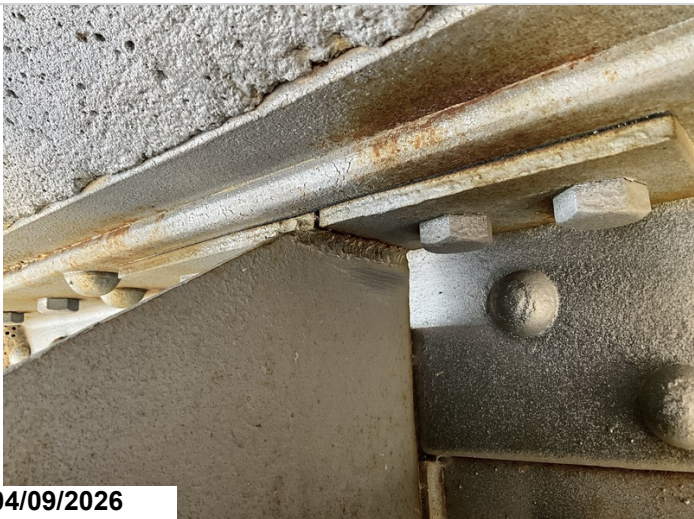
Span 15, Stringers 1 - 3, at Floorbeam 71, Pin and Hanger Assembly: Pack rust between hanger bar and stringer web. 3LF CS3 corrosion.

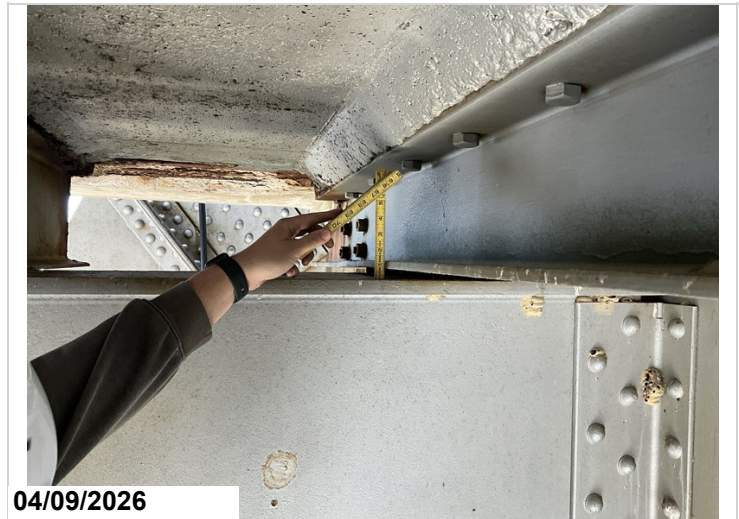
Span 15, Stringer 1, Floorbeam 71: Cracked weld in stringer kicker plate. 1LF CS3 crack.

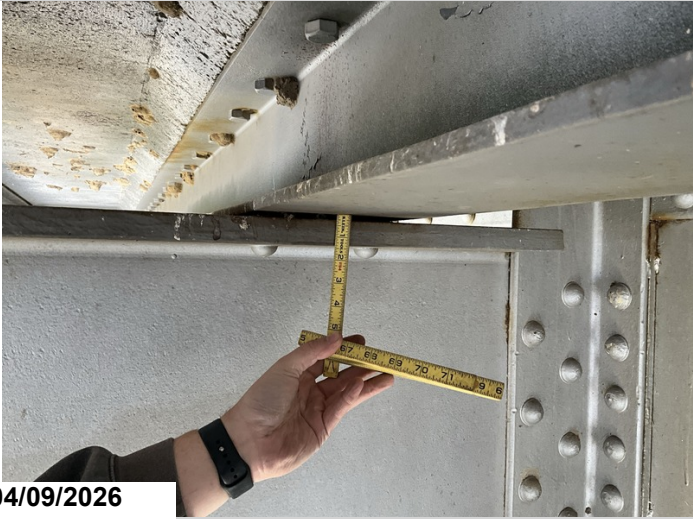
Span 15, Floorbeam 74, stringer 1, 3/4" gap between top flange of stringer and deck joist, 1 broken rivet

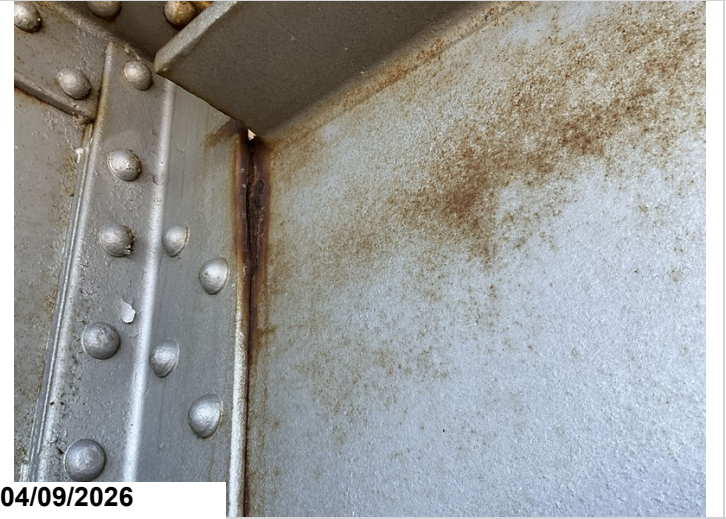
Span 15, Floorbeam 74, stringer 2, 1/4" gap between top flange of stringer and deck joist, 1 broken rivet

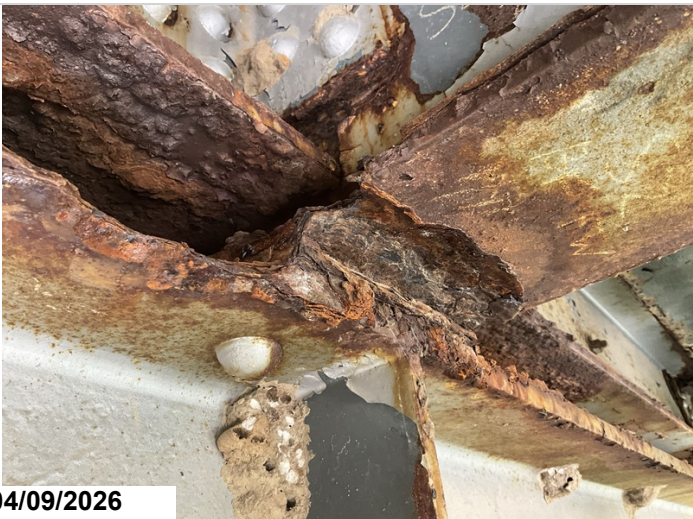
Span 15, Stringer 1, Floorbeam 73: Active corrosion with pack rust up to 3/8" at the angle connection plate. 1LF CS3 corrosion.

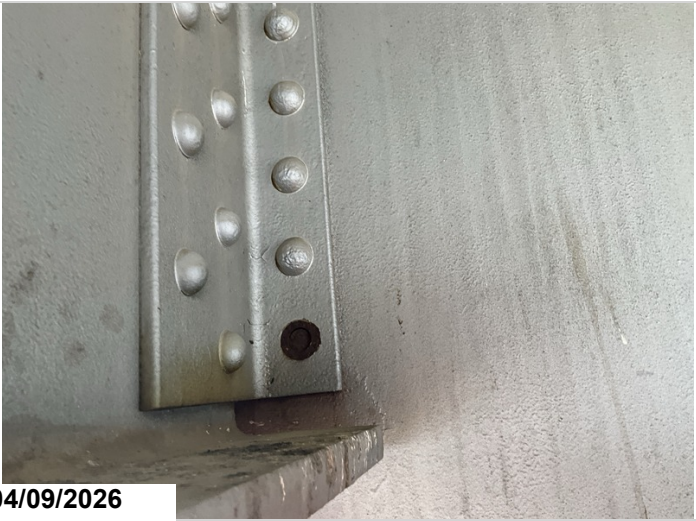
Span 13, floor beam 40 back, stringer 2, joist to stringer bolts broken. Shim plate loose, 25% section loss to the top flange. 1LF, CS3.

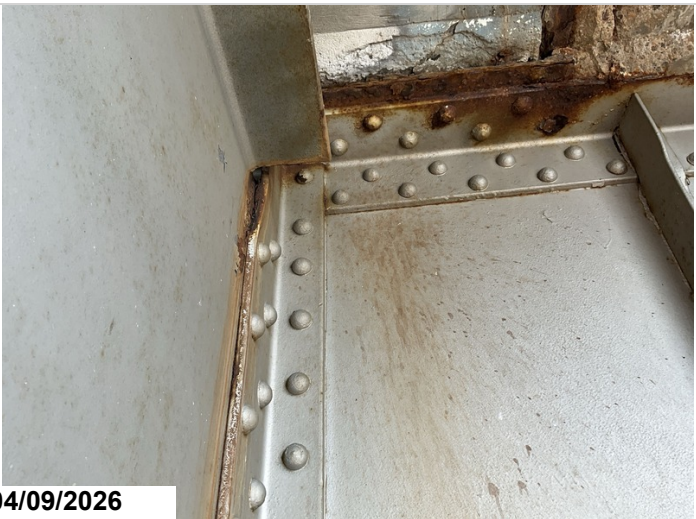
Span 13, Stringer 3, Floorbeam 41, Back: One missing bolt. 1LF CS3 connection.

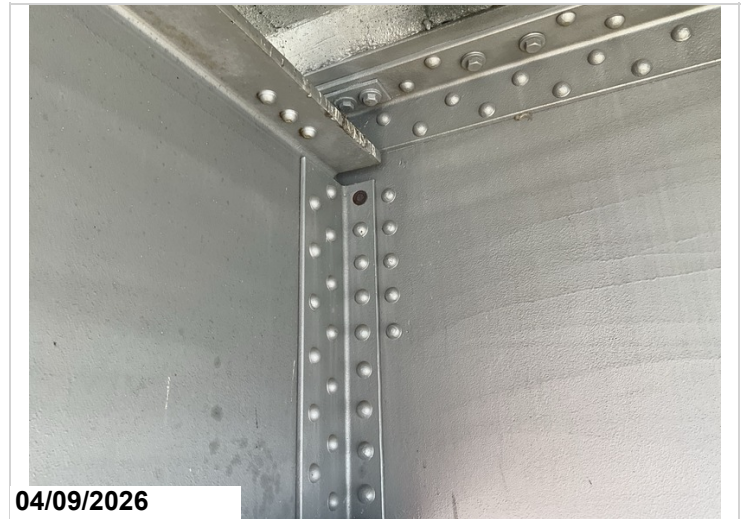
Span 13, Stringer 3, Floorbeam 42, Back: Active corrosion with pack rust between the stringer and angle connection plate. 1LF CS3 corrosion.

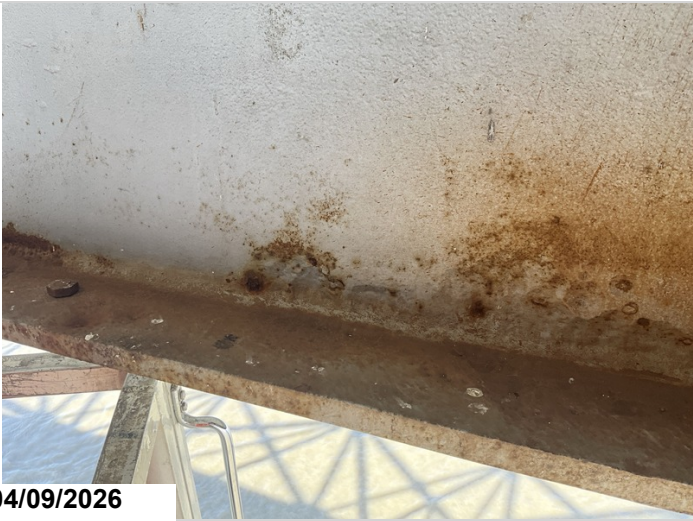
Span 13, Stringer 2, Floorbeam 40, Ahead: One sheared rivet head. 1LF CS3 connection.

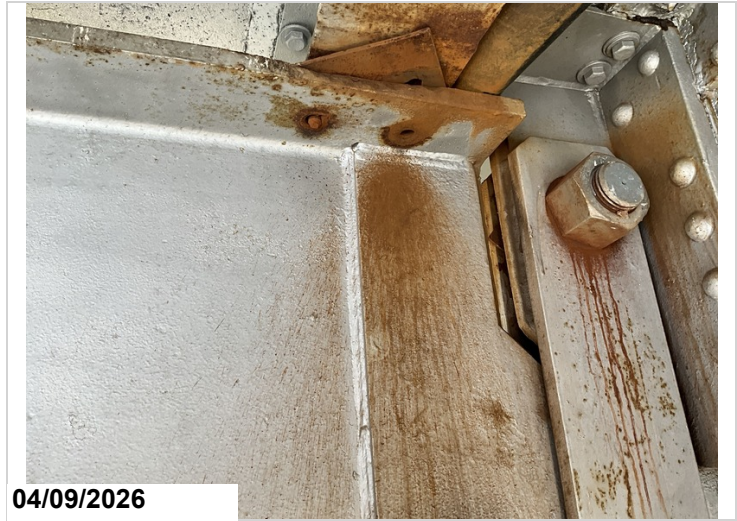
Span 13, Stringer 2, Floorbeam 40, Ahead: Deep pitting to the web and bottom flange. 3LF CS3 corrosion.

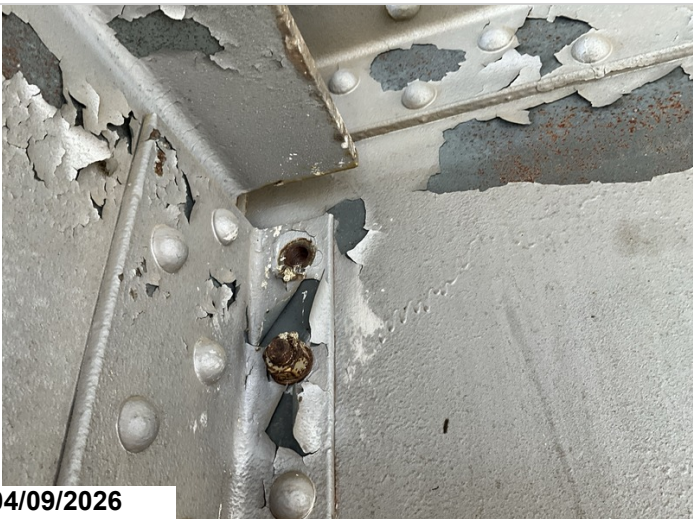
Span 13, floor beam 40 back, stringer 2, broken and missing bolts at the last floor joist stringer connection. 1LF, CS3.

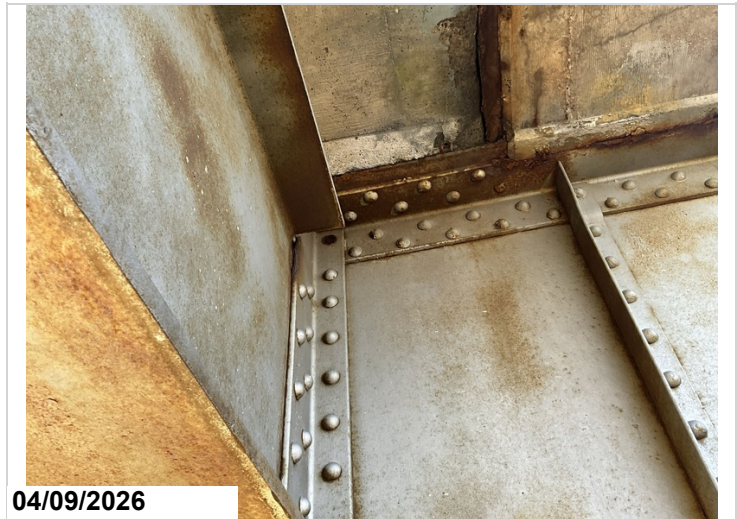
Span 13, Stringer 3, Floorbeam 37, Ahead: Missing bolt. 1LF CS3 connection.

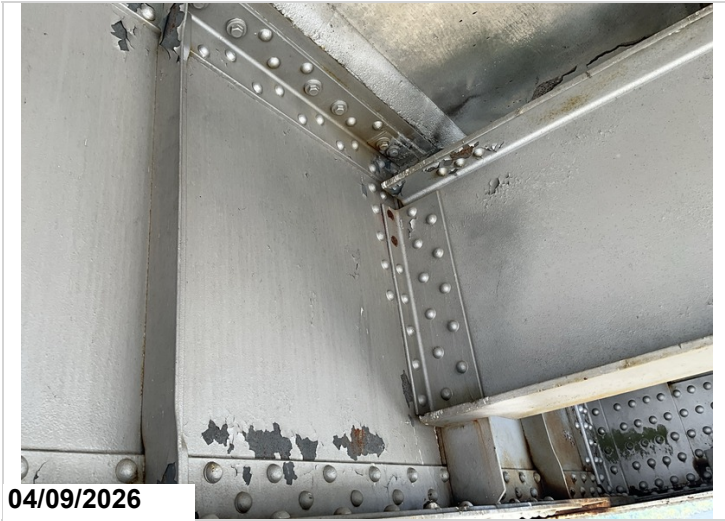
Span 13, Stringer 1, Floorbeam 37, Ahead: One sheared rivet head. 1LF CS3 connection.

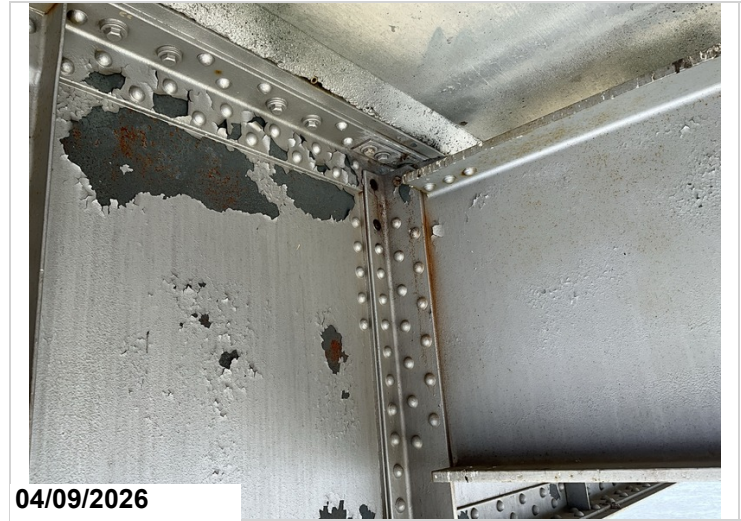
Span 13, Stringer 1, Floorbeam 36, Ahead: One sheared rivet head. 1LF CS3 connection.

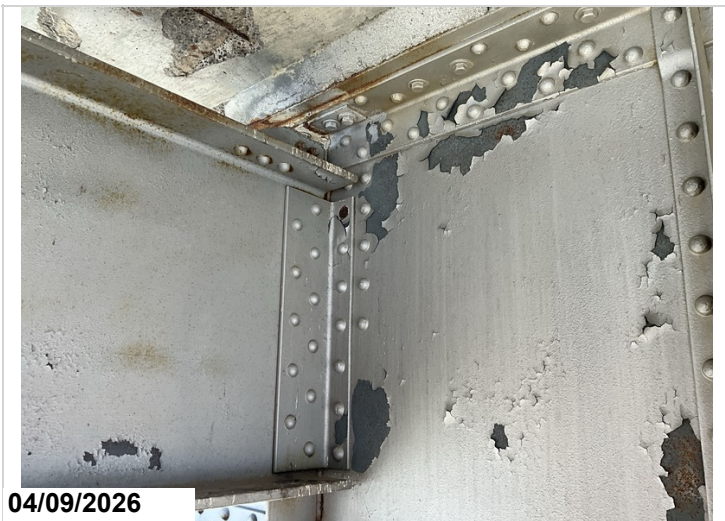
Span 13, Stringer 2, Floorbeam 36, Ahead: Three total sheared rivet heads. 1LF CS3 connection.
