## Bridge 02899 Inspection Report

Arnold Road ID:54x49x11xA, Arnold Log mile:0.569

# National Bridge Inventory Data Sheet

| IDENTIFICATION | |
|---|---|
| (7) Facility Carried | US 49- Phillips Co |

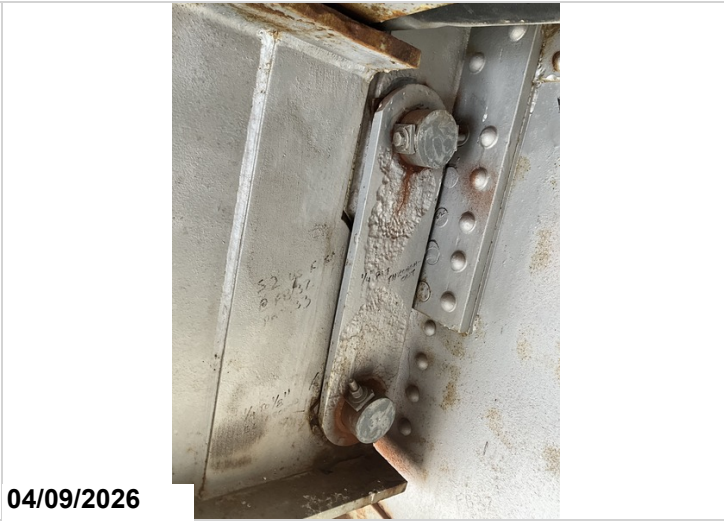
Span 13, floor beam 36 back, stringer 2, broken bolts on the stringer deck joist connection. 1LF, CS3.

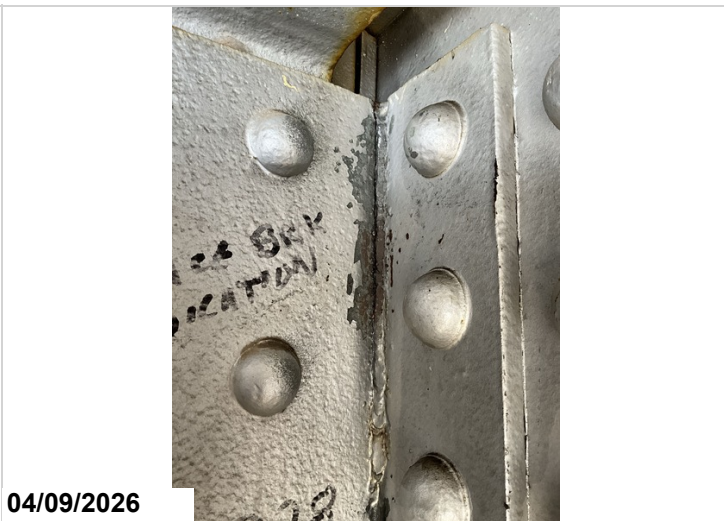
Span 12, Stringer 2 to Floorbeam 28 Connection, Ahead: 11" crack in the welded connection. 1LF CS3 crack.

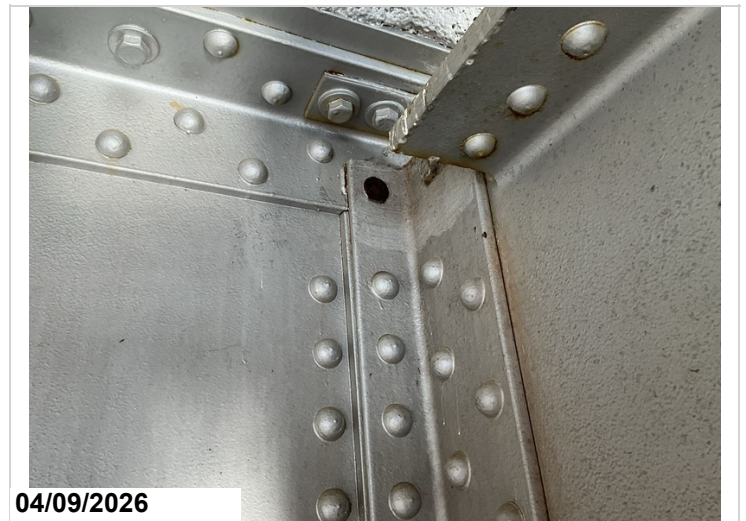
Span 12, Stringer 2 to Floorbeam 28 Connection, Ahead: 11" crack in the welded connection. 1LF CS3 crack.

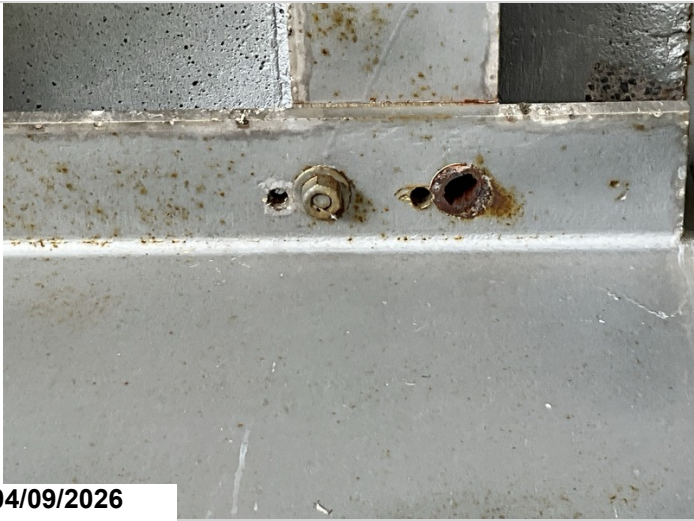
Span 12, Stringer 2, Floorbeam 28, Back: One sheared rivet head. 1LF CS3 connection.

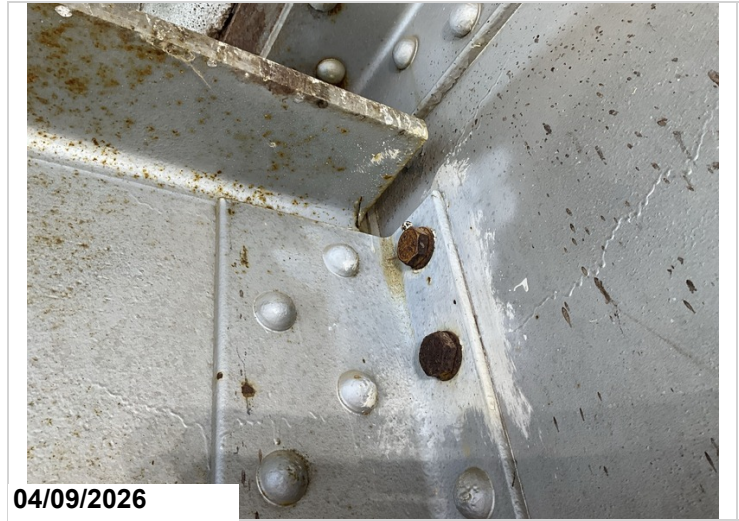
Span 12, panel point 25 back, stringer 2, missing bolt on last deck joist.

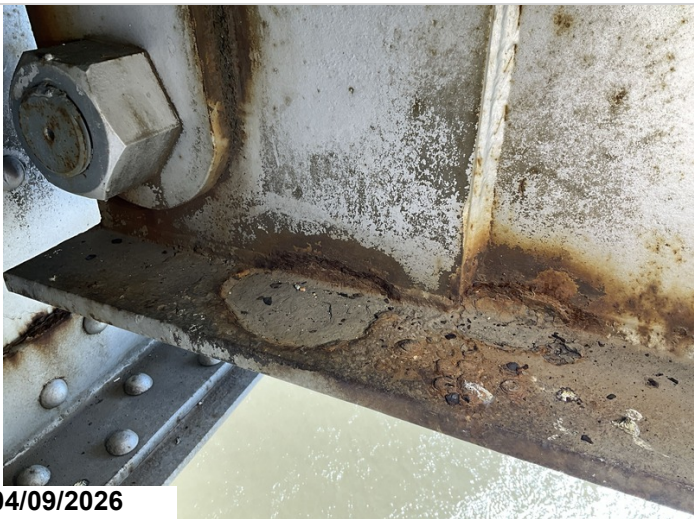
Span 12 ahead, floor beam 24, stringer 3, cut in the web/top flange at the end of the stringer. Typical to stringer 1.

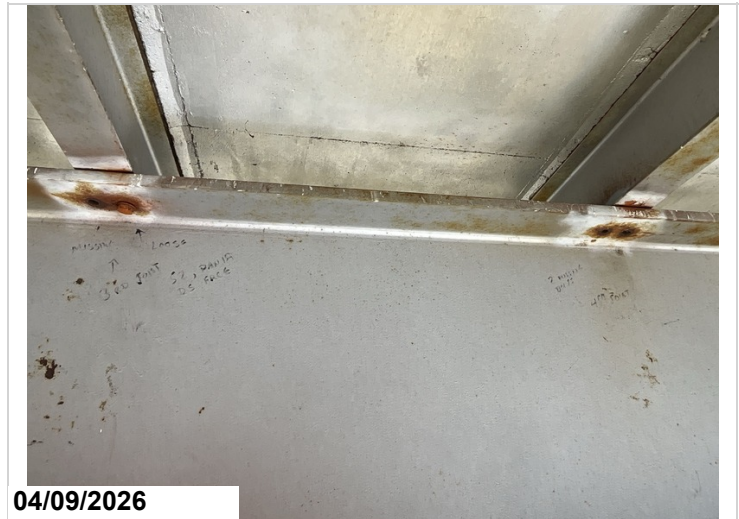
Span 12, Stringer 3, Left, Floorbeam 22, Back: Active corrosion with section loss up to 3/16" to the bottom flange. 1LF CS3 corrosion.

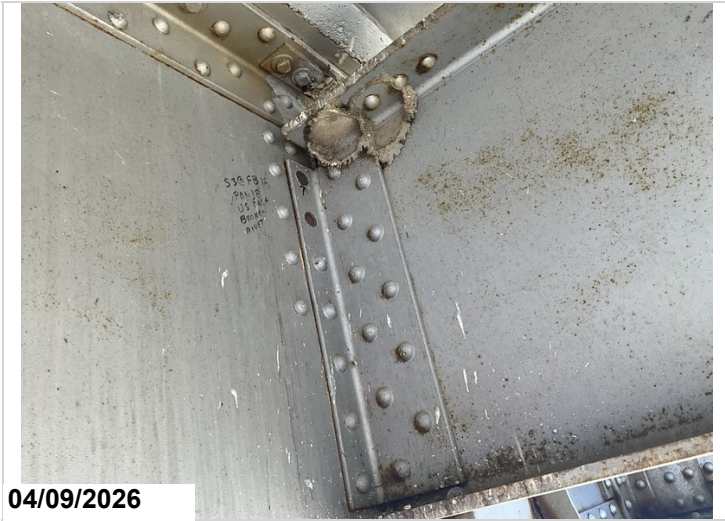
Span 12 between floor beams 17 and 18, stringer 2, 1 missing and 1 loose bolt on deck joist 3, 2 missing bolts on deck joists 4.

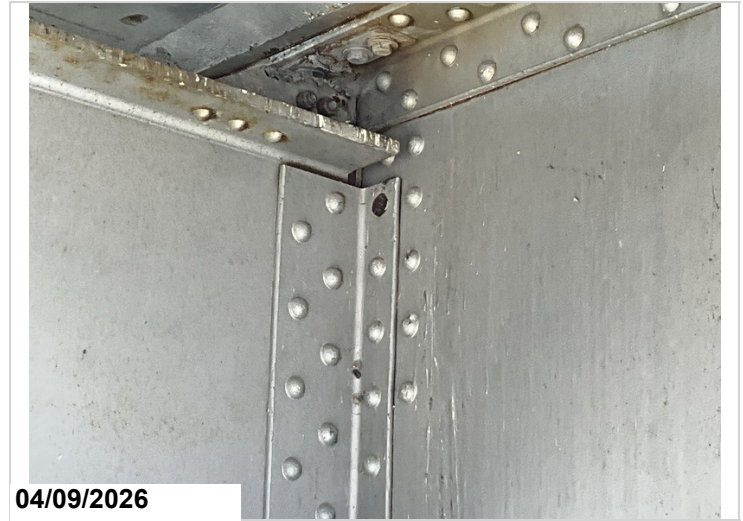
Span 12, Stringer 3, Floorbeam 18, Ahead: Two sheared rivet heads. 1LF CS3 connection.

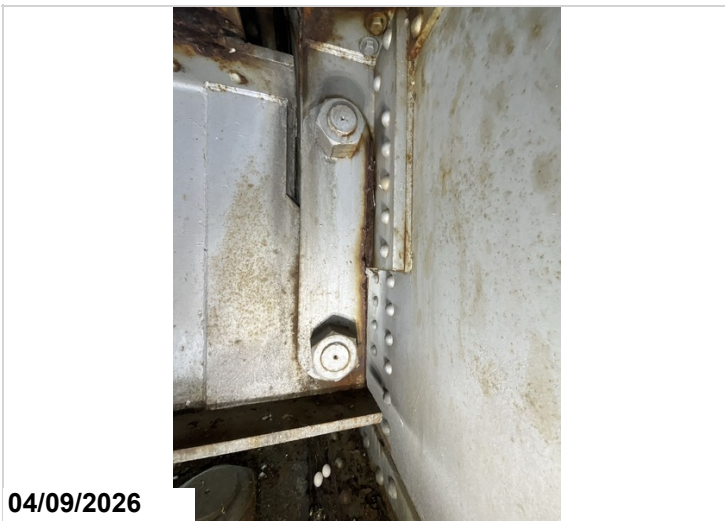
Span 12, Stringer 1, Floorbeam 18, Ahead: One sheared rivet head. 1LF CS3 connection.

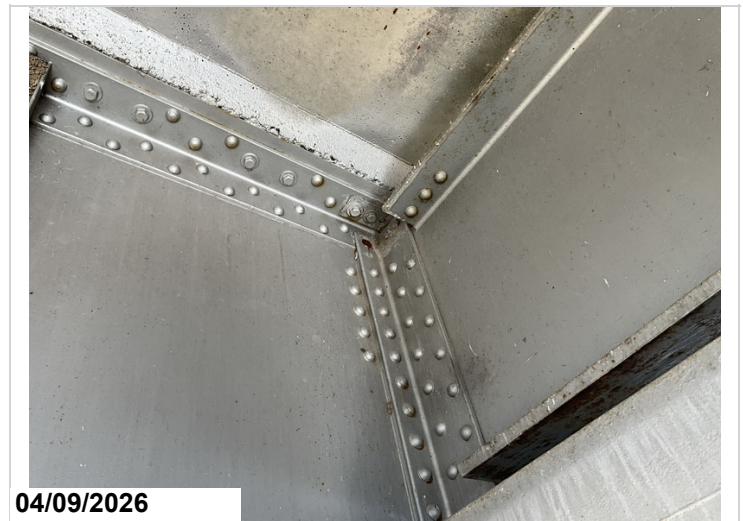
Span 12, floor beam 15 back, stringer 2, section loss to the hangers on both sides, 1EA, CS3.

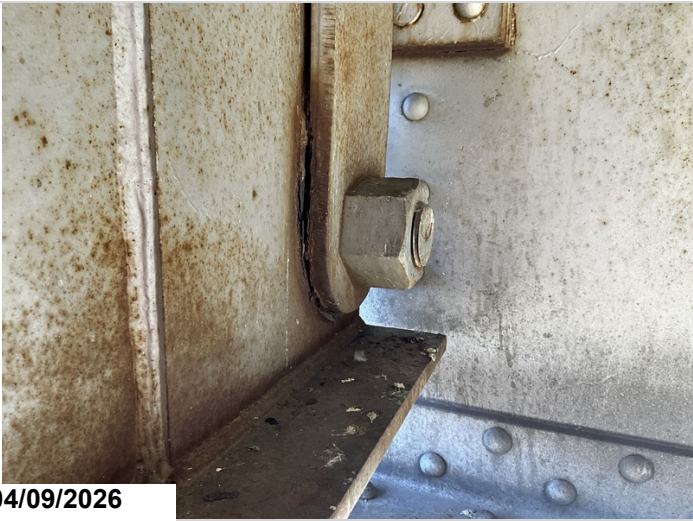
Span 12, Stringer 2, Floorbeam 15, Ahead: One sheared rivet head. 1LF CS3 connection.

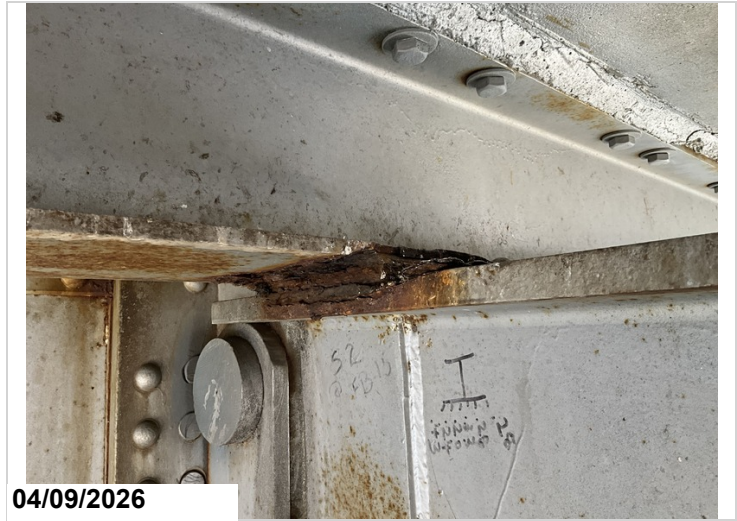
Span 12, Stringer 1, Floorbeam 12, Back: Active corrosion with pack rust between the stringer and the hanger bar. 1LF CS3 corrosion.

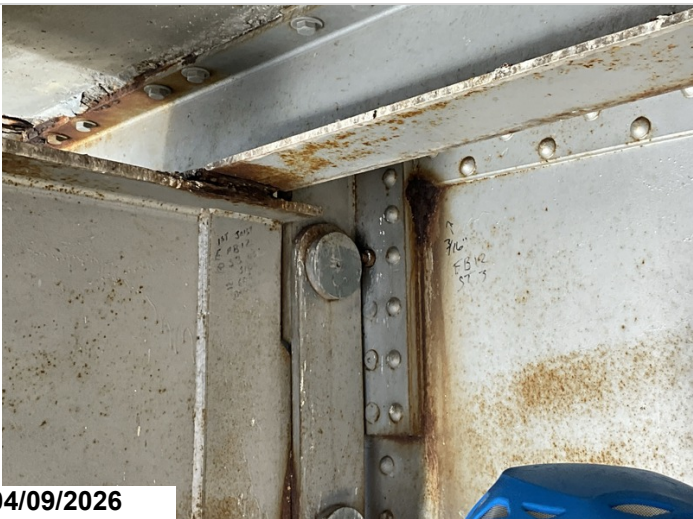
Span 12, Stringer 2, Floorbeam 15, Back: Active corrosion with section loss up to 1/4" to the top flange with pack rust between the stringer and the deck joist. 1LF CS3 corrosion.

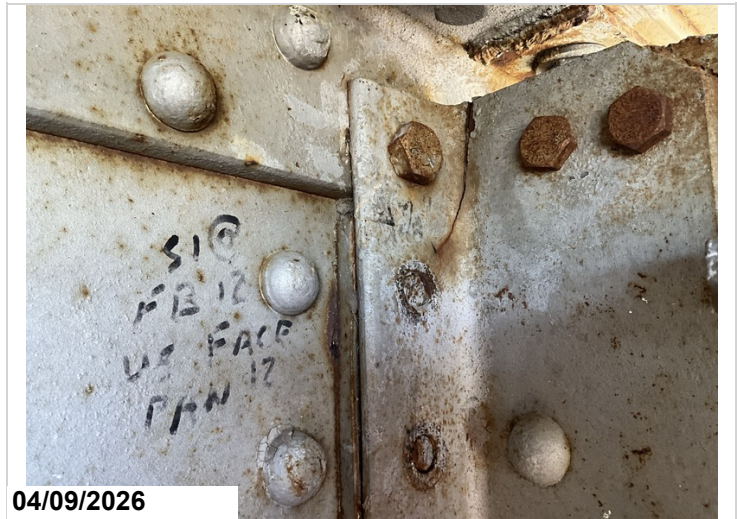
Span 12, floor beam 12 ahead, 3/16" section loss to the web at the stringer connection, 1LF, CS3. Pack rust between the stringer and deck joists causing with the bottom flange of the deck joist down to a knife's edge.. 1LF, CS3.

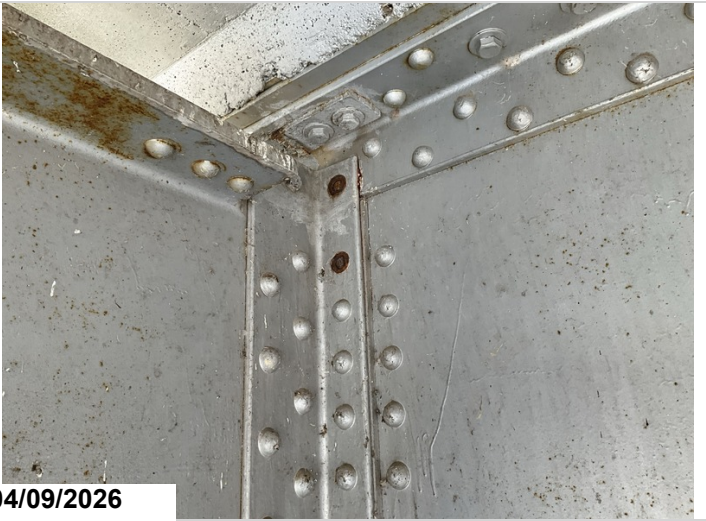
Span 12, Stringer 1, Left, Floorbeam 12, Back: 4 1/2" crack in the left floor beam to stringer connection angle, 2 missing rivets. 1LF CS3 crack.

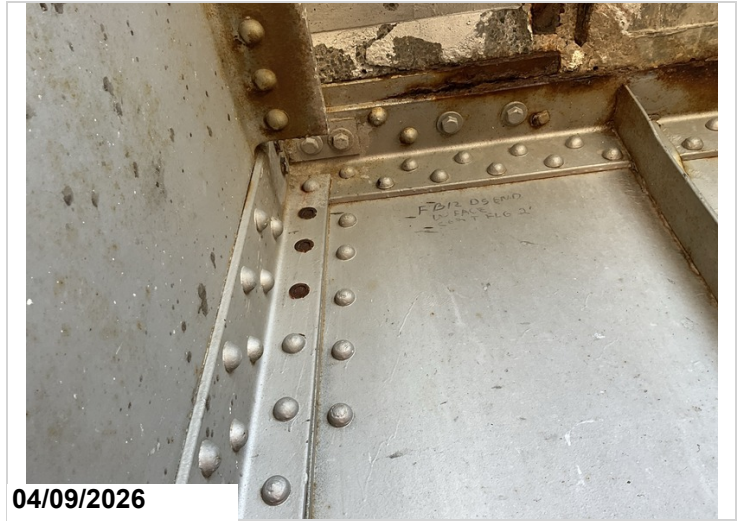
Span 12, Stringer 2, Floorbeam 12, Back: Two sheared rivet heads. 1LF CS3 connection.

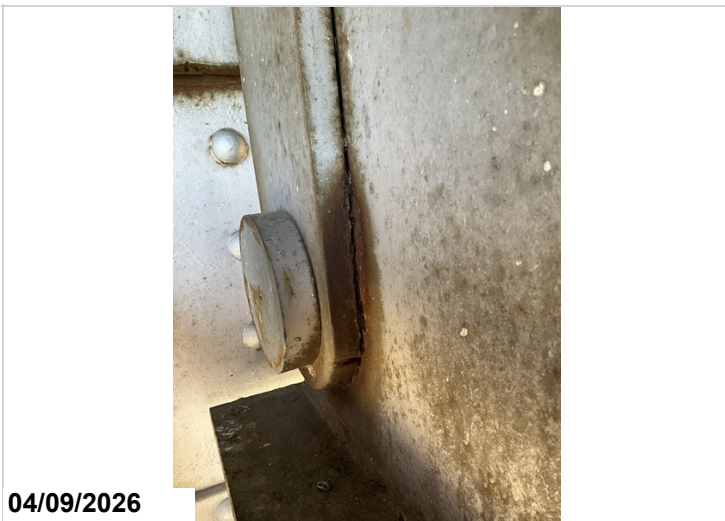
Span 12, Stringer 3, Floorbeam 12, Back: Three sheared rivet heads. 1LF CS3 connection.

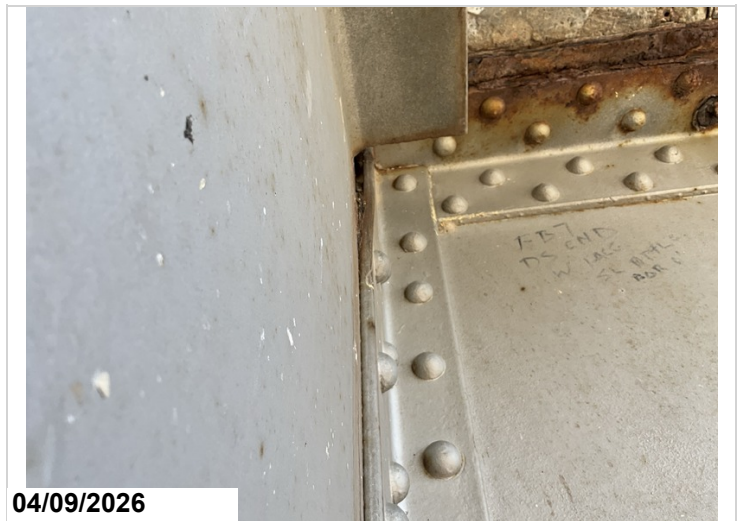
Span 11, Stringer 1, Floorbeam 8, Back: Active corrosion with pack rust between the stringer web and the hanger bar. 1LF CS3 corrosion.

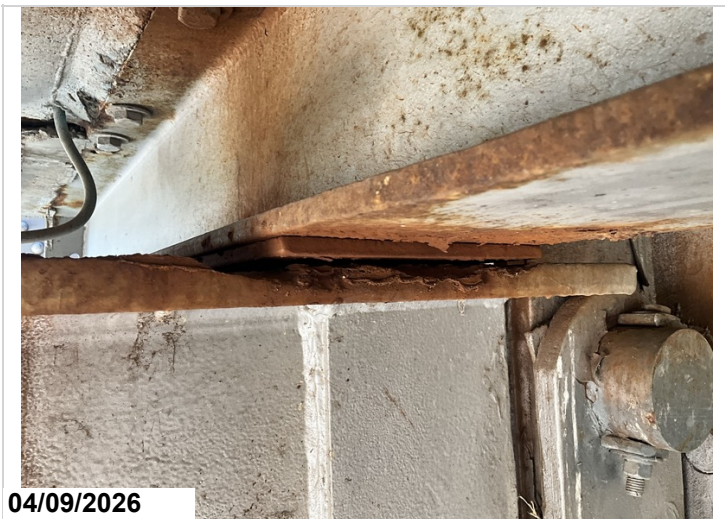
Span 11, Stringer 3, Floorbeam 7, Ahead: Distortion along the bottom flange. 25LF CS2 distortion.

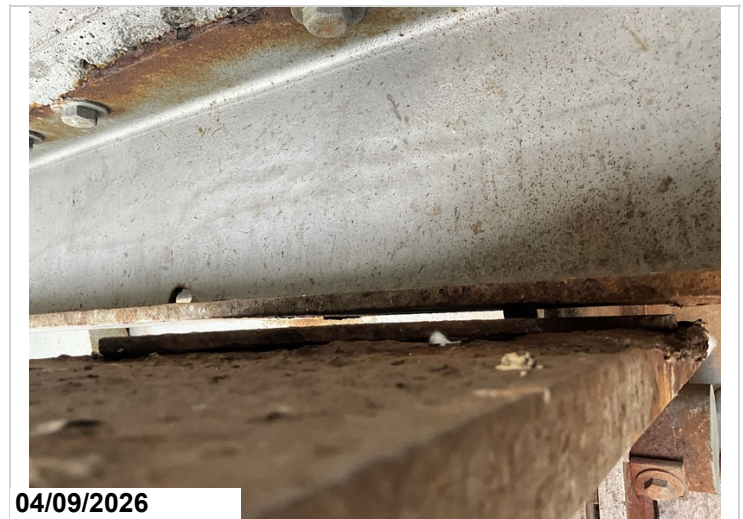
Span 11, Stringer 1, Floorbeam 6, Back: Missing bolt at the stringer to deck joist connection, along with active corrosion with flaking rust along the top flange. 1LF CS3 corrosion.

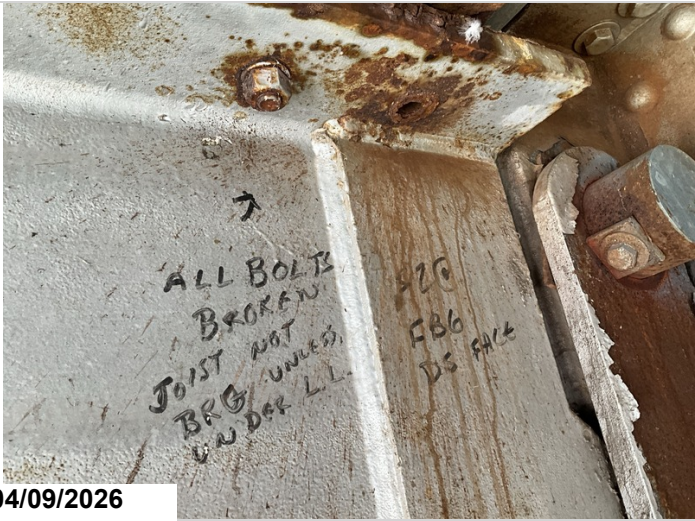
Span 11, Stringer 2, Floorbeam 6, Back: Missing bolt at the stringer to deck joist connection, along with active corrosion with flaking rust along the top flange. 1LF CS3 corrosion.

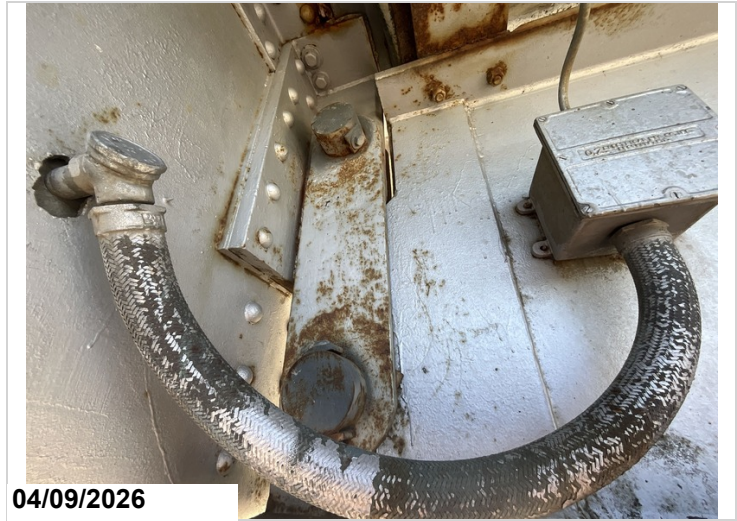
Span 11, Stringer 2, Floorbeam 6, Back: Missing bolt at the stringer to deck joist connection, along with active corrosion with flaking rust along the top flange. 1LF CS3 corrosion.

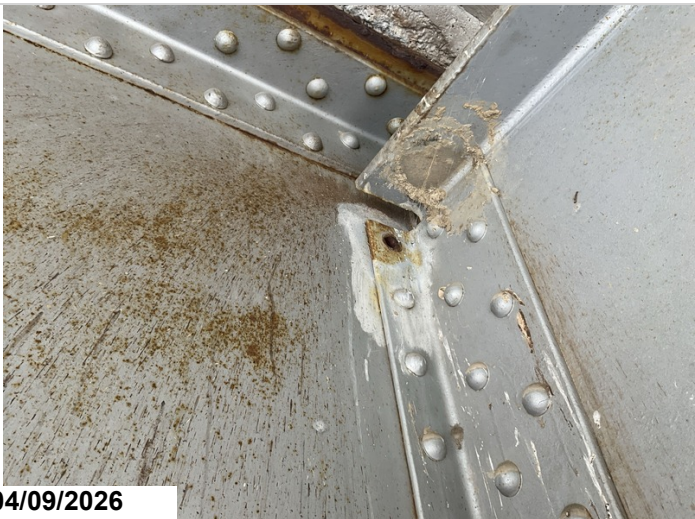
Span 11, Stringer 1, Pin and Hanger Assembly, Floorbeam 3: Active corrosion with pitting the the hanger bar. 1EA CS3 corrosion.

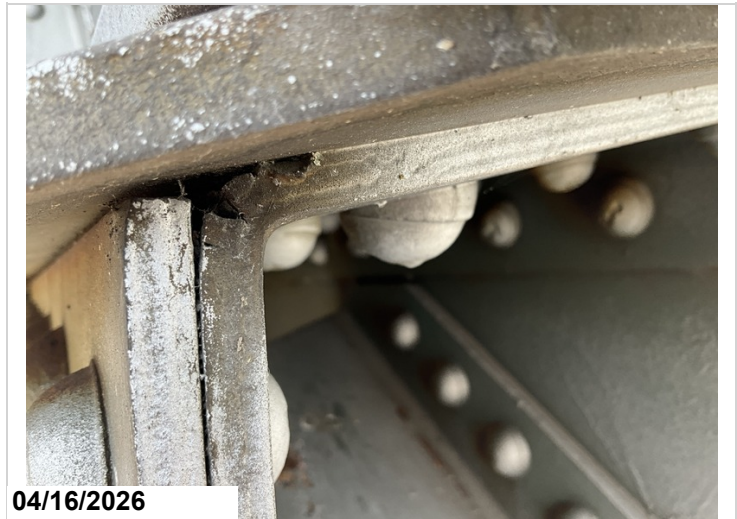
Span 11, Stringer 3, Floorbeam 2, Back: Missing Rivet. 1LF CS3 connection.

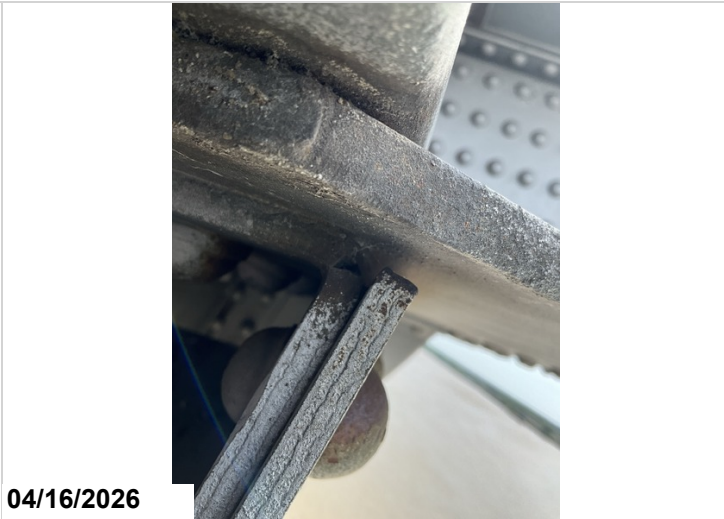
Span 14, Truss 2, PP52, Upper Chord to lateral bracing connection: Connection angle at Upper Chord has a crack in the bend of the angle, approximately 1/4" long. Does not appear to be a working crack. 1LF CS3 crack.

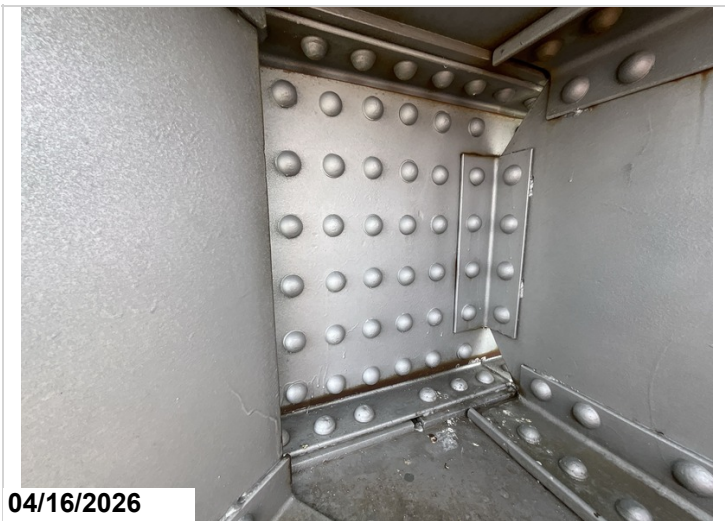
Span 13, Truss 2, L41, Top Flange, Back of Vertical: Active corrosion with holes in the top flange in a 5' area, with a total of 6' containing section loss. 1LF CS3 corrosion and 5LF CS4 corrosion.

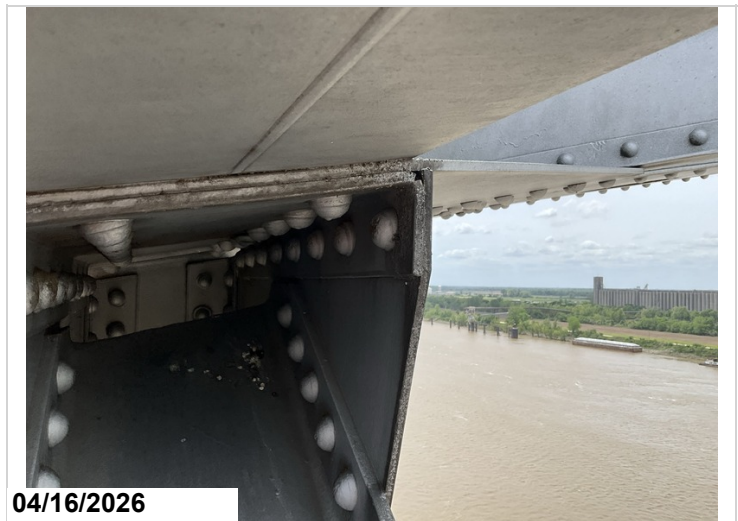
Span 13, Truss 2, PP 39, Left: Typical minor corrosion along the Upper Chord.

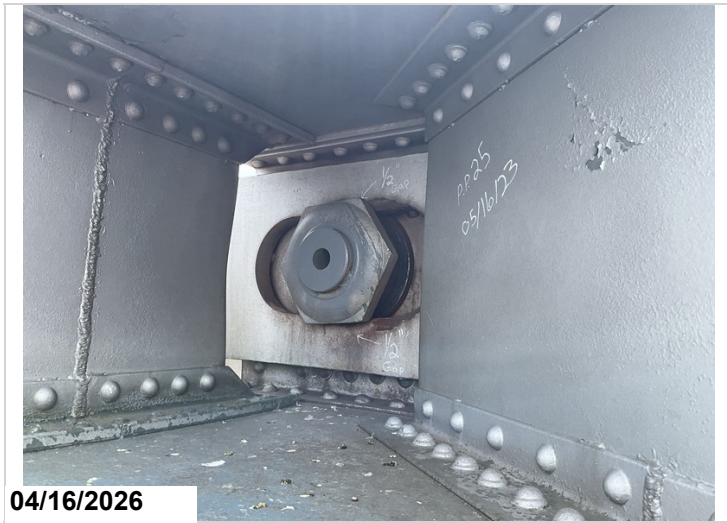
Span 12, Truss 2, PP 25, Left: Windlock.

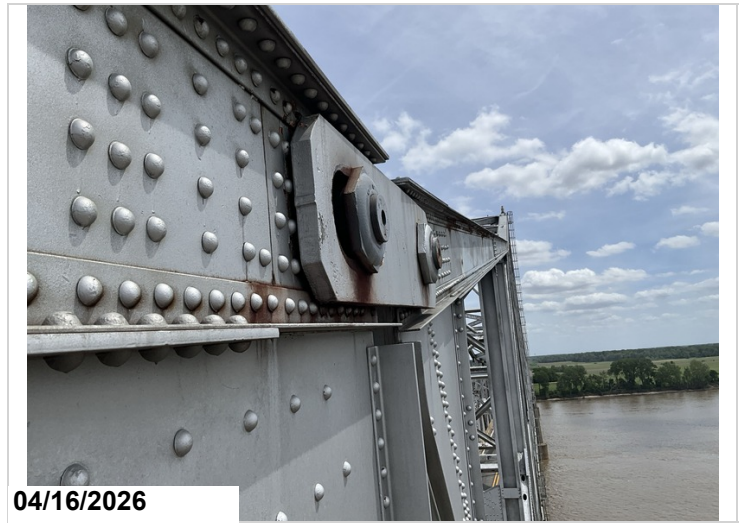
Span 12, Truss 2, PP 25, Right: Windlock.

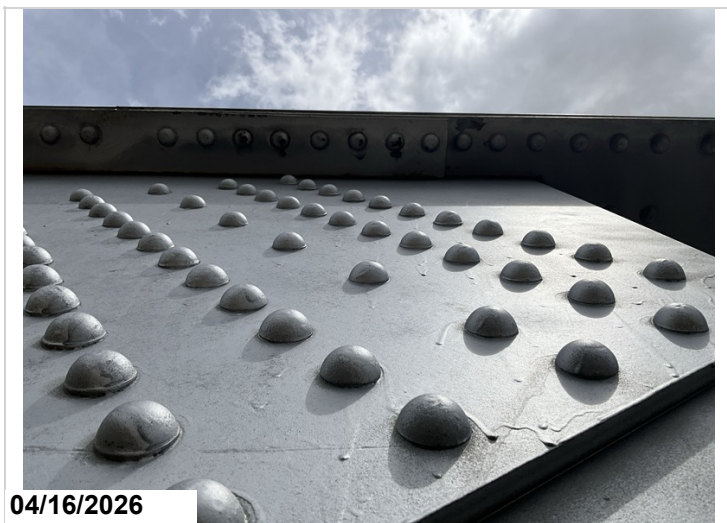
Span 12, Truss 2, PP23, Upper Chord, Right: Minor Active corrosion with pack rust at the Upper Chord the Gusset Plate connection. 1LF CS3 corrosion.

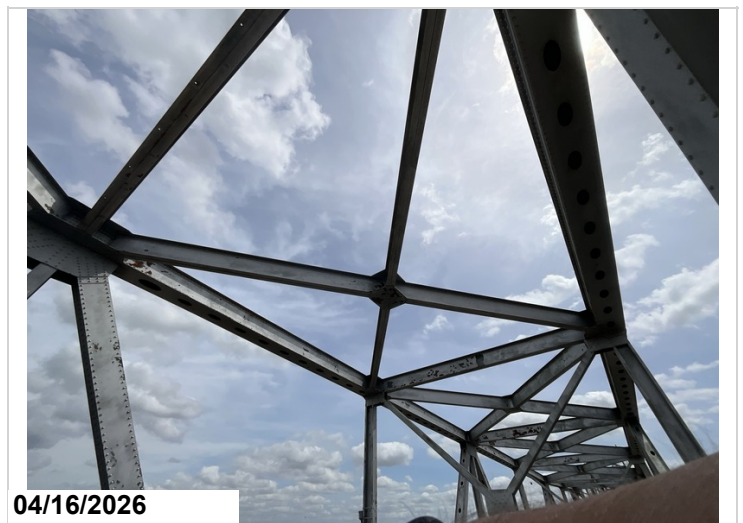
Typical lateral bracing.

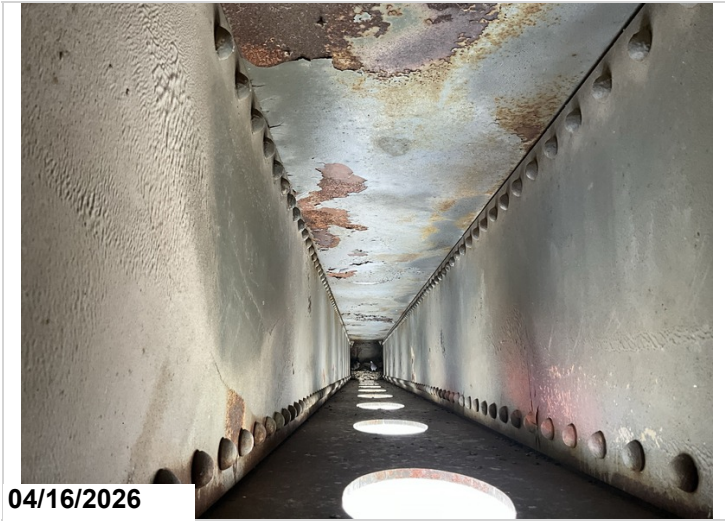
Span 12, Truss 2, Ahead of PP 15: Typical condition of the inside of Upper Chord.

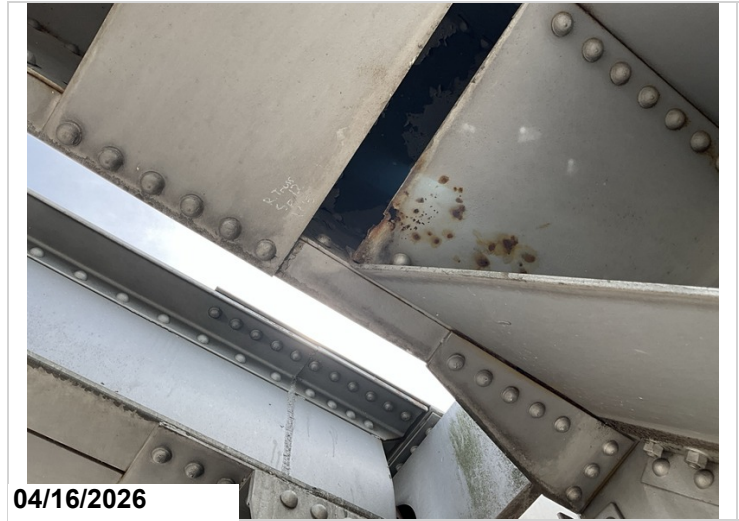
Span 12, Truss 2, PP15, Bottom later Gusset Plate near top pin: Active corrosion with holes. 1LF CS3 corrosion.

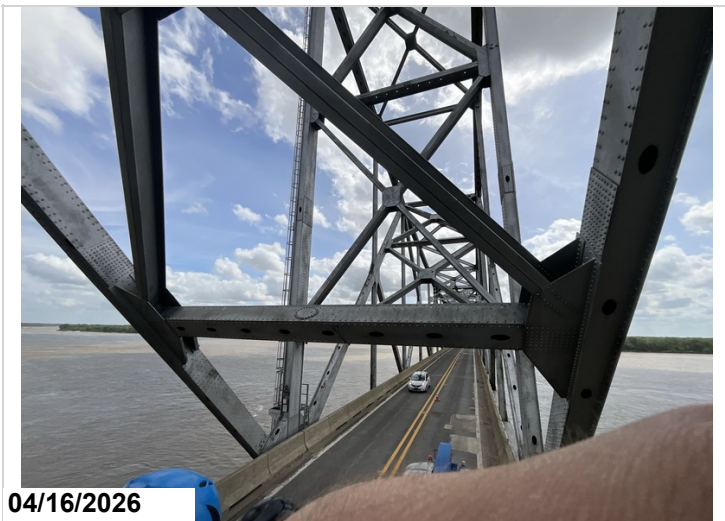
Typical lateral portal bracing.

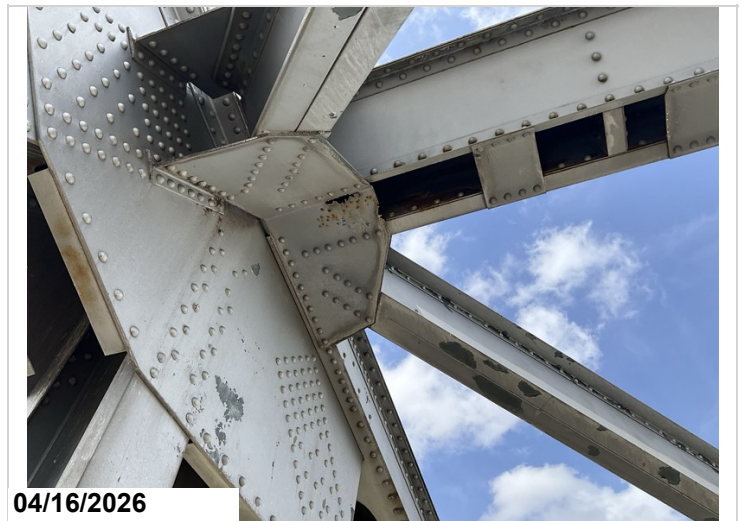
Span 11, Truss 2, Upper Chord, PP8: Active corrosion with a hole in the bottom lateral Gusset Plate. 1LF CS3 corrosion.

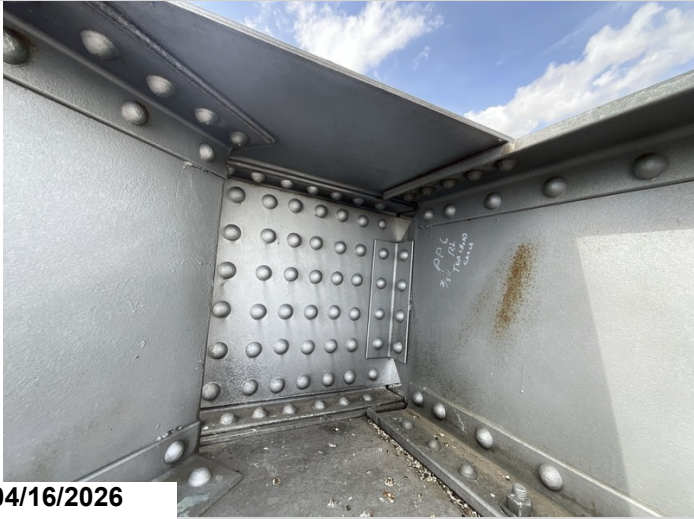
Span 11, Truss 2, Upper Chord, PP6, Left: 3/8" crack in tack weld on the Top Flange. 1LF CS2 crack.

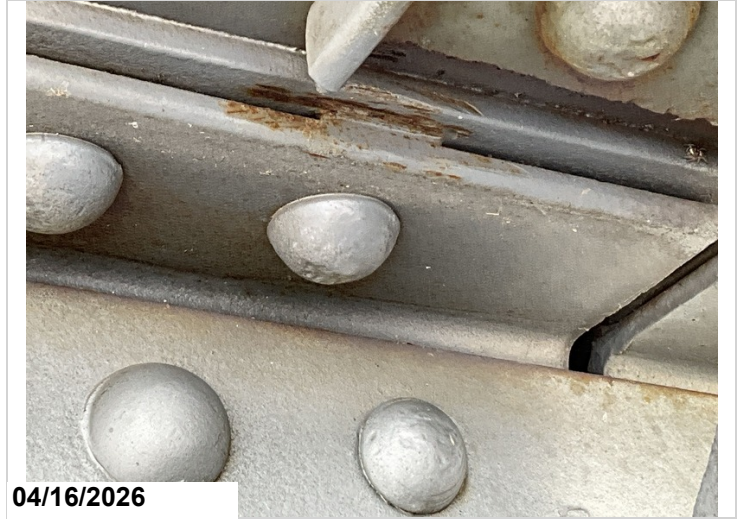
Span 11, Truss 2, Upper Chord, PP6, Left: 3/8" crack in tack weld on the Top Flange. 1LF CS2 crack.

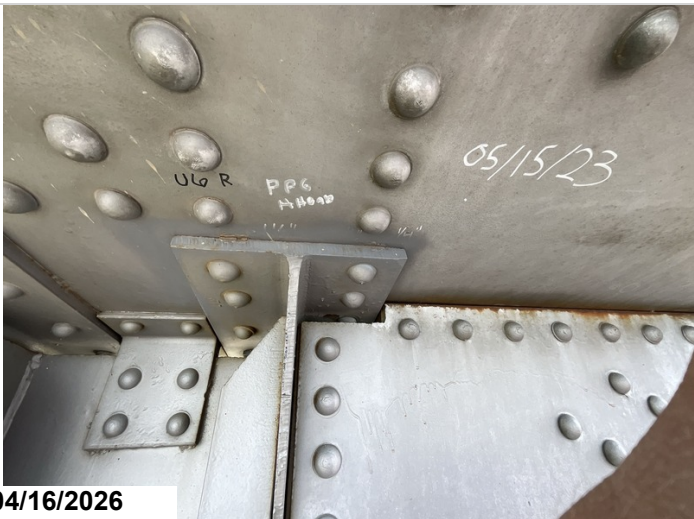
Span 11, Truss 2, PP6, Upper Chord, vertical to Upper Chord connection: Ground tack welds.

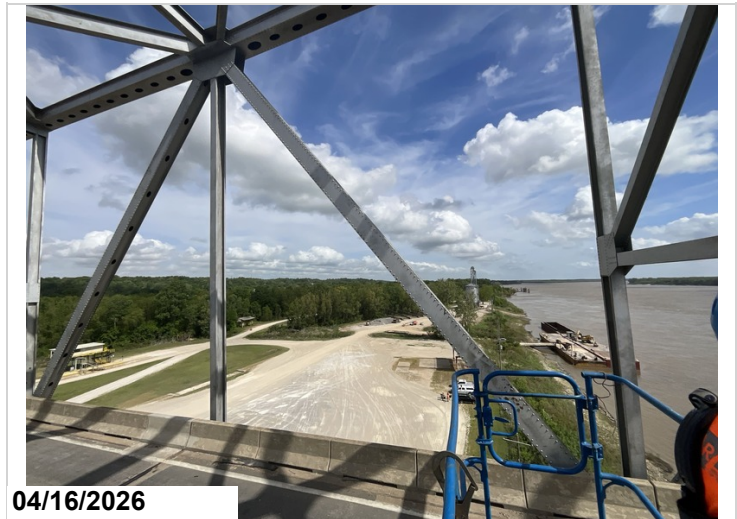
Typical diagonal.

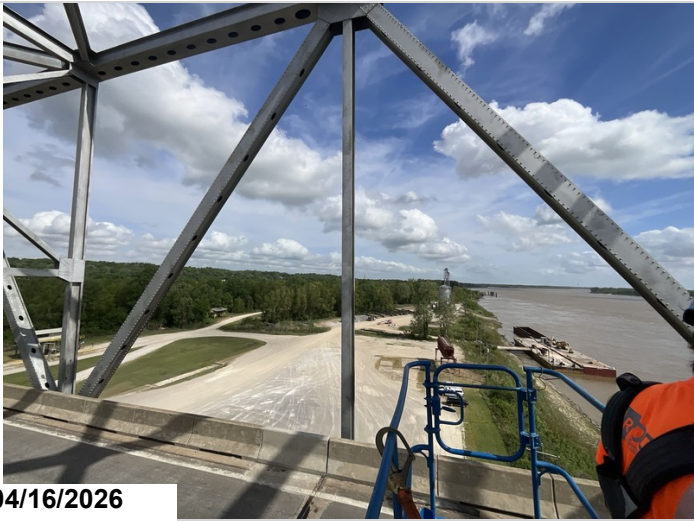
Typical vertical.

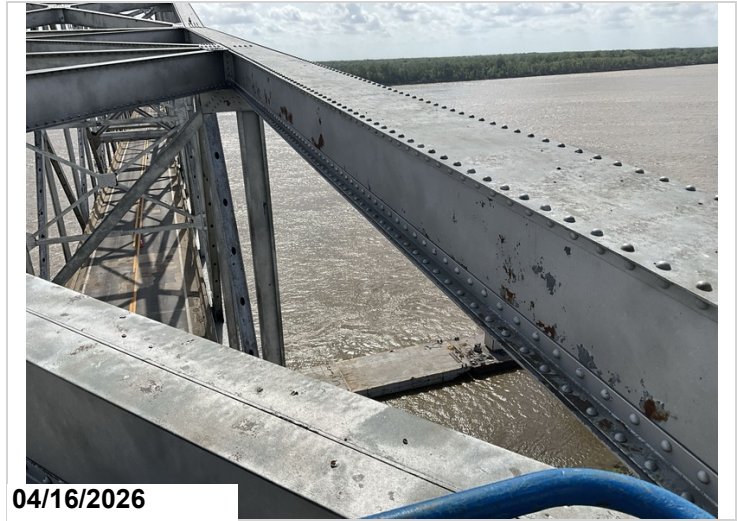
Span 10, Truss 2, Upper Chord, PP3 - 4: Typical surface corrosion.

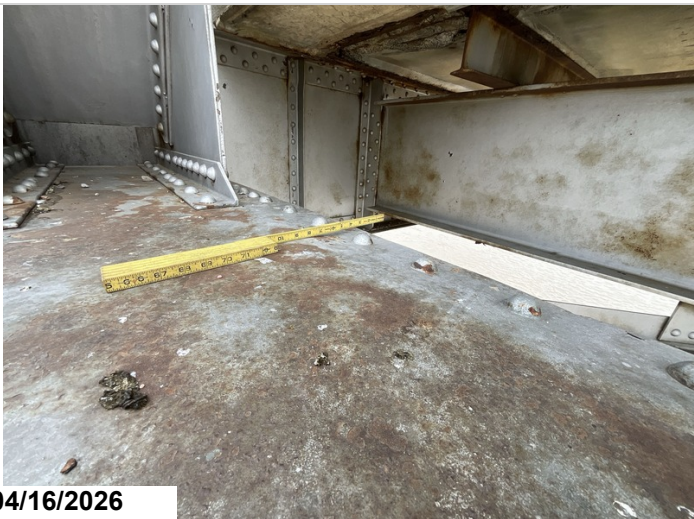
Span 13, Truss 1, Top Flange, PP42, Back, Top Flange to Right Web connection: Active corrosion with pack rust from, causing distortion in Top Flange. 15LF CS2 distortion.

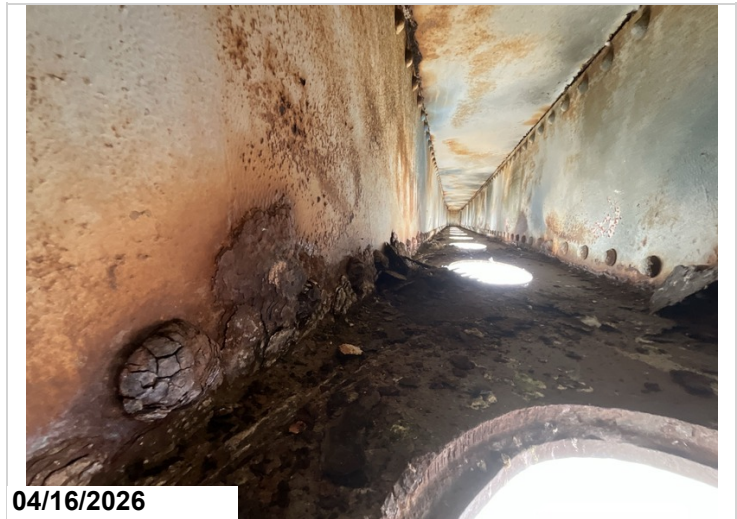
Span 13, Truss 1, Inside of the Lower Chord, PP42, Back: Active corrosion with laminated rust build up. 7LF CS3 corrosion.

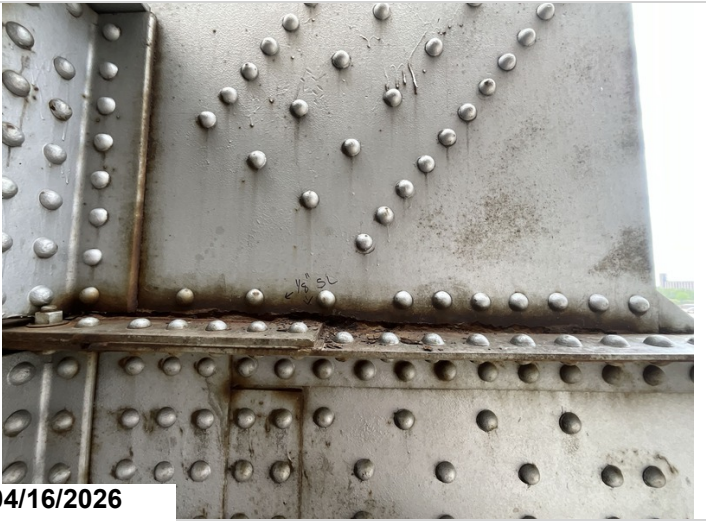
Span 13, Truss 2, PP42, Lower Chord: Active corrosion with section loss up to 1/8" to the Gusset Plate.

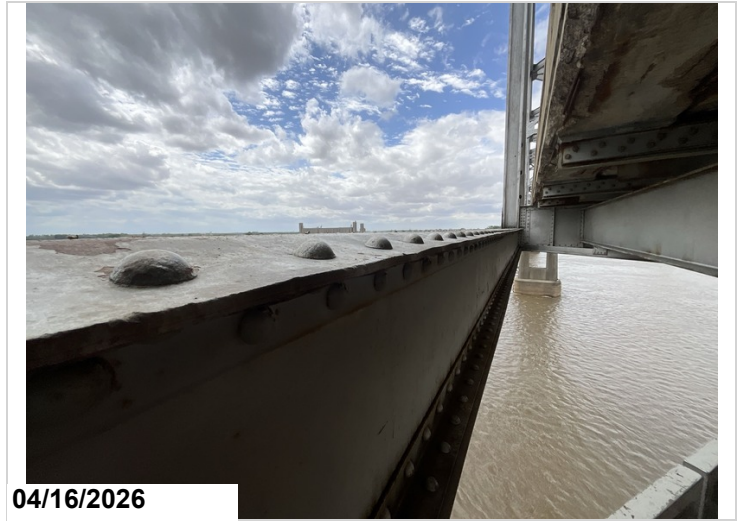
Span 13, Truss 2, Top Flange, PP42, Back, Top Flange to left Web connection: Active corrosion with pack rust from 3/4" to 1", causing distortion in Top Flange. 20LF CS2 distortion.

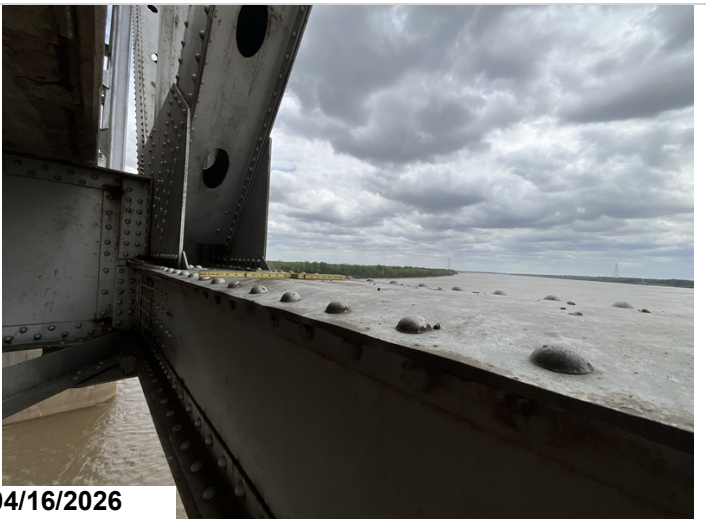
Span 13, Truss 2, Top Flange, PP42, Back, Top Flange to left Web connection: Active corrosion with pack rust from 3/4" to 1", causing distortion in Top Flange. 20LF CS2 distortion.

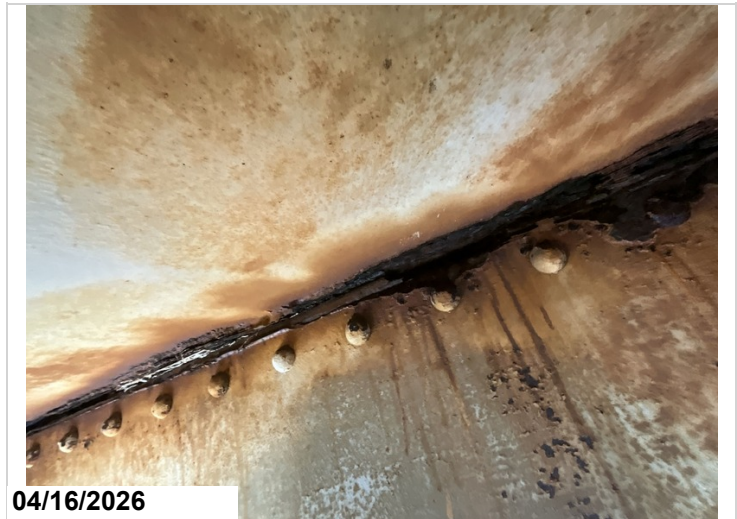
Span 13, Truss 2, Top Flange, PP42, Back, Top Flange to left Web connection: Active corrosion with pack rust from 3/4" to 1", causing distortion in Top Flange. 20LF CS2 distortion.

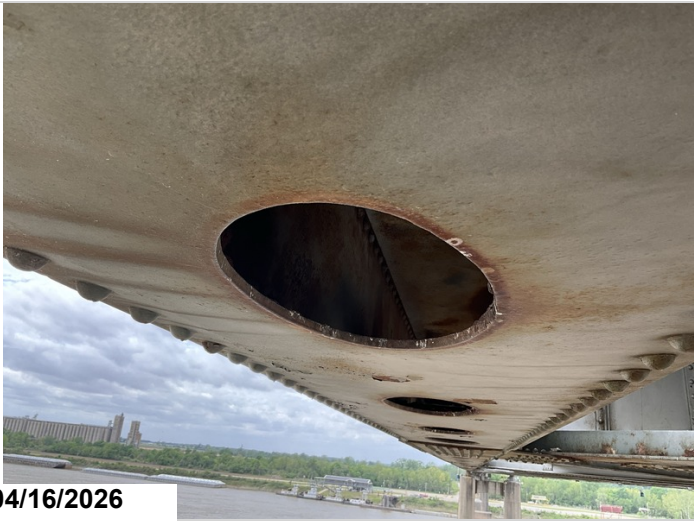
Span 13, Truss 2, Top Flange, PP42, Back, Top Flange to left Web connection: Active corrosion with pack rust, causing distortion in Top Flange. 20LF CS2 distortion.

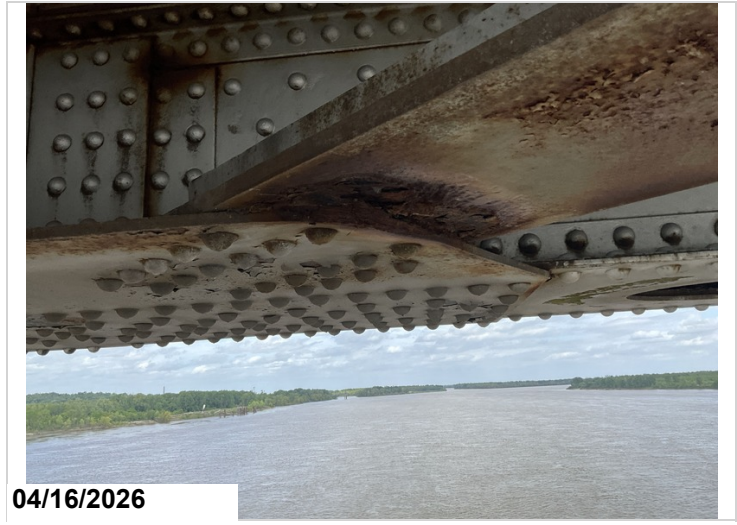
Span 13: Typical lateral bracing connection condition.

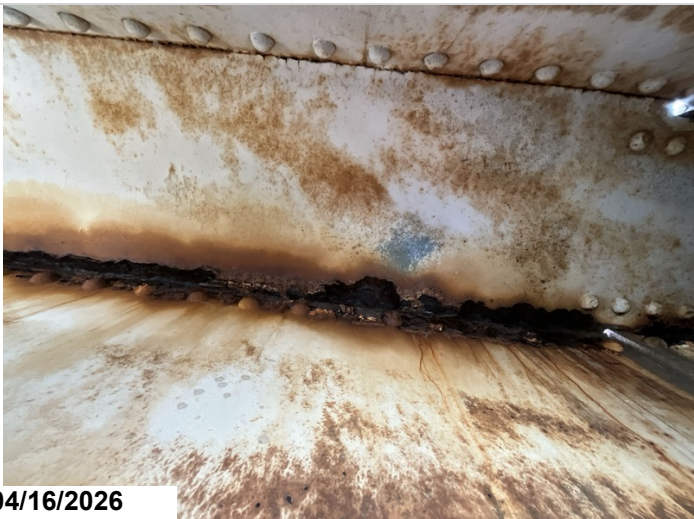
Span 13, Truss 1, Inside of the lower chord, PP42, Ahead: Active corrosion with section loss up to 5/16" to bottom of Top Flange and webs. 10LF CS3 corrosion.

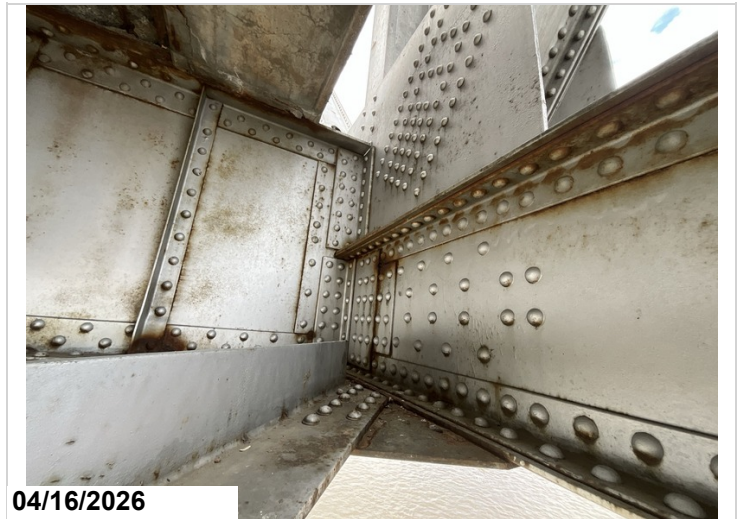
Span 13, Truss 1, PP42: Lower Chord to Floorbeam connection.

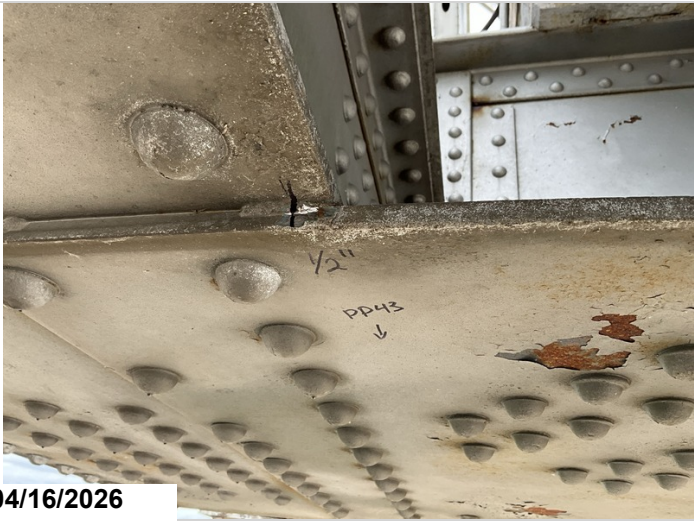
Span 13, Truss 1, Lower Chord to Bottom lateral Gusset Plate connection, PP43, Back: 1/2" crack in tack weld. 1LF CS3 crack.

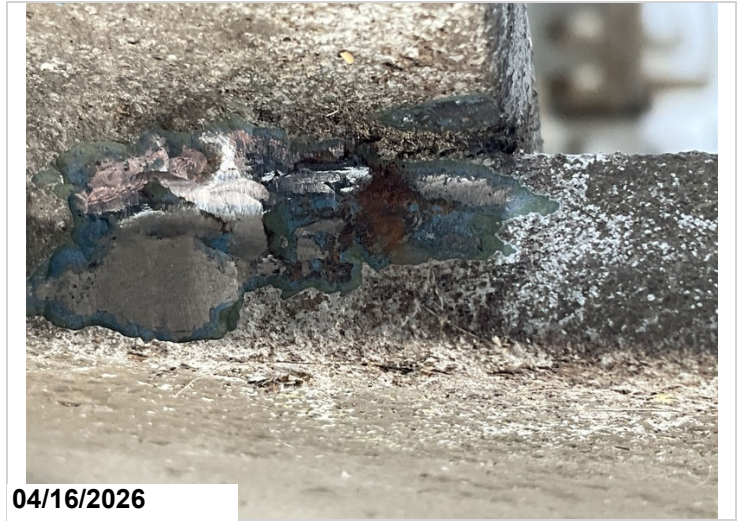
Span 13, Truss 1, Lower Chord to Bottom lateral Gusset Plate connection, PP43, Back: 1/2" crack in tack weld. 1LF CS3 crack.

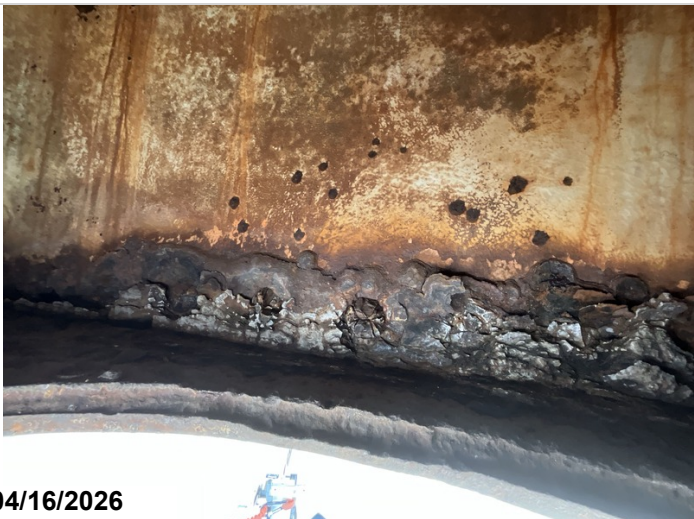
Span 13, Truss 2, inside of the Lower Chord, PP44, Back: Active corrosion with laminated rust build up along the webs. 8LF CS3 corrosion.

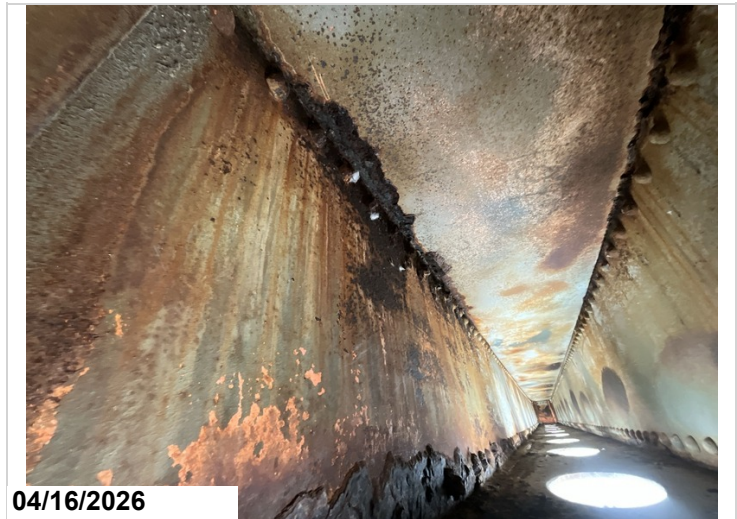
Span 13, Truss 2, Inside of Lower Chord: Active corrosion with section loss up to 1/4" to the Top Flange. 10LF CS3 corrosion.
