## Bridge 02899 Inspection Report

Arnold Road ID:54x49x11xA, Arnold Log mile:0.569

# National Bridge Inventory Data Sheet

| IDENTIFICATION | |
|---|---|
| (7) Facility Carried | US 49- Phillips Co |

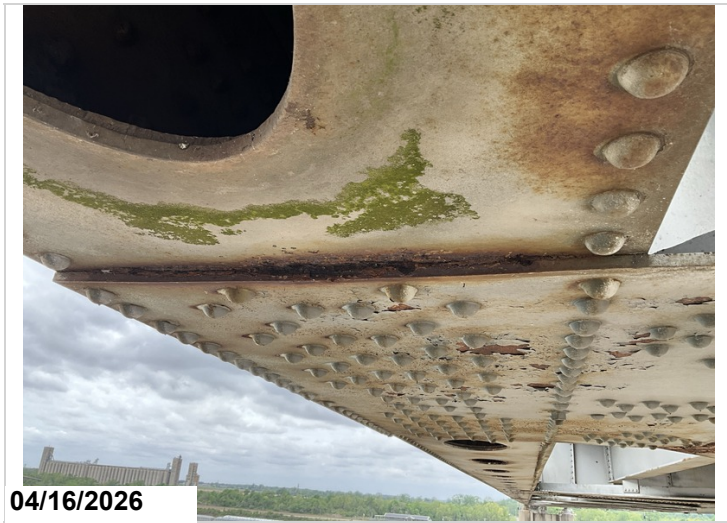
Span 13, Truss 2, Lower Chord, PP44, Ahead: Active corrosion with pack rust up to 1/8" at the bottom flange to bottom lateral gusset plate connection. 1LF CS3 corrosion.

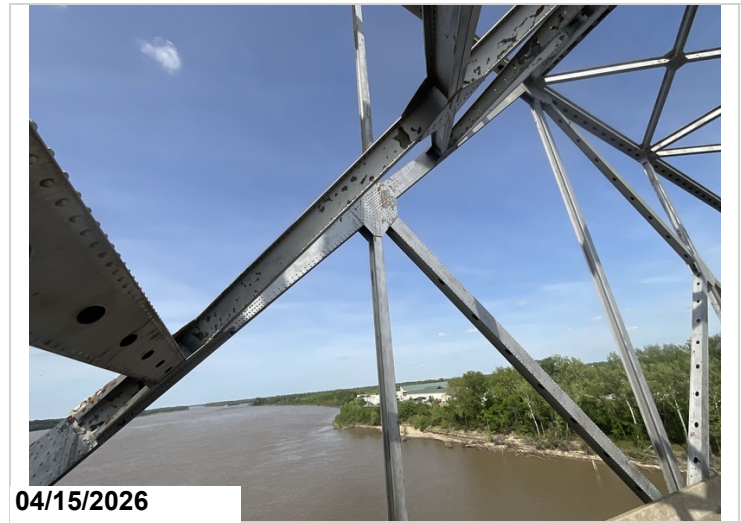
Typical verticals

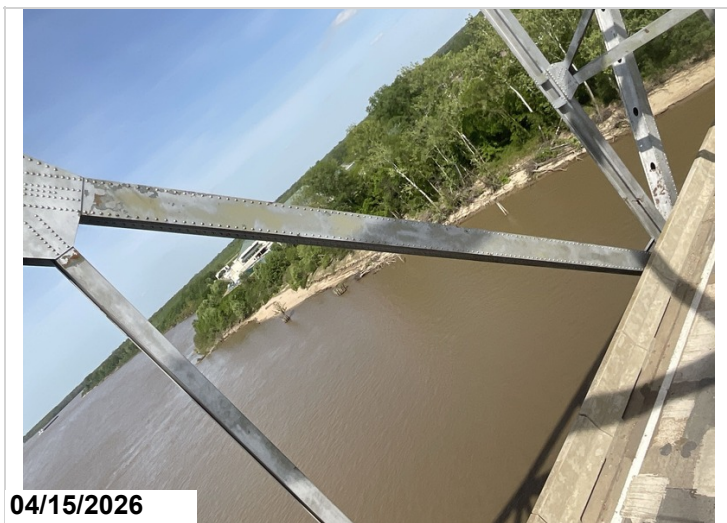
Typical diagonal

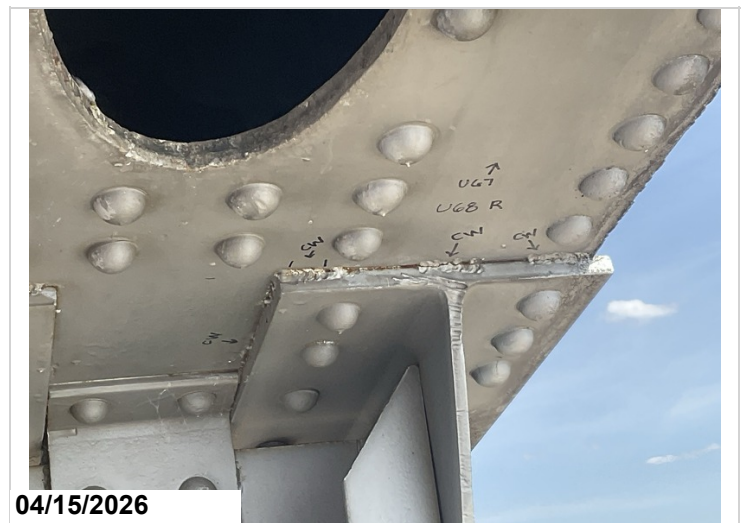
Span 15, Truss 2, PP68, Upper Chord Connection Plate:  
Cracked tack weld, self arrested. 1LF CS2 crack.

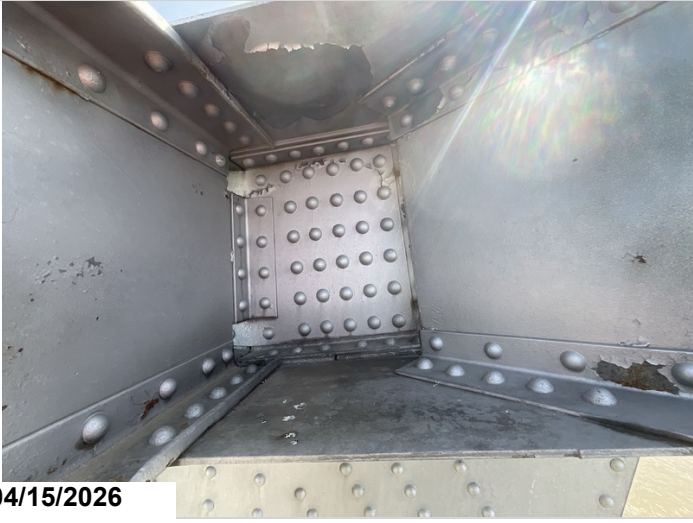
Typical condition of upper lateral bracing

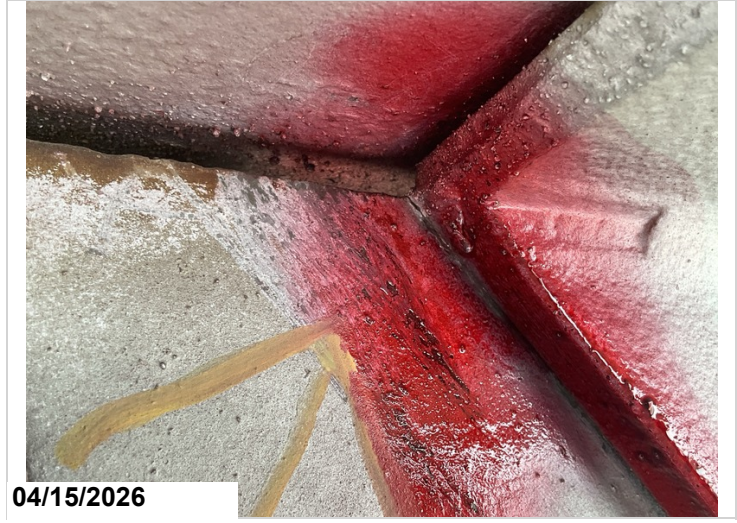
Span 15, Truss 2, PP70, Upper Chord to Lateral Bracing  
Connection Plate: 1/2" crack in the connection plate. 1LF  
CS3 crack.

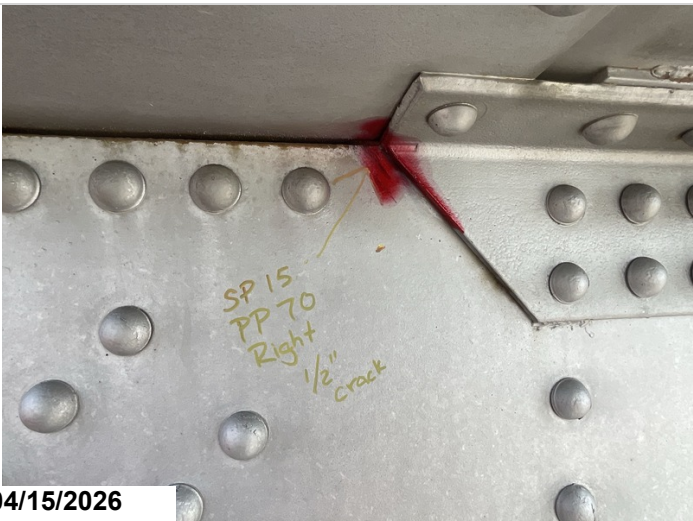
Span 15, Truss 2, PP70, Upper Chord to Lateral Bracing  
Connection Plate: 1/2" crack in the connection plate. 1LF  
CS3 crack.

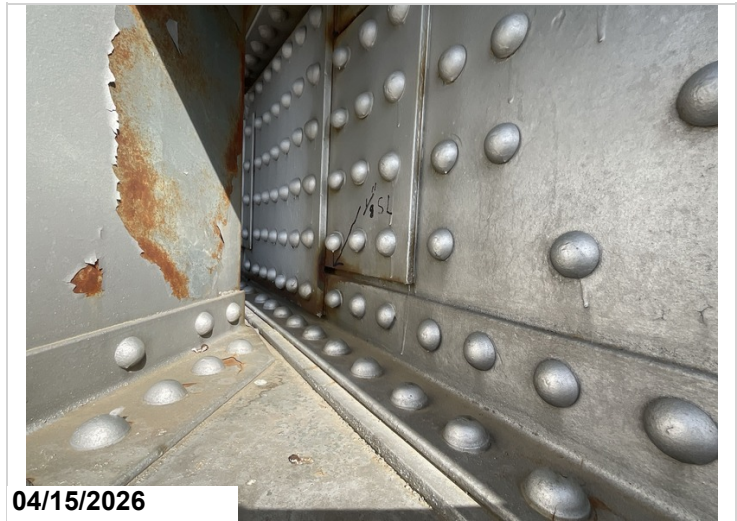
Span 13, Truss 1, PP37, Upper Chord Connection Plate:  
Active corrosion with section loss up to 1/8". 1LF CS3  
corrosion.

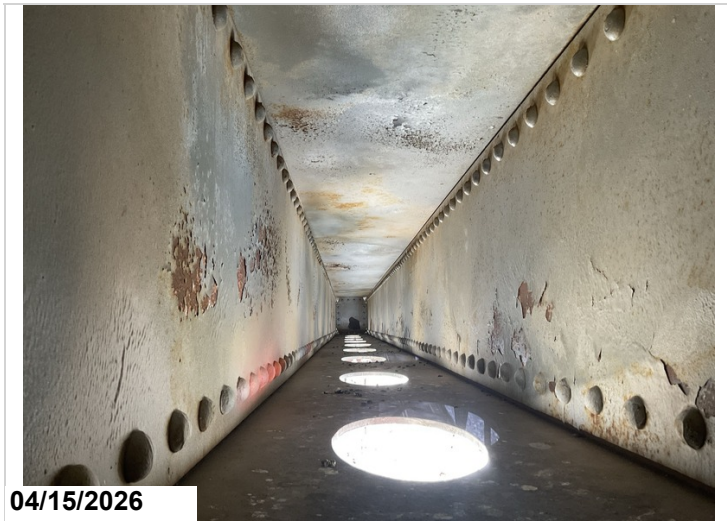
Typical condition of inside of upper chord

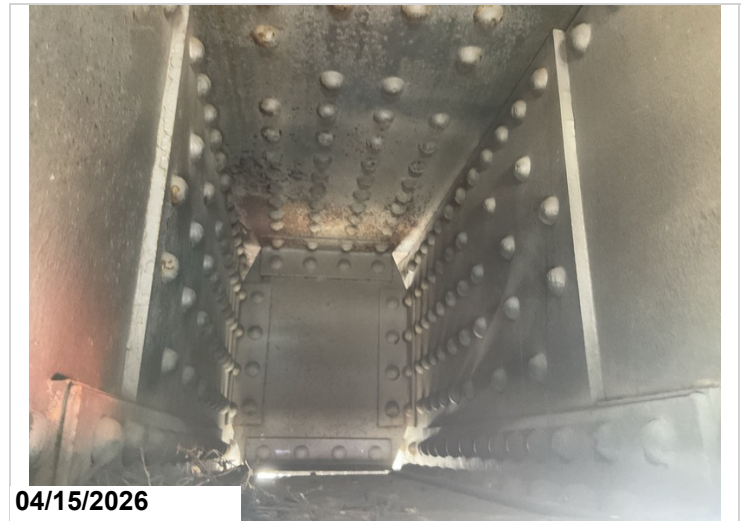
Span 13, Truss 1, PP35: Typical condition of the inside of the upper chord.

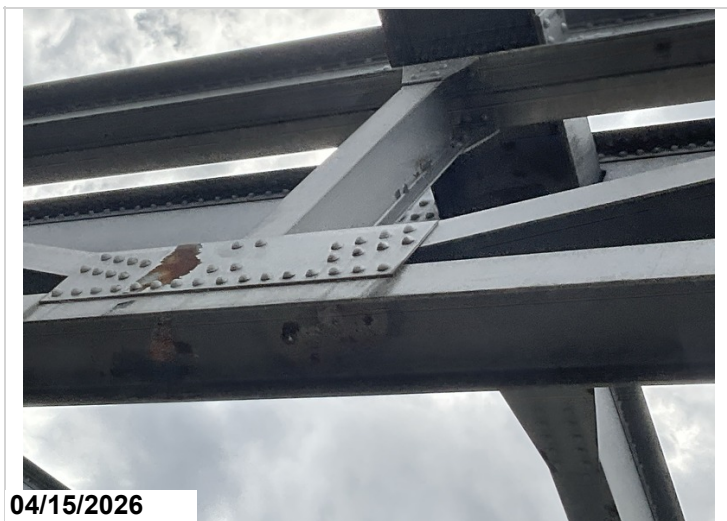
Span 12, PP15, Upper Lateral Bracing: Active corrosion with a hole, can not measure due to being over traffic.

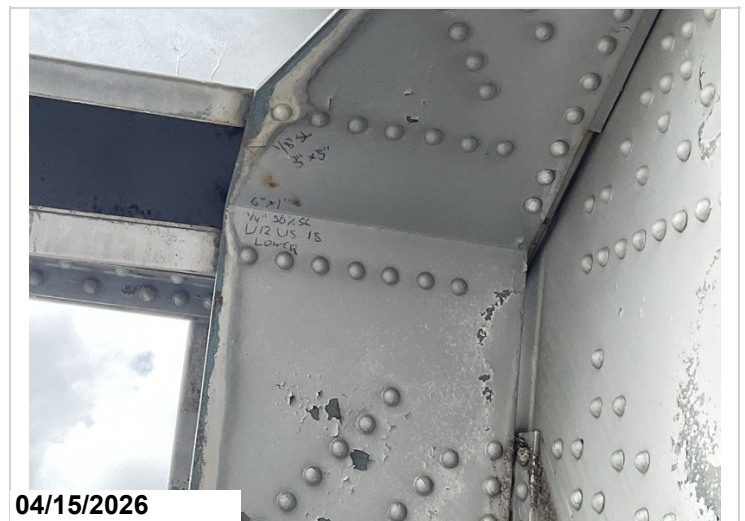
Can't reach due to equipment

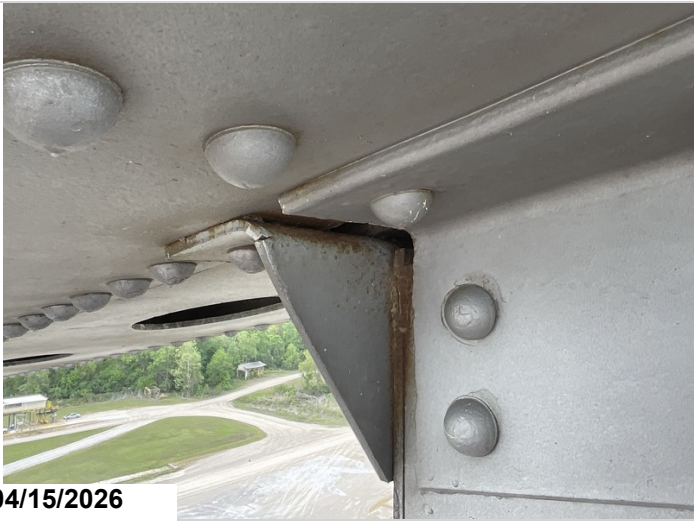
Span 11, Truss 1, PP7, Upper Chord to lateral bracing connection: Connection angle at Upper Chord has a crack in the bend of the angle, approximately 1/2" long. Does not appear to be a working crack. 1LF CS3 crack.

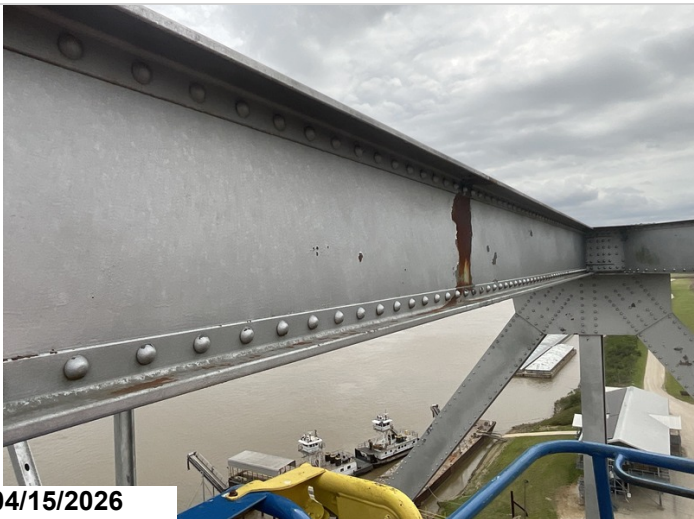
Span 11, PP3, Lateral Bracing: Surface corrosion with flaking paint.

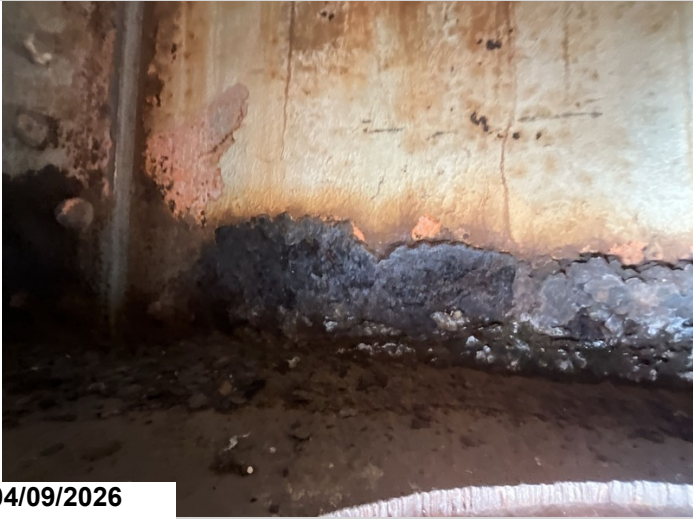
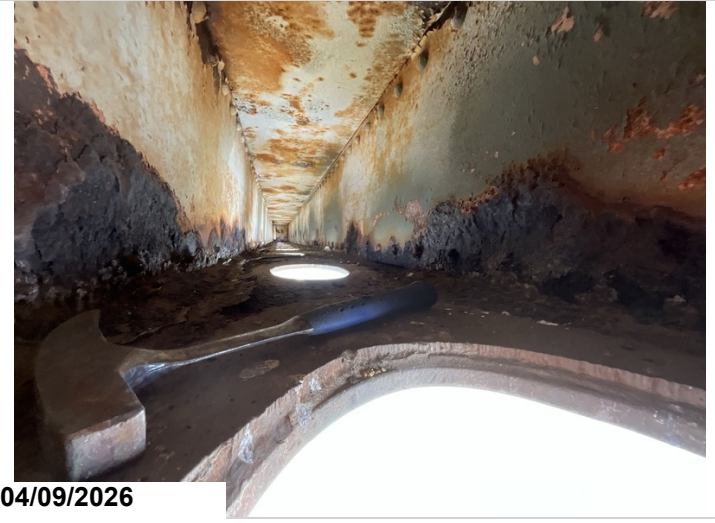
Span 13, Truss 2, Inside of the Lower Chord, PP46, Ahead: Inside webs has heavy Active corrosion with flaking rust and section loss ranging from 3/8 to 7/16" for 4'. 15LF CS3 corrosion.

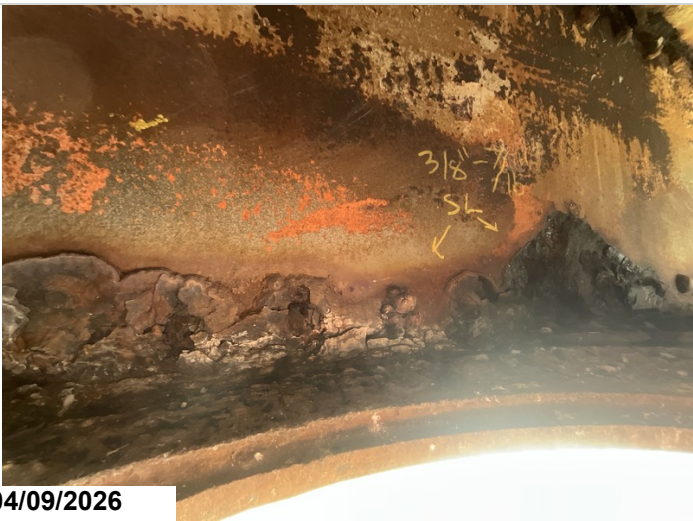
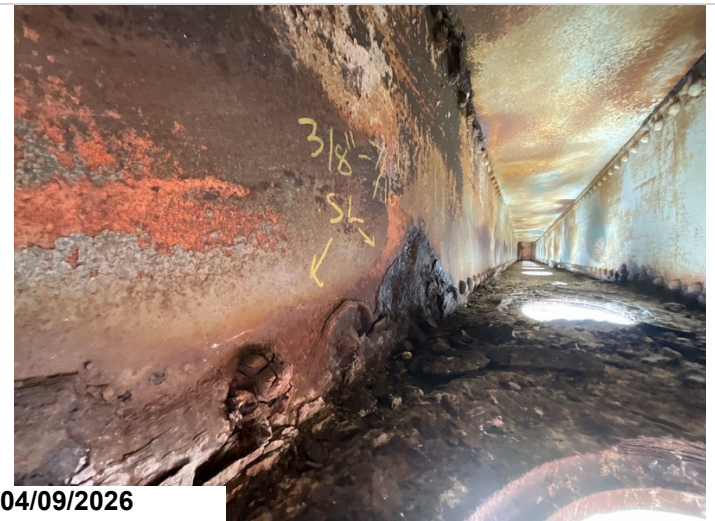
Span 13, Truss 2, Inside of the Lower Chord, PP46, Back: Right inside web has heavy Active corrosion with flaking rust and section loss ranging from 3/8 to 7/16" for 4'. 8LF CS3 corrosion.

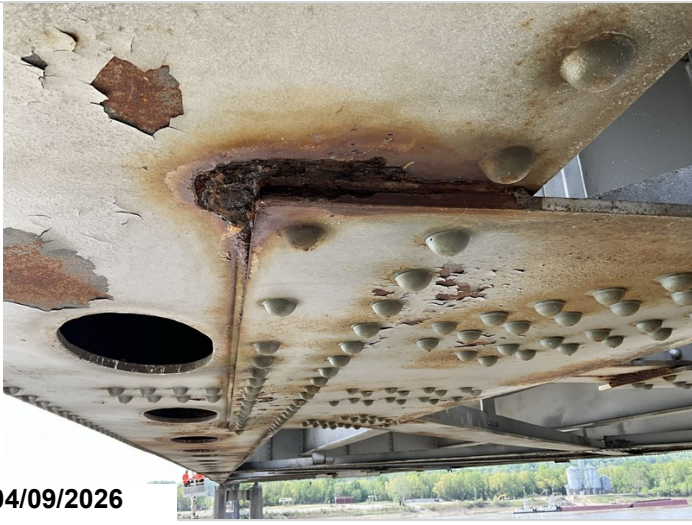
Span 13, Truss 2, Lower Chord, PP45, Ahead: Active corrosion with section loss up to 1/8" and pack rust up to 3/8" at the bottom flange to bottom lateral gusset plate connection. 1LF CS3 corrosion.

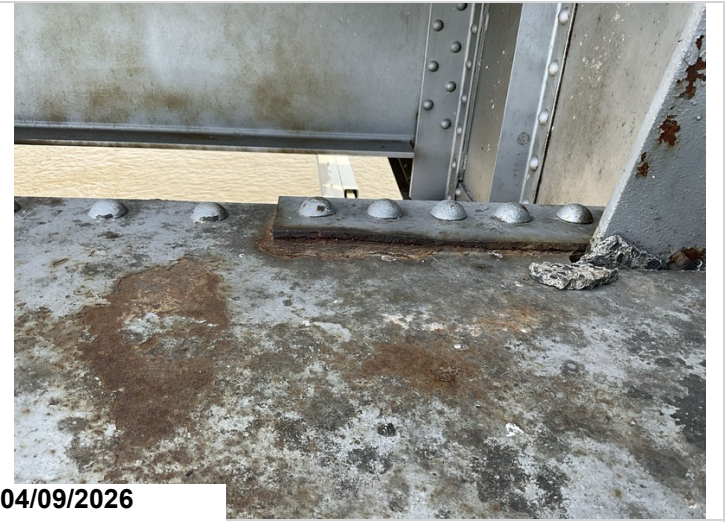
Span 13, Truss 1, PP45: Typical corrosion at Vertical only connections.

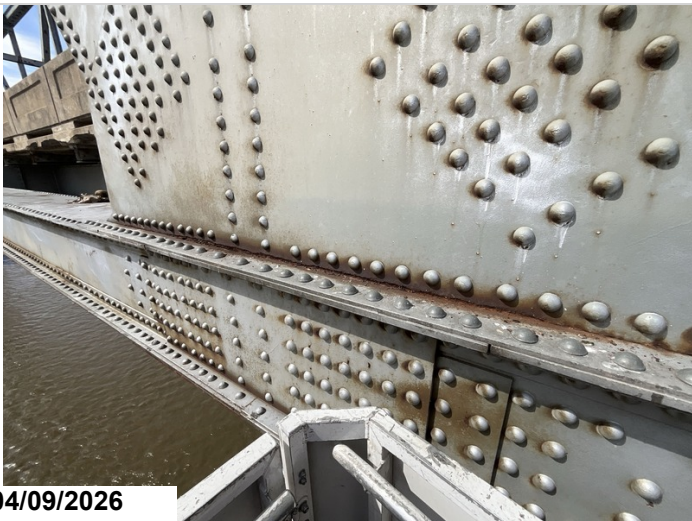
Span 13, Truss 2, Gusset Plate Lower Chord, PP44: Active corrosion with section loss up to 3/16" to the Gusset Plate.

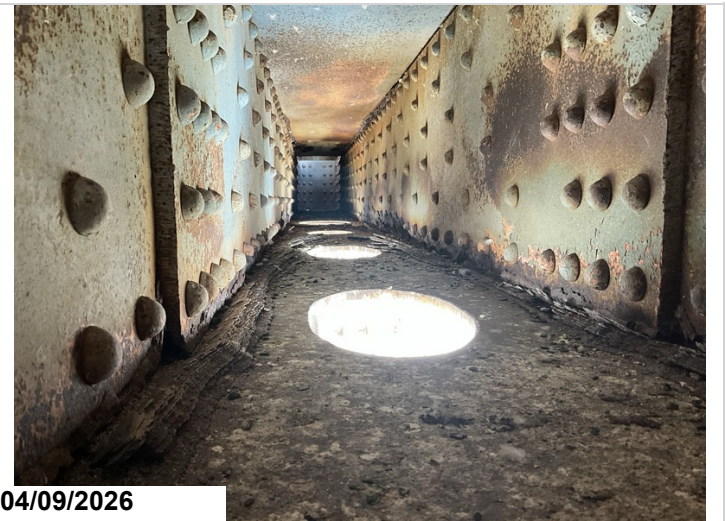
Span 13, Truss 2, Inside of the Lower Chord, PP48, Back: Heavy Active corrosion with heavy flaking rust along top of Bottom Flange and inside webs. 12LF CS3 corrosion.

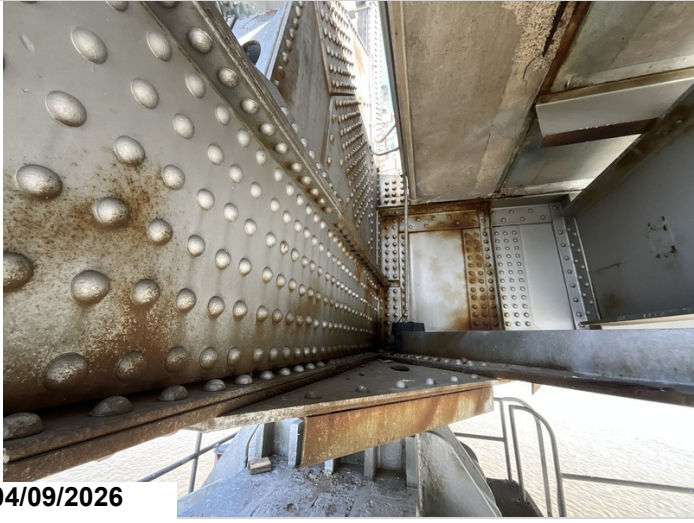
Span 13, Truss 1, Lower Chord to Floorbeam connection:  
Typical condition of connection at a Pier.

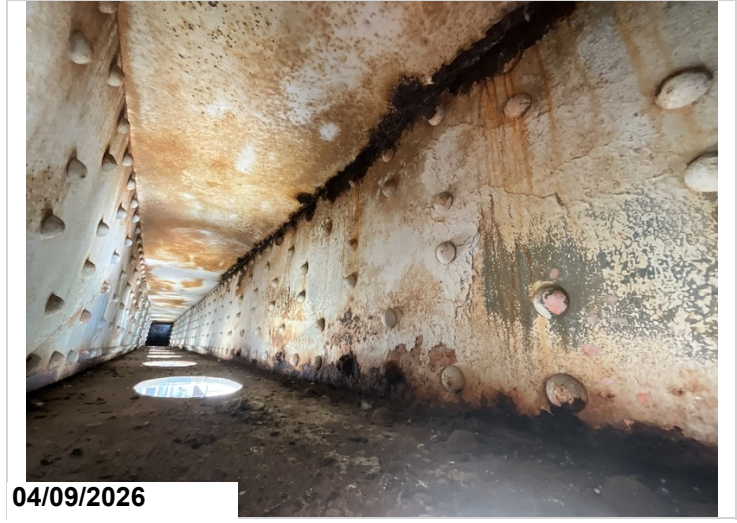
| ELEMENTS | DESCRIPTION | UNITS | TOTAL | CS1 | CS2 | CS3 | CS4 |
|---|---|---|---|---|---|---|---|
| | Span 13, Truss 1, L47, Ahead, Inside of Lower Chord: Active corrosion with flaking rust and pack rust between the top flange and web plates. 14LF CS3 corrosion. | | | | | | |

Span 13, Truss 1, Inside of the lower chord, PP47, Ahead:  
Active corrosion with flaking rust and pack rust between the  
top flange and the web plates. 14LF CS3 corrosion.

| ELEMENTS | DESCRIPTION | UNITS | TOTAL | CS1 | CS2 | CS3 | CS4 |
|---|---|---|---|---|---|---|---|
| Span 13, Truss 1, L47, Ahead, Inside of Lower Chord: | Active corrosion with flaking rust and pack rust between the top flange and web plates. 14LF CS3 corrosion. | | | | | | |

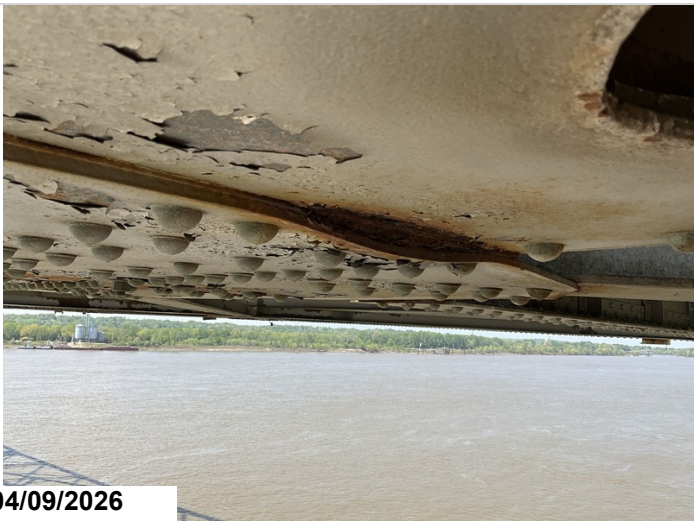
Span 15, Truss 2, Lower Chord, PP70, Ahead: Active  
corrosion with pack rust up to 7/8" between Lower Chord  
and lateral Gusset Plate. 1LF CS3 corrosion.

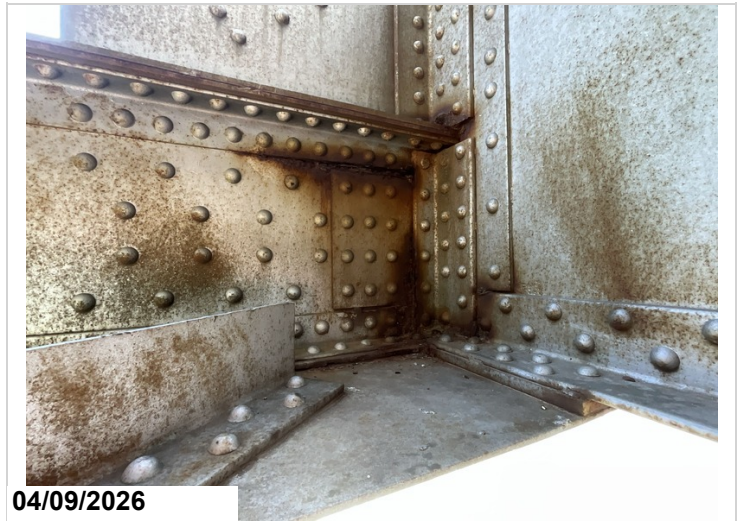
Span 15, Truss 2, Lower Chord to Floorbeam 70 connection:  
Typical corrosion at Lower Chord to Floorbeam connections.

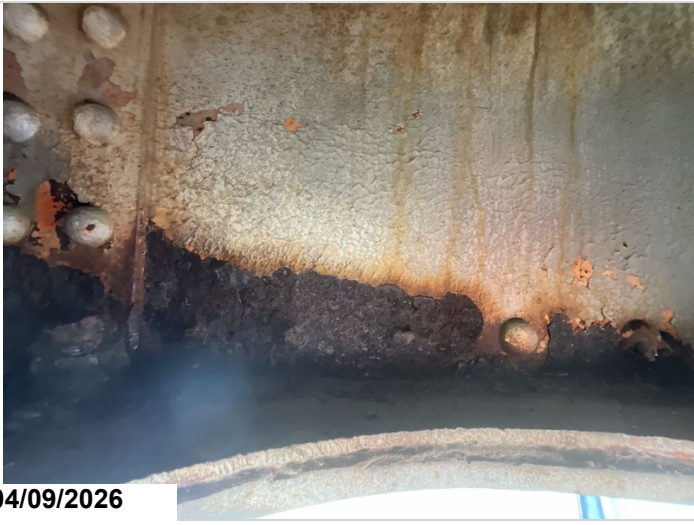
Span 15, Truss 1, Inside of Lower Chord, PP66, Back: Active corrosion with heavy section loss to rivets and the inside webs. 4LF CS3 corrosion.

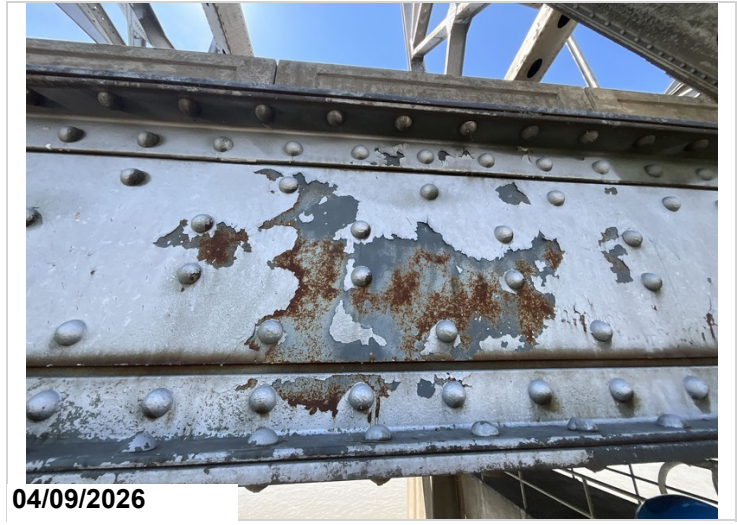
Typical paint condition.

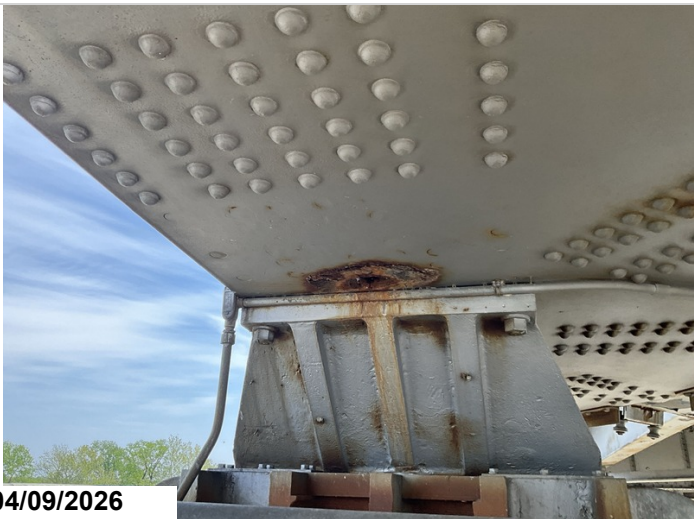
Span 14, Truss 1, Lower Chord, PP64, Back: Active corrosion with flaking rust along bottom of lateral Gusset Plate. 2LF CS3 corrosion.

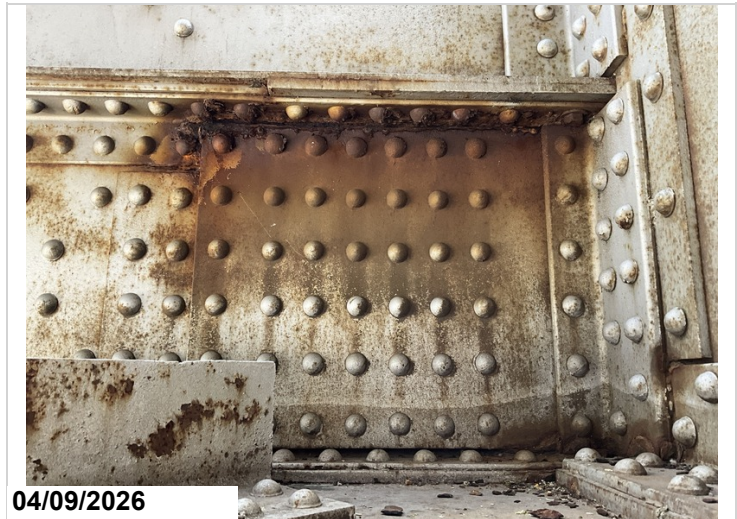
Typical Floorbeam to Lower Chord connection. PP62.

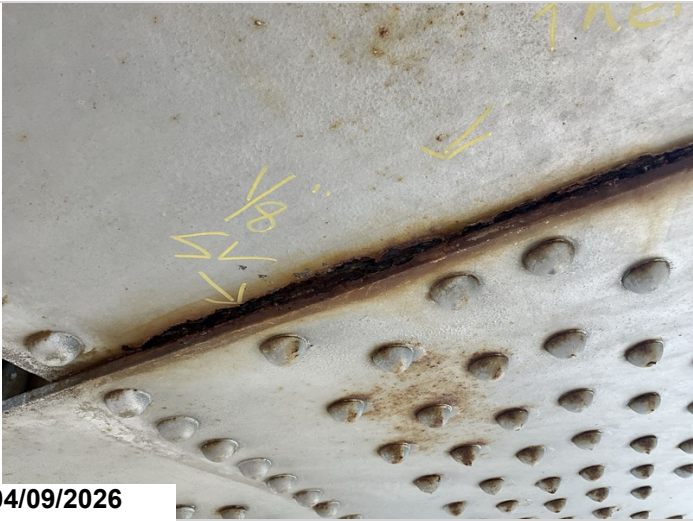
Span 14, Truss 2, Lower Chord, PP62, Back: Active corrosion with section loss up to 1/8" to the bottom flange at the bottom lateral gusset plate connection. 1LF CS3 corrosion.

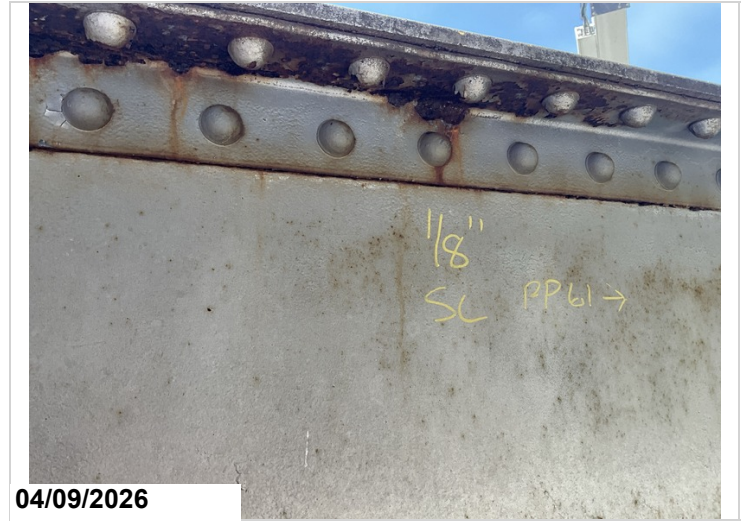
Span 14, Truss 2, Lower Chord, PP61 - 62, Left Top angle connection: Active corrosion with section loss up to 1/8". 2LF CS3 corrosion.

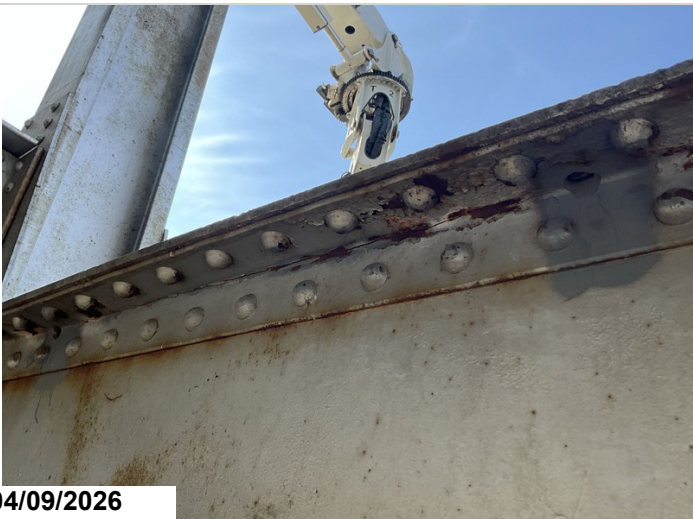
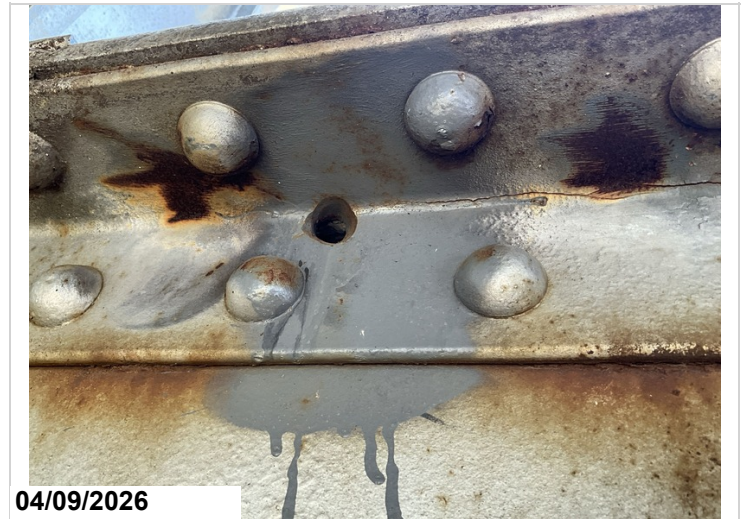
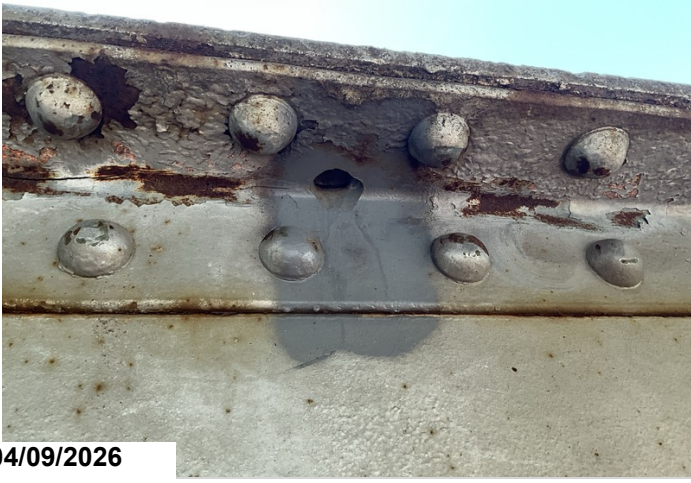
Span 14, Truss 2, Lower Chord, Left, PP61, Back, Top flange to web Angle connection: Arrested crack in angle. 3LF CS2 crack.

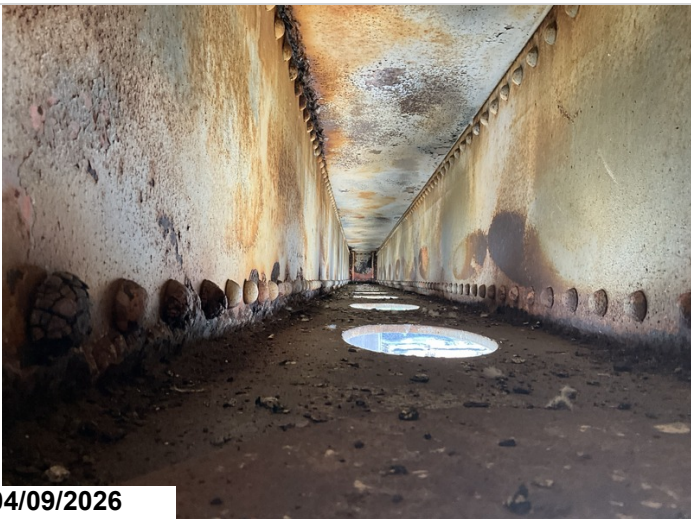
Span 14, Truss 2, Inside of the lower chord, PP60, Ahead: Active corrosion with flaking rust and section loss to the webs and the top flange. 12LF CS3 corrosion.

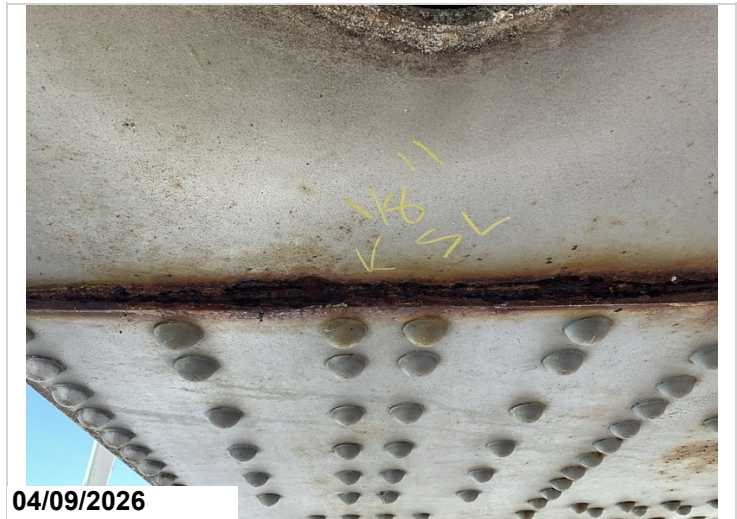
Span 14, Truss 2, Lower Chord, PP60, Ahead: Active corrosion with section loss up to 1/8" to the Bottom Flange at the bottom lateral gusset plate connection. 1LF CS3 corrosion.

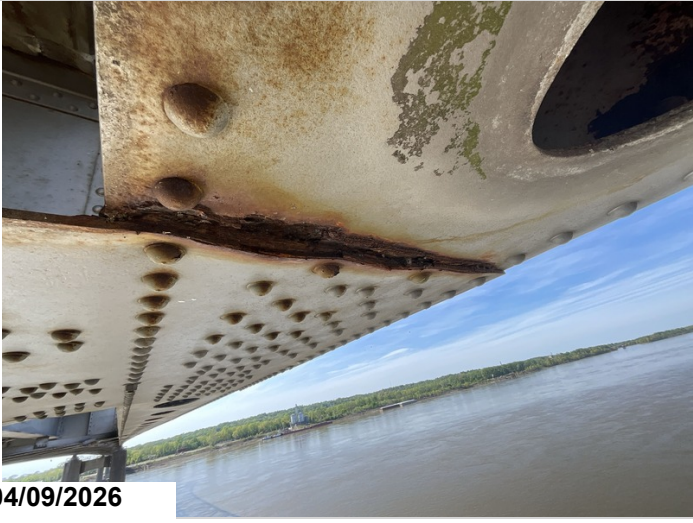
Span 14, Truss 1, Lower Chord, PP58, Ahead: Active corrosion with section loss up to 3/16" to the Bottom Flange of the Lower Chord and pack rust up to 5/8" between Bottom Flange of Lower Chord and lateral Gusset Plate. 1LF CS3 corrosion.

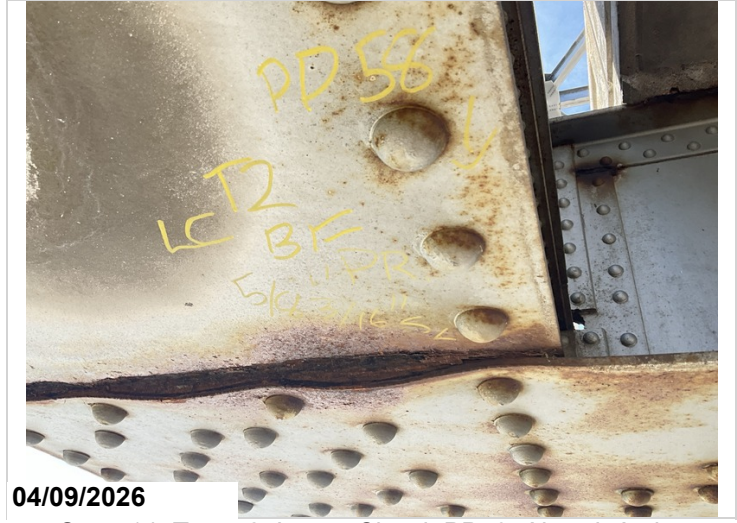
Span 14, Truss 2, Lower Chord, PP58, Ahead: Active corrosion with section loss up to 3/16" to the Bottom Flange of the Lower Chord and pack rust up to 5/8" between Bottom Flange of Lower Chord and lateral Gusset Plate. 1LF CS3 corrosion.

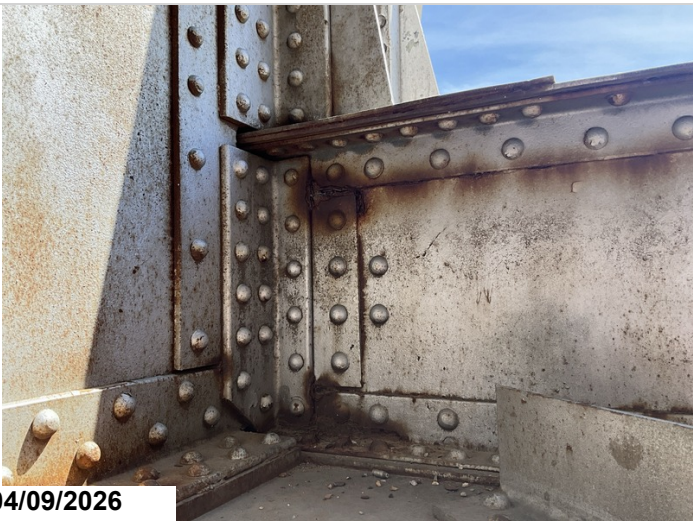
Typical crevice corrosion at the Lower Chord to Floorbeam connection.

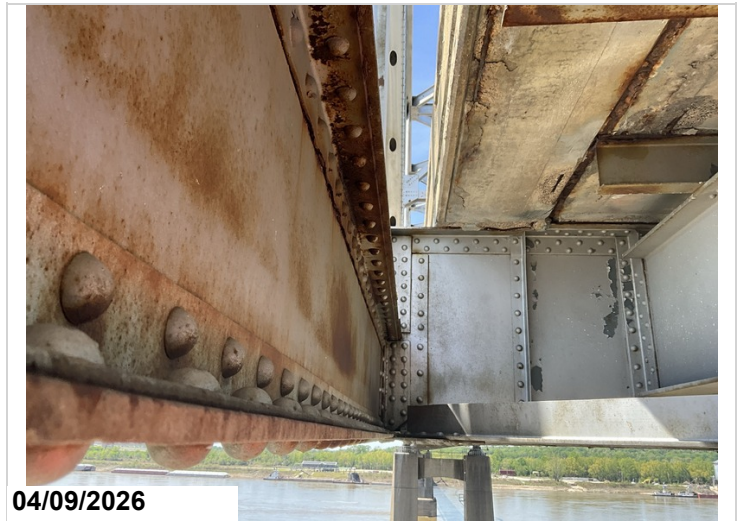
Lower Chord: Typical Active corrosion with pack rust between webs and flange angle connections.

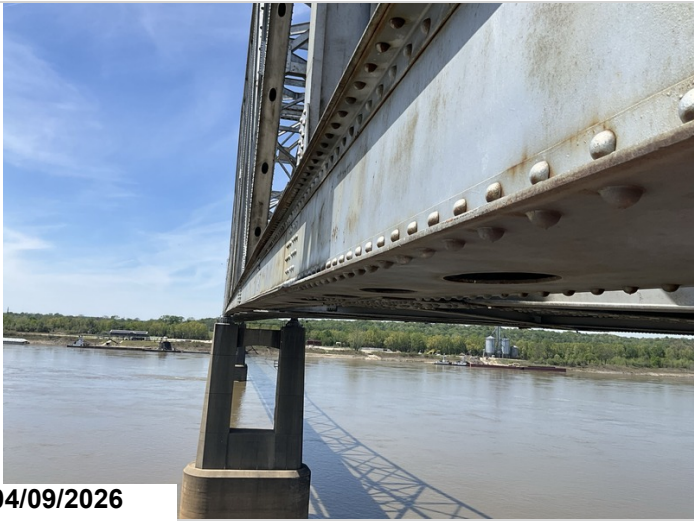
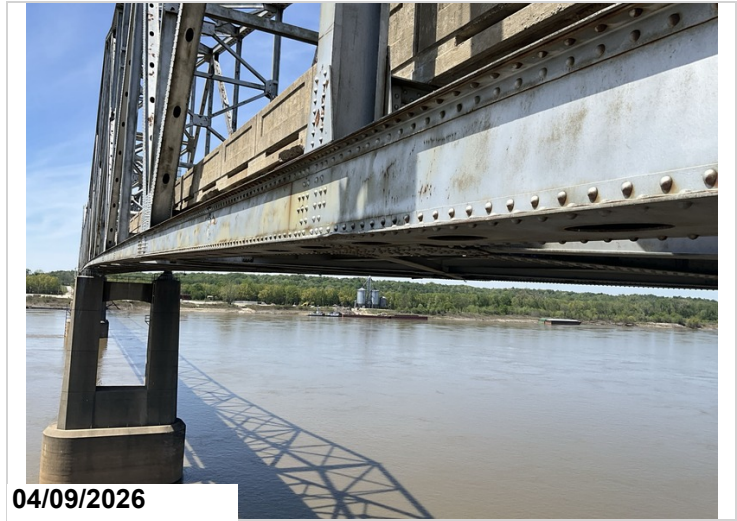
Span 14, Truss 2, Lower Chord, Right, PP55, Ahead: Minor distortion along the bottom flange. 1LF CS2 Distortion.

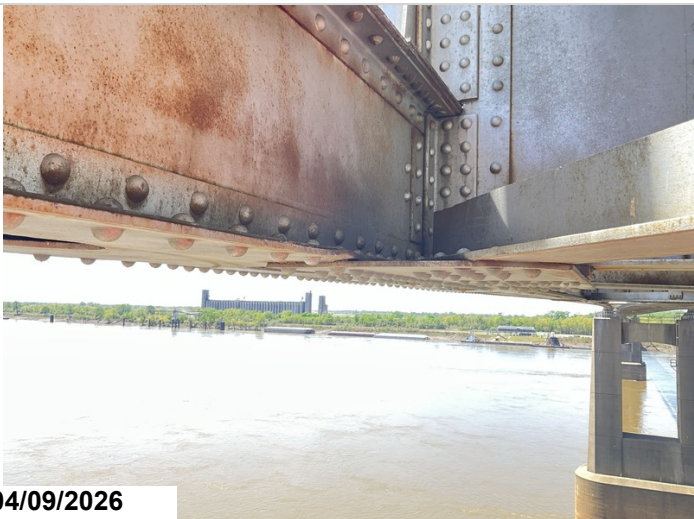
Span 14, Truss 2, Lower Chord, Left, PP55, Ahead: Minor distortion along the bottom flange. 1LF CS2 Distortion.

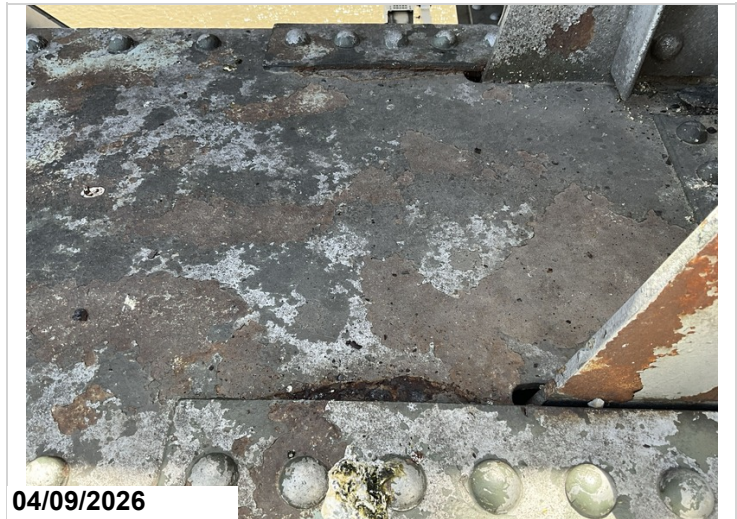
Span 14, Truss 1, Lower Chord, PP55: Active corrosion with section loss up to 3/16" to the top flange adjacent to the vertical connection. 1LF CS3 corrosion.

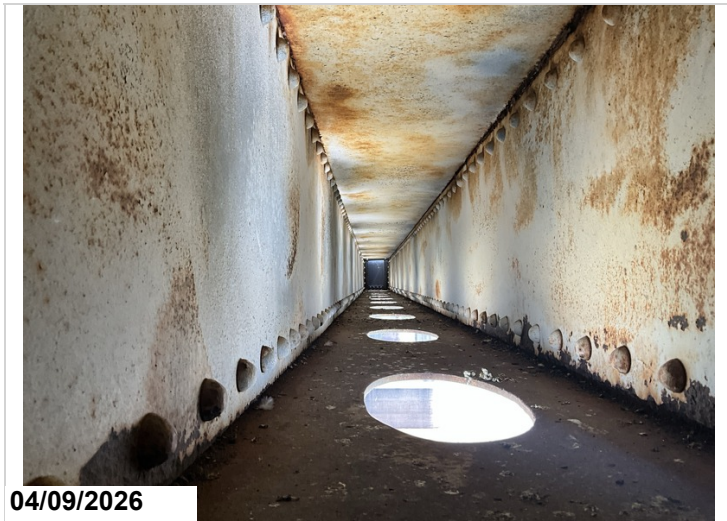
Typical inside of Lower Chord.

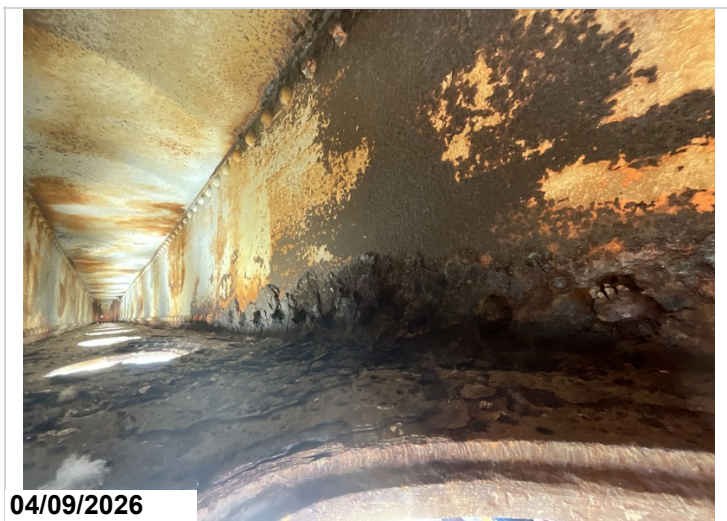
Span 14, Truss 2, Lower Chord, PP52, Starting at first portal back of 52: Active corrosion with heavy section loss to Inside left web and 13 rivets. 10LF CS3 corrosion.

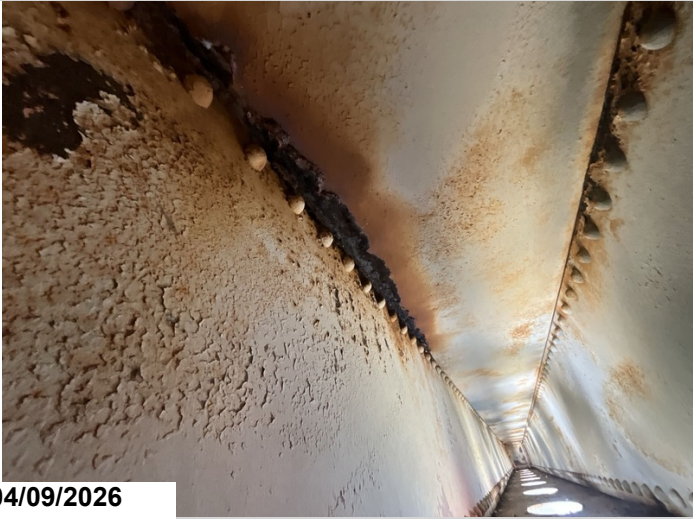
Span 14, Truss 1, Lower Chord, PP52, Back: Active corrosion with section loss up to 1/4". 9LF CS3 corrosion.

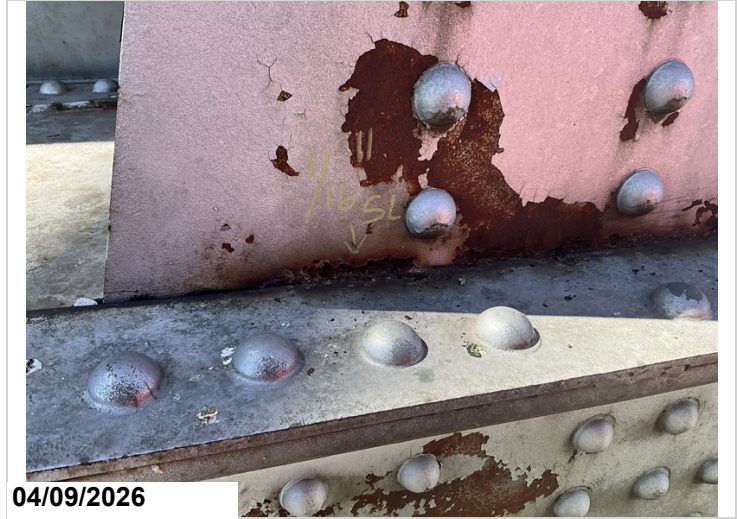
Span 14, Truss 1, PP51, Vertical connection plate: Active corrosion with section loss up to 1/16". 1LF CS3 corrosion.

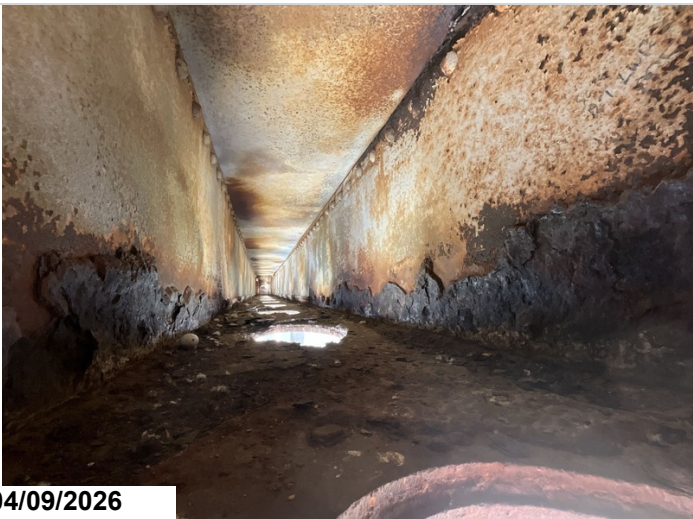
Span 14, Truss 2, Lower Chord, PP50, Back: Active corrosion with flaking rust along inside of Lower Chord. 12LF CS3 corrosion.

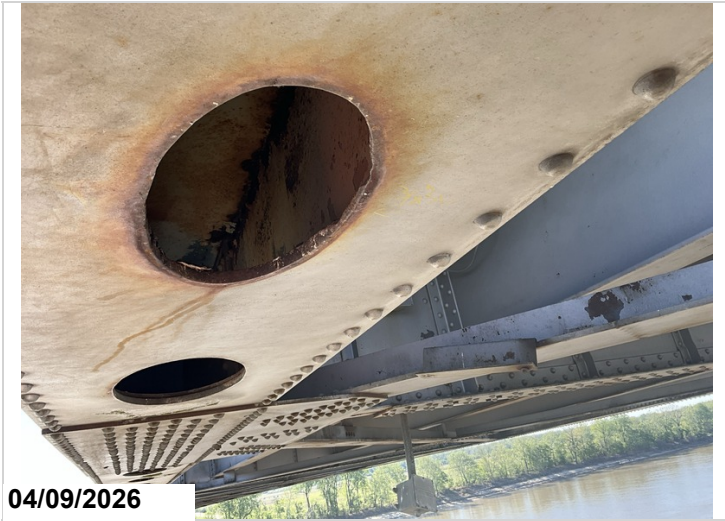
Span 14, Truss 2, Lower Chord, PP50, Back: Active corrosion with section loss up to 1/2" to the Bottom Flange at two portals. 5LF CS3 corrosion.

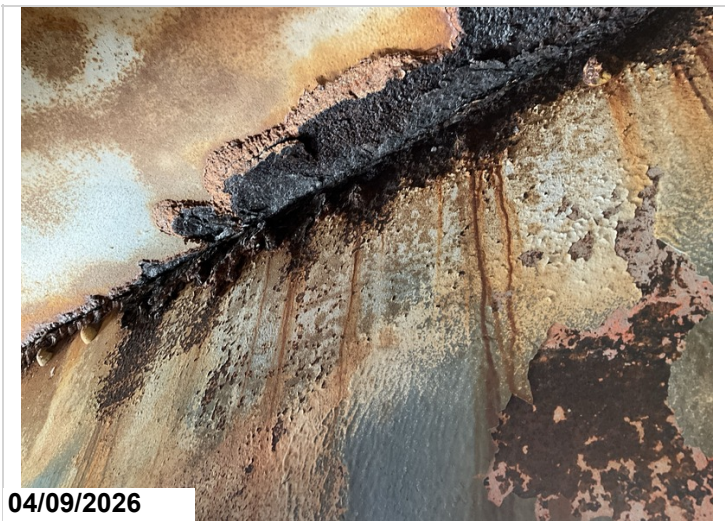
Span 14, Truss 1, Lower Chord, PP50, Back: Active corrosion with section loss up to 3/8" to the Bottom Flange at two portals. 8LF CS3 corrosion.

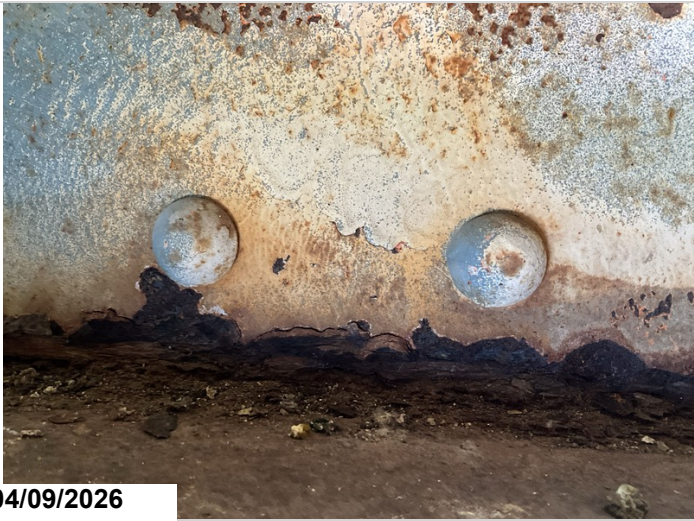
Span 14, Truss 1, Inside of the lower Chord, PP48 - PP49: Active corrosion with flaking rust to the flanges and the webs. 8LF CS3 corrosion.

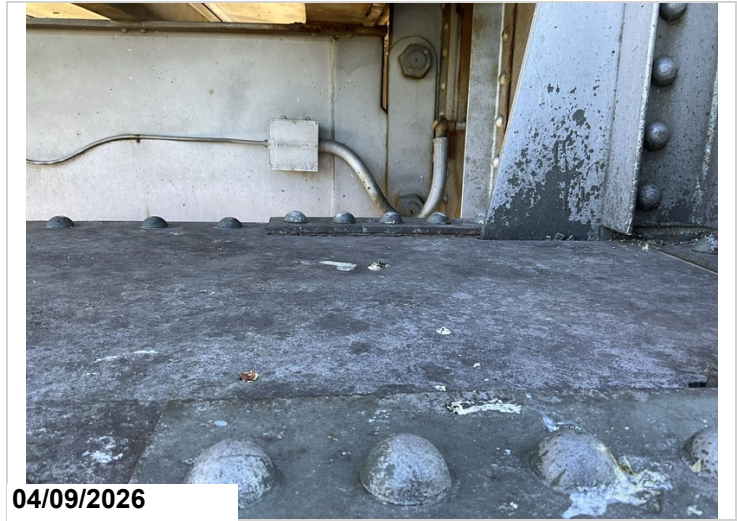
Span 15, Truss 1 and 2, Lower Chord, PP71 - PP72: Active corrosion with section loss up to 1/8" to the webs near the bottom flange. 4LF CS3 corrosion.

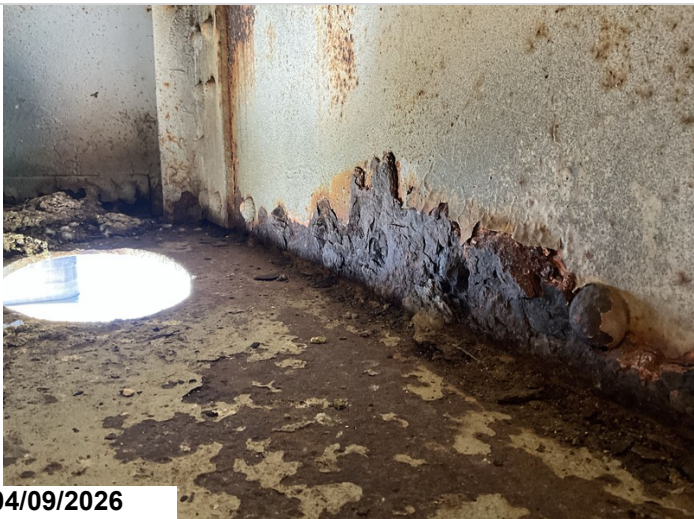
Span 15, Truss 1, Lower Chord to Vertical connection: Typical minor pack rust at the riveted connection. CS3 corrosion.

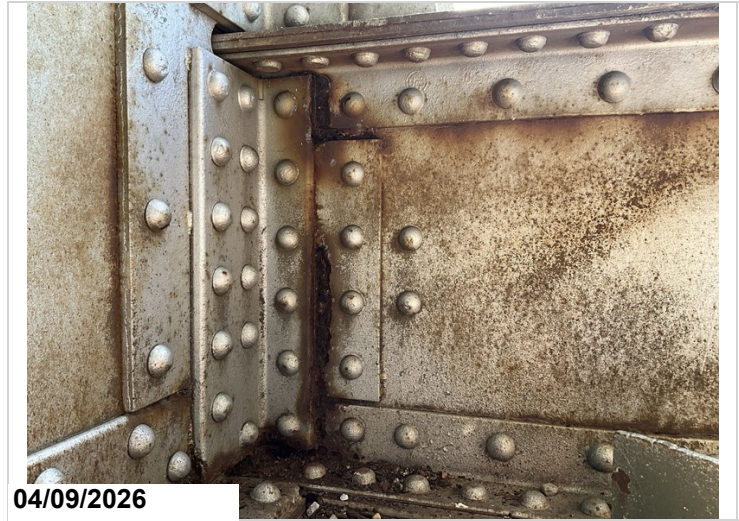
Span 15, Truss 1, Lower Chord, PP73: Active corrosion with section loss up to 1/16" to the bottom flange at the bottom lateral gusset plate connection. 1LF CS3 corrosion.
