## Bridge 02899 Inspection Report

Arnold Road ID:54x49x11xA, Arnold Log mile:0.569

# National Bridge Inventory Data Sheet

| IDENTIFICATION | |
|---|---|
| (7) Facility Carried | US 49- Phillips Co |

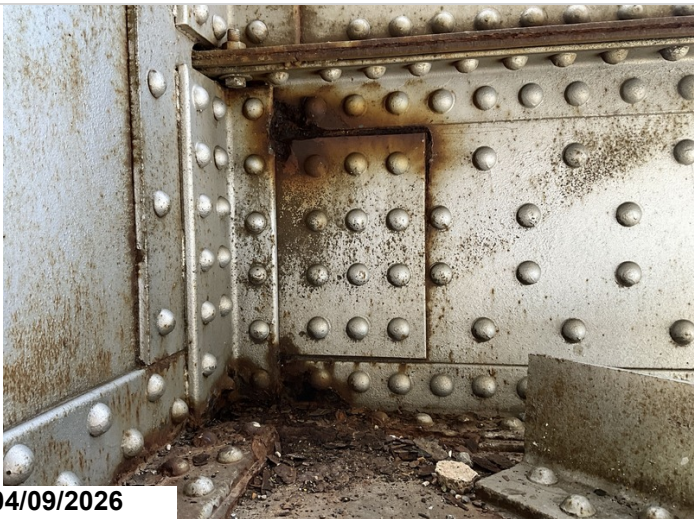
Span 15, Truss 2, PP73, Lower Chord to Floorbeam connection: Active corrosion with section loss to connection members. 1LF CS3 corrosion.

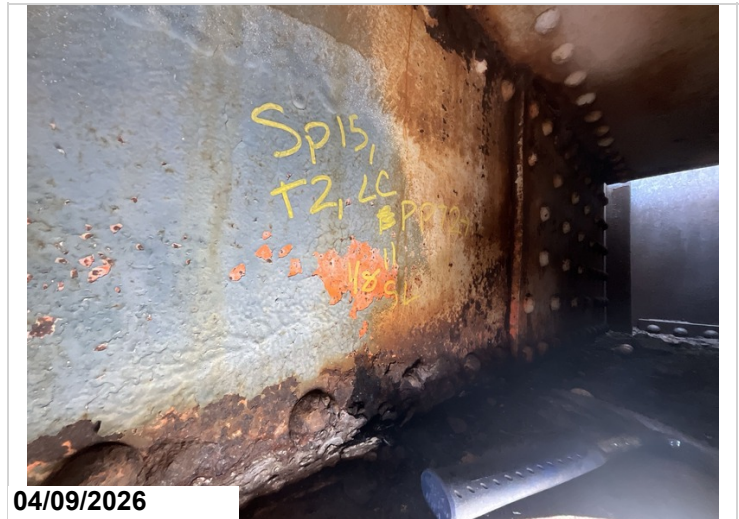
Span 15, Truss 2, PP72, Lower Chord to Floorbeam connection: Active corrosion with section loss to connection members. 2LF CS3 corrosion.

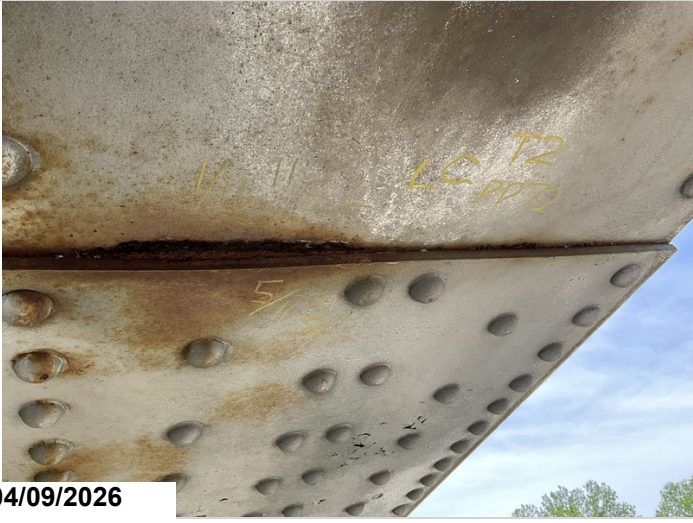
Span 15, Truss 2, Lower Chord, PP72, Back: Active corrosion with flaking rust and section loss up to 1/8" to the inside webs. 6LF CS3 corrosion.

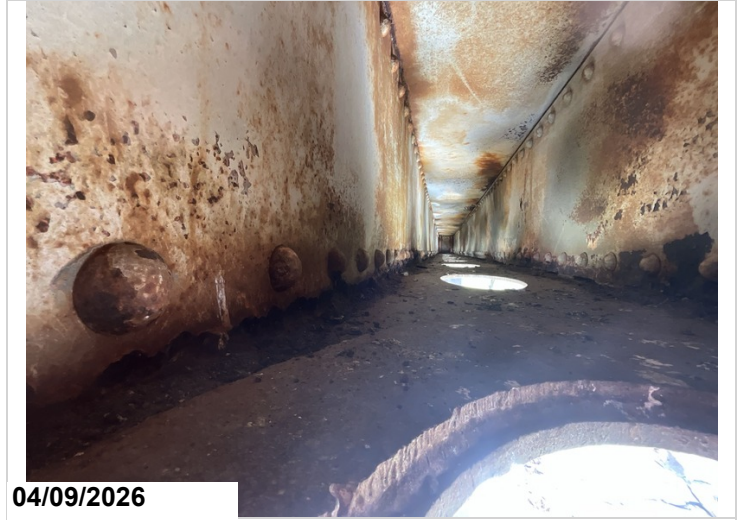
Span 15, Truss 2, Lower Chord , PP72: Active corrosion with pack rust up to 5/16 and section loss up to 1/16" to the bottom flange at the bottom lateral gusset plate connection. 1LF CS3 corrosion.

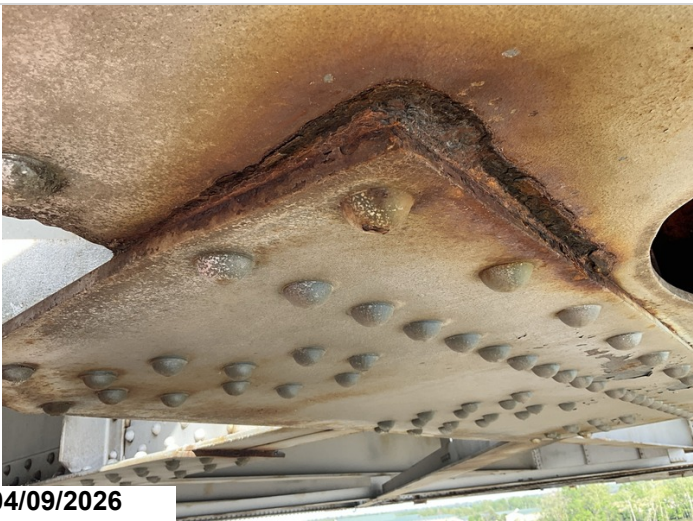
Span 15, Truss 2, Lower Chord, Between PP72 and 73: Active corrosion with flaking rust and section loss up to 3/16" to the inside webs. 12LF CS3 corrosion.

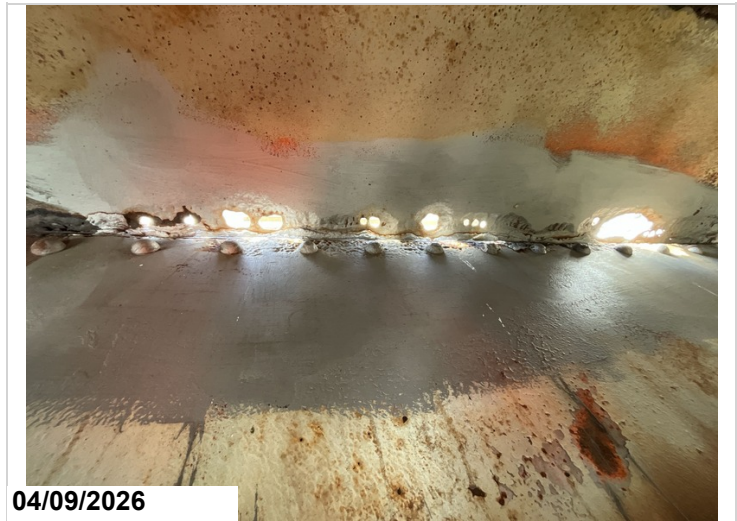
Span 13, Truss 2, Lower Chord, PP41: Active corrosion pack rust and section loss up to 1/8" to the bottom flange at the bottom lateral gusset plate connection. 1LF CS3 corrosion.

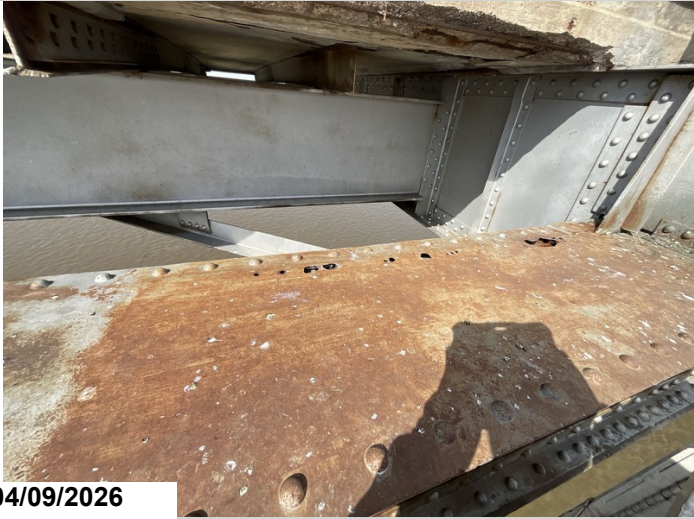
Span 13, right lower chord back of panel point 41, holes in top plate, 4 feet total in length. 4LF, CS3.

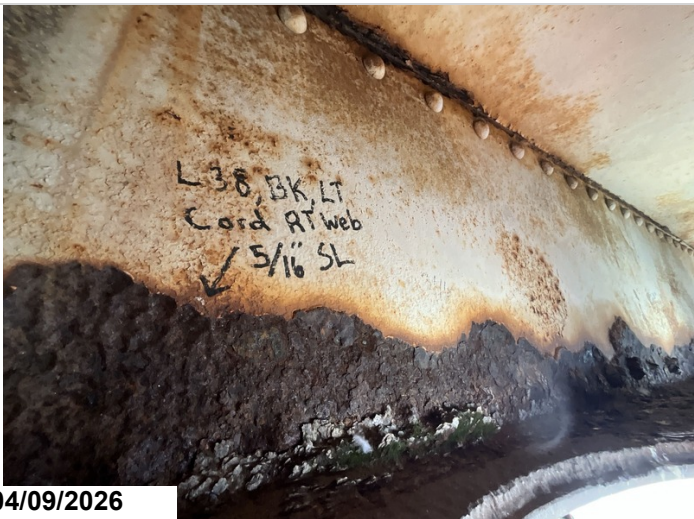
Span 13, Truss 2, Inside of the lower chord, PP42, Back: Active corrosion with section loss up to 5/16" to the web. 12LF CS3 corrosion.

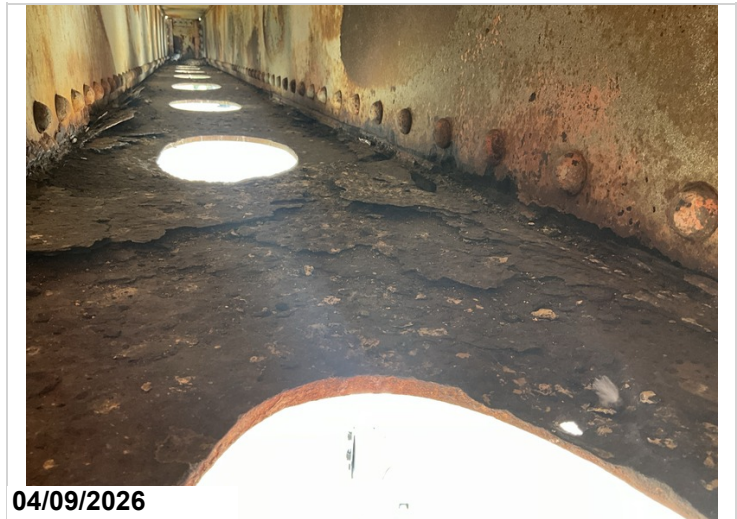
Span 13, Truss 1, Inside of the lower chord, PP38, Back: Active corrosion with section loss up to 5/16" to the web. 8LF CS3 corrosion.

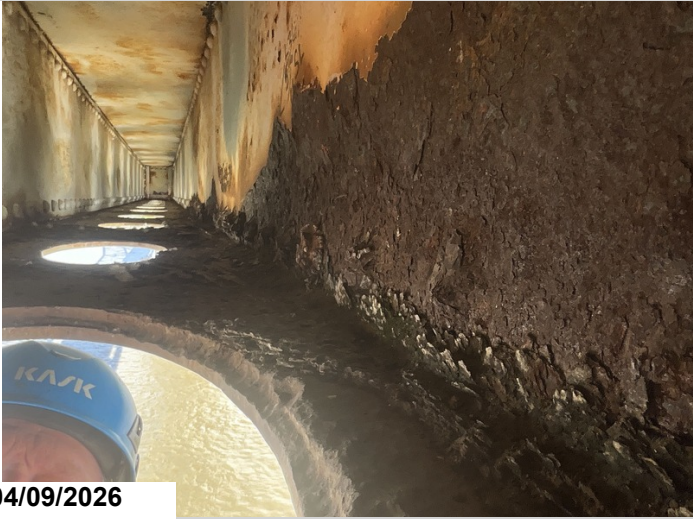
Span 13, Truss 2, Inside of the lower chord, Second Portal hole ahead of PP38: Active corrosion with section loss approximately up to 1/2" along with a 1/4" diameter hole in the bottom flange. 12LF CS3 corrosion.

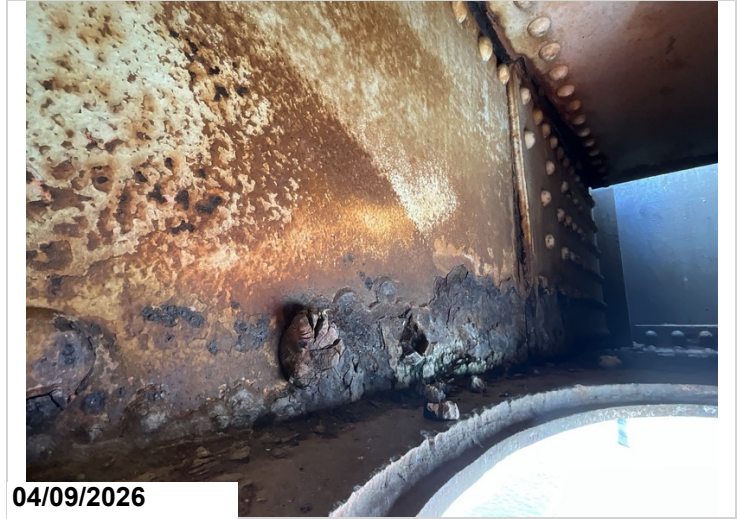
Span 13, Truss 1, Inside of the lower chord, PP36, Ahead:  
Active corrosion with section loss and flaking rust along the web. 10LF CS3 corrosion.

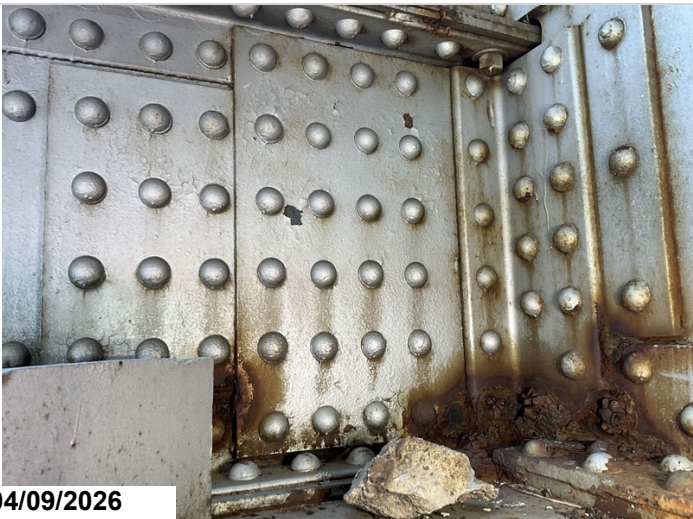
Span 13, Truss 2, Inside of the lower chord, PP38, Back:  
Active corrosion with laminated rust build up along the web and corroded rivet heads. 6LF CS3 corrosion.

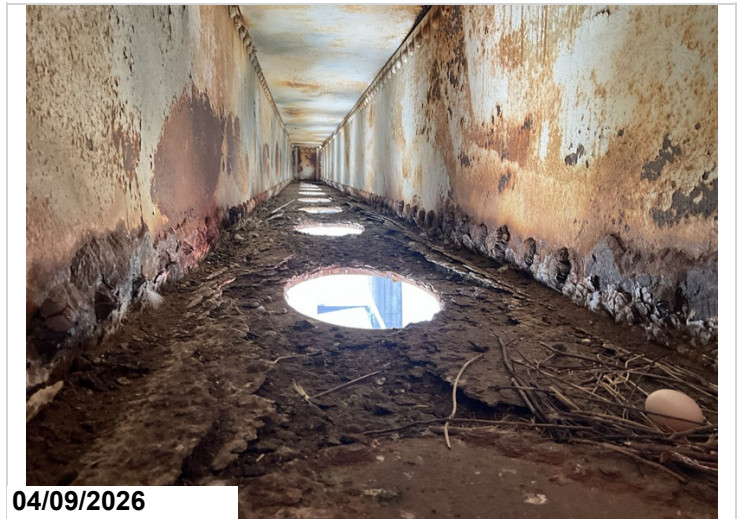
Span 13, Truss 2, Lower Chord, PP36: Active corrosion with  
crevice corrosion along the floorbeam connection plates.  
1LF CS3 corrosion.

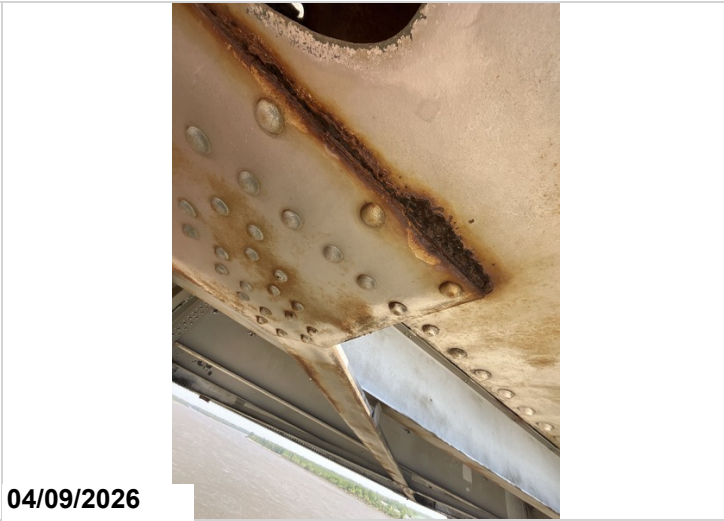
Span 13, Truss 2, Inside of the lower chord, PP36, Back:  
Active corrosion with flaking rust and section loss to the rivet  
heads along the bottom flange and webs. 12LF CS3  
corrosion.

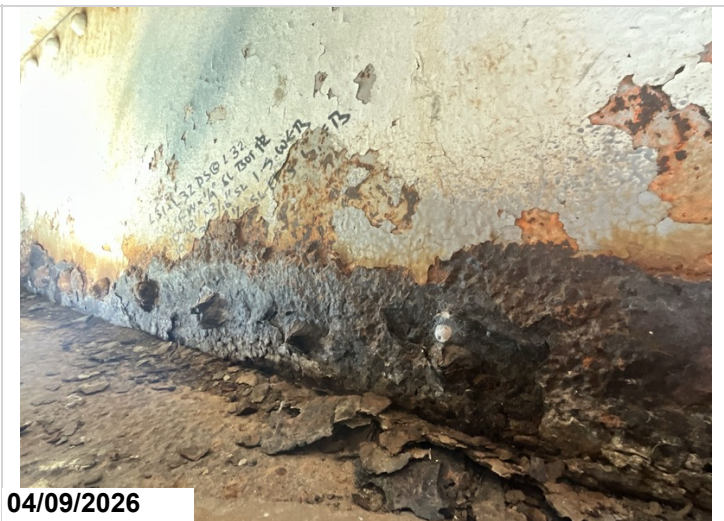
Span 13, Truss 2, Lower Chord, PP34, Left: Active corrosion with crevice corrosion along the built up members adjacent to the floorbeam connection. 1LF CS3 corrosion.

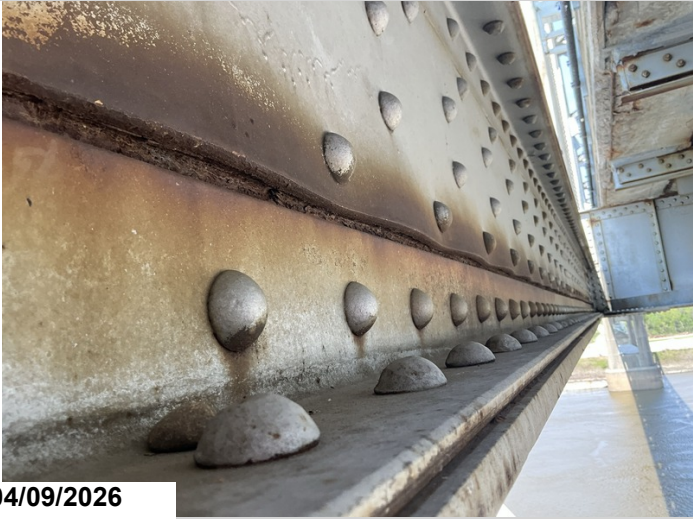
Span 13, Truss 2, Inside of the lower chord, PP32: Active corrosion with section loss up to 3/16" adjacent to the angle connection plates along the top flange. 4LF CS3 corrosion.

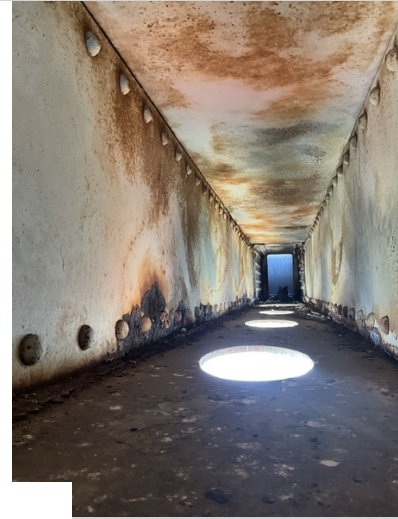
Span 12, Truss 2, Lower Chord, Left: Active corrosion with pack rust between the web and the built up web plate along the lower chord, causing minor distortion. 20LF CS3 corrosion.

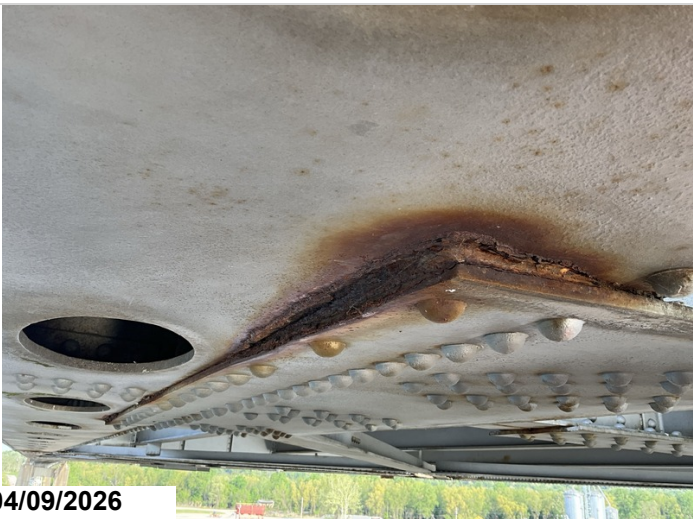
Span 12, Truss 1, Inside of the lower chord, PP28, Ahead: Active corrosion with laminating rust and section loss up to 1/8" to the web. 15LF CS3 corrosion.

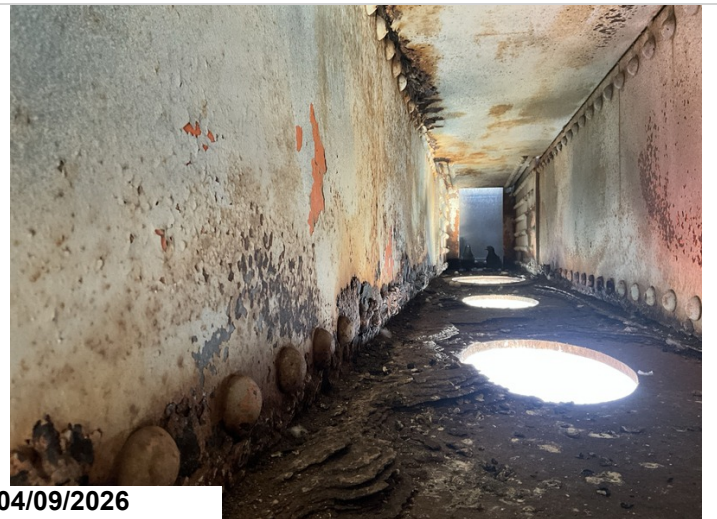
Span 12, Truss 2, Lower Chord, PP27: Active corrosion with pack rust up to 1/2" between the bottom flange and the bottom lateral gusset plate. 1LF CS3 corrosion.

Span 12, Truss 1, Lower Chord, PP27: Active corrosion with pack rust up to 1/2" between the bottom flange and the bottom lateral gusset plate. 1LF CS3 corrosion.

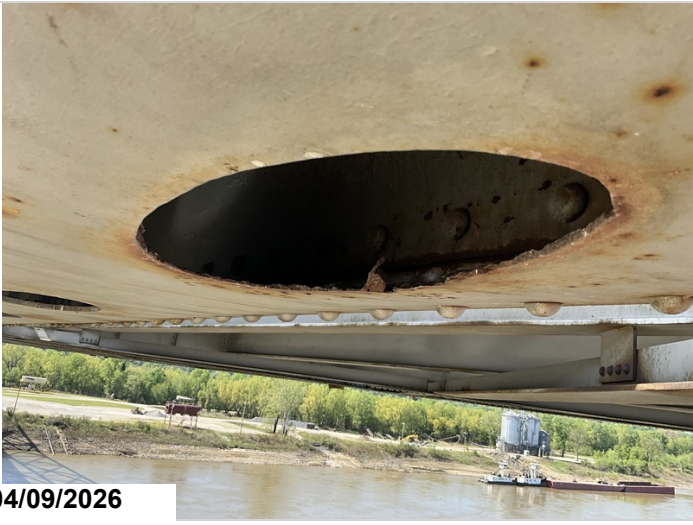
Span 12, Truss 1, Inside of Lower Chord, PP26, Ahead: Active corrosion with section loss to the webs of the lower chord. 12LF CS3 corrosion.

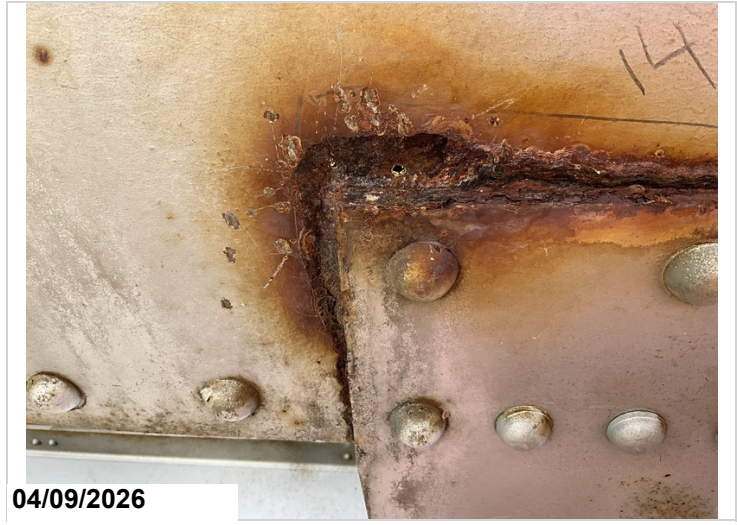
Span 12, Truss 2, Lower Chord, Second Portal Hole Back from PP23: Active corrosion with the bottom flange section remaining down to a knife's edge. 2LF CS3 corrosion.

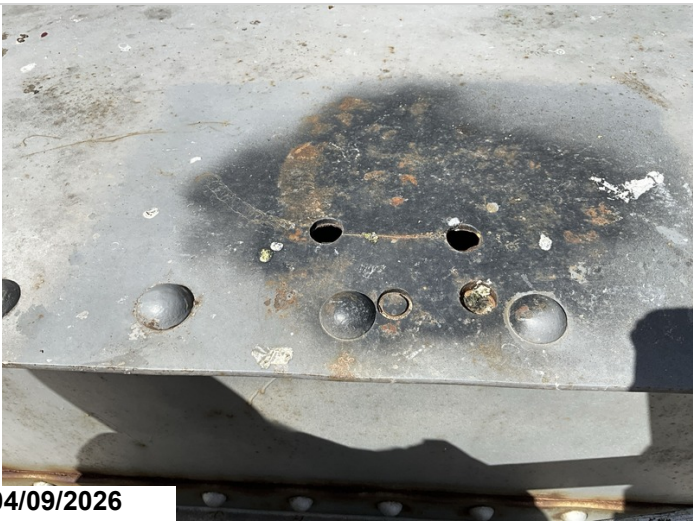
Span 12, Truss, 2, Lower Chord, PP23, Back: Active corrosion with section loss up to 3/16" along with pin holes in the bottom flange of the lower chord. 1LF CS3 corrosion.

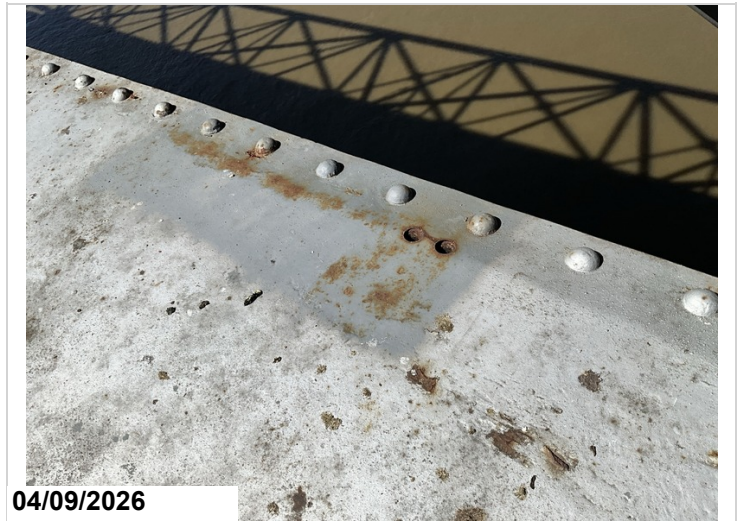
Span 12, Truss 2, Lower Chord, PP23, Back: Arrested crack in the top flange. 1LF CS2 crack.

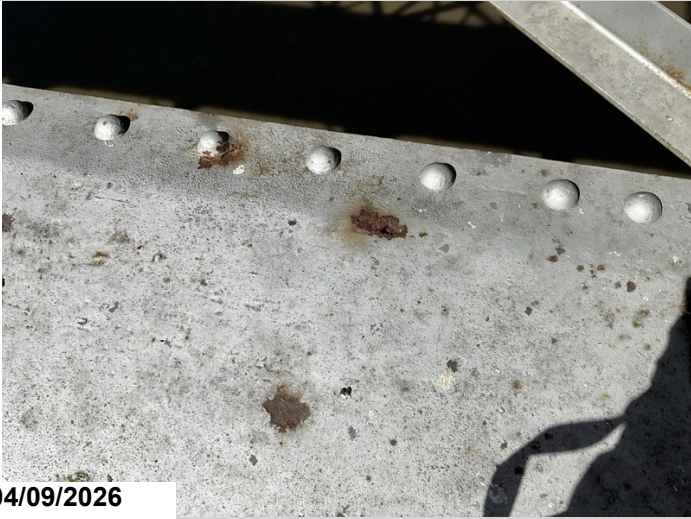
Span 12, Truss 2, Lower Chord, PP24, Back: Arrested crack in the top flange. 1LF CS2 crack.

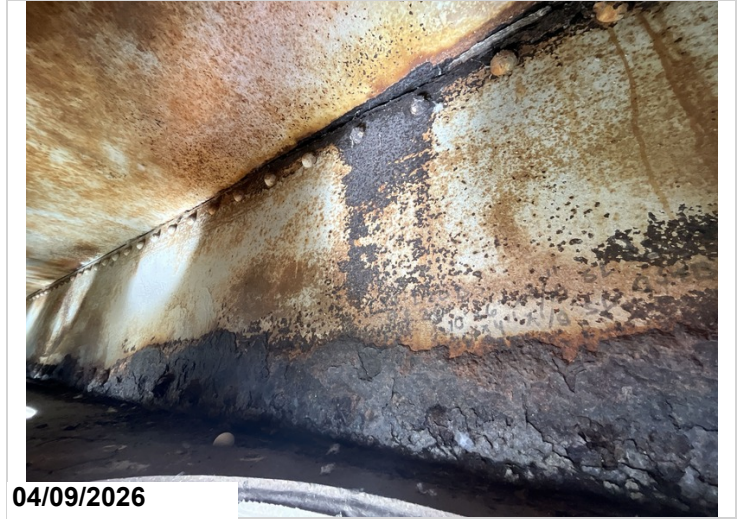
Span 12, Truss 2, Lower Chord, PP24, Back: Active corrosion with a 1/4" diameter hole in the top flange of the lower chord. 1LF CS4 corrosion.

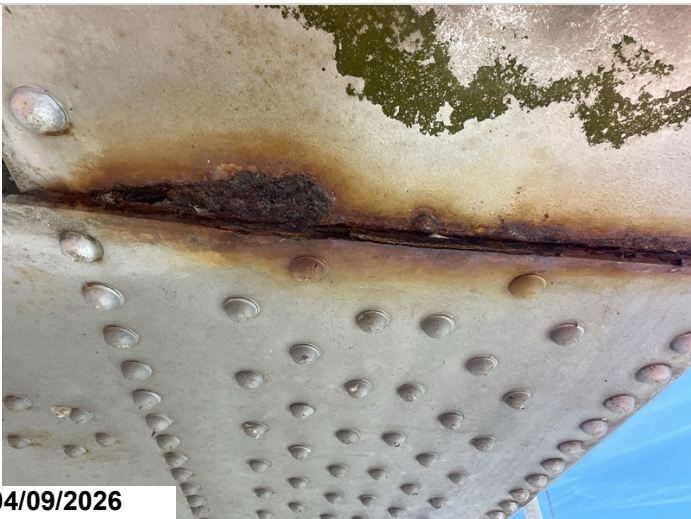
Span 12, Truss 2, Lower chord, flaking rust to the web plate pack rust between top plate and web plate. 12LF CS3 corrosion.

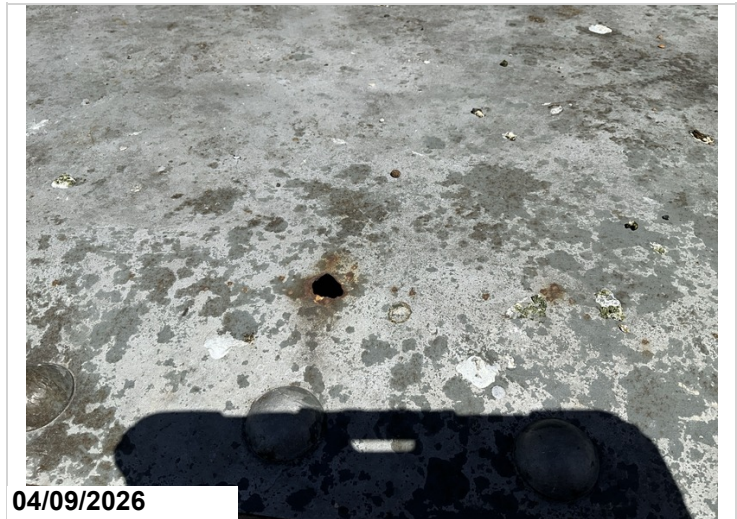
Span 12, Truss 2, Lower Chord, PP20: Active corrosion with section loss up to 1/8" to the bottom flange at the bottom lateral gusset plate connection. 1LF CS3 corrosion.

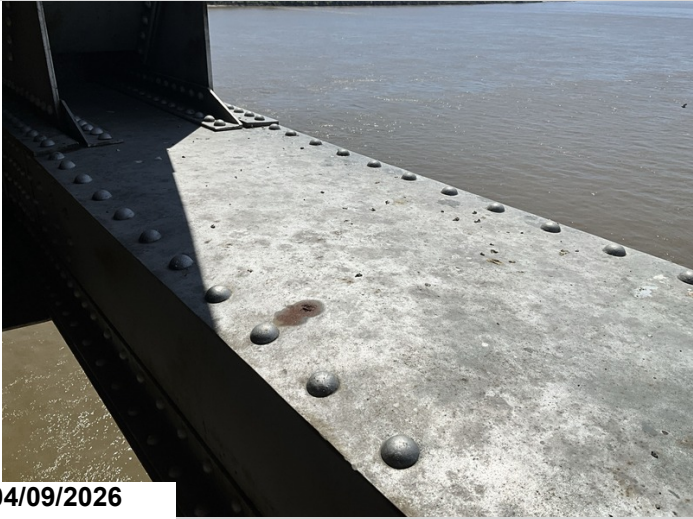
Span 12, Truss 2, Lower Chord, Back of PP19: Active corrosion with a 1" diameter hole in the top flange. 1LF CS4 corrosion.

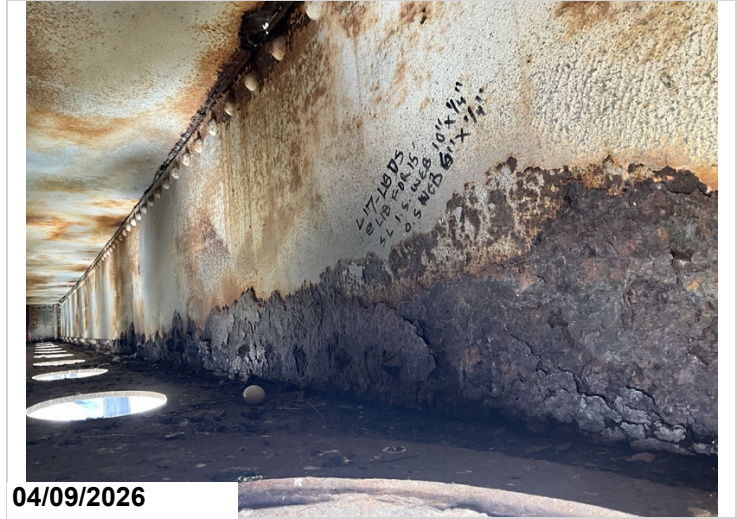
Span 12, Truss 2, Lower Chord, Back of PP18: Active corrosion with a 3/4" diameter hole in the top flange. 1LF CS4 corrosion.

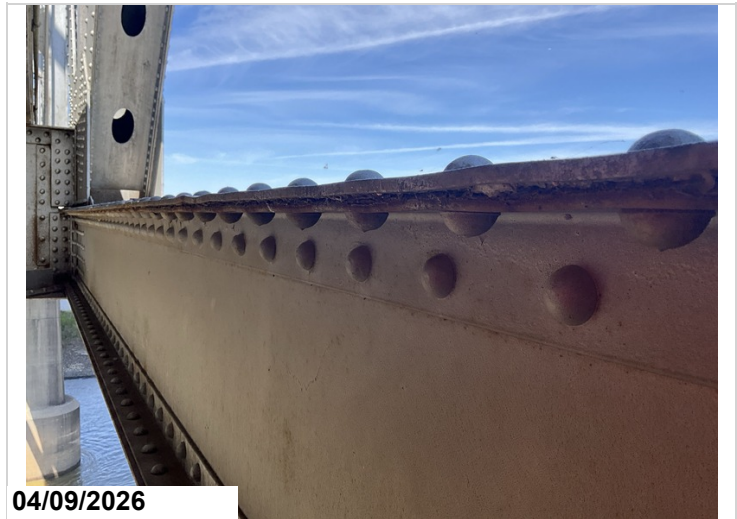
Span 12, Truss 1, Lower Chord, PP16, Ahead: Active corrosion with pack rust between the web and bottom flange angle connection. 15LF CS3 corrosion.

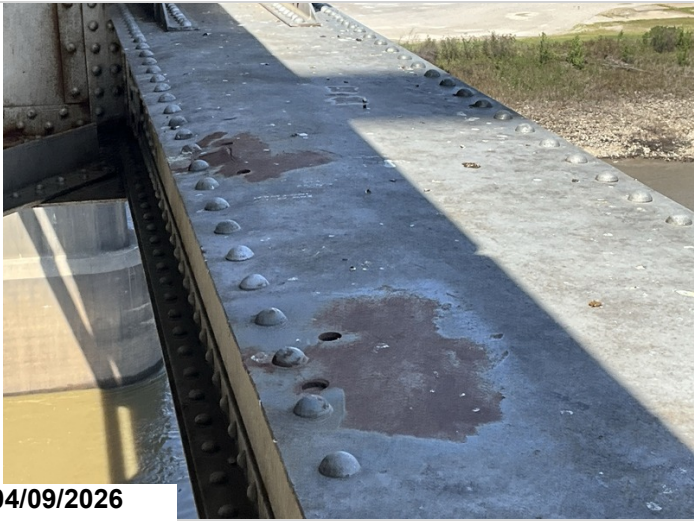
Span 12, Truss 1, Lower Chord, Ahead of PP16: Arrested crack in the top flange. 4LF CS2 crack.

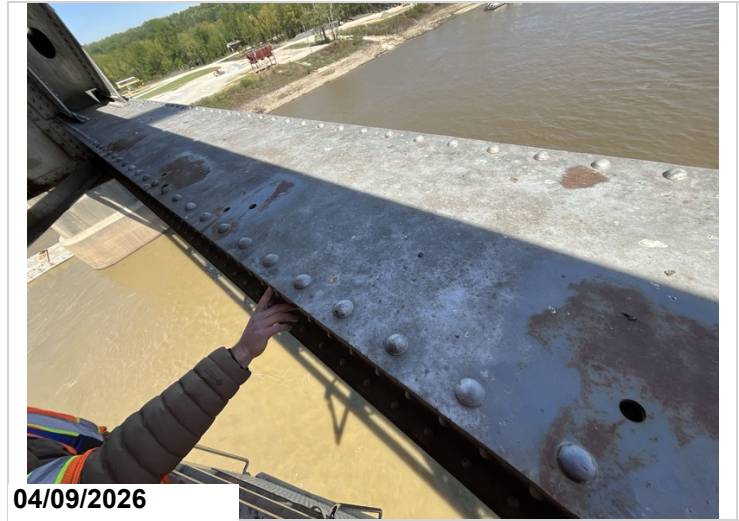
Span 12, Truss 1, Lower Chord, Ahead of PP16: Arrested crack in the top flange. 4LF CS2 crack.

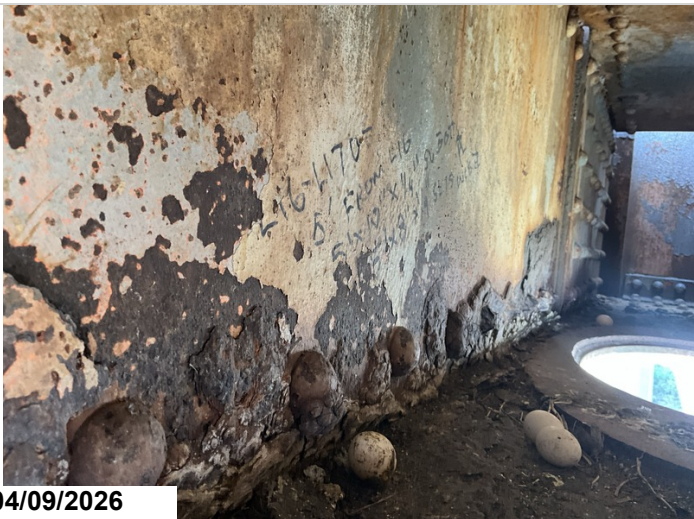
Span 12, Truss 1, Inside of the lower chord, PP16, Ahead: Active corrosion with flaking rust along the web. 8LF CS3 corrosion.

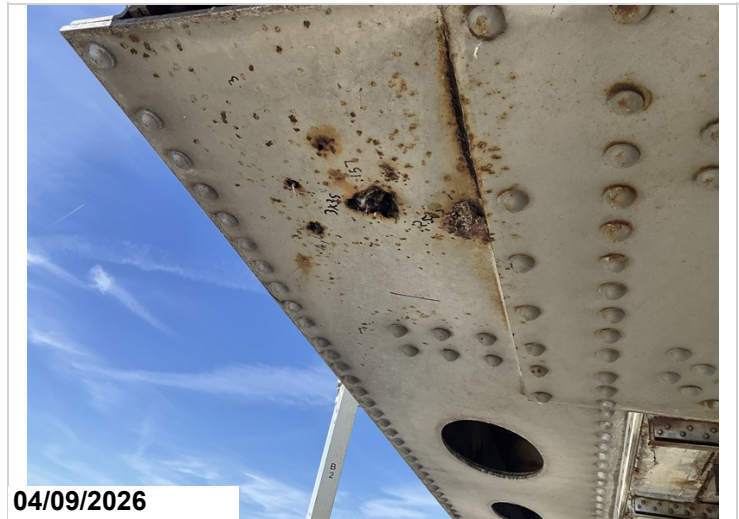
Span 12, Truss 2, Lower Chord, PP15: Active corrosion with holes in the bottom flange of the lower chord 3 1/2" X 3", 2 1/2" X 2", 1", 1/2", and 1/4" in sizes. The inside of the chord is filled with pigeon dung. 2LF CS4 corrosion.

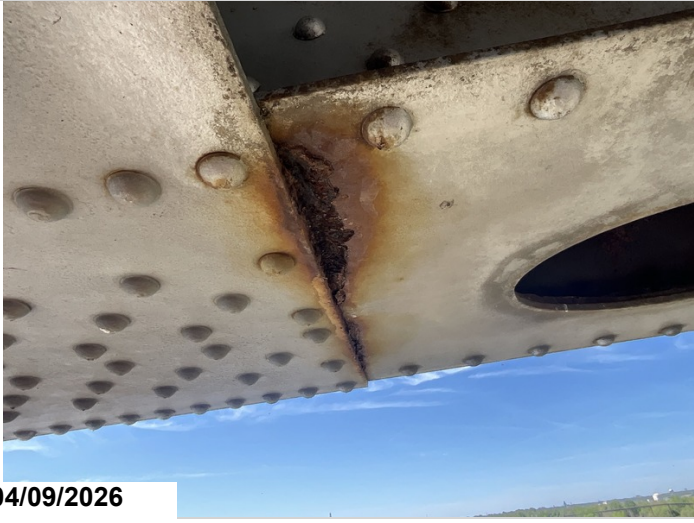
Span 12, Truss 2, Lower Chord, PP16: Active corrosion with section loss up to 1/4" to the bottom flange at the bottom lateral gusset plate connection. 1LF CS3 corrosion.

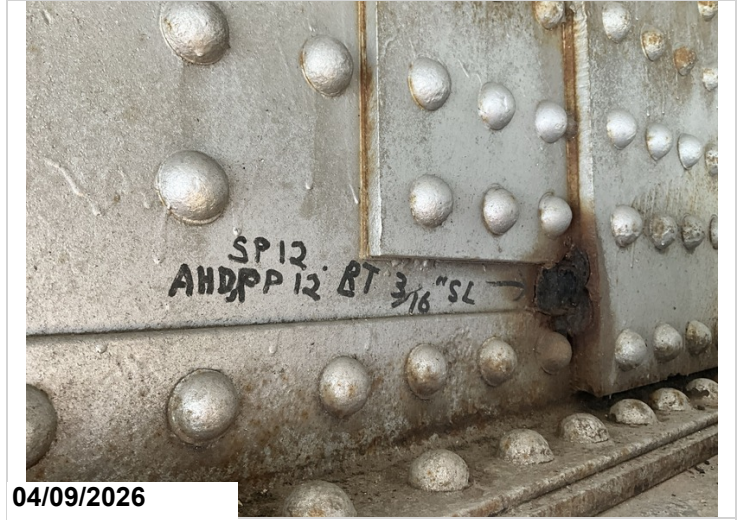
Span 12, panel point 12 lower chord, 3/16" section loss to web, 1LF, CS3.

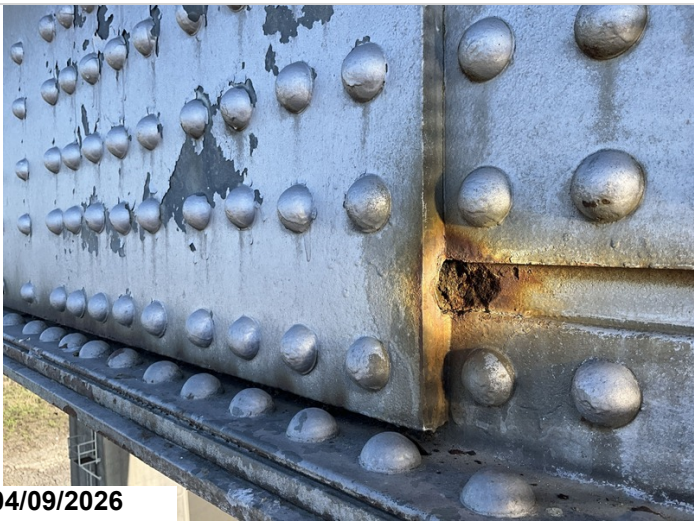
Span 12, Truss 2, Lower Chord, PP12: Active corrosion with section loss up to 3/16" to the web at the build up area. 1LF CS3 corrosion.

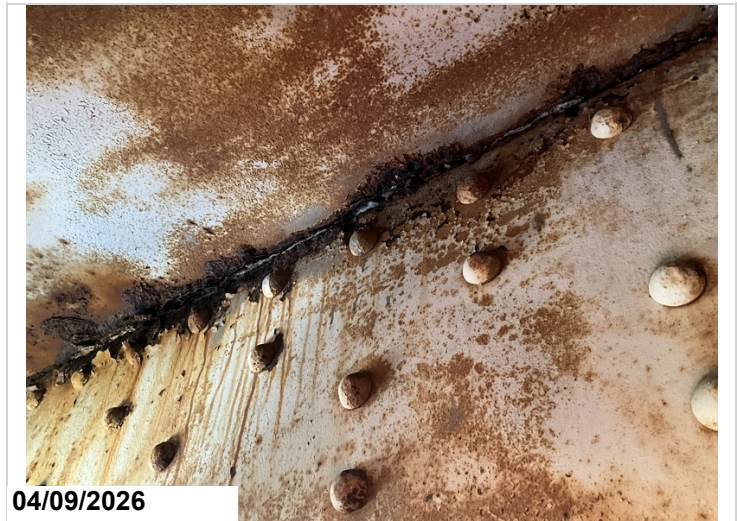
Span 12, Truss 2, Inside of the lower chord, PP11: Moderate corrosion along the top flange and web. 4LF CS3 corrosion.

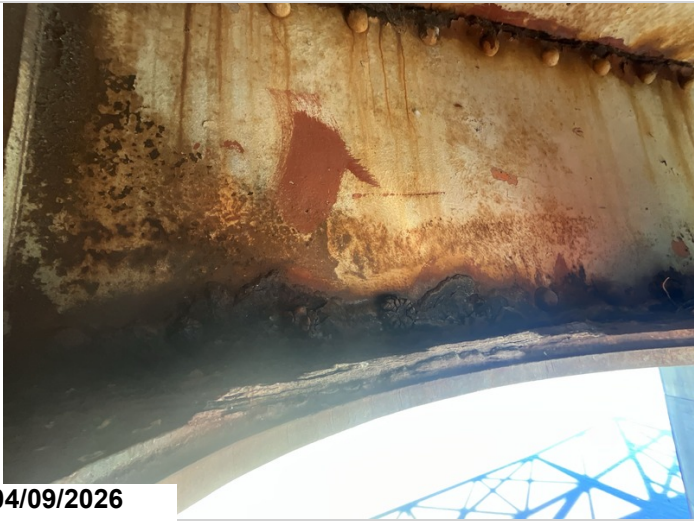
Span 11, Truss 2, Inside of the lower chord, PP8: Active corrosion with flaking rust along the web and bottom flange. 4LF CS3 corrosion.

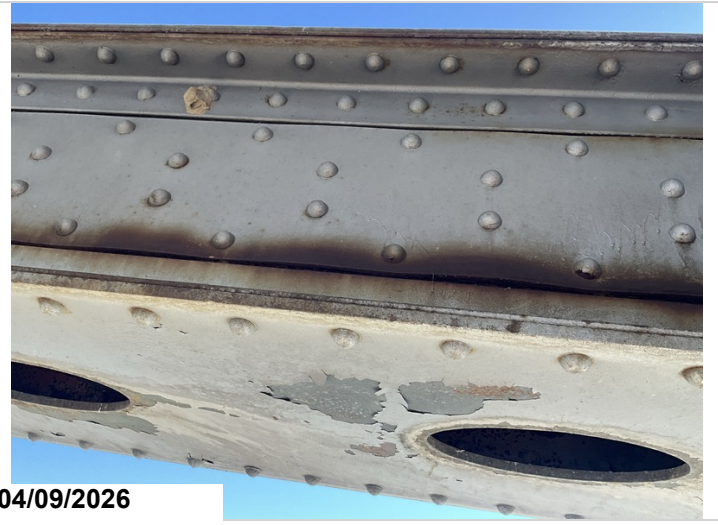
Span 11, Truss 2, Lower Chord, Ahead of PP9: Active corrosion with pack rust between the web and bottom flange angle connection. 20LF CS3 corrosion.

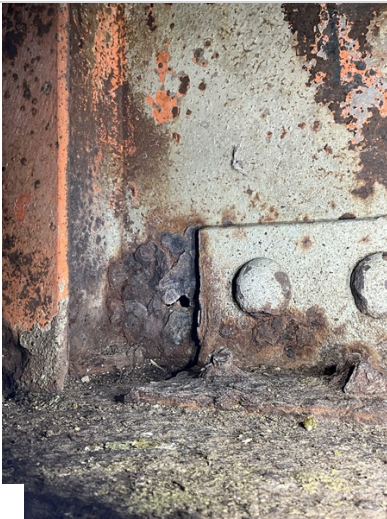
Span 11, Truss 2, Lower chord, PP9: Active corrosion with a 1/2" diameter hole in the bulkhead at the floorbeam connection. 1LF CS3 corrosion.

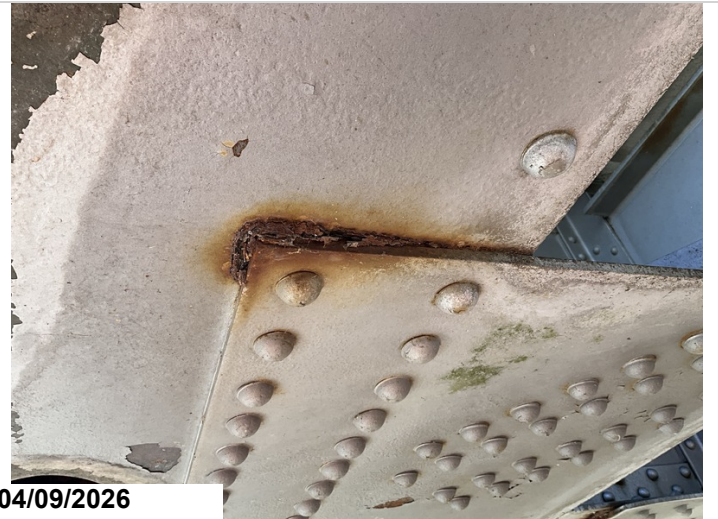
Span 11, panel point 9, flaking rust in the bottom of the lower chord at the gusset, 1LF, CS3.

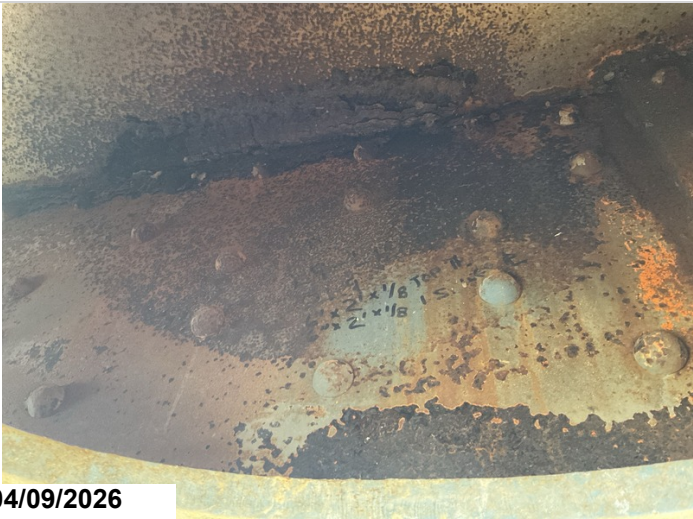
Span 11, Truss 1, Lower Chord, PP9, Ahead: Active corrosion with laminating rust along the top flange. 2LF CS3 corrosion.

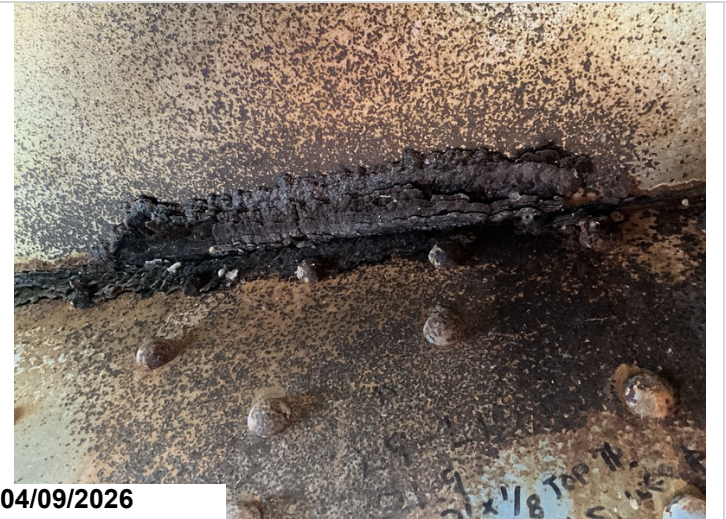
Span 11, Truss 1, Lower Chord, PP9, Ahead: Active corrosion with laminating rust along the top flange. 2LF CS3 corrosion.

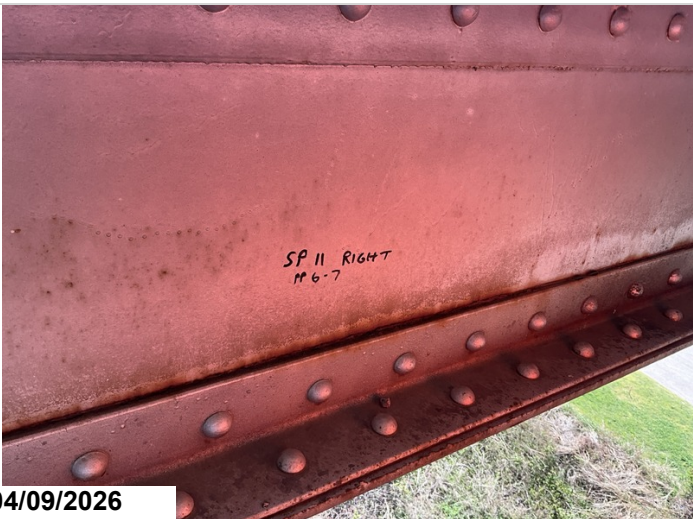
Span 11, Truss 2, Lower Chord, PP6 - PP7: Active corrosion with pack rust between the web and bottom flange angle connection. 8LF CS3 corrosion.

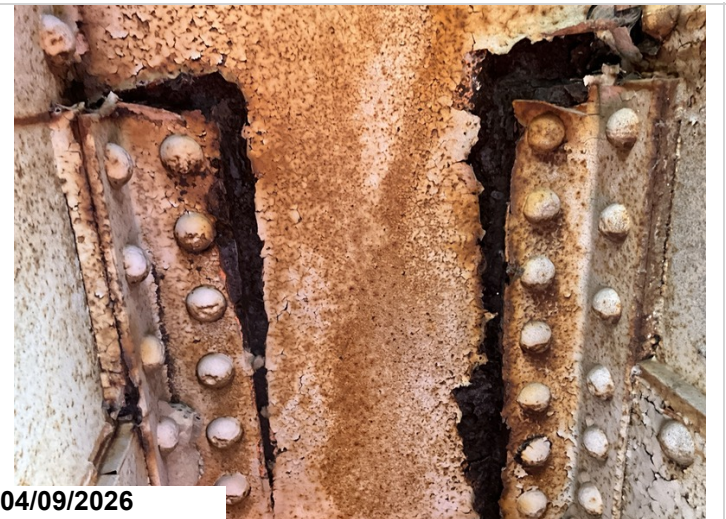
Span 11, Truss 1, Lower chord, PP6: Active corrosion with moderate section loss to the top flange. 3LF CS3 corrosion.

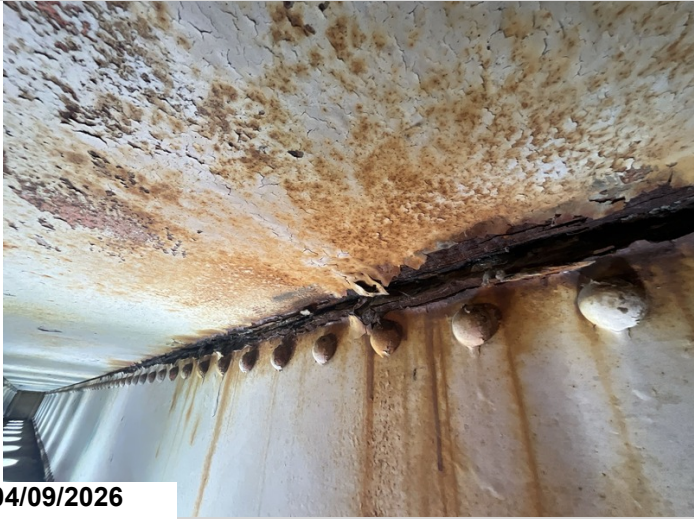
Span 11, Truss 2, Inside of the lower chord, PP4, Back: Active corrosion with pack rust and between the web and top flange plates. 12LF CS3 corrosion.

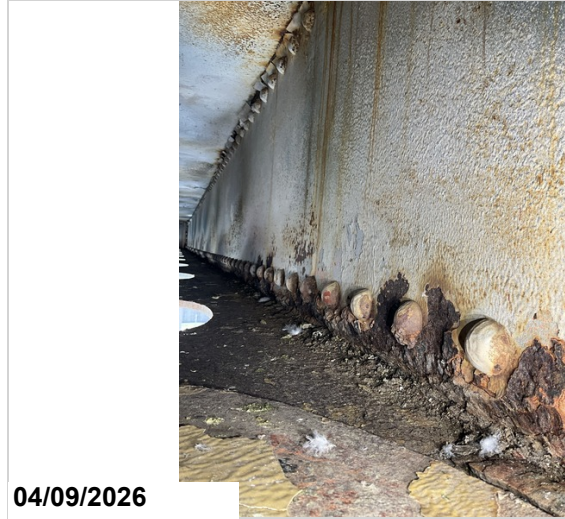
Span 11, Truss 2, Inside of the lower chord, PP6, Back: Active corrosion with moderate section loss to the web near the bottom flange. 8LF CS3 corrosion.

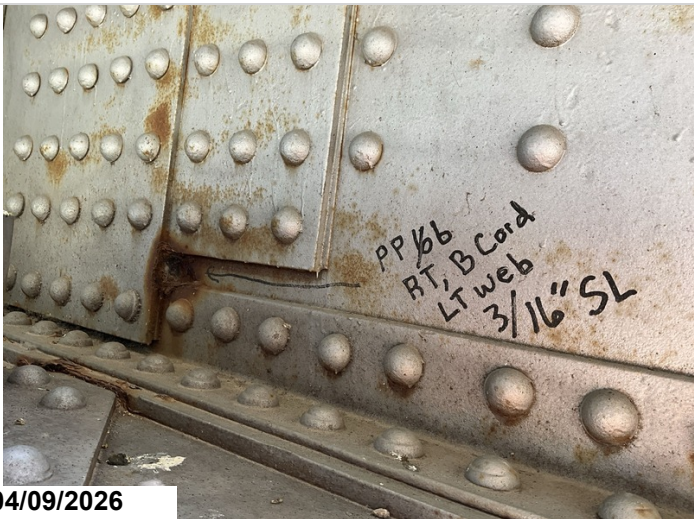
Span 11, Truss 2, Lower Chord, PP6, Back: Active corrosion with section loss up to 3/16" to the web adjacent to the floorbeam connection. 1LF CS3 corrosion.

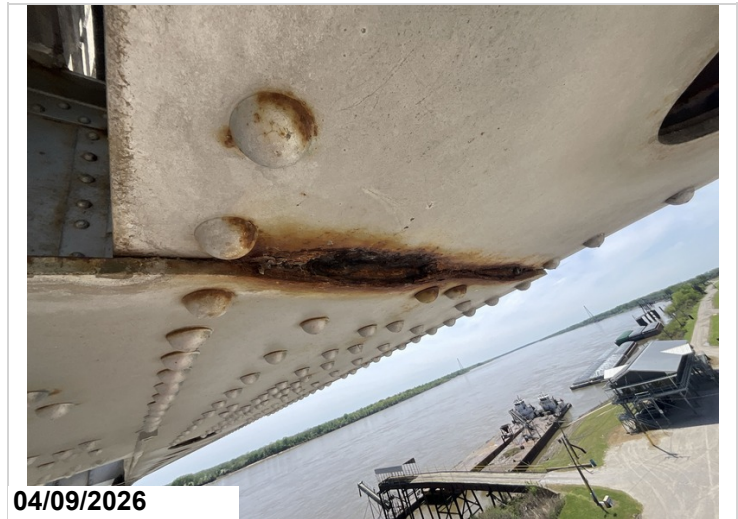
Span 11, Truss 1, Lower Chord, at PP1: Active corrosion with pack rust between the lower chord and the bottom lateral gusset plate. 1LF CS3 corrosion.

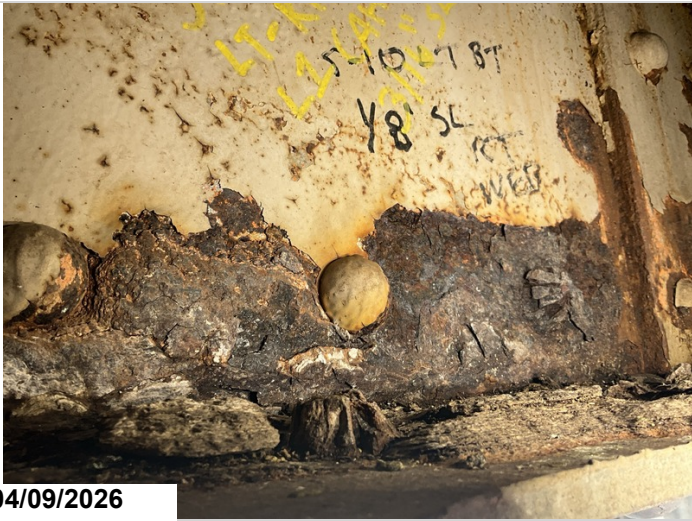
Span 11, Lower Chord, Ahead of PP1: Active corrosion with section loss up to 3/16" to the webs. 2LF CS3 corrosion.

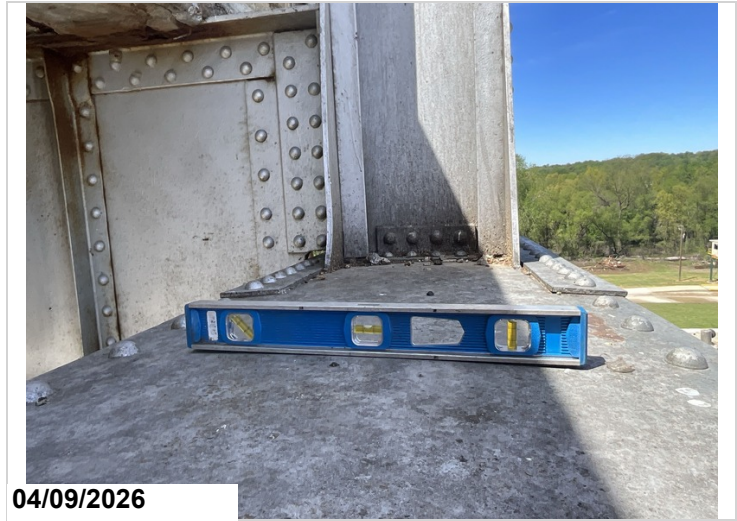
Span 11, Truss 1, Lower Chord: Distortion in the top flange. 10LF CS2 distortion.

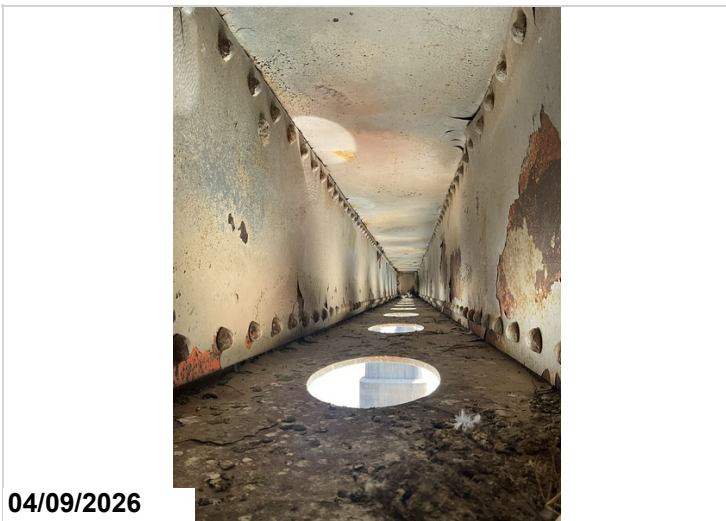
Span 11, Truss 2, PP1: Typical view of inside of lower chord.

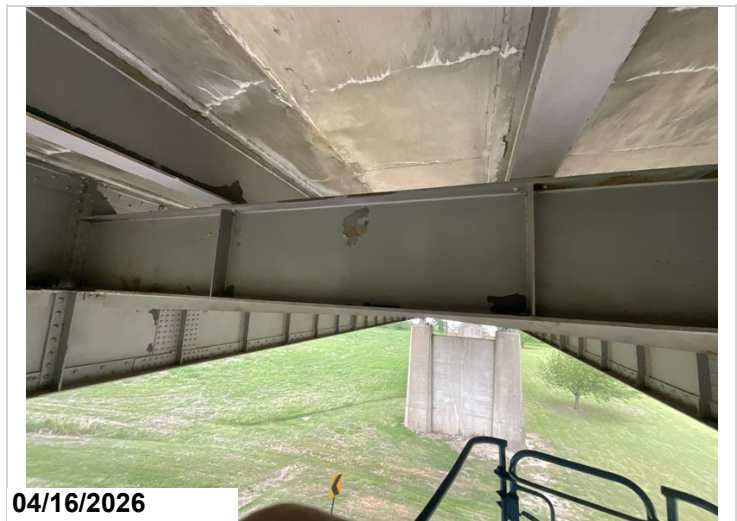
Span 20, Floorbeam 4: Typical minor flaking paint.

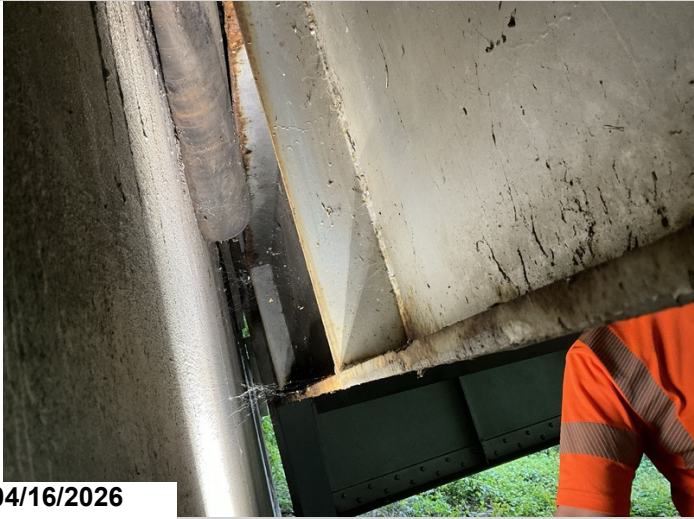
Span 21, Floorbeam 6, Ahead: Active corrosion with section loss approximately up to 5/16" to the bottom flange, between Stringers 1 and 2. 5LF CS3 corrosion.

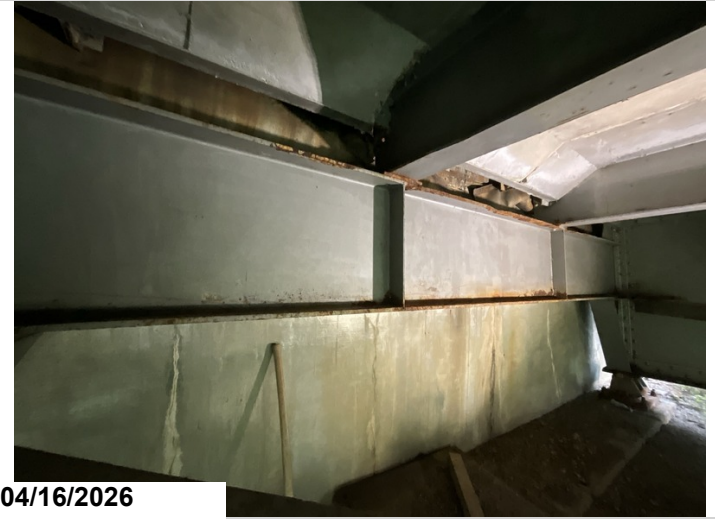
Span 21, Floorbeam 6, Back: Active corrosion with section loss up to 1/2" to the top flange, adjacent to both Stringers 1 and 2. 8LF CS3 corrosion.

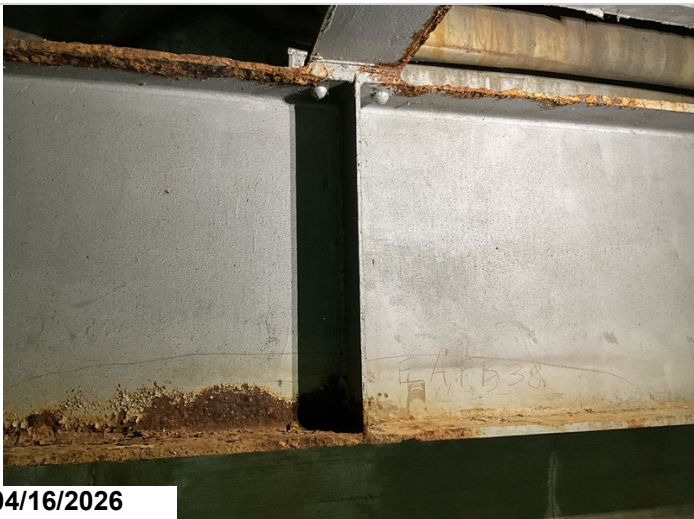
Span 21, Floorbeam 6, Back: Active corrosion with section loss up to 1/2" to the top flange, adjacent to both Stringers 1 and 2. 8LF CS3 corrosion.
