## Bridge 02899 Inspection Report

Arnold Road ID:54x49x11xA, Arnold Log mile:0.569

# National Bridge Inventory Data Sheet

| IDENTIFICATION | |
|---|---|
| (7) Facility Carried | US 49- Phillips Co |

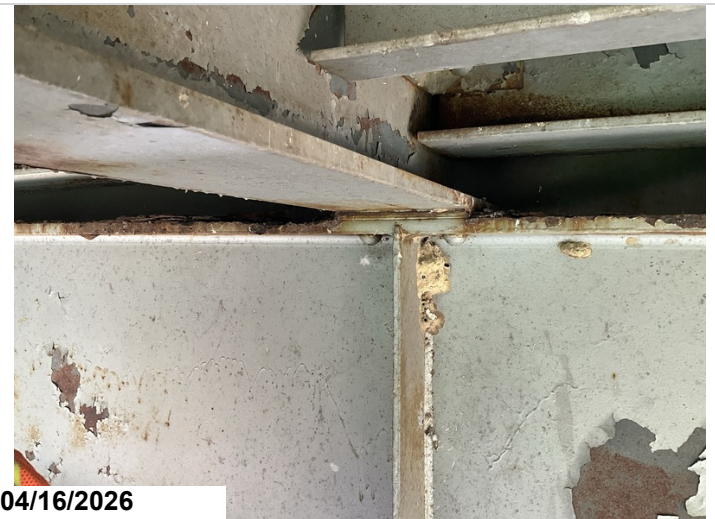
Span 16, Floorbeam 1, Ahead, Adjacent to stiffener 2: Active corrosion with section loss up to 3/8" to top flange and section loss up to 1/4" to bottom flange in same location. 5LF CS3 corrosion.

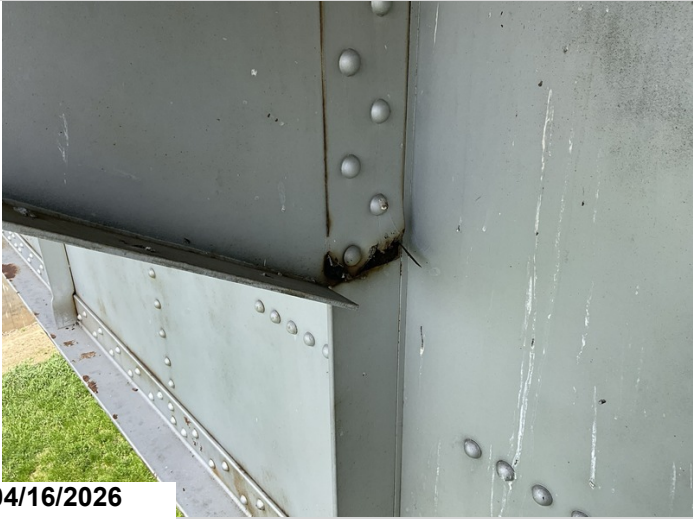
Span 17, Floorbeam 5, Girder 2, Cantilever: Active corrosion to the filler plate that is on the outside of the connection. 1LF CS3 corrosion.

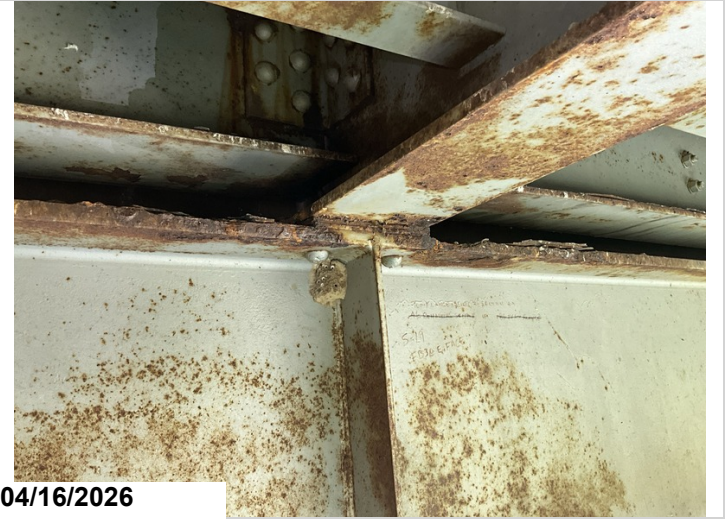
Span 19, Floorbeam 3, Ahead, Stiffener 2: Active corrosion with up to 3/8" section loss in the Top Flange. 4 LF CS3 corrosion.

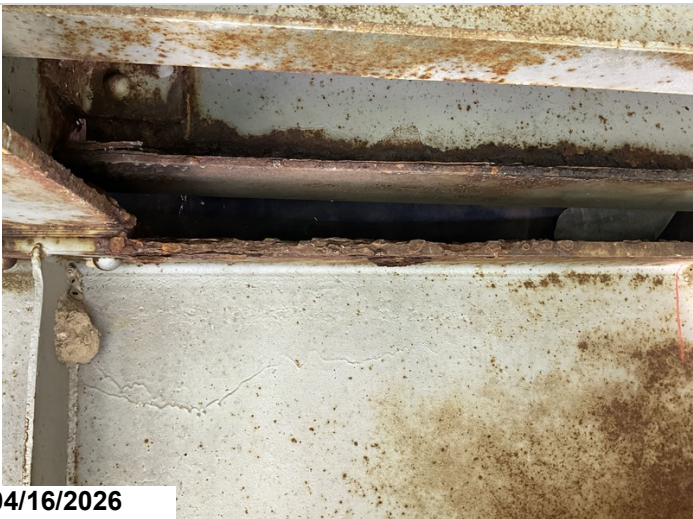
Span 19, Floorbeam 2, Back, Right of Stiffener 2: Active corrosion with up to 1/4" section loss in the Top Flange. 3 LF CS3 corrosion.

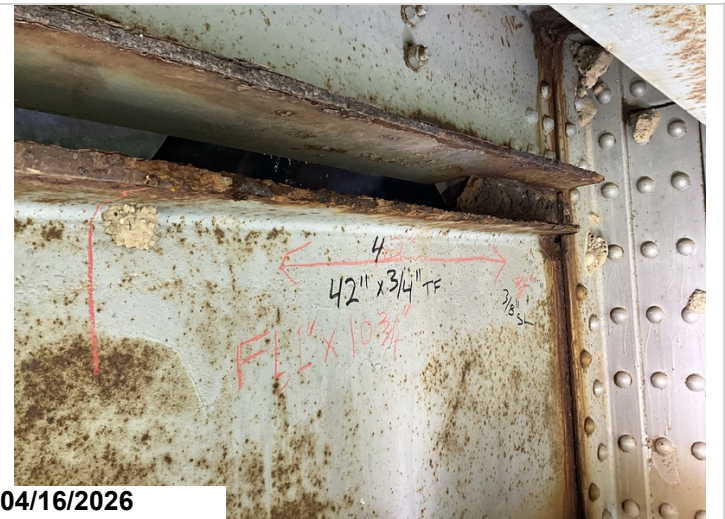
Span 19, Floorbeam 2, Back, Right: Active corrosion with section loss to the top flange down to a knives edge remaining for a 42" X 3/4" area, along with active corrosion with section loss up to 3/8" to the upper web. 5LF CS3 corrosion.

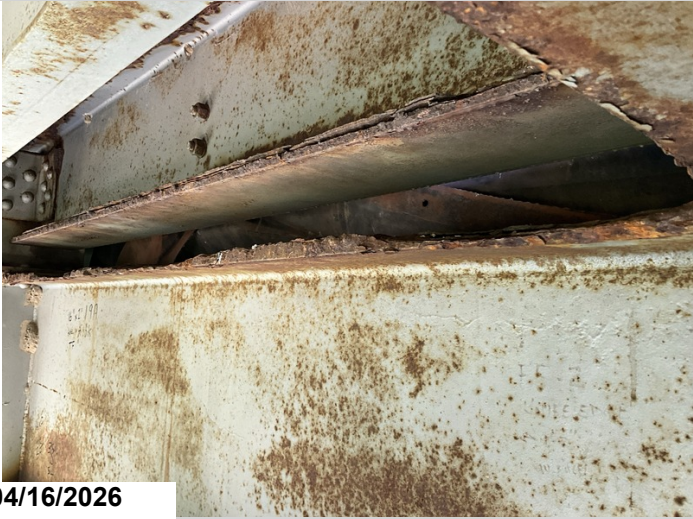
Span 19, Floorbeam 2, Back, Left of Stiffener 2: Active corrosion down to knife edge in the Top Flange. 6 LF CS3 corrosion.

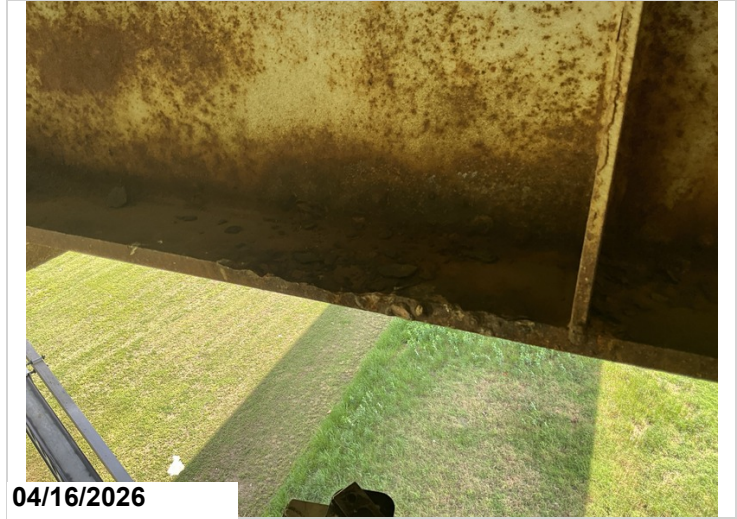
Span 19, Floorbeam 2, Back, Left of Stiffener 2: Active corrosion with section loss up to 3/8" to the Bottom Flange. 2LF CS3 corrosion.

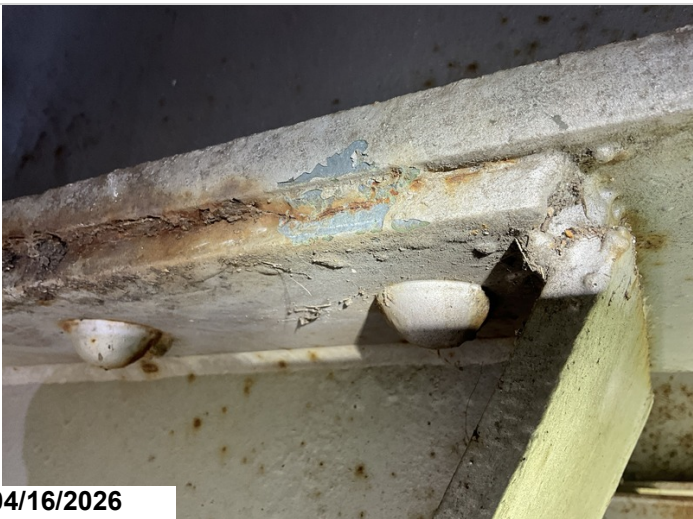
Span 19, Floorbeam 3, Back, Left: Cracked tack weld at the bottom flange to knee brace connection, fully arrested. 1LF CS2 crack.

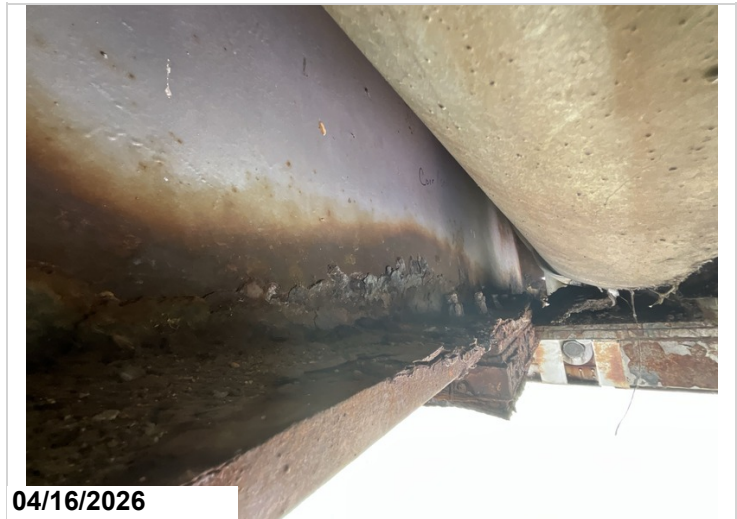
Span 19, Floorbeam 3, Back, Above Windlock: Severe corrosion to the web and bottom flange above the windlock area. 10LF CS3 corrosion.

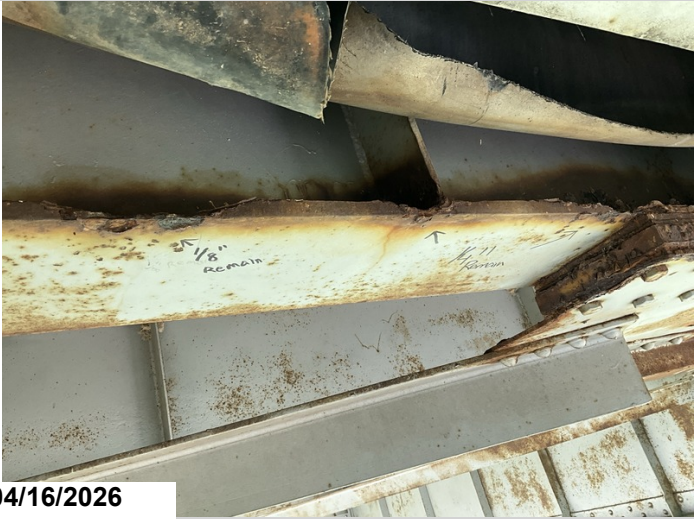
Span 19, Floorbeam 3, Back, Adjacent to Stiffener 1: Active corrosion with section loss with as little as 1/8" remaining to the bottom flange. 5LF CS3 corrosion.

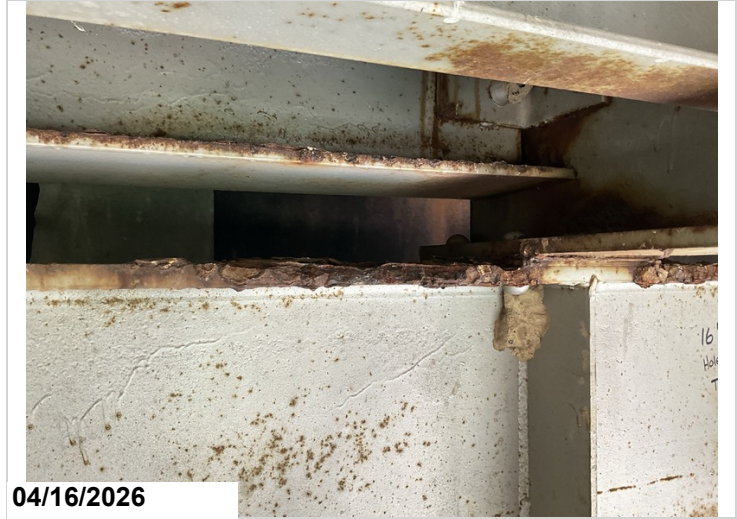
Span 19, Floorbeam 2, Back, Adjacent to Stiffener 1: Active corrosion with section loss up to 3/8" to the top flange. 2LF CS3 corrosion.

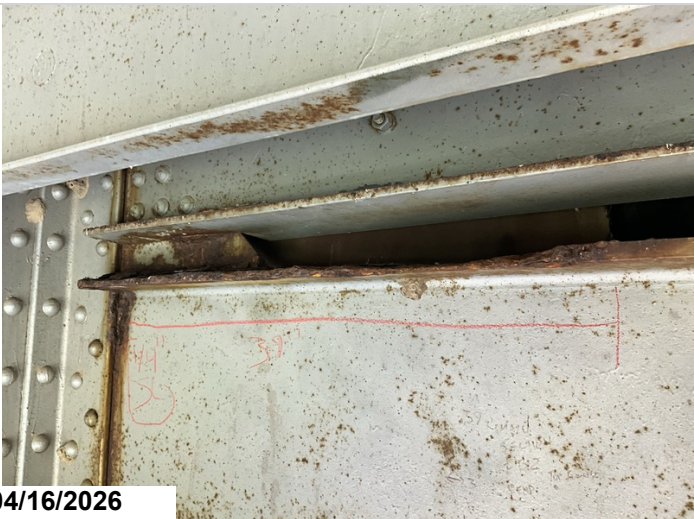
Span 19, Floorbeam 2, Back, Left: Active corrosion with section loss with as little as a knives edge remaining to the top flange for 39". 4LF CS3 corrosion.

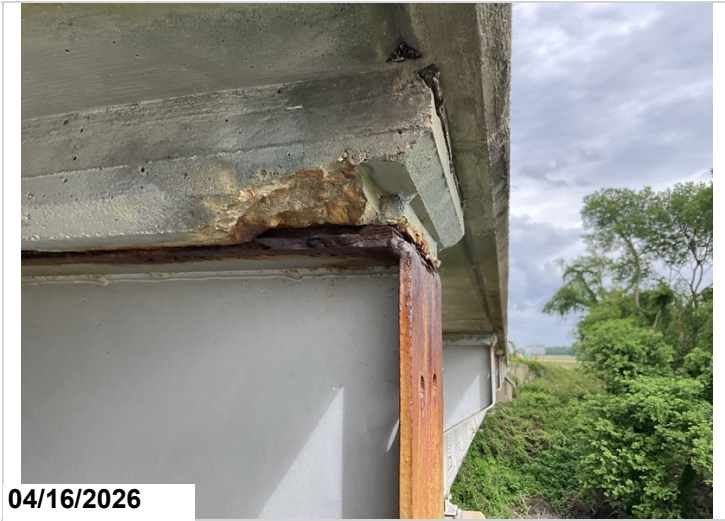
Span 19, Floorbeam 2, Back, Left: Active corrosion with section loss up to 1/4" to the web. 1LF CS3 corrosion.

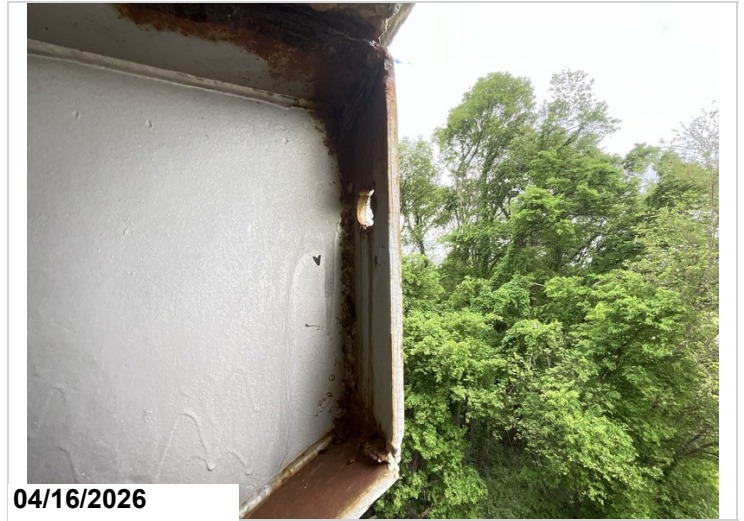
Span 20, Cantilever Floorbeam sections: Typical Active corrosion with pack rust up to 3/8".

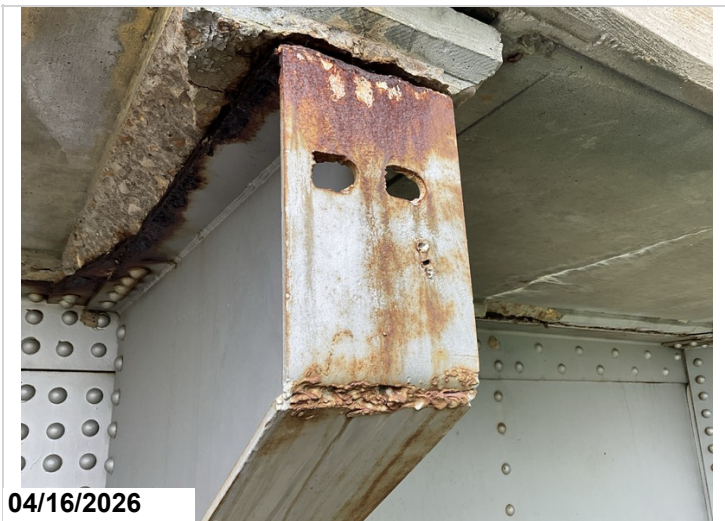
Typical poor quality welds along cantilever Floorbeam sections.

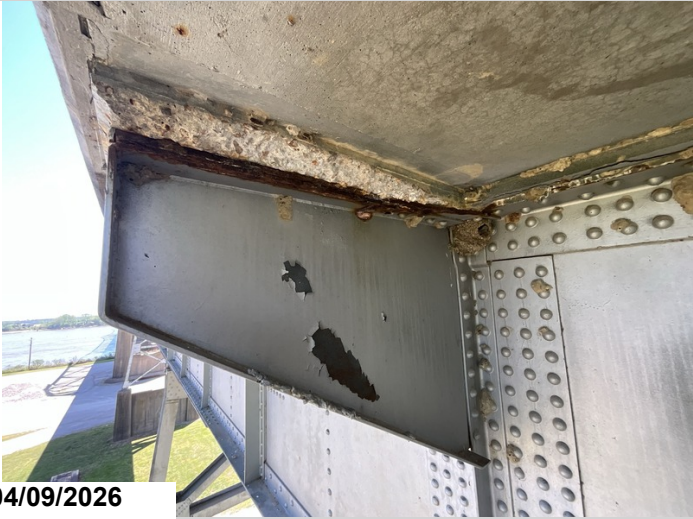
Span 7, Right Cantilever on Ahead side of Pin and Hanger Assembly: Typical active corrosion at the Pin and Hanger locations. CS3 corrosion.

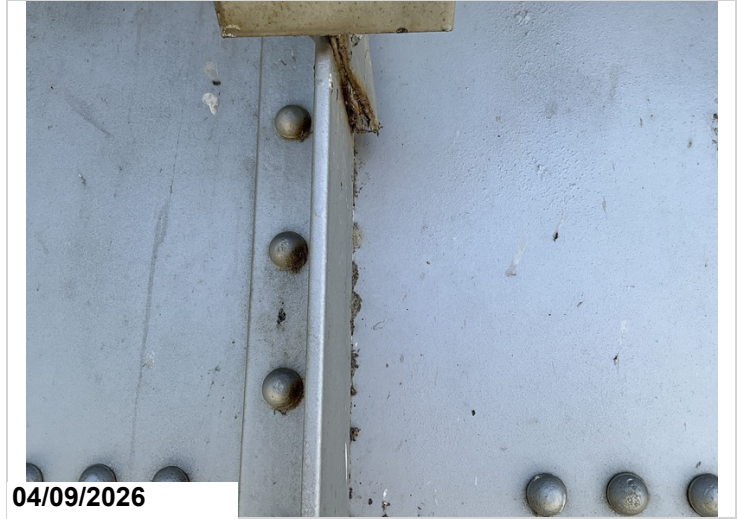
Span 8, Left Cantilever Sections: Active corrosion with pack rust between the top flange of the cantilever sections and the deck. Typical defect throughout the structure. CS3 corrosion.

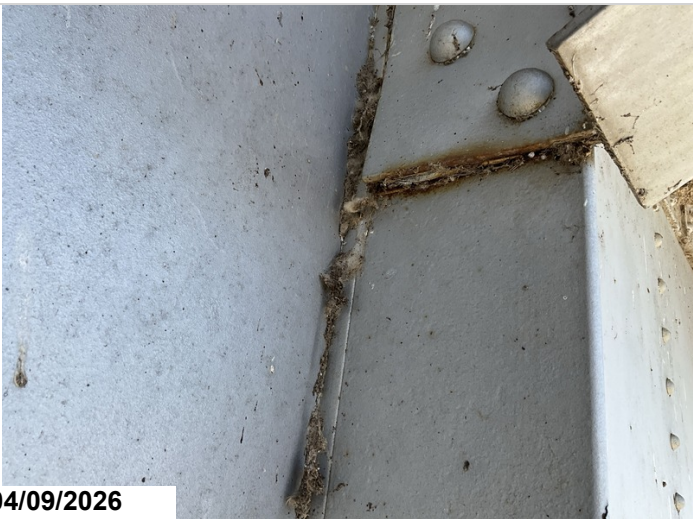
Span 8, Floorbeam 5, Right Cantilever: Active corrosion with pack rust up to 7/8" between Floorbeam web and Girder stiffener. 1LF CS3 corrosion.

Span 8, Floorbeam 6, Right Cantilever: Active corrosion with pack rust up to 3/4" between Floorbeam web and Girder stiffener. 1LF CS3 corrosion.

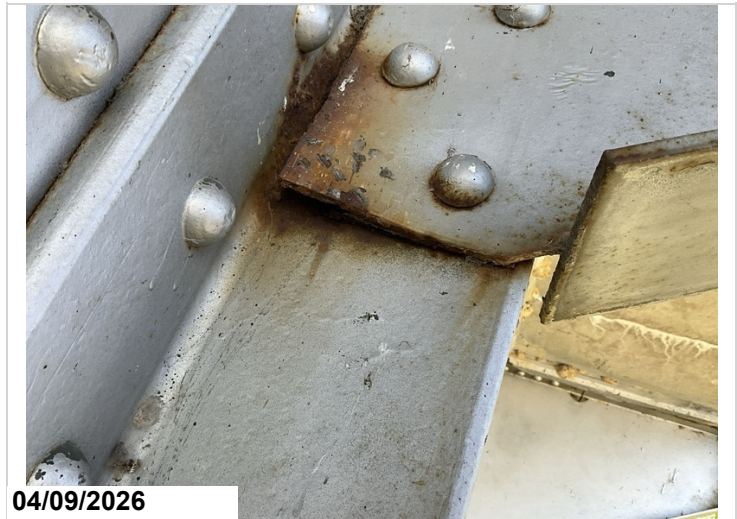
Span 9, Floorbeam 2, Right Cantilever: Active corrosion with pack rust up to 1/2" between Floorbeam web and Girder stiffener. 1LF CS3 corrosion.

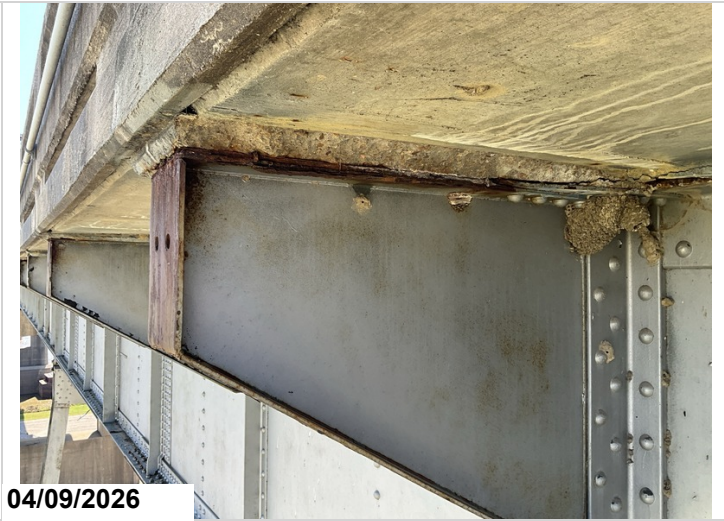
Span 9, Floorbeam 1, Left Cantilever: Active corrosion with pack rust up to 1" at the Floorbeam to girder stiffener connection. 1LF CS3 corrosion.

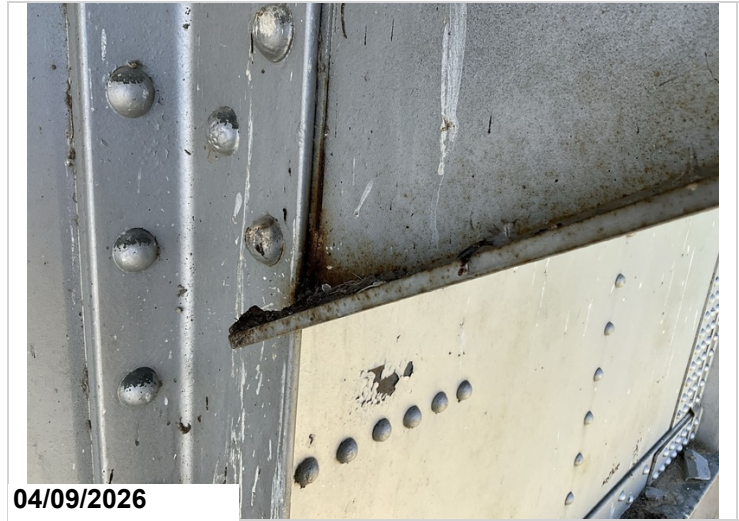
Span 9, Floorbeam 5, Left, Cantilever: Active corrosion with pack rust up to 1/2" between Top Flange of Floorbeam and the deck. 3LF CS3 corrosion.

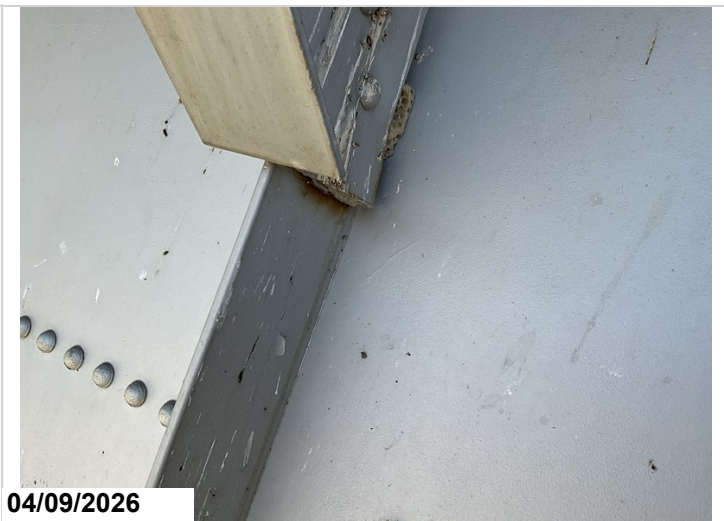
Span 9, Floorbeam 4, Left Cantilever: Cracked tack weld, fully arrested. 1LF CS2 crack.

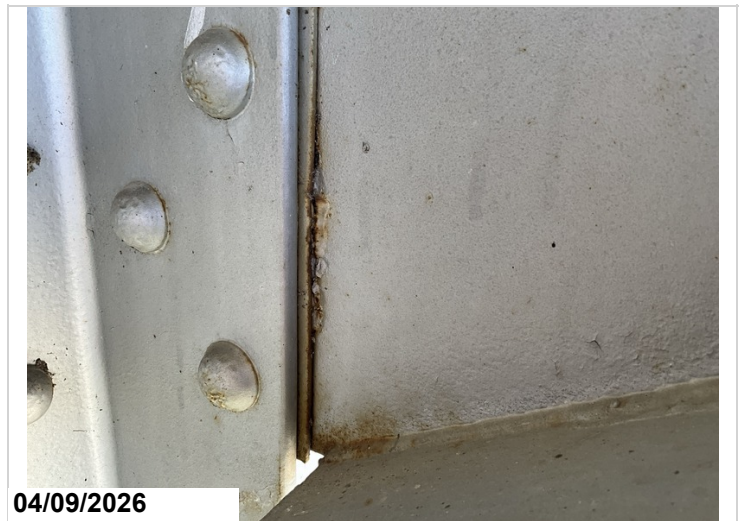
Span 9, Floorbeam 6, Right Cantilever: Active corrosion with pack rust up to 3/4" between Floorbeam web and girder stiffener. 1LF CS3 corrosion.

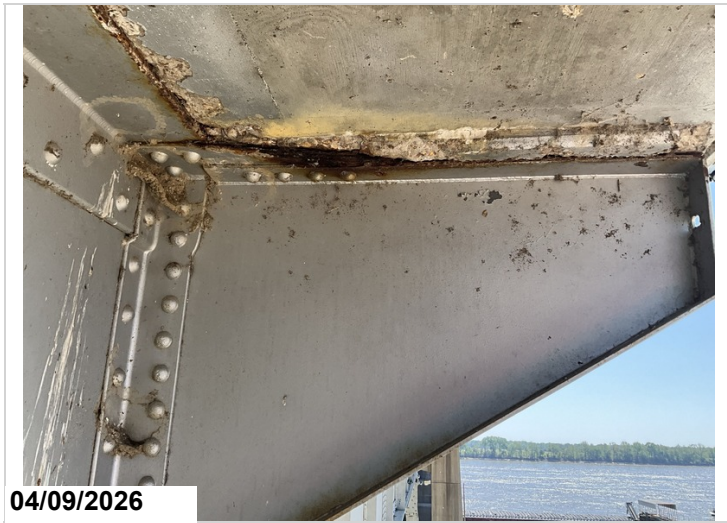
Span 9, Floorbeam 6, Right Cantilever: Self arrested cracked tack weld. 1LF CS2 crack.

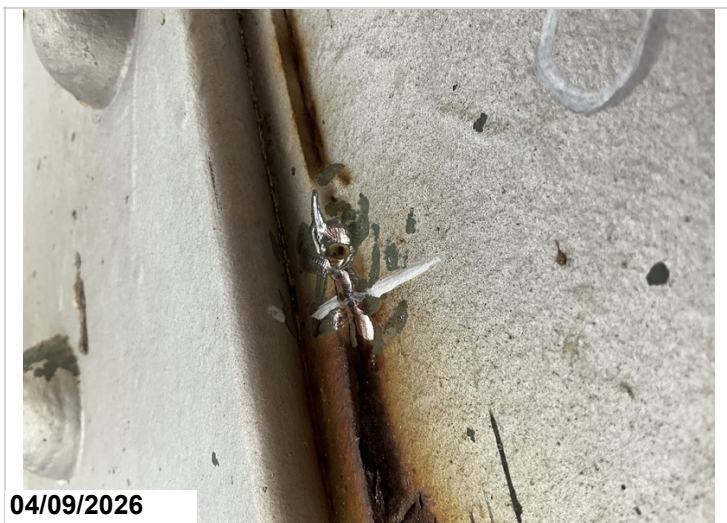
Span 10, Floorbeam 3, Left Cantilever: 3/8" crack in the bottom tack weld at the girder stiffener plate. 1LF CS3 crack.

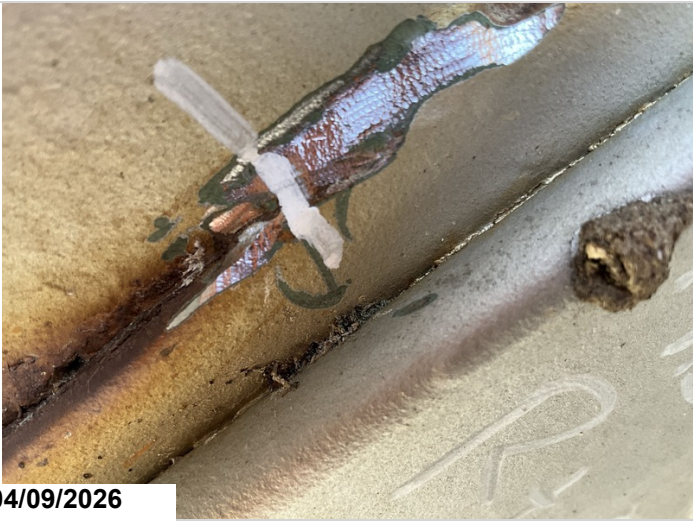
Span 10, Floorbeam 2, Right Cantilever: 1/4" crack in the bottom tack weld at the girder stiffener plate. 1LF CS3 crack.

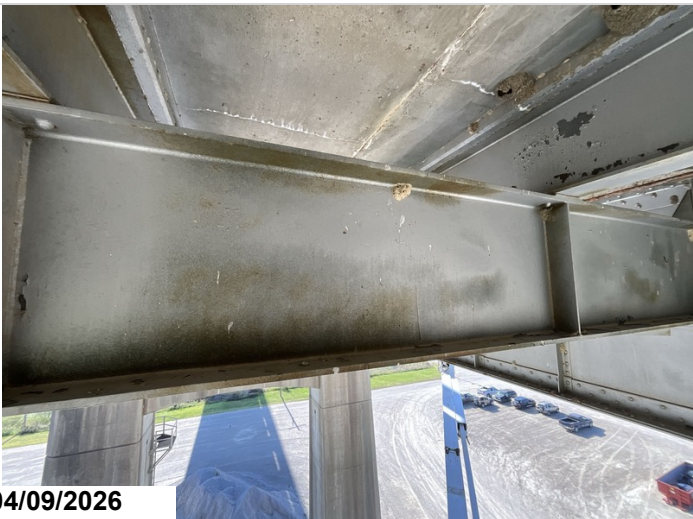
Span 10, Right Cantilever Floorbeam ahead of Floorbeam 5: Typical Active corrosion with flaking rust along the Top Flange. CS3 corrosion.

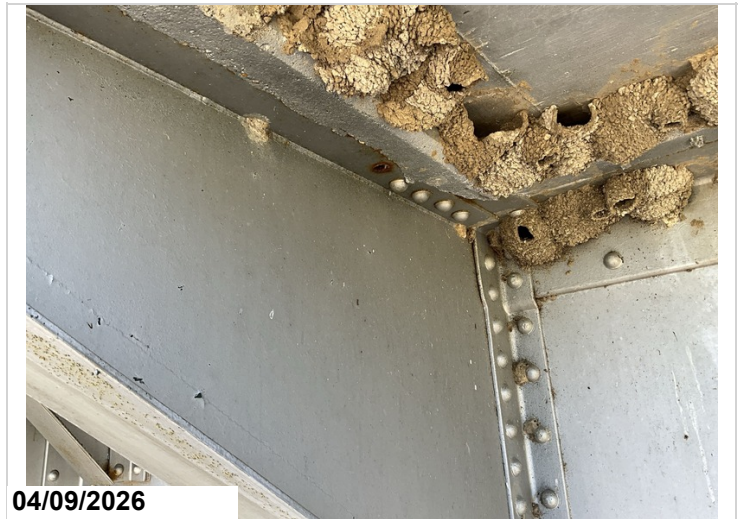
Span 10, Floorbeams: Active corrosion with surface rust along web and flanges. CS2 corrosion.

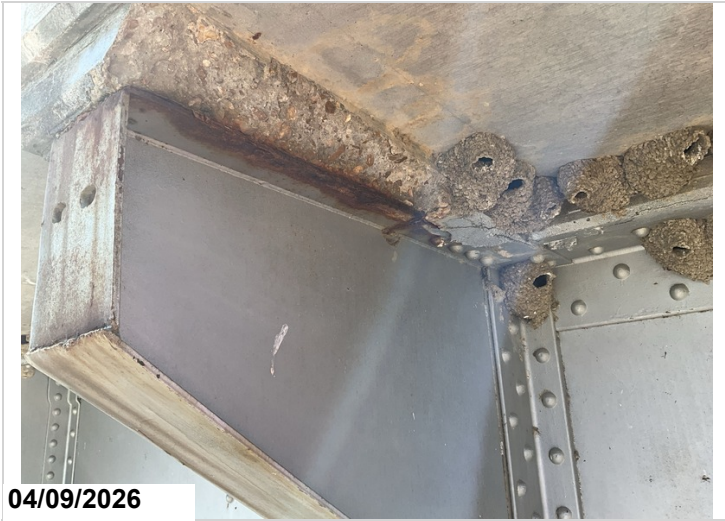
Span 10, Left, Second to last cantilever section before Floorbeam 6: Missing rivet. 1LF CS2 connection.

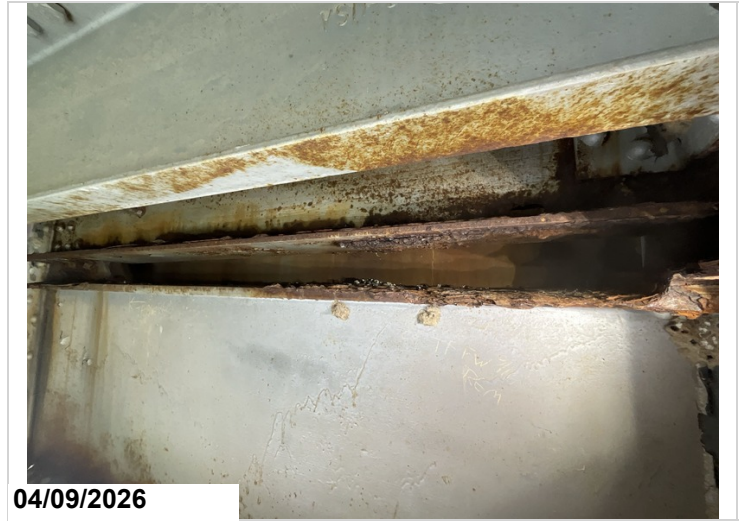
Span 10, Left Cantilever Floorbeam sections: Typical corrosion along the Top Flange.

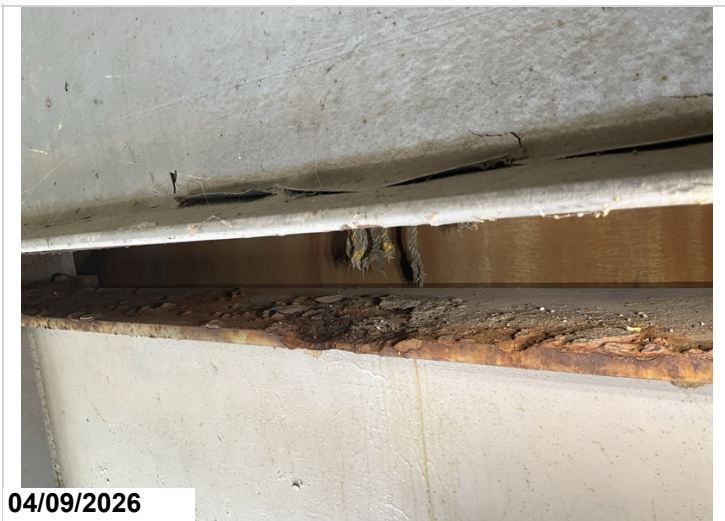
Span 7, Floorbeam 7, Ahead, Adjacent to Stringer 2: Active corrosion with section loss to the top flange. 6LF CS3 corrosion.

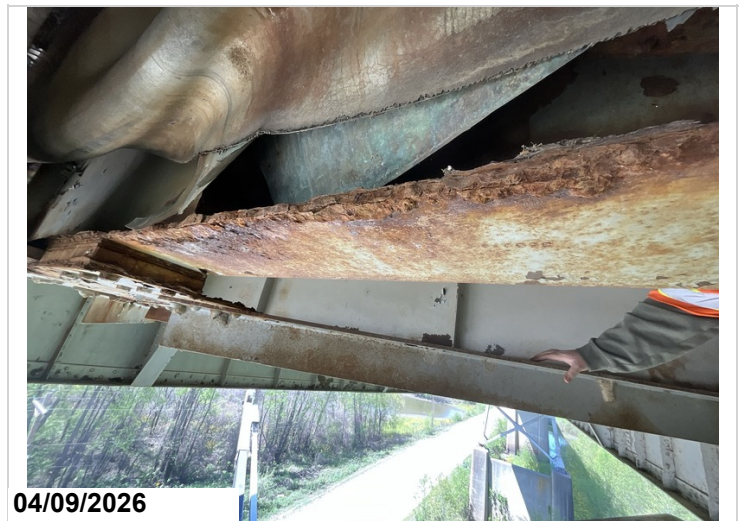
Span 7, Floorbeam 7, Near Centerline: Active corrosion with moderate section loss to the top flange. 4LF CS3 corrosion.

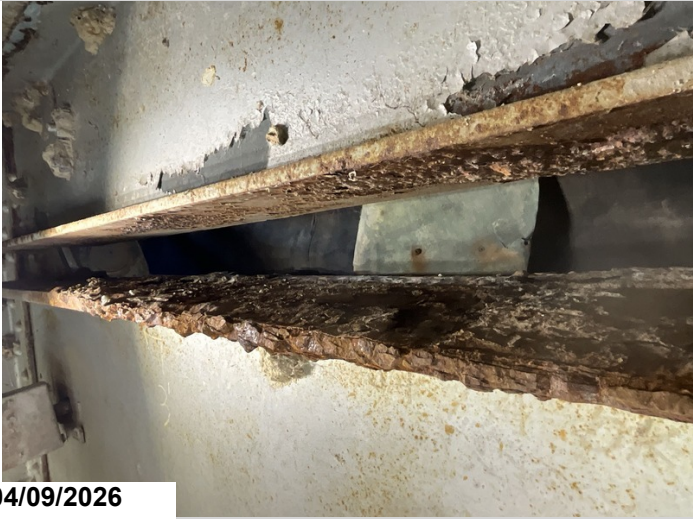
Span 7, Floorbeam 6, Left of Windlock: Moderate to heavy corrosion along the bottom flange. 4LF CS3 corrosion.

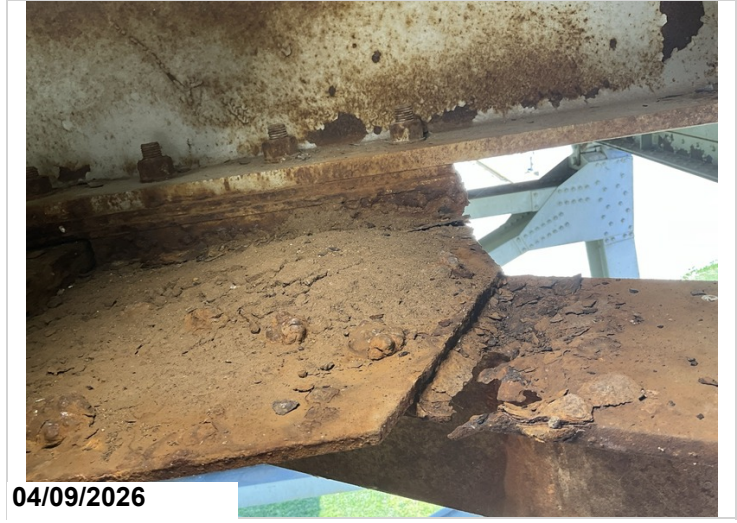
Span 7, Floorbeam 6, Left: Active corrosion with section loss to the top flange. 6LF CS3 corrosion.

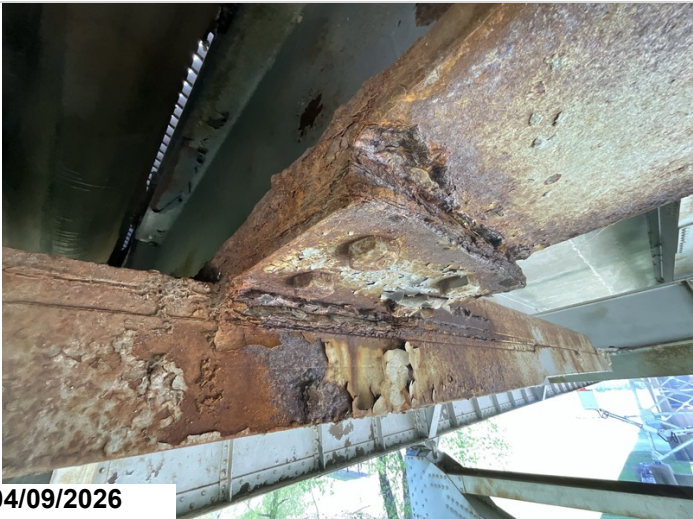
Span 7, Back of Floorbeam 6, Right: Active corrosion with a 3 1/2" hole in the cross bracing.

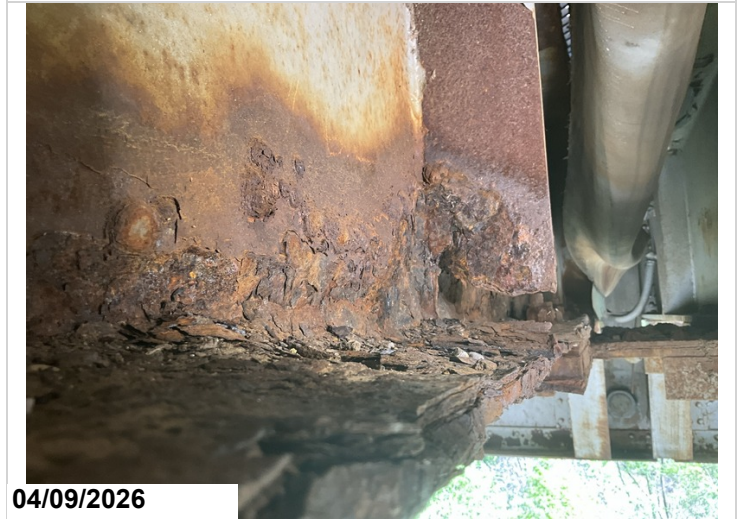
Span 7, Floorbeam 7, Right of Windlock, Bottom Flange:  
Active corrosion with section loss up to 3/8". 1LF CS3 corrosion.

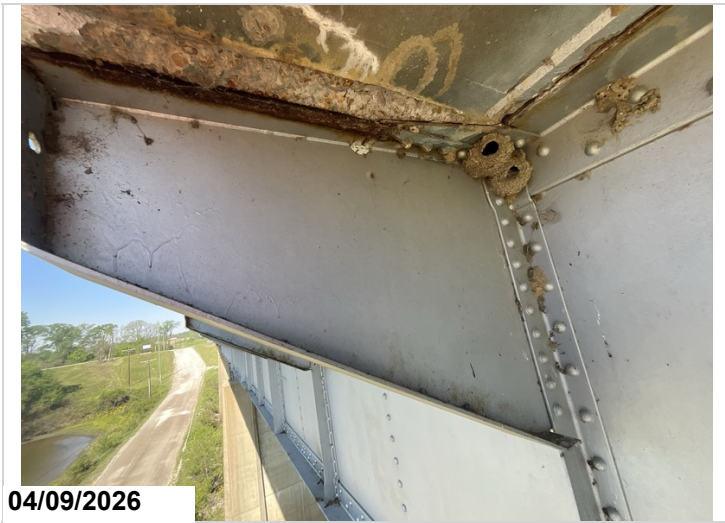
Span 7, Floorbeam 6, Ahead: Active corrosion with section loss up to 1/4" to the web, knives edge section remaining to the bottom flange, and a 4 1/2" X 3" Hole in Stiffener 2. 6LF CS3 corrosion.

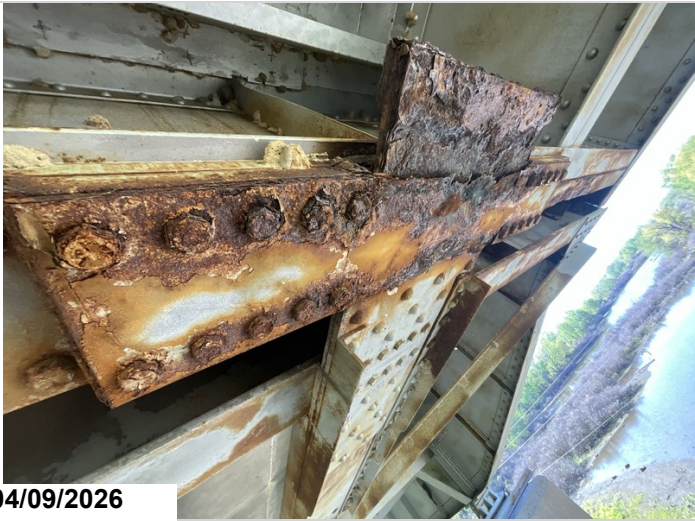
Span 4, Cross-Girder, Back of Assembly Joint: Active corrosion with a 2" X 1" hole in the Bottom Flange along with a 12" area of the bottom flange at a knives edge remaining thickness. 2LF CS4 corrosion.

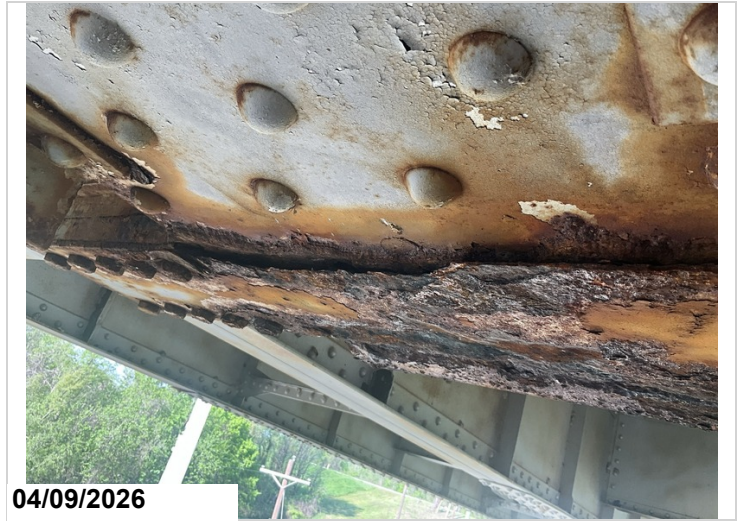
Span 4, Windlock: Moderate to Heavy corrosion.

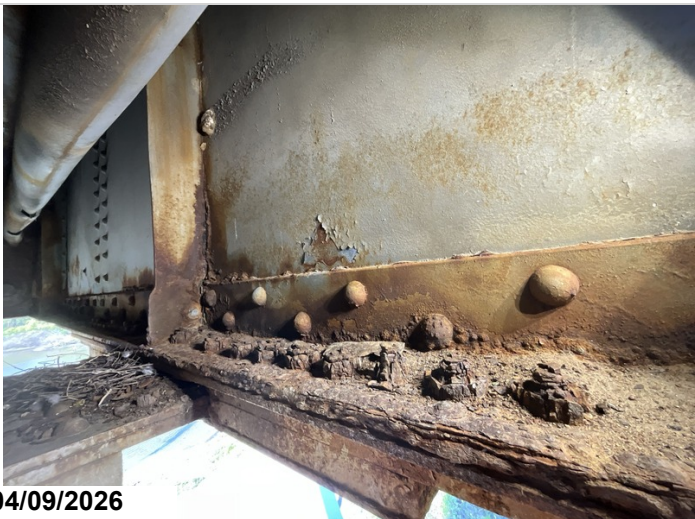
Span 4, Windlock: 3/8" bottom plate down th a knife's edge of section remaining. CS3 corrosion.

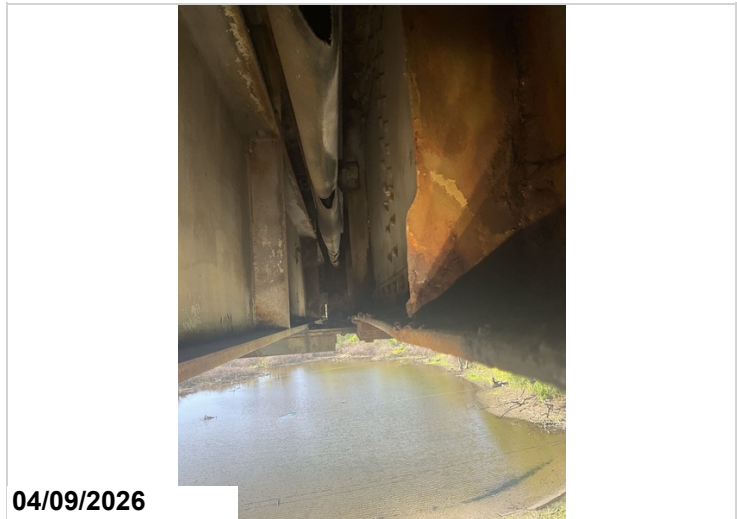
Span 4, Ahead of of Cross-Girder: Active corrosion with flaking rust and moderate section loss to the riveted connections above the windlock. 5LF CS3 corrosion.

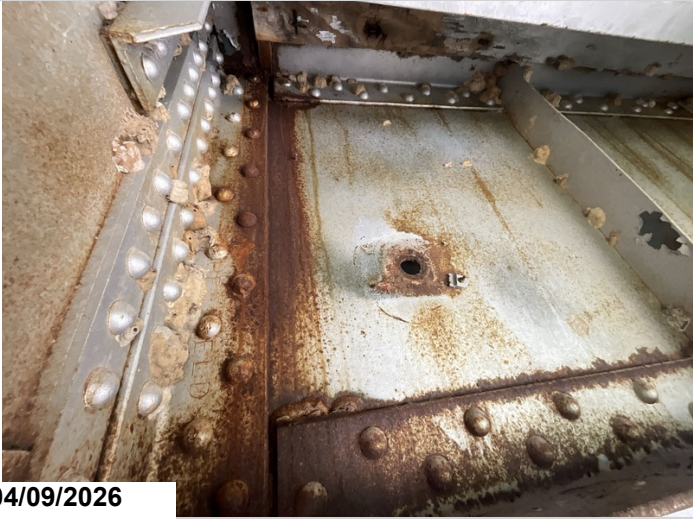
Span 4, Cross-Girder: Minor distortion along the bottom flange. 8LF CS2 distortion.

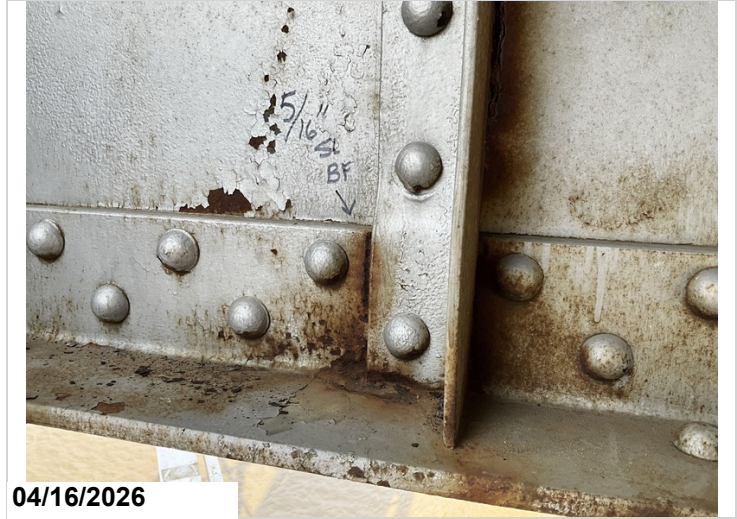
Span 4, Cross-Girder, Back, Adjacent to Girder 1: Active corrosion with pack rust between the web and the flange angles. 1LF CS3 corrosion.

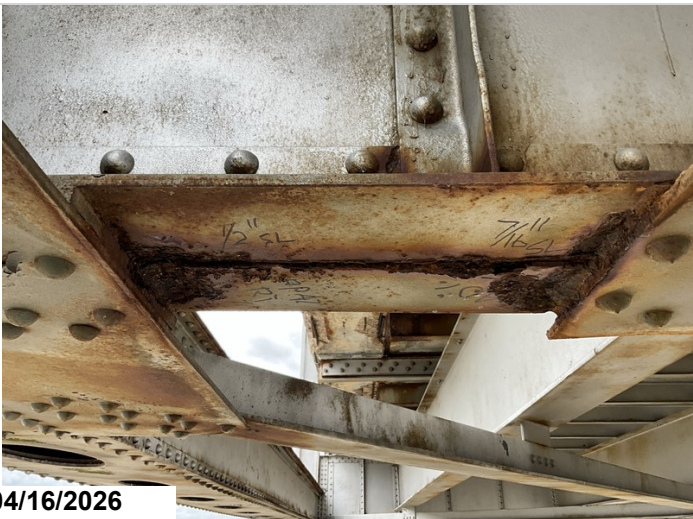
Span 13, Floorbeam 42, Back, Adjacent to Stiffener 1: Active corrosion with section loss up to 5/16" to the bottom flange angle. 1LF CS3 corrosion.

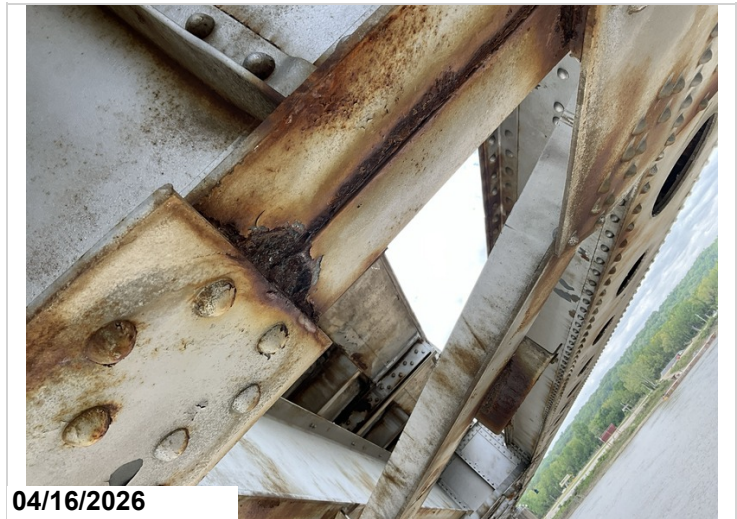
Span 13, Floorbeam 42, Bottom Flange, Right: Active corrosion with section loss ranging from 7/16" - 1/2". 2LF CS3 corrosion.

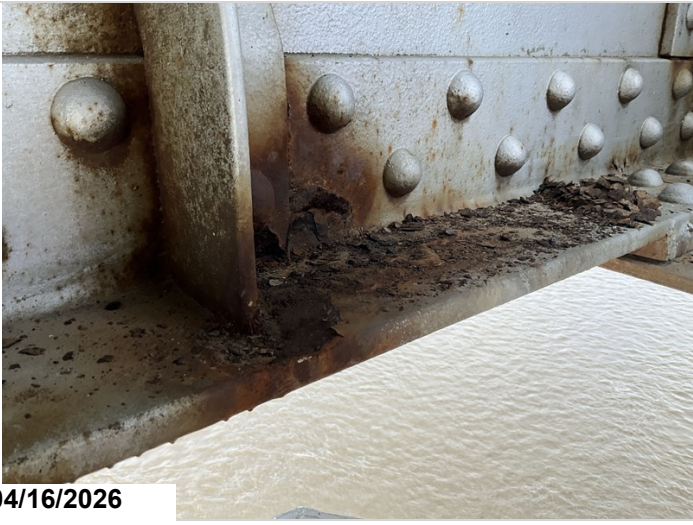
Span 13, Floorbeam 42, Bottom Flange, Left: Active corrosion with section loss up to 1/4". 1LF CS3 corrosion.

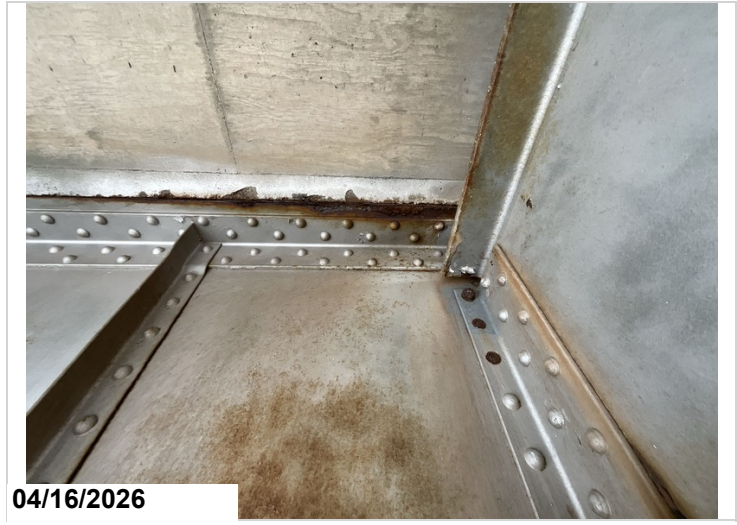
Span 13, Floorbeam 42, Ahead, Left of Stiffener 1: Active corrosion with section loss up to 1/4" to the web to bottom flange angle. 2LF CS3 corrosion.

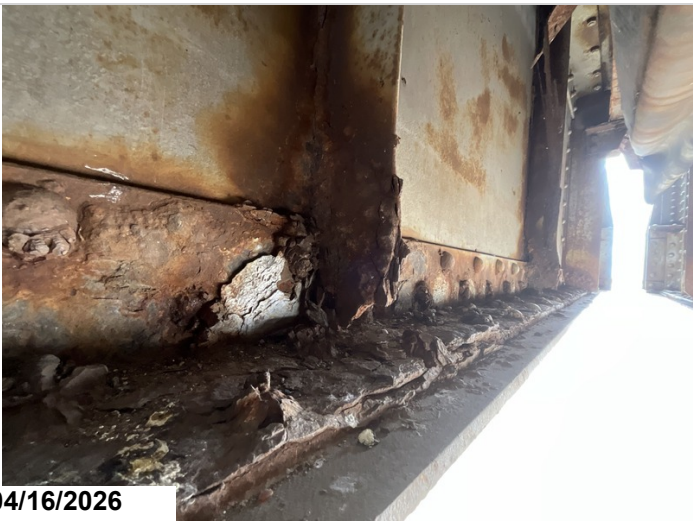
Span 13, Floorbeam 42, Ahead, Top Flange, Right and Left: Active corrosion with flaking rust and pack rust between the top flange and the deck. 8LF CS3 corrosion.

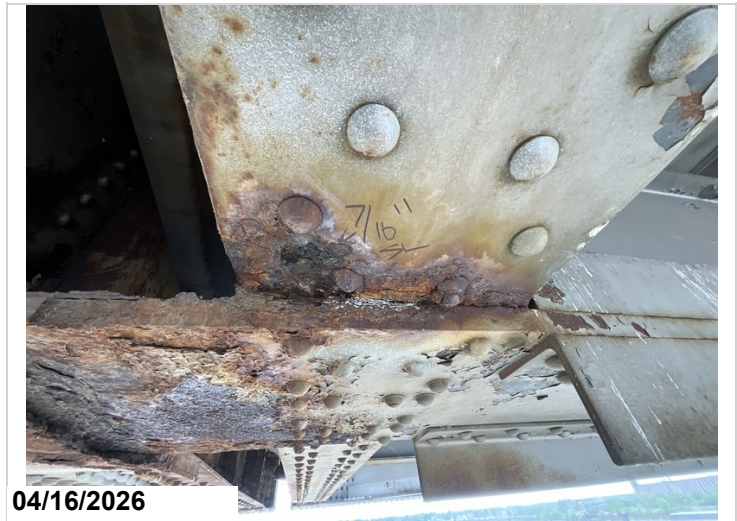
Span 13, Back Floorbeam at PP43, Ahead, Stiffeners 3 - 6: Active corrosion with holes in the stiffeners.

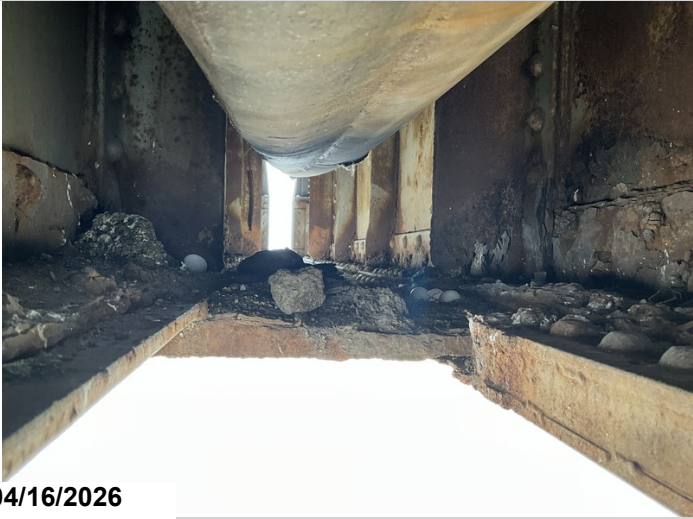
Span 13, Back Floorbeam at PP43, Left of Windlock: Active corrosion with section loss up to 5/16" to Bottom Flange cover plate. 1LF CS3 corrosion.

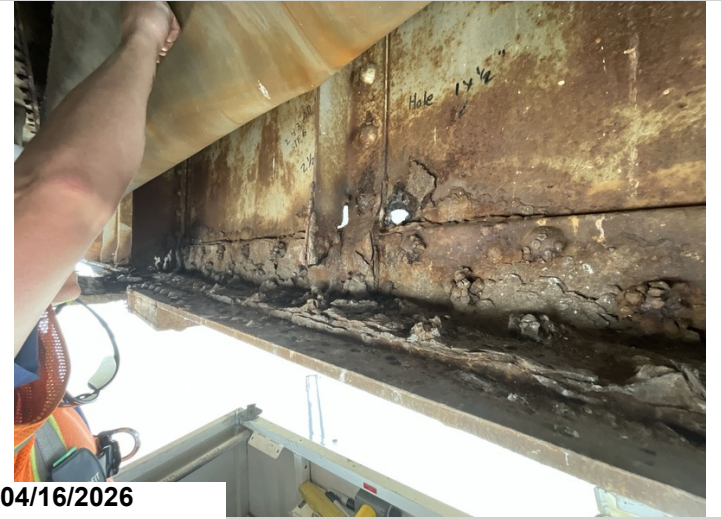
Span 13, Floorbeams at PP43: Active corrosion with moderate to heavy section loss to the flanges and webs. 30LF Per Floorbeam CS3 corrosion. 60LF Total Minus CS4.

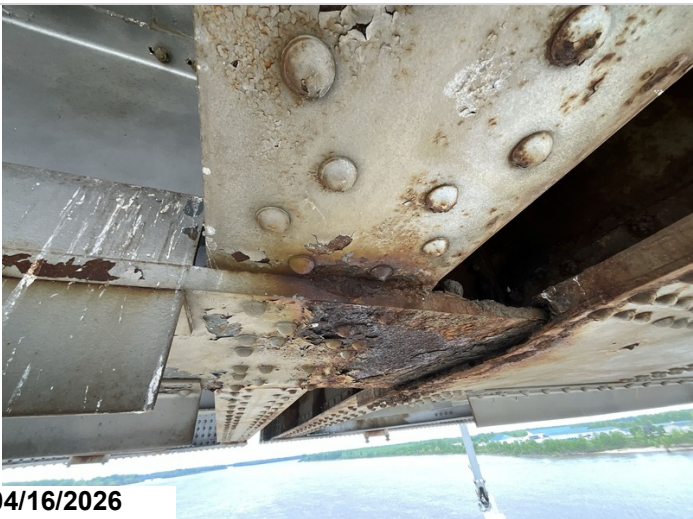
Span 13, Floorbeams at PP43: Active corrosion with moderate to heavy section loss to the flanges and webs. CS3 corrosion.

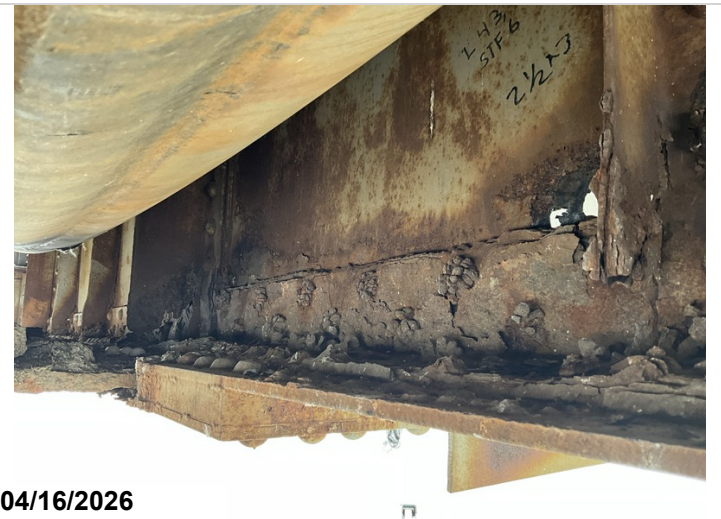
Span 13, Back Floorbeam at PP43, Right of Windlock: Active corrosion with section loss up to 5/16" to Bottom Flange cover plate. 1LF CS3 corrosion.

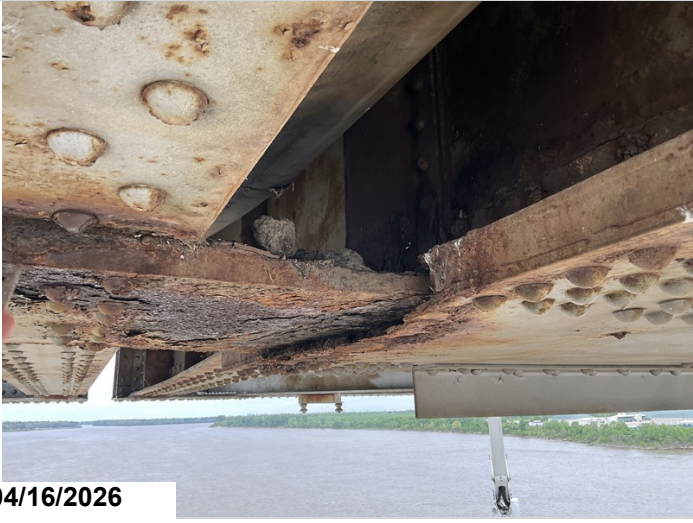
Span 13, Ahead Floorbeam at PP43, Back, Stiffeners 5 - 7: Active corrosion with holes in the stiffeners.

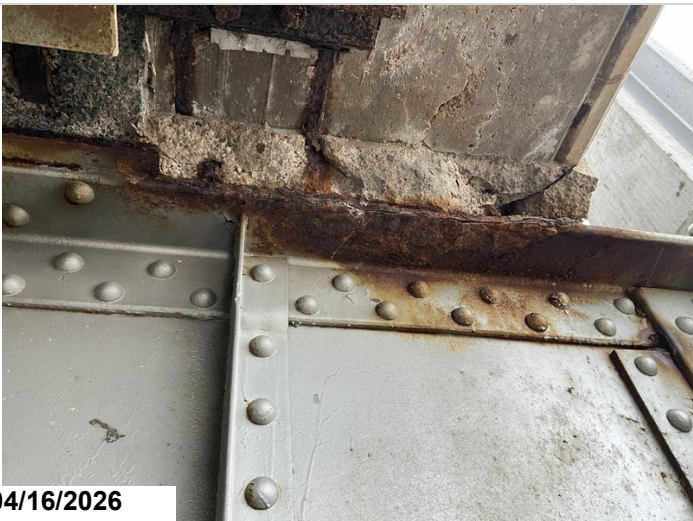
Span 13, Back Floorbeam at PP43, Back, Adjacent to Stiffener 9: Active corrosion with section loss to the web to bottom flange angle up to 3/8". 1LF CS3 corrosion.

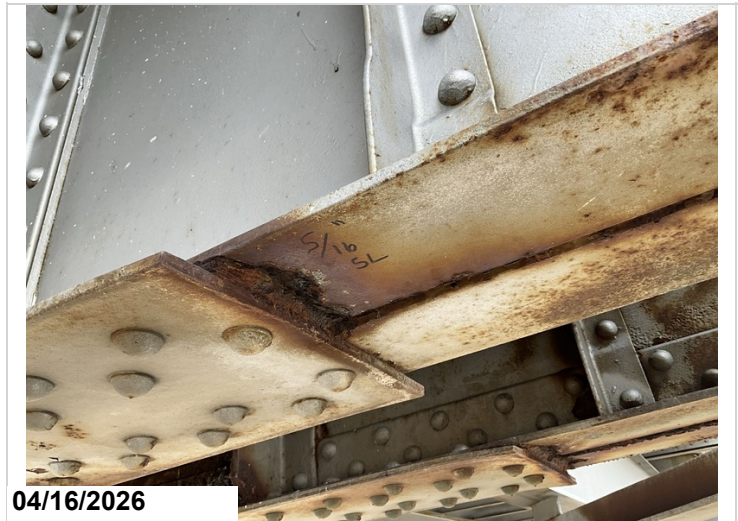
Span 13, Back Floorbeam at PP43, Back, Top Flange, Right: Active corrosion with flaking rust along the Top Flange. 3LF CS3 corrosion.
