## Bridge 02899 Inspection Report

Arnold Road ID:54x49x11xA, Arnold Log mile:0.569

# National Bridge Inventory Data Sheet

| IDENTIFICATION | |
|---|---|
| (7) Facility Carried | US 49- Phillips Co |

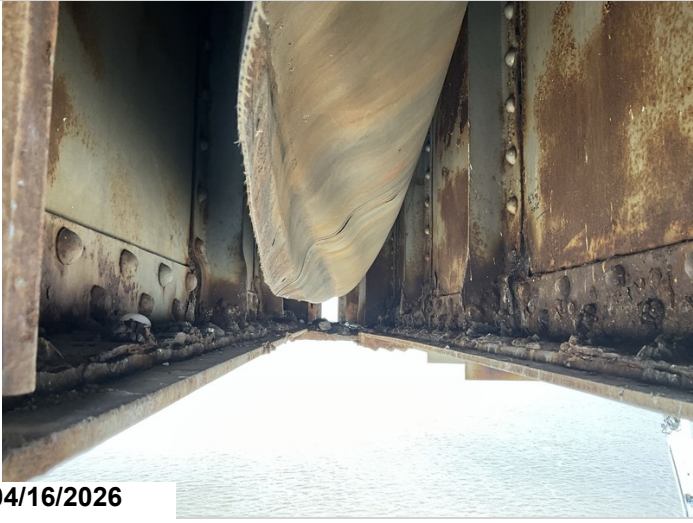
Span 13, Back Floorbeam at PP43, Bottom Flange, Right: Active corrosion with section loss up to 5/16". 1LF CS3 corrosion.

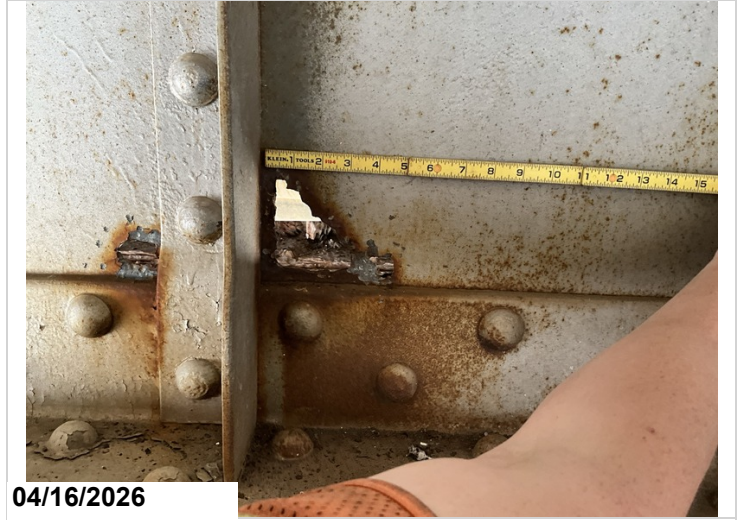
Span 13, Floorbeams at PP43: Active corrosion with moderate to heavy section loss to the flanges and webs. CS3 corrosion.

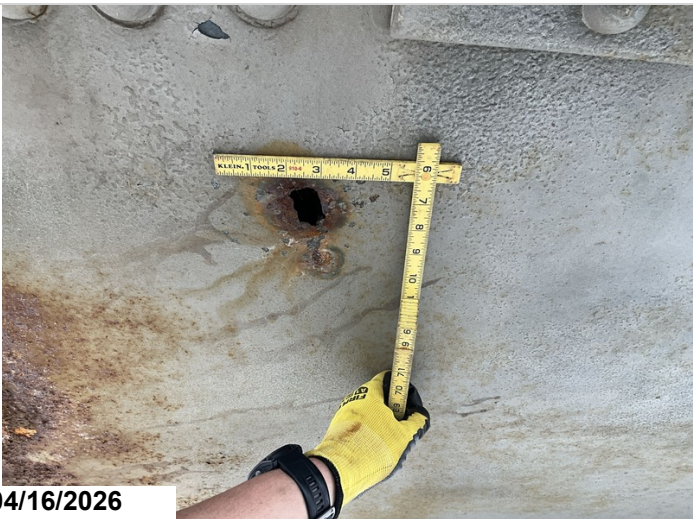
Span 13, Ahead Floorbeam at PP43, Adjacent to Stiffener 6: Active corrosion with a 5" X 4" Hole in the web on the left side of the stiffener and a 1 1/2" X 1" Hole in the web on the right side of the stiffener. 1LF CS4 corrosion.

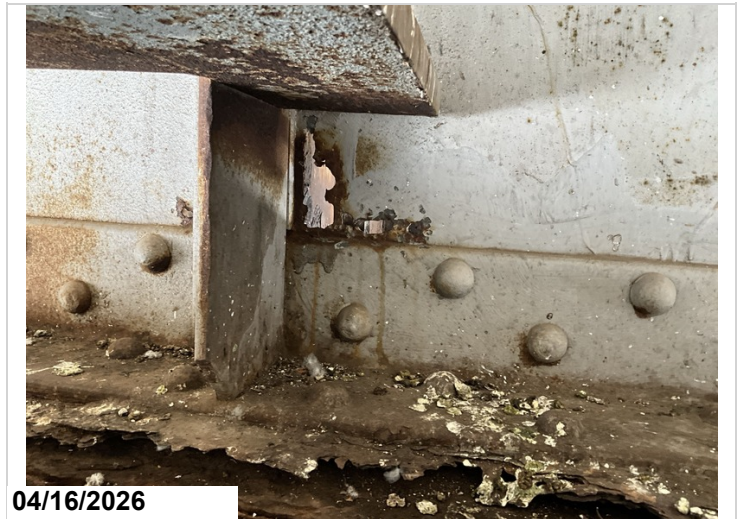
Span 13, PP43, Ahead of Windlock: Hole in lateral Gusset Plate at Windlock to Floorbeam connection.

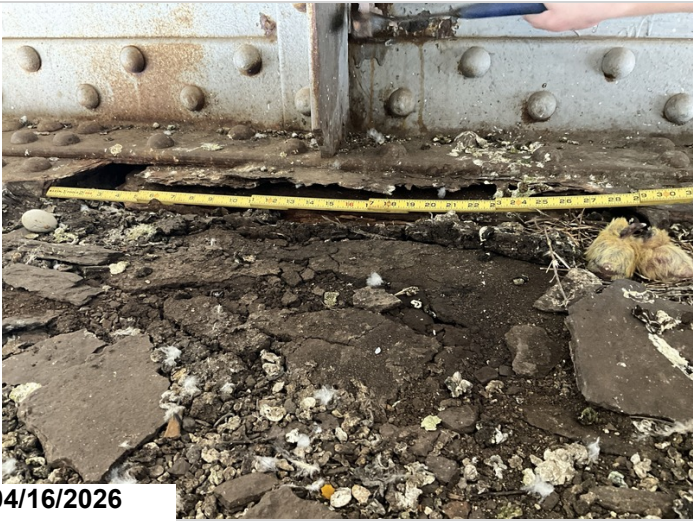
Span 13, Ahead Floorbeam at PP43, Adjacent to Stiffener 5: Active corrosion with a 6" X 5" Hole in the web on the left side of the stiffener. 1LF CS4 corrosion.

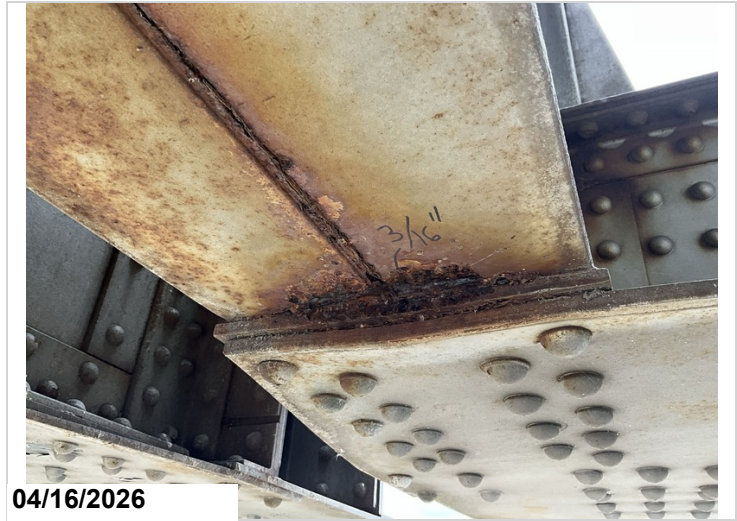
| ELEMENTS | DESCRIPTION | UNITS | TOTAL | CS1 | CS2 | CS3 | CS4 |
|---|---|---|---|---|---|---|---|
| | Span 13, Ahead Floorbeam at PP43, Ahead, Bottom Flange Cover Plate: Active corrosion with a 29" X 4" Hole in the cover plate. 3LF CS4 corrosion. | | | | | | |

Span 13, Ahead Floorbeam at PP43, Ahead, Bottom Flange  
Cover Plate: Active corrosion with a 29" X 4" Hole in the  
cover plate. 3LF CS4 corrosion.

Span 13, Ahead Floorbeam at PP43, Ahead, Bottom Flange Cover Plate: Active corrosion with a 29" X 4" Hole in the cover plate. 3LF CS4 corrosion.

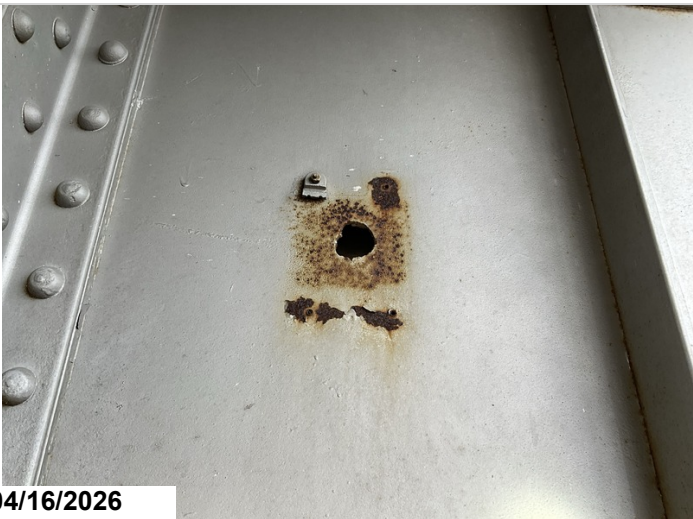
Span 13, Ahead Floorbeam at PP43, Bottom Flange, Left:  
Active corrosion with section loss up to 3/16" to the bottom  
flange. 1LF CS3 corrosion.  
Span 13, Ahead Floorbeam at PP43, Bottom Flange, Right:  
Active corrosion with section loss up to 3/8" to the bottom  
flange. 1LF CS3 corrosion.

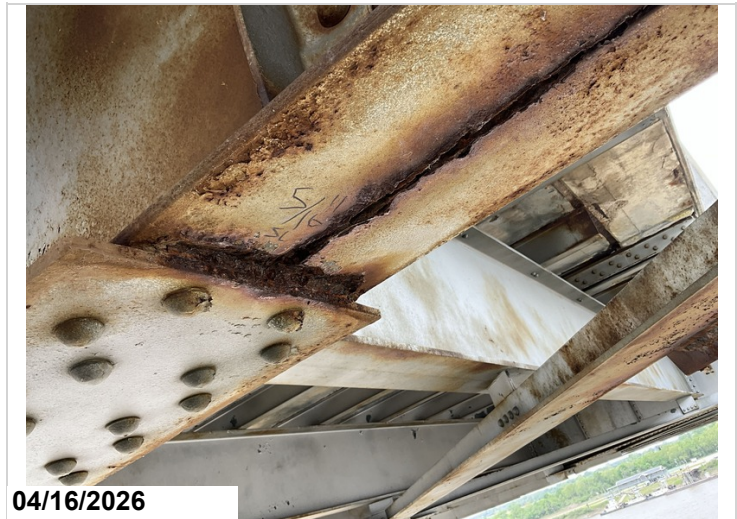
Ahead Floorbeam at PP43: Unclassified poor detail.

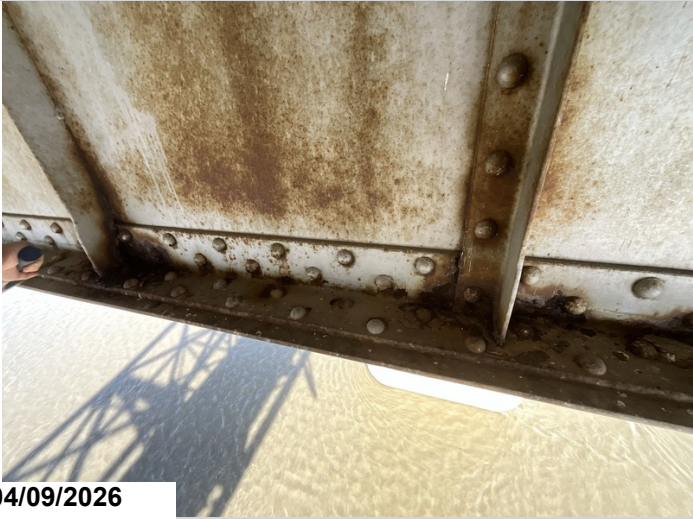
Span 13, Floorbeam 44, Bottom Flange, Left: Active  
corrosion with section loss up to 5/16" to the bottom flange.  
1LF CS3 corrosion.  
Span 13, Floorbeam 44, Bottom Flange, Right: Active  
corrosion with section loss up to 1/4" to the bottom flange.  
1LF CS3 corrosion.

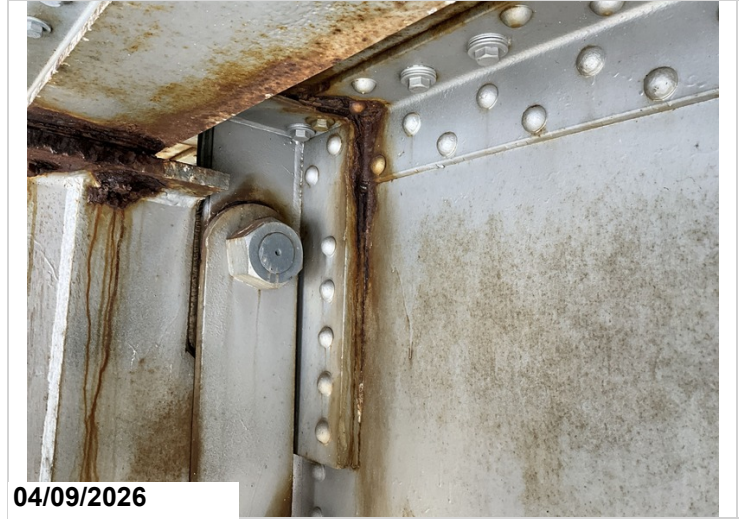
Span 13, Floorbeam 46, Back: Active corrosion with flaking rust and moderate section loss to the web to bottom flange angles. 2LF CS3 corrosion.

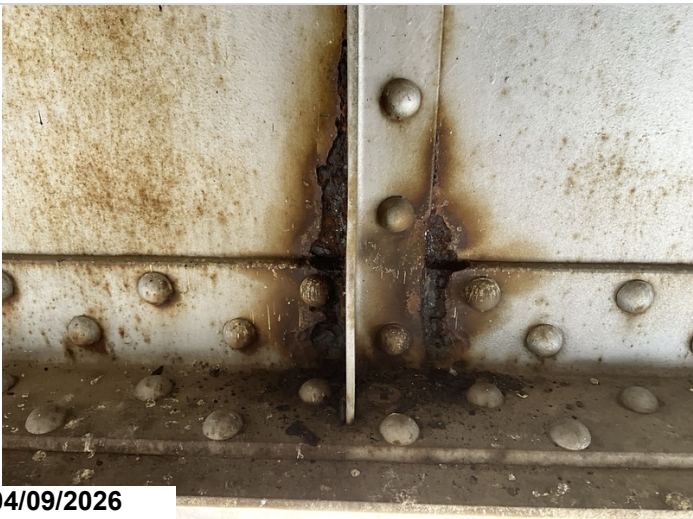
Span 13, Floorbeam 46, Right of Stringer 2: Active corrosion with section loss up to 3/16" to the web. 1LF CS3 corrosion.

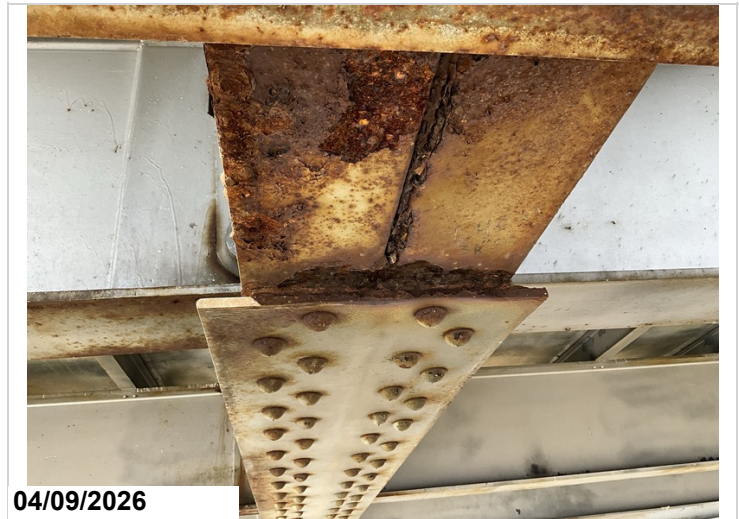
Span 13, Floorbeam 46, Back, Adjacent to Stiffener 5: Active corrosion with section loss up to 1/8" to the web. 1LF CS3 corrosion.

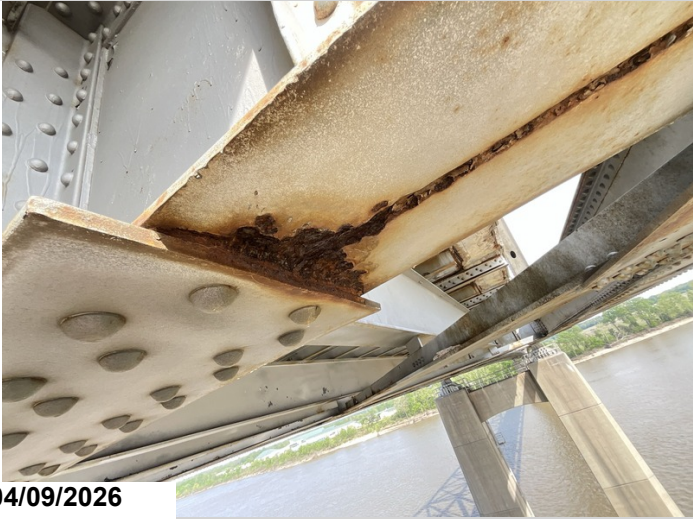
Span 13, Floorbeam 46, Bottom Flange, Right: Active corrosion with section loss from 7/16" - 1/2" to the bottom flange. 2LF CS3 corrosion.  
Span 13, Floorbeam 46, Bottom Flange, Left: Active corrosion with section loss from 1/4" to the bottom flange. 1LF CS3 corrosion.

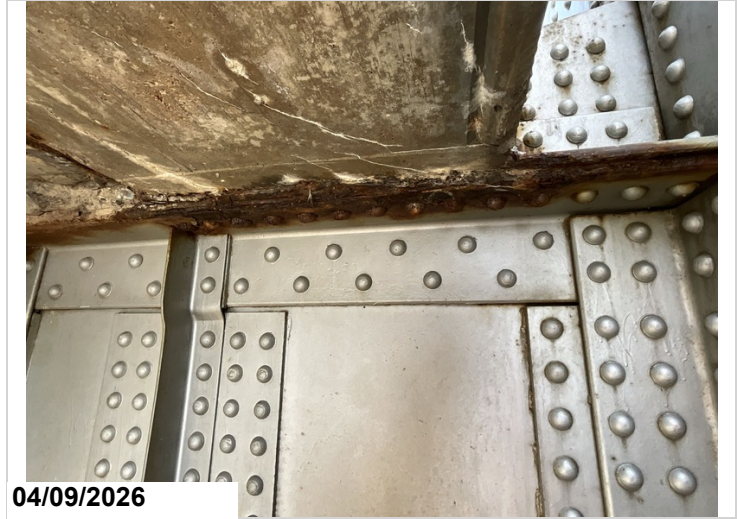
Span 13, Floorbeam 45, Bottom Flange, Right: Active corrosion with section loss from 7/16" to the bottom flange. 1LF CS3 corrosion.

Span 13, Floorbeam 45, Bottom Flange, Left: Active corrosion with section loss from 5/16" to the bottom flange. 1LF CS3 corrosion.

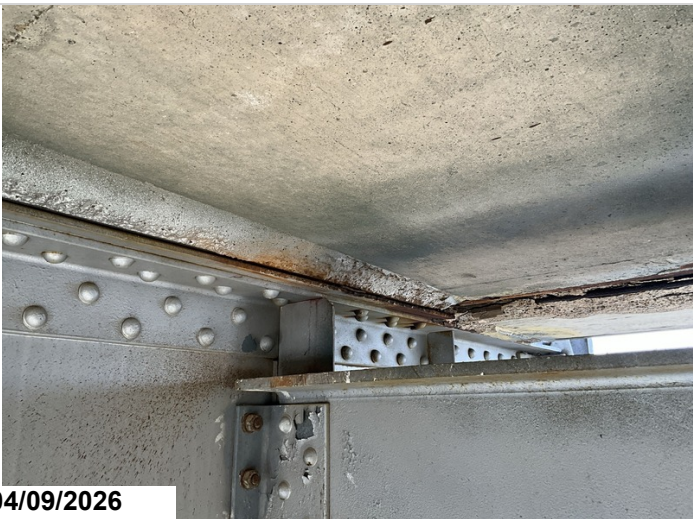
Span 13, Floorbeam 48, Top Flange, Right, Back: Heavy Active corrosion with flaking rust and section loss. 4LF CS3 corrosion.

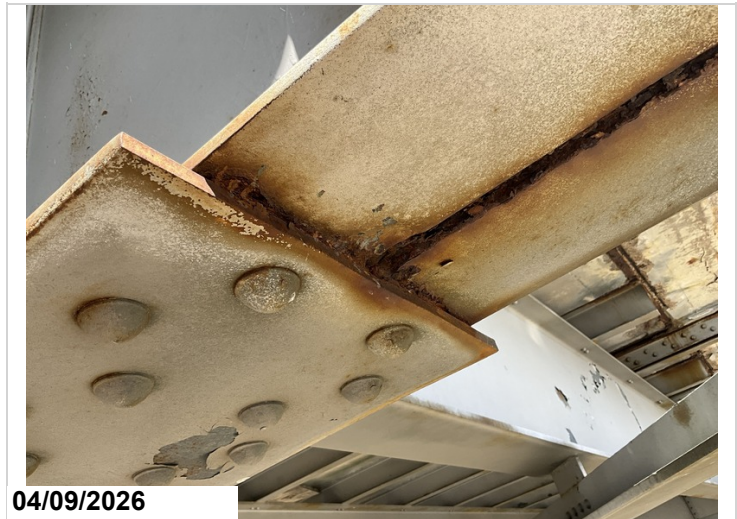
Span 13, Floorbeam 47, Above Stringers 1 and 3: Active corrosion with pack rust and section loss to the Top Flange. 7LF CS3 corrosion.

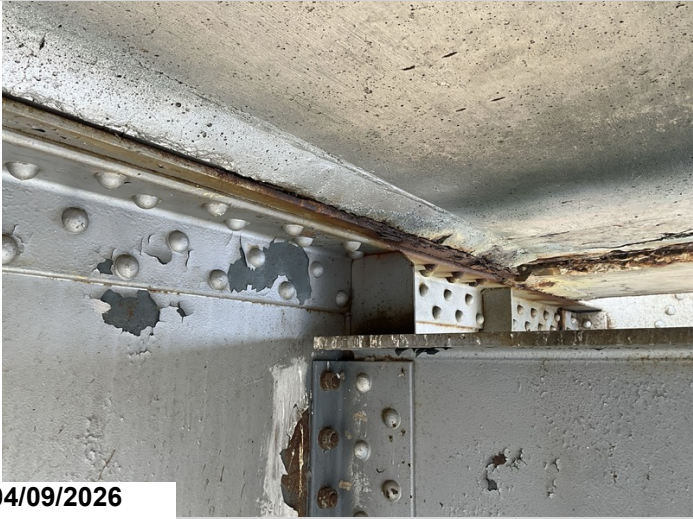
Span 13, Floorbeam 47, Bottom Flange, Right: Active corrosion with section loss from 3/16" to the bottom flange. 1LF CS3 corrosion.

Span 13, Floorbeam 47, Bottom Flange, Left: Active corrosion with section loss from 5/16" to the bottom flange. 1LF CS3 corrosion.

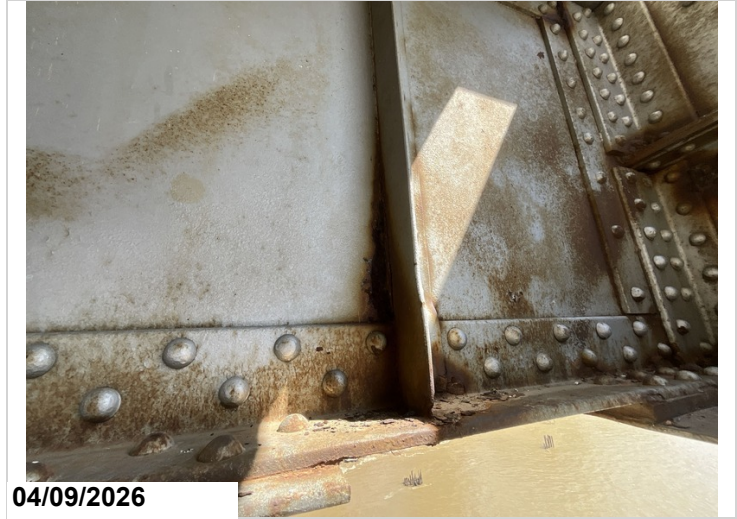
Span 15, Floorbeam 70, Above Stringers 1 and 3: Active corrosion with pack rust and section loss to the Top Flange. 8LF CS3 corrosion.

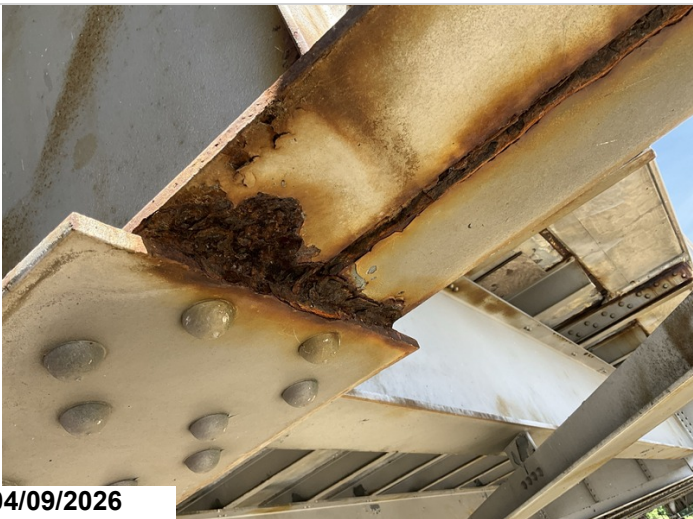
Span 15, Floorbeam 70, Back, Adjacent to Stiffener 9: Active corrosion with section loss up to 3/16" to the web. 1LF CS3 corrosion.

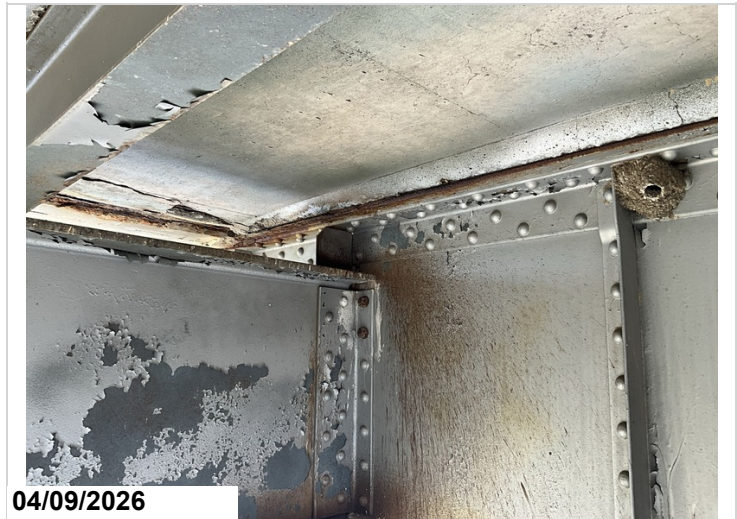
Span 15, Floorbeam 70, Bottom Flange, Right: Active corrosion with section loss from 5/16" to the bottom flange. 1LF CS3 corrosion.

Span 15, Floorbeam 70, Bottom Flange, Left: Active corrosion with section loss from 1/4" to the bottom flange. 1LF CS3 corrosion.

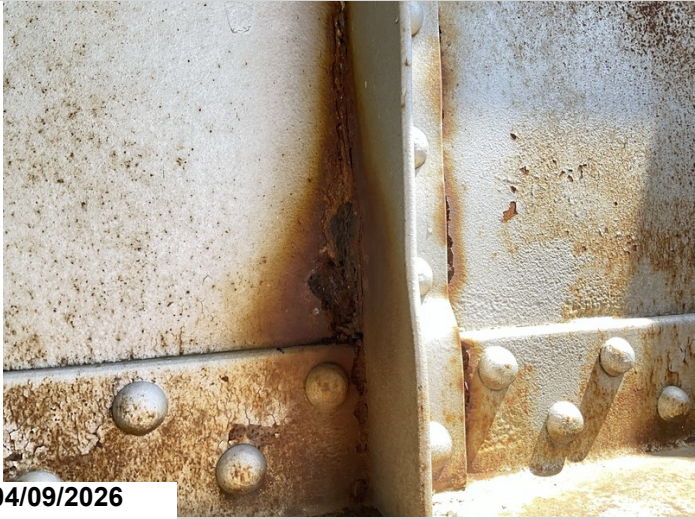
Span 15, Floorbeam 69, Above Stringers 1 and 3: Active corrosion with pack rust and section loss to the Top Flange. 8LF CS3 corrosion.

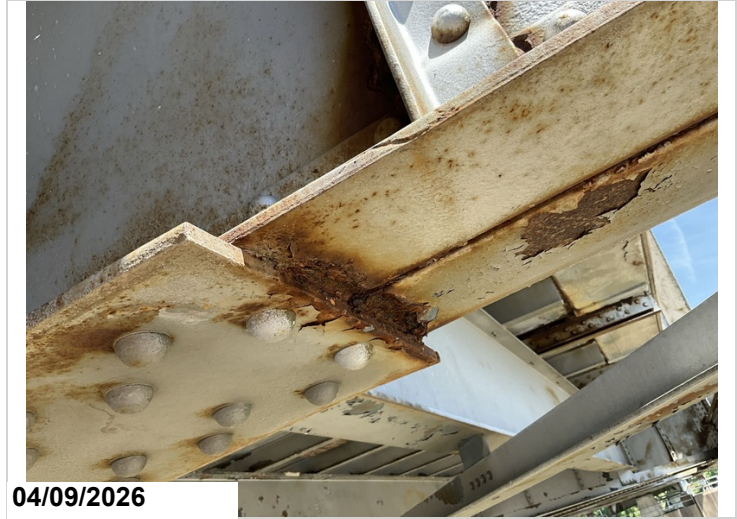
Span 15, Floorbeam 69, Back, Adjacent to Stiffener 9: Active corrosion with section loss up to 3/16". 1LF CS3 corrosion.

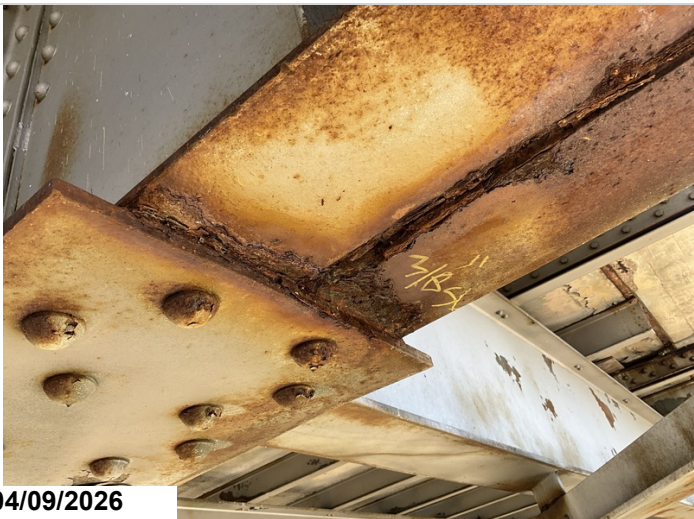
Span 15, Floorbeam 67, Bottom Flange, Right: Active corrosion with section loss up to 3/16". 1LF CS3 corrosion.

Span 15, Floorbeam 67, Bottom Flange, Left: Active corrosion with section loss up to 1/4". 1LF CS3 corrosion.

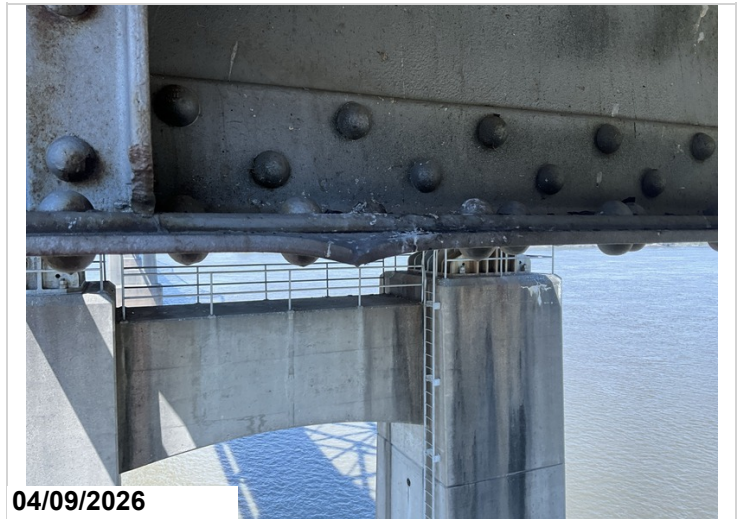
Span 15, Floorbeam 66, Bottom Flange, Right: Active corrosion with section loss up to 3/8". 1LF CS3 corrosion.

Span 15, Floorbeam 66, Bottom Flange, Left: Active corrosion with section loss up to 1/8". 1LF CS3 corrosion.

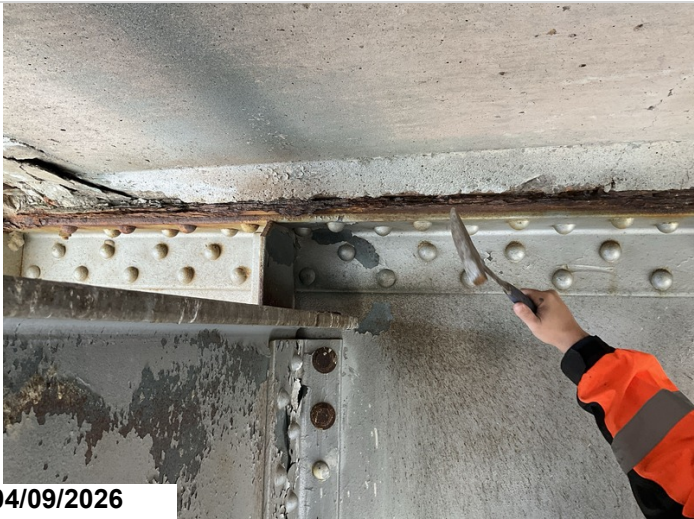
Span 15, Floorbeam 65, Ahead, left of Stringer 3, Bottom Flange, Left: 5/8" distortion to the bottom flange. 1LF CS2 distortion.

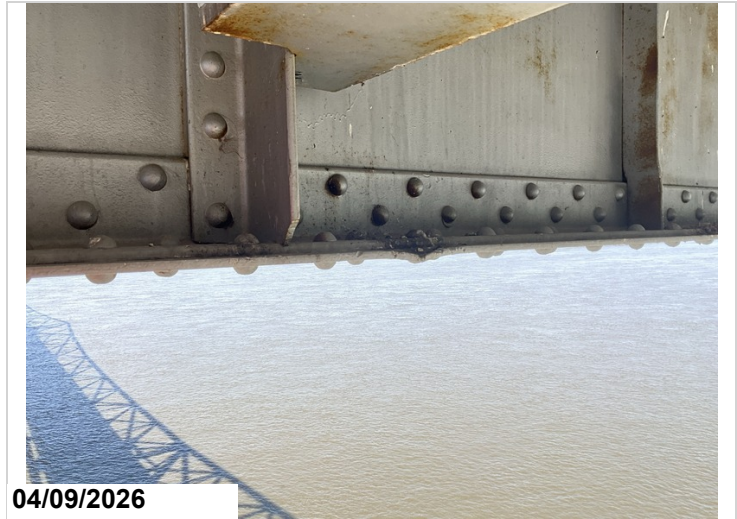
Span 15, Floorbeam 65, Top Flange, Ahead, Above Stringer 3: Active corrosion with heavy flaking rust, pack rust and section loss for and 8' area. Top Flange has knife's edge section remaining. 5LF CS3 corrosion.

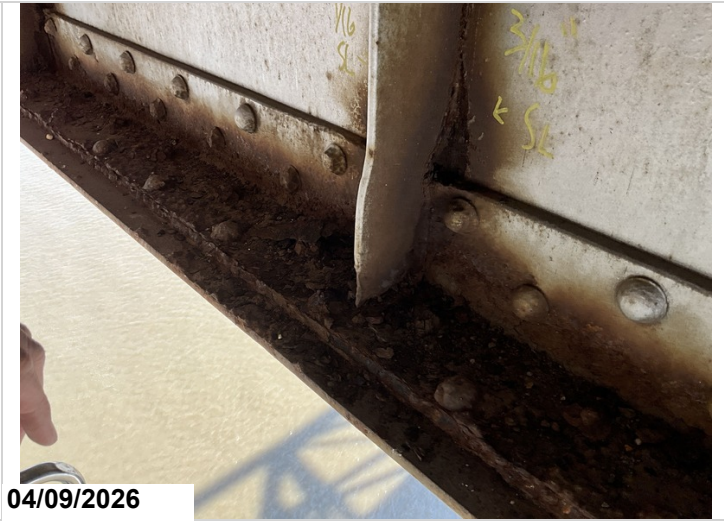
Span 14, Floorbeam 62, Back, Adjacent to Stiffener 2: Active corrosion with section loss up to 1/4" to the web. 1LF CS3 corrosion.

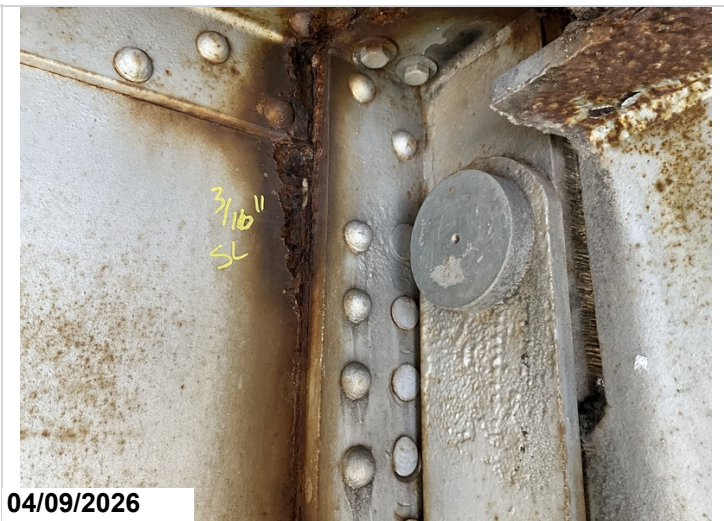
Span 14, Floorbeam 62, Back, Adjacent to Stiffener 3: Active corrosion with section loss up to 3/16" to the web. 1LF CS3 corrosion.

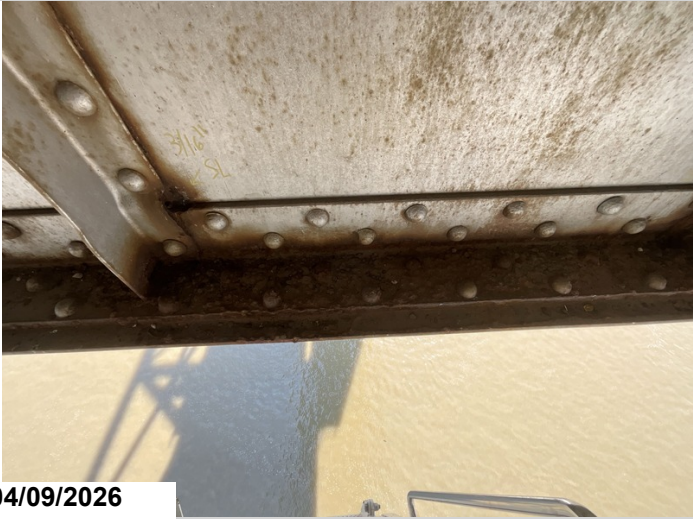
Span 14, Floorbeam 62 to Stringer 2 Connection: Active corrosion with section loss up to 1/8" to Floorbeam web and 1/16" to stringer webs. 1LF CS3 corrosion.

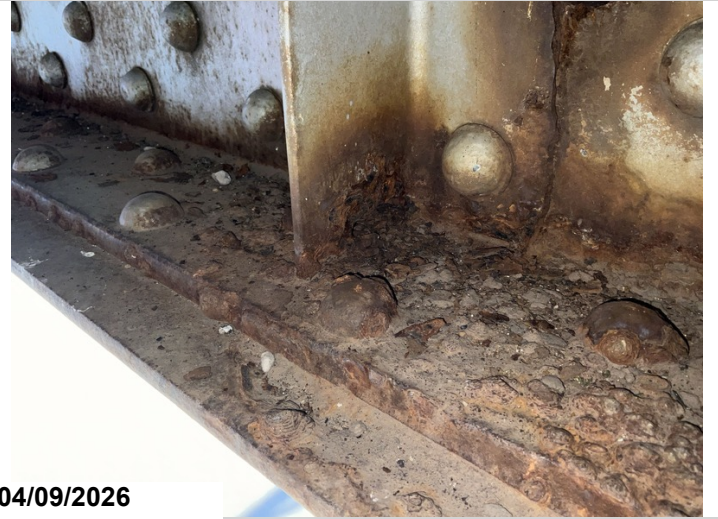
Span 14, Floorbeam 62, Back, Bottom Flange: Active corrosion with flaking rust and section loss. 20LF CS3 corrosion.

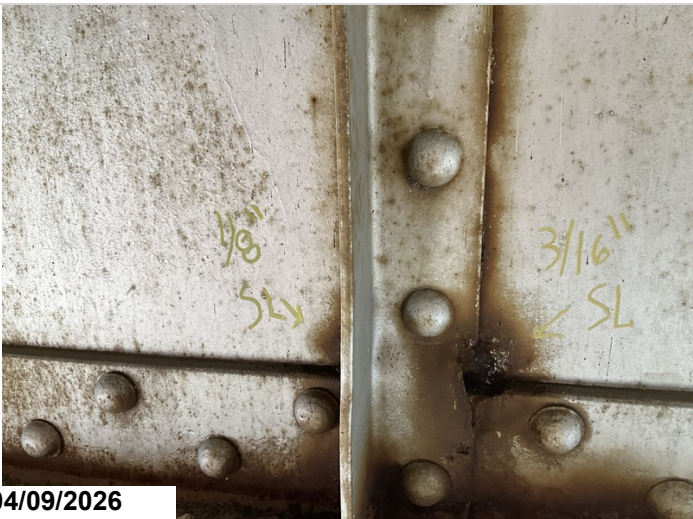
Span 14, Floorbeam 62, Back, Stiffener 4: Active corrosion with a hole in the stiffener.

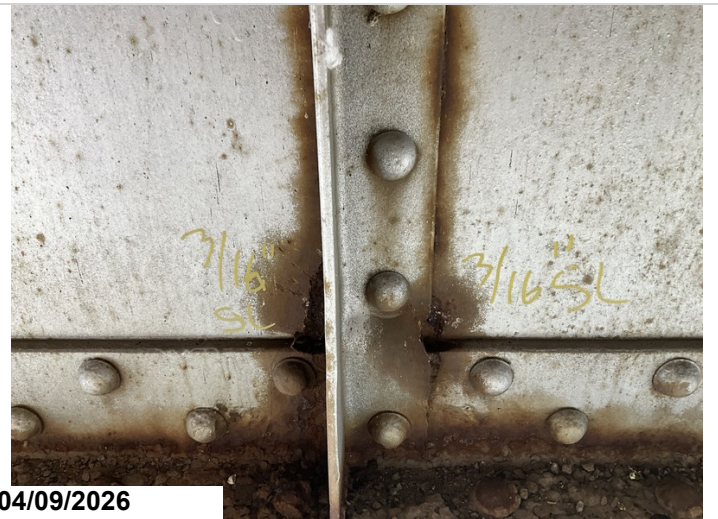
Span 14, Floorbeam 62, Back, adjacent to Stiffener 4: Active corrosion with section loss up to 3/16" to the web. 1LF CS3 corrosion.

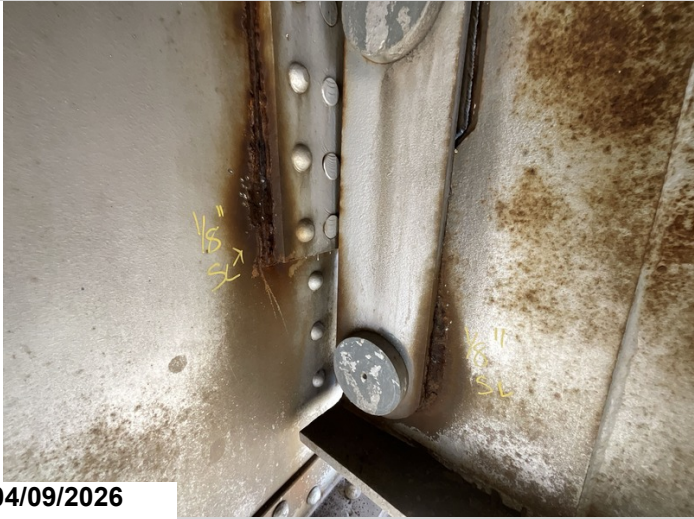
Span 14, Floorbeam 62, Back, adjacent to Stiffener 5: Active corrosion with section loss up to 3/16" to the web. 1LF CS3 corrosion.

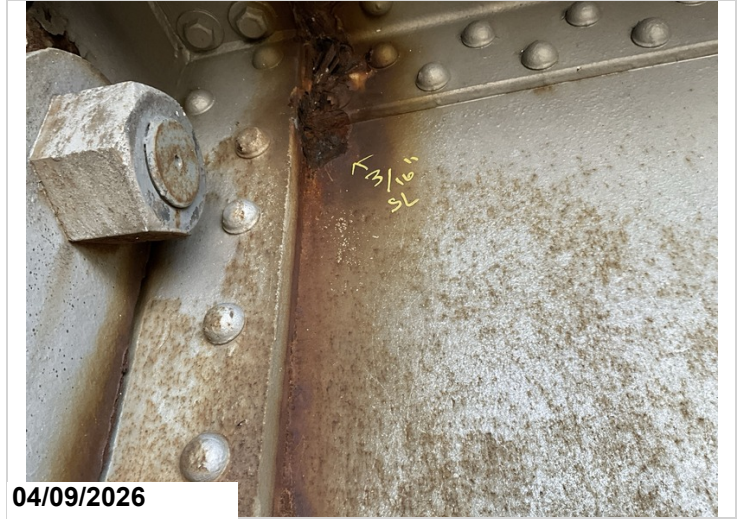
Span 14, Floorbeam 62 to Stringer 3 Connection: Active corrosion with section loss up to 1/8" to Floorbeam and Stringer webs. 1LF CS3 corrosion.

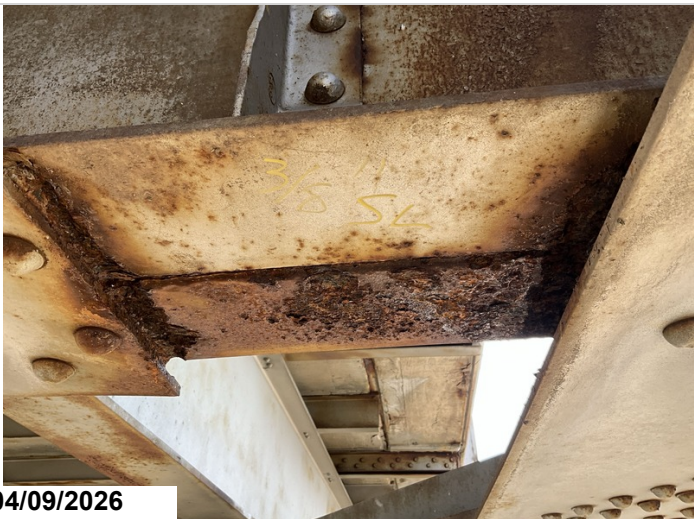
Span 14, Floorbeam 62, Back, Adjacent to Stringer 3, Web: Active corrosion with section loss up to 3/16" to the web. 1LF CS3 corrosion.

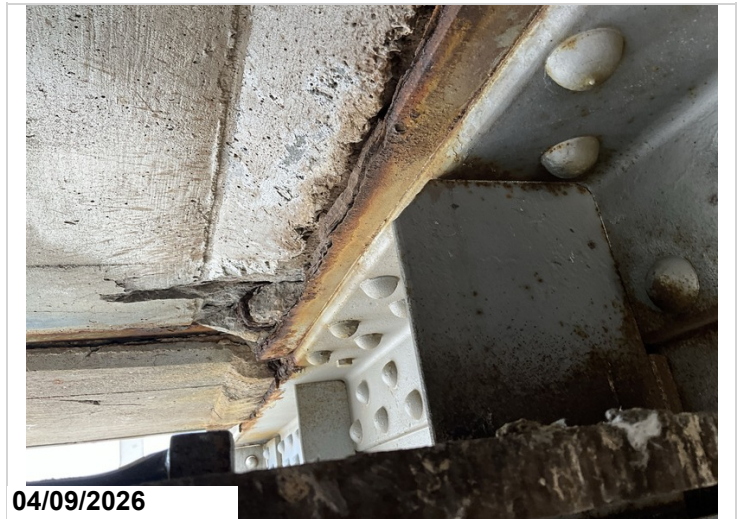
Span 14, Floorbeam 62, Bottom Flange, Right: Active corrosion with section up to 3/8" to the bottom flange. 1LF CS3 corrosion.

Span 14, Floorbeam 62, Bottom Flange, Left: Active corrosion with section up to 1/4" to the bottom flange. 1LF CS3 corrosion.

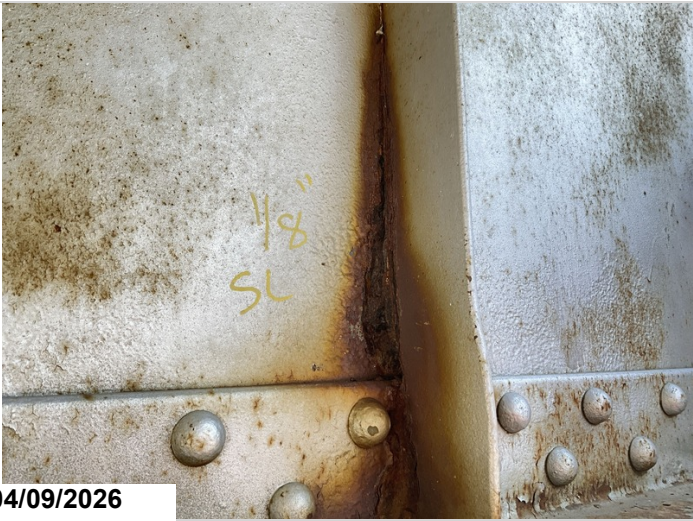
Span 14, Floorbeam 61, Top Flange, Ahead, Above Stringer 3: Active corrosion with section loss with a 24" X 1/2" area of section remaining down to knife's edge. 2LF CS3 corrosion.

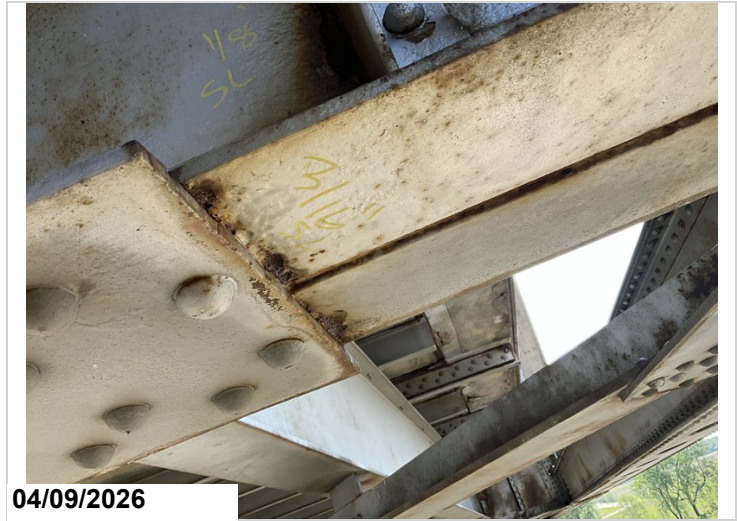
Span 14, Floorbeam 61, Back, Left of Stiffener 9, Web:  
Active corrosion with section loss up to 1/8" to the web. 1LF  
CS3 corrosion.

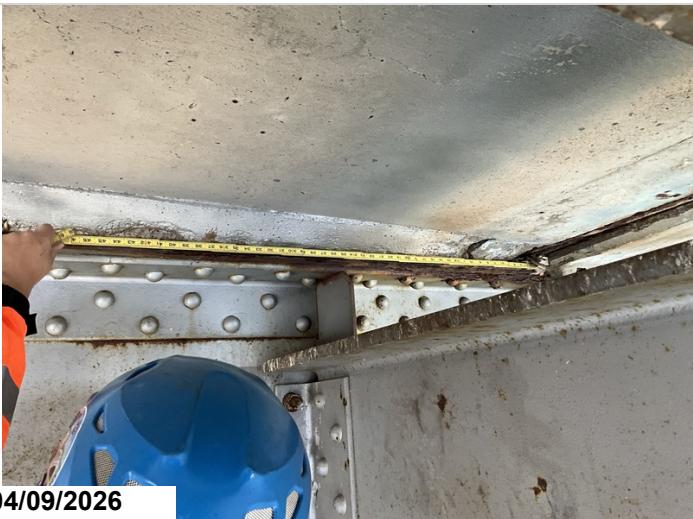
Span 14, Floorbeam 61, Bottom Flange, Right: Active  
corrosion with section loss up to 3/16" to the bottom flange.  
1LF CS3 corrosion.

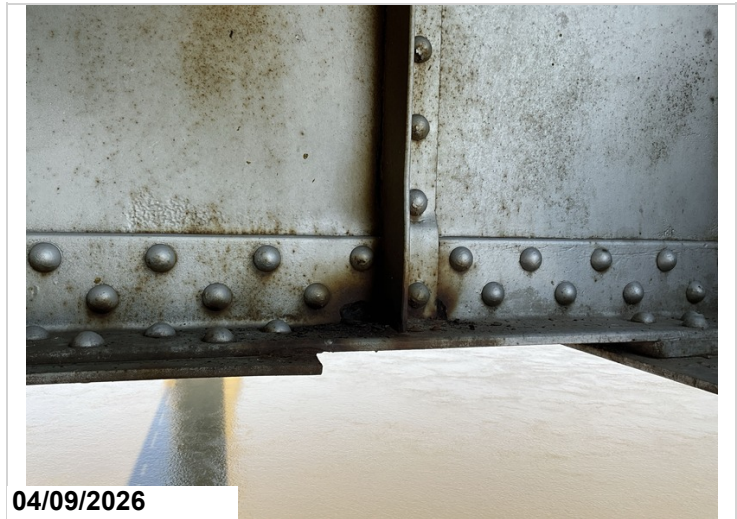
Span 14, Floorbeam 60, Ahead, Top Flange, Above Stringer  
1: 42" area of 1/8" remaining thickness to the Top Flange.  
4LF CS3 corrosion.

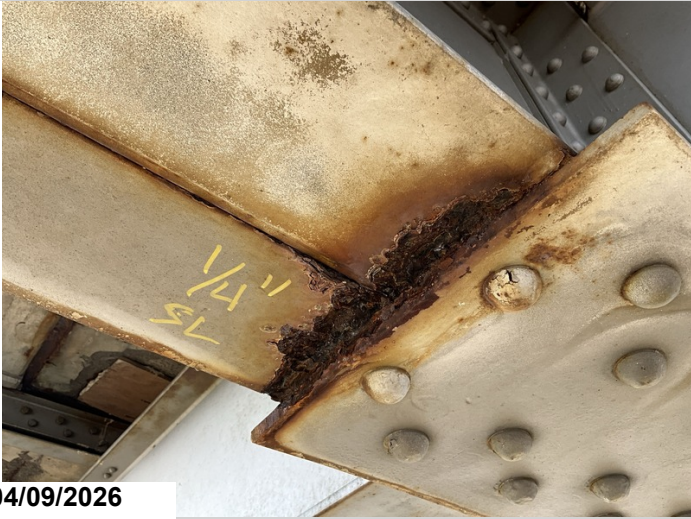
Span 14, Floorbeam 60, Ahead, Stiffener 1: Heavy corrosion  
to stiffener and adjacent angle connections. 1LF CS3  
corrosion.

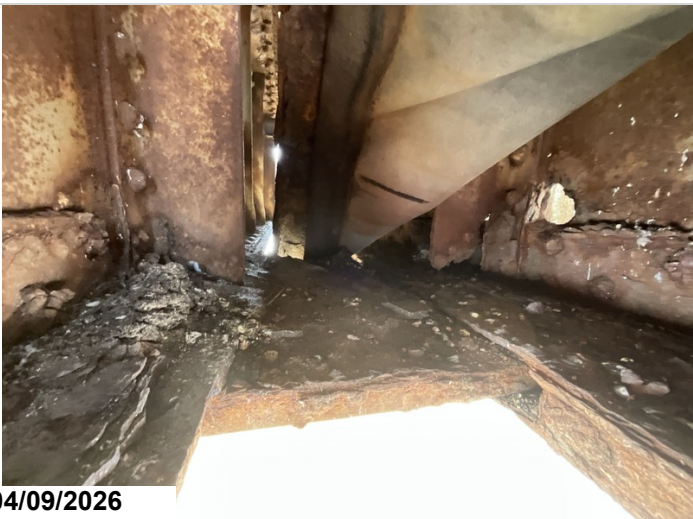
Span 14, Ahead of back Floorbeam at PP59, Top Flange: Heavy corrosion with heavy section loss to the Top Flange. Full-length CS3 corrosion. 30LF Minus CS4.

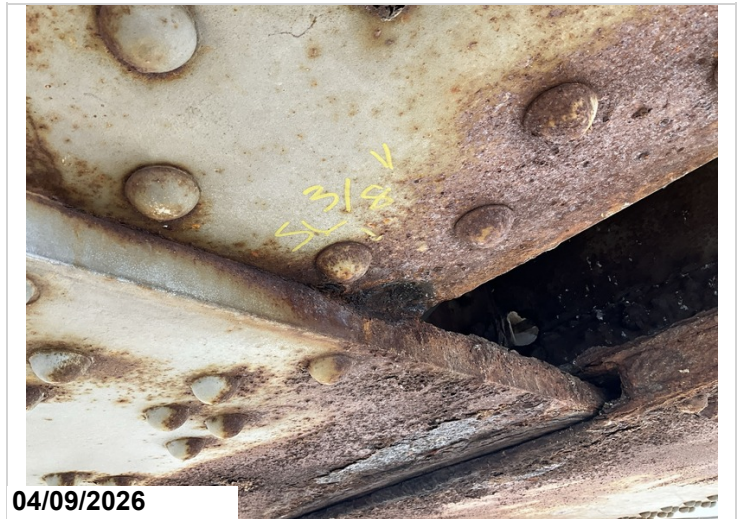
Span 14, PP59, wind lock: Heavy corrosion.

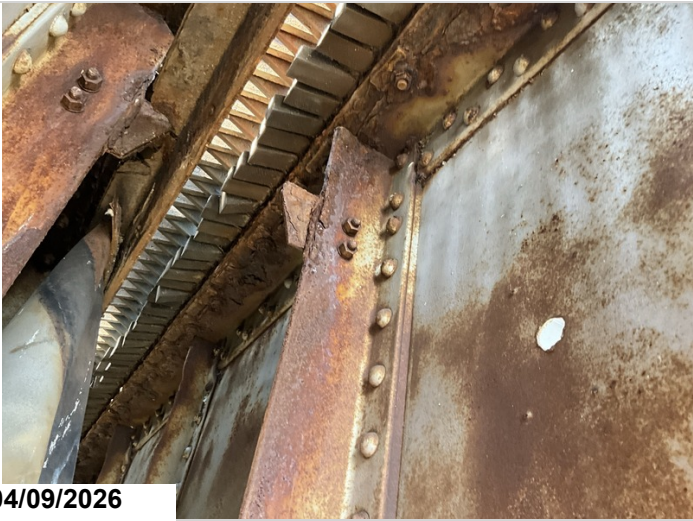
Span 14, PP59, Back Floorbeam, Bottom Flange, Right of Windlock: Active corrosion with section loss up to 3/8" in Bottom Flange. 1LF CS3 corrosion.

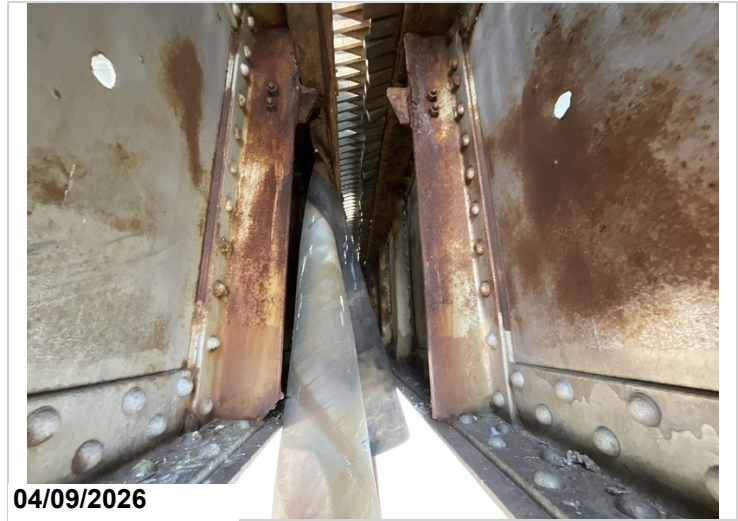
Span 14, Ahead of back Floorbeam at PP59, Top Flange:  
Heavy corrosion with heavy section loss to the Top Flange.

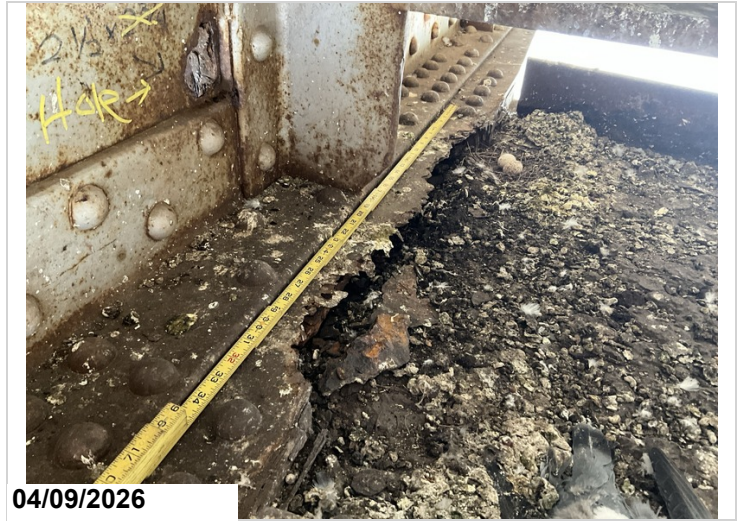
Span 14, Ahead Floorbeam ar PP59, Bottom Flange, below Stringer 2: Active corrosion with a 36" X 3" Hole in the Bottom Flange. 3LF CS4 corrosion.

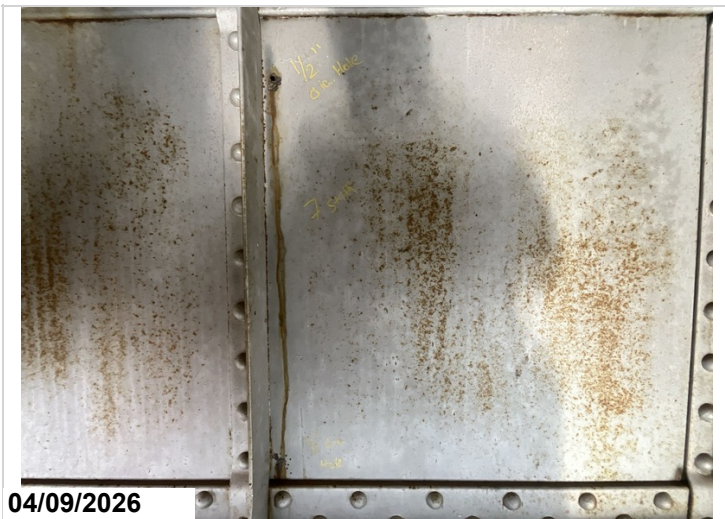
Span 14, Ahead Floorbeam at PP59, adjacent to Stiffener 7:  
Active corrosion with two 1/2" diameter holes in the web.  
1LF CS4 corrosion.

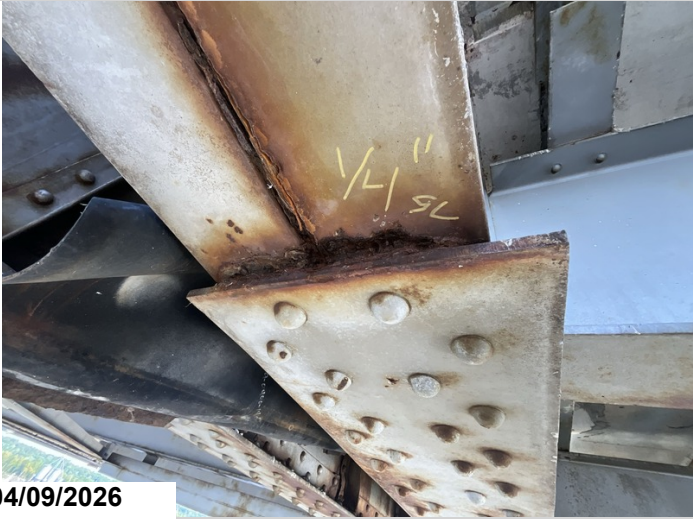
Span 14, Ahead Floorbeam at PP59, adjacent to Stiffener 8:  
Active corrosion with a 1 1/2" X 1 1/4" hole in the web. 1LF  
CS4 corrosion.

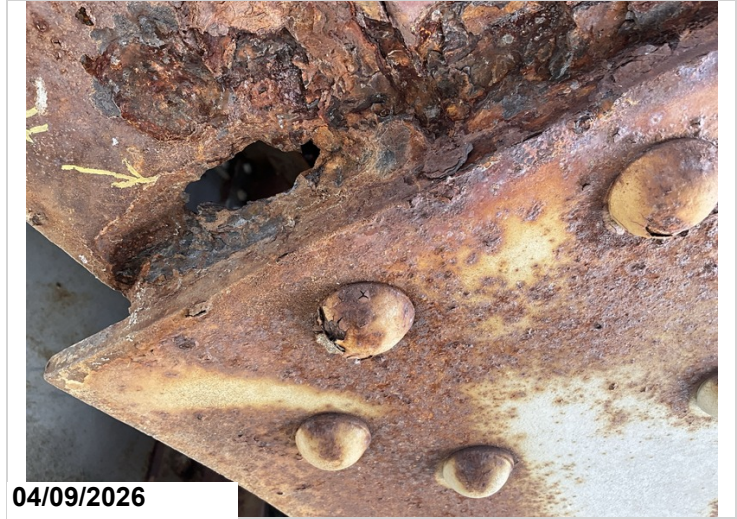
Span 14, Ahead Floorbeam at PP59, Bottom Flange, Right:  
Active corrosion with section loss up to 1/4" to the bottom  
flange. 1LF CS3 corrosion.

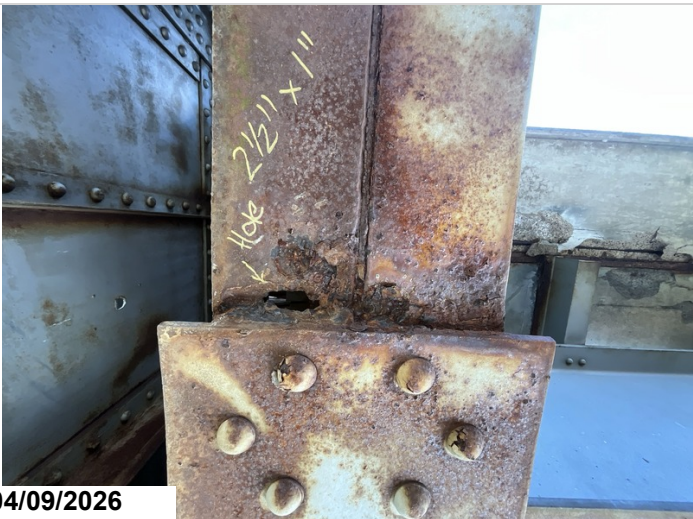
Span 14, Back Floorbeam at PP59, Bottom Flange, Left:  
Active corrosion with a 2 1/2" X 1" hole in the Bottom Flange.  
1LF CS4 corrosion.

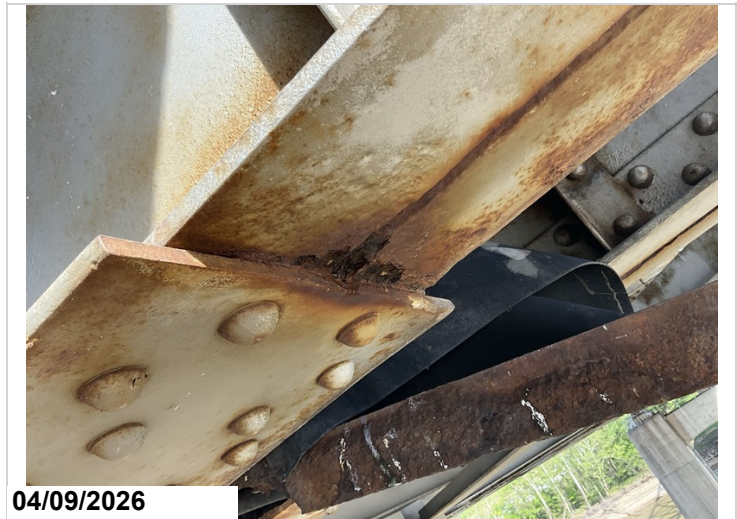
Span 14, Back Floorbeam at PP59, Bottom Flange, Left:  
Active corrosion with a 2 1/2" X 1" hole in the Bottom Flange.  
1LF CS4 corrosion.

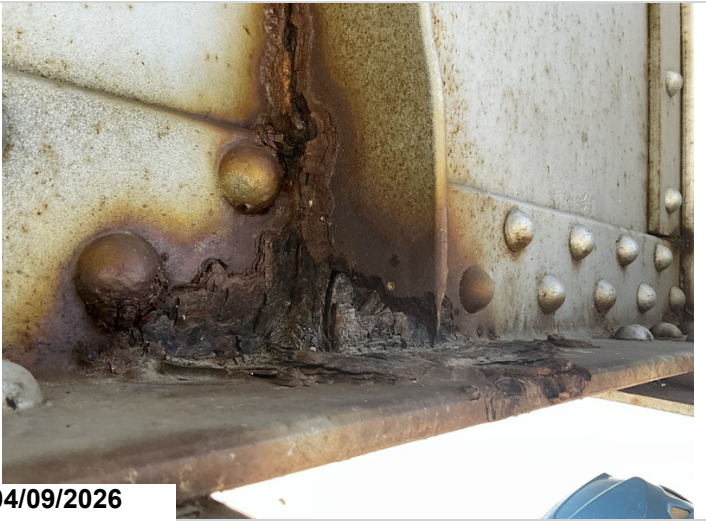
Span 14, Back Floorbeam at PP59, Bottom Flange: Active  
corrosion with section loss up to 1/4" to the bottom flange.  
1LF CS3 corrosion.

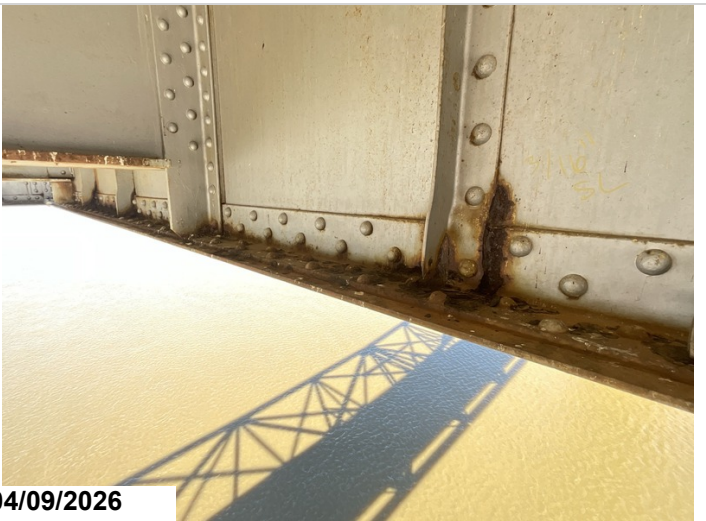
Span 14, Floorbeam 58, Right, Bottom Flange: Active corrosion with section loss up to 5/16" to the bottom flange. 1LF CS3 corrosion.

Span 14, Floorbeam 58, Left, Bottom Flange: Active corrosion with section loss up to 1/4" to the bottom flange. 1LF CS3 corrosion.

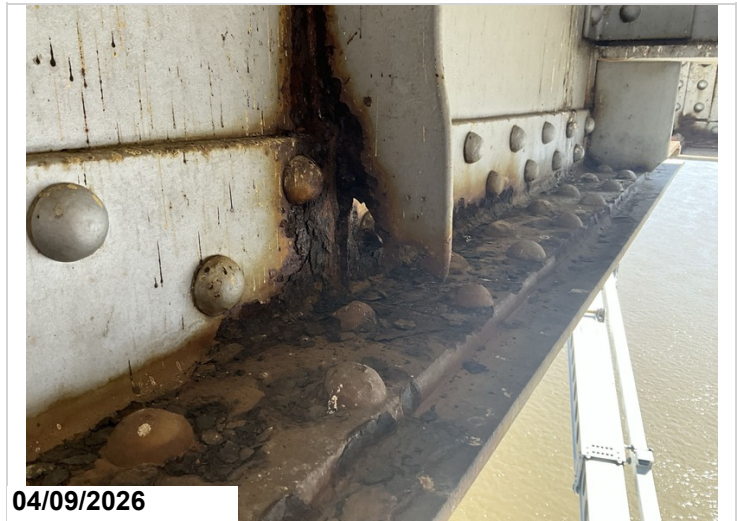
Floorbeam 57: Needs Bottom Flange repair more than 56.

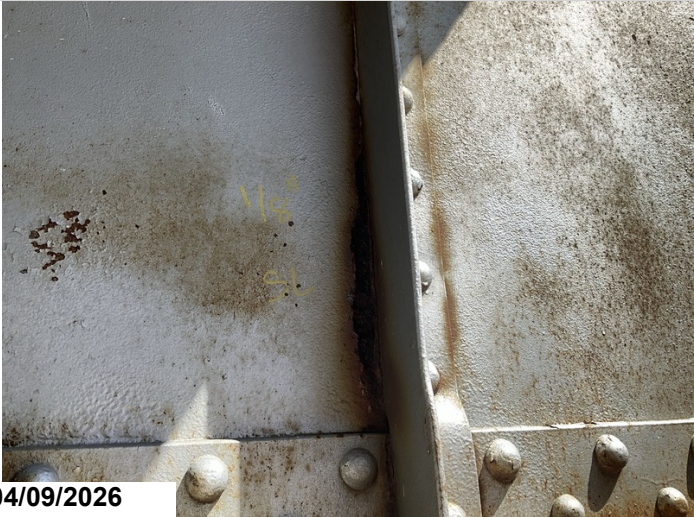
Span 14, Floorbeam 57, Back, Stiffeners 3, 6 and 7: Active corrosion with holes in the stiffeners. 3LF CS3 corrosion.
