## Bridge 02899 Inspection Report

Arnold Road ID:54x49x11xA, Arnold Log mile:0.569

# National Bridge Inventory Data Sheet

| IDENTIFICATION | |
|---|---|
| (7) Facility Carried | US 49- Phillips Co |

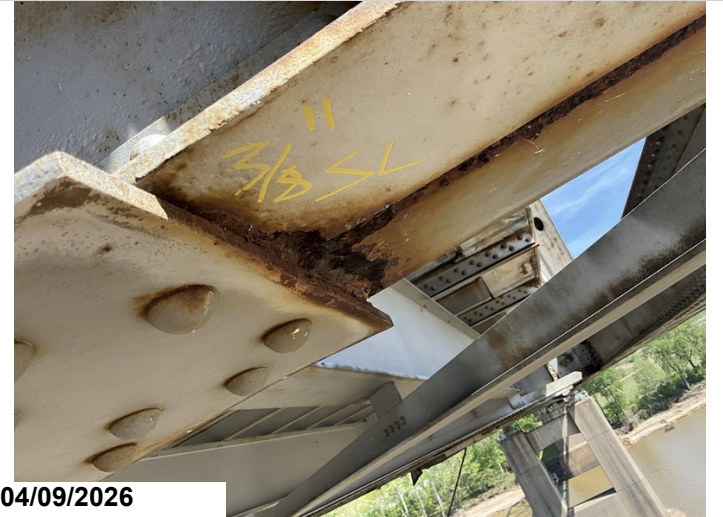
Span 14, Floorbeam 57, Back, Adjacent to Stiffener 9: Active corrosion with section loss up to 1/8" to the web. 1LF CS3 corrosion.

Span 14, Floorbeam 57, Back, Adjacent to Stiffeners 3 and 7: Active corrosion with section loss up to 3/16" to the web. 2LF CS3 corrosion.

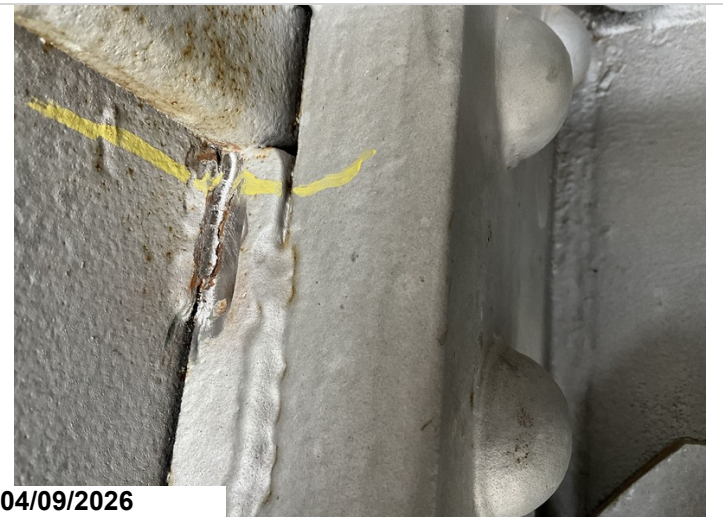
Span 14, Floorbeam 56 to Stringer 2 Pin and Hanger Assembly connection: Cracked tack welds, has self arrested. 1LF CS2 crack.

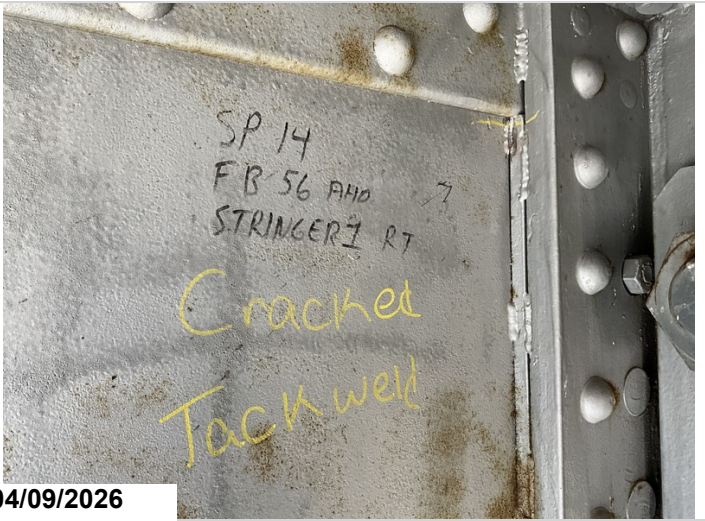
Span 14, Floorbeam 56 to Stringer 1, Pin and Hanger Assembly connection: Cracked tack weld, has not self arrested. 1LF CS2 crack.

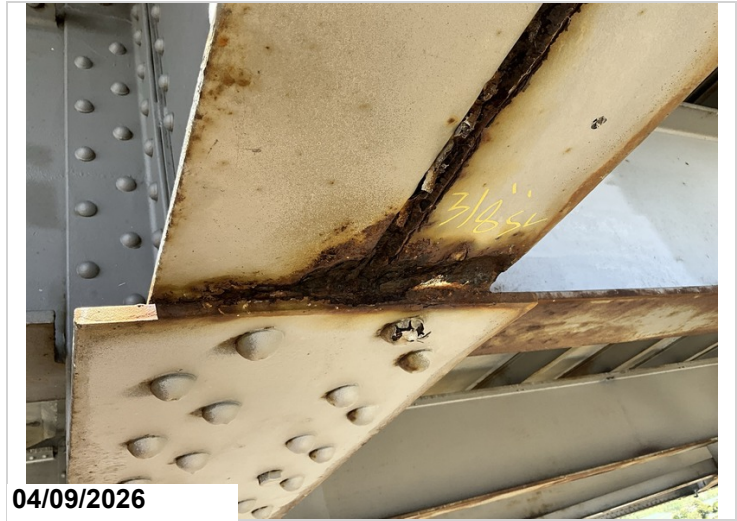
Span 14, Floorbeam 56 to Stringer 1, Pin and Hanger Assembly connection: Cracked tack weld, has not self arrested. 1LF CS2 crack.

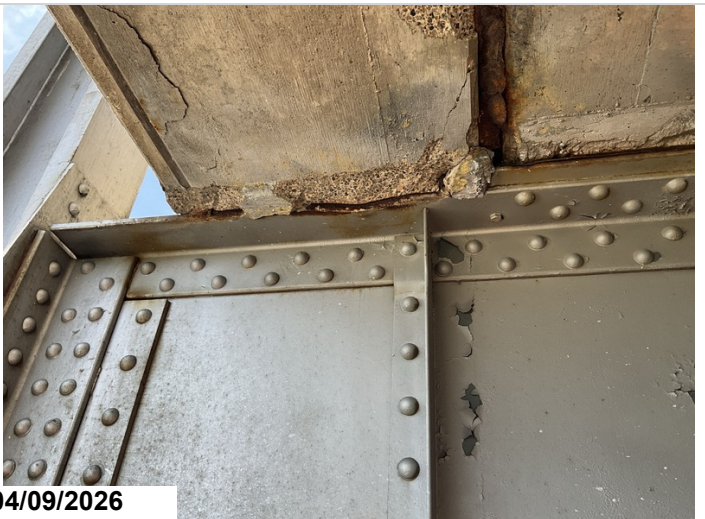
Span 14, Floorbeam 56, Right, Bottom Flange: Active corrosion with section loss up to 3/8" to the bottom flange. 1LF CS3 corrosion.

Span 14, Floorbeam 56, Left, Bottom Flange: Active corrosion with section loss up to 1/4" to the bottom flange. 1LF CS3 corrosion.

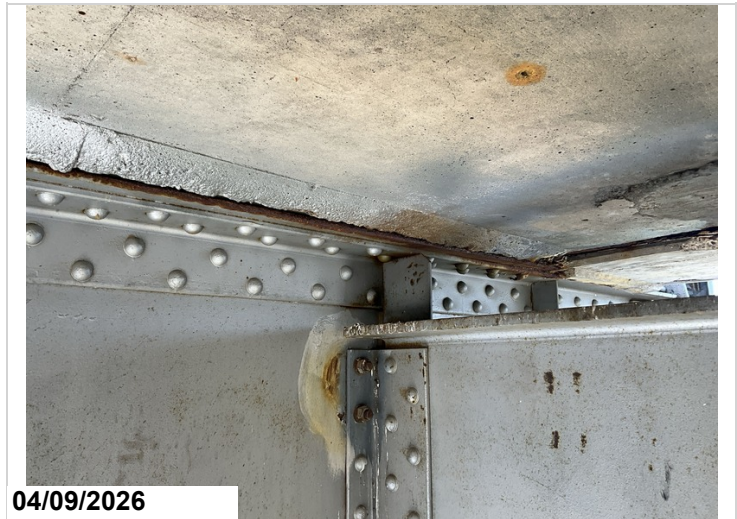
Span 14, Floorbeam 55, Ahead, Right: Distortion in Top Flange. 2LF CS2 distortion.

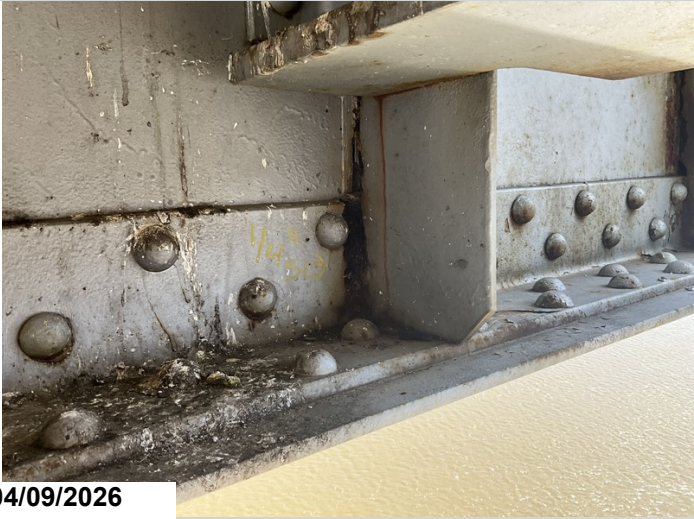
Span 14, Floorbeam 55, Top Flange: Typical Active corrosion with pack rust between the Top Flange and the deck. 6LF CS3 corrosion.

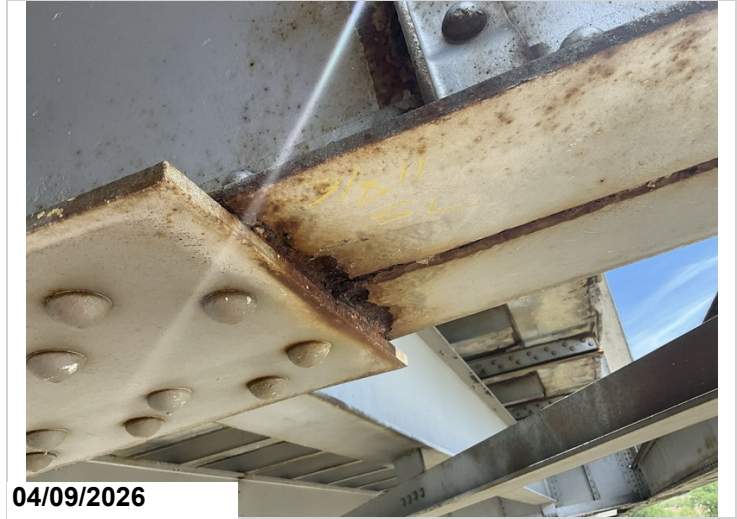
Span 14, Floorbeam 55, Back, Adjacent to Stiffener 8: Active corrosion with section loss up to 1/4" to bottom flange angle connection. 1LF CS3 corrosion.

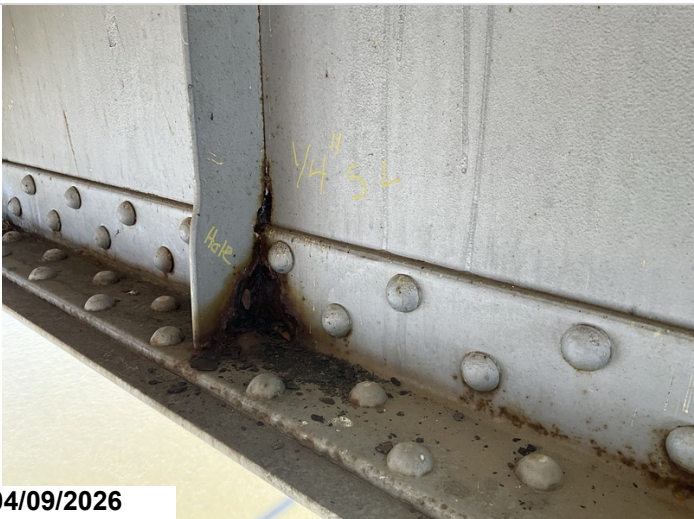
Span 14, Floorbeam 55, Right, Bottom Flange: Active corrosion with section loss up to 3/8" to the bottom flange. 1LF CS3 corrosion.

Span 14, Floorbeam 55, Left, Bottom Flange: Active corrosion with section loss up to 3/16" to the bottom flange. 1LF CS3 corrosion.

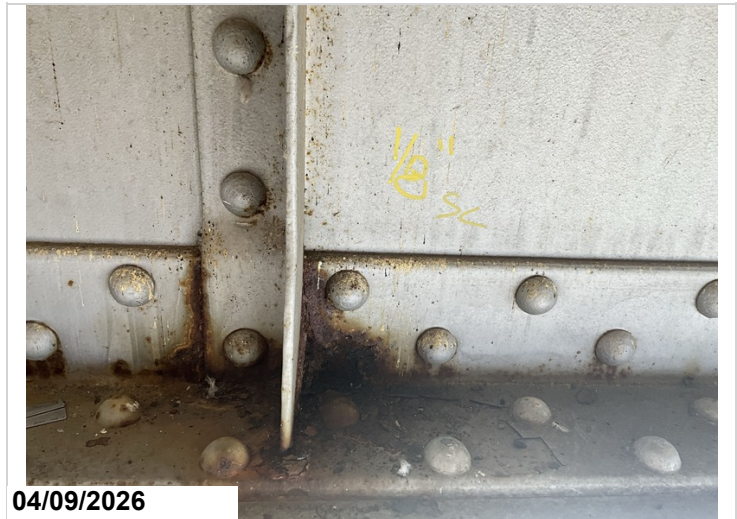
Span 14, Floorbeam 54, Back, Adjacent to Stiffener 3: Active corrosion with section loss up to 1/4" to the bottom flange angle connection, along with a hole in the stiffener. 1LF CS3 corrosion.

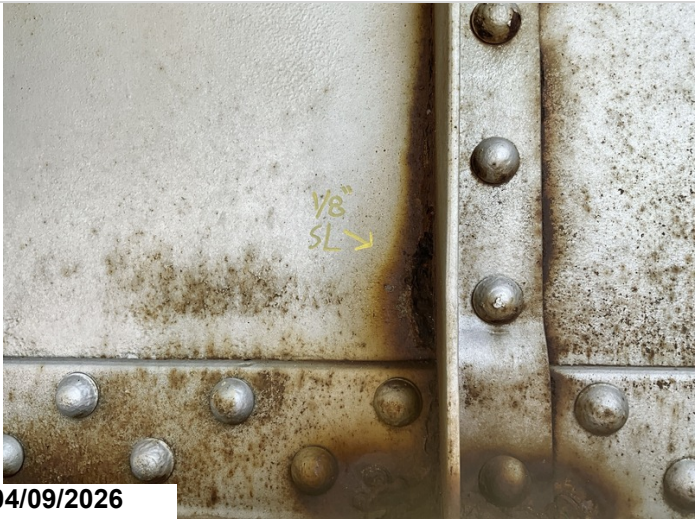
Span 14, Floorbeam 54, Back, Adjacent to Stiffener 4: Active corrosion with section loss up to 1/8" to the bottom flange angle connection. 1LF CS3 corrosion.

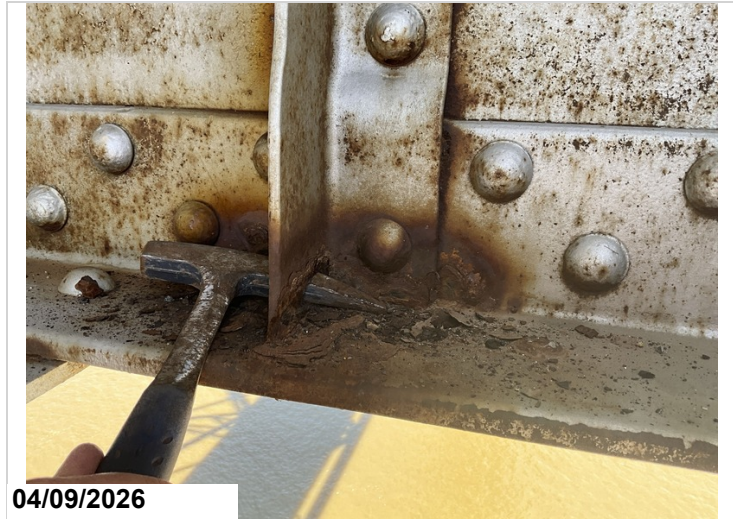
Span 14, Floorbeam 54, Back, Left of Stiffener 9: Active corrosion with section loss up to 1/8" to the web. 1LF CS3 corrosion.

Span 14, Floorbeam 54, Back, Left of Stiffener 7: Active corrosion with section loss up to 3/16" to the web. 1LF CS3 corrosion.

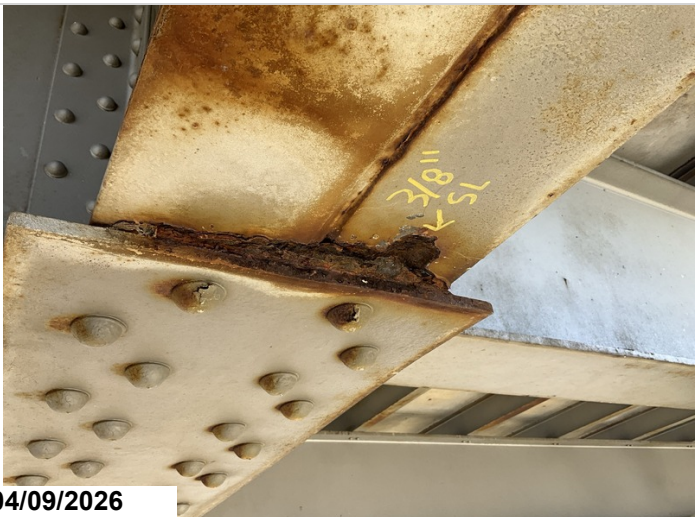
Span 14, Floorbeam 54, Back, Stiffener 9: Active corrosion with a hole in the stiffener. 1LF CS3 corrosion.

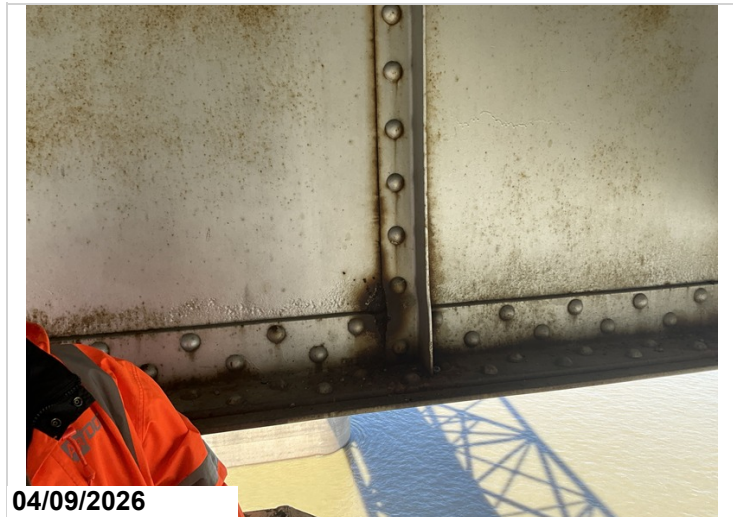
Span 14, Floorbeam 54, Right, Bottom Flange: Active corrosion with section loss up to 3/8" to the bottom flange. 1LF CS3 corrosion.

Span 14, Floorbeam 54, Left, Bottom Flange: Active corrosion with section loss up to 3/16" to the bottom flange. 1LF CS3 corrosion.

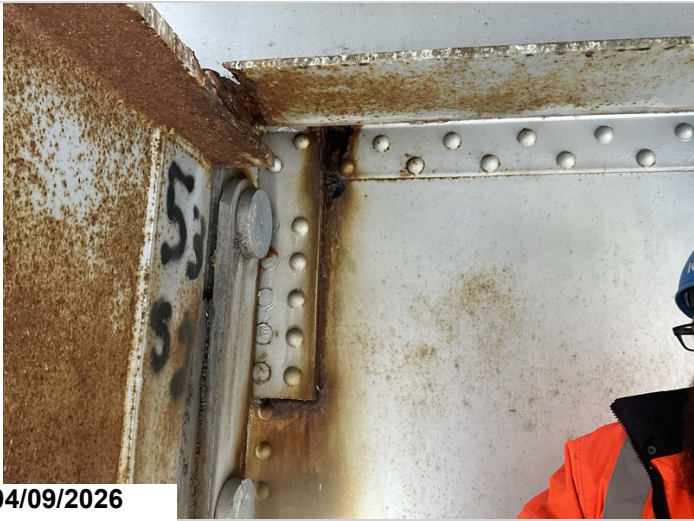
Span 14, Floorbeam 53, Ahead, Right of Stiffener 5: Active corrosion with section loss up to 1/16" to the web. 1LF CS3 corrosion.

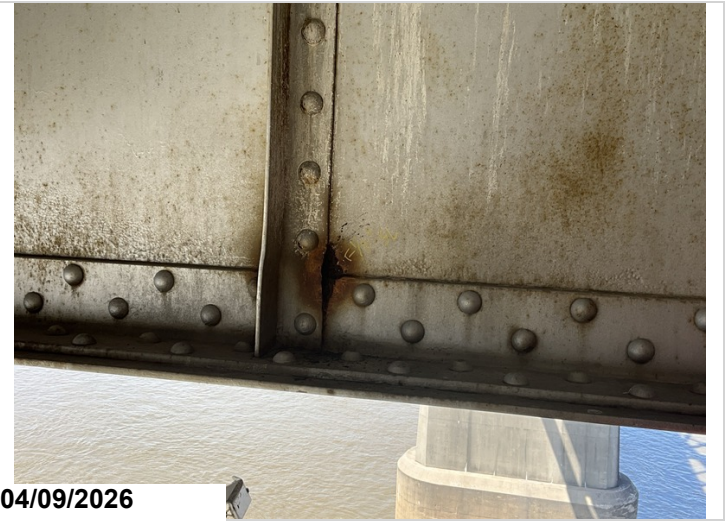
Span 14, Floorbeam 53, Ahead, Left of Stringer 2: Active corrosion with section loss up to 3/16" to the web. 1LF CS3 corrosion.

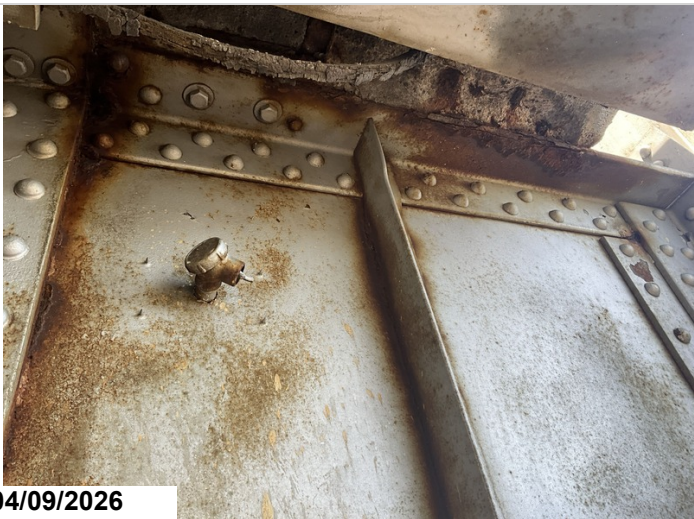
Span 14, Floorbeam 53, Ahead, left of Stiffener 3: Active corrosion with section loss up to 1/8" to the web. 1LF CS3 corrosion.

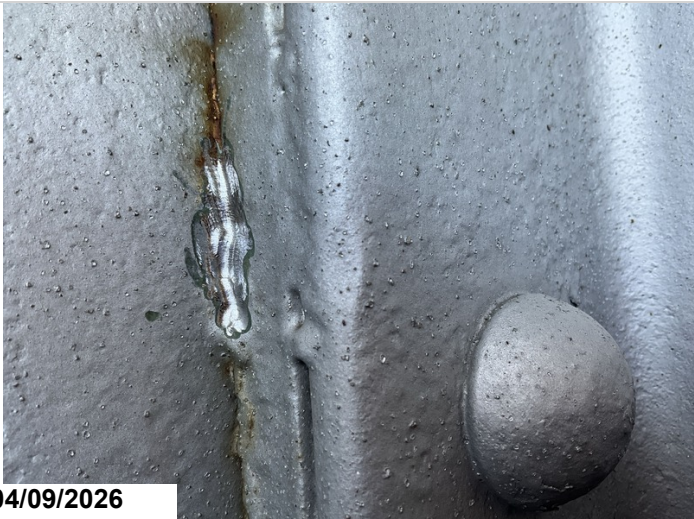
Span 14, Floorbeam 53, Back, Bottom of Stringer 3 connection: 3/4" crack in tack weld. 1LF CS3 crack.

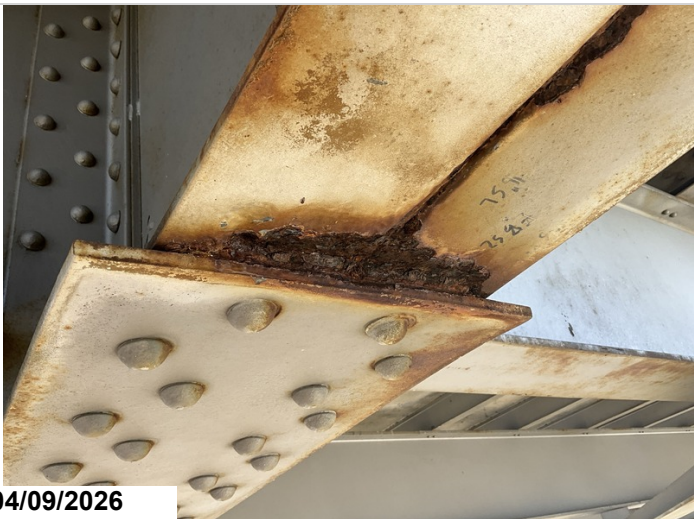
Span 14, Floorbeam 52, Back, Adjacent to Stiffener 8: Active corrosion with section loss up to 1/4" to the bottom flange angle connection. 1LF CS3 corrosion.

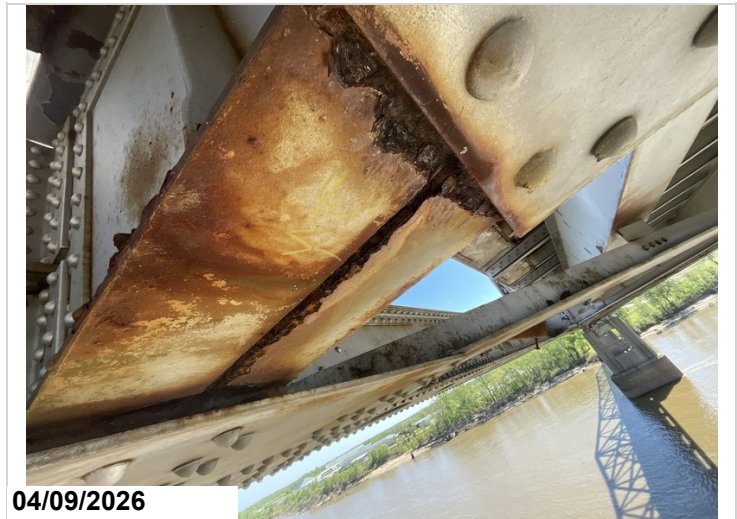
Span 14, Floorbeam 52, Right, Bottom Flange: Active corrosion with section loss up to 3/8" to the bottom flange. 2LF CS3 corrosion.

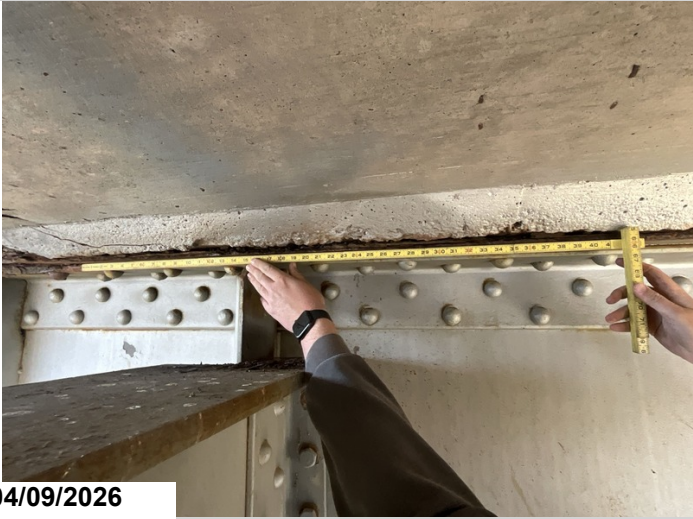
Span 14, Floorbeam 51, Left, Bottom Flange: Active corrosion with section loss up to 1/4" to the bottom flange. 2LF CS3 corrosion.

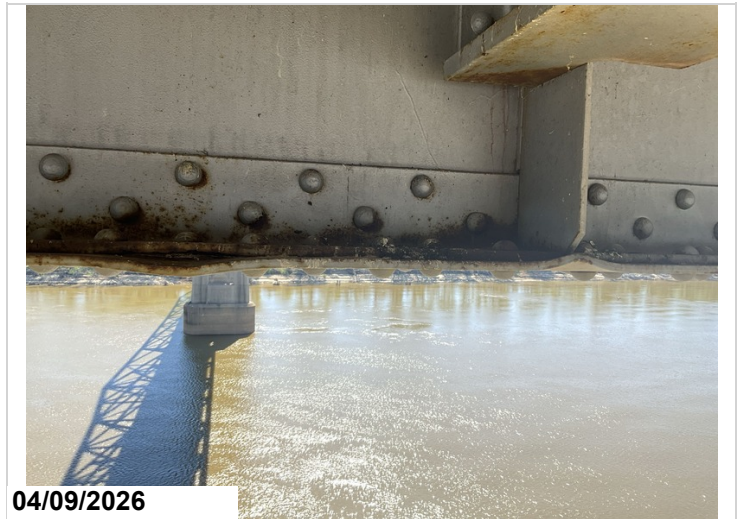
Span 14, Floorbeam 51, Back, Adjacent to Stringer 2: Active corrosion with pack rust up to 5/16" causing distortion. 1LF CS3 corrosion and 1LF CS2 distortion.

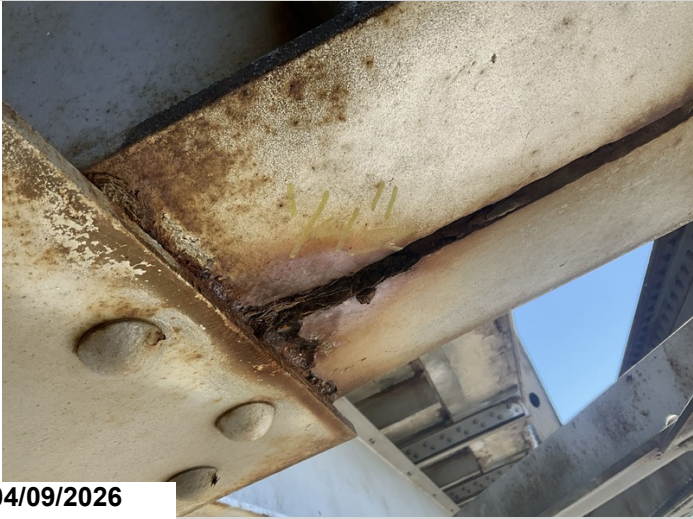
Span 14, Floorbeam 51, Back, Adjacent to Stringer 2: Active corrosion with pack rust up to 5/16" causing distortion. 1LF CS3 corrosion and 1LF CS2 distortion.

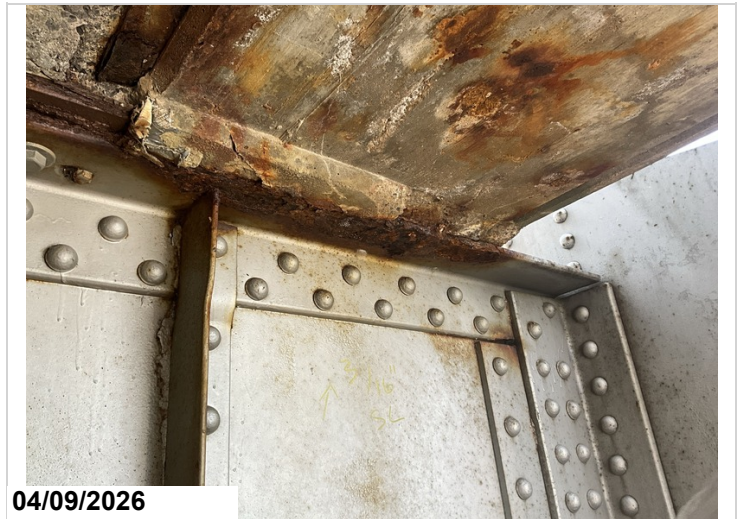
Span 14, Floorbeam 50, Ahead, Adjacent to Stringer 1: Active corrosion with section loss up to 1/4" to the web. 1LF CS3 corrosion.

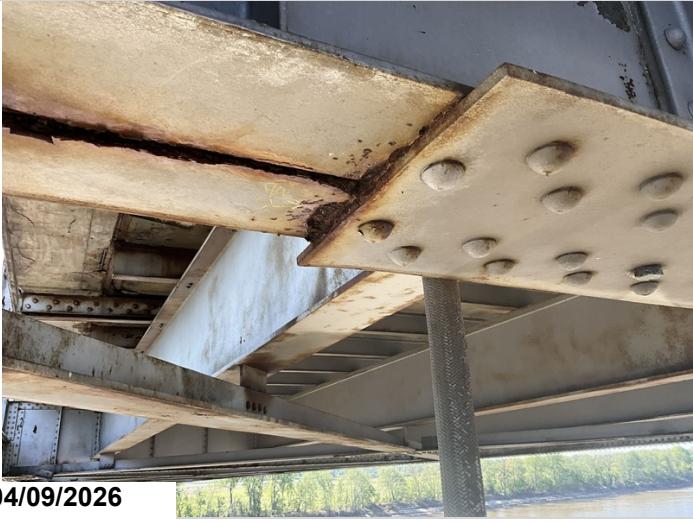
Span 14, Floorbeam 50, Back, Right: Active corrosion with section loss up to 3/16" to the top flange. 3LF CS3 corrosion.

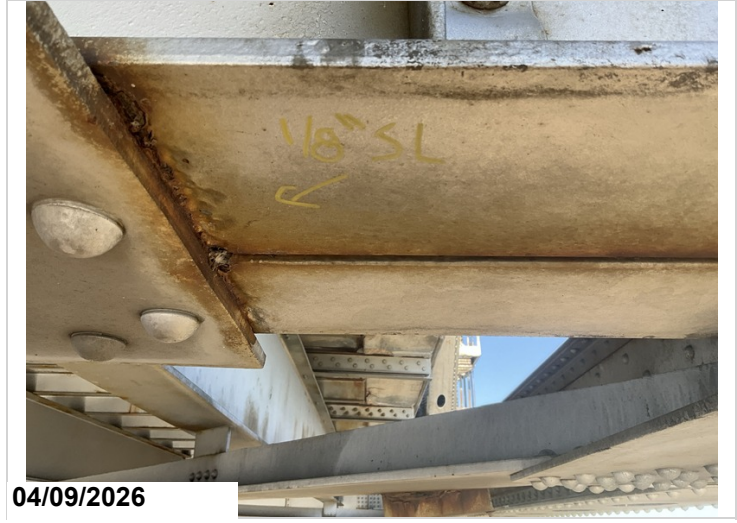
Span 14, Floorbeam 50, Left, Bottom Flange: Active corrosion with section loss up to 1/4" to the bottom flange. 1LF CS3 corrosion.  
Span 14, Floorbeam 50, Right, Bottom Flange: Active corrosion with section loss up to 1/4" to the bottom flange. 1LF CS3 corrosion.

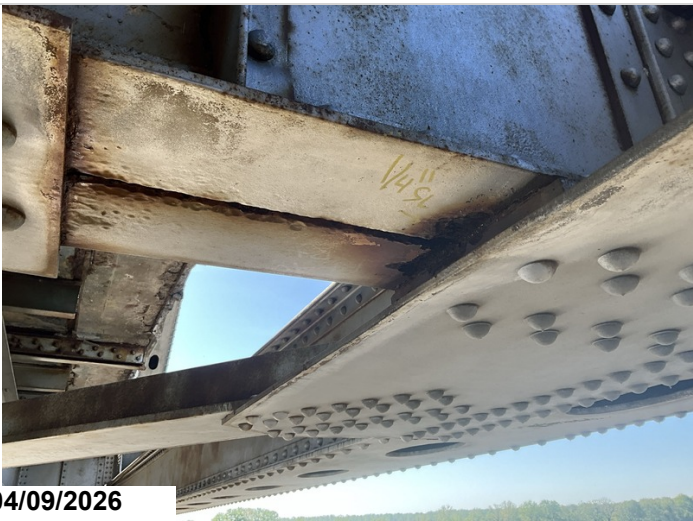
Span 14, Floorbeam 49, Left, Bottom Flange: Active corrosion with section loss up to 1/8" to the bottom flange. 1LF CS3 corrosion.

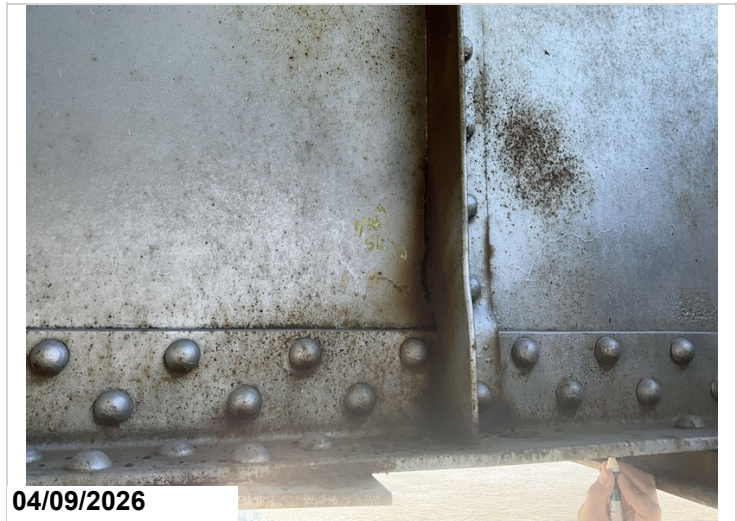
Span 14, Floorbeam 49, Right, Bottom Flange: Active corrosion with section loss up to 1/4" to the bottom flange. 1LF CS3 corrosion.

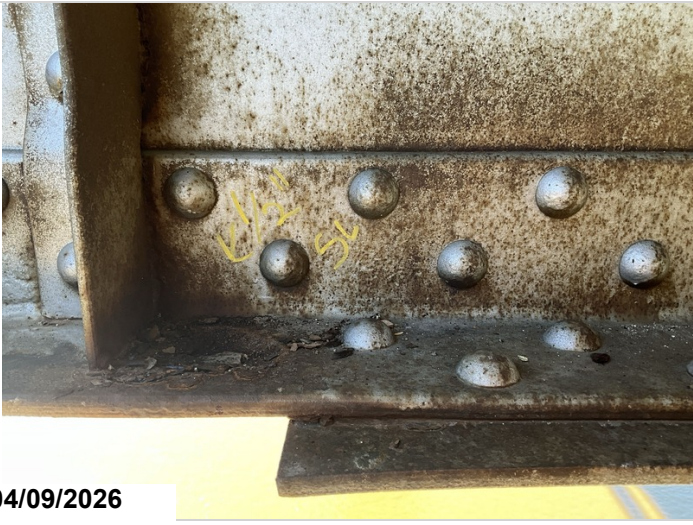
Span 15, Floorbeam 71, Ahead, Adjacent to Stiffener 6:  
Active corrosion with section loss up to 1/2" to the bottom  
flange angle connection. 1LF CS3 corrosion.

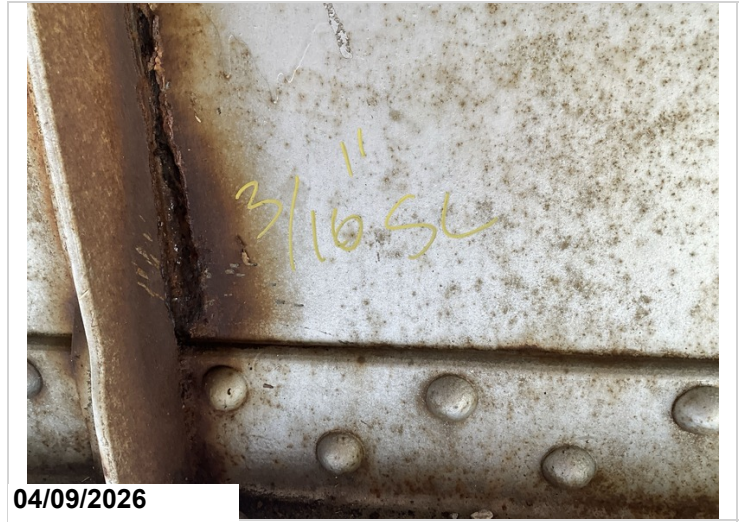
Span 15, Floorbeam 71, Ahead, Adjacent to Stiffener 5:  
Active corrosion with section loss up to 3/16" to the web. 1LF  
CS3 corrosion.

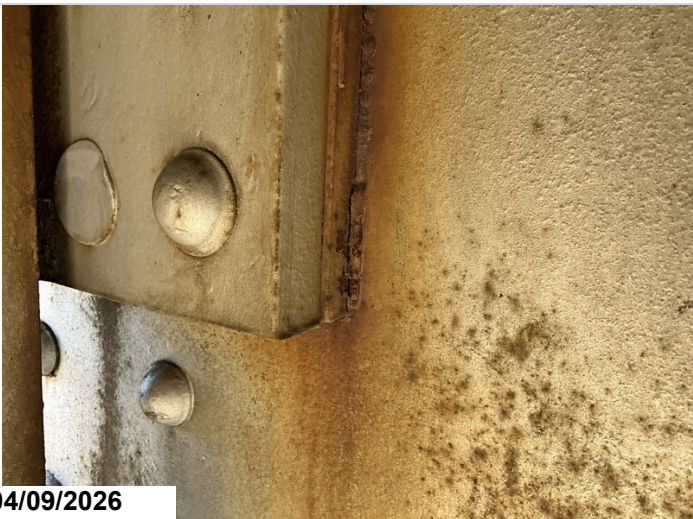
Span 15, Floorbeam 71, Ahead, Adjacent to Stringer 3:  
Cracked tack weld at Pin and Hanger Assembly connection  
plate. Crack has self-arrested. 1LF CS2 crack.

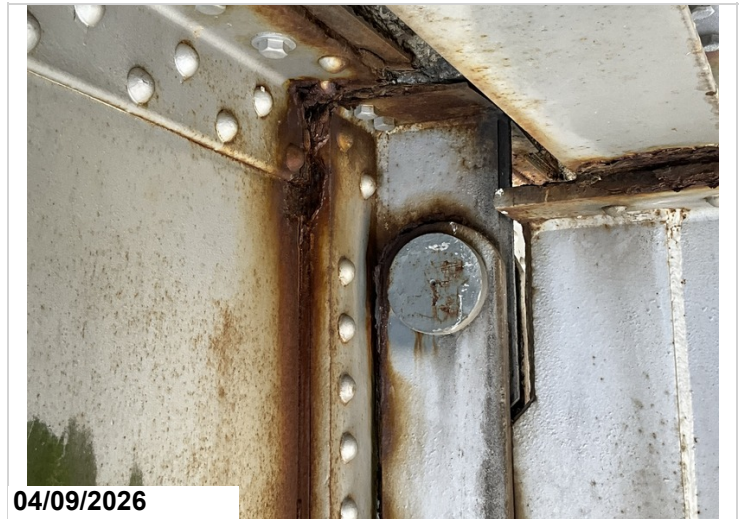
Span 15, Floorbeam 71, Adjacent to the Pin and Hanger  
Assembly at Stringer 2: Active corrosion with section loss up  
to 1/8" to the web. 1LF CS3 corrosion.

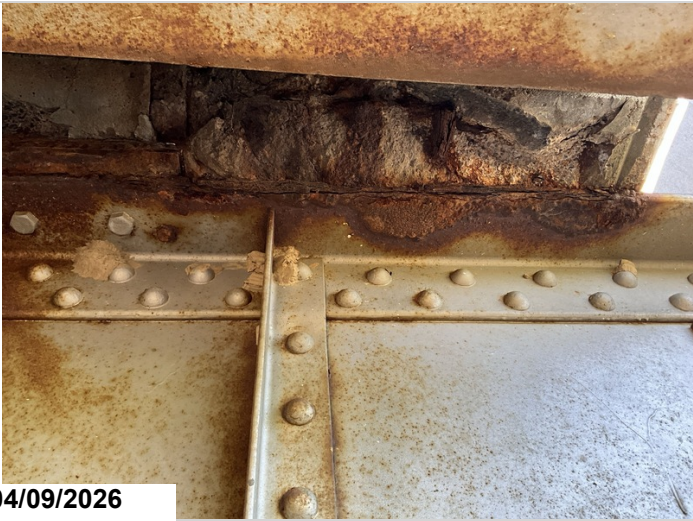
Span 15, Floorbeam 71, Ahead, Above Stiffener 1: Active corrosion with pack rust between the top flange and the deck. 3LF CS3 corrosion.

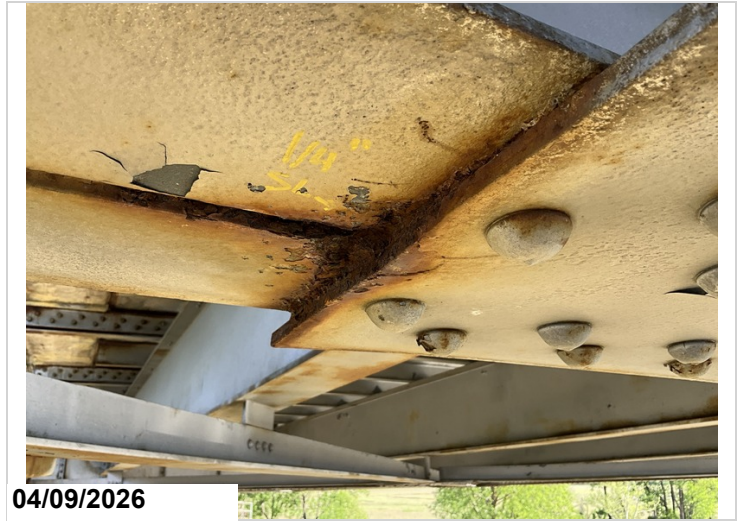
Span 15, Floorbeam 71, Left, Bottom Flange: Active corrosion with section loss up to 1/4" to the bottom flange. 1LF CS3 corrosion.

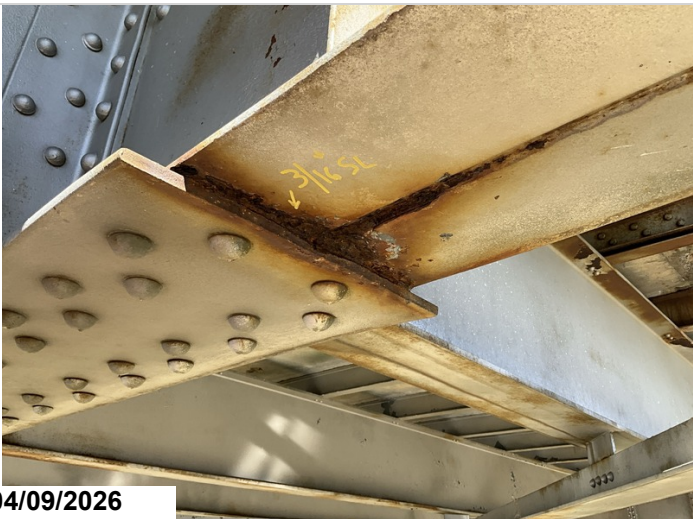
Span 15, Floorbeam 71, Right, Bottom Flange: Active corrosion with section loss up to 3/16" to the bottom flange. 1LF CS3 corrosion.

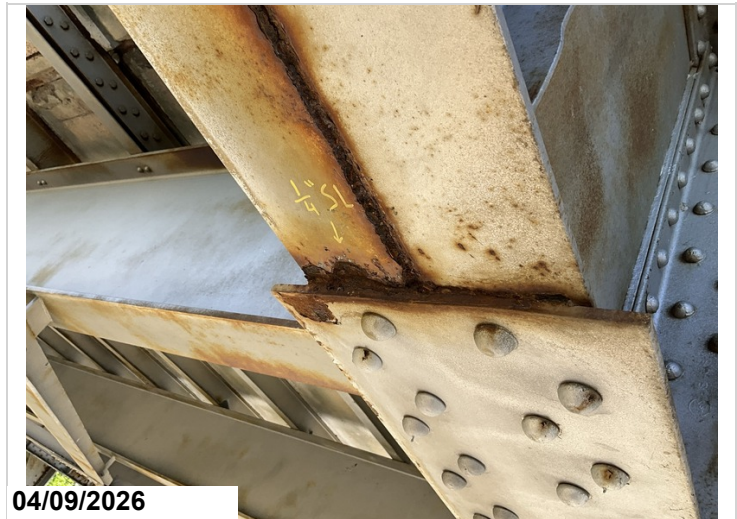
Span 15, Floorbeam 73, Left, Bottom Flange: Active corrosion with section loss up to 1/4" to the bottom flange. 1LF CS3 corrosion.

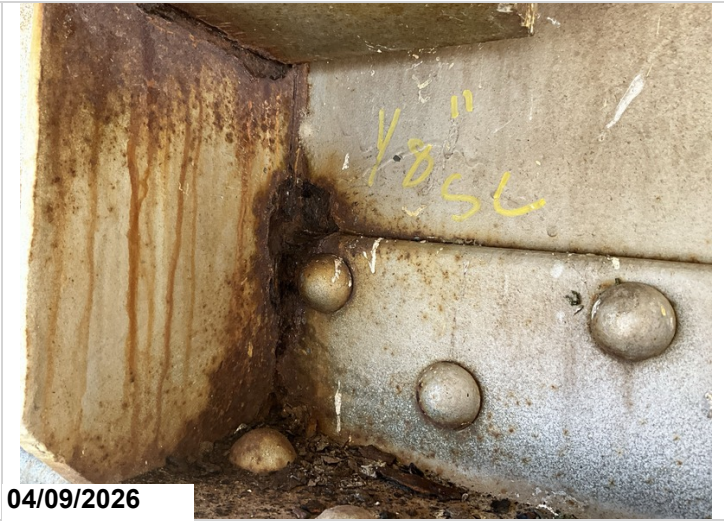
Span 15, Floorbeam 73, Back, Adjacent to Stiffener 2: Active corrosion with section loss up to 1/8" to the web. 1LF CS3 corrosion.

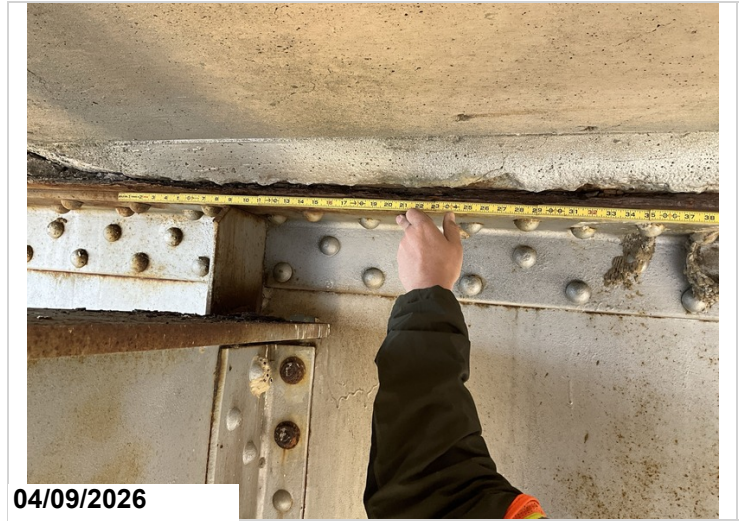
Span 15, Floorbeam 73, Back, Top Flange, Above Stringer 1: Active corrosion with section loss causing holes for a 32" area along the Top Flange. 3LF CS4 corrosion.

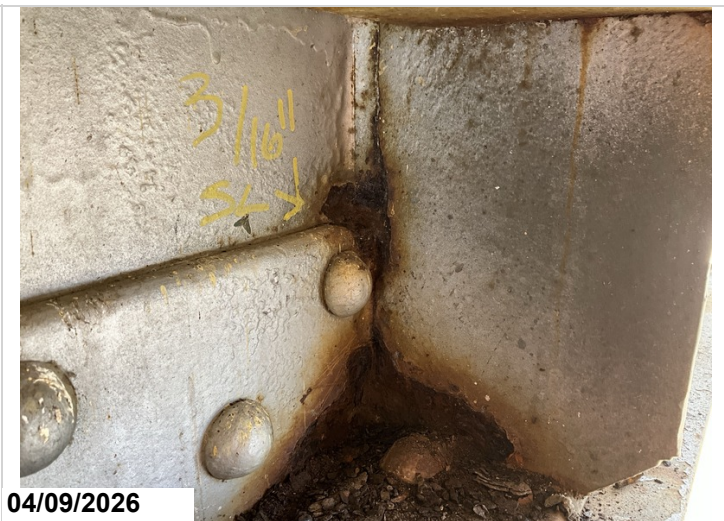
Span 15, Floorbeam 73, Adjacent to Stiffener 8: Active corrosion with section loss up to 3/16" to the web. 1LF CS3 corrosion.

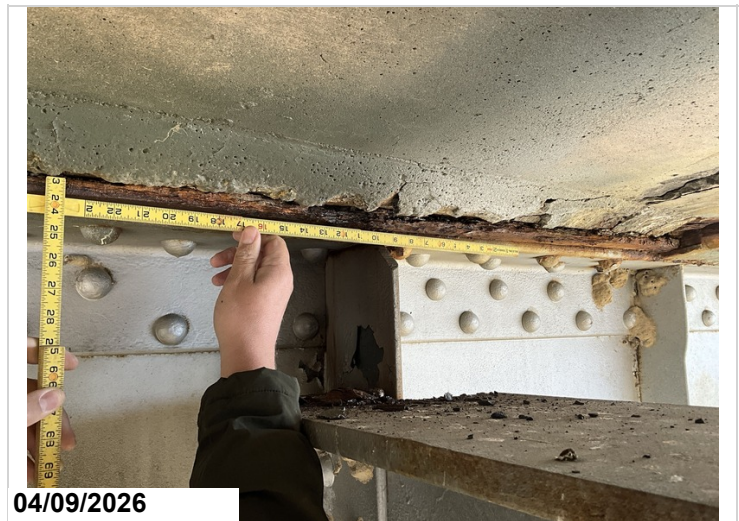
Span 15, Floorbeam 73, Ahead, Above Stringer 3: Active corrosion with pack rust and section loss to the Top Flange causing holes and knife's edge section remaining for 16" X 1". 2LF CS4 corrosion.

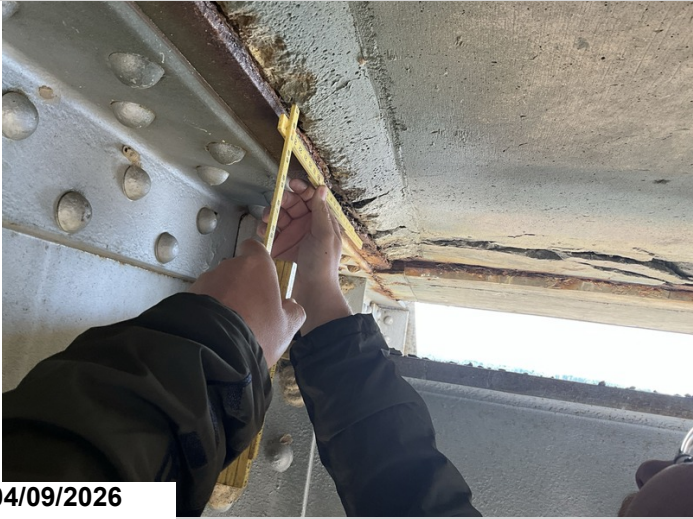
Span 15, Floorbeam 73, Ahead, Above Stringer 3: Active corrosion with pack rust and section loss to the Top Flange causing holes and knife's edge section remaining for 16" X 1". 2LF CS4 corrosion.

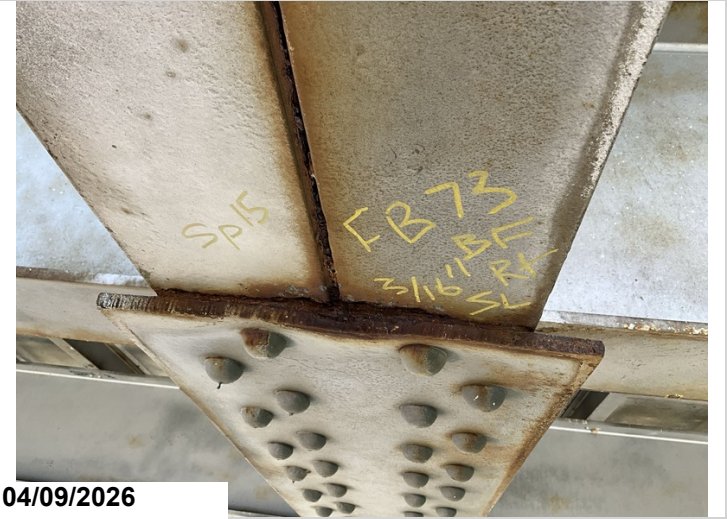
Span 15, Floorbeam 73, Right, Bottom Flange: Active corrosion with section loss up to 3/16" to the bottom flange. 1LF CS3 corrosion.

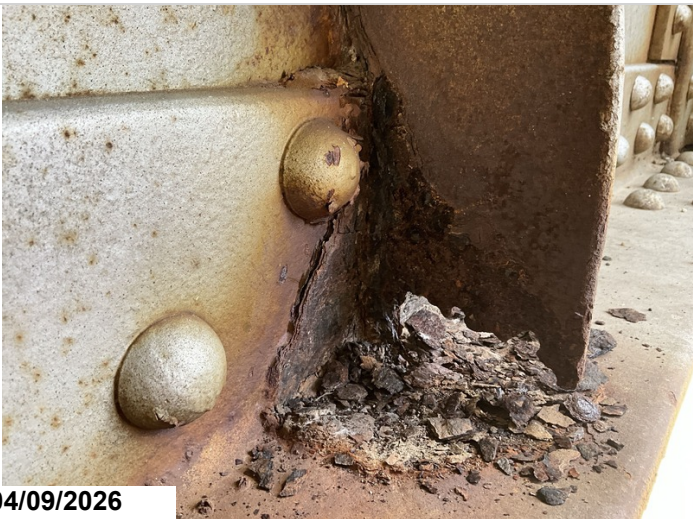
Span 15, Floorbeam 72, Ahead, Stiffener 1: Active corrosion with a hole in the stiffener. 1LF CS3 corrosion.

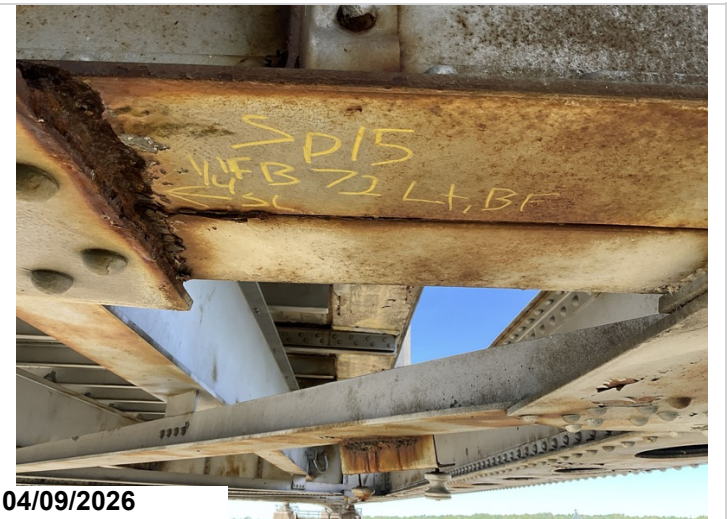
Span 15, Floorbeam 72, Left, Bottom Flange: Active corrosion with section loss up to 1/4" to the bottom flange. 1LF CS3 corrosion.

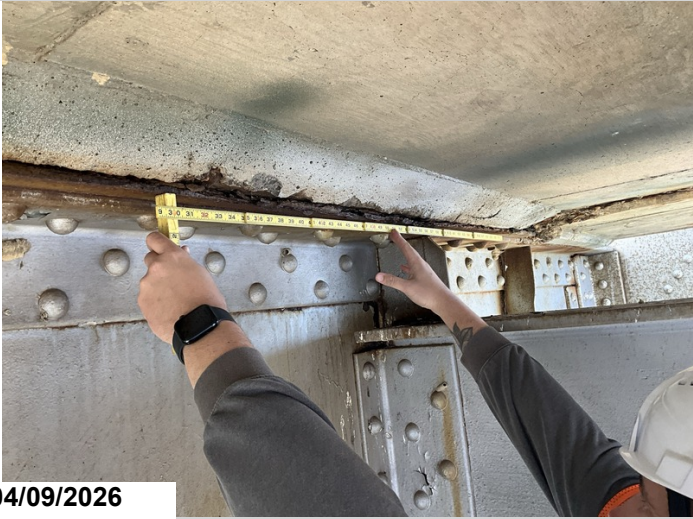
Span 15, Floorbeam 72, Back, Above Stringer 3: Active corrosion with section loss causing holes and knife's edge section remaining to top flange 3'x1". 3LF CS4 corrosion.

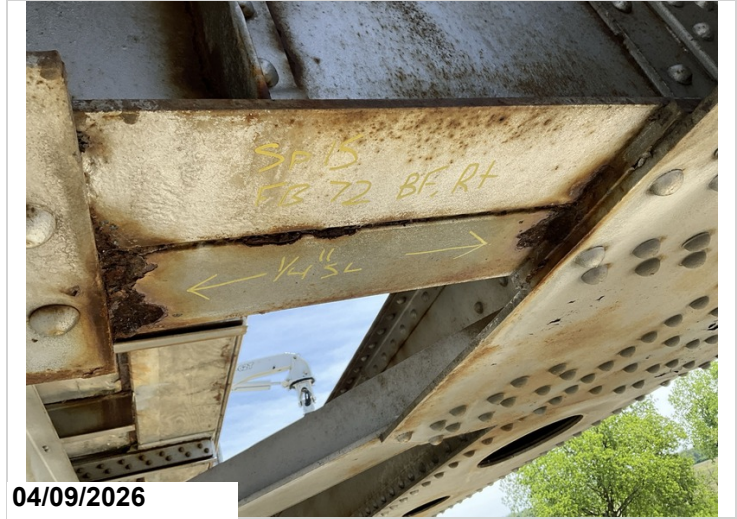
Span 15, Floorbeam 72, Right, Bottom Flange: Active corrosion with section loss up to 1/4" to the bottom flange. 2LF CS3 corrosion.

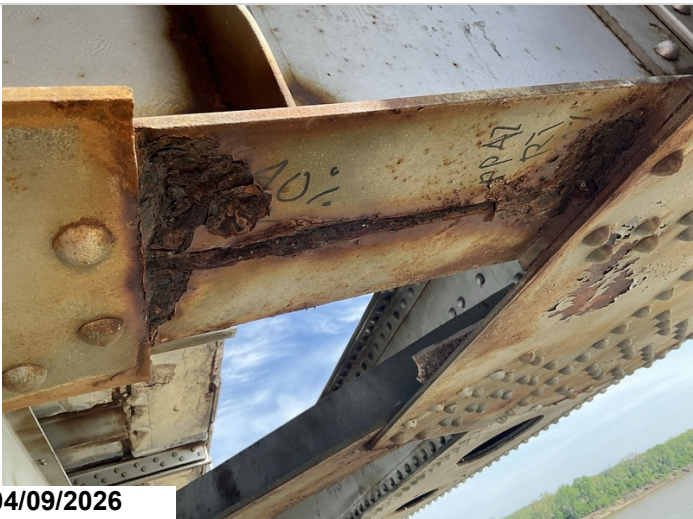
Span 13, Floorbeam 42, Right, Bottom Flange: Active corrosion with section loss up to 1/4" to the bottom flange. 1LF CS3 corrosion.

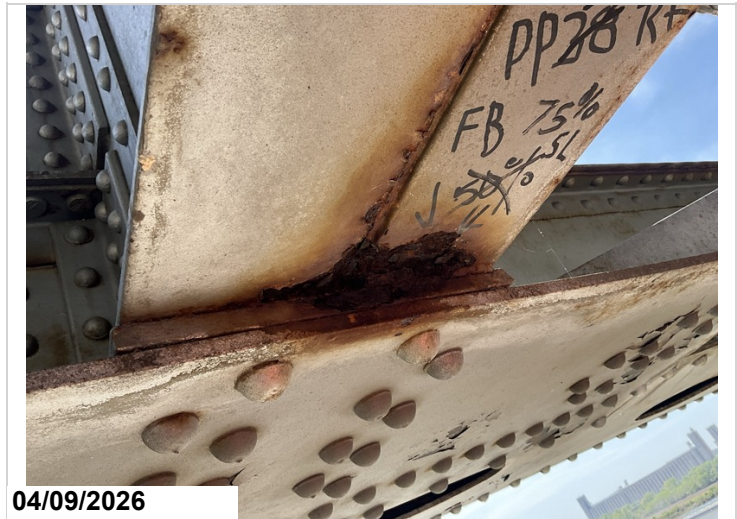
Span 13, Floorbeam 37, Right, Bottom Flange: Active corrosion with section loss up to 3/8" to the bottom flange. 2LF CS3 corrosion.

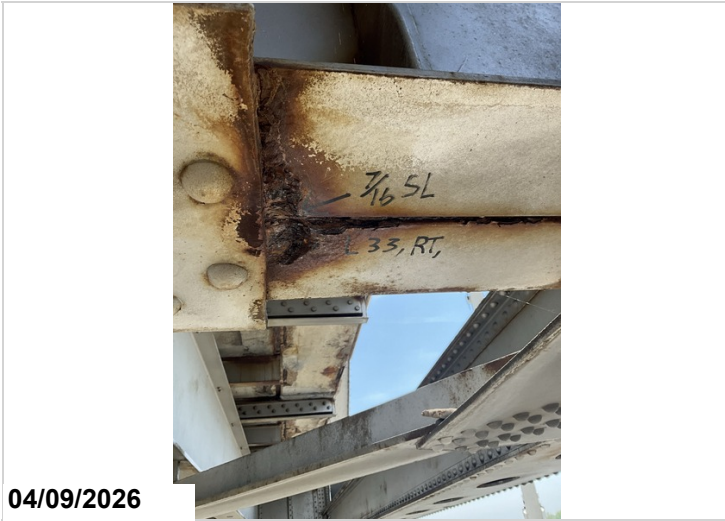
Span 13, Floorbeam 33, Right, Bottom Flange: Active corrosion with section loss up to 7/16" to the bottom flange. 1LF CS3 corrosion.

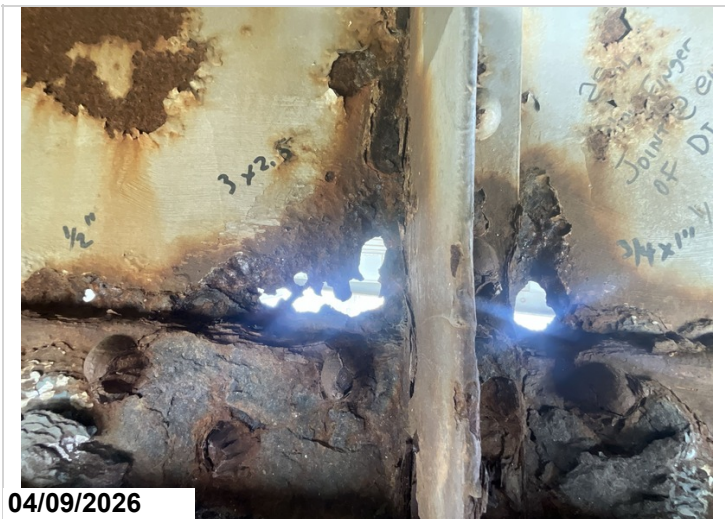
Span 12, Ahead Floorbeam at PP25, Adjacent to Stiffener 7: Active corrosion with a 1/2" diameter hole, 3" X 2 1/2" hole, and a 1" X 3/4" hole in the web. 2LF CS4 corrosion.

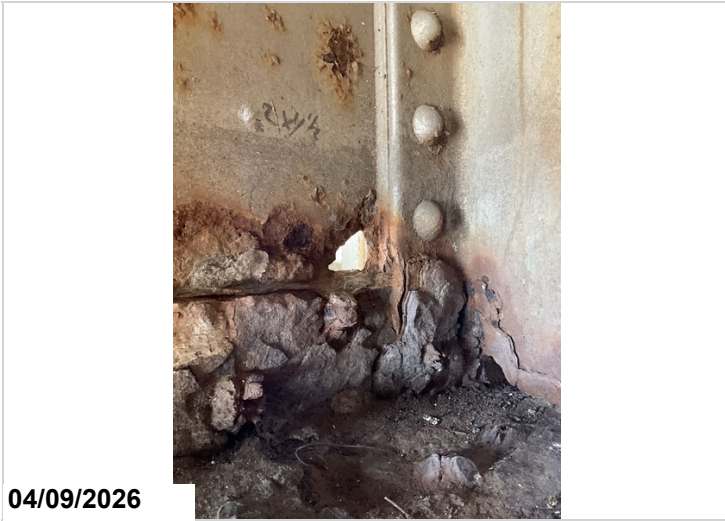
Span 12, Back Floorbeam at PP25, Adjacent to Stiffener 5:  
Active corrosion with a 2" X 1 1/2" hole in the web. 1LF CS4 corrosion.

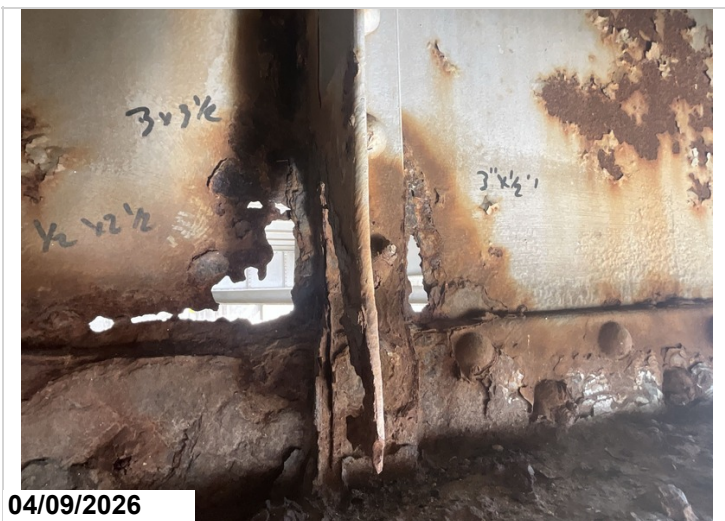
Span 12, Ahead Floorbeam at PP25, Adjacent to Stiffener 6:  
Active corrosion with a 4" X 6" hole and a 3" X 1/2" hole in the web. 1LF CS4 corrosion.

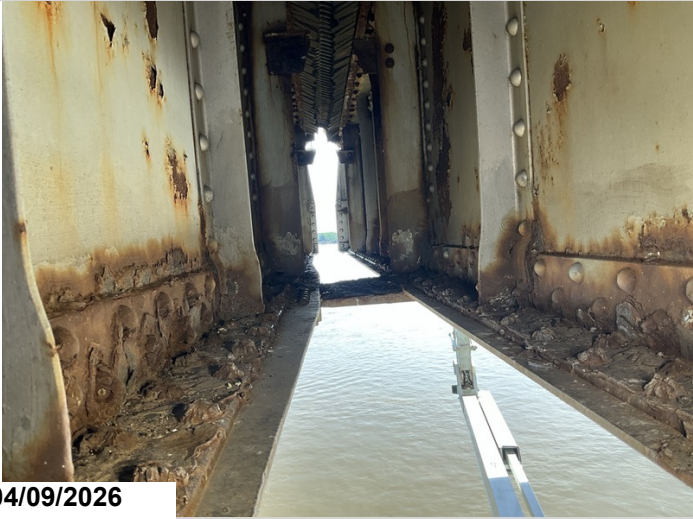
Span 12, Floorbeams at PP25: Heavy corrosion along the bottom flange. 60LF CS3 corrosion. Minus CS4

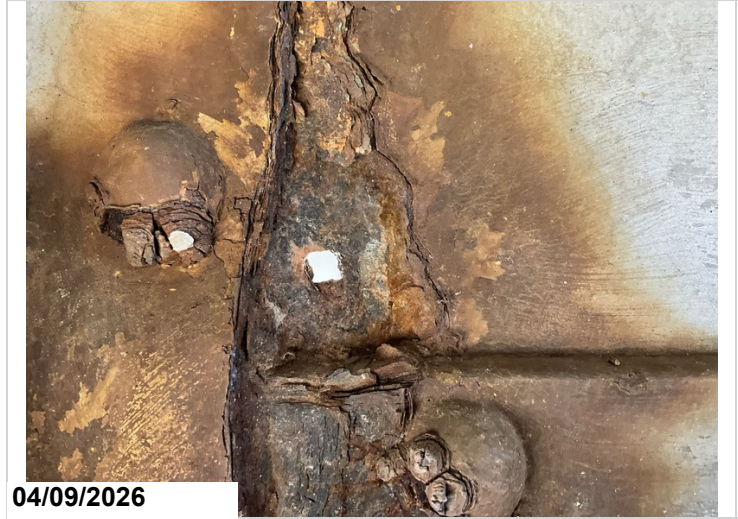
Span 12, Back Floorbeam at PP25, Adjacent to Stiffener 3: Active corrosion with a 1/2" diameter hole in the web. 1LF CS4 corrosion.  
Span 12, Ahead Floorbeam at PP25, Adjacent to Stiffener 3: Active corrosion with a 1/2" diameter hole in the web. 1LF CS4 corrosion.

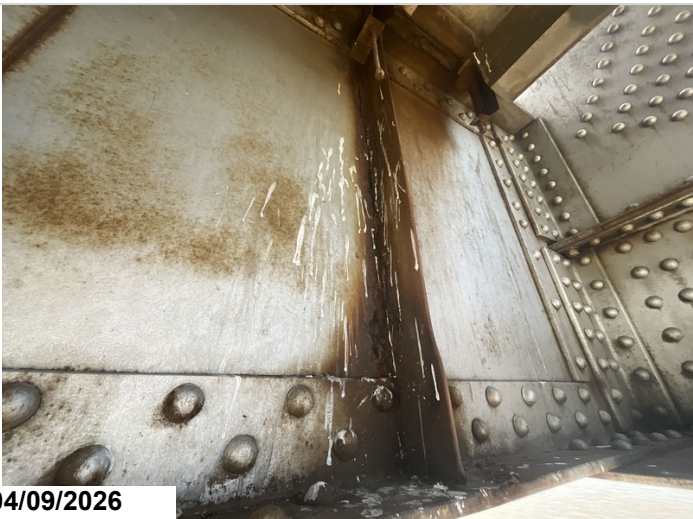
Span 12, Floorbeam 24, Ahead, Adjacent to Stiffener 1: Active corrosion with pack rust between the web and the stiffener. 1LF CS3 corrosion.
