## Bridge 02899 Inspection Report

Arnold Road ID:54x49x11xA, Arnold Log mile:0.569

# National Bridge Inventory Data Sheet

| IDENTIFICATION | |
|---|---|
| (7) Facility Carried | US 49- Phillips Co |

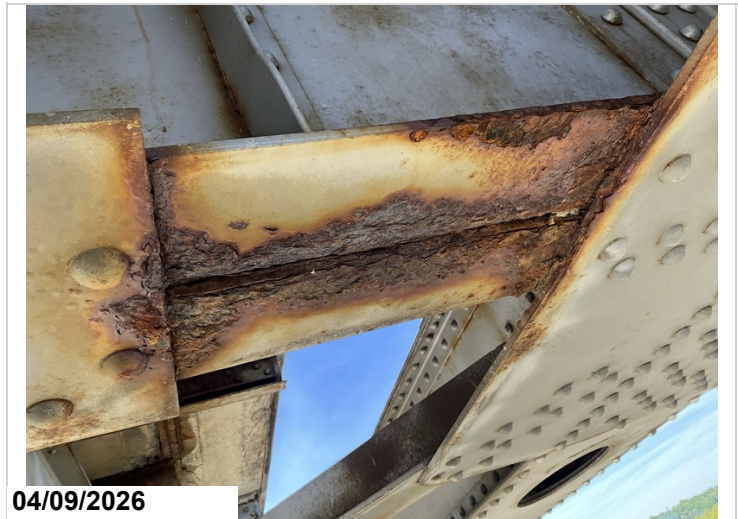
Span 12, Floorbeam 22, Left, Bottom Flange: Active corrosion with moderate flaking rust and section loss to the bottom flange. 2LF CS3 corrosion.

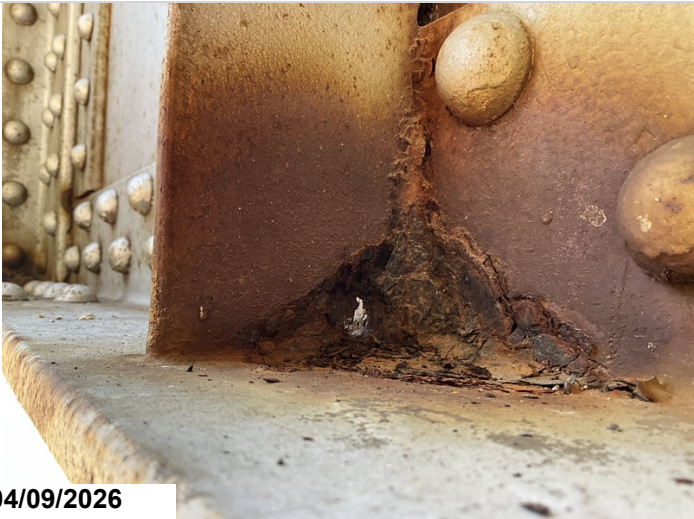
Span 12, Floorbeam 21, Ahead, Adjacent to Stiffener 9:  
Active corrosion with section loss up to 1/4" to the bottom  
flange angle connection, along with a hole in the stiffener.  
1LF CS3 corrosion.

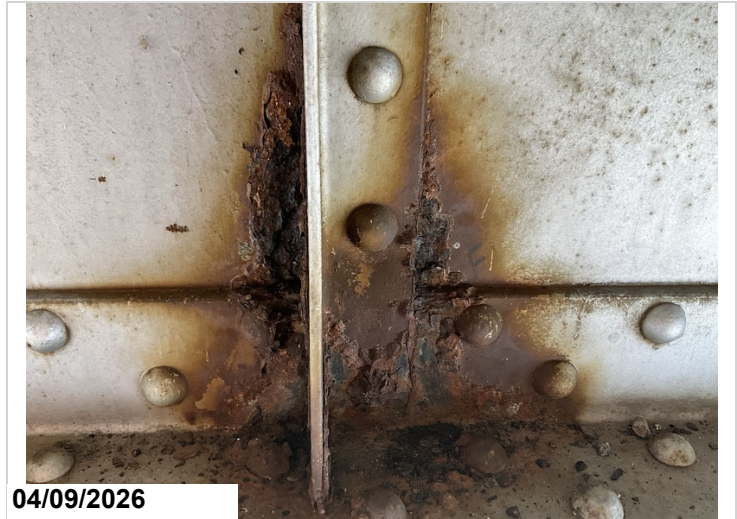
Span 12, Floorbeam 22, Adjacent to Stiffener 5: Active  
corrosion with section loss up to 1/8" to the web. 1LF CS3  
corrosion.

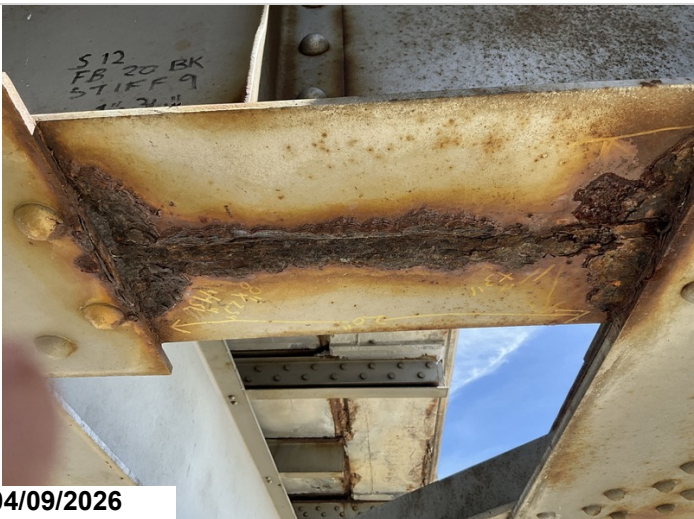
Span 12, Floorbeam 20, Right, Bottom Flange: Active  
corrosion with section loss up to 1/4" to the bottom flange.  
2LF CS3 corrosion.

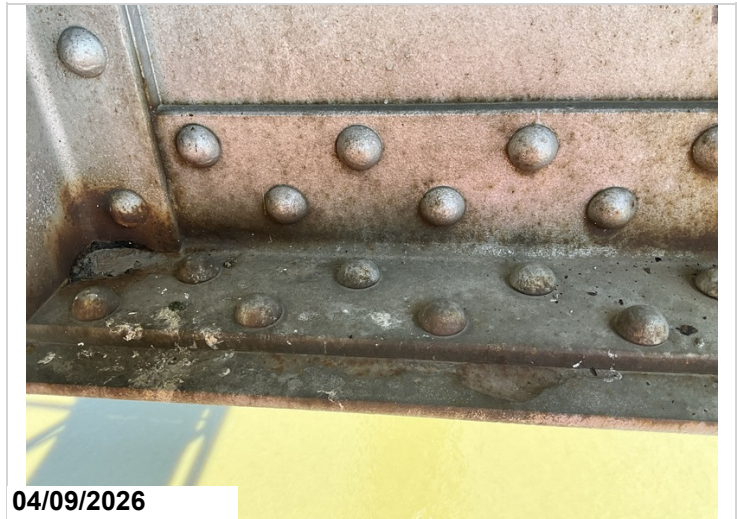
Span 12, Floorbeam 20, Back, Right: Active corrosion with  
section loss to the bottom flange cover plate. 2LF CS3  
corrosion.

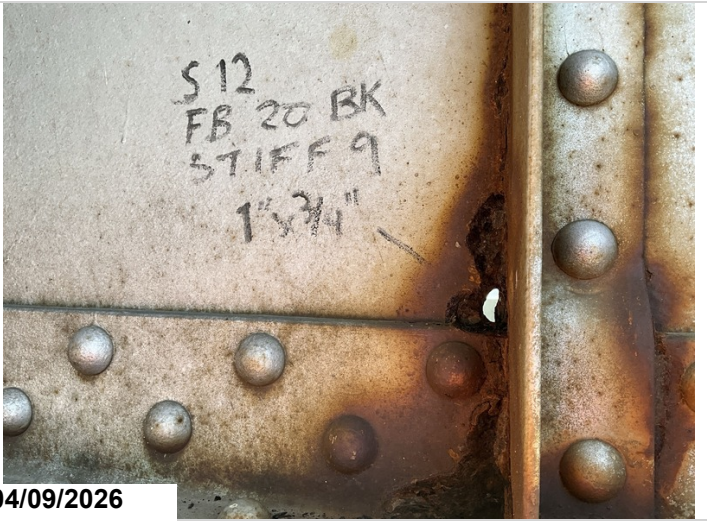
Span 12, Floorbeam 20, Back, Adjacent to Stiffener 9: Active corrosion with a 1" X 3/4" hole in the web. 1LF CS4 corrosion.

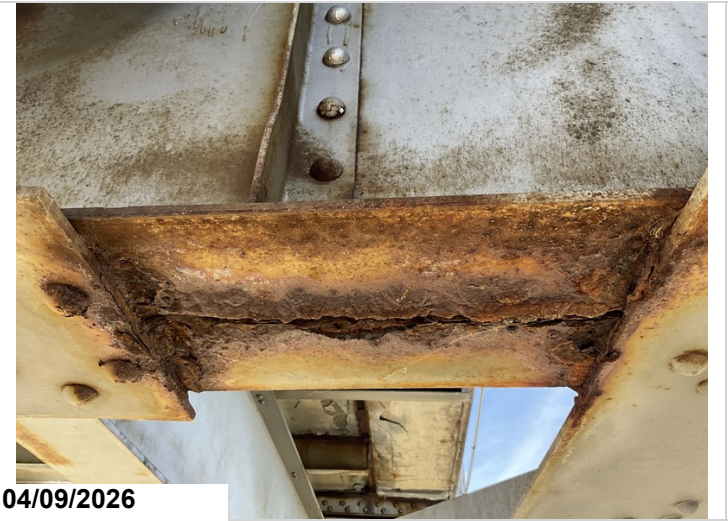
Span 12, Floorbeam 18, Left, Bottom Flange: Active corrosion with section loss up to 5/16" to the bottom flange. 2LF CS3 corrosion.

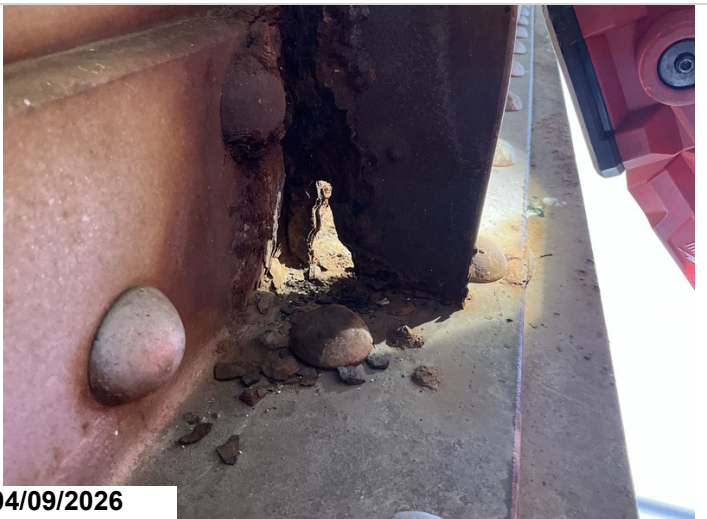
Span 12, Floorbeam 18, Ahead, Stiffener 3: Active corrosion with a hole in the bottom of the stiffener. 1LF CS3 corrosion.

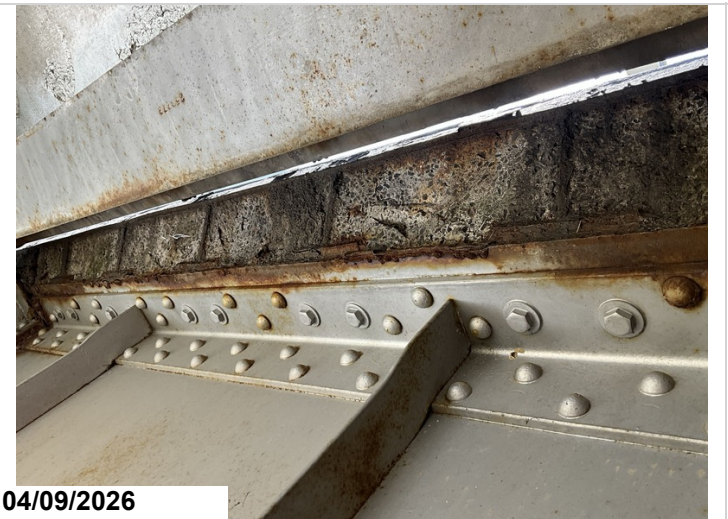
Span 12, Floorbeam 18, Ahead: Moderate corrosion along the top flange. 12LF CS3 corrosion.

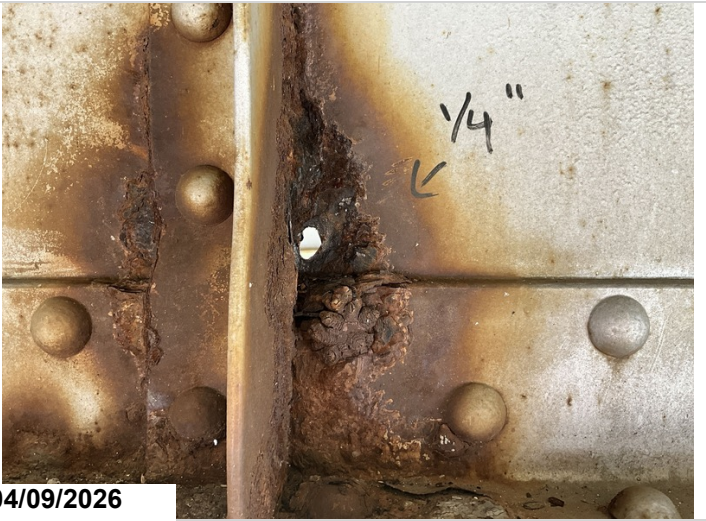
Span 12, Floorbeam 18, Back, Adjacent to Stiffener 7: Active corrosion with a 1" X 5/8" hole in the web. 1LF CS4 corrosion.

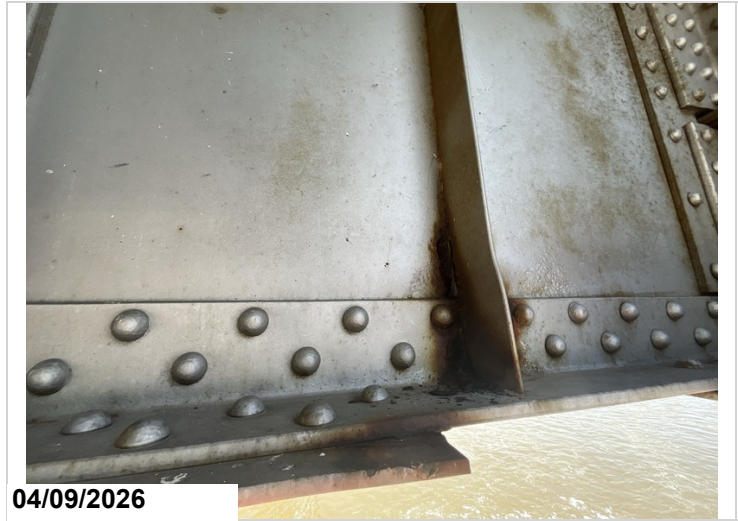
Span 12, Floorbeam 18, Back, Adjacent to Stiffener 9: Active corrosion with section loss up to 3/16" to the web. 1LF CS3 corrosion.

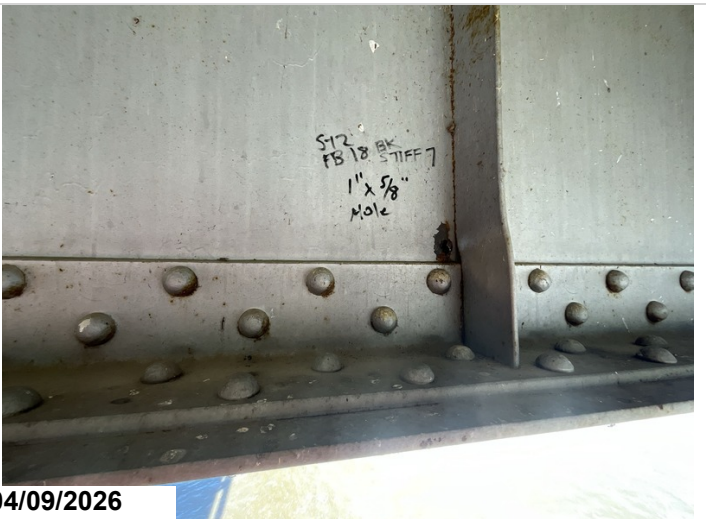
Span 12, Floorbeam 18, Back, Adjacent to Stiffener 7: Active corrosion with a 1" X 5/8" hole in the web. 1LF CS4 corrosion.

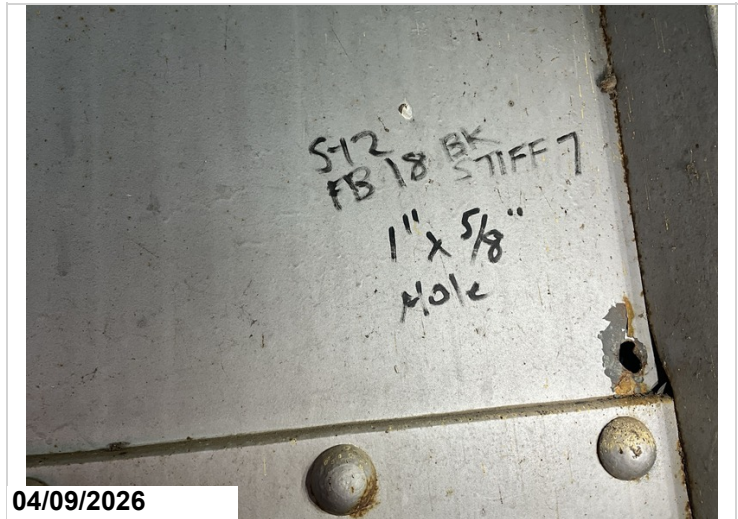
Span 12, Floorbeam 18, Back, Adjacent to Stiffener 7: Active corrosion with a 1" X 5/8" hole in the web. 1LF CS4 corrosion.

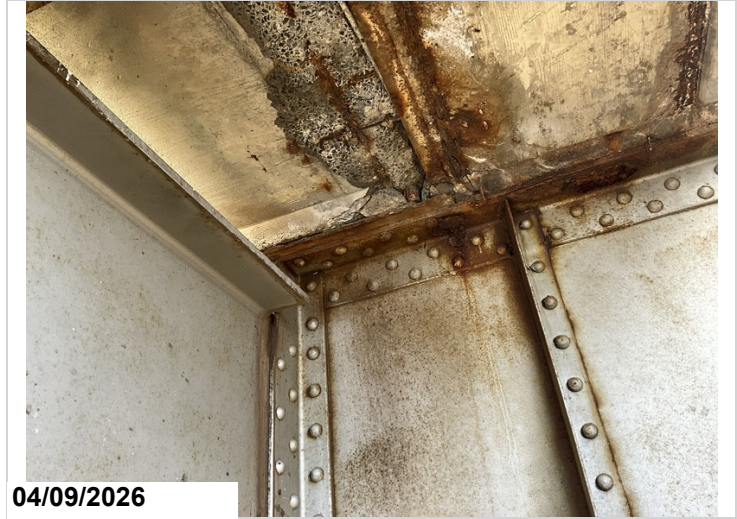
Span 12, Floorbeam 16, Left, Bottom Flange: Active corrosion with section loss up to 5/16" to the bottom flange. 2LF CS3 corrosion.

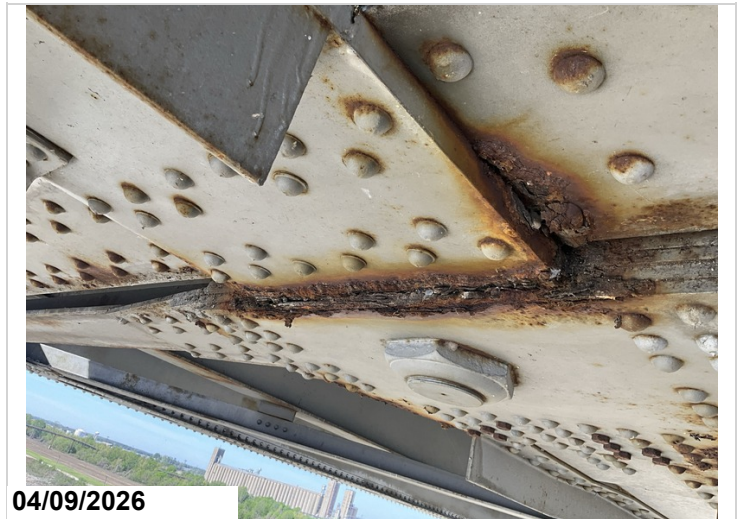
Span 12, Floorbeam 15, Right, Bottom Flange: Active corrosion with section loss up to 5/16" to the bottom flange. 2LF CS3 corrosion.

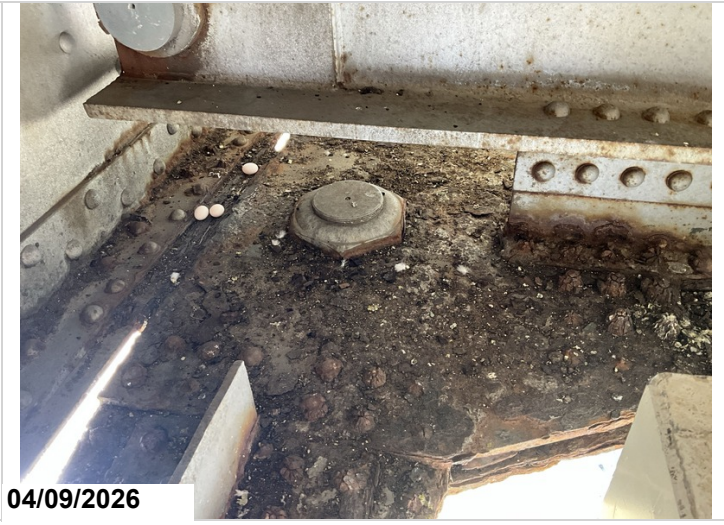
Span 12, PP15, Windlock: Heavy corrosion. CS3 corrosion.

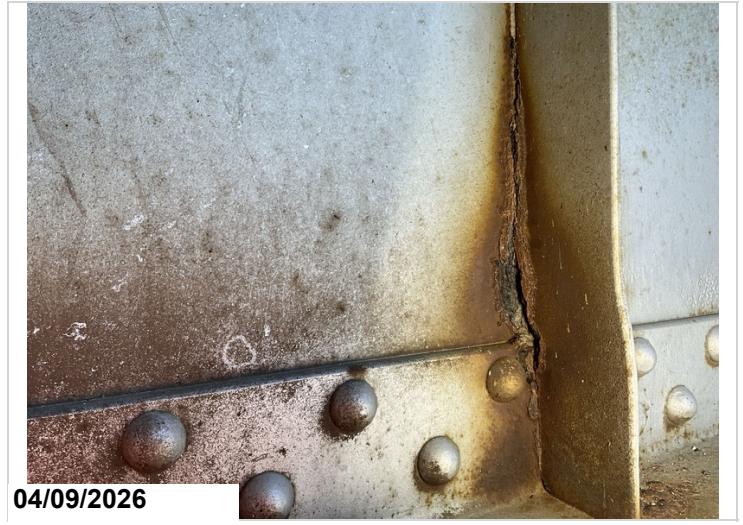
Span 12, PP15, Windlock: Heavy corrosion. CS3 corrosion.

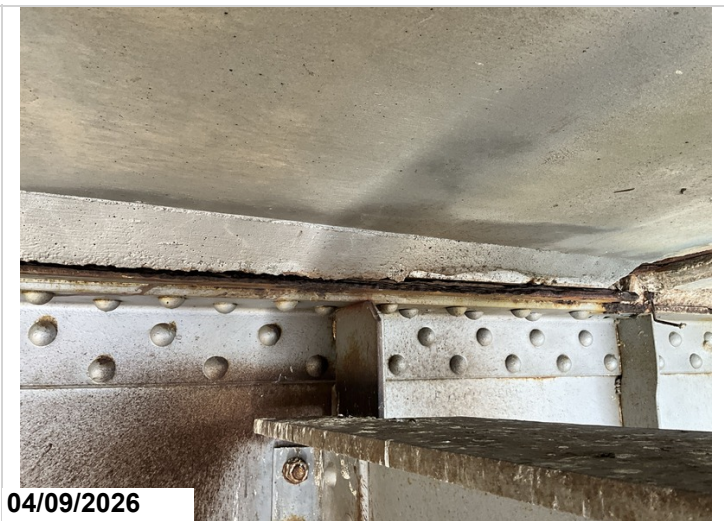
Span 12, Floorbeam 16, Baack, Adjacent to Stiffener 9:  
Active corrosion with pack rust. 1LF CS3 corrosion.

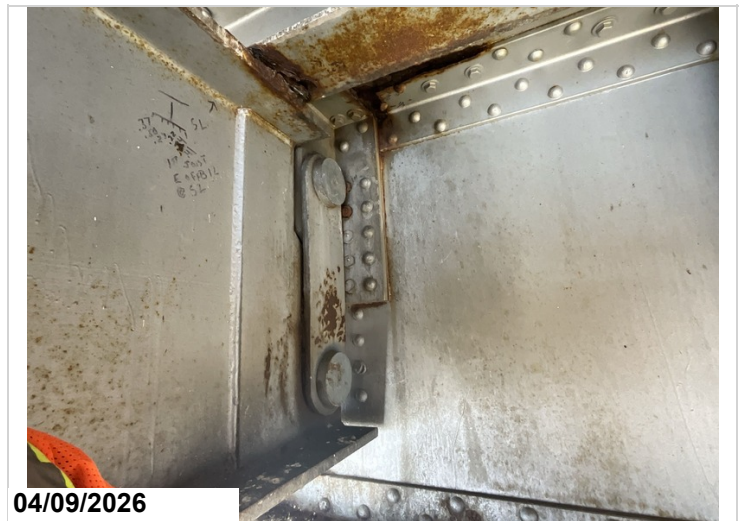
Span 12, Floorbeam 14, Ahead, Adjacent to Stringer 1:  
Active corrosion with pack rust between the top flange and  
the deck. 5LF CS3 corrosion.

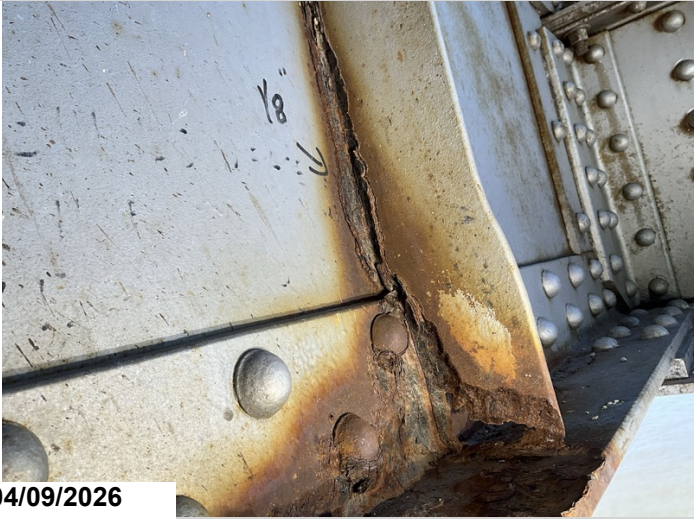
Span 12, Floorbeam 12, Ahead, Adjacent to Stringer 2:  
Active corrosion with section up to 3/8\"/>

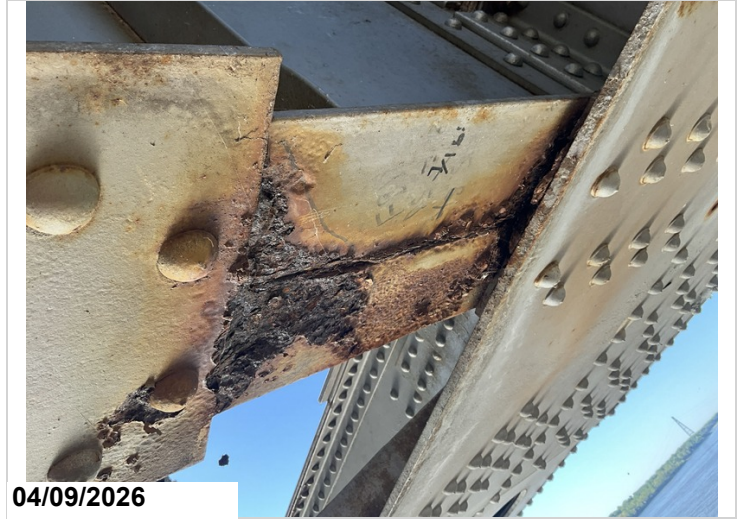
Span 12, Floorbeam 14, Back, Stiffener 9: Active corrosion with pack rust between the web and the stiffener up to 1/8" and a hole in the bottom of the stiffener. 1LF CS3 corrosion.

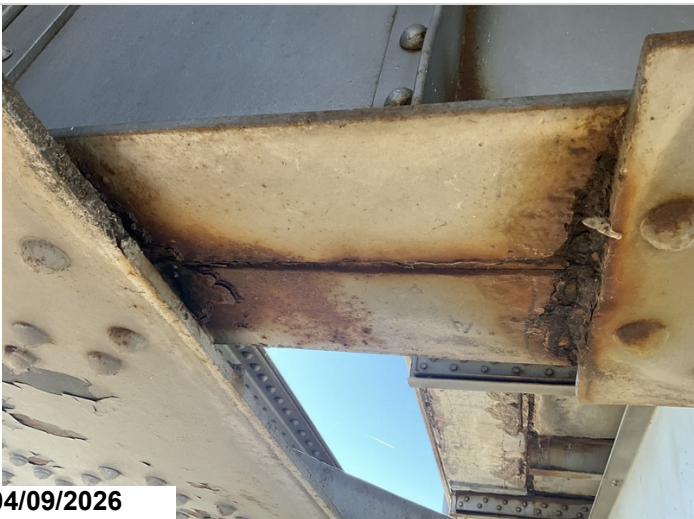
Span 12, Floorbeam 12, Right, Bottom Flange: Active corrosion with section loss up to 3/8" to the bottom flange. 2LF CS3 corrosion.

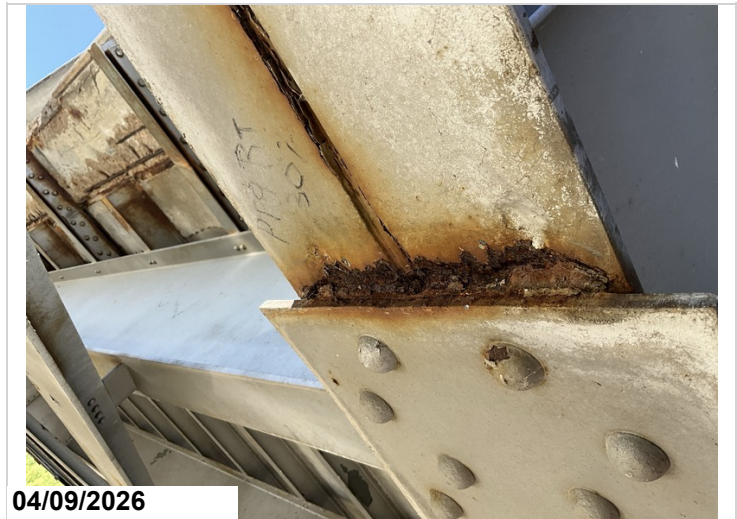
Span 11, Floorbeam 8, Right, Bottom Flange: Active corrosion with section loss up to 1/4" to the bottom flange. 2LF CS3 corrosion.

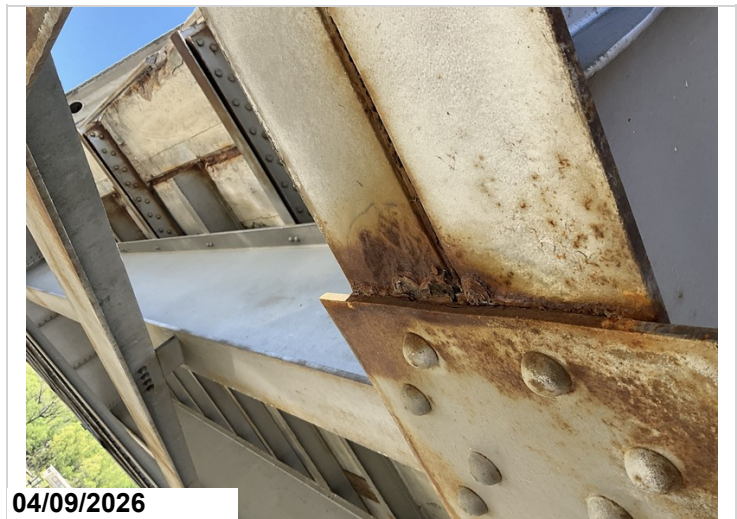
Span 11, Floorbeam 6, Right, Bottom Flange: Active corrosion with section loss up to 3/8" to the bottom flange. 1LF CS3 corrosion.

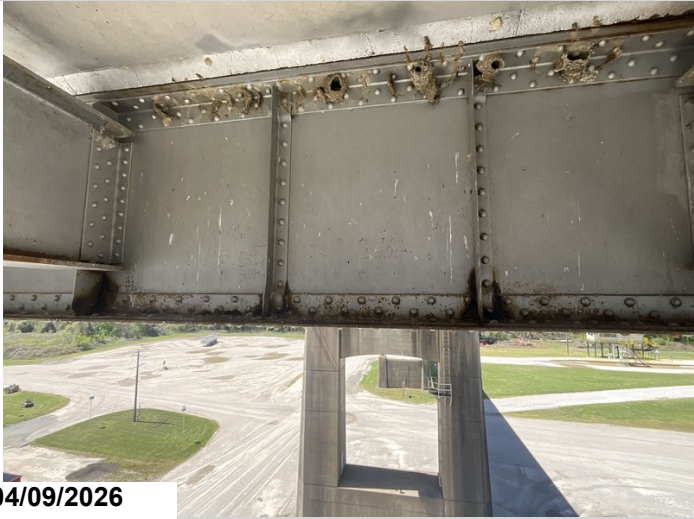
Span 11, Floorbeam 7, Right, Bottom Flange: Active corrosion with pack rust between the bottom flange and the cover plate. 1LF CS3 corrosion.

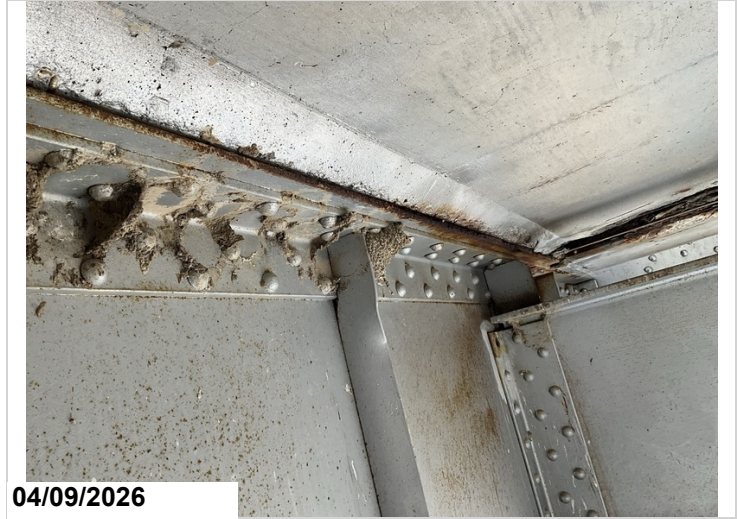
Span 11, Floorbeam 2, Ahead: Active corrosion with section loss up to 1/4" to the web adjacent to the stiffeners. 5LF CS3 corrosion.

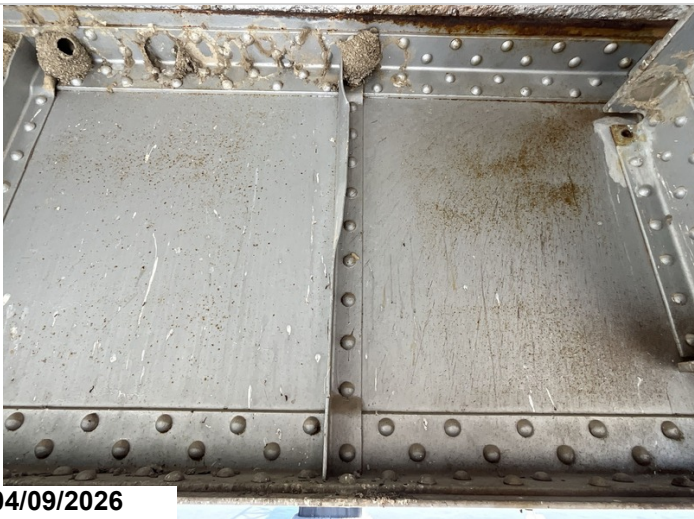
Span 11, Floorbeam 2, Back: Moderate corrosion to the top flange. 6LF CS3 corrosion.

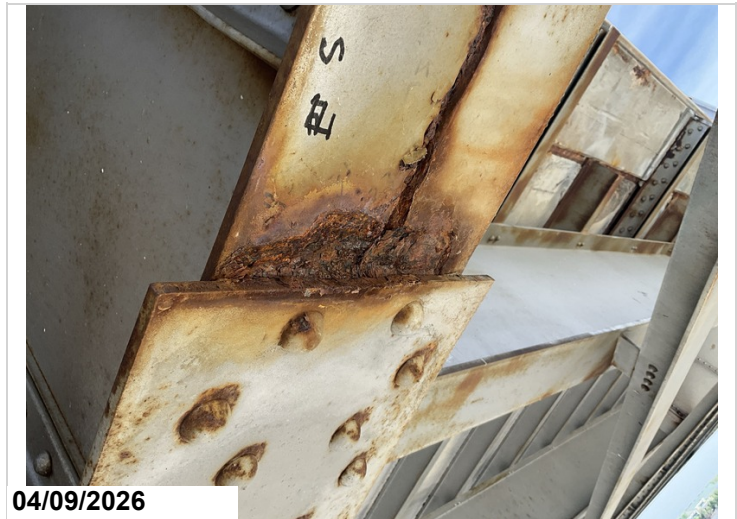
Span 11, Floorbeam 2, Back, Stiffener 7: Minor distortion in the stiffener. 1LF CS2 distortion.

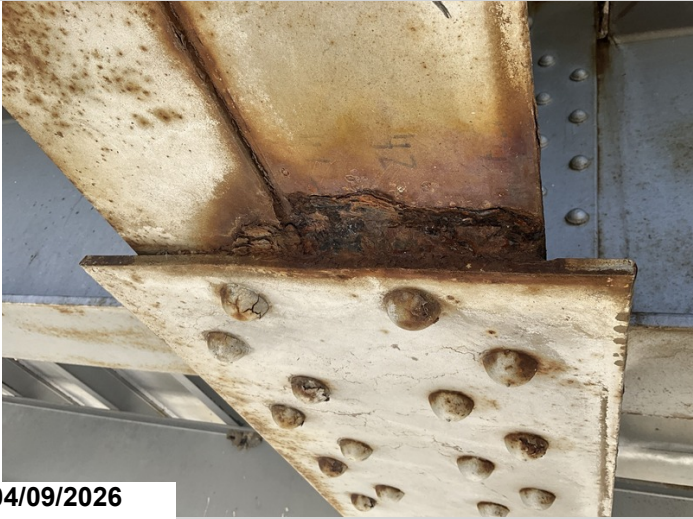
Span 11, Floorbeam 2, Right, Bottom Flange: Active corrosion with section loss up to 1/2" to the bottom flange. 2LF CS3 corrosion.

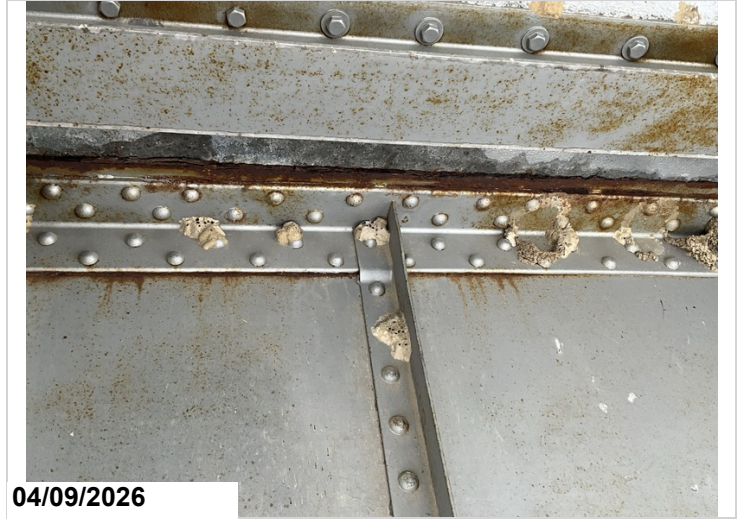
Span 11, Floorbeam 1, Left, Bottom Flange: Active corrosion with section loss up to 3/8" to the bottom flange. 1LF CS3 corrosion.

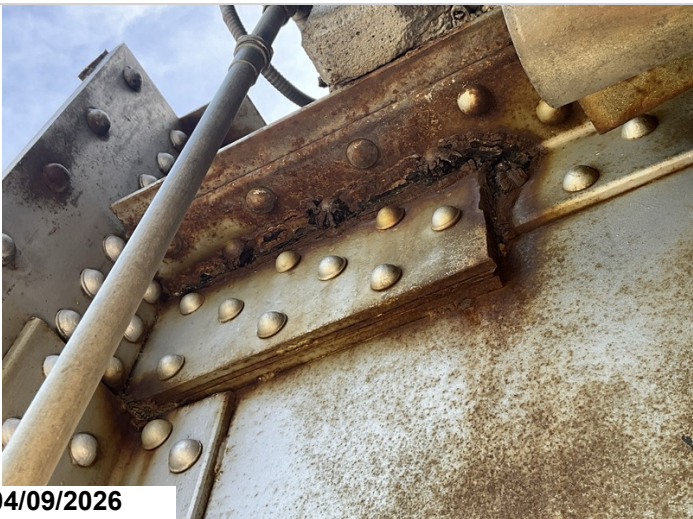
Span 11, Floorbeam 0, Ahead, Bay 2: Active corrosion with section loss to the top flange. 10LF CS3 corrosion.

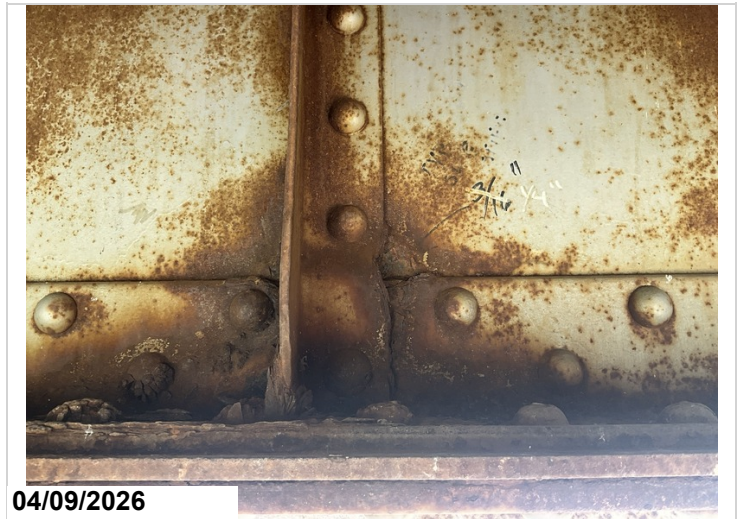
Span 11, Floorbeam 0, Back, Left and Right: Moderate corrosion to the top flange and the rivets. 4LF CS3 corrosion.

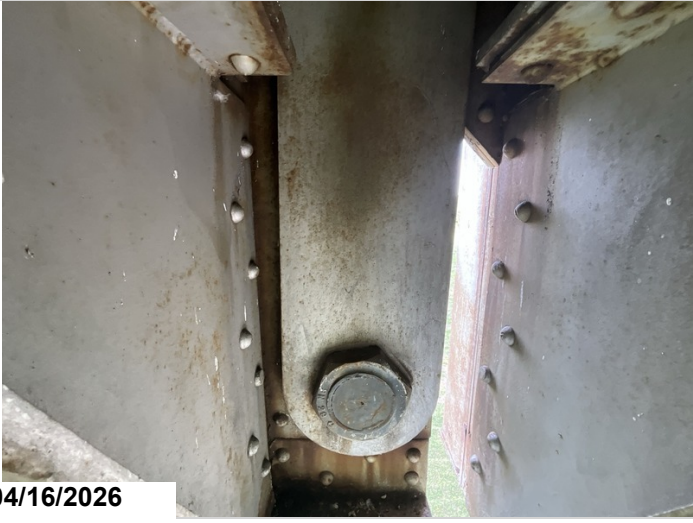
Span 11, Floorbeam 0 back, stiffener 6: Active corrosion with 1/4" section loss to the web above the bottom flange angle. Stiffeners 3-7 are in similar condition. 5LF CS3 corrosion.

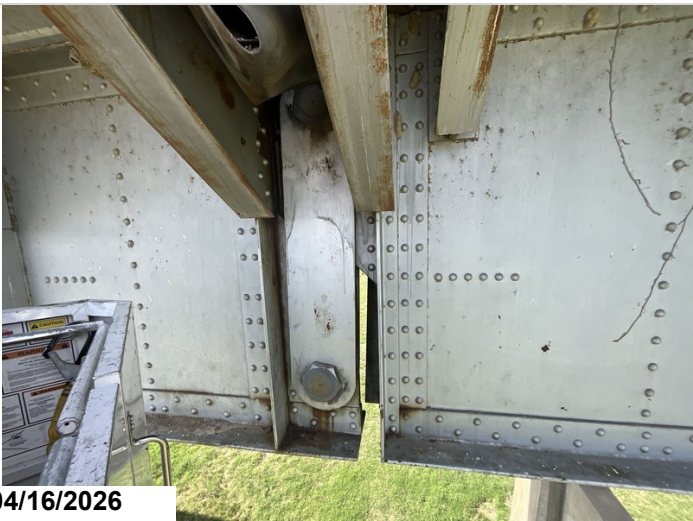
Span 19, Girder 1, right hanger of pin and hanger assembly: corrosion with up to 3/8" section loss to back side of hanger bar at lower pin section. 1EA CS3 corrosion.

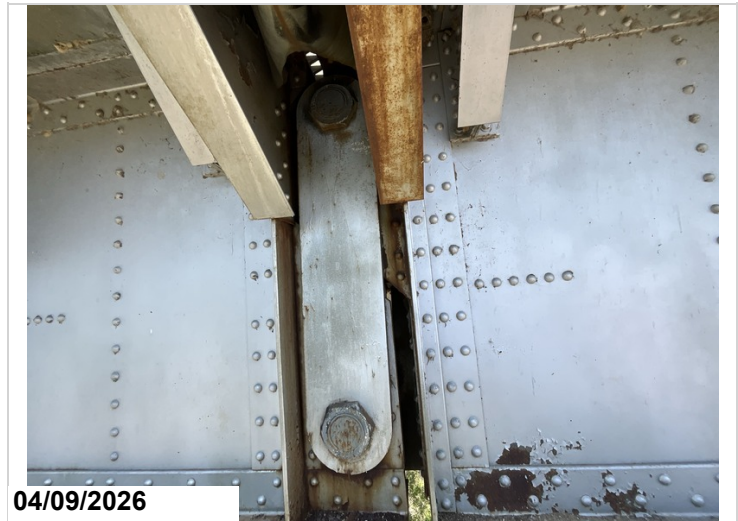
Span 19, Girder 1: pin and hanger assembly. Minor surface corrosion on exterior.

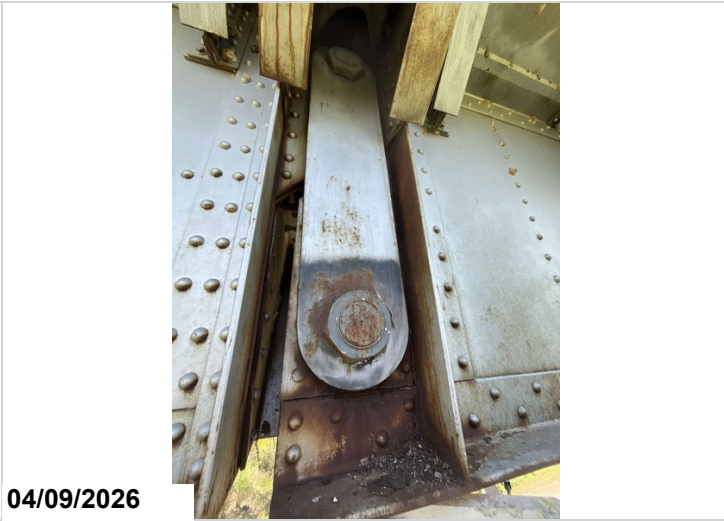
Span 7, Girder 2, Pin and Hanger Assembly: Active corrosion with section loss to the back side of the hanger bar ranging from 3/16" to 1/4". 1EA CS3 corrosion.

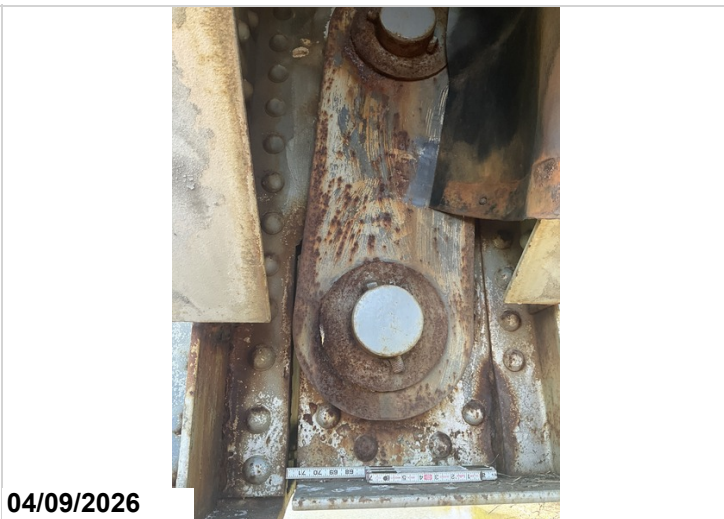
Span 4, Girder 2, Pin and Hanger Assembly: 7/16" gap between Girder 1 and Floorbeam 1 in Span 4. 66 degree air temperature.

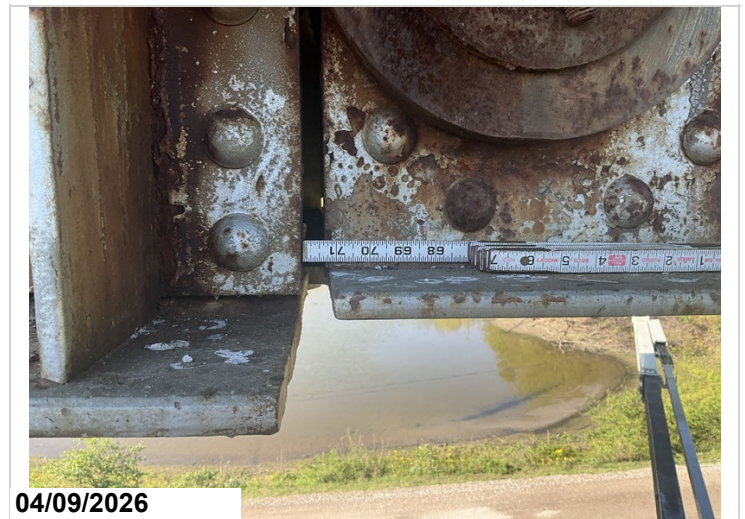
Span 4, Girder 1, Pin and Hanger Assembly: 5/8" gap between Girder 1 and Floorbeam 1 in Span 4. 66 degree air temperature.

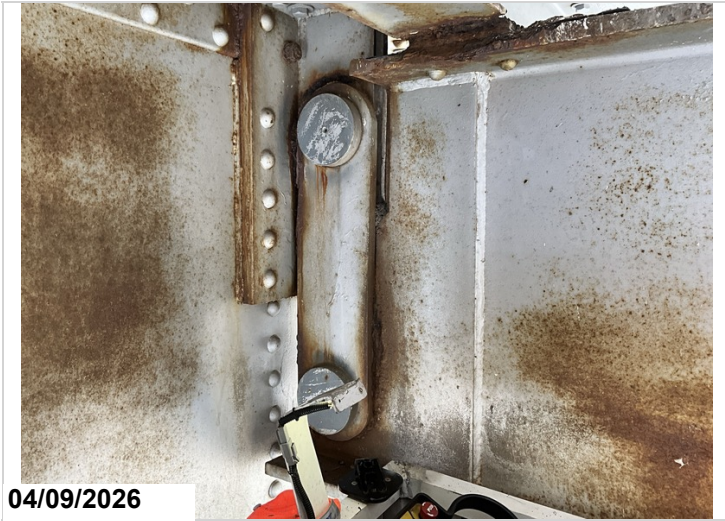
Span 15, Stringer 3, Ahead of Floorbeam 66, Pin and Hanger Assembly: Active corrosion with pack rust between web of Stringer and hanger bar. 3/8". 1EA CS3 corrosion.

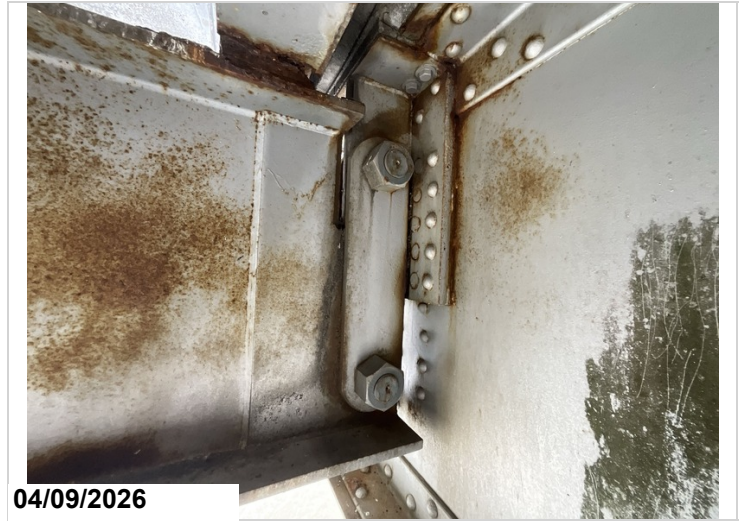
Span 15, Stringer 2, Ahead of Floorbeam 66, Pin and Hanger Assembly: Active corrosion with pack rust up to 3/4" between hanger bar. 1EA CS3 corrosion.

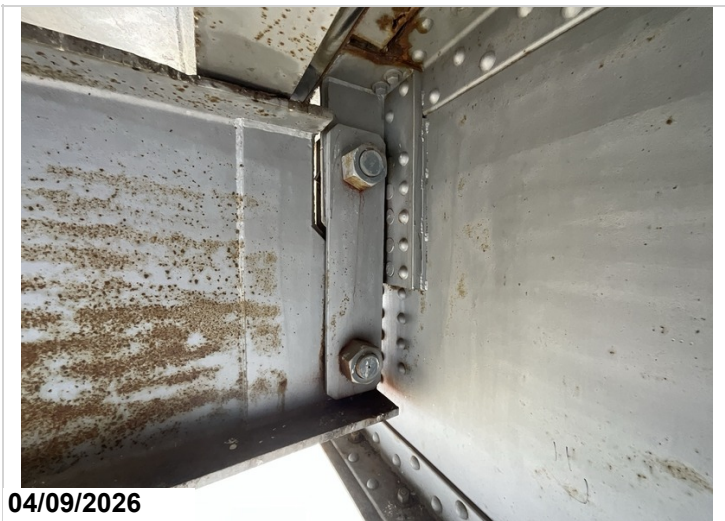
Span 15, Stringer 2, Ahead of Floorbeam 66: Pin and Hanger Assembly.

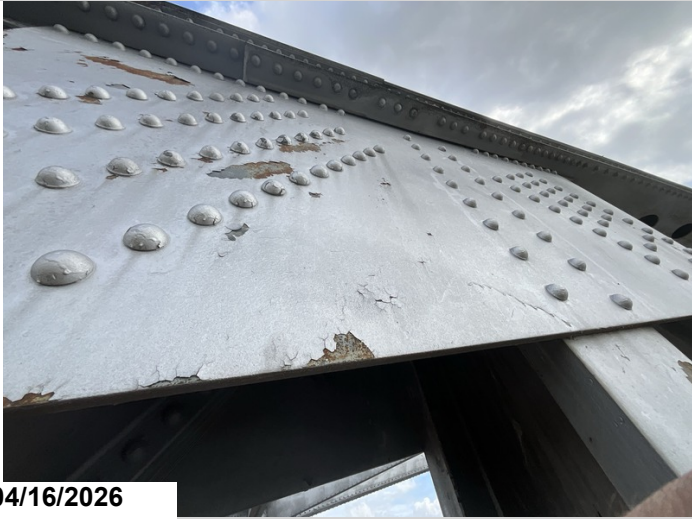
Span 13, Truss 2, PP45: Gusset Plate has minor surface corrosion.

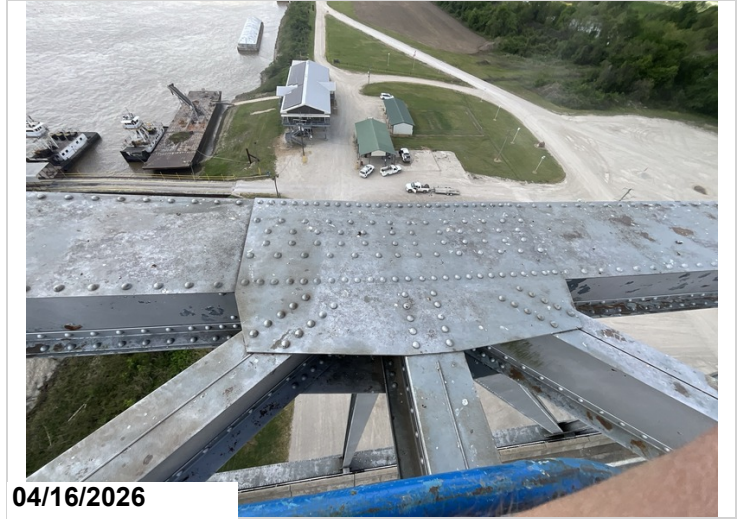
Typical upper Gusset Plate.

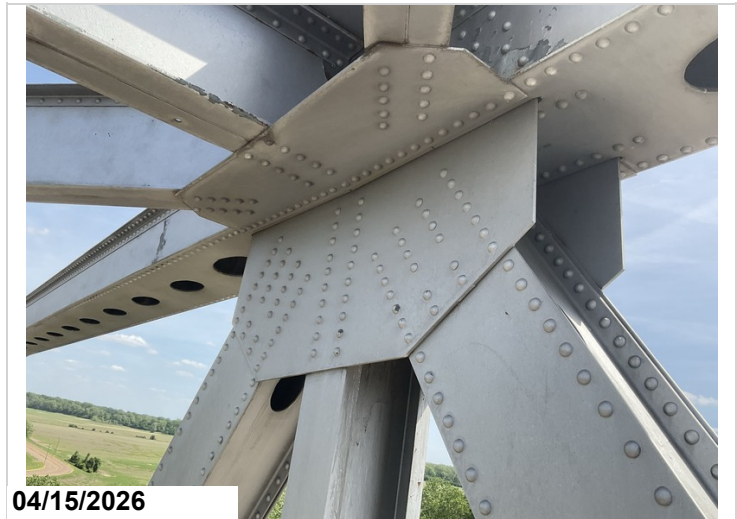
Span 13, Truss 2, PP44, Gusset Plate: Active corrosion with section loss up to 3/16".

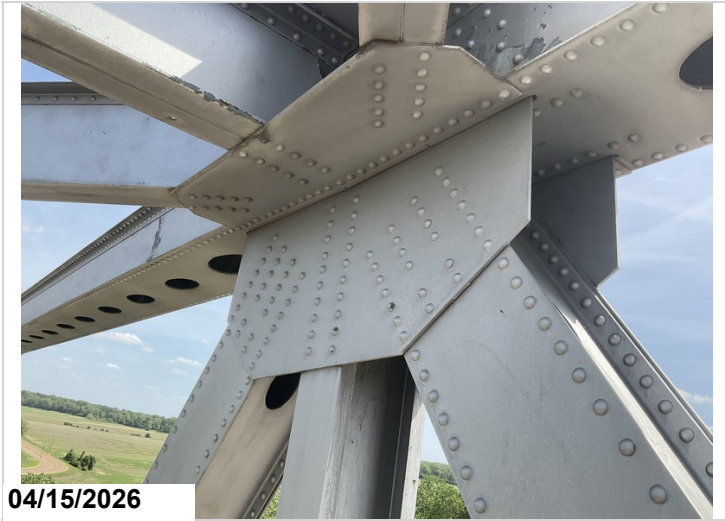
Typical condition Gusset Plate

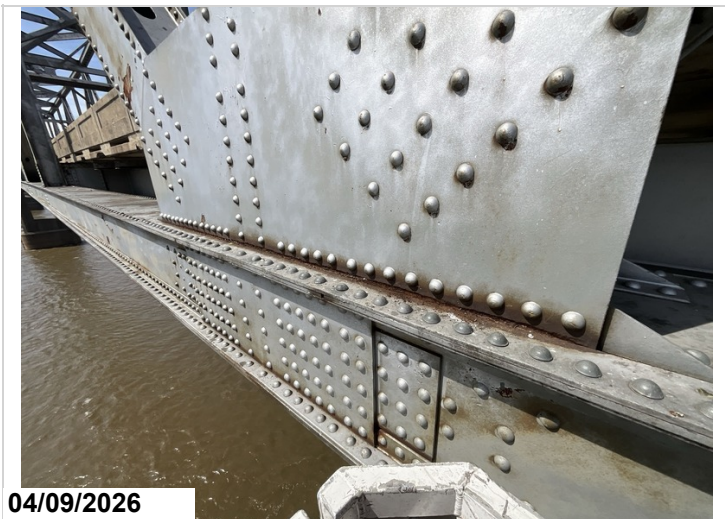
Span 15, Truss 1, L64, Inside Gusset Plate: Cracked tack weld. 1LF CS3 crack.

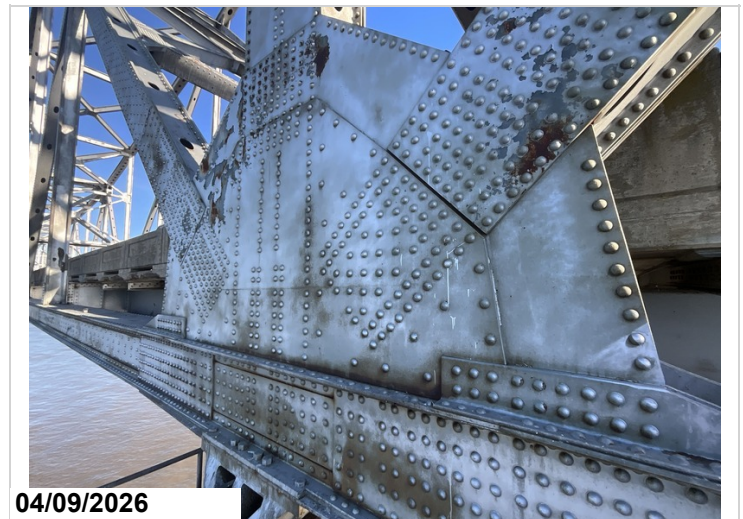
Span 13, Truss 2, Gusset Plate, Lower Chord at PP46:  
Active corrosion with section loss up to 3/16" to the Gusset Plate.

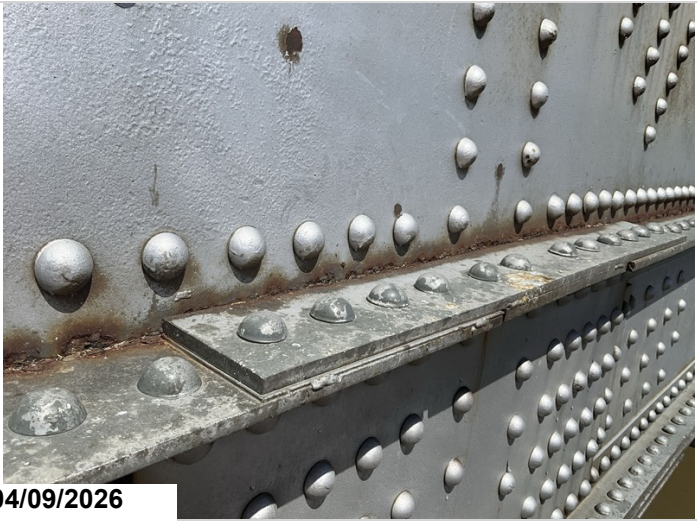
Typical Gusset Plate.

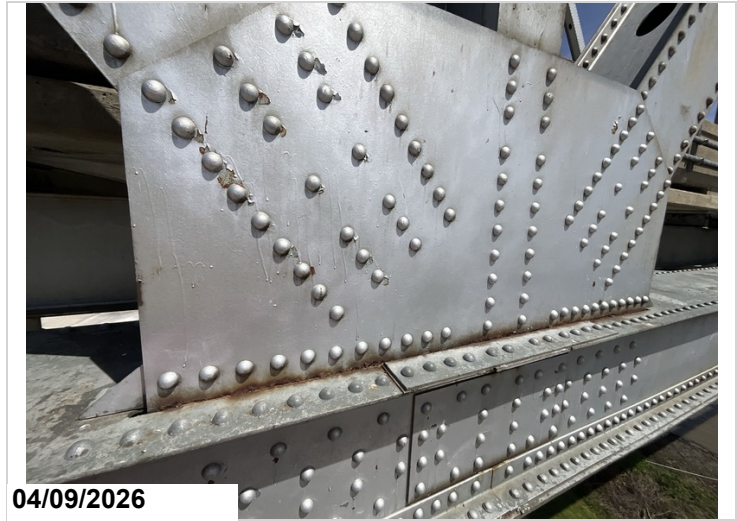
Span 11, Truss 2, Gusset Plate, PP4: Active corrosion with section loss along the bottom of the gusset plate. 1EA CS3 corrosion.

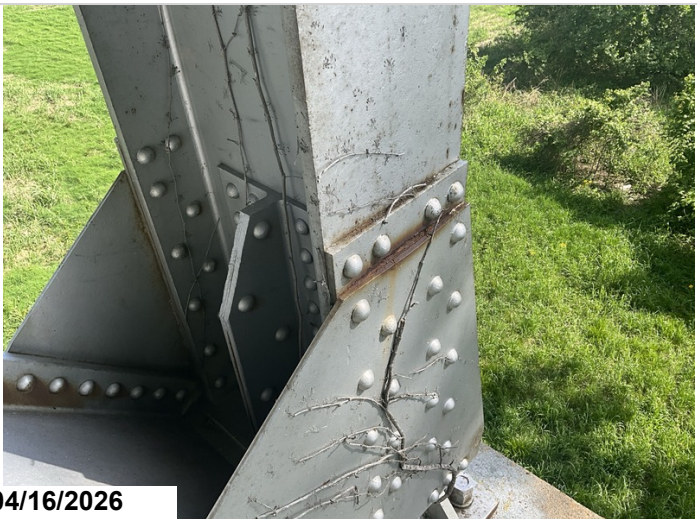
Span 11, Truss 2, Gusset Plate, PP2: Active corrosion with section loss along the bottom of the gusset plate. 1EA CS3 corrosion.

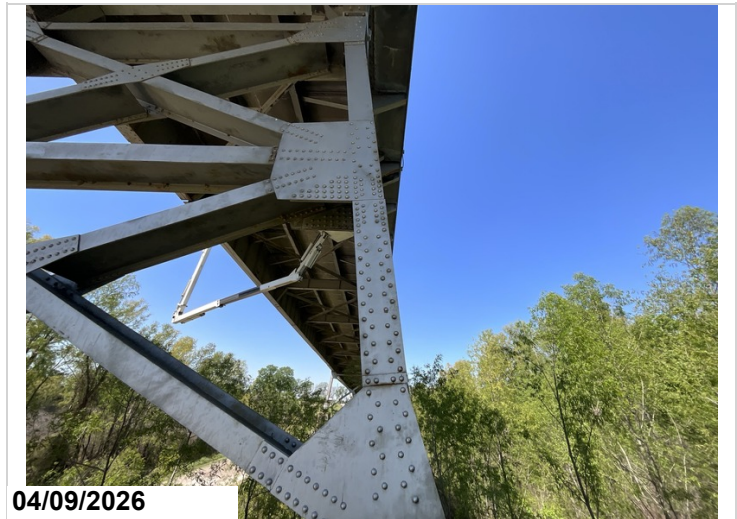
Pier 16, Column 2: Active corrosion with pack rust between Column and Gusset Plates. 1EA CS3 corrosion.

Pier 16, Column 1: Active corrosion with pack rust between Column and Gusset Plates. 1EA CS3 corrosion.

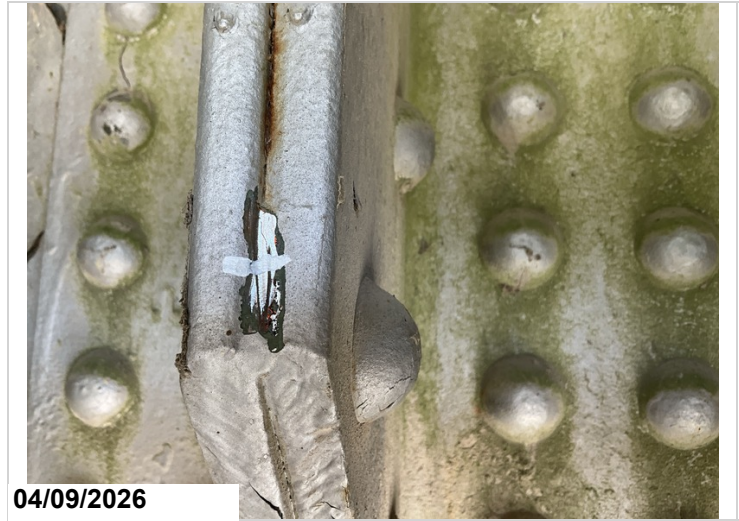
Pier 8, Column 1, Right, Near Top: 1/2" crack in tack weld in the angle connection plates under the Bearing. 1EA CS2 crack.

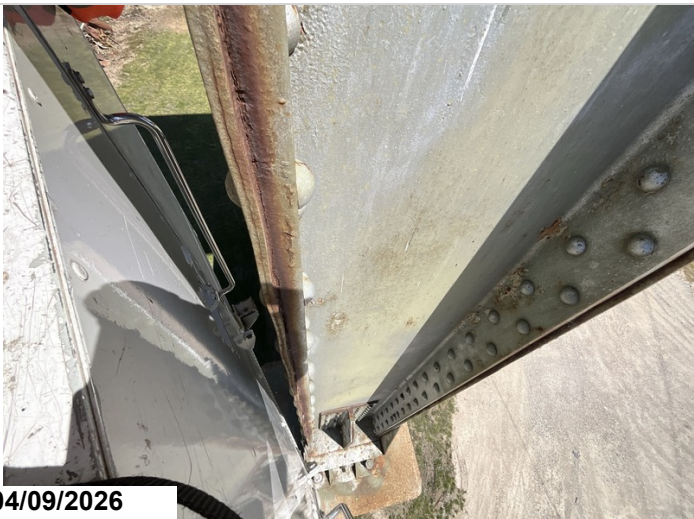
Pier 8, Column 1, Right, Near Top: 1/2" crack in tack weld in the angle connection plates under the Bearing. 1EA CS2 crack.

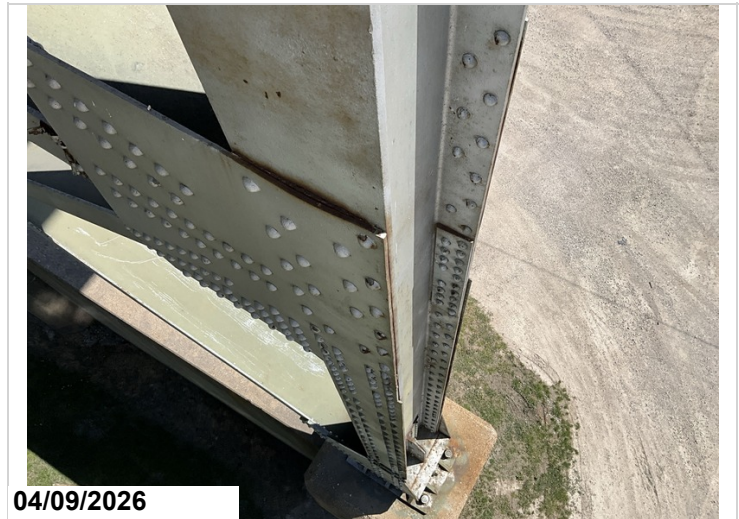
Steel Columns: Typical minor pack rust between flanges and flange cover plates.

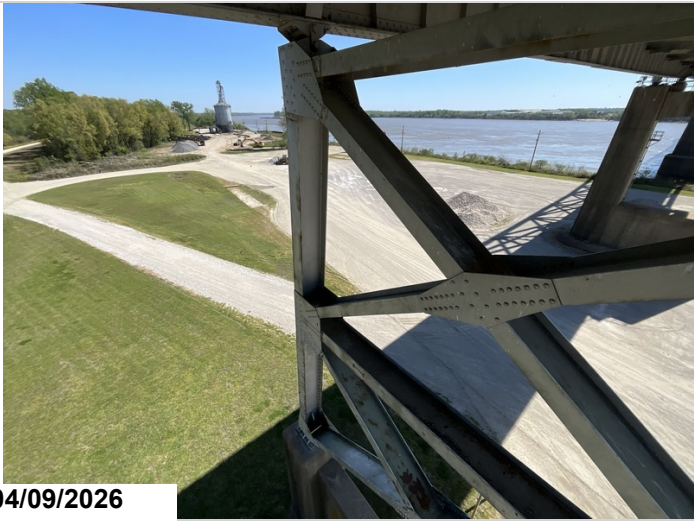
Pier 8, Column 2: Active corrosion with pack rust between Column and Gusset Plates. 1EA CS3 corrosion.

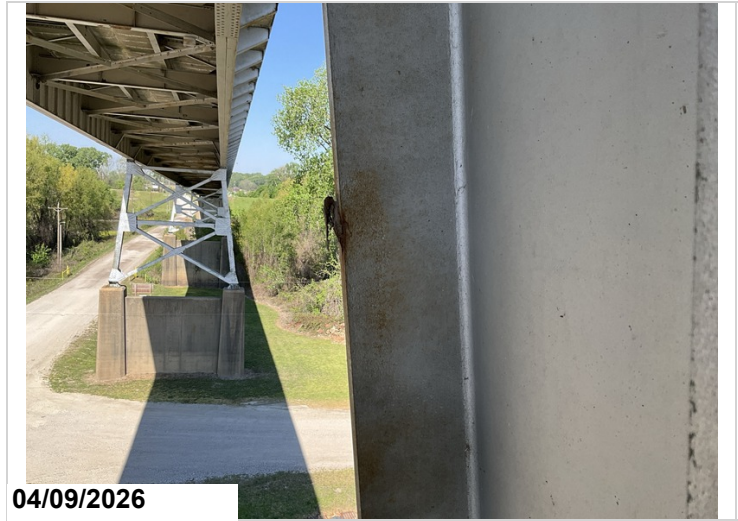
Typical Steel Column.
