## Bridge 02899 Inspection Report

Arnold Road ID:54x49x11xA, Arnold Log mile:0.569

# National Bridge Inventory Data Sheet

| IDENTIFICATION | |
|---|---|
| (7) Facility Carried | US 49- Phillips Co |

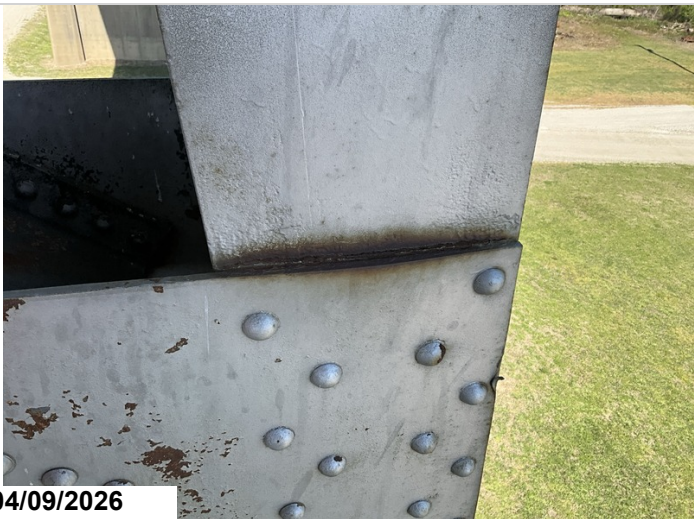
Pier 9, Column 1, Back flange: Rolling defect between the top and middle Gusset Plate.

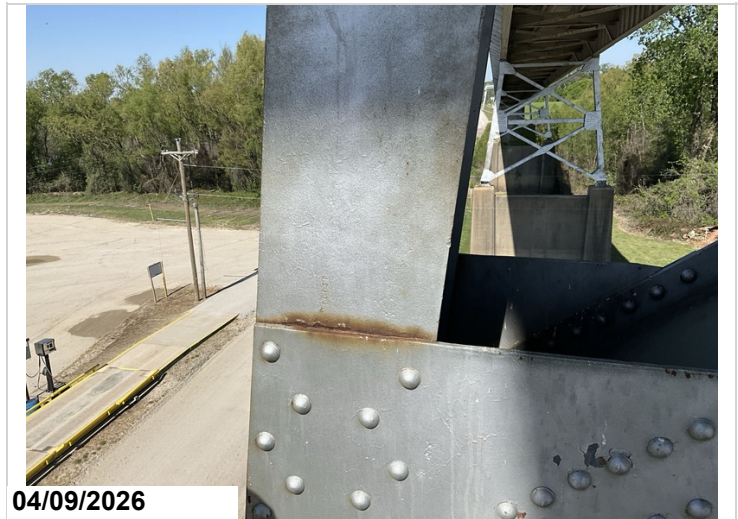
Pier 9, Column 1, Ahead: Active corrosion with pack rust at the middle Gusset Plate connection. 1EA CS3 corrosion.

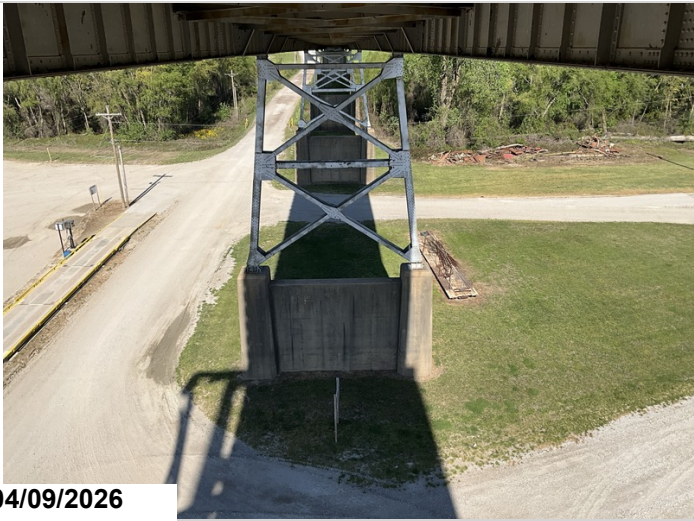
Pier 9, Column 2, Ahead: Active corrosion with pack rust at the middle and bottom Gusset Plate connection. 1EA CS3 corrosion.

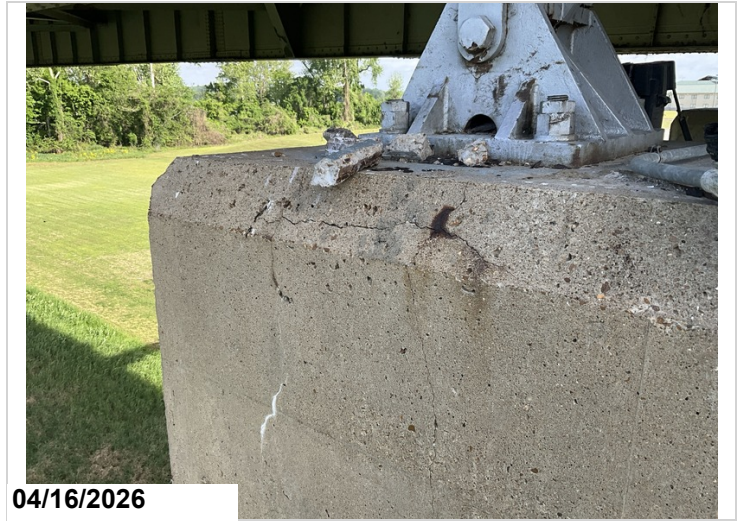
Typical Steel Column substructure unit.

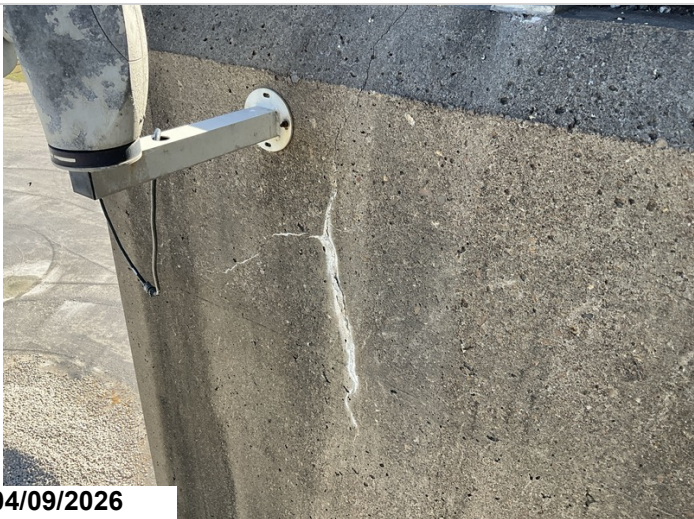
Pier 19, Column 2, right: cracking with efflorescence and rust staining. 1 EA CS3.

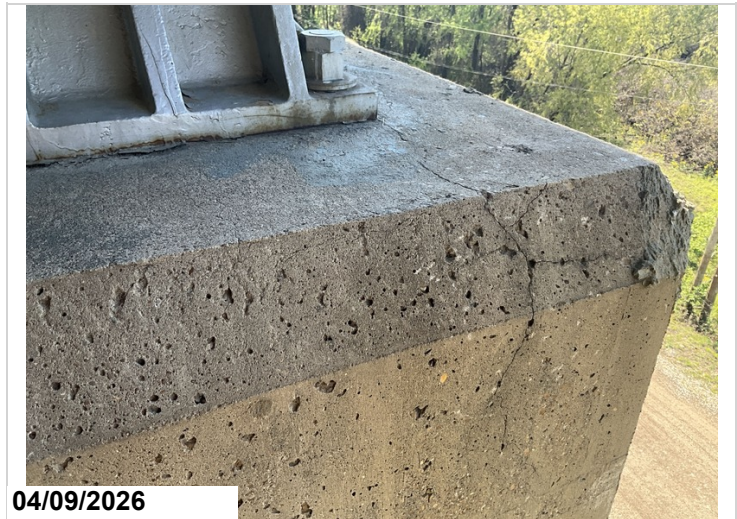
Pier 10, Column 1, Back: Cracking with efflorescence build-up below the bearing. 1EA CS3 efflorescence.

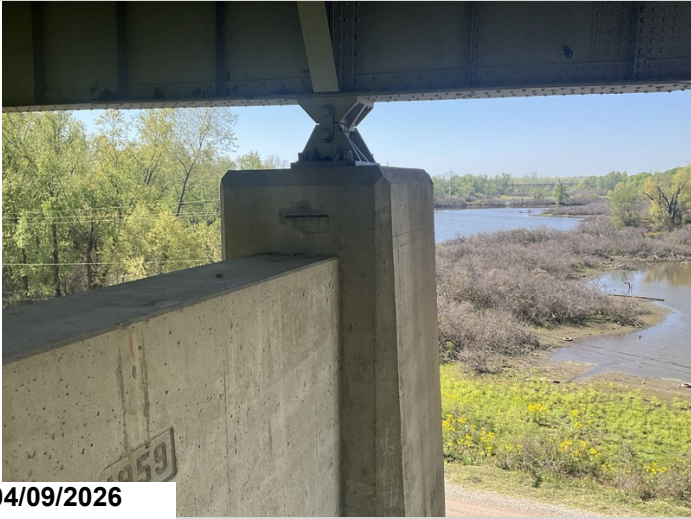
Pier 5, Column 2: Cracking near the bearing area. 1EA CS2 cracking.

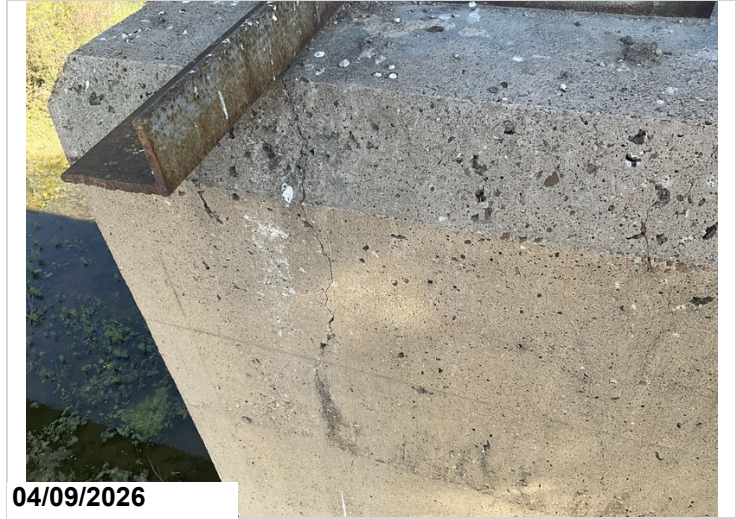
Pier 5, Column 2: Spalling with exposed reinforcing steel.  
1EA CS3 exposed reinforcing steel.

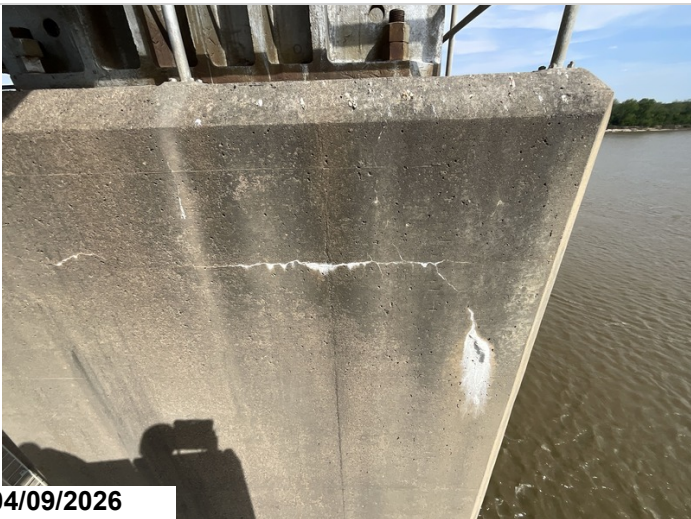
Pier 4, Column 2: Vertical cracking. 1EA CS2 cracking.

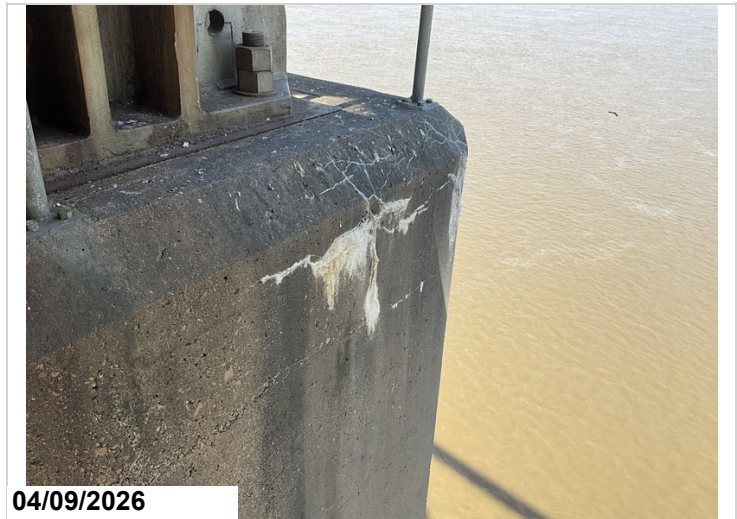
Pier 13, Column 2, Back: Cracking with efflorescence build up.

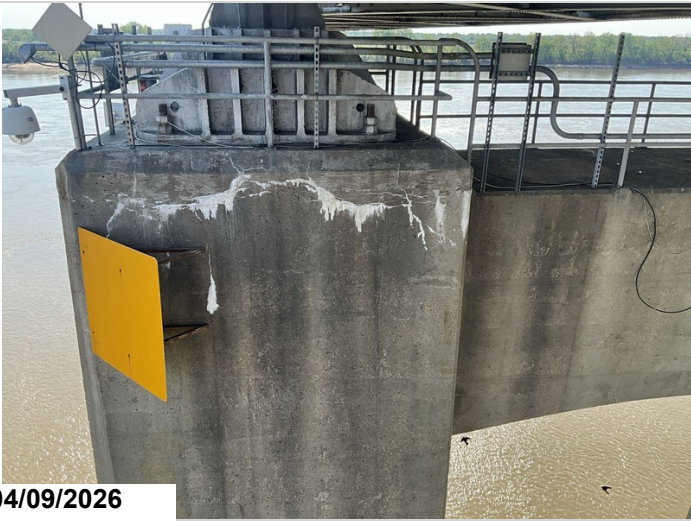
Pier 14, Column 1: Cracking with efflorescence build up. 1EA CS3 efflorescence.

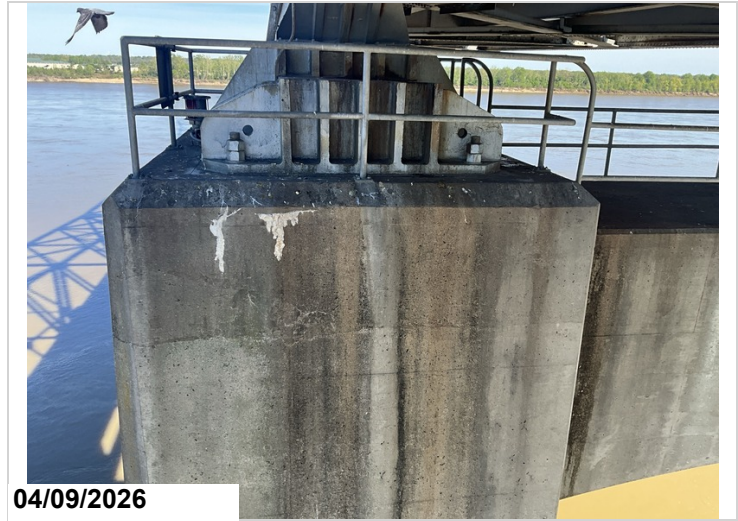
Pier 13, Column 1, Back: Cracking with efflorescence build-up below the bearing area. 1EA CS3 efflorescence.

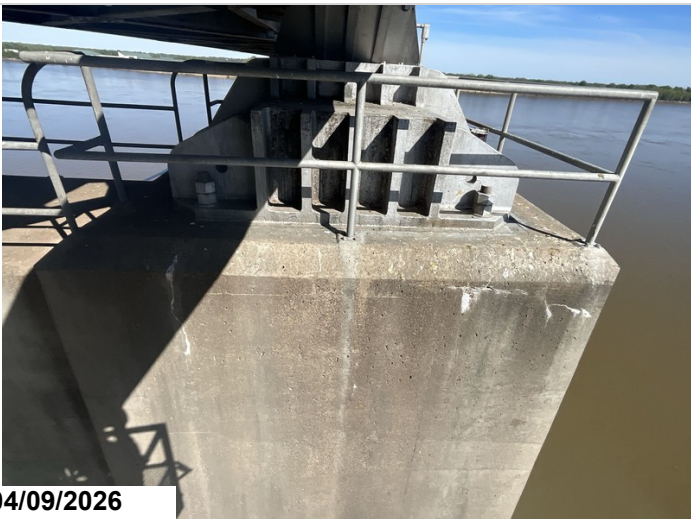
Pier 12, Column 1, Back: Cracking with efflorescence build-up below the bearing. 1EA CS3 efflorescence.

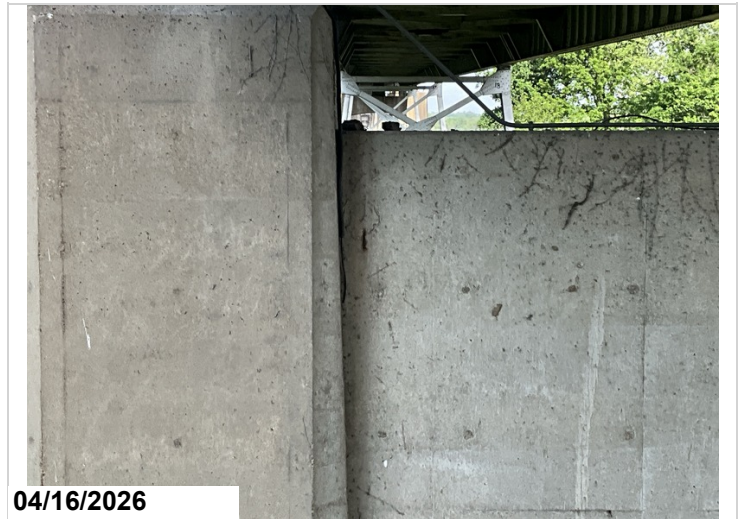
Pier 12, Column 2, Back: Cracking with efflorescence build-up below the bearing. 1EA CS3 efflorescence.

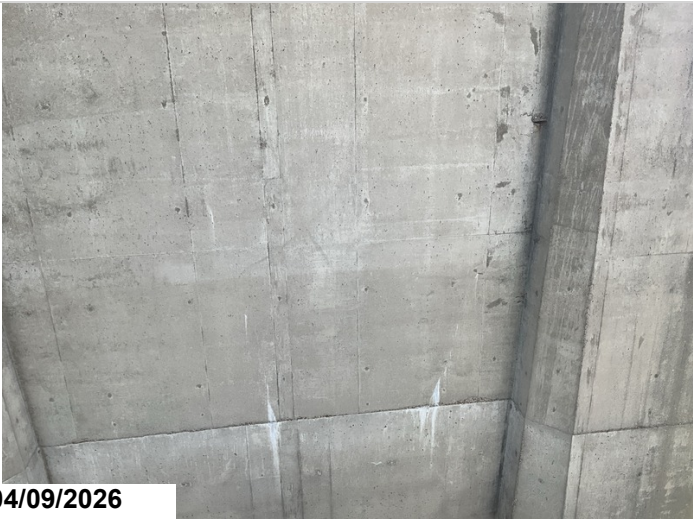
Pier 19, ahead, right: exposed rebar with adjacent delamination to top of pier wall. 1 LF CS3.

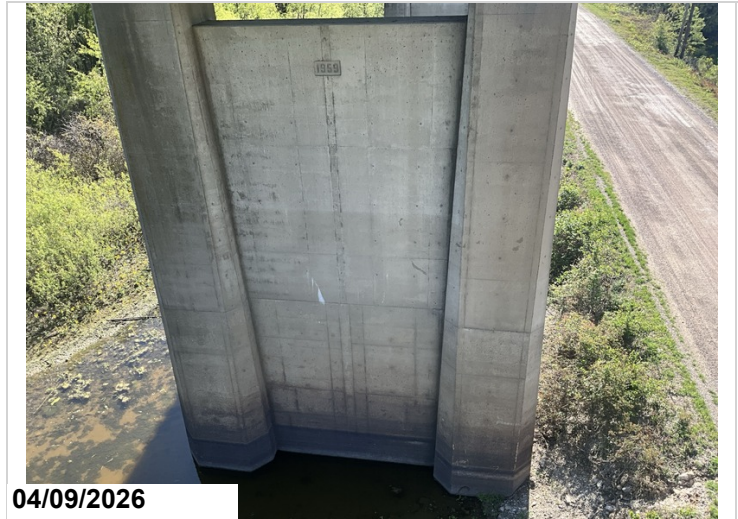
Pier 5, Wall, Back: Vertical cracking with efflorescence build-up and spalling with exposed reinforcing steel. 3LF CS3 efflorescence and 1LF CS3 exposed reinforcing steel.

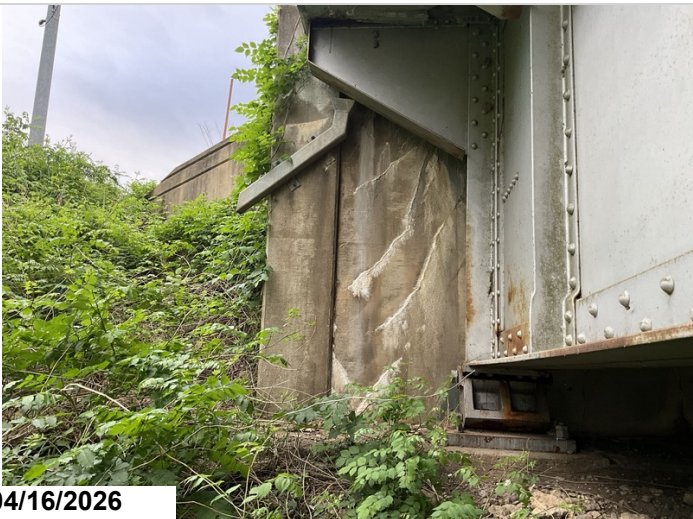
Pier 4, Wall, Back: Cracking with efflorescence. 5LF CS2 efflorescence.

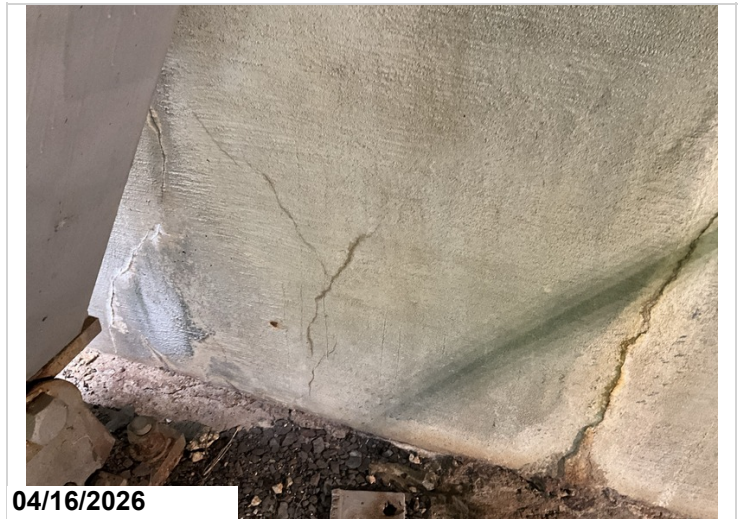
Abutment 2: Cracking with efflorescence. 12LF CS3 efflorescence.

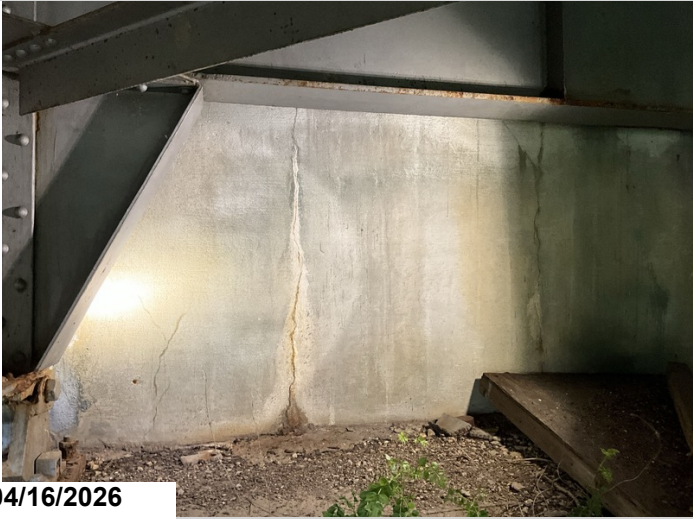
Abutment 2: Vertical cracking. 7LF CS2 cracking. 2LF CS2 delam.

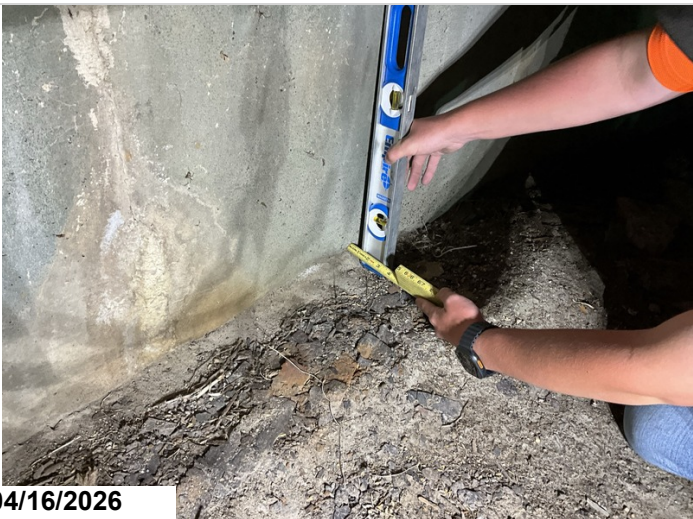
Abutment 1, Left: 7/8" per 2'.

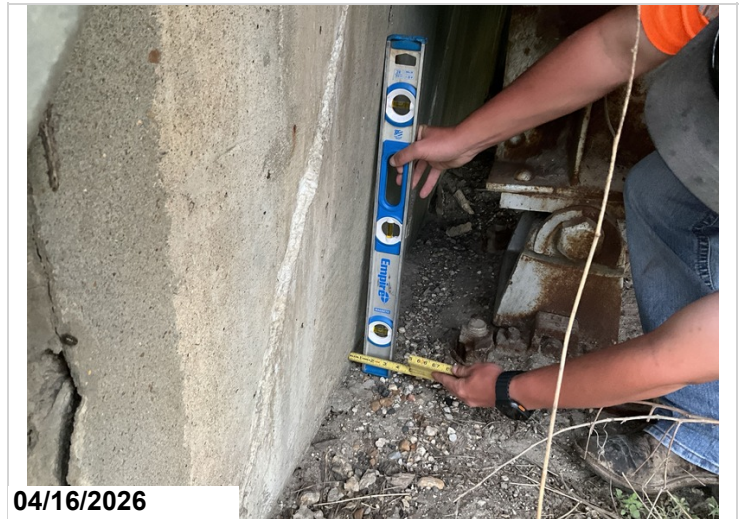
Abutment 1, Right: 1" per 2'  
Bay 3: 1"

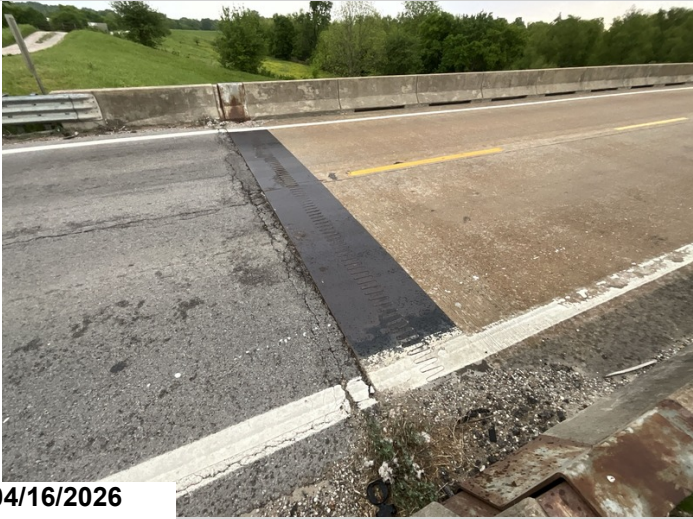
Abutment 1, Joint: Fingers closed due to rotation in abutment.

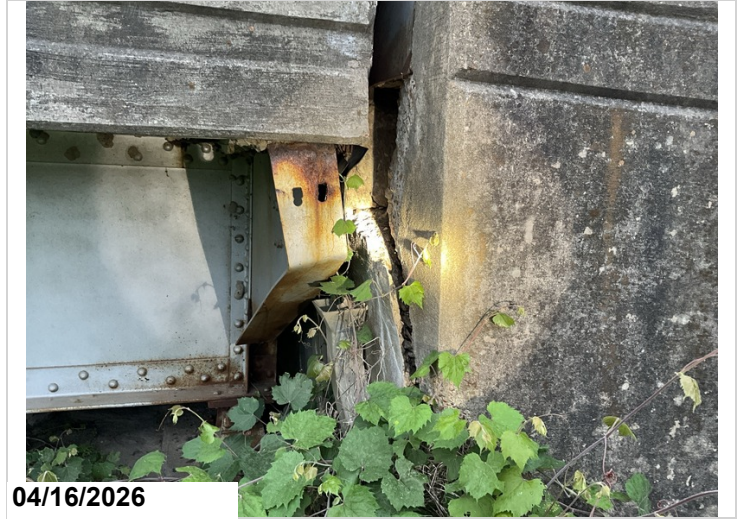
Abutment 1, Left: Backwall has spalled and is rotated towards Pier 1.

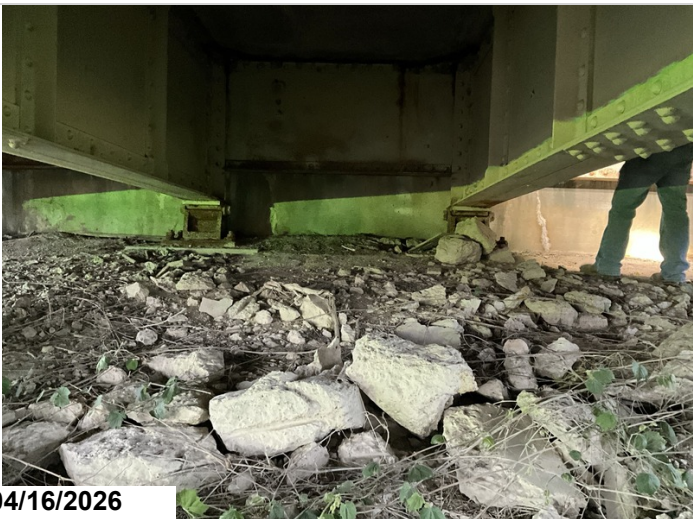
Abutment 1: Cracking with efflorescence. 10LF CS3 efflorescence.

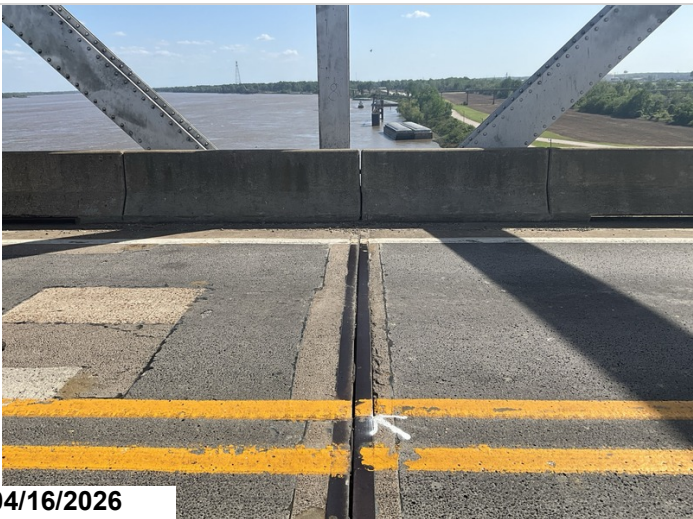
PP8, Joint: Cracked and loose for 56" on Mississippi bound lane.

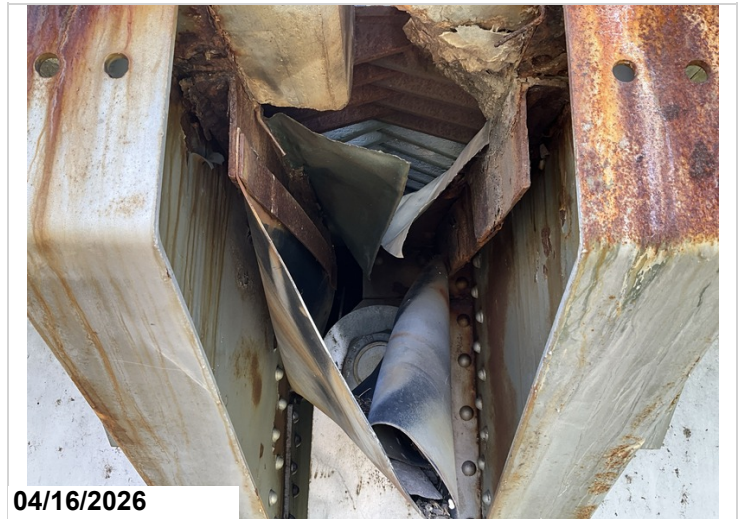
Span 19, pin and hanger: joint material torn loose on Cantilever. Corrosion to top flange of cantilever Floorbeam members.

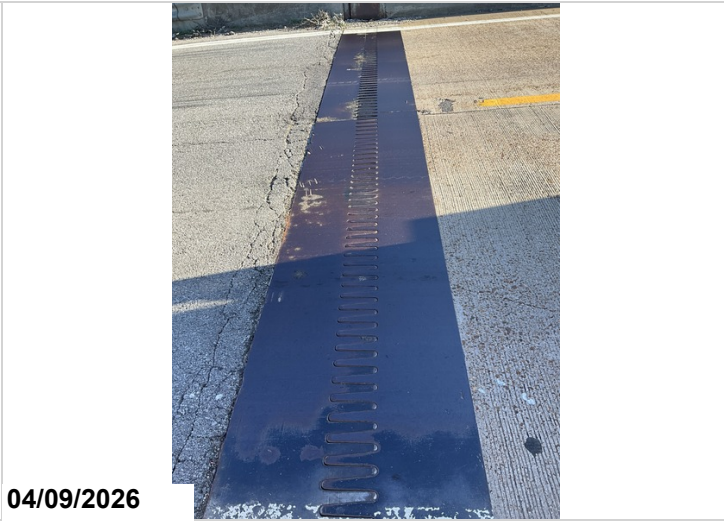
Abutment 1 joint is closed. Fingers of left lane on the ahead side are up to 3/4" higher than on the backside.

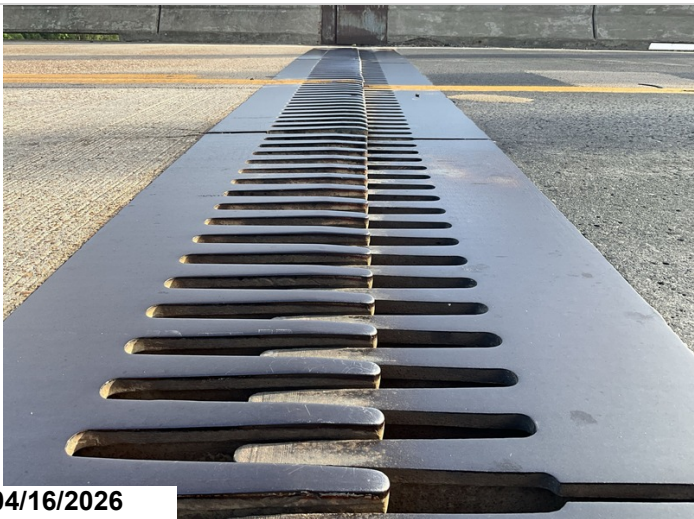
Pier 10, Joint: Approach span side of joint raised approximately 1 1/4", with the worst being on the Mississippi Bound lane and center line.

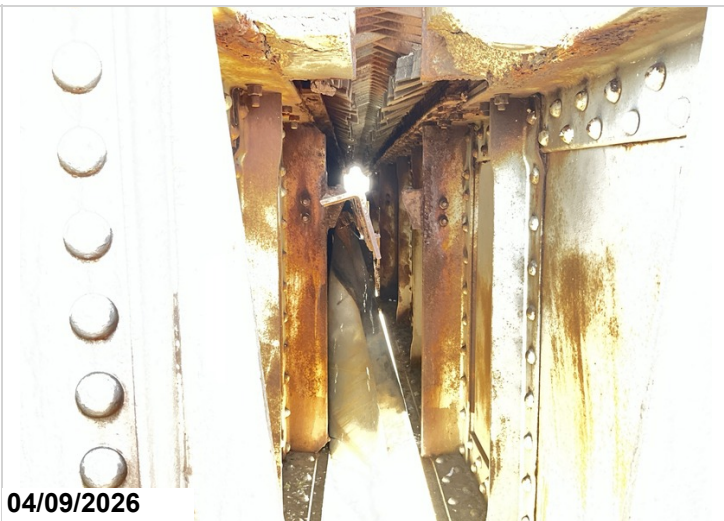
Span 14, PP59, Joint seal and angle connection plate:  
Corroded and broken away from the connection areas,  
causing the joint seal and angles to have little to no  
effectiveness.

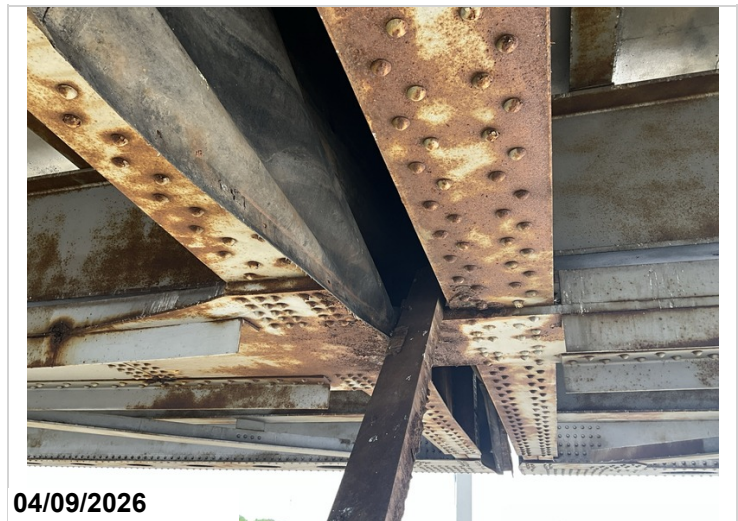
Span 14, PP59, Joint seal and angle connection plate:  
Corroded and broken away from the connection areas,  
causing the joint seal and angles to have little to no  
effectiveness.

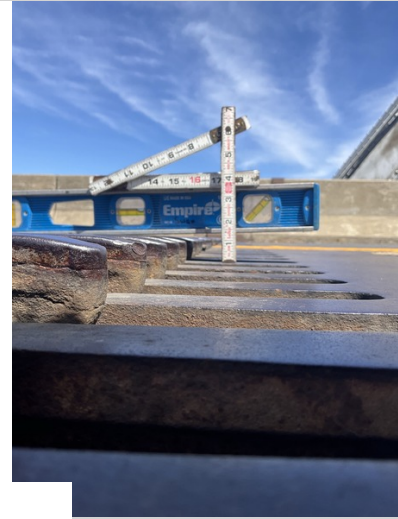
Panel point 0, the back side of the finger joint is up to 1 1/2" higher than the ahead side.

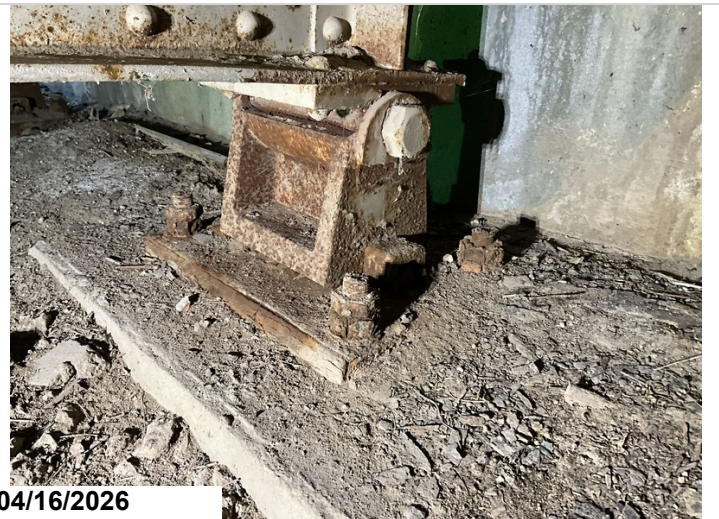
Typical bearings at Abutment 1.

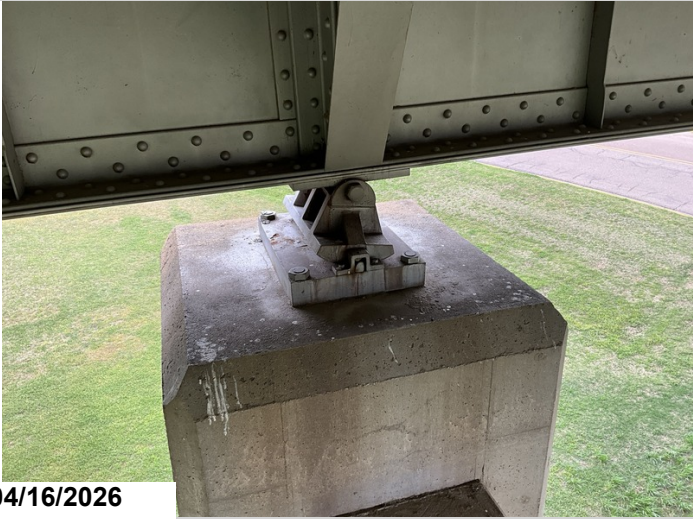
Pier 20, Bearings: Slightly leaning back towards Pier 19.

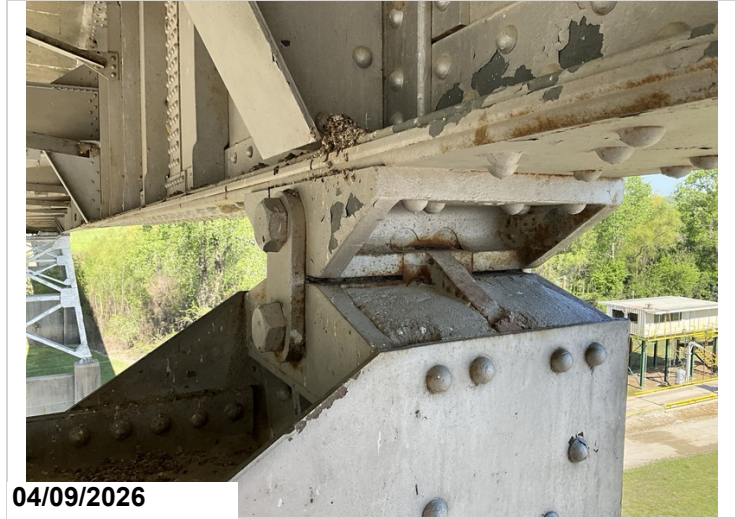
Pier 9, Girder 1: Typical Girder to Steel Column bearing.

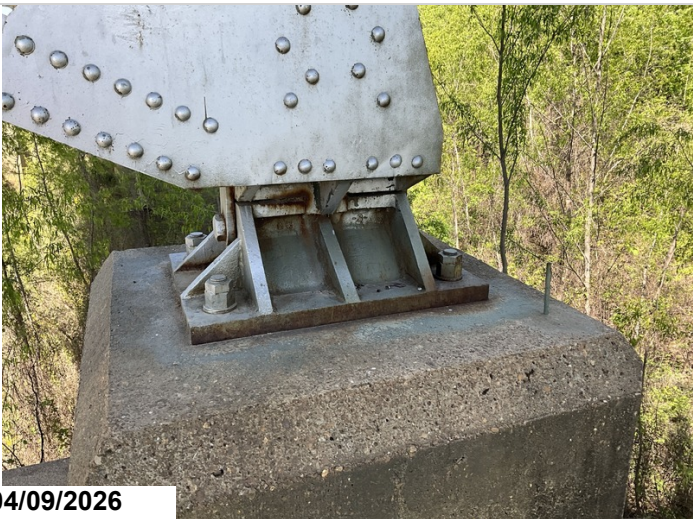
Pier 7, Steel Column Bearing 1.

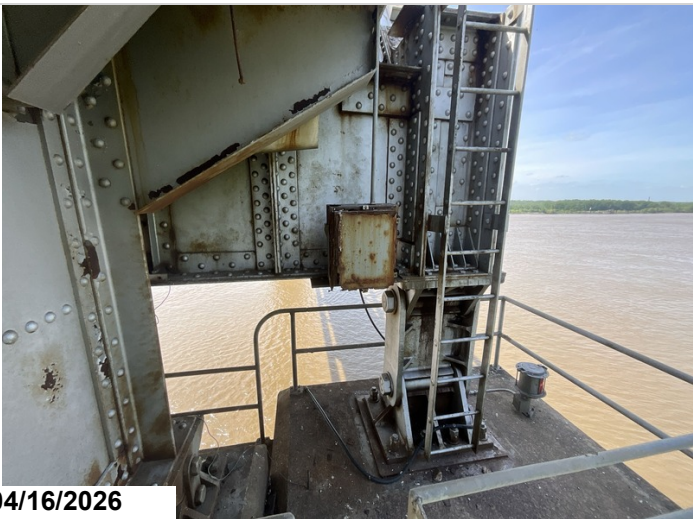
Pier 15, Left: Electric box has heavy corrosion and holes.

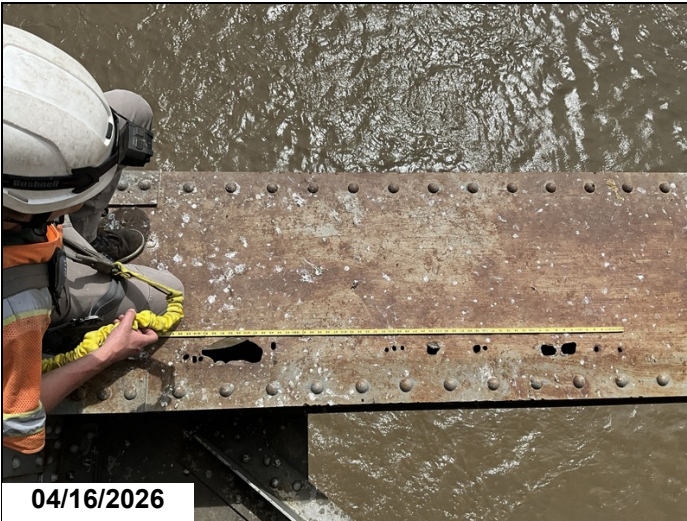
Span 13, Truss 2, L41, Top Flange, Back of Vertical: Active corrosion with holes in the top flange in a 5' area, with a total of 6' containing section loss. 1LF CS3 corrosion and 5LF CS4 corrosion.

Span 13, Truss 2, Lower Chord, PP41, Back: Active corrosion with holes in the top flange in a 5' area, with a total of 6' containing section loss. 1LF CS3 corrosion and 5LF CS4 corrosion.

Assigned to Contract Rehabilitation. Set to let early 2026. KAW 5/1/2025

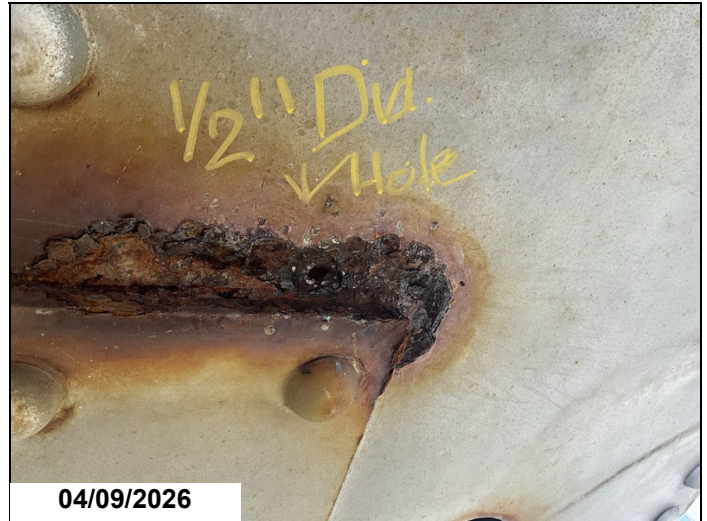
Span 14, Truss 2, L55, Lower Chord: Active corrosion with a 1/2" diameter hole in the bottom flange. 1LF CS4 corrosion.

Span 14, Truss 2, Lower Chord, PP55: Active corrosion with a 1/2" diameter hole in the Bottom Flange at the lateral Gusset Plate connection. 1LF CS4 corrosion.

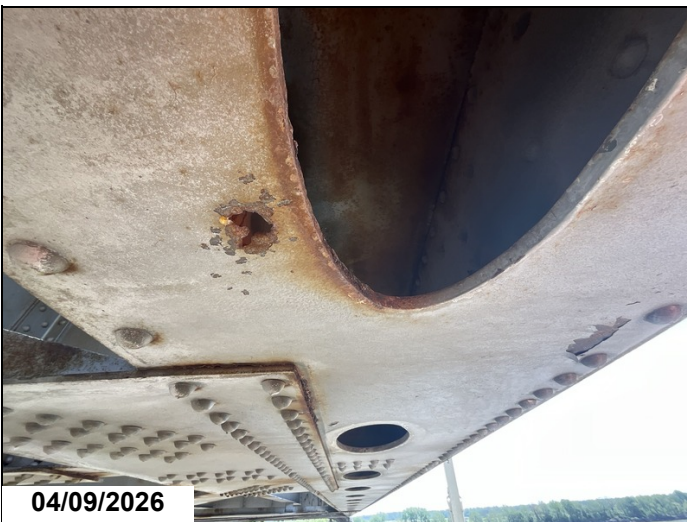
Span 13, Truss 2, L31, Second Portal Back, Bottom Flange: Heavy section loss with 2" diameter hole. 2LF CS4 corrosion.

Span 13, Truss 2, Lower Chord, Second Portal hole back from PP31: Active corrosion with a 1 1/2" Diameter hole in the bottom flange of the lower chord. 1LF CS4 corrosion.

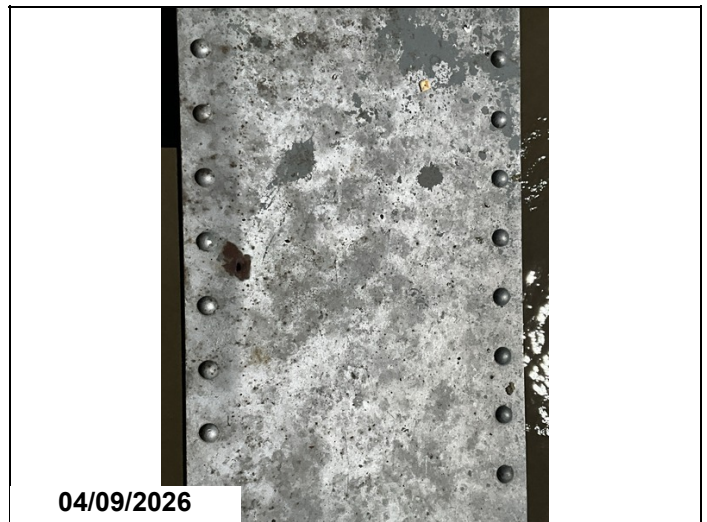
Span 12, Truss 2, L19, Back, Top Flange: 1/2" x 1" corrosion hole. 1LF CS4 corrosion.

Span 12, Truss 2, Lower Chord, PP19, Back: Active corrosion with a 1" X 3/4" hole in the top flange of the lower chord. 1LF CS4 corrosion.

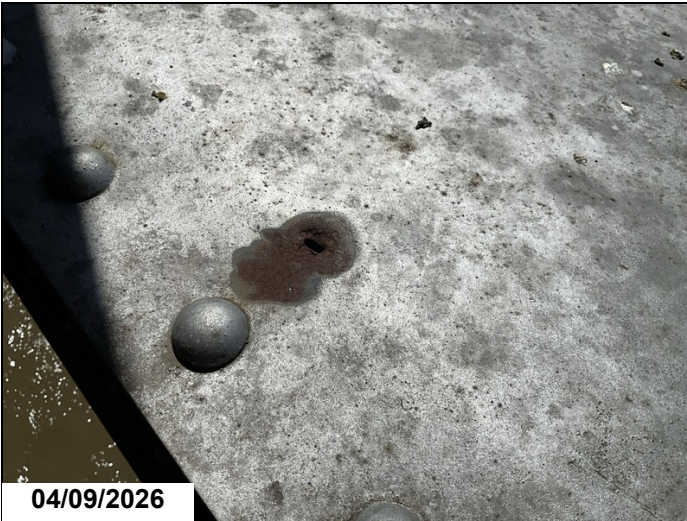
Span 12, Truss 2, L18, Back, Top Flange: 1/2" diameter corrosion hole. 1LF CS4 corrosion.

Span 12, Truss 2, Lower Chord, Back of PP18: Active corrosion with a 3/4" diameter hole in the top flange. 1LF CS4 corrosion.

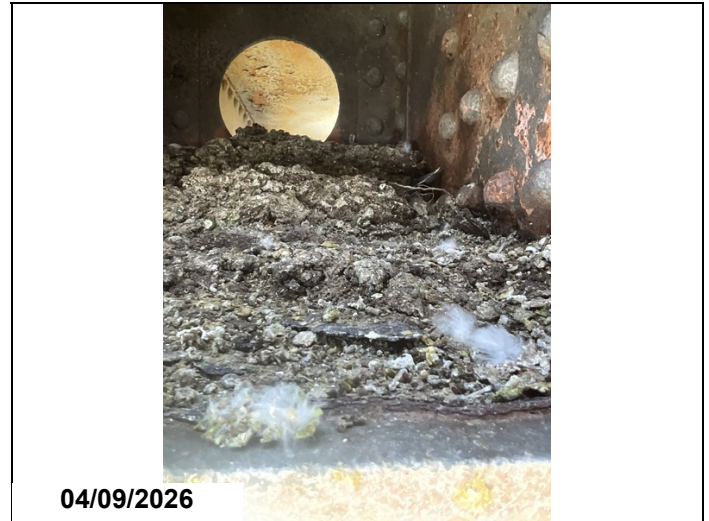
Span 12, Truss 2, L15, Back, Bottom Plate: Three holes rusted through. 2LF CS4 corrosion.

Span 12, Truss 2, Lower Chord, PP15: Active corrosion with holes in the bottom flange of the lower chord 3 1/2" X 3", 2 1/2" X 2", 1", 1/2", and 1/4" in sizes. The inside of the chord is filled with pigeon dung. 2LF CS4 corrosion.

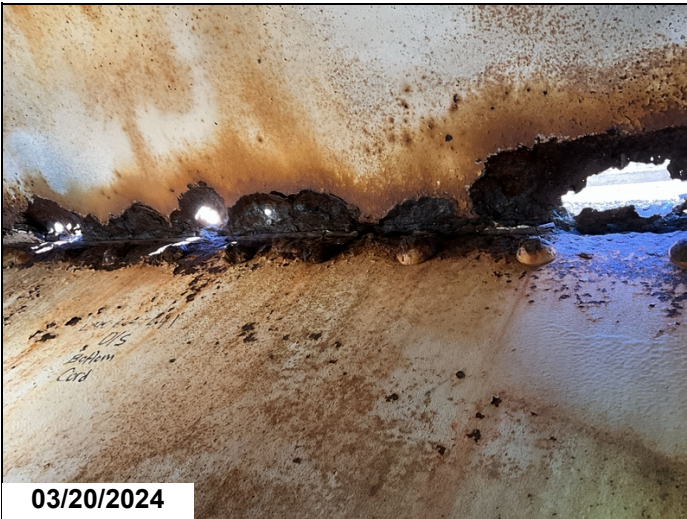
Span 13, Lower 41, right, bottom chord, inside: top plate showing holes and section loss. 3LF CS4

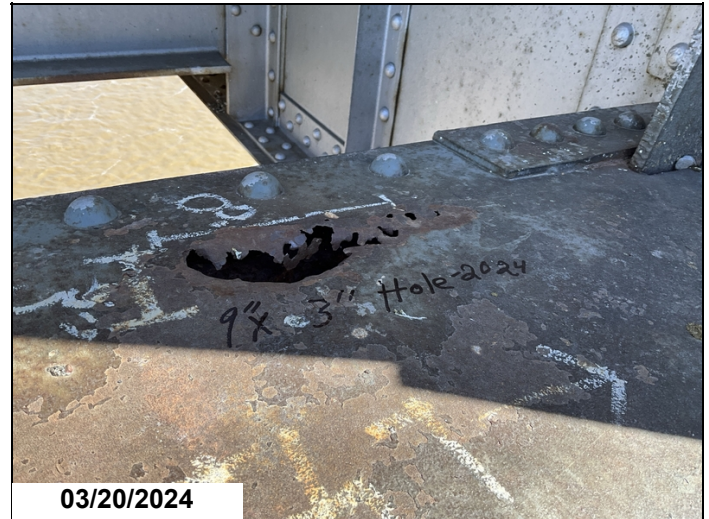
Span 13, Lower 41, right, bottom chord, top flange: Corrosion has developed a hole. 1LF CS3

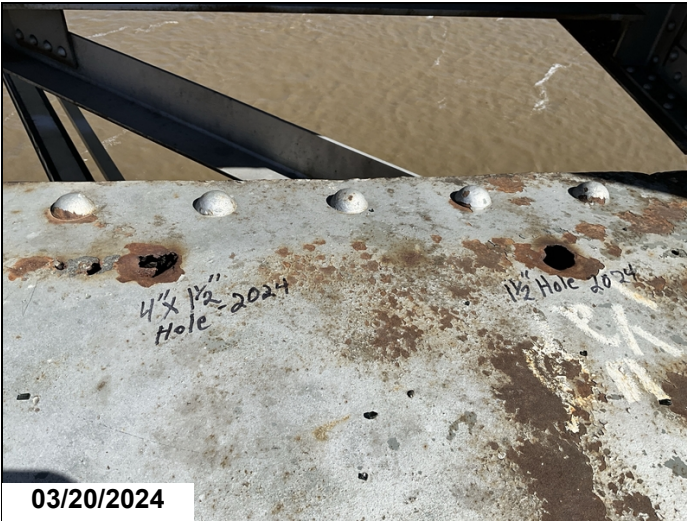
Span 13, Lower 41, right, bottom chord, top flange:  
Corrosion has developed a hole. 3LF CS3

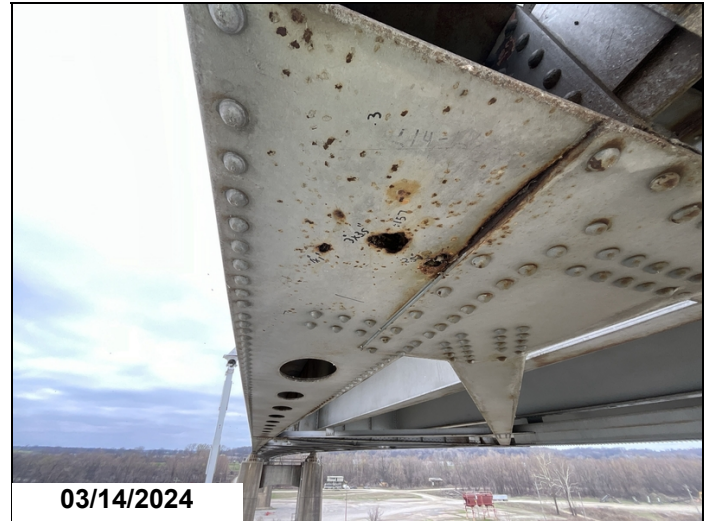
Span 12, Lower 15, back, Right, bottom chord, Bottom  
Plate: Has 3 holes rusted through 3" x 3.5", 2.5" x 2", 1" x  
1". 3LF CS4

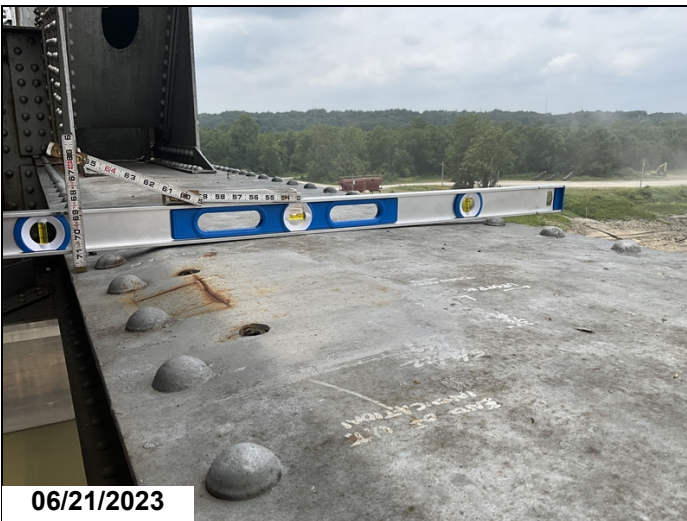
Span 12, left lower chord ahead of panel point 16,  
bowing in top flange, CS 2 distortion.

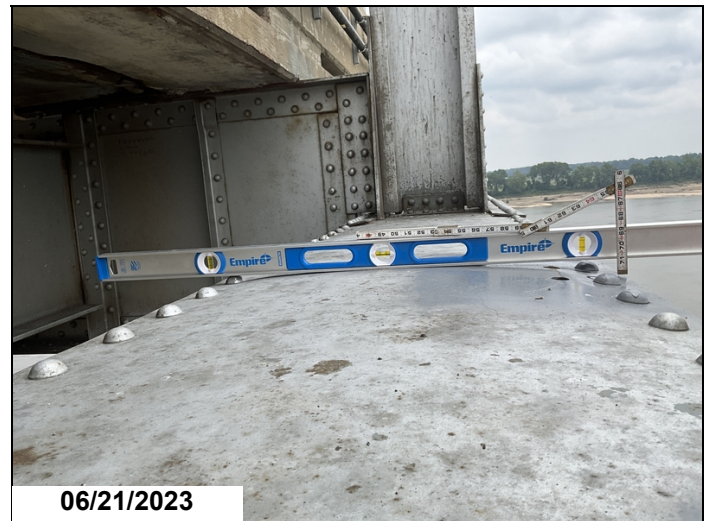
Span 12, right lower chord behind panel point 23, bowing  
in the top flange, CS 2 distortion.

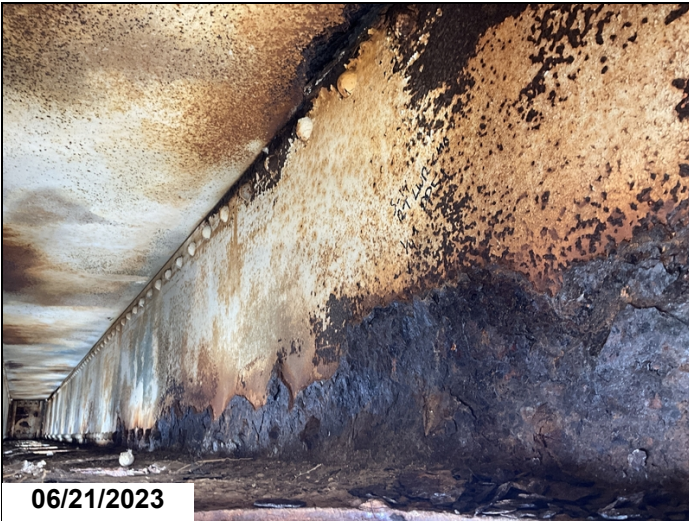
Span 14, right lower chord, back of panel point 51, 1/4" section loss to left web, CS 3.

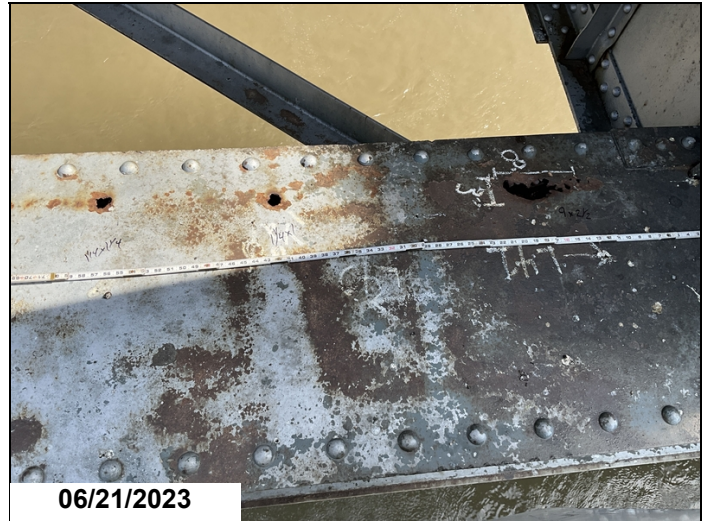
Span 13, Right, L41, Back, top flange: Corrosion with various holes rusted through measuring at 9"x2 1/2" 1"x1 1/4" and 1 1/4" x 1 1/4", CS4 - has been cleaned and painted. March 2024 KAW

Span 13, Right, Back of L41, top flange: Corrosion with various holes rusted through measuring at 9"x2 1/2" 1"x1 1/4" and 1 1/4" x 1 1/4", CS4

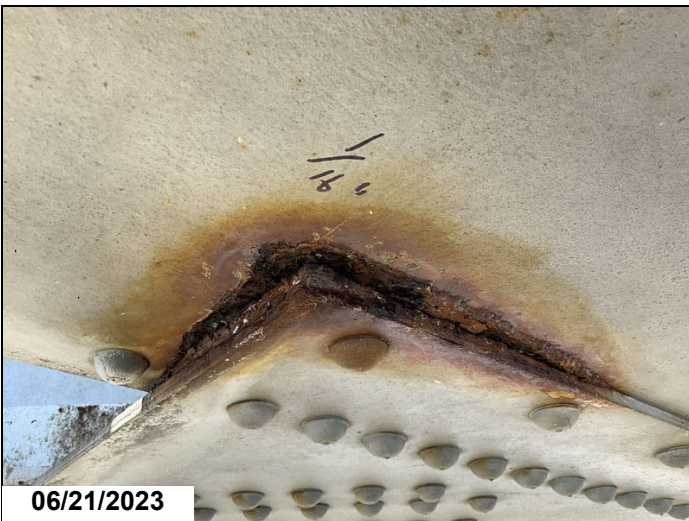
Span 12, panel point 27 left, 1/16" section loss to bottom flange, 1/2" pack rust at gusset, CS 3.

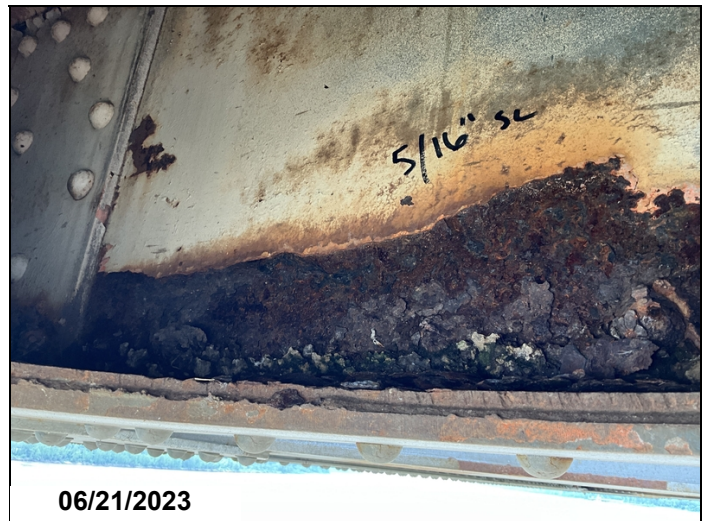
Span 12, left lower chord, right web, 5/16" section loss, CS 3.

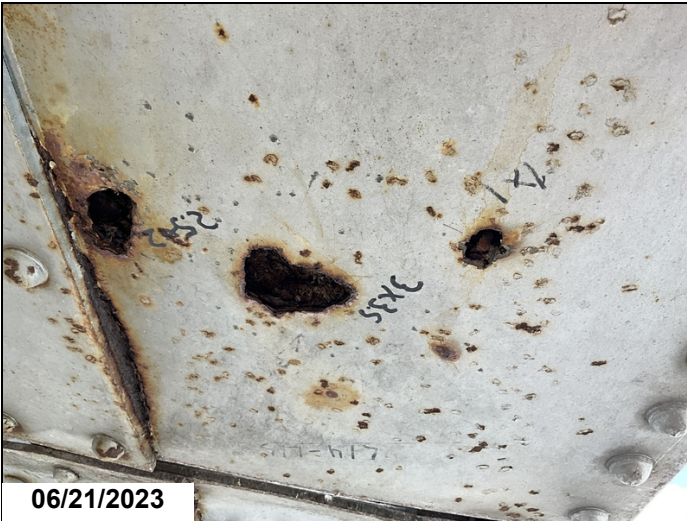
Span 12, right lower chord, holes in the bottom flange at the wind lock location, CS 3. Holes measure 3 x 3.5", 2 x 2.5" and 1 x 1". The bottom flange measures .157" at the thinnest measurable area next to the largest hole. The area extends from the end of the chord back towards panel point 14 for 36". 20% section loss by width, 69% section loss outside of the holes by depth. CS 3.

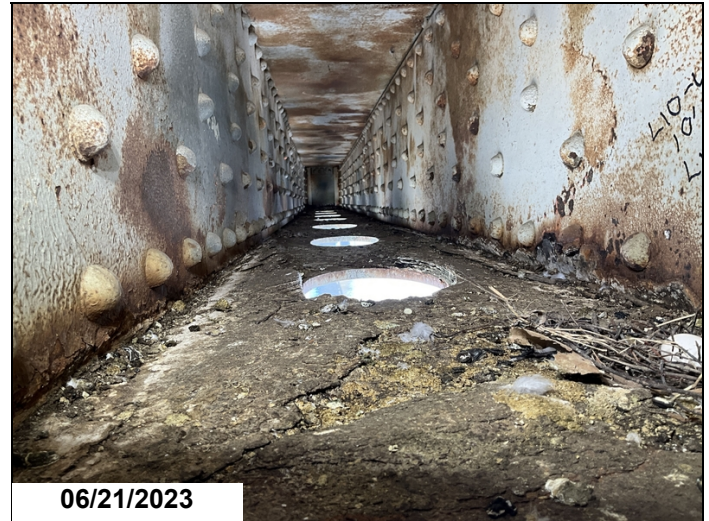
Span 12, left lower chord ahead of panel point 10, laminating rust in the bottom flange and section loss in the webs, CS 3.

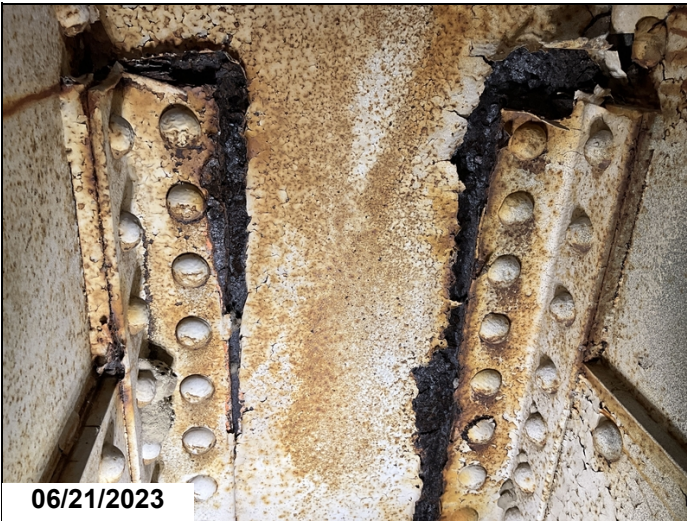
Span 11, left lower chord, top flange, section loss around the angles, CS 3.

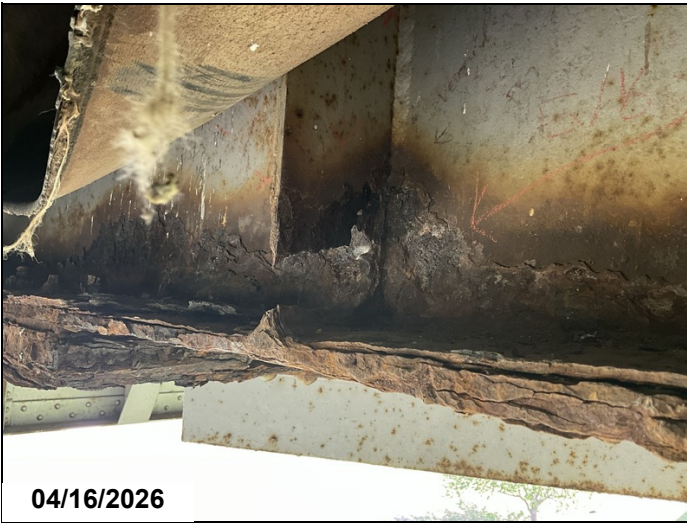
Span 19, Floorbeam 3, Back, Near Stiffener 2: Active corrosion with multiple areas of section loss, with section loss up to 3/8" to the bottom flange and lower web. Stiffener 2 has a 4" tall hole. 5LF CS3 corrosion.

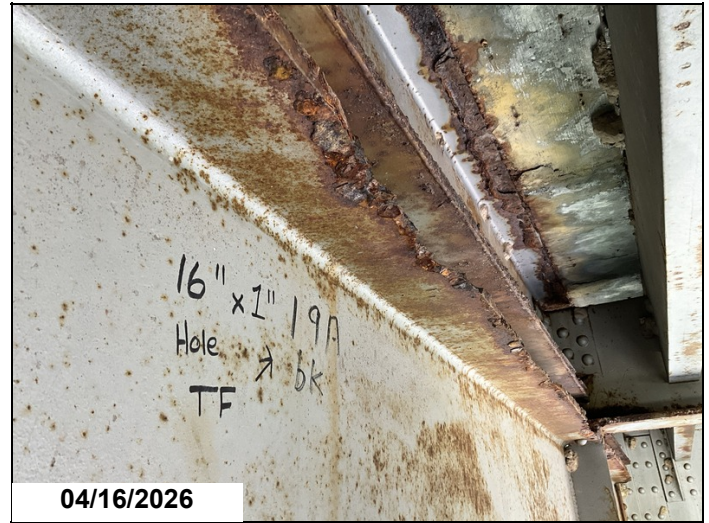
Span 19, Floorbeam 2, Back, Right of Stiffener 1: Active corrosion with a 16" X 1" hole in the Top Flange. 2LF CS4 corrosion.

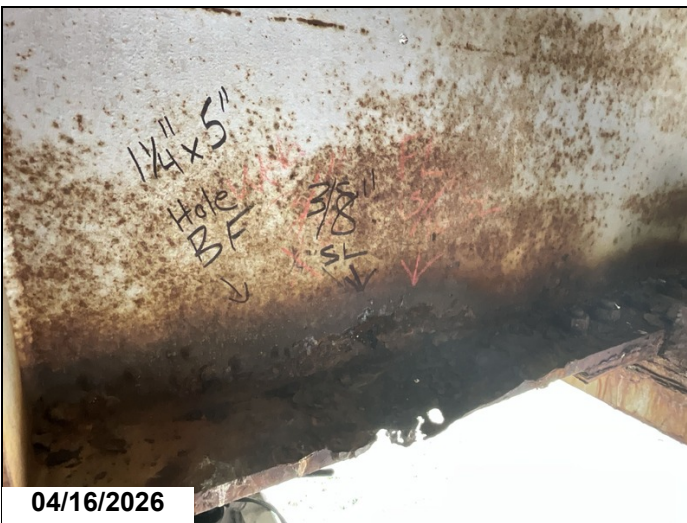
Span 19, Floorbeam 2, Back, Right of Stiffener 1: Active corrosion with section to the web up to 3/8" and a 5" X 1 1/4" hole in the Bottom Flange. 1LF CS4 corrosion.
