## Bridge 02899 Inspection Report

Arnold Road ID:54x49x11xA, Arnold Log mile:0.569

# National Bridge Inventory Data Sheet

| IDENTIFICATION | |
|---|---|
| (7) Facility Carried | US 49- Phillips Co |

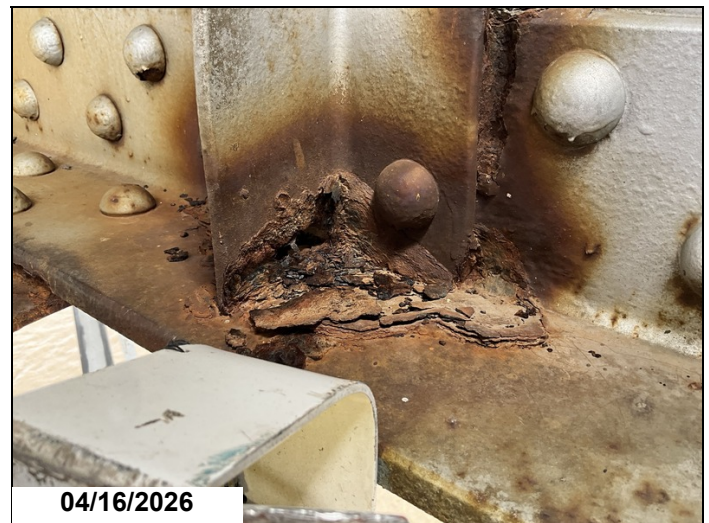
Span 13, Floorbeam 42, Back, Stiffener 9: Active corrosion with a hole in the stiffener. 1LF CS3 corrosion.

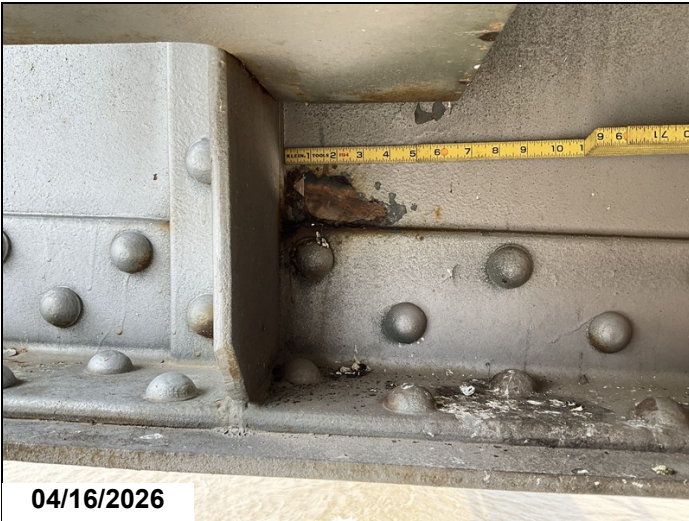
Span 13, Ahead Floorbeam at PP43, Adjacent to Stiffener 8: Active corrosion with a 4" X 2" Hole in web. 1LF CS4 corrosion.

ARDOT and MDOT preparing plans for major bridge retrofit. 5/1/2024 KAW  
Assigned to contract rehabilitation set to let in early 2026. 5/1/2025 KAW

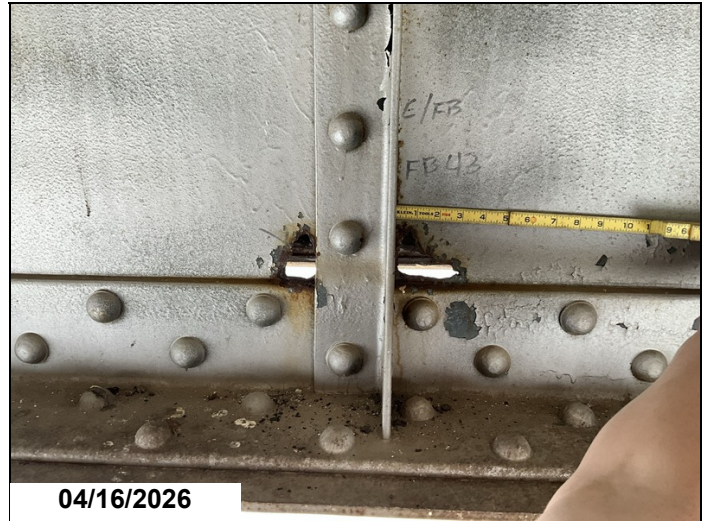
Span 13, Ahead Floorbeam at PP43, Adjacent to Stiffener 7: Active corrosion with a 3" X 2" Hole in the web on the left side of the stiffener and a 1 1/2" X 2 1/4" Hole in the web on the right side of the stiffener. 1LF CS4 corrosion.

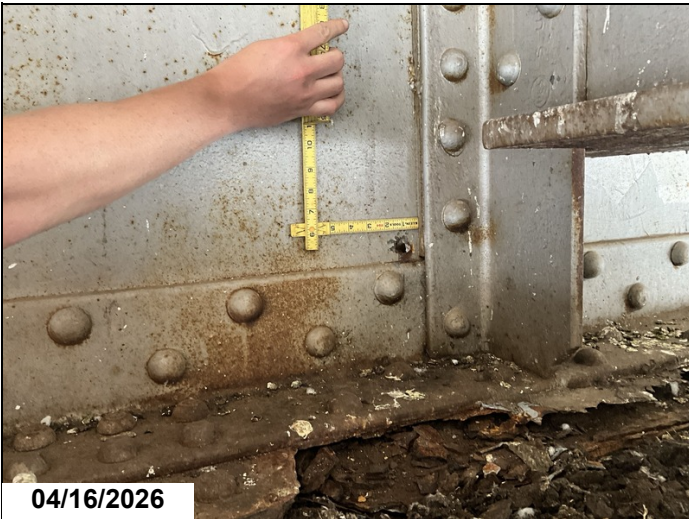
Span 13, Ahead Floorbeam at PP43, Adjacent to Stiffener 5: Active corrosion with a 1" X 1" Hole in the web on the right side of the stiffener. 1LF CS4 corrosion.

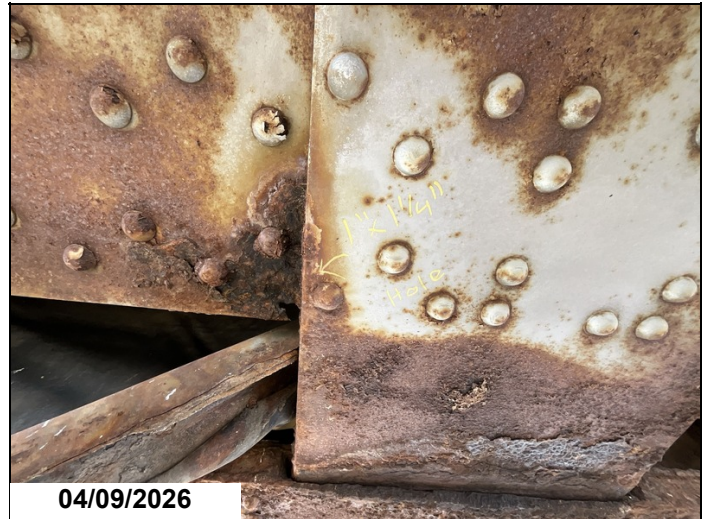
Span 14, PP59, Back Floorbeam, Bottom Flange, Left of Windlock: Active corrosion with a 1" X 1 1/4" hole in Bottom Flange. 1LF CS4 corrosion.

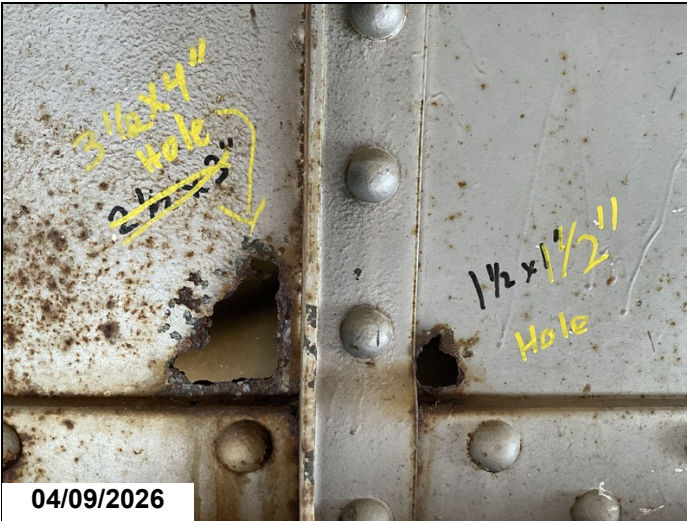
Span 14, Ahead Floorbeam at PP59, Stiffener 4: Active corrosion with a 3 1/2" X 4" hole and a 1 1/2" diameter hole in the web of the floorbeam. 1LF CS4 corrosion.

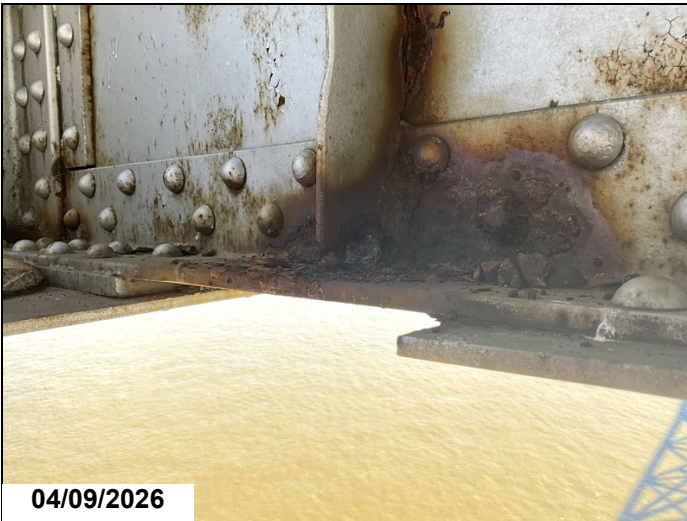
04/09/2026

Span 14, Ahead Floorbeam at PP59, Stiffener 5: Active corrosion with a 6" X 7 1/2" hole in the web. 1LF CS4 corrosion.

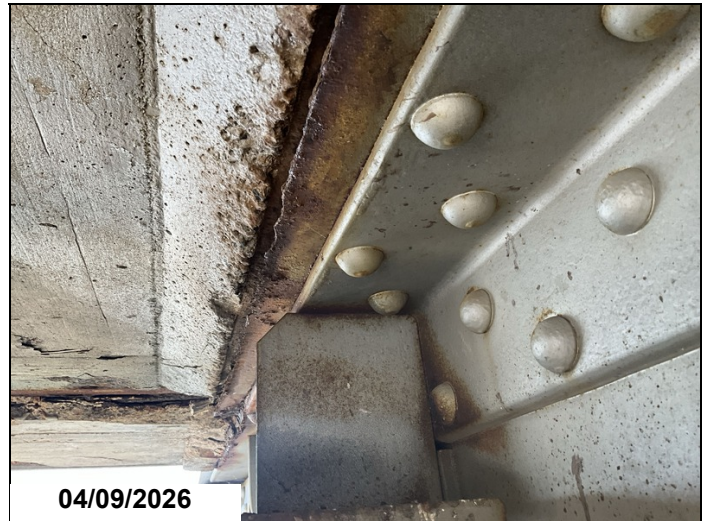
04/09/2026

Span 14, Floorbeam 52, Back and Ahead, Stiffener 1: Active corrosion with a hole in the stiffener. 1LF CS3 corrosion.

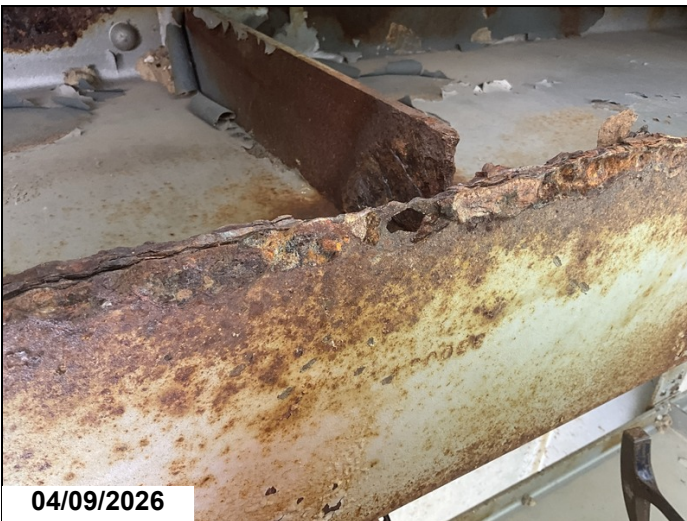
Span 7, Floorbeams 6 and 7: Moderate to heavy corrosion to the webs and the bottom flange, as well as heavy corrosion to the windlock. 12LF CS3 corrosion.

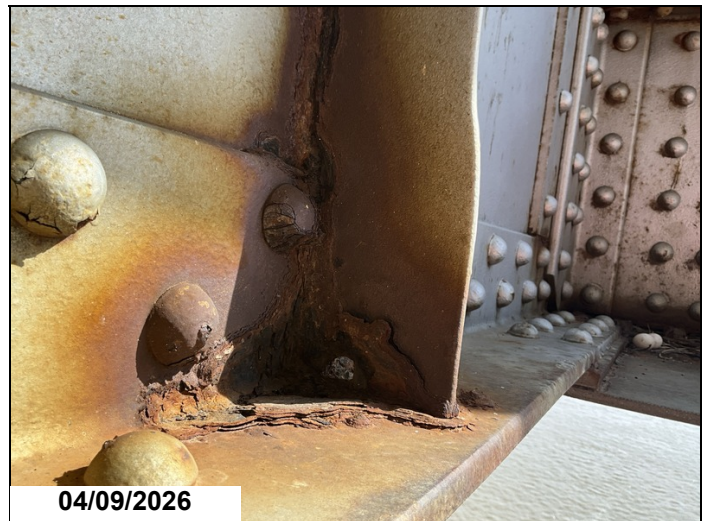
Span 7, Floorbeam 6, Bottom flange, Right of Windlock: Active corrosion with a 1" diameter hole in the bottom flange. 1LF CS4 corrosion.

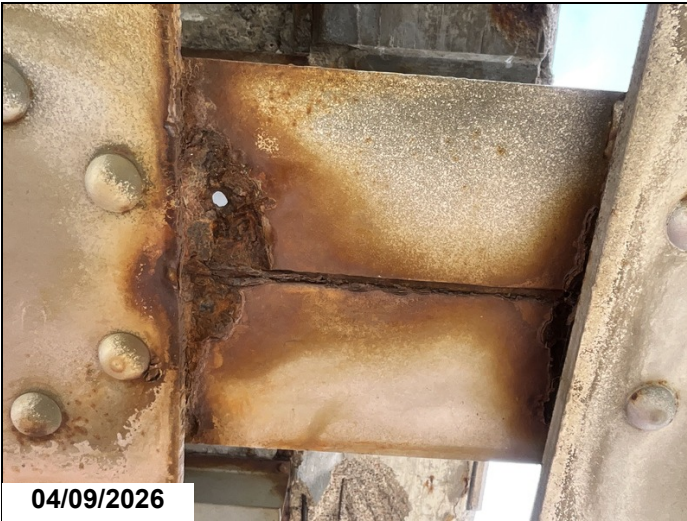
Span 13, Floorbeam 42, Back, Stiffener 9: Active corrosion with a hole in the stiffener. 1LF CS3 corrosion.

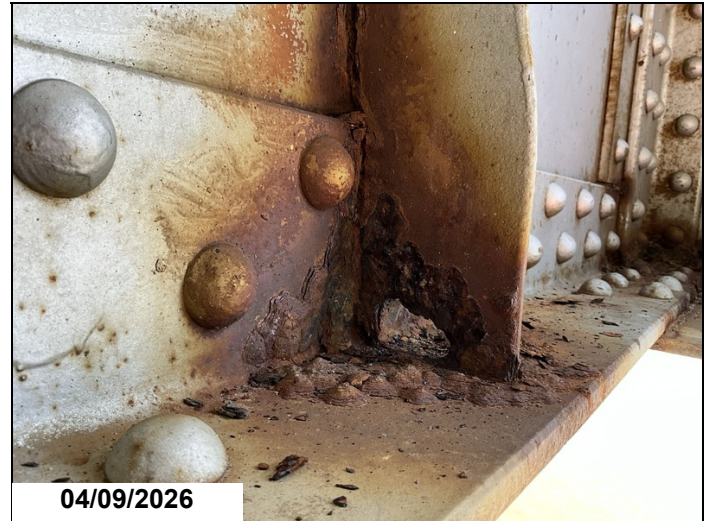
Span 12, Floorbeam 29, Right, Bottom Flange: Active corrosion with a 1/2" diameter hole in the bottom flange. 1LF CS4 corrosion.

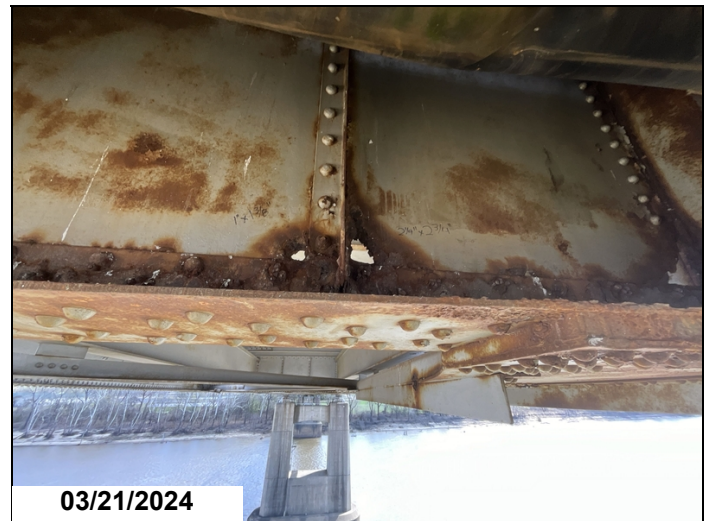
03/21/2024  
Span 14, Floor beam 59, Ahead, Bottom web juncture, Adjacent to the 4th stiffener from L59, Left: Has active corrosion with a 1" x 1 3/8" hole and a 2.25" x 2.75" hole. 1LF CS4

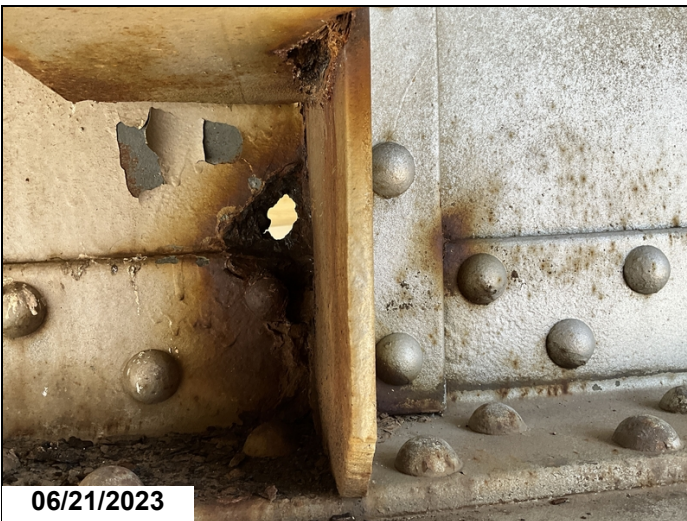
Span 14, Floor beam 59, ahead, 1/2" x 1/2" hole in the web on the left side of stiffener 3, 1/2" x 2 1/4" hole on the right side. CS4

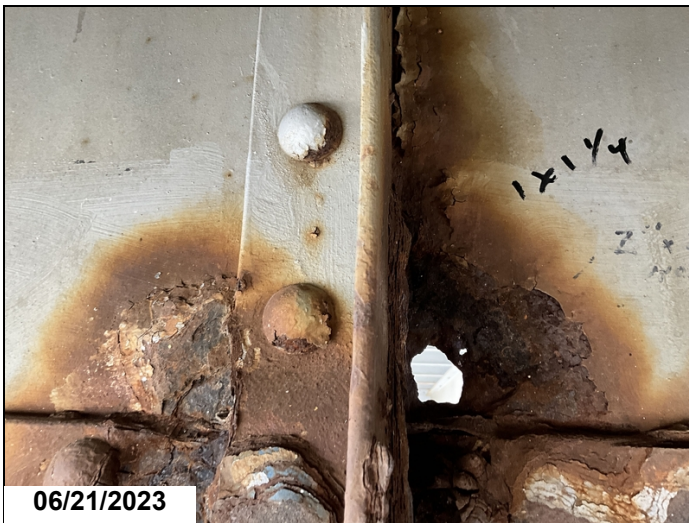
06/21/2023

Span 12, Floor beam 25, ahead, stiffener 6, 2 1/2 x 1/2", 3 x 3 1/2" holes on the left side, 3 x 1/2" hole on the right side. CS 3.

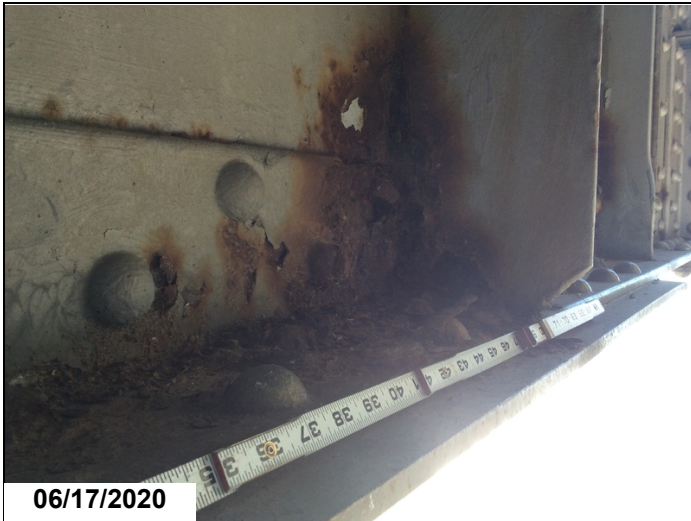
06/17/2020

PP 25 ahead floor beam: 2 small holes in the web of the floor beam due to active corrosion.

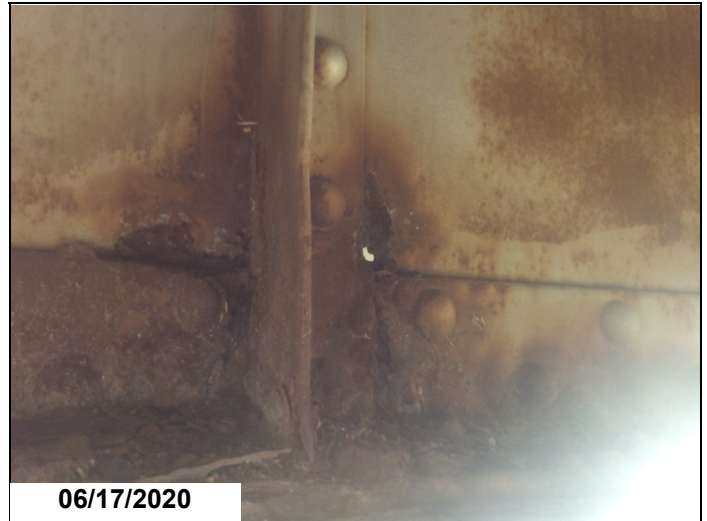
PP 25: A 2"x1 1/2" hole in the web of the ahead floor beam.

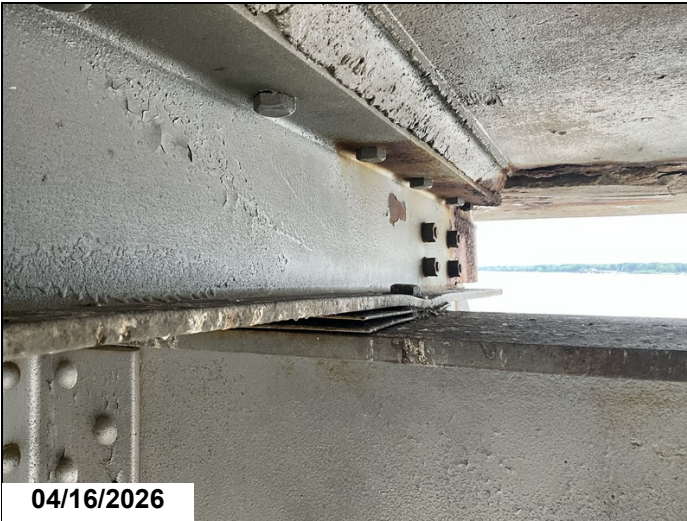
Span 13, Last Deck Joist before PP43, Over Stringer 3: Active corrosion with pack rust, causing distortion along the bottom flange. 1LF CS3 distortion. Typical at this location.

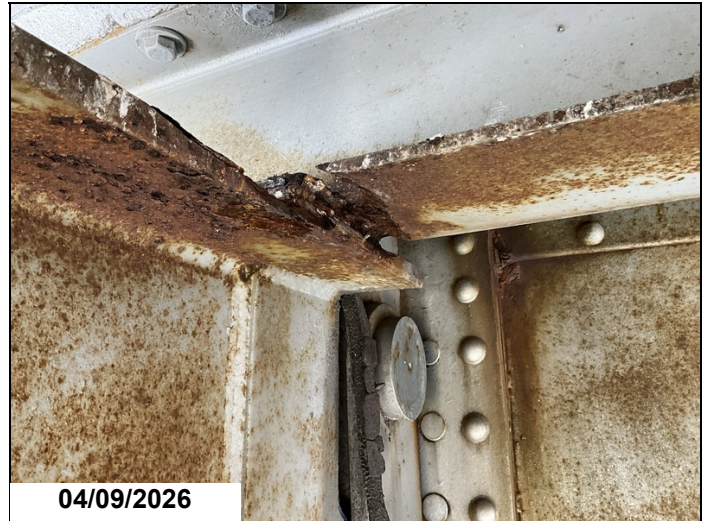
Span 15, First Deck Joist ahead of Floorbeam 66, Above Stringer 3: Active corrosion with a hole in the bottom flange of the deck joist. 1LF CS4 corrosion.

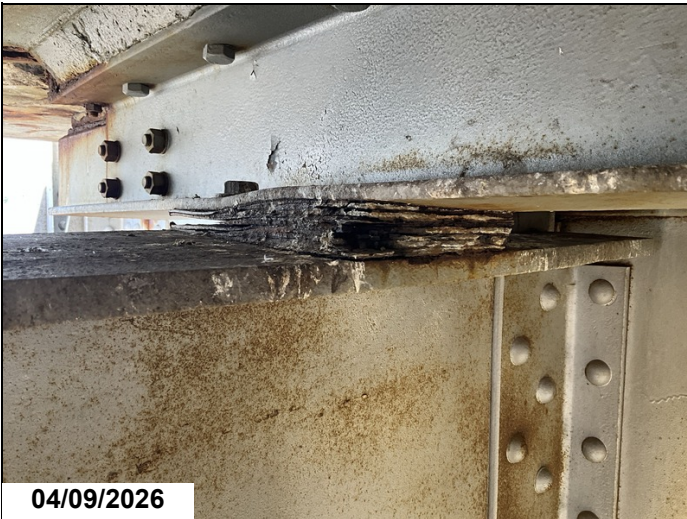
Span 14, Last deck joist before PP59, Stringer 1: Active corrosion with pack rust up to 1 3/4" between the bottom flange of the deck joist and the top flange of the stringer, causing distortion in both the deck joist and the stringer. 2LF CS3 distortion.

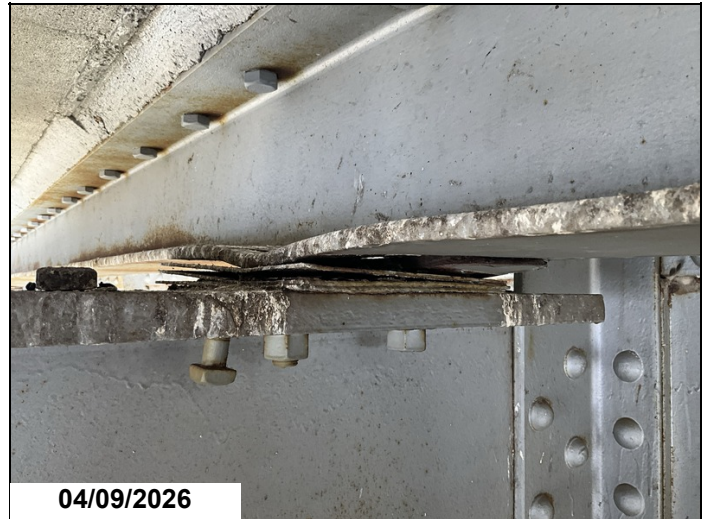
Span 14, Last deck joist before PP59, Stringer 2: Active corrosion with pack rust, causing a fracture in the bottom flange of the deck joist on both the ahead and back side, making a "Half-Moon" shape around the stringer connection bolts. 1LF CS3 crack.

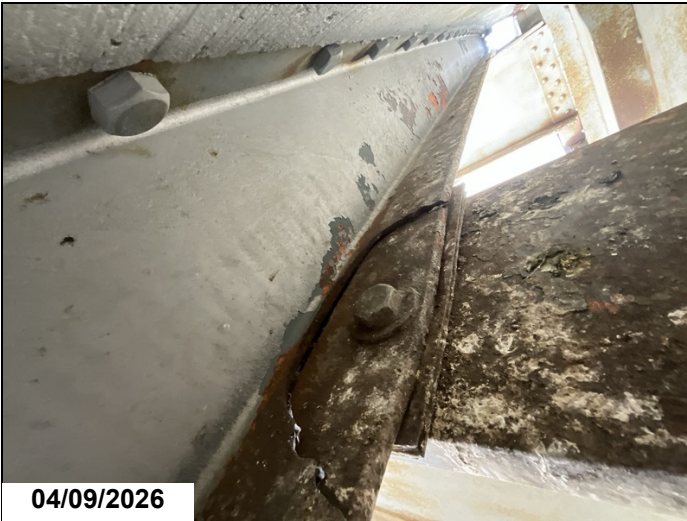
Span 14, Last deck joist before PP59, Stringer 2: Active corrosion with pack rust, causing a fracture in the bottom flange of the deck joist on both the ahead and back side, making a "Half-Moon" shape around the stringer connection bolts. 1LF CS3 crack.

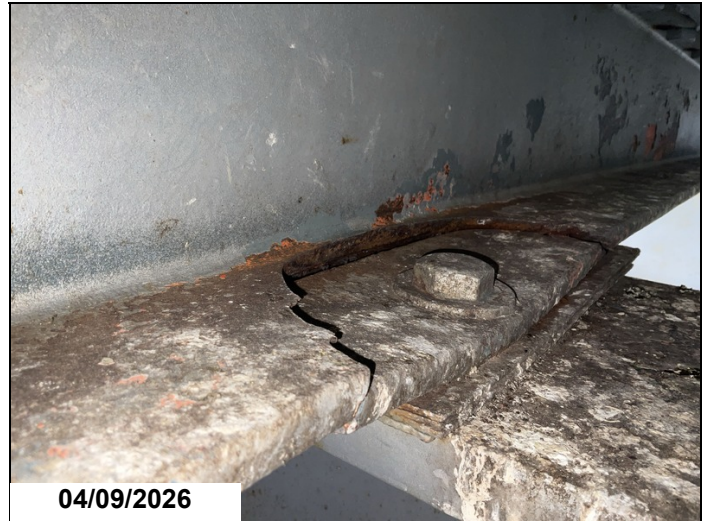
Span 14, Last deck joist before PP59, Stringer 2: Active corrosion with pack rust, causing a fracture in the bottom flange of the deck joist on both the ahead and back side, making a "Half-Moon" shape around the stringer connection bolts. 1LF CS3 crack.

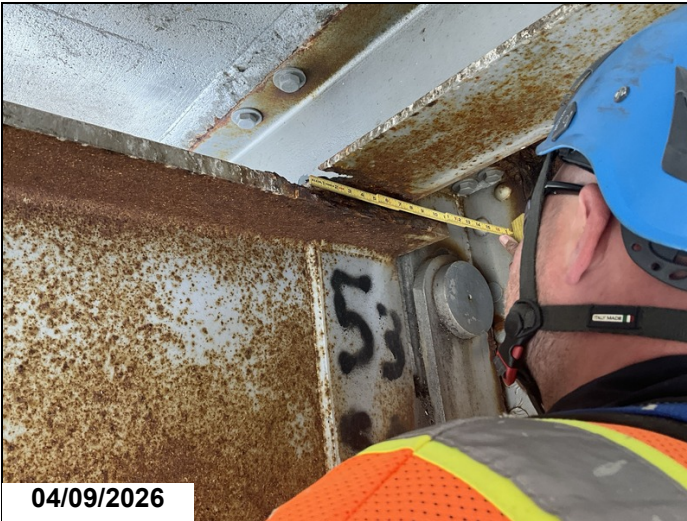
Span 14, First Deck Joist ahead of Floorbeam 53, Above Stringer 2: Active corrosion with a hole in the bottom flange of the deck joist. 1LF CS4 corrosion.

Span 14, First Deck Joist ahead of Floorbeam 53, Above Stringer 3: Active corrosion with a hole in the bottom flange of the deck joist. 1LF CS4 corrosion.

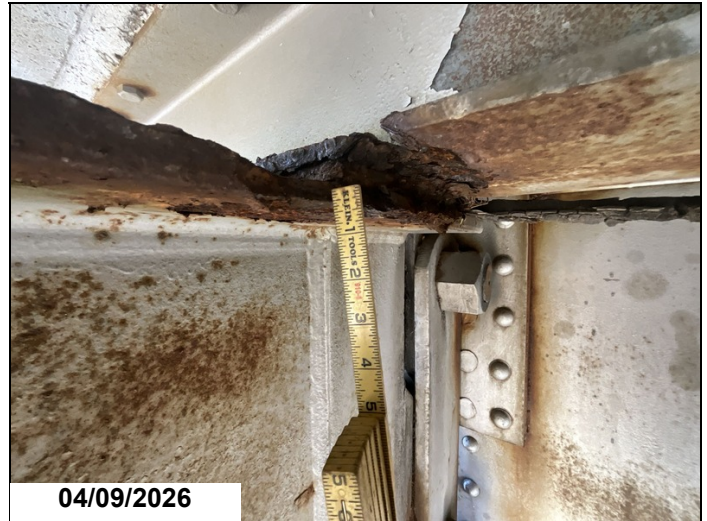
Span 15, First Deck Joist ahead of Floorbeam 71, Above Stringer 3: Active corrosion with a hole in the bottom flange of the deck joist. 1LF CS4 corrosion.

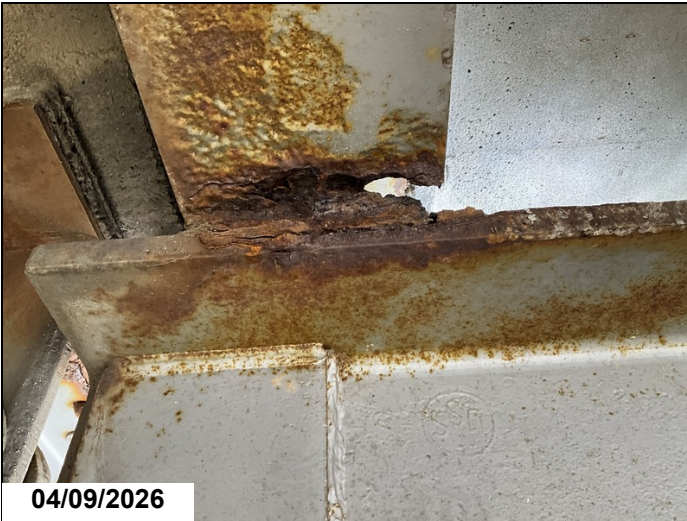
**04/09/2026**

Span 12, Deck Joist, Back of Floorbeam 22, above Stringer 2: Active corrosion with a 2 1/2" X 1" Hole in the bottom flange of the Deck Joist. 1LF CS4 corrosion.

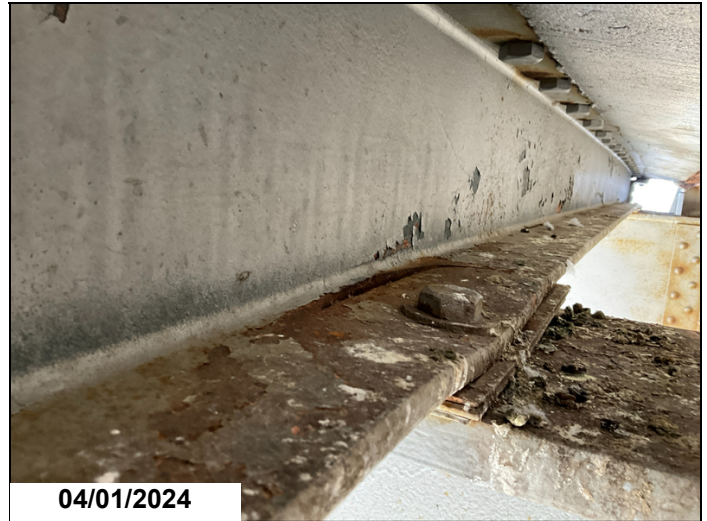
**04/01/2024**

Span 15, 1st deck joist, back of floor beam 59, above stringer 2: Bottom flange has a 10" crack. CS3

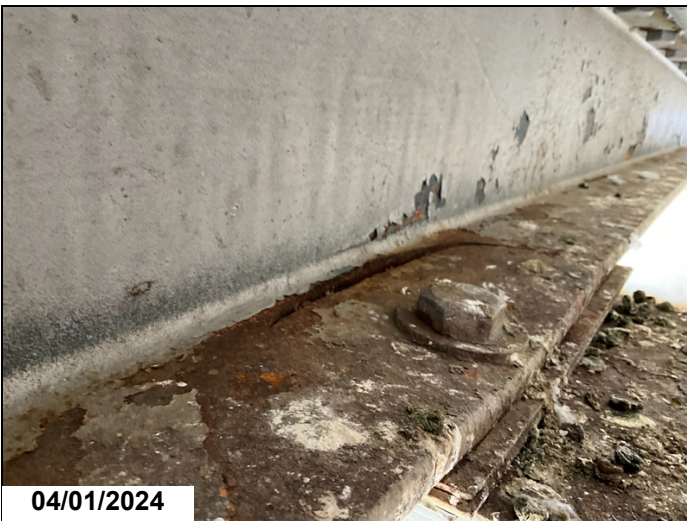
**04/01/2024**

Span 15, 1st deck joist, back of floor beam 59, above stringer 2: Bottom flange has a 10" crack. CS3

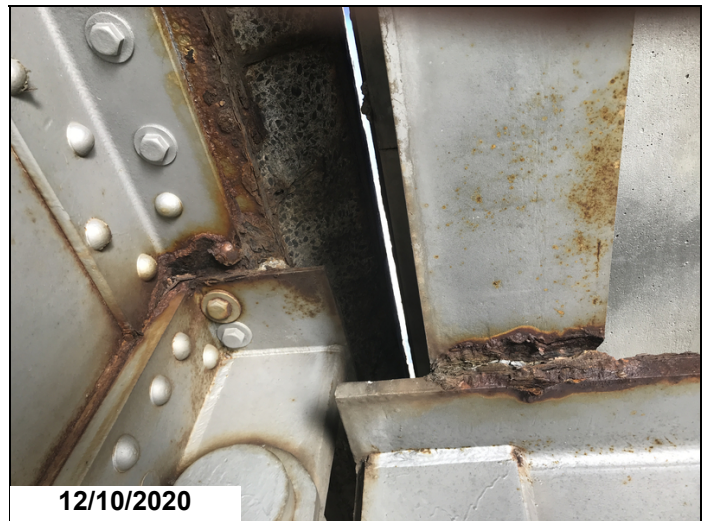
Panel point 18 stringer 1 active corrosion with section loss to the transverse stiffener

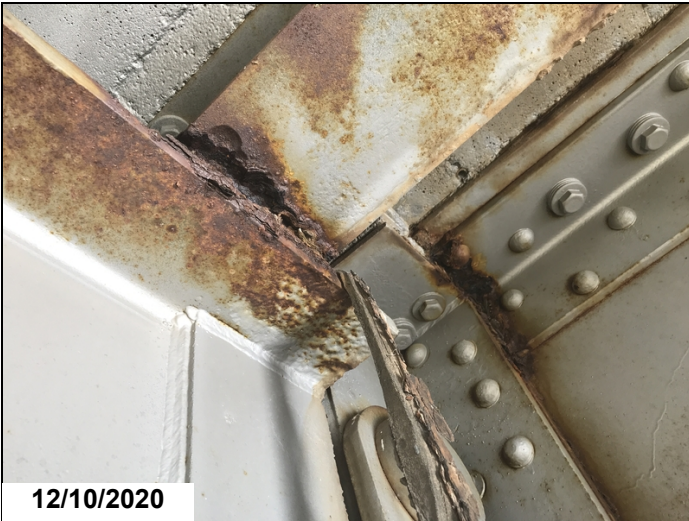
Panel point 46 stringer 1 transverse stinger active corrosion with section loss (Bk)

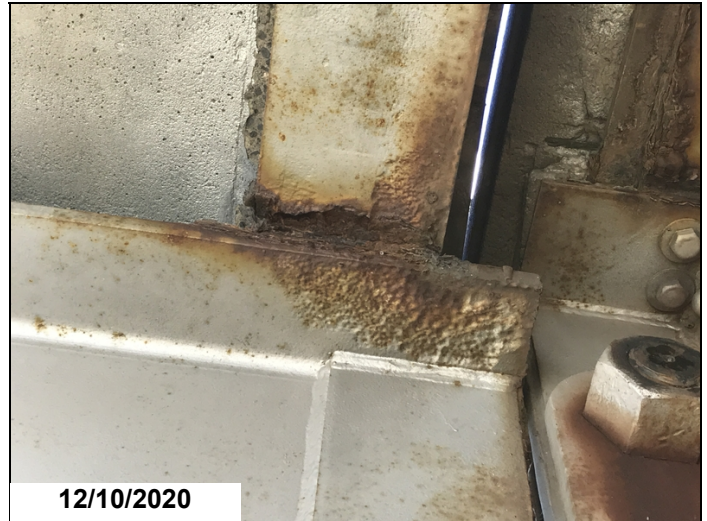
Panel point 62 stringers 1-3 active corrosion with up to 100% section loss on transverse stringer due to open joint

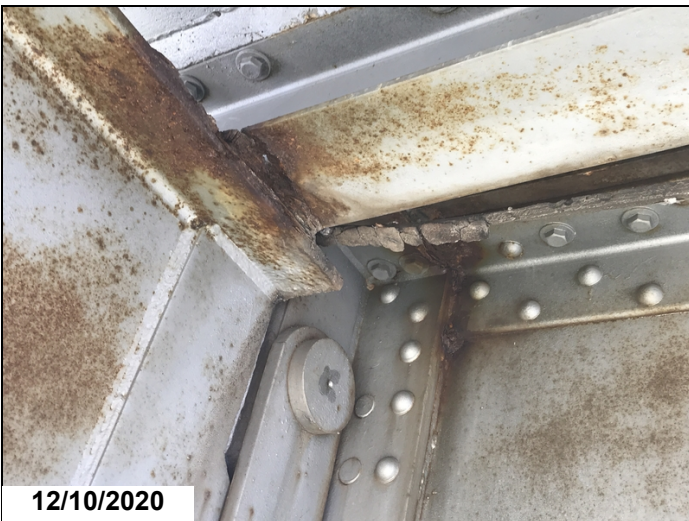
Due to open joint at panel point 66 transverse stringer at 1-3 have advanced section loss with up to 100%

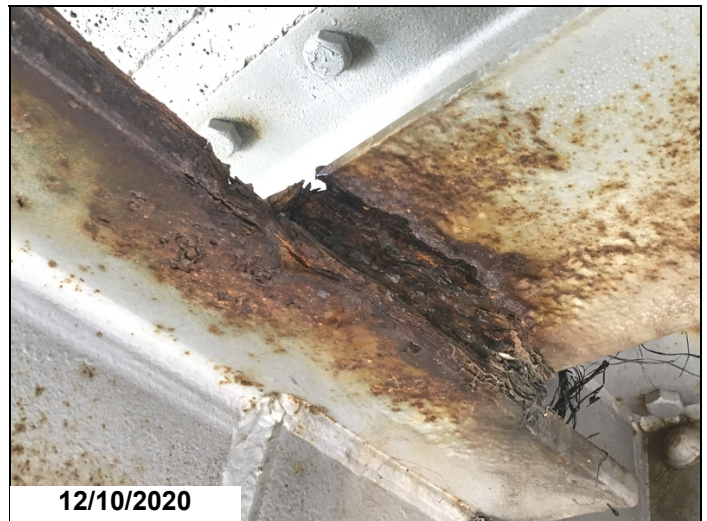
Panel point 71 transverse stringer adjacent to stringer 3 active corrosion with up to 100% section loss

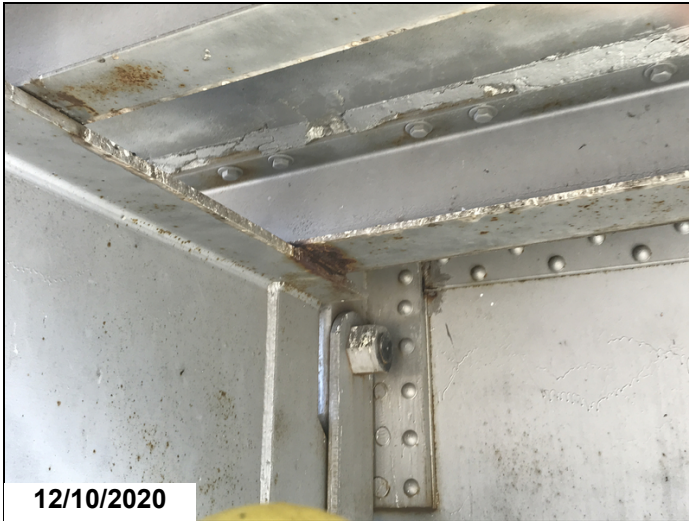
Panel point 15 stringer 1 section typical at joint locations

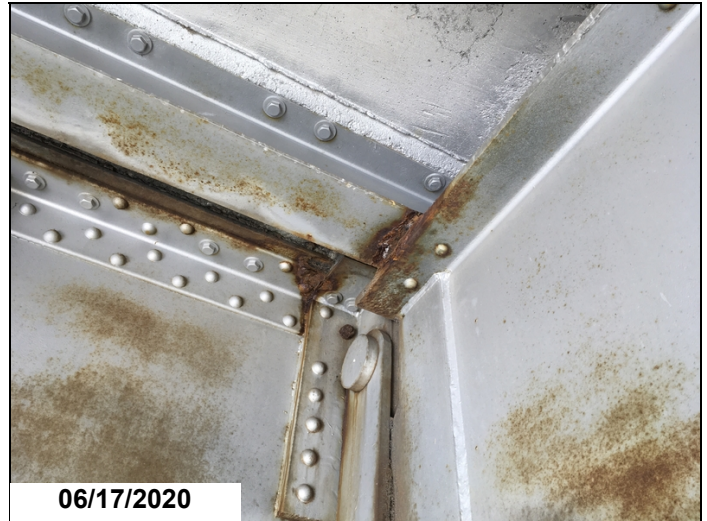
PP 66, Ahead, Stringer 2, Deck Joist, Bottom Flange: Knife edge section loss.

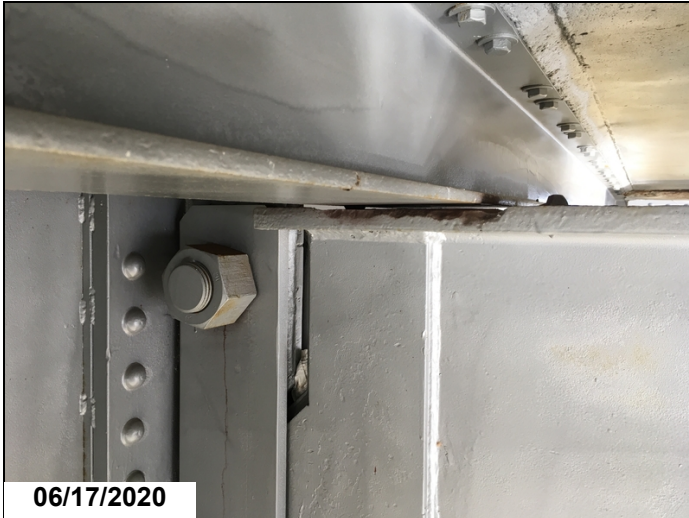
PP 56, Stringer 2, Ahead, Deck Joist: Floating. Missing shim plate.

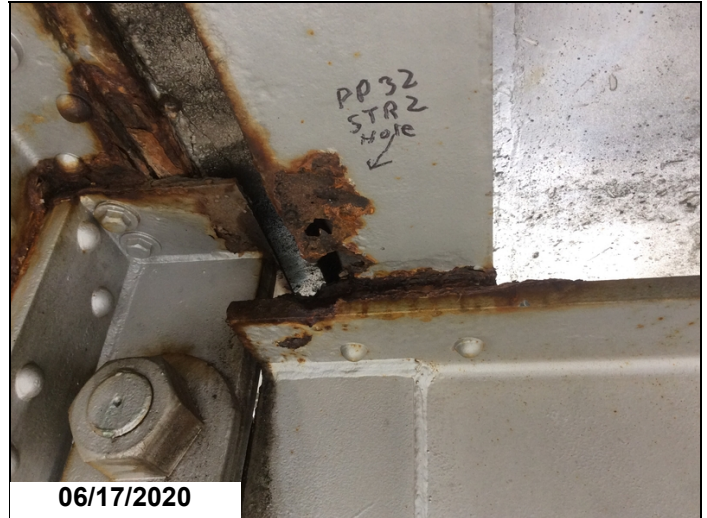
PP 32: Hole corroded through bottom flange of deck joist at Str 2.

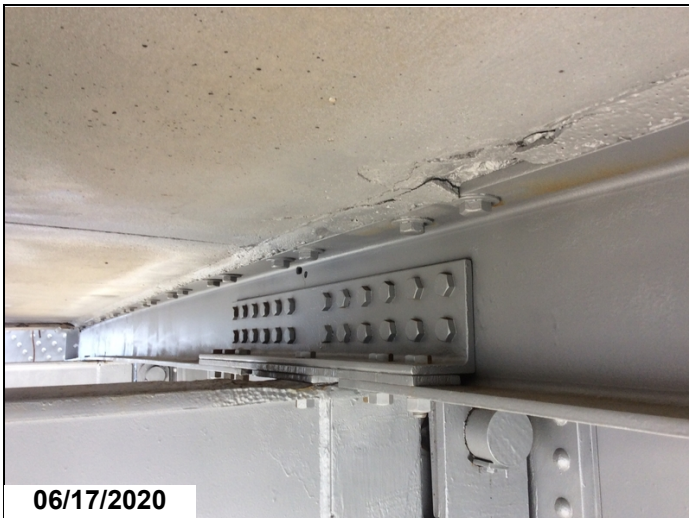
PP 36: Repaired area above Str 2.

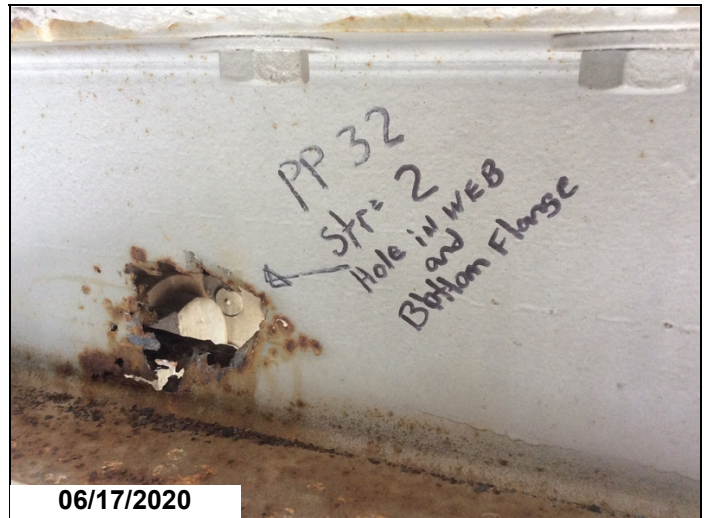
PP 32: Hole in web and bottom flange of deck joist at Str 2.

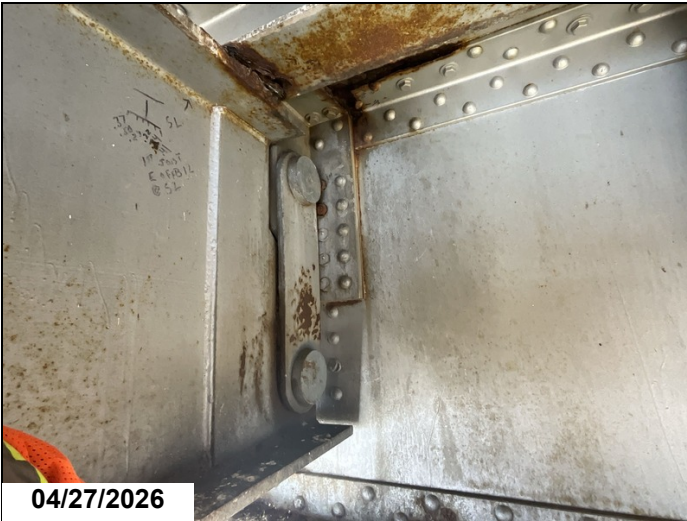
Span 12, Ahead of Floorbeam 12 Hanger Bar, Stringer 2: Corrosion with flaking rust, pack rust (between the hanger bar and stringer), and section loss up to 1", CS3

Span 12, Floorbeam 12, Stringer 2, Pin and Hanger Assembly: Active corrosion with pack rust between the stringer web and the hanger bar, along with the pin and hanger appearing to be frozen. 1EA CS3 corrosion.

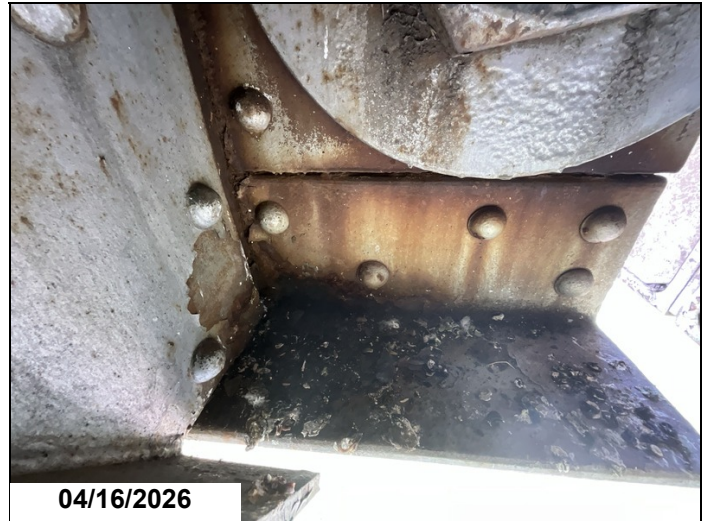
Span 19, Girder 2, Bottom Flange Angle, below Pin and Hanger Assembly: Active corrosion with section loss up to 3/8.

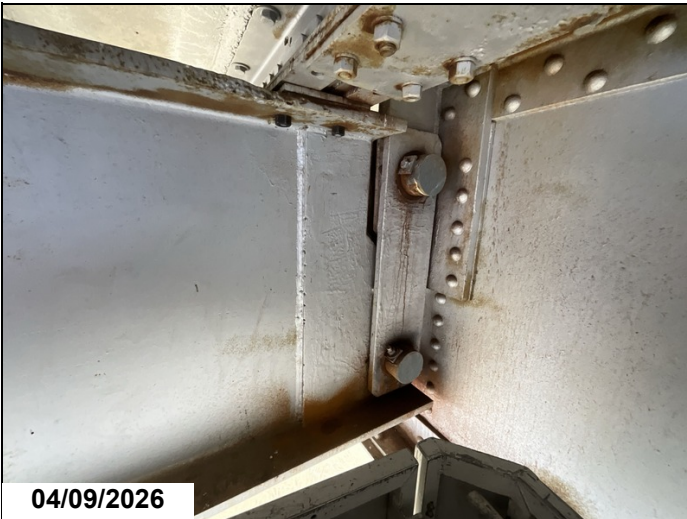
Span 13, Floorbeam 36, Stringer 2, Pin and Hanger Assembly: Assembly is moving vertically under live load.

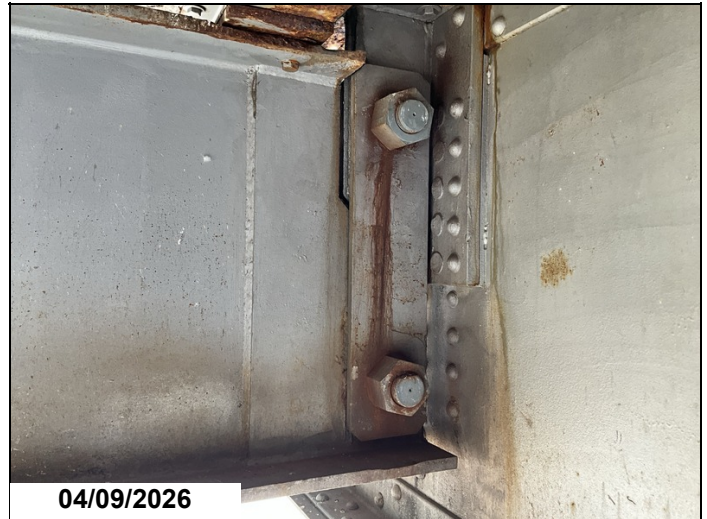
Span 14, Floorbeam 68, Stringer 2, Pin and Hanger Assembly: Assembly is moving vertically under live load.

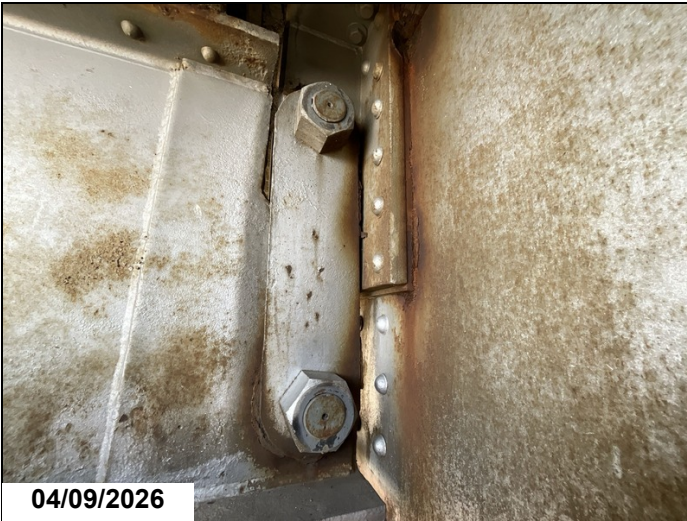
Span 14, Back of Floorbeam 62, Each hanger bar and stringer has active corrosion with flaking rust and section loss ranging from 1/16" to 1/4", CS3

Span 14, Stringers 1 - 3, Back of Floorbeam 62, Pin and Hanger Assembly: Active corrosion with pack rust up to 1/2" between stringer and hanger bar. 3LF CS3 corrosion.

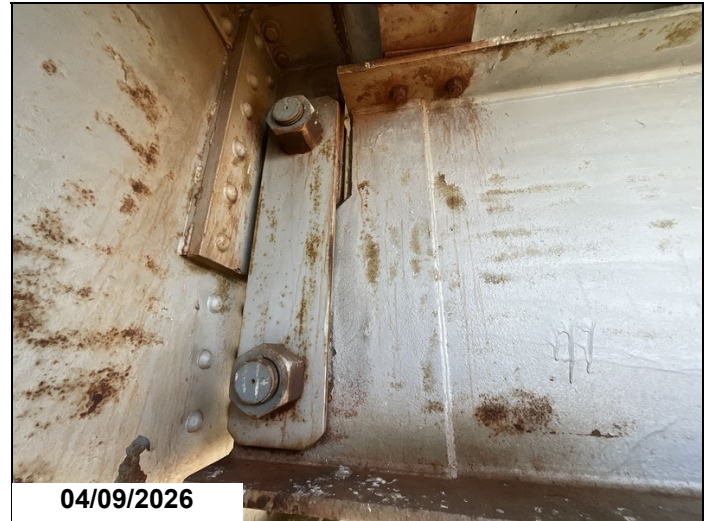
Span 14, Floorbeam 56, Stringer 3, Pin and Hanger Assembly: Assembly is moving vertically under live load.

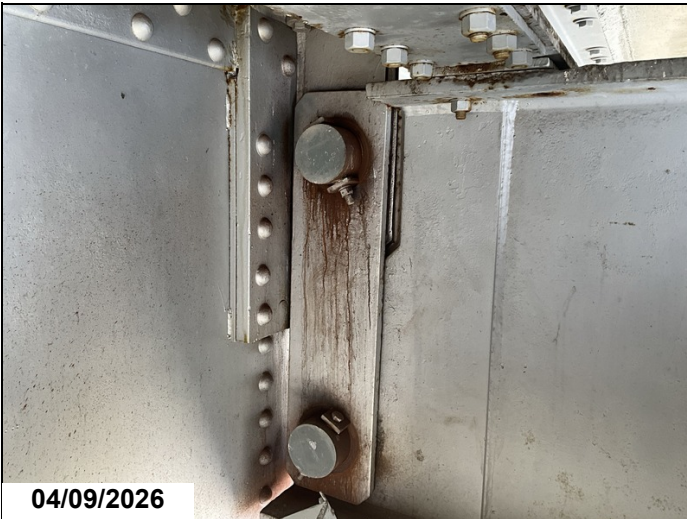
Span 14, Ahead of Floorbeam 50, Each hanger bar and stringer has active corrosion with flaking rust and section loss ranging from 1/16" to 1/8", CS3

Span 14, Floorbeam 50, Stringer 2, Pin and Hanger Assembly: Assembly is moving vertically under live load.

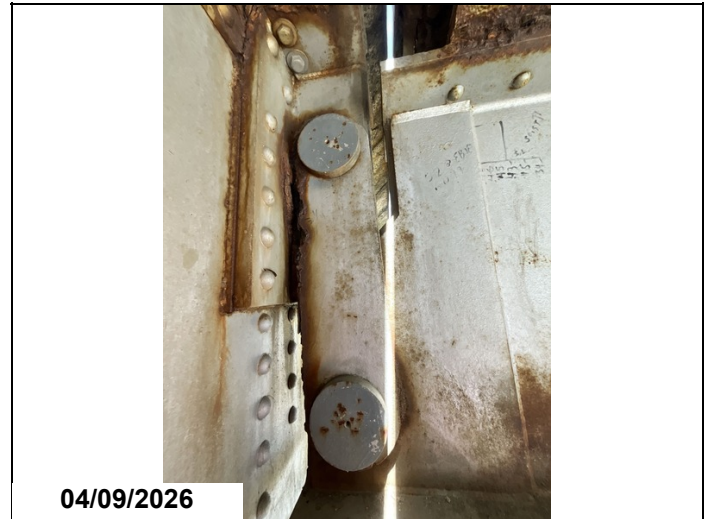
Span 12, Ahead of Floorbeam 18, Hanger Bars, Stringers 1-3: Corrosion with flaking rust, pack rust, and section loss ranging from 1/8" to 1/4", CS3

Span 12, floor beam 18 ahead, stringer 2, up to 1/2" section of the 8" wide hanger is lost. Pin and hanger is frozen. 1EA, CS3.

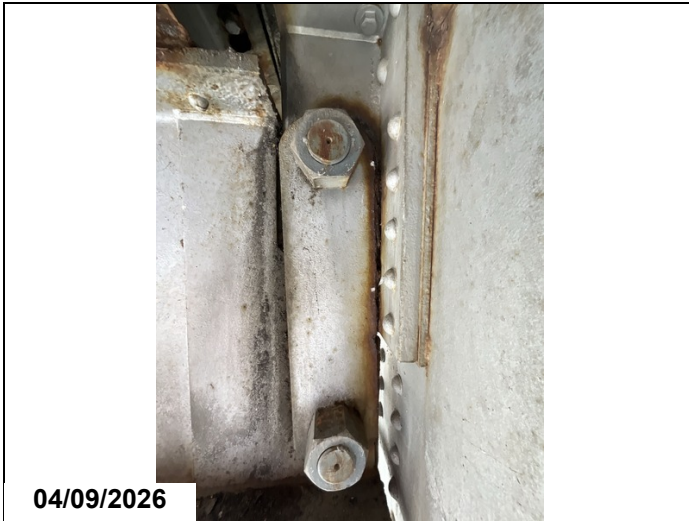
Span 11, Floorbeam 8, Stringer 2, Pin and Hanger Assembly: Pin and Hanger assembly is frozen. 1EA CS3 movement.

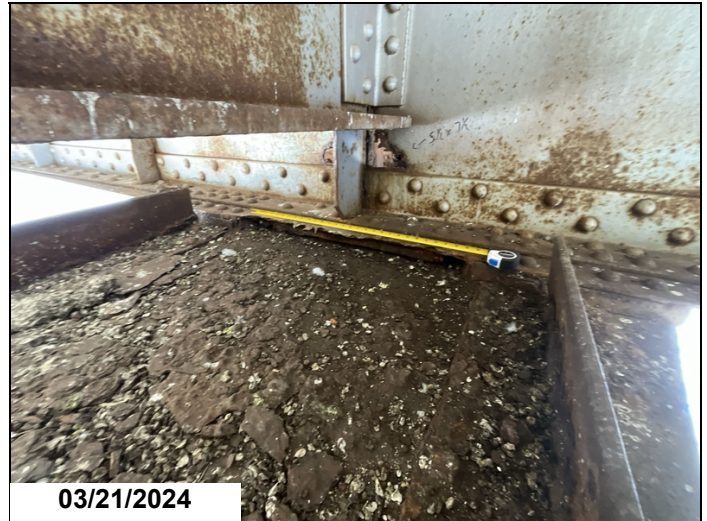
Span 14, Floor beam 59, Bottom flange, along the Windlock: Has heavy corrosion with 30" x 2" of 100% section loss. 3LF CS4

Span 14, Ahead of Floor Beam 59, Bottom Flange (Cover Plate): Corrosion with a 30" x 2" hole rusted through the centerline of the cover plate, CS4

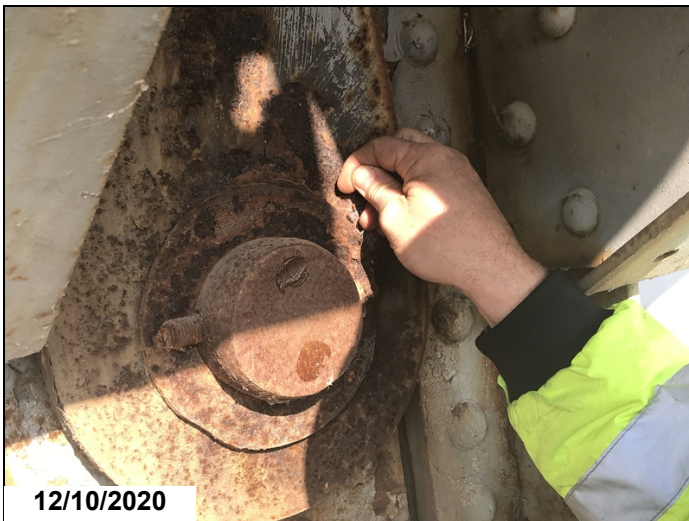
Girder 4 span 4 flaking rust with active corrosion on hanger at bottom pin

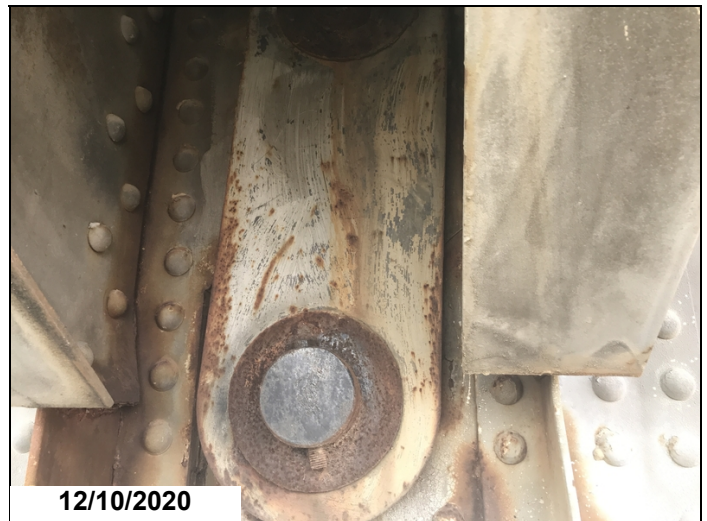
Typical pin and hangers span 4

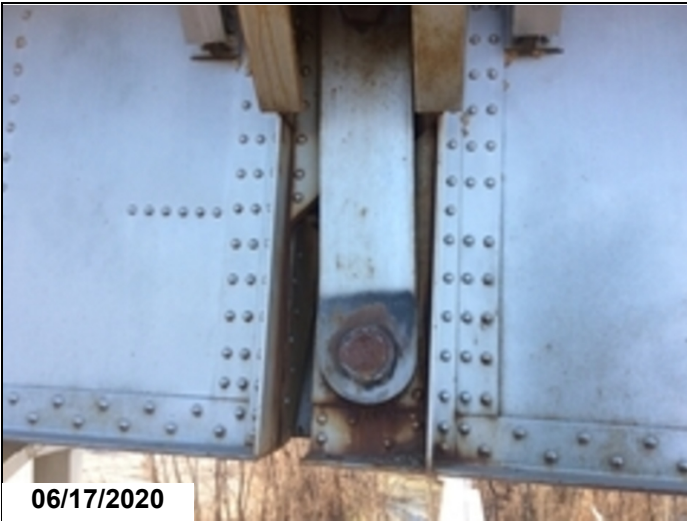
Span 7 hanger bars active corrosion.

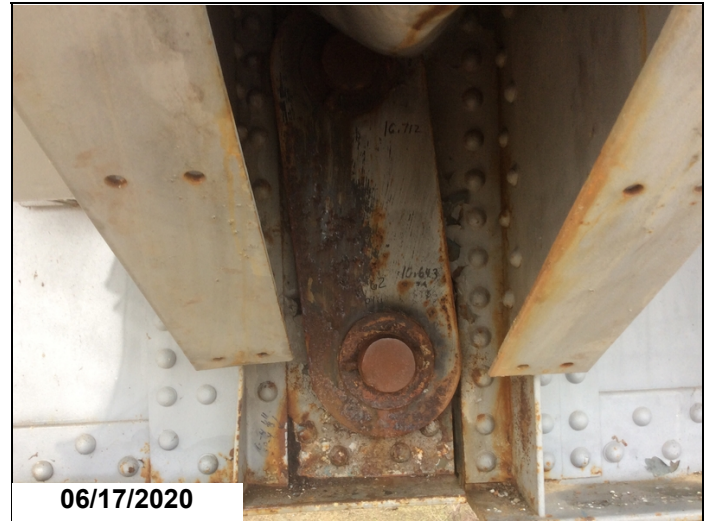
Joint 4A: Hanger bar assembly has active corrosion.

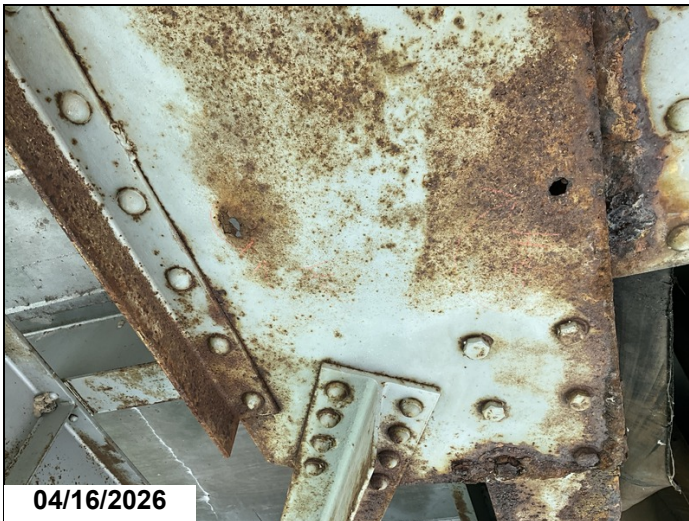
Span 19, Floorbeam 3, Windlock Gusset: Active corrosion with section loss and two 1" Diameter holes.

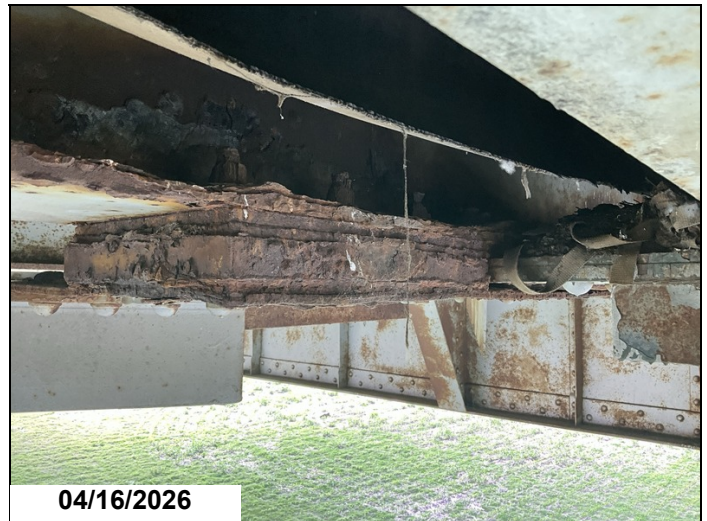
Span 19, Windlock: Heavy active corrosion.

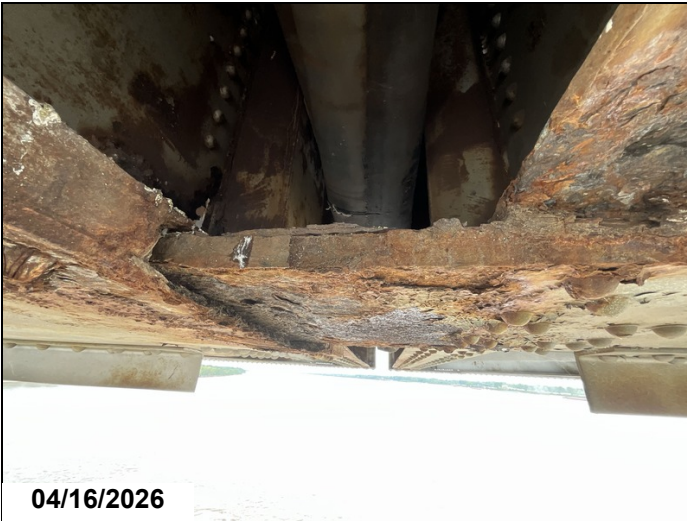
Span 13, PP43, Windlock: Severe corrosion.

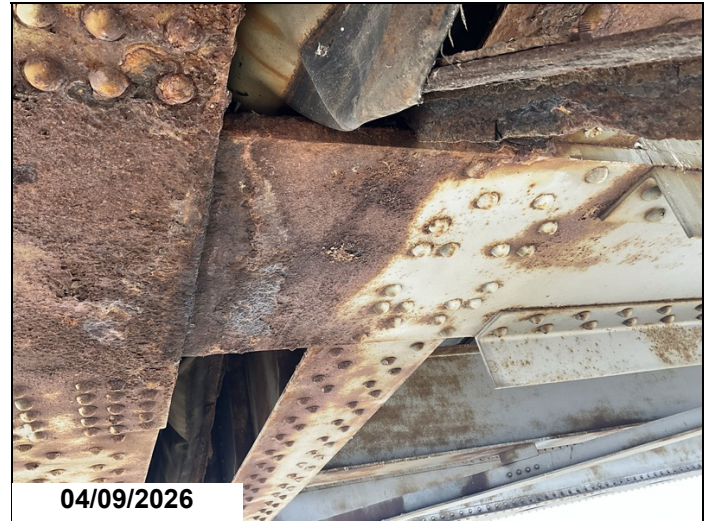
Span 14PP59, wind lock: Heavy corrosion.
