## Bridge 02899 Inspection Report

Arnold Road ID:54x49x11xA, Arnold Log mile:0.569

# National Bridge Inventory Data Sheet

| IDENTIFICATION | |
|---|---|
| (7) Facility Carried | US 49- Phillips Co |

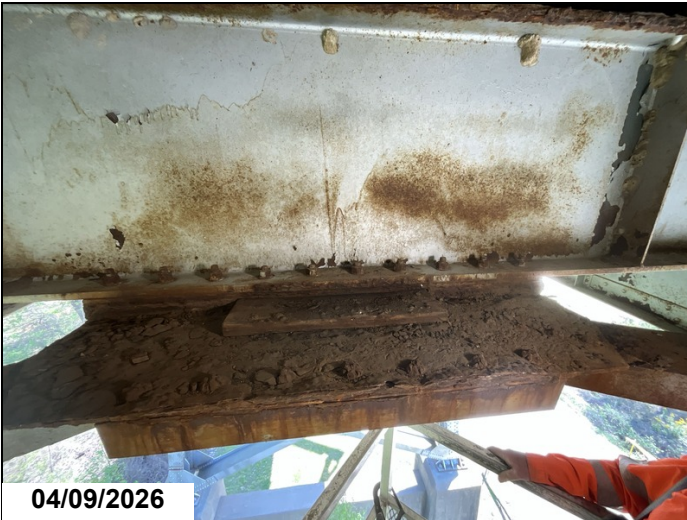
Span 7, Back of Floorbeam 6, Windlock: Active corrosion with moderate to heavy flaking rust and section loss. CS3 corrosion.

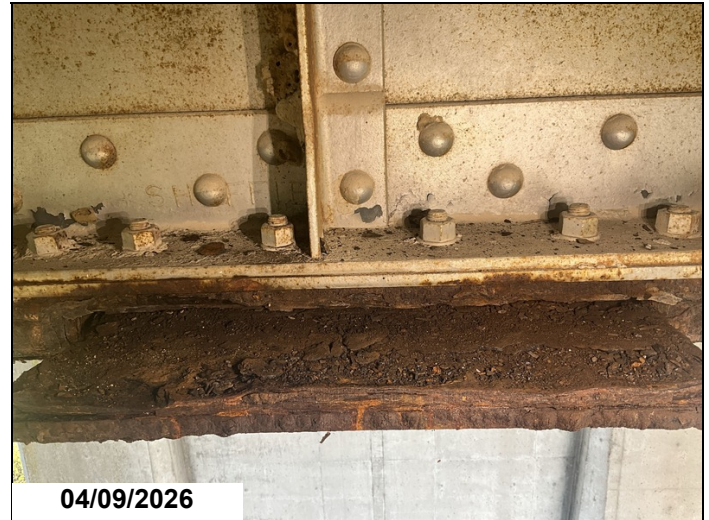
Span 4, Windlock: Moderate to Heavy corrosion.

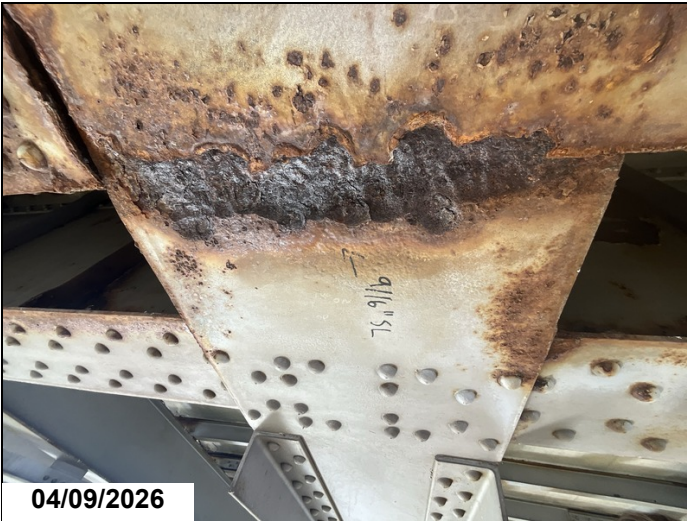
Span 12, panel point 25, 9/16" section loss to the windlock.

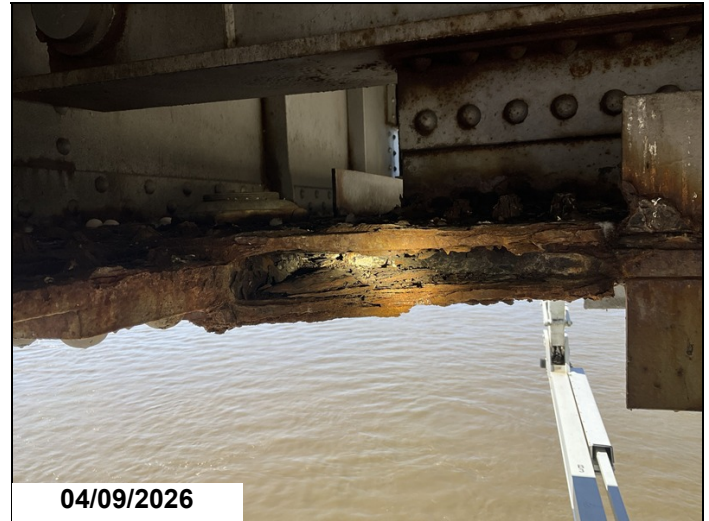
Span 12, PP15, Windlock: Heavy corrosion. CS3 corrosion.

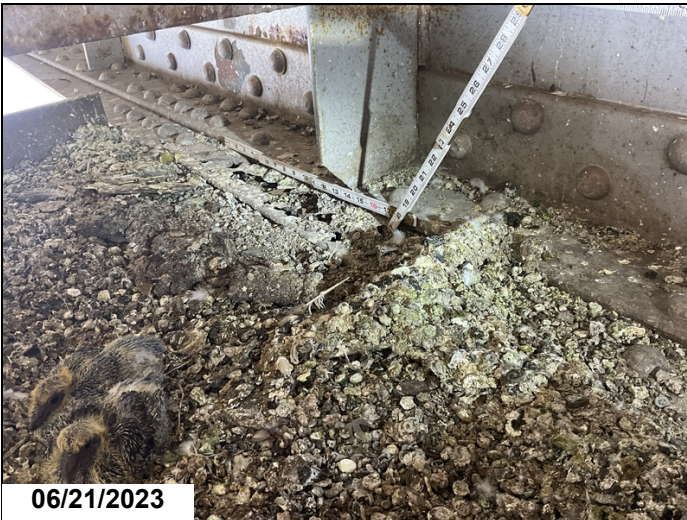
Span 12, Ahead of Floor Beam 25, Bottom Flange: heave corrosion with flaking rust, laminated rust, pack rust, and 27" of section loss ranging from knife edge to 100%, CS4

Span 12, Ahead of Floor Beam 25, Bottom Flange (Cover Plate): Corrosion with a 25" x 3" hole, CS4

Span 12, floor beam 25 ahead, bottom flange has a 19" x 3" hole above wind lock. CS 3.

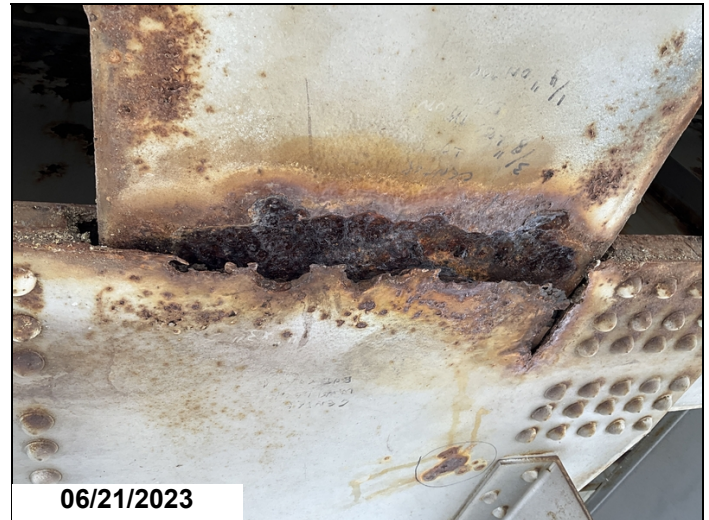
Span 12, panel point 25 wind lock, 9/16" section loss, pack rust, cs 3.

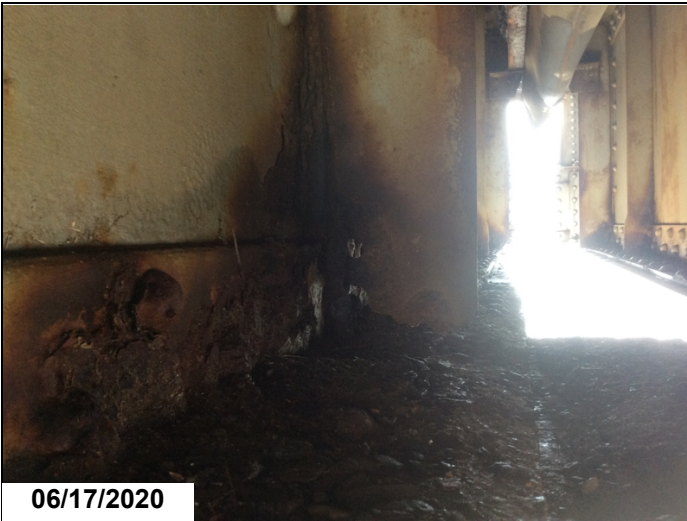
PP 59: Ahead FB has heavy corrosion and SL to bottom flange at Wind lock, also web stiffener at CL has hole rusted through the bottom.

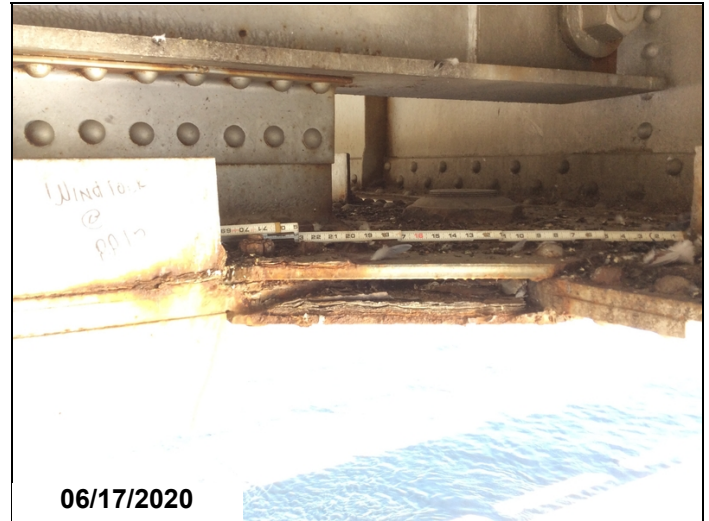
Windlock at PP15: Heavy amounts of corrosion and debris.

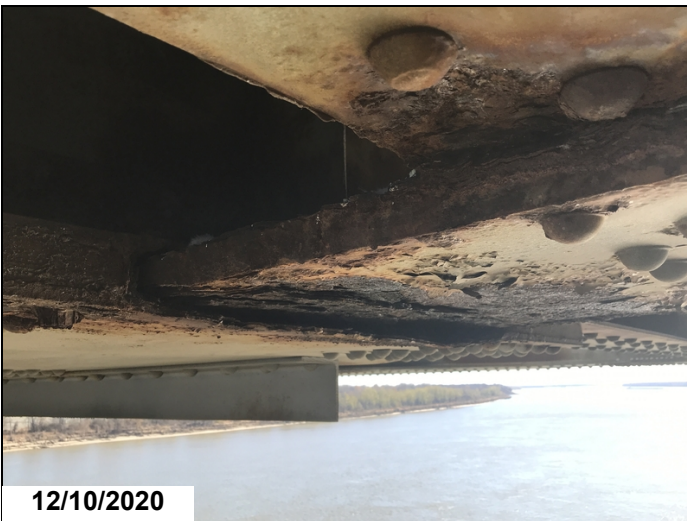
Panel point 43 wind lock has active corrosion with pack rust

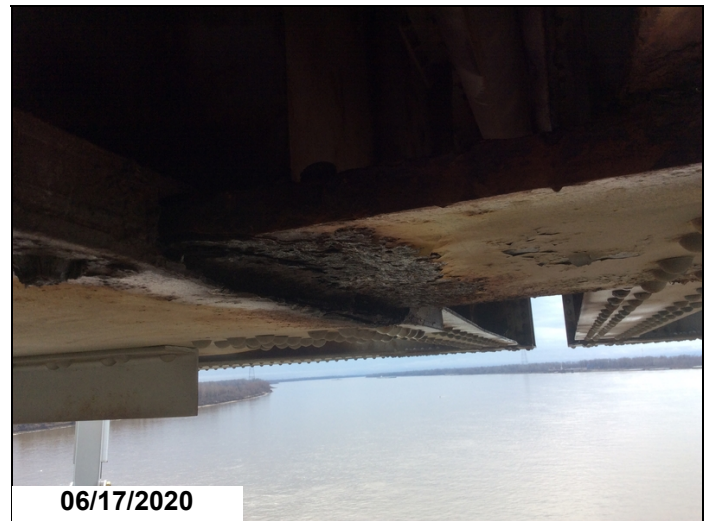
Span 13, Ahead of Floor Beam 43, Bottom Flange (Cover Plate): Corrosion with a 25" x 4" hole, the centerline of the cover plate, CS4

PP 43: Wind lock has sever SL.

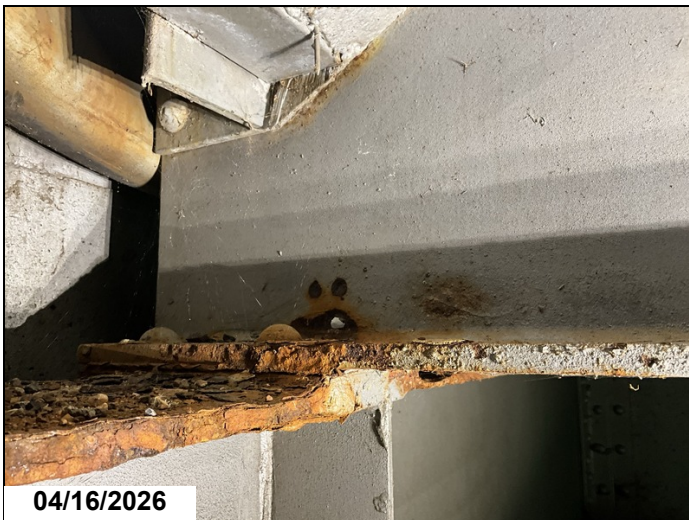
Span 21, Abutment 2, Stringer 2: Active corrosion with an area of 3" X 1" of knife-edge section remaining, along with a 1" Diameter hole in the web along the bottom web juncture. 1LF CS4 corrosion.

Span 21, Abutment 2, Stringer 2: Active corrosion with an area of 3" X 1" of knife's edge section remaining along with a 1" Diameter hole in web along the bottom web juncture. 1LF CS4 corrosion.

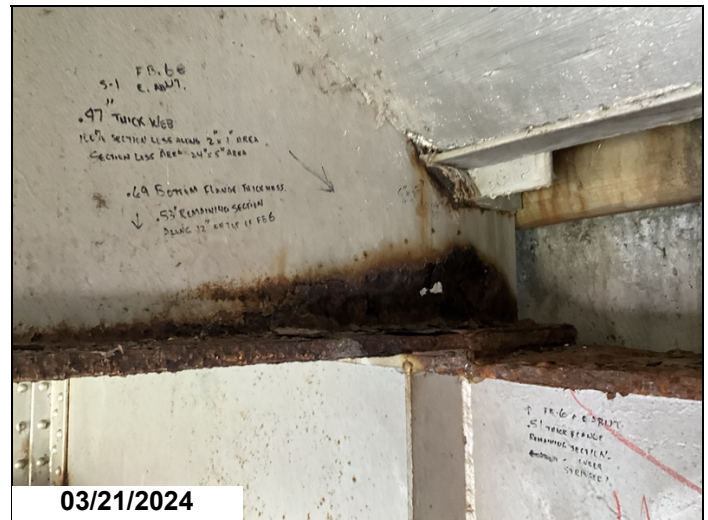
Abutment 2, stringer 1: Corrosion with flaking rust and a 3" x 1" hole along the bottom web juncture. 1LF CS4

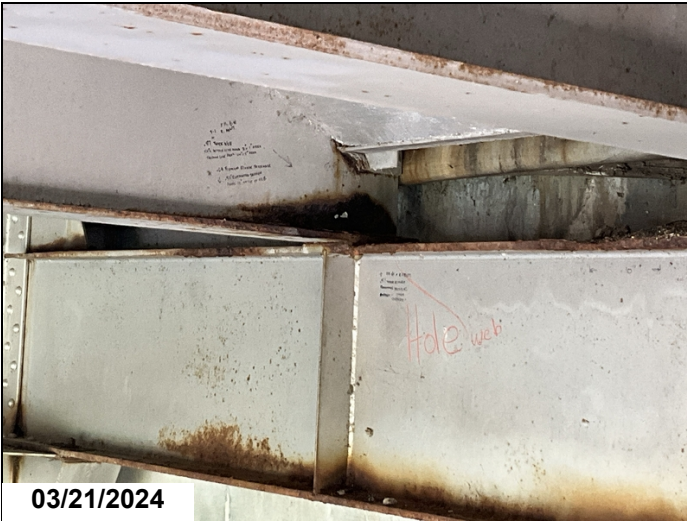
Abutment 2, stringer 1: Corrosion with flaking rust and a 3" x 1" hole along the bottom web juncture. 1LF CS4

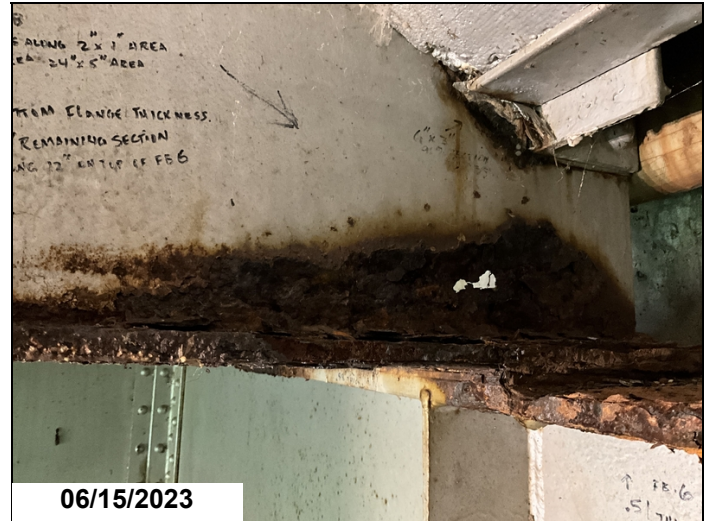
Span 21, floor beam 6, stringer 1 has a 3"x1" hole in the web, CS 3.

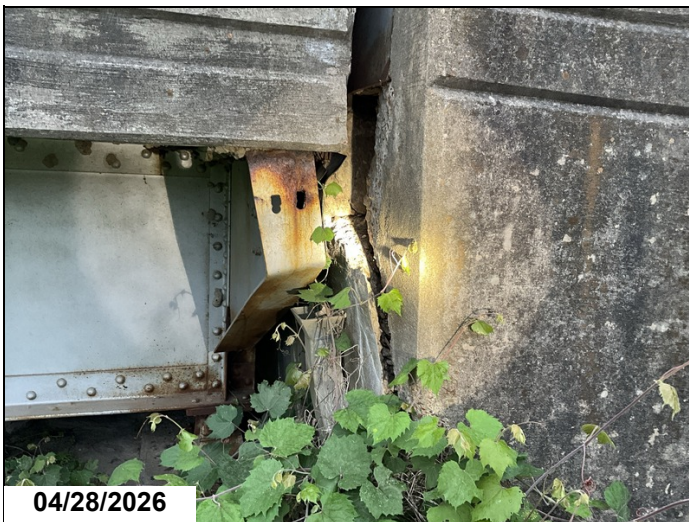
Abutment 1: Rotation along the backwall, rotating towards Pier 1 and causing the joint to close.

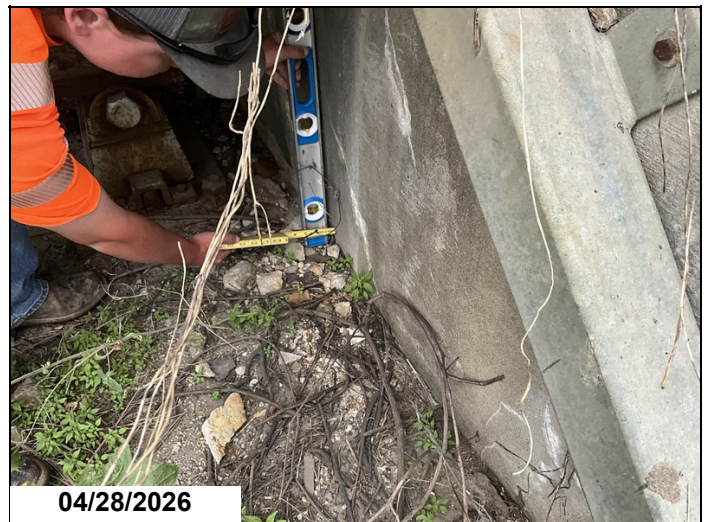
Abutment 1, Left of Girder 1: Rotated 7/8" per Two feet towards Pier 1.

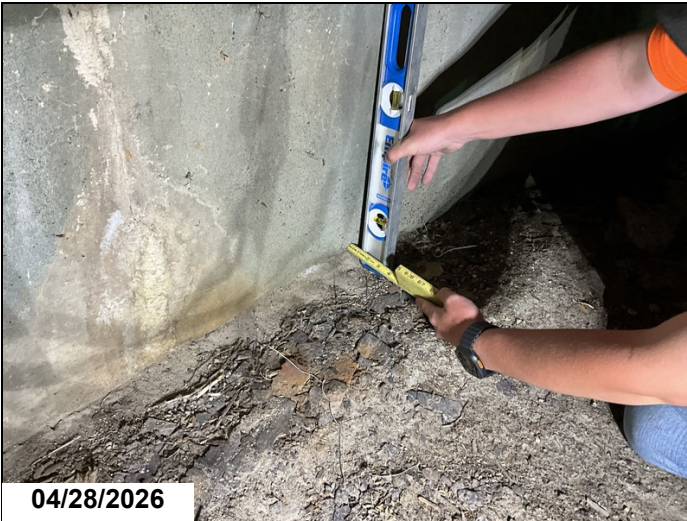
Abutment 1, Bay 1: Rotated 1" per Two feet towards Pier 1.  
Abutment 1, Bay 2: Rotated 1" per Two feet towards Pier 1.

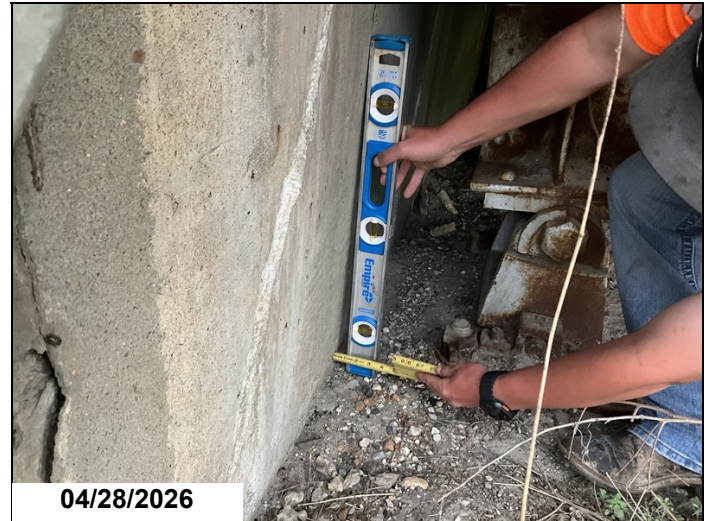
Abutment 1, Bay 3: Rotated 1" per Two feet towards Pier 1.  
Abutment 1, Right of Girder 4: Rotated 1" per Two feet towards Pier 1.

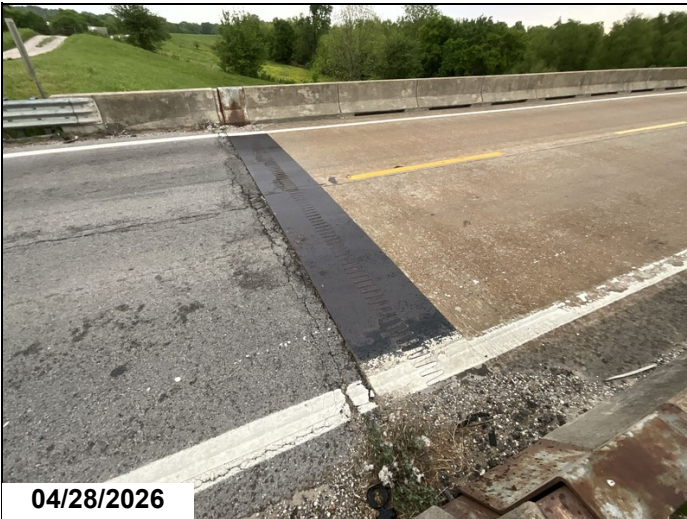
Abutment 1, Joint: Fingers closed due to rotation in abutment.

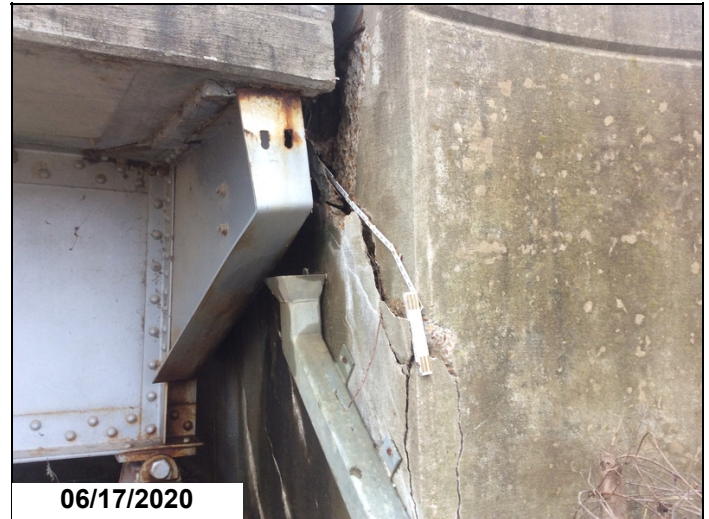
Joint armor is broke and back wall has 1/12" diagonal crack extending the full height of back wall. The back wall appears to be rotated forward.

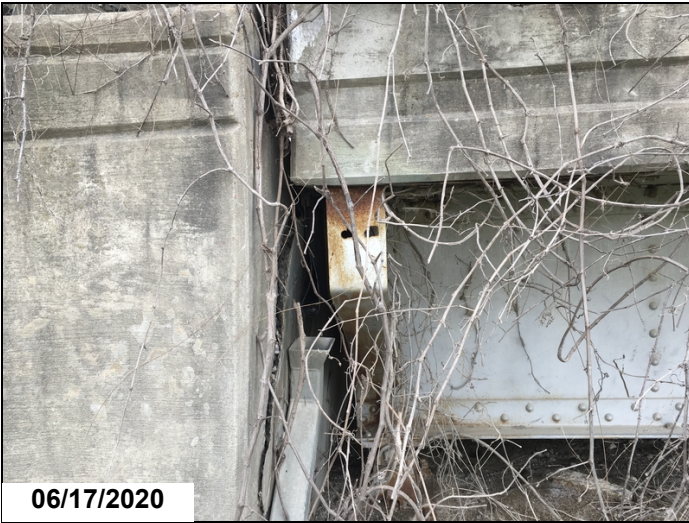
Abutment 1, Right, Backwall: Spalling.

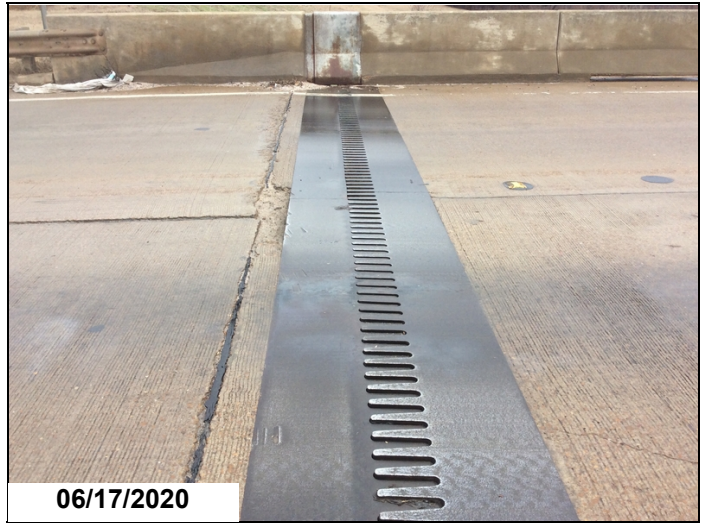
North abutment assembly joint has closed up due to back-wall rotated forward.

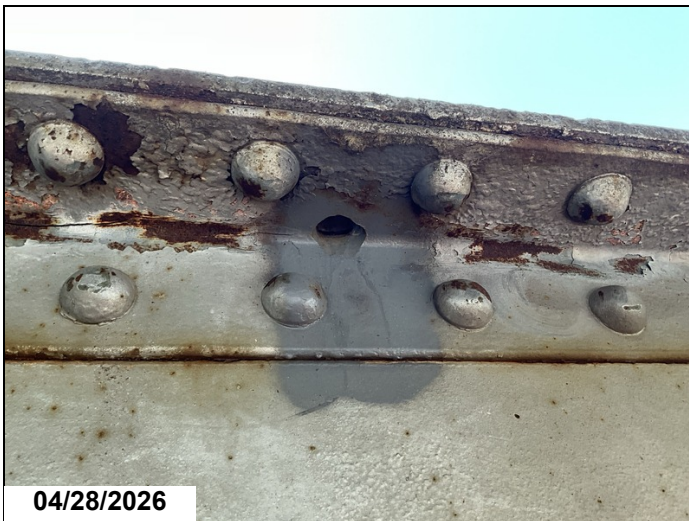
Due to the internal redundancy nature of the built up member, the crack will not propagate out of the angle into the top flange or the web plate.

Span 14, Truss 2, Lower Chord, Left, PP61, Back, Top flange to web Angle connection: Arrested crack in angle. 3LF CS2 crack.

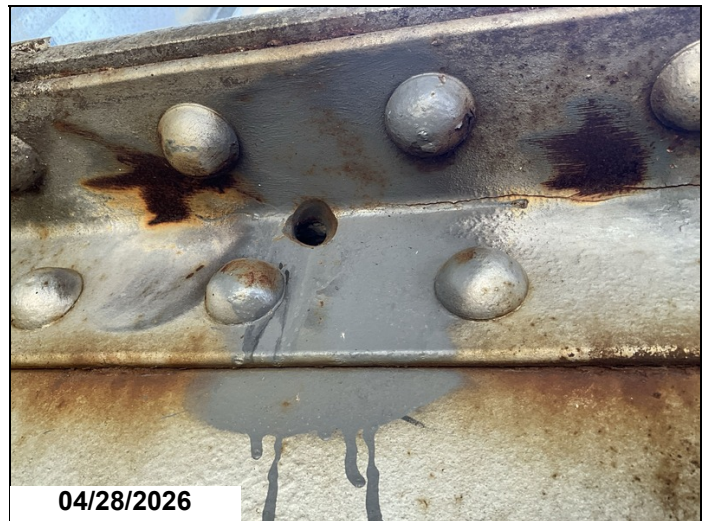
Span 14, Truss 2, Lower Chord, Left, PP61, Back, Top flange to web Angle connection: Arrested crack in angle. 3LF CS2 crack.

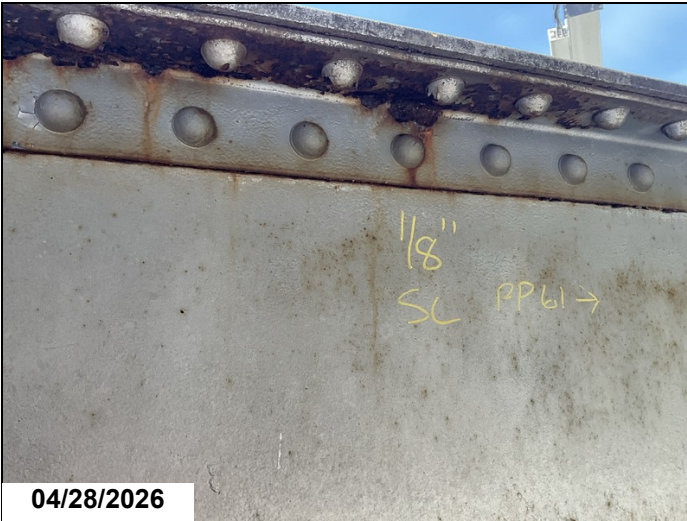
Span 14, Truss 2, Lower Chord, PP61 - 62, Left Top angle connection: Active corrosion with section loss up to 1/8". 2LF CS3 corrosion.

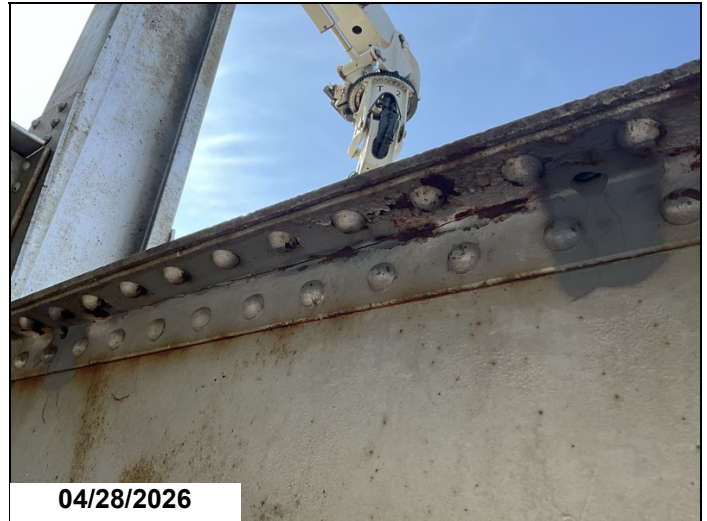
Span 14, Truss 2, Lower Chord, Left, PP61, Back, Top flange to web Angle connection: Arrested crack in angle. 3LF CS2 crack.

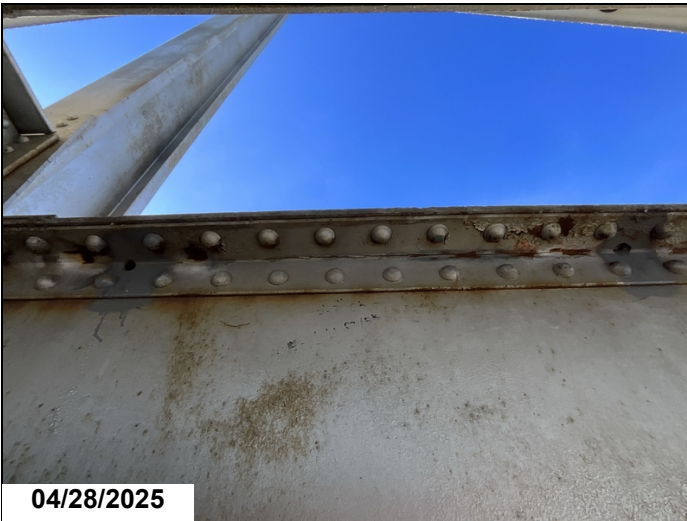
Span 14, L61, Right, lower chord, back, inside web: 3'3" arrested crack. 3LF CS

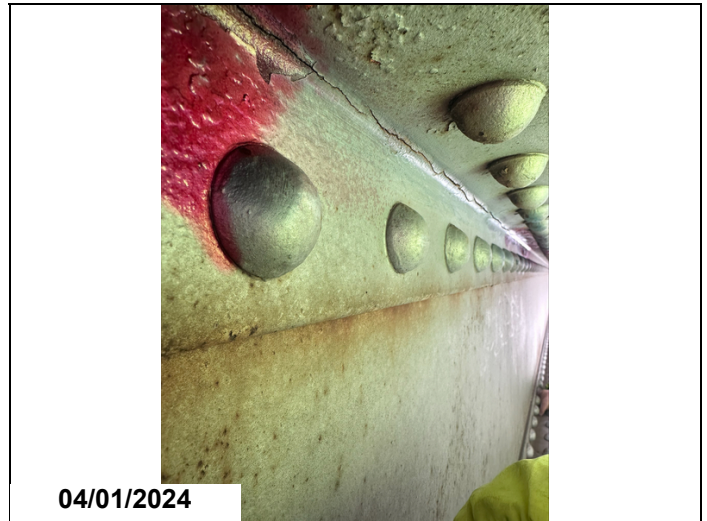
L61, Ahead, Right: 3'-3" Crack on the upstream face of the top flange angle plate. CS3

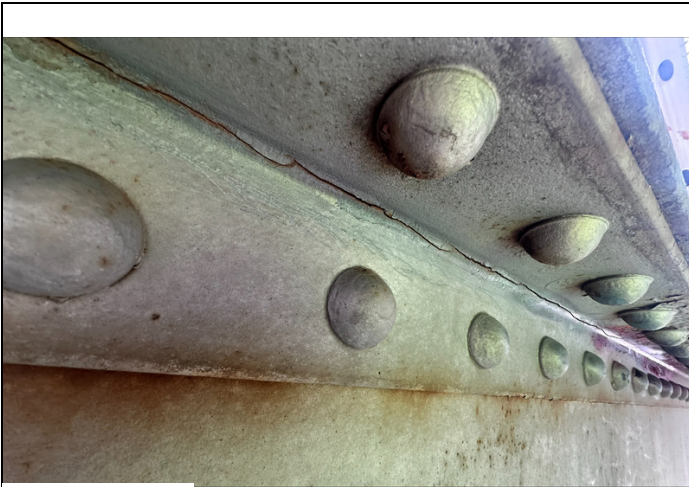
L61, Ahead, Right: 3'-3" Crack on the upstream face of the top flange angle plate. CS3

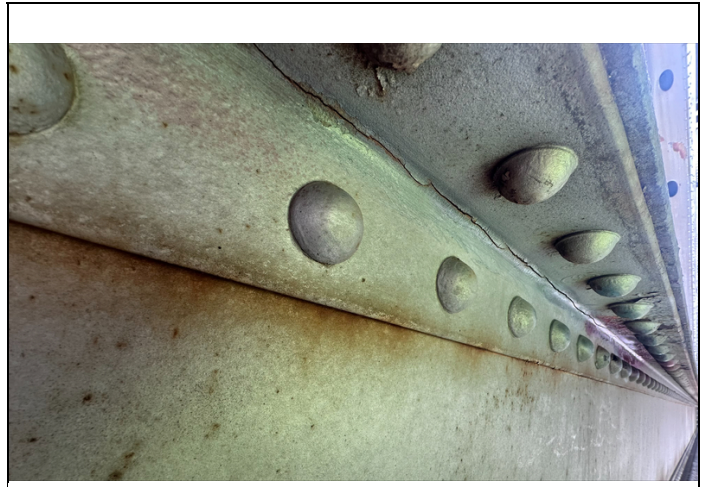
L61, Ahead, Right: 3'-3" Crack on the upstream face of the top flange angle plate. CS3

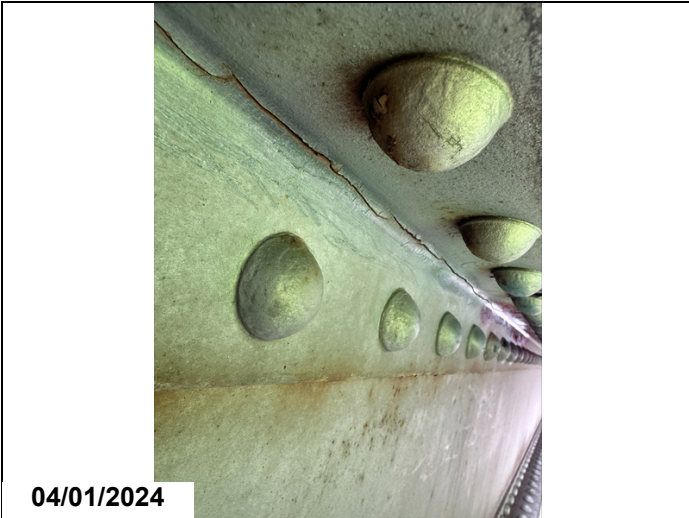
L61, Ahead, Right: 3'-3" Crack on the upstream face of the top flange angle plate. CS3

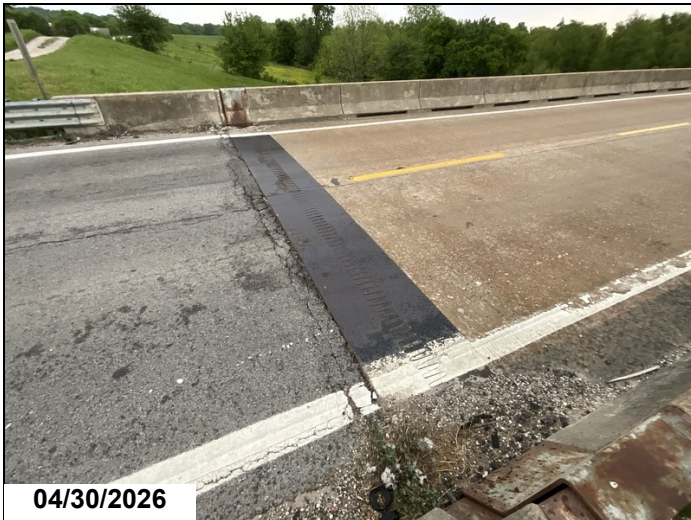
Abutment 1, Approach Roadway: Pot hole has been filled in with asphalt.

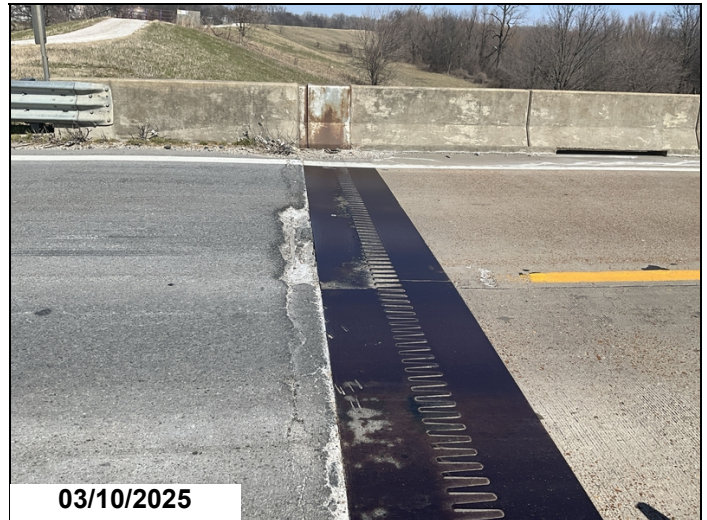
Bent 1, large pothole in the approach roadway at the joint.

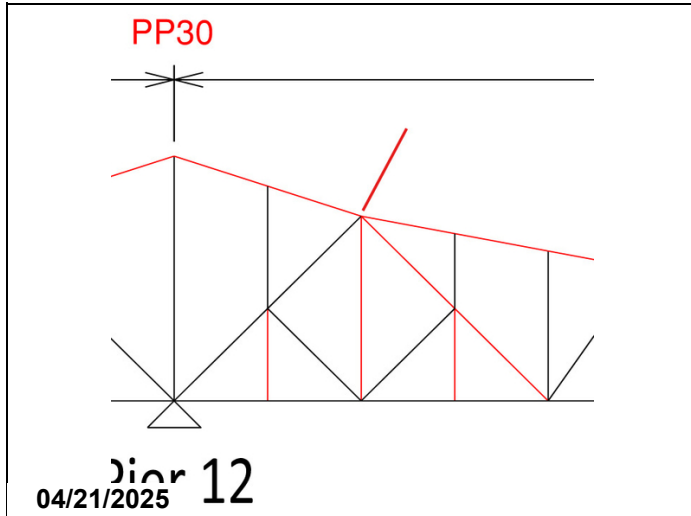
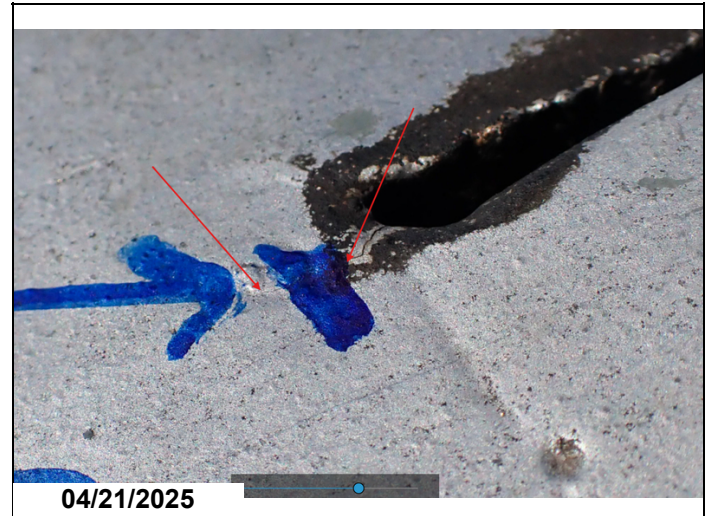
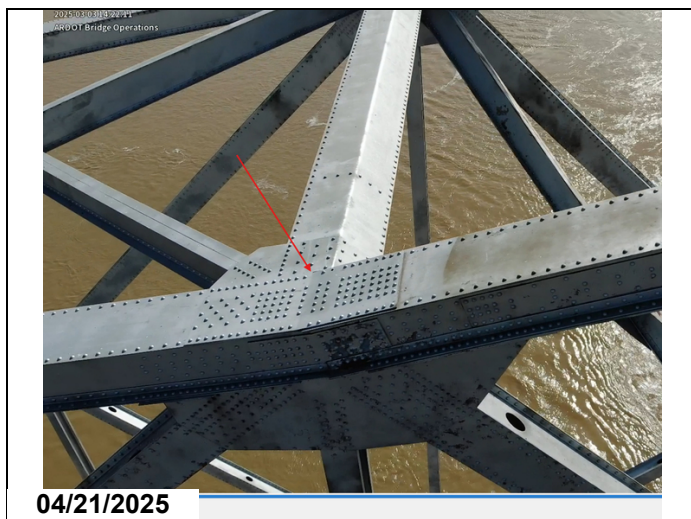
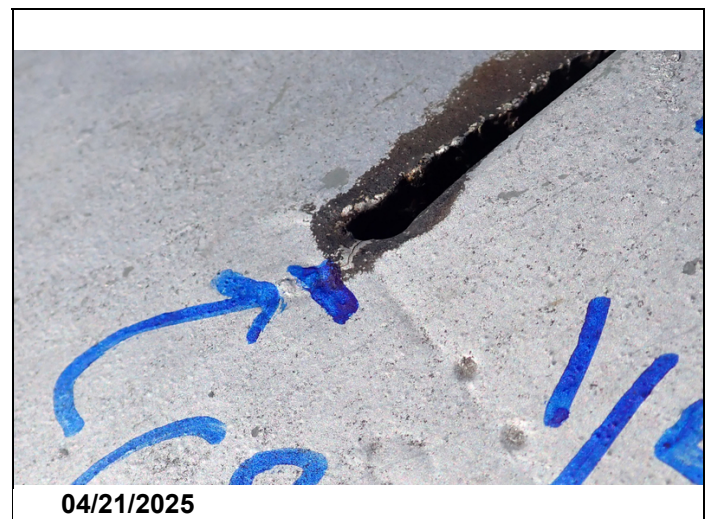
Span 13, U32, Left, upper splice plate at the reentrant corner of the cope: 1/4-inch-long crack. 1LF CS3

Assigned to Contract Rehabilitation. Set to let early 2026. KAW 5/1/2025  
2026 - The man lift used by Bridge Operations is not tall enough to reach this location. Climbers were not at this inspection. This location will be looked at again during the 2027 inspection.

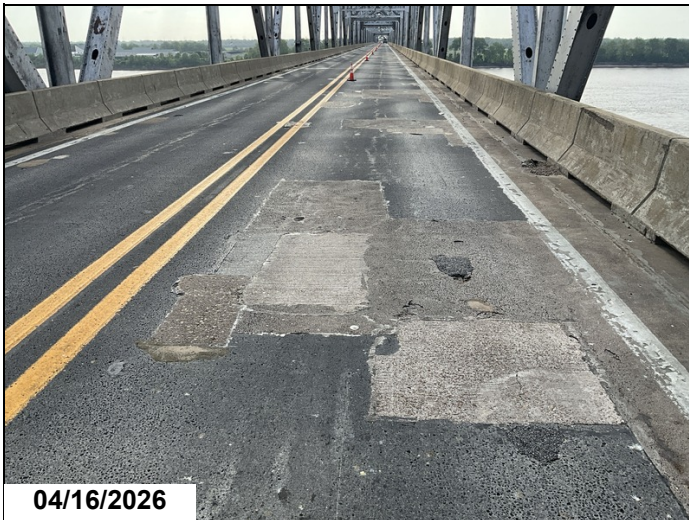
PP15 - PP18: 305SF of CS2 delam/patched areas and 73SF of CS3 spalling and unsound patched areas, along with 1SF of CS3 exposed reinforcing steel.

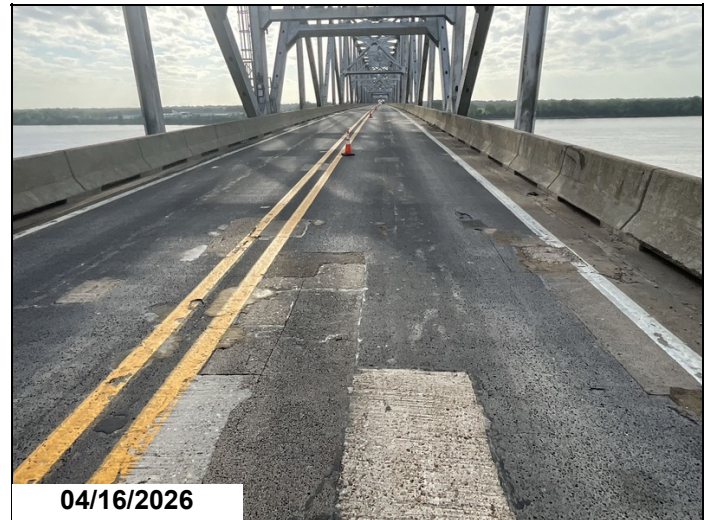
PP8 - PP12: 156SF of CS2 delam/patched areas and 68SF of CS3 spalling and unsound patched areas, along with 3SF of CS3 exposed reinforcing steel.

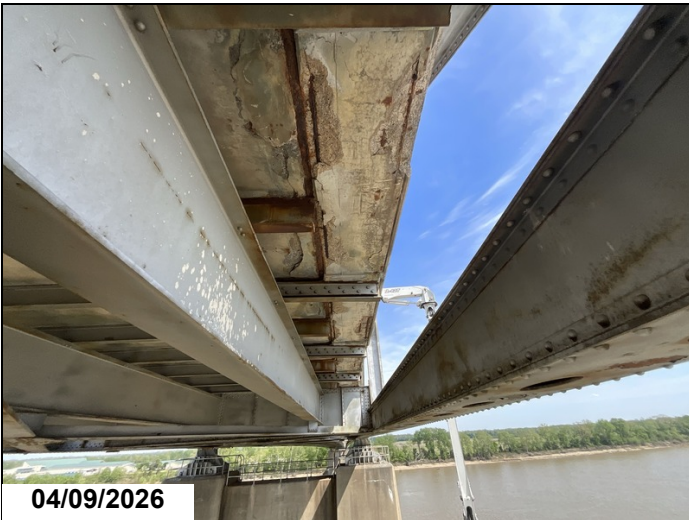
Typical overhang condition.

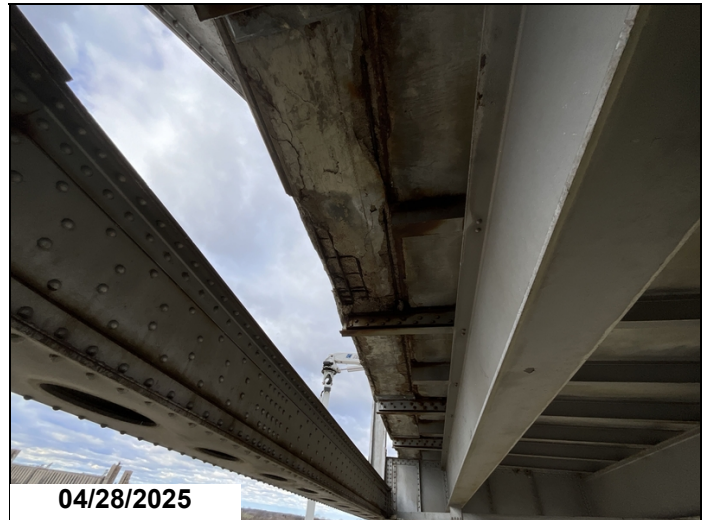
Span 11, right, back from pier 11: has concrete deterioration and spalling with exposed rebar with section loss. 50SF CS3

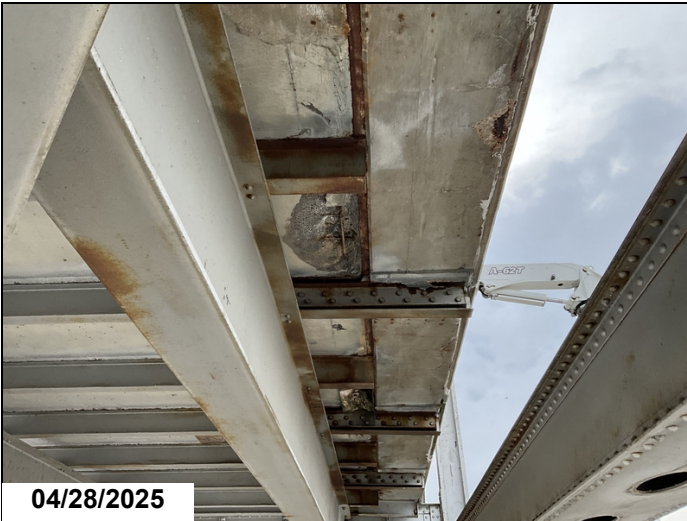
Span 11, ahead of floor beam 2, right side: has a 2' x 2' by 6" deep spall in the under surface. 4SF CS3

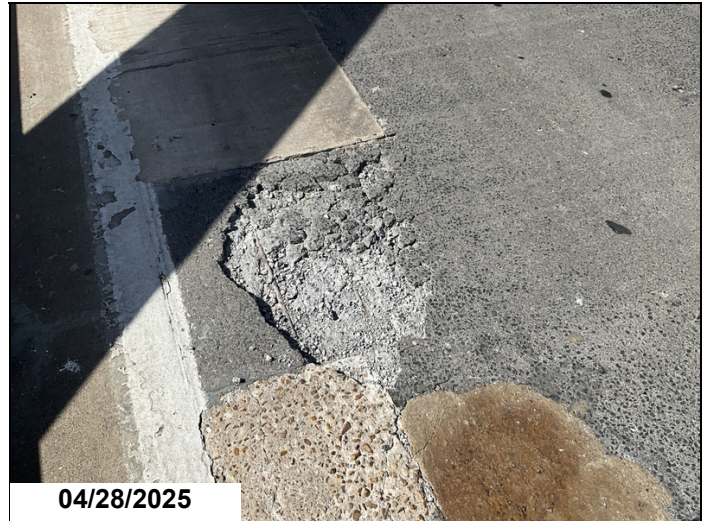
Span 11, Panel point 1: large spall with exposed rebar. 6SF CS3

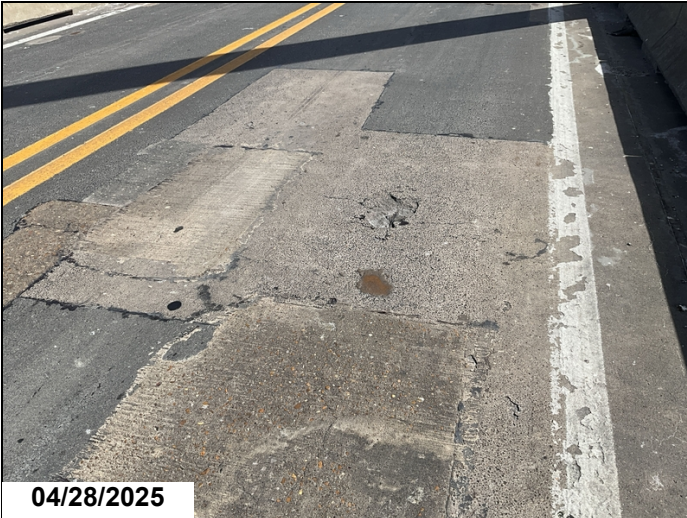
Span 12, eastbound lane: sound patches and moderate spall with exposed rebar. 120SF CS2, 4SF CS3

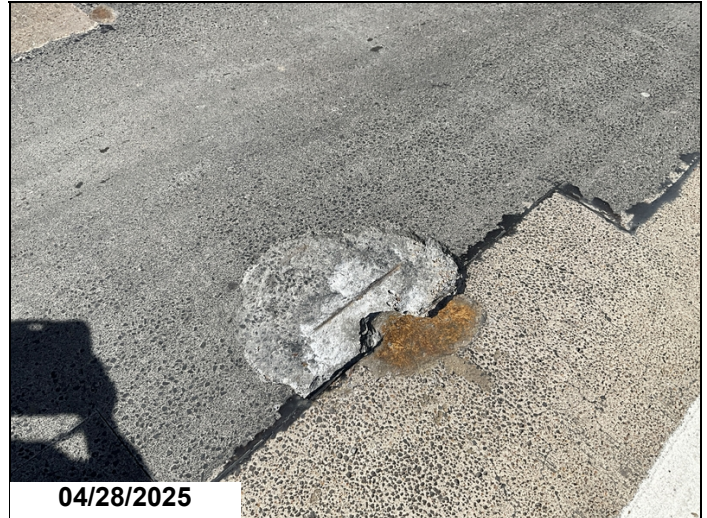
Span 13, Panel point 35, right lane: moderate spall with exposed rebar. 6SF CS3

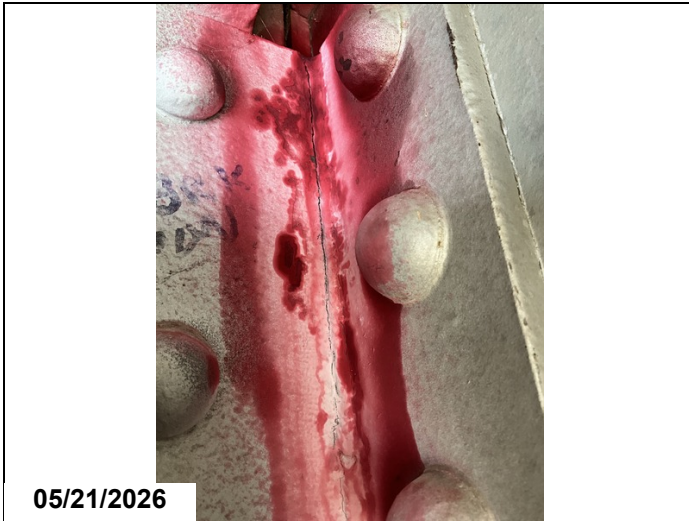
Span 12, Stringer 2 to Floorbeam 28 Connection, Ahead:  
11" crack in the welded connection. 1LF CS3 crack.

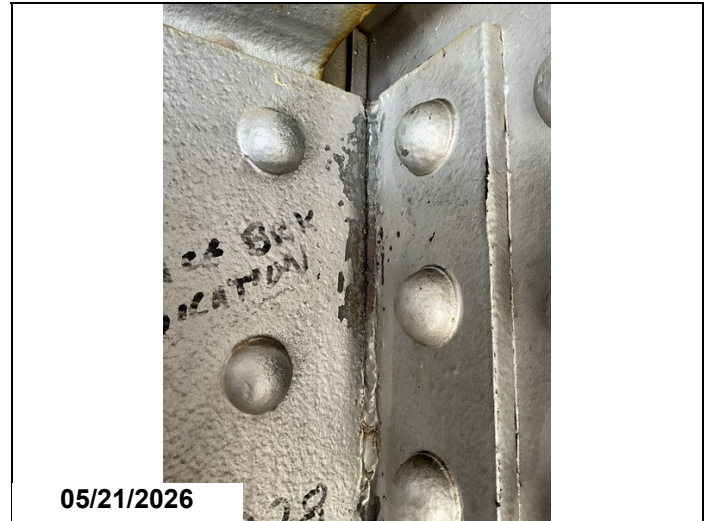
Span 12, Stringer 2 to Floorbeam 28 Connection, Ahead:  
11" crack in the welded connection. 1LF CS3 crack.

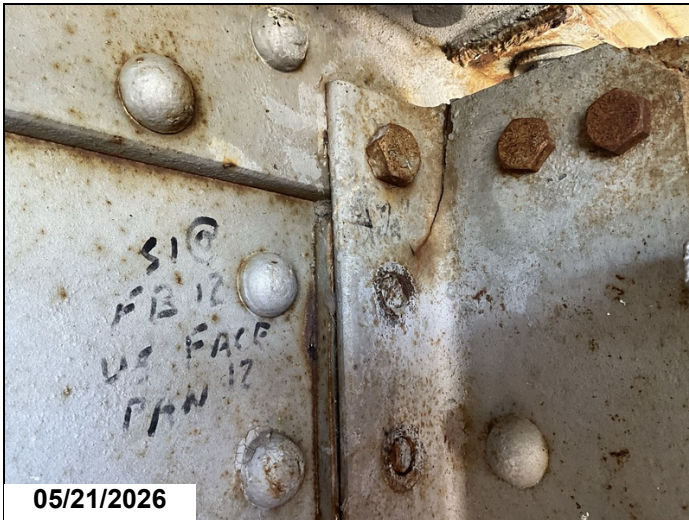
Span 12, Stringer 1, Left, Floorbeam 12, Back: 4 1/2"  
crack in the left floor beam to stringer connection angle, 2  
missing rivets. 1LF CS3 crack.

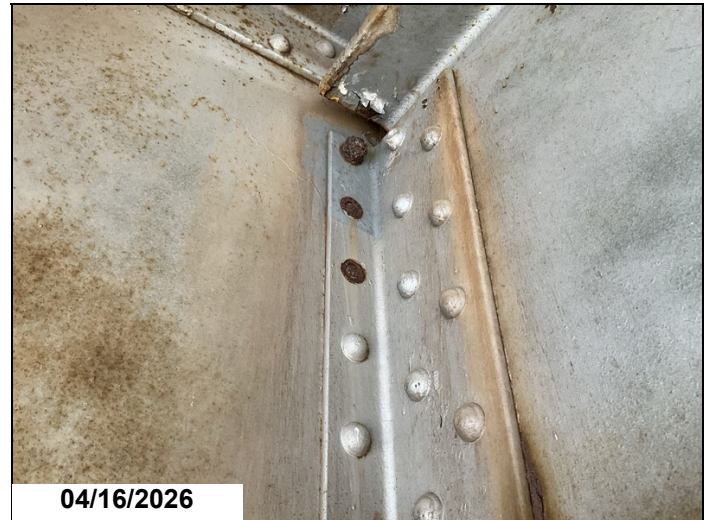
Span 13, Stringer 1, Floorbeam 42: Two sheared bolts.  
1LF CS3 connection.

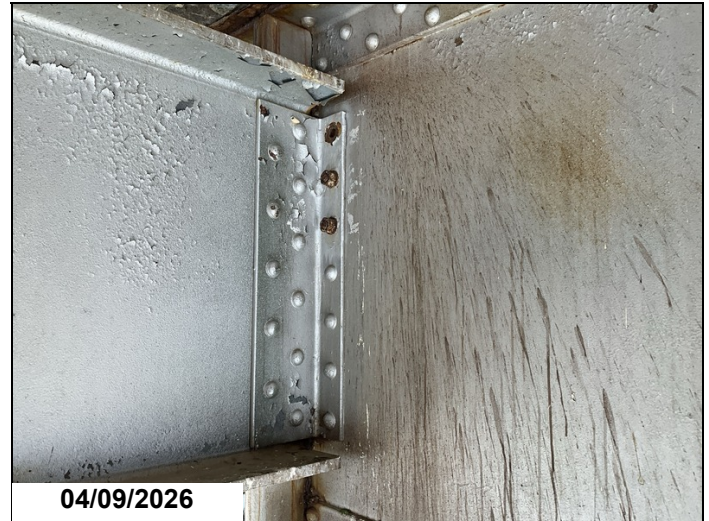
Span 13, Stringer 1, Floorbeam 44: Missing rivet. 1LF CS3 connection.

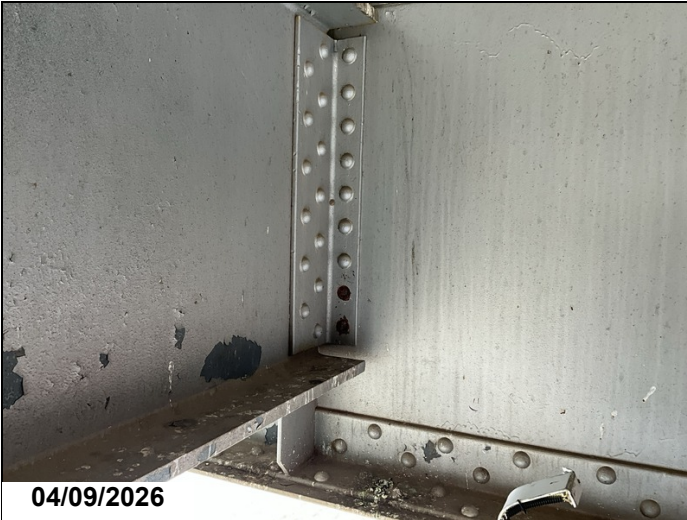
Span 15, Stringer 1, Floorbeam 70: One missing bolt. 1LF CS3 connection.

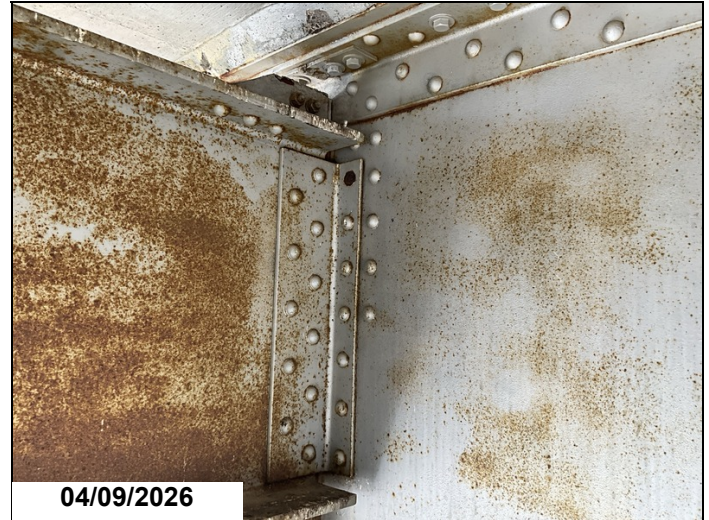
Span 15, Stringer 2, Floorbeam 69, Ahead: Two sheared rivet heads. 1LF CS3 connection.

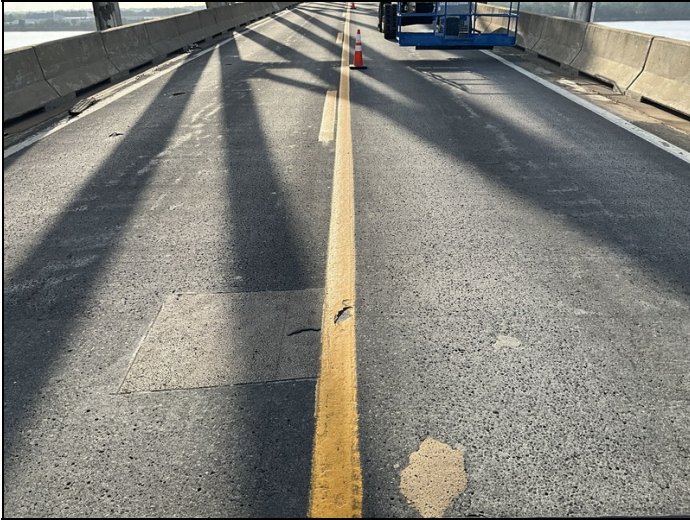
Gutter lines are full of debris.

Deck washing could be used.

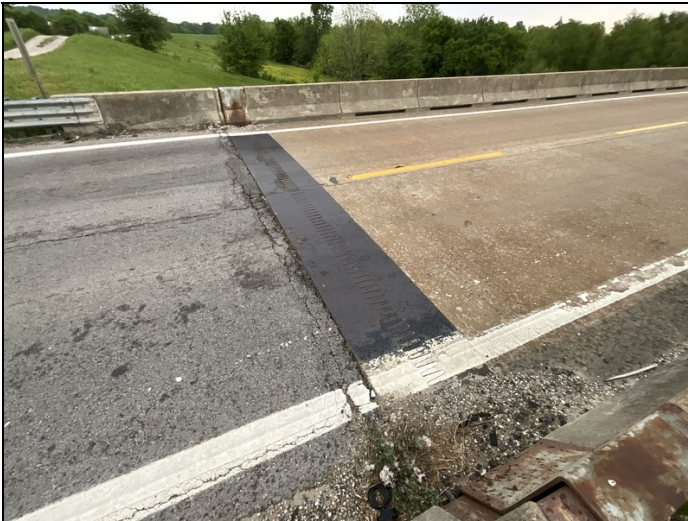
Pourable joints and finger joint seals are missing, torn, or split.

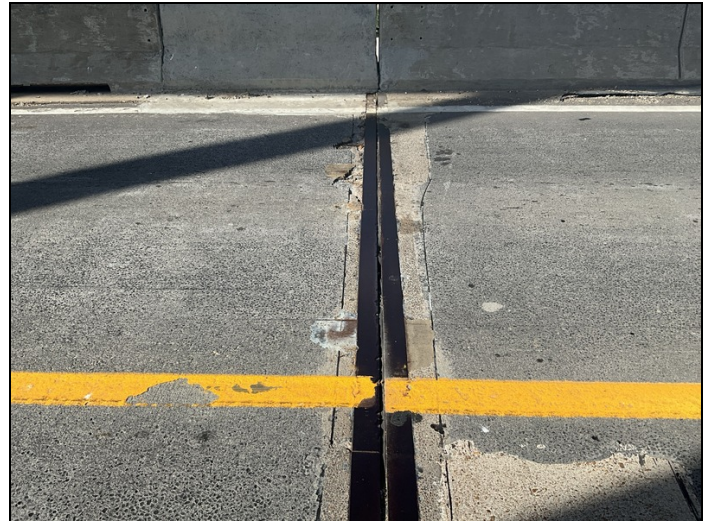
Abutment 1, Joint: Fingers closed due to rotation in abutment.

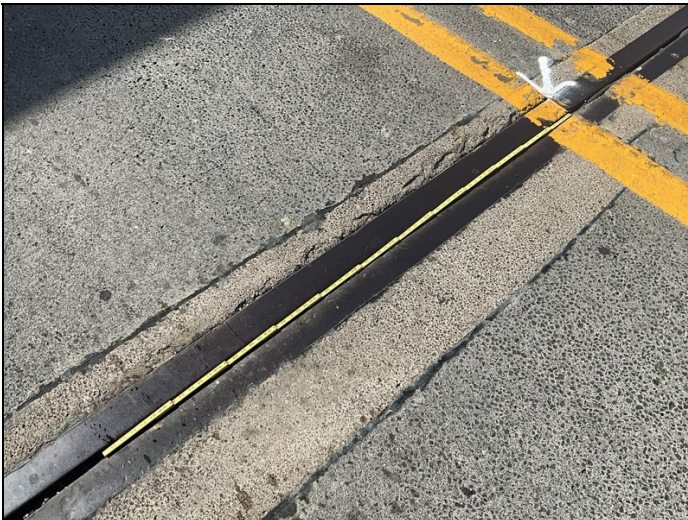
PP3: Joint loose in Arkansas bound lane 9'.

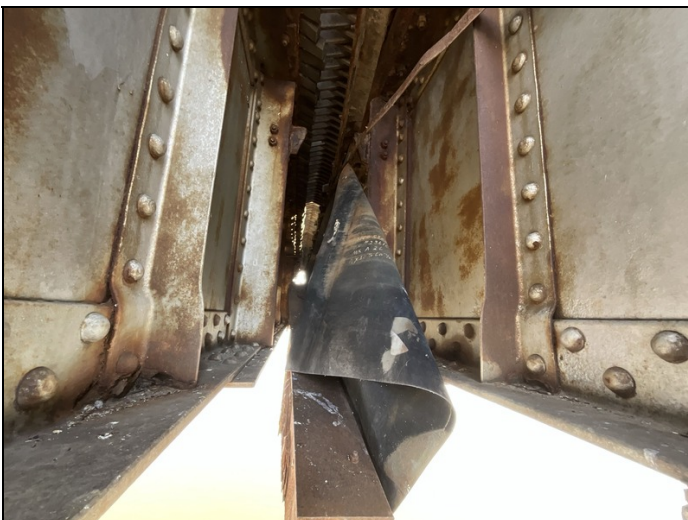
Span 19, pin and hanger joint: trough torn full length of joint. LF CS4

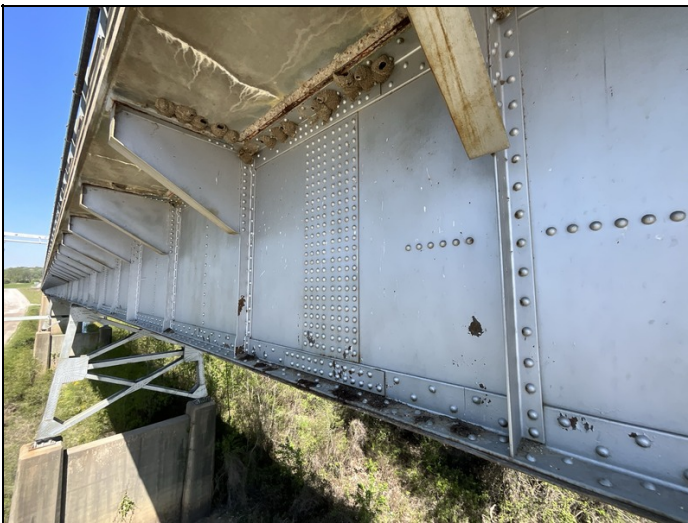
Span 8, Girder 2, Second Field Splice Plate.

The bottom chord, floor beams, and bearings have corrosion ranging from fretting rust to areas of flaking rust, pack rust, and laminated rust to areas of section loss. The worst case for corrosion along the bottom chord was the inside portion of the lower chord. The worst case for corrosion along the floor beams was at each joint location.

Girders, Floorbeams, and Bearings have a failed paint system that needs to be fixed. The paint is chalky, with areas of flaking rust. The corrosion ranges from surface rust to isolated areas of flaking rust. The worst cases of corrosion were between the bottom flange and the bottom flange cover plate, splice plate connections, and along the edges of the top flanges.
