## Bridge 02899 Inspection Report

Arnold Road ID:54x49x11xA, Arnold Log mile:0.569

# National Bridge Inventory Data Sheet

| IDENTIFICATION | |
|---|---|
| (7) Facility Carried | US 49- Phillips Co |

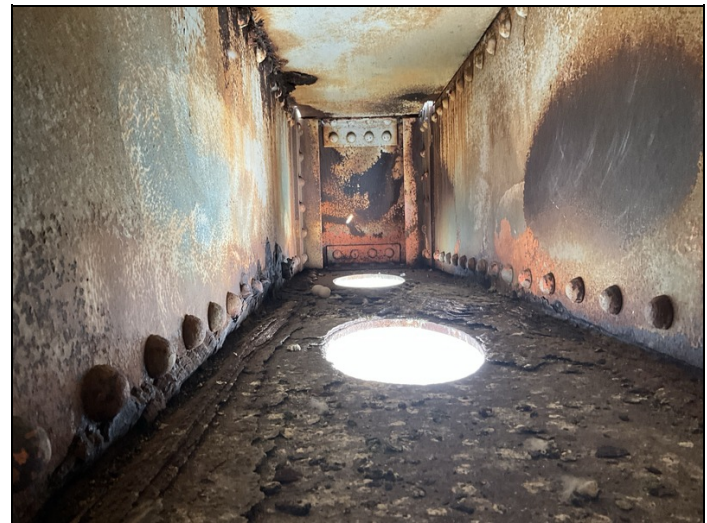
Span 13, Truss 2, Inside of the Lower Chord, PP45,  
Back: Heavy Active corrosion with heavy flaking rust  
along top of Bottom Flange and inside webs. 10LF CS3  
corrosion.

Girders, Floorbeams, and Bearings have a failed paint system that needs to be fixed. The paint is chalky, with areas of flaking rust. The corrosion ranges from surface rust to isolated areas of flaking rust. The worst cases of corrosion were between the bottom flange and the bottom flange cover plate, splice plate connections, and along the edges of the top flanges.

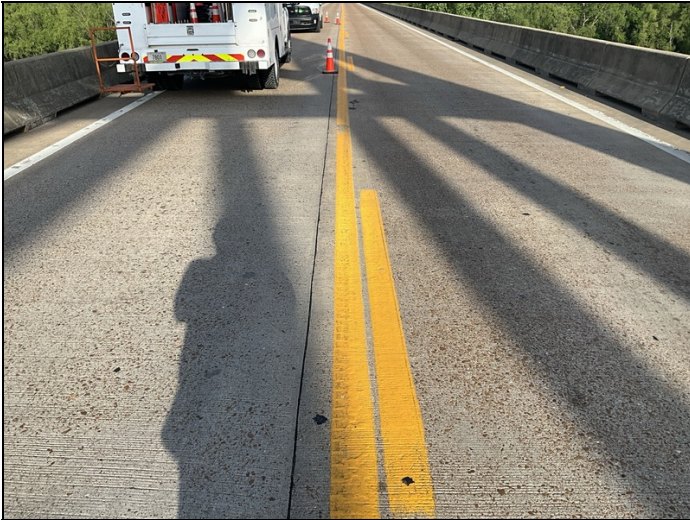
The approach spans are in great condition overall and would greatly benefit from a polymer overlay due to numerous open deck cracks.

Approach Spans: Transverse cracking and abrasion.
