Bridge #23167(Routine, Underwater type 2)

Bethel Blacktop Rd over Illinois River - Wash.

Team Lead: Bob McEntyre Inspection Date: April 14, 2020

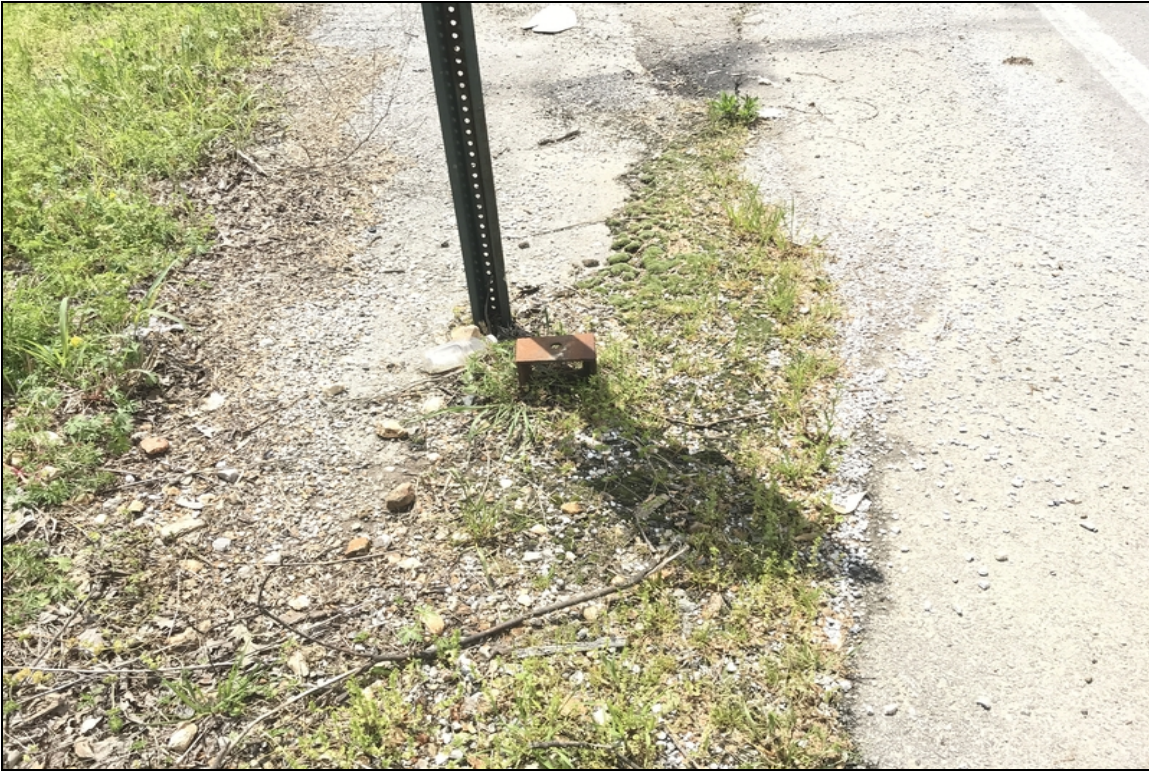
Ground Anchorage for Southeast approach railing.

The Southeast approach railing has collision damage that has broken the railing loose from the ground anchorage and destroyed the turndown section of railing.

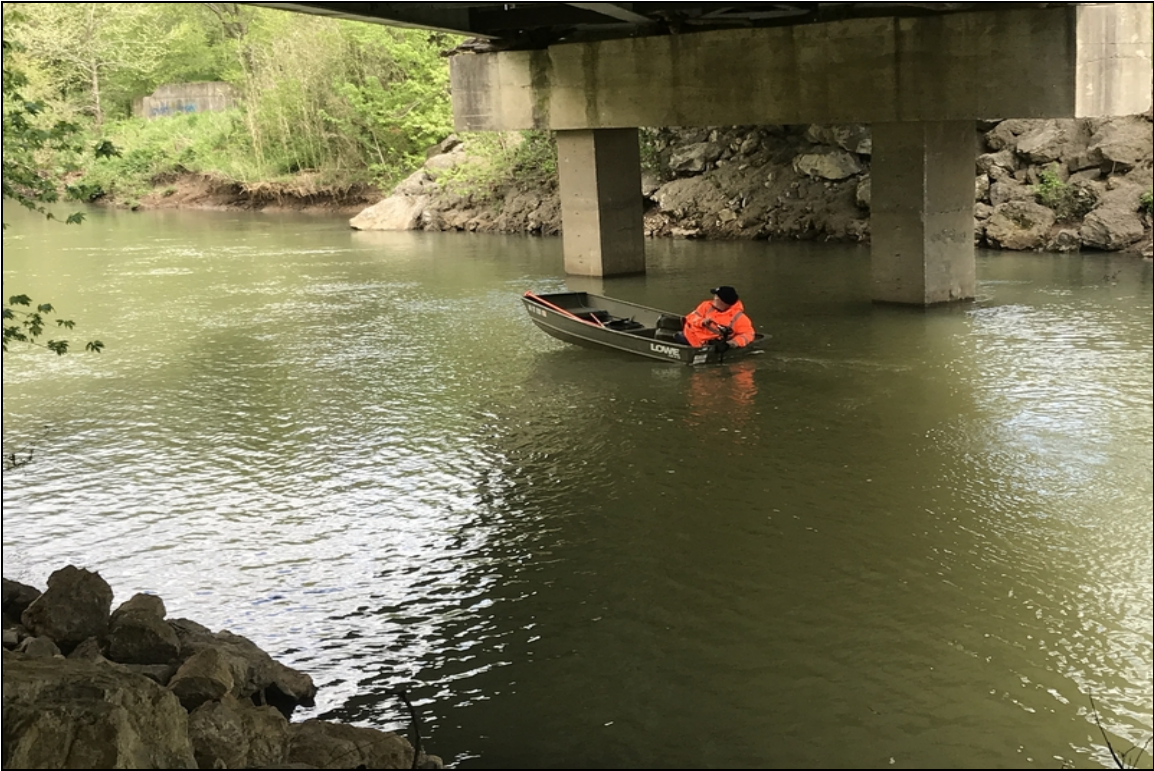
Boat utilized for inspection.

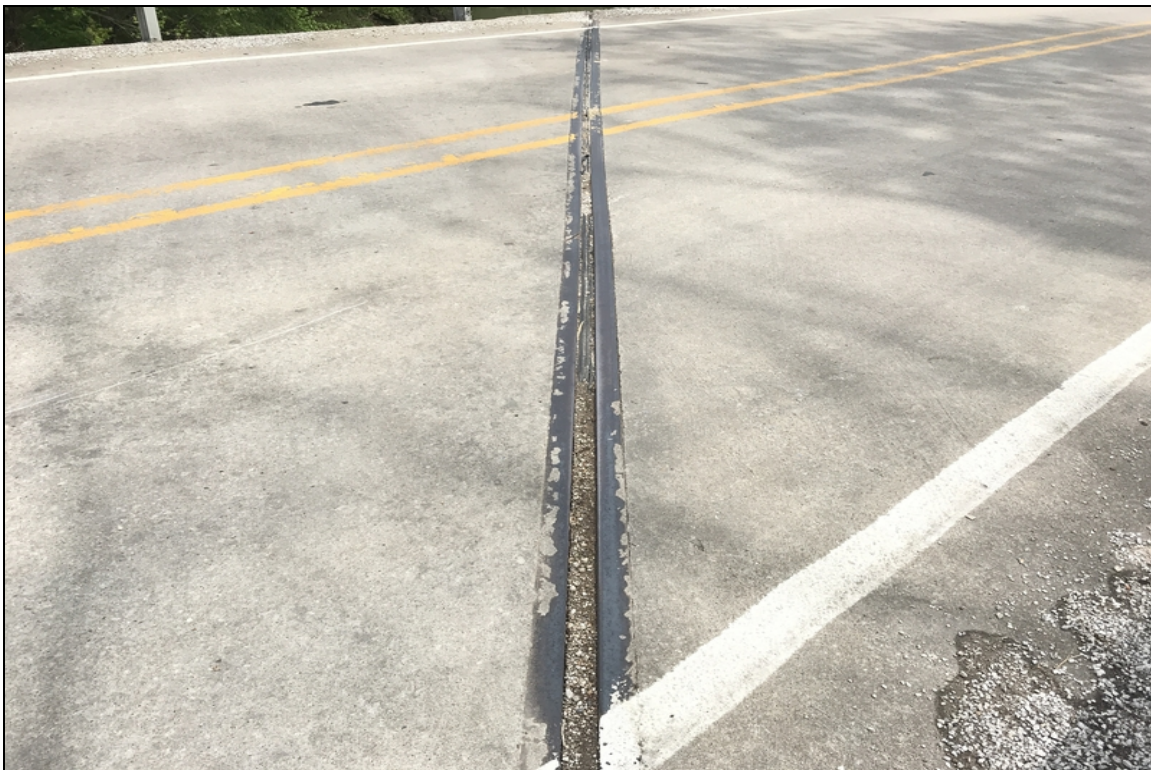
Bent 2 expansion joint.

The expansion joint seals have areas of rips / tears and adhesion failure. Staining on the bent caps indicate that the joint seals leak.
