Asset #22133(Routine, Underwater type 2)

CR 856-A over DRAINAGE DITCH

Location: 2.5 MI W OF CARAWAY

Team Lead: Brandon Sutton, Inspection Date: 07/05/2023

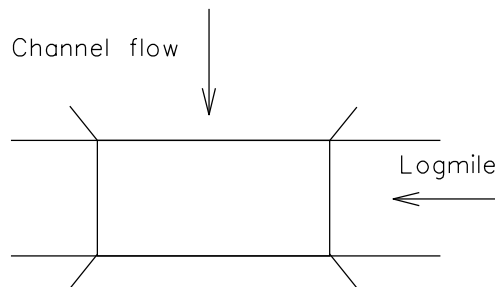
Channel profiled from top of deck on Lt side (downstream side)
 Green soundings taken on 10/13/1999
 Red soundings taken on 9/15/2011
 Blue soundings taken on 7/2/2019
 Blue soundings taken on 7/5/2023
