Asset #23814(Routine, Underwater type 2)

CR 874-A over Honey Cypress Ditch

Location: 2 miles South of Caraway

Team Lead: Brandon Sutton Inspection Date: 08/07/2023

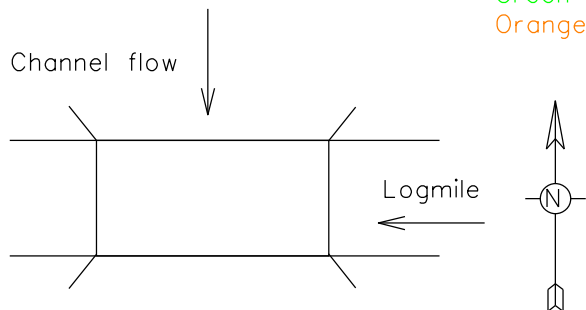
Channel profiled from top of deck on Lt side (down stream side)
Green soundings taken on 8/5/2019
Orange soundings taken on 8/7/2023
