Asset #20790(Routine, NSTM)
CR 60-B/COUNTRY CL over THOMAS CREEK

Location: 2.6 MI CR 60 & SH 9 JCT

Team Lead: Chris Doggett Inspection Date: 11/16/2023

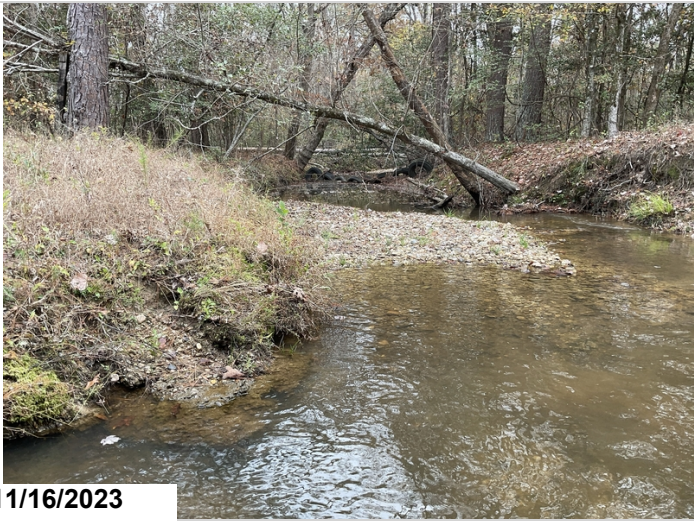
61 - Channel/Channel Protection (5 - Bank protection is being eroded. River control devices and/or embankment have major damage. Trees and brush restrict the channel.)

Channel looking down stream

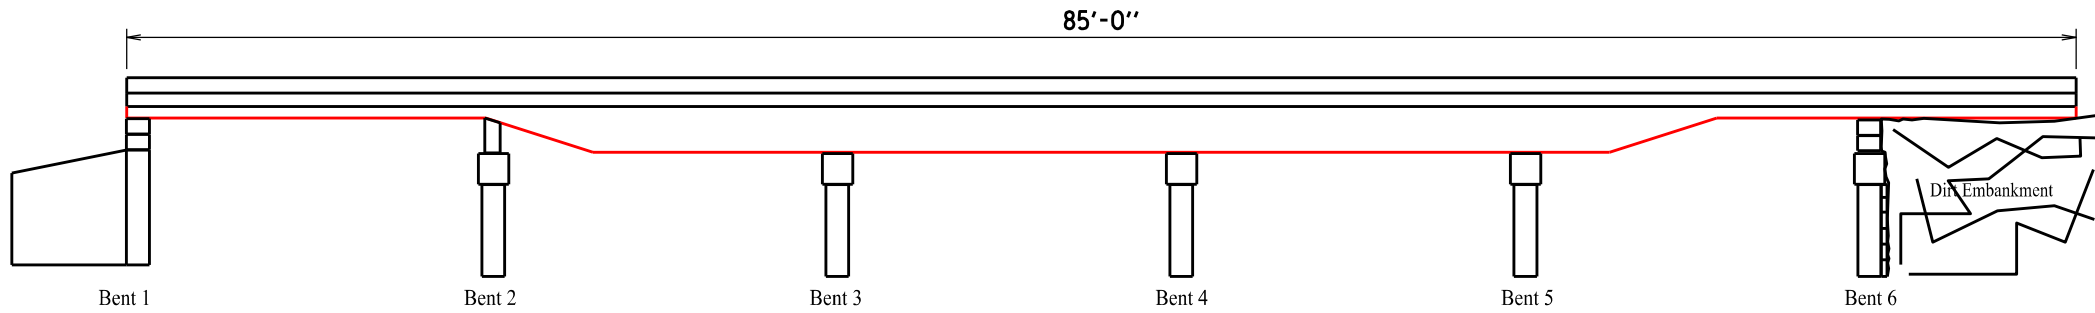
Elevation View

All NSTM's are shown in red.
