Asset #20976(Routine, NSTM)

CR324/Country Club over CLEAR CREEK

Location: 4.5 MI W GRANT CO. LINE

Team Lead: Keith Harris Inspection Date: 11/13/2024

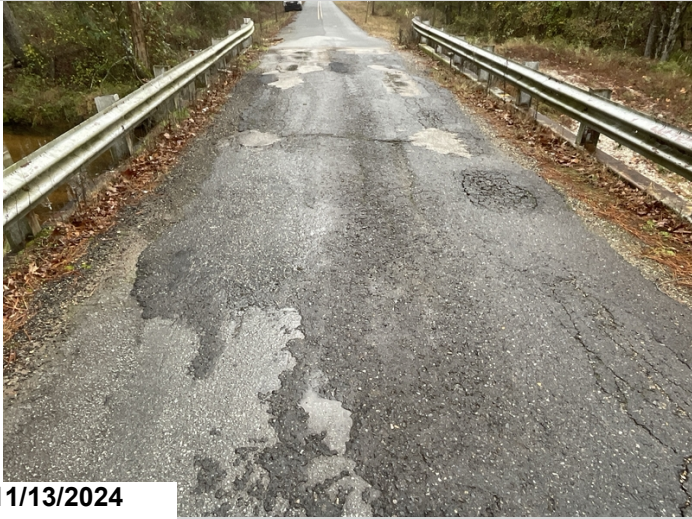
Deck overview

Wearing surface has small potholes, patches and large cracks.

Steel deck has active corrosion and with section loss.

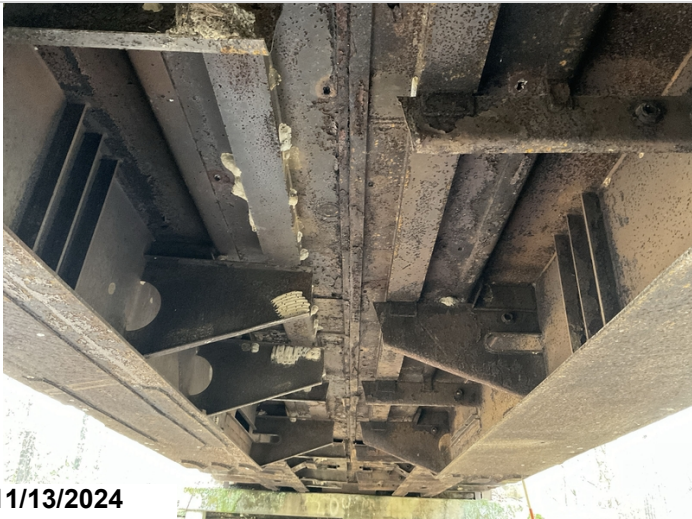
NSTM

Bent 1, left car: both left and right car center sills are notched to fit the abutment.

Special attention was given to these coped areas.
