Asset #14366(Routine)

CR 3390 - D over Spadra Creek

Location: 1.8MI E 103

Team Lead: Rhett Franks, Inspection Date: 01/25/2024

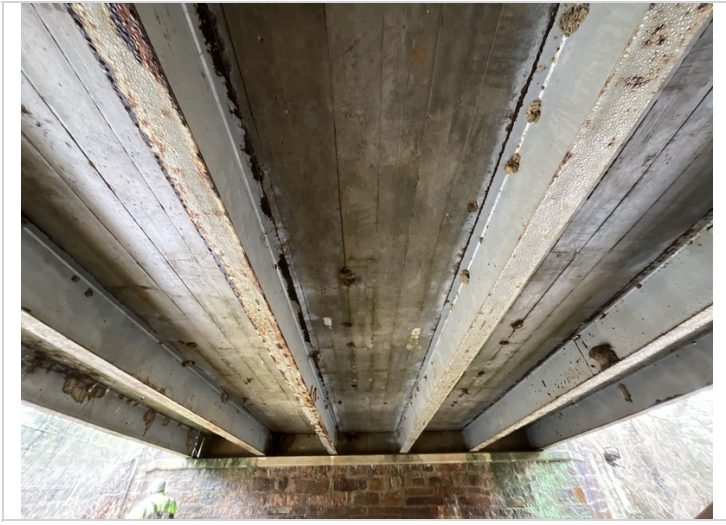
Overall the deck is in good condition, has a asphalt wearing surface, soffits have scattered areas of cracking with/without efflorescence.

Typical undersurface

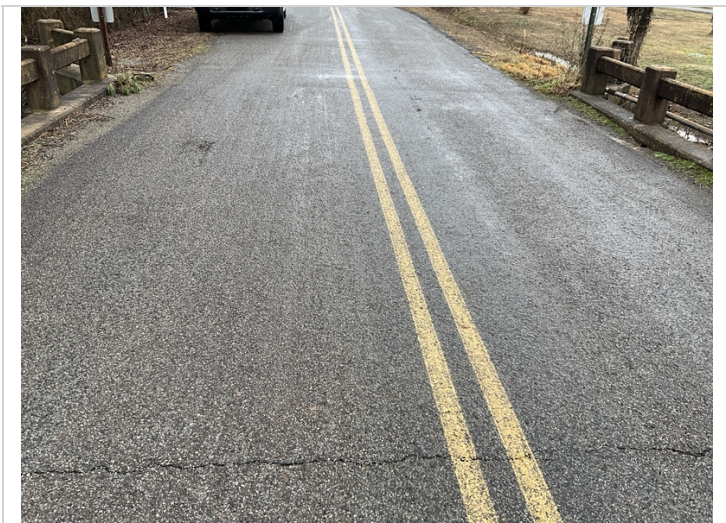
Typical deck
