Asset #06786(Routine)

C.R. 26 ZONE -E over I 49 N.B. & S.B LNS

Location: 5.0 MI. NO. OF FOUKE

Team Lead: John King, Inspection Date: 04/03/2023

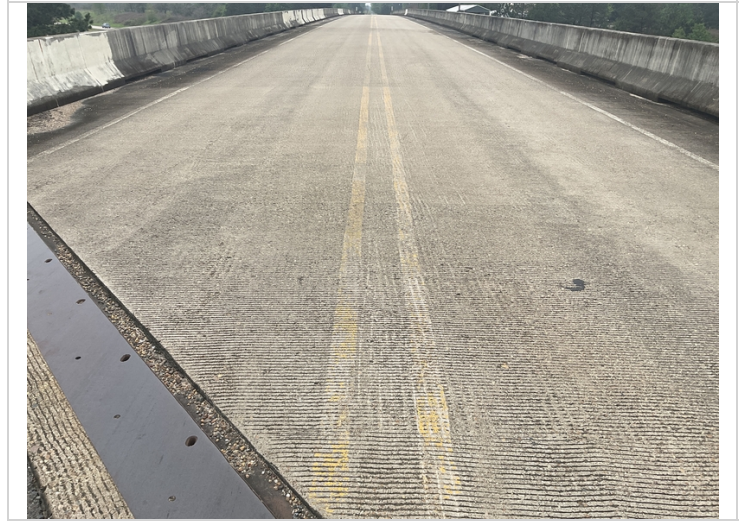
Typical deck

rated a 7 Due to minor cracking in deck, Minor efflorescence and cracking in deck overhang

Minor cracking in deck various locations

04/2023 bridge deck has crack to top side and deck pans on bottom side. may look at polymer overlay...

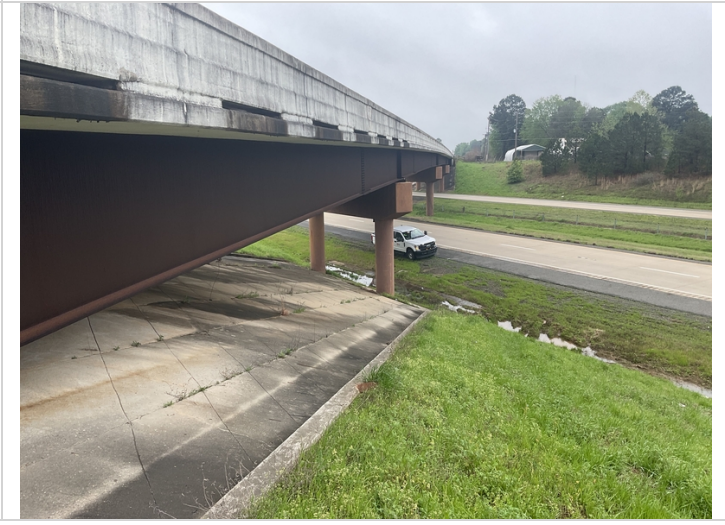
Elevation

(331) Cracking in concrete bridge railing in various locations Efflorescence in various locations of bridge railing Some efflorescence is maplike across various locations.

Cracking in bridge concrete railing various locations
