Route:15 Section:00 Log:0.9

Arnold Road ID:55xSTRAWBERRYRDx3xA, Arnold Log mile:4.145

District 03, 109 - Pike County

IDENTIFICATION	
(1) State Names	5 - Arkansas
(8) Structure Number	23145
(5) Inventory Route	1
(2) Highway Agency District	03 - District 03
(3) County Code	109 - Pike County

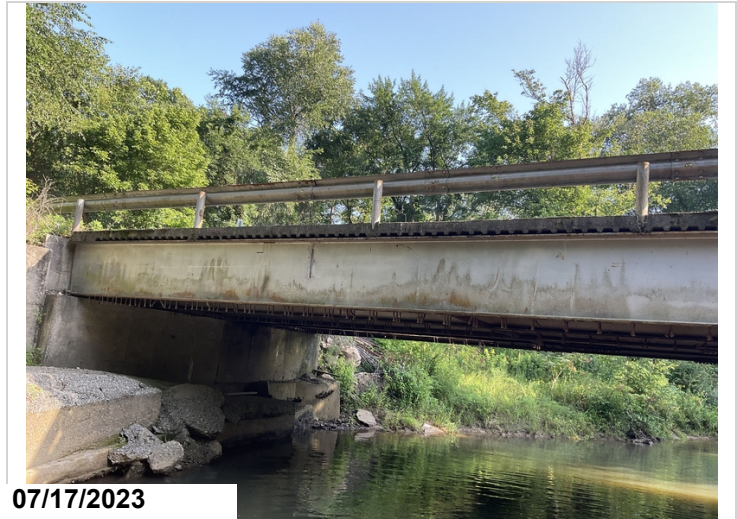
Outside of deck

Deck rating is a 7 this inspection due to various locations of cracking throughout all spans. Underside of concrete deck has stay in place forms.

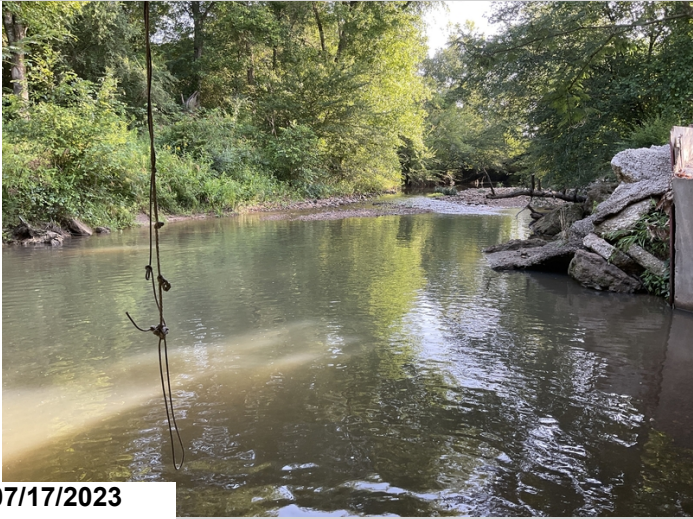
Upstream

61 - Channel/Channel Protection (6 - Bank is beginning to slump. River control devices and embankment protection have widespread minor damage. There is minor stream bed movement evident. Debris is restricting the channel slightly.)
Channel is rated a 6 this inspection due to widespread damage in various locations both up and downstream.

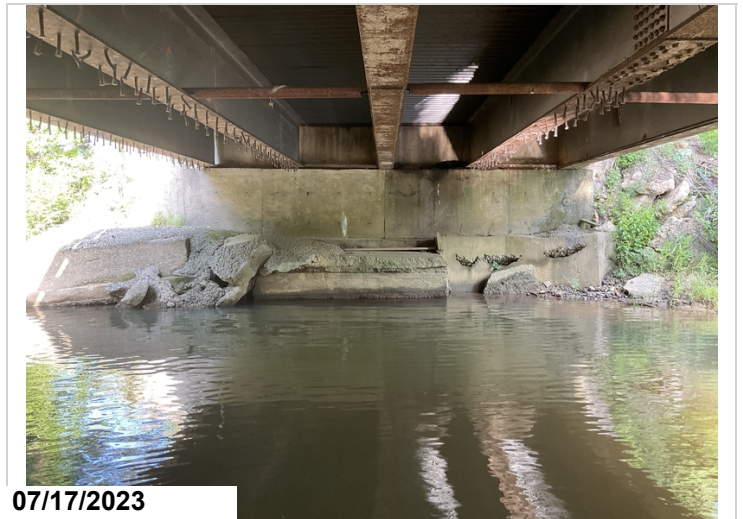
Abutment 1

Substructure rating is a 6 this inspection due to various locations of cracking with efflorescence, and abrasion in various locations of abutments 1 & 2.

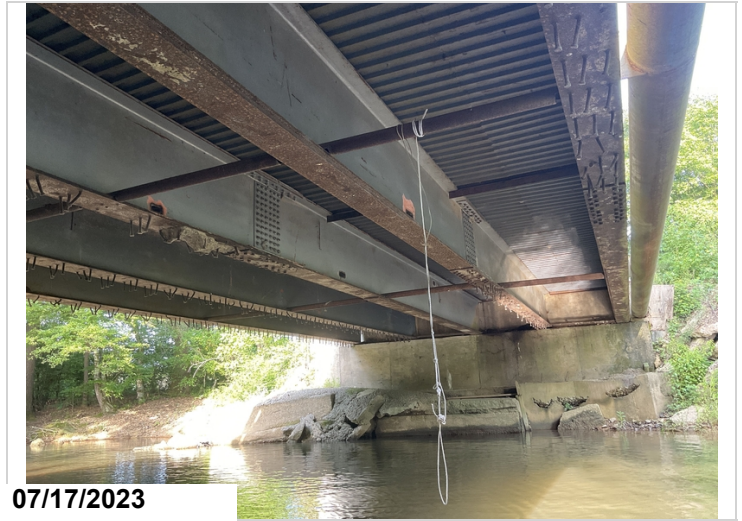
Beam photo

Dropped superstructure rating to a 6 this inspection due to corrosion on all beams around bottom flanges. Old state beams were used, beams were flipped over with shear studs down.
