Asset #23415(Routine, Underwater type 2)

CR 11-B-HEAD ROAD over SALINE CREEK

Location: 2.75 MI S. PIKE CITY

Team Lead: John King Inspection Date: 03/19/2024

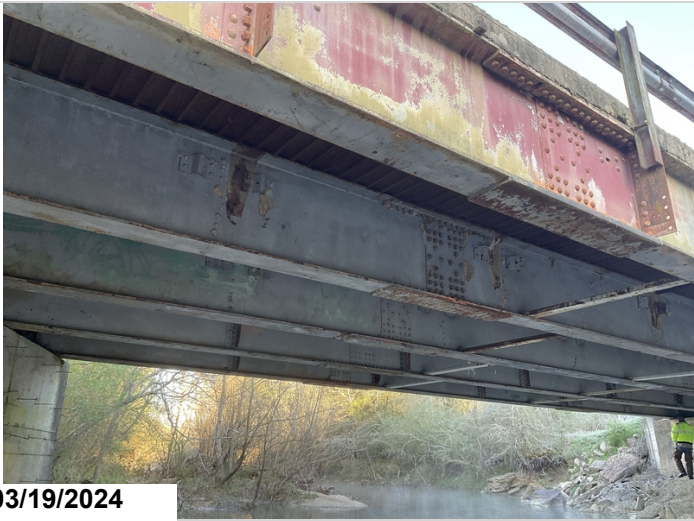
Painted steel beam photo

Superstructure rating is a 7 this inspection due to very minor corrosion to the bottom flanges of all the painted steel beams. Beam 5, Minor corrosion, Typical throughout all beams
