Asset #04340(Routine, Underwater type 2)

CR11-Center Point over BARNES CREEK

Location: .40 M W SH 249

Team Lead: Bryan Saunders Inspection Date: 06/12/2023

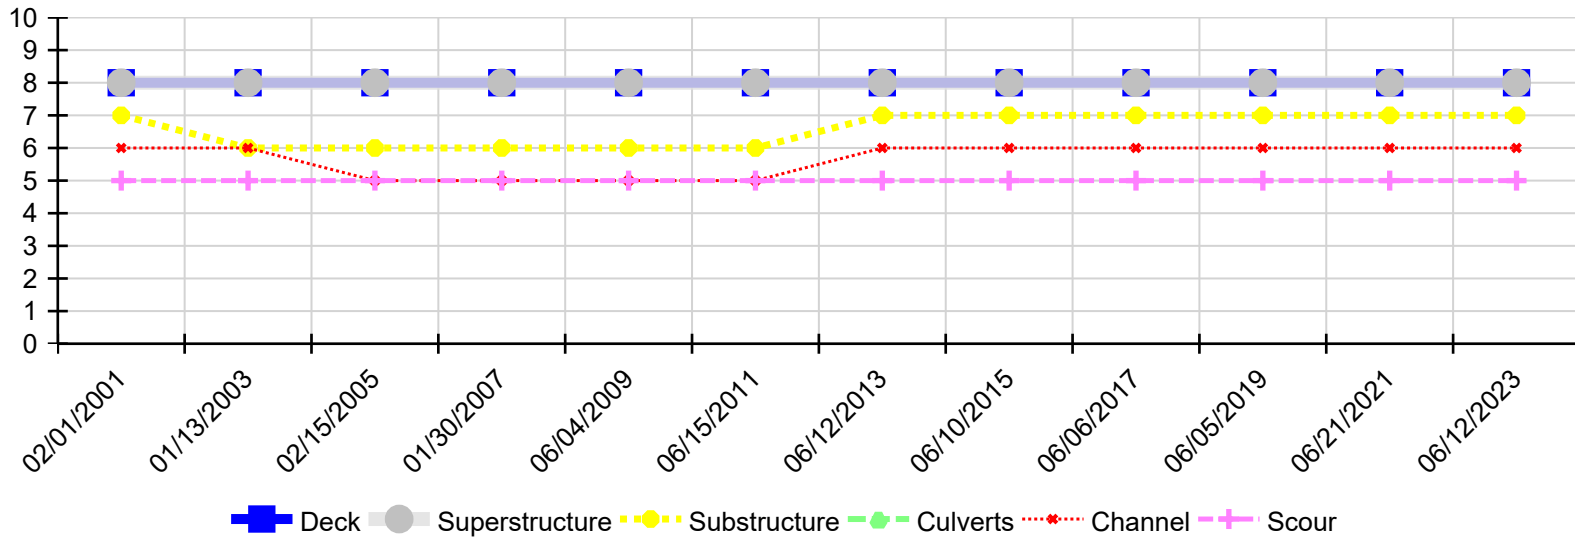
Condition History

Inspection Date	Deck	Superstructure	Substructure	Culverts	Channel	Scour
06/12/2023	8	8	7	N	6	5
06/21/2021	8	8	7	N	6	5
06/05/2019	8	8	7	N	6	5
06/06/2017	8	8	7	N	6	5
06/10/2015	8	8	7	N	6	5
06/12/2013	8	8	7	N	6	5
06/15/2011	8	8	6	N	5	5
06/04/2009	8	8	6	N	5	5
01/30/2007	8	8	6	N	5	5
02/15/2005	8	8	6	N	5	5
01/13/2003	8	8	6	N	6	5
02/01/2001	8	8	7	N	6	5
