Asset #20440(Routine, NSTM)

CR 304 E MAGNOLIA over BRANCH OF BELLVILLE CR

Location: 1 MI SO OF LOCKSBURG

Team Lead: Jared Kegley, Inspection Date: 06/26/2023

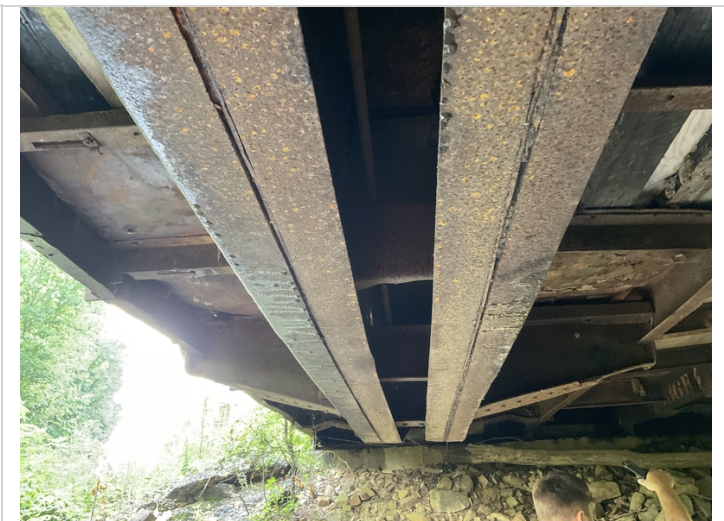
Beam 1

Superstructure is rated a 4 this inspection due to both main beams 1 & 2 as well as bracing having advanced corrosion with pitting throughout various locations. Old damage to beam 1 has large vertical crack near mid span. Portion of crack has been welded on both sides of beam.

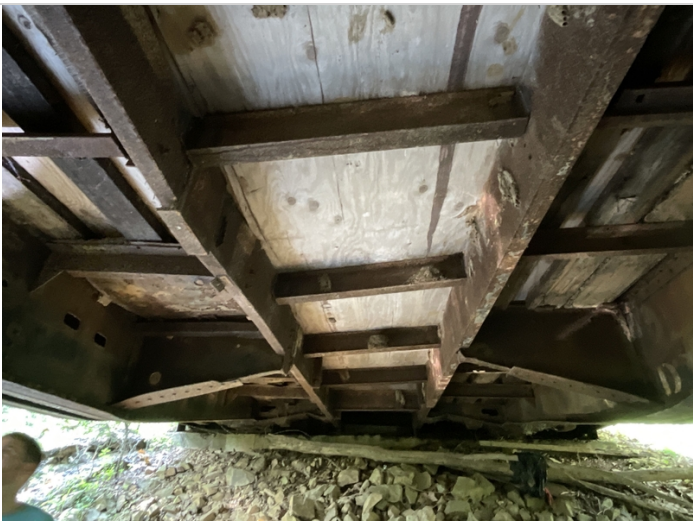
Deck rating is a 6 this inspection due to deterioration to concrete deck underneath wearing surface.

Underside of deck photo

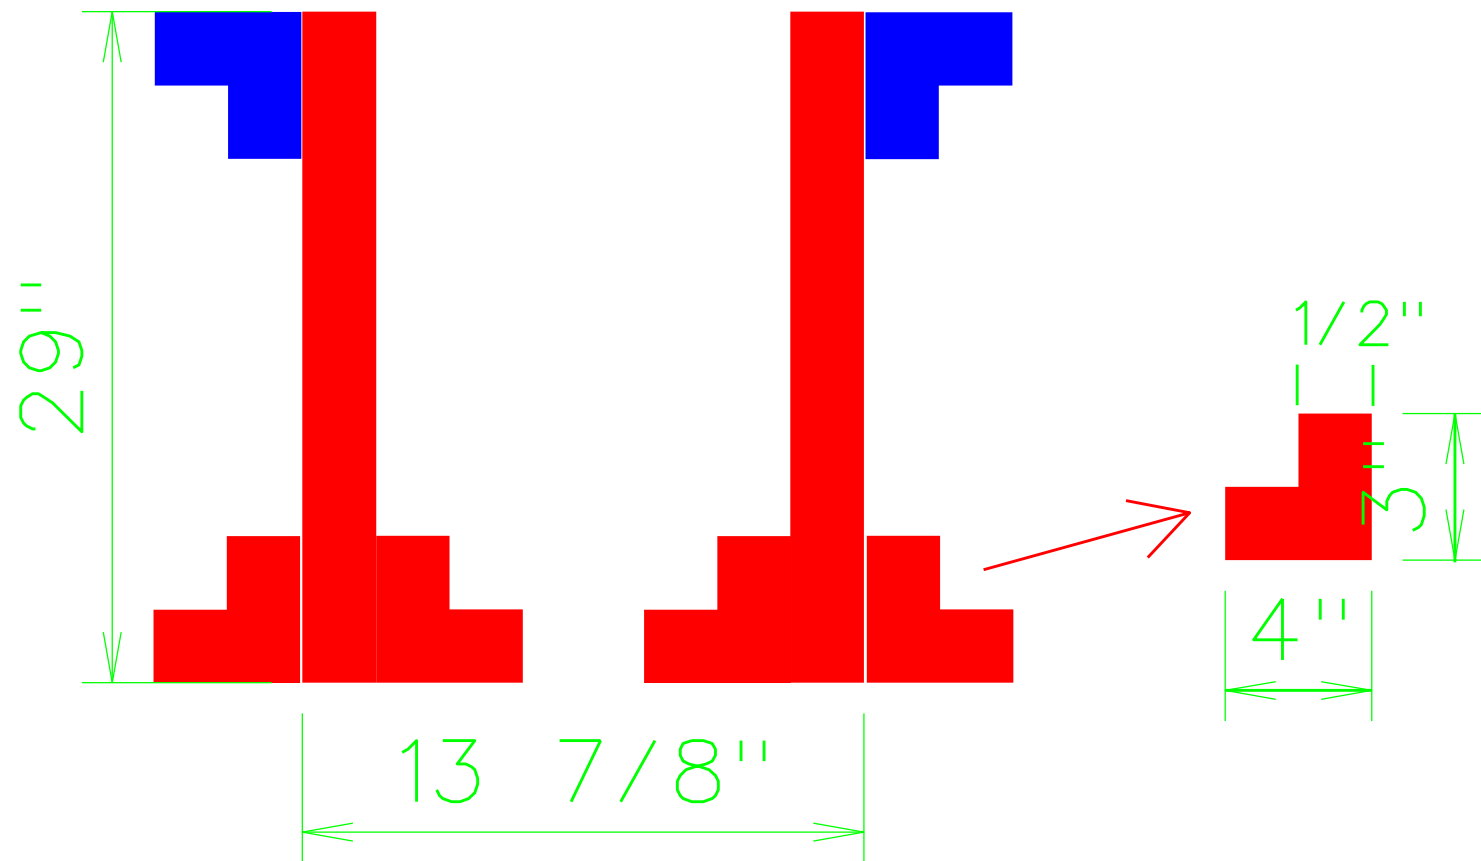
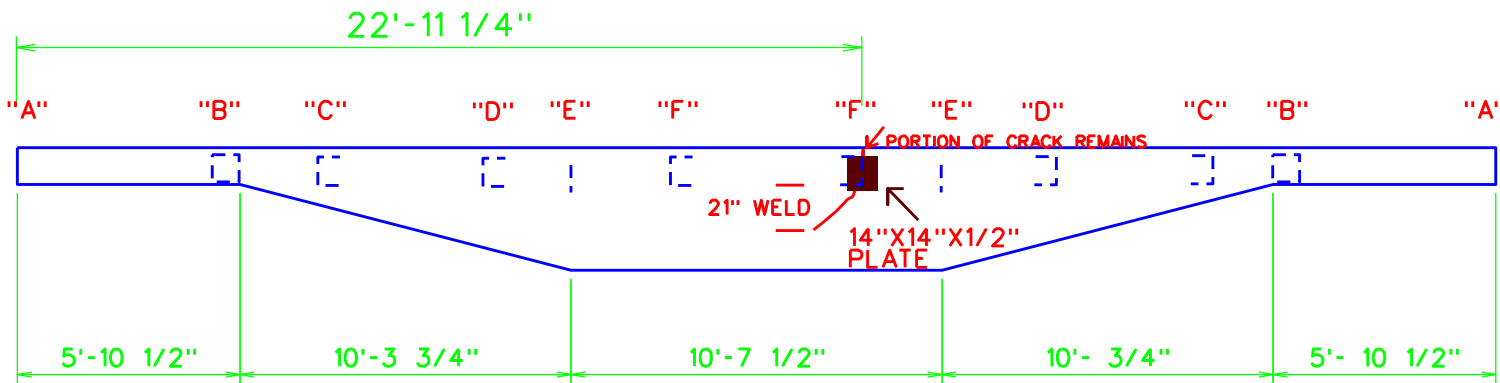
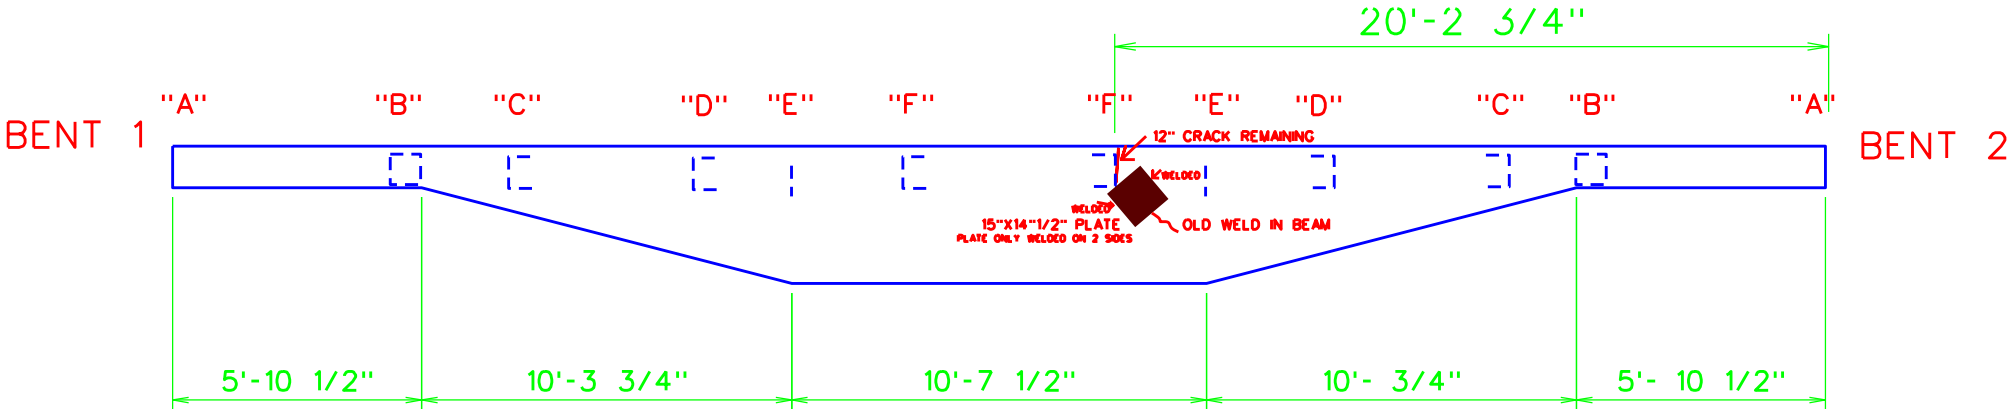
OUTSIDE/LEFT SIDE CAR 1
MAIN SILL

MAIN SILL OF CAR #1 IS IN POOR CONDITION DUE TO OLD DAMAGE CAUSING A LARGE CRACK. A PORTION OF THE CRACK HAS BEEN WELDED UP. TOP 12" PORTION IS STILL GAPPED OPEN, RIGHT AND LEFT SIDES.
MAIN SILL OF CAR #2 IS IN SATISFACTORY CONDITION AND SHOULD BE INSPECTED FOR CRACKS IN WELDS AND CRACKS THAT ARE DUE TO STEEL FATIGUE.

CALIPERS AND/OR ULTRA SONIC GAUGE TO MEASURE ANY SECTION LOSS. DYE PENETRANT TO DETERMINE CRACK LENGTHS IF ANY ARE FOUND.
