Asset #18313(Routine, Underwater type 2)

Hogeye Road over Illinois River-Wash. Co.

Location: 0.05 M JCT SH 156 & 265

Team Lead: Eric West, Inspection Date: 12/05/2022

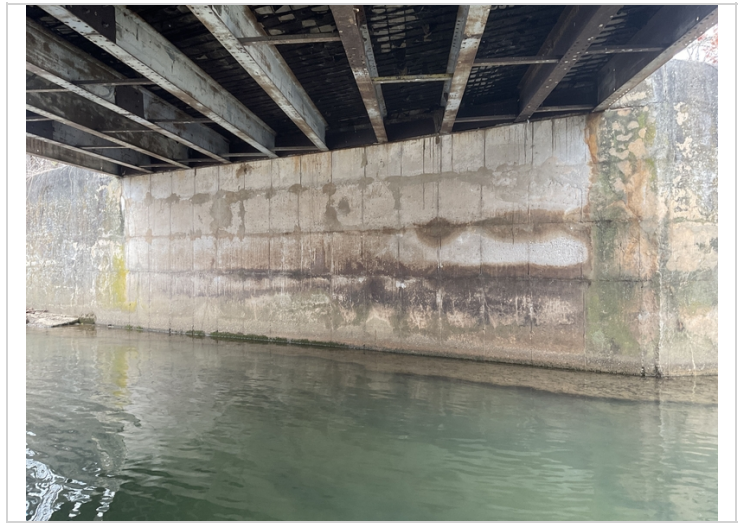
- Abutment #1 has a diagonal crack at the Lt & Rt wing wall juncture and a vertical crack in bay #7.
- Abutment #2 has diagonal cracks adjacent to beams # 1 & 10 at the wing wall juncture.
- Light abrasion along the base of the abutments.
- Footings appear to be founded on a non-uniform solid rock channel.

- Abutment #1 footing is exposed with voids along and under the footing. Some voids reach within 1" of the abutment stem but no voids were found that extends under the abutment stem.
- Bent #2 footing is exposed with voids along the edge of the irregular footing. The backside of the footing has minor voids along the edge of the footing. The aheadface has voids that extend up to the face of the pier wall. The inlet end appears to be completely undermined for approximately 18" under the footing longitudinally.
- Bent #3 footing has voids that penetrate under the edge of the footing but do not reach the face of the pier wall. The aheadface is partially exposed but not undermined.
- Abutment #2 footing has cover and is not exposed.

Abutment #1 typical.

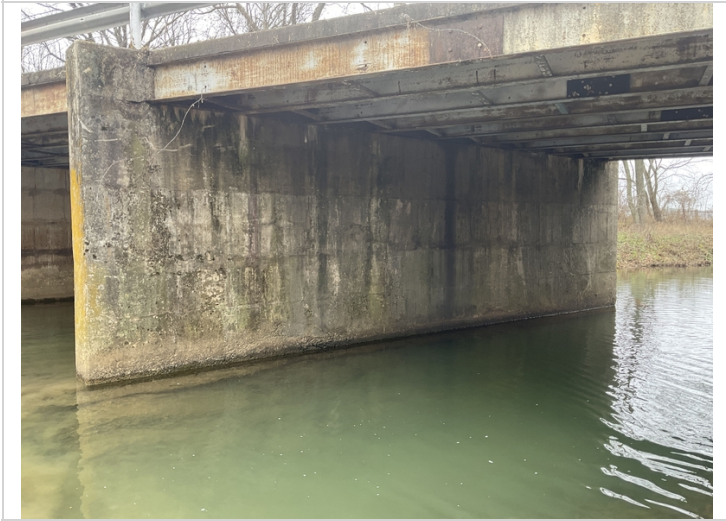
11/03/2020 - RSM & SPC: Underwater Type II inspection: There are voids under the edges of the non-uniform concrete footings that are exposed at abutment # 1 and bents # 2 and # 3. The left end (inlet end) of Bent # 2 footing has undermining that penetrates the width under the end of footing transversely and up to 18" under the pier wall measured along the length of pier wall. The area of undermining extends approximately 4' in length. Abutment # 2 footing has cover.

Bent #2 typical.

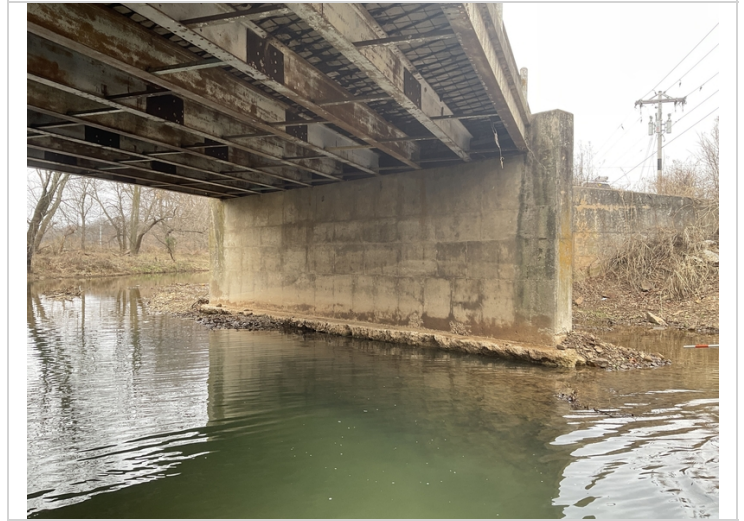
Bent #3 typical.
