Bridge #00503(Accident)
US 67-19- LM 3.23 over FOURCHE RELIEF
Location: 3.17 MI NE JCT US 62 & 67

Team Lead: Richard Jones Inspection Date: March 12, 2019

(43) Main Structure Type	14
Material	1-Concrete
Type	4-Tee beam
(44) Approach Structure Type	00
Material	0-Other
Type	0-Other
(45) No. of Spans in Main Unit	4

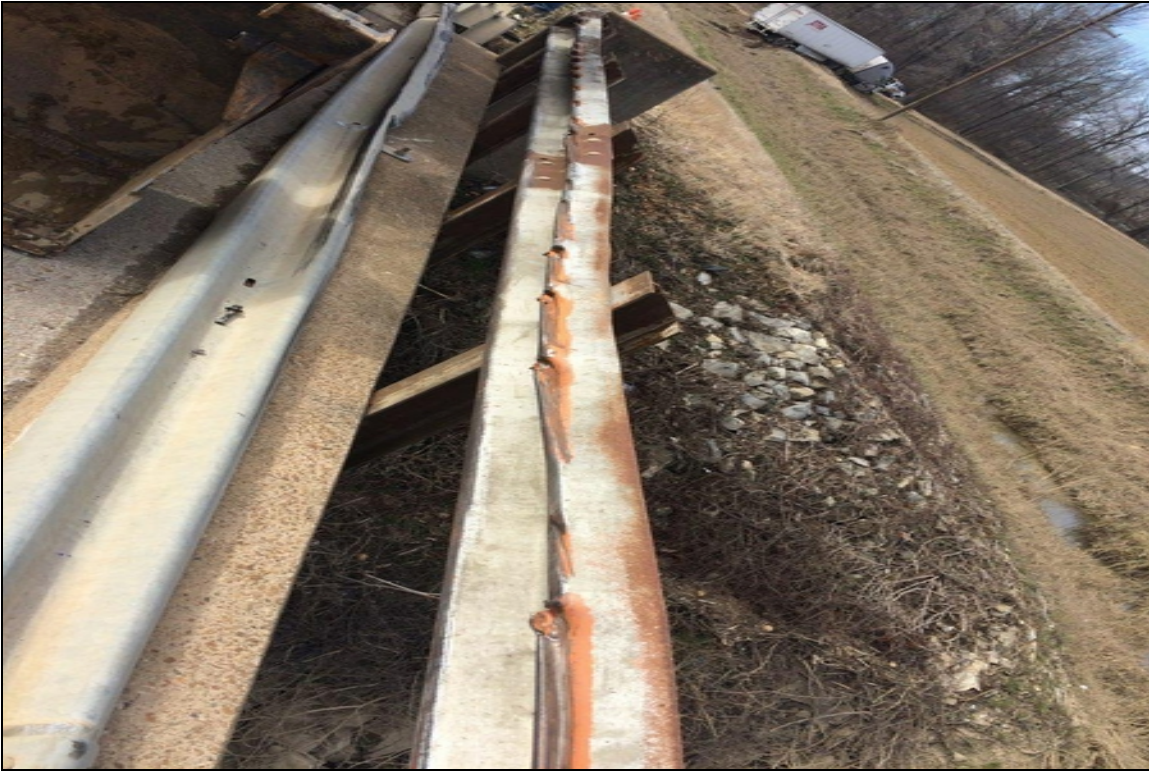
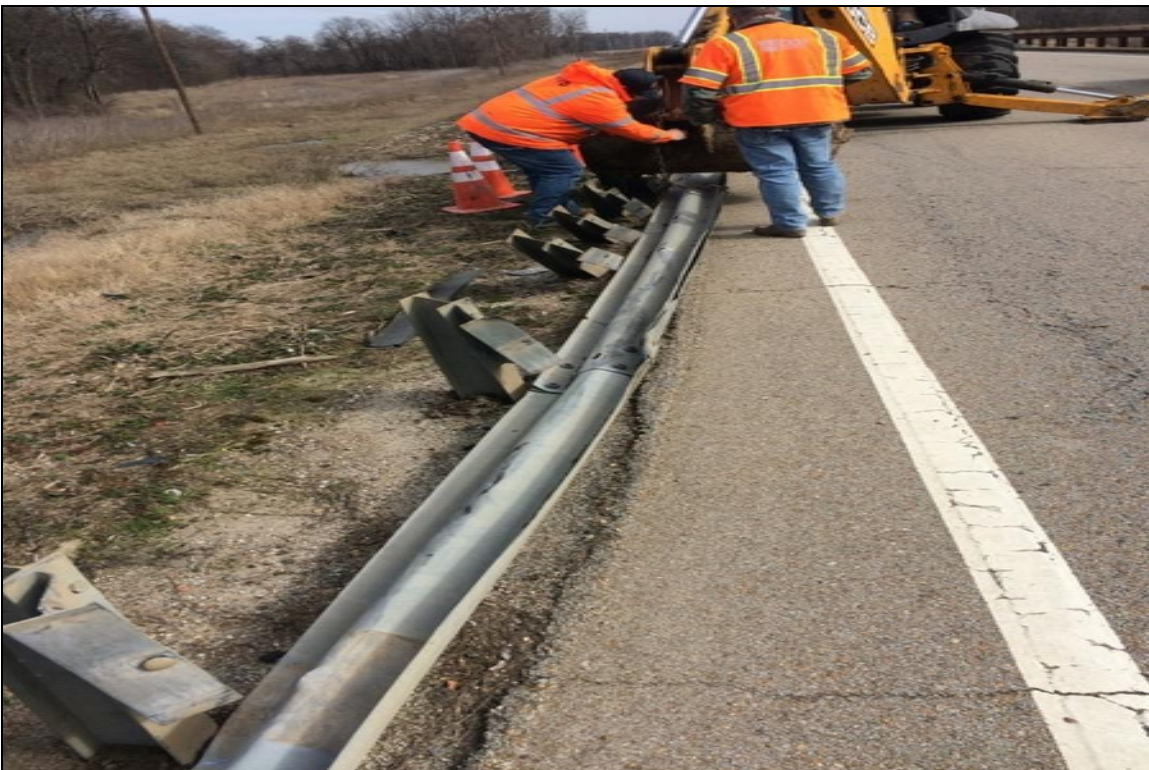
Bridge #00503(Accident)

On 3/6/19 a West bound 18 wheeler hit the Lt bridge rail at spans 1 – 3 and the Lt approach rail at beginning end of bridge. District bridge crew replaced approach rail, bridge rail, and several bridge rail posts on 3/11/19 and 3/12/19. No other damage to bridge was noted. Other notes left from previous inspection. Concrete deck with asphalt overlay. The wearing surface has moderate to heavy map cracking in wheel path, also over joints.

Span 1 outside Girders 1 & 6 over bent 2, span 3 outside girders 1 & 6 over bent 4 and span 4 outside girder 1 over bent 4 each have moderate to wide diagonal / vertical cracks on end over caps. Girder 6 over Bents 2 & 4 grouted but still cracked. Several concrete diaphragms between girders over caps have moderate to heavy cracking. Steel masonry plates on Bt. 3 under outside girders 1 and 6 are rusted with pitting.
