Bridge #03084(Routine)

US 49-02- LM 8.71 over HURRICANE CREEK

Team Lead: James Adams Inspection Date: November 19, 2020

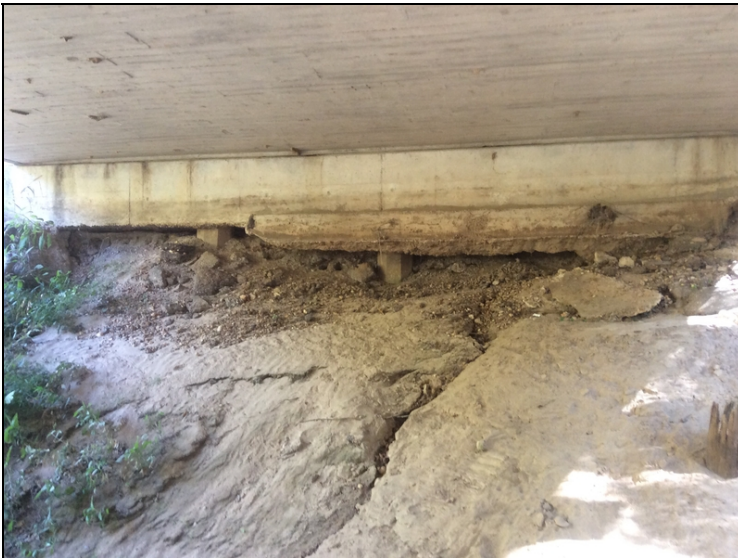
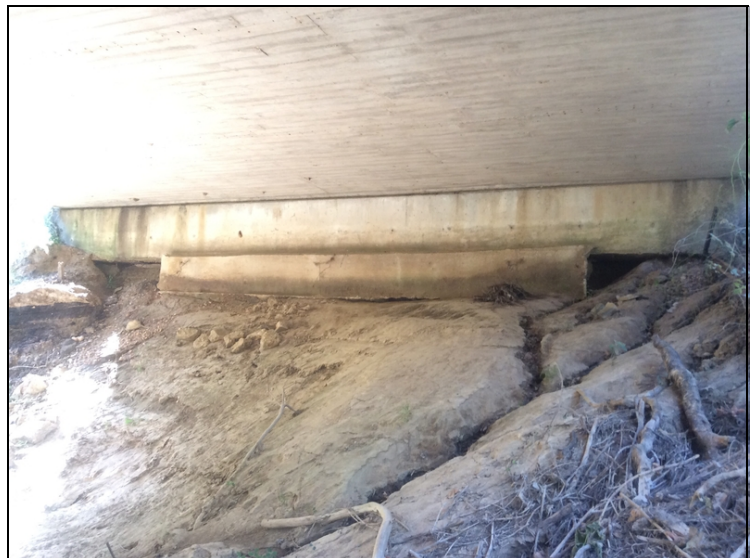
Bent 1 abutment is undermined up to 1.5' below and 2' back under. Bent 4 is undermined for 8' on each end up to 2' below and 3' back under abutment. Some repairs have been made in the past near centerline.

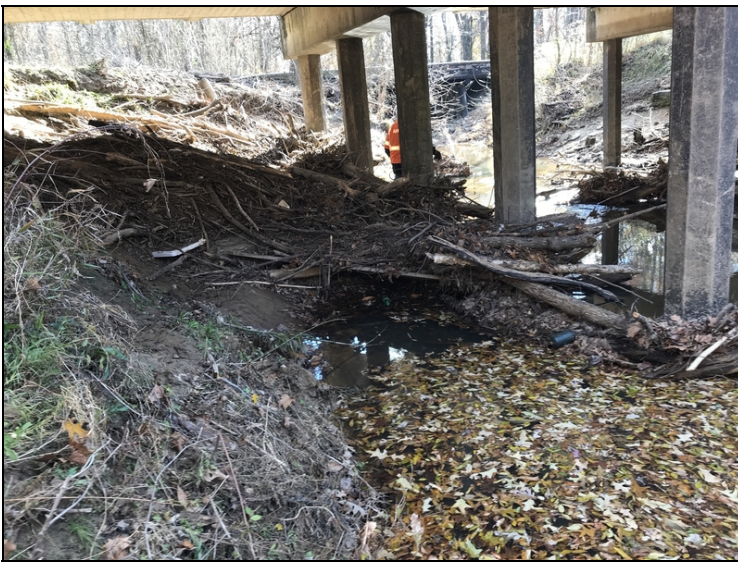
Bent 2 Drift

Moderate drift buildup on slope under span 1 and against bent 2 piles.

to Greene Co Crew for removal KAW 2/15/19
