**Bridge #07140(Routine)**  
**US 67 - 02 -20.10 over GARLAND CREEK**

**Location: 2.04 MI SW NEVADA CO LN**

**Team Lead: Charlie Rogers Inspection Date: September 10, 2018**

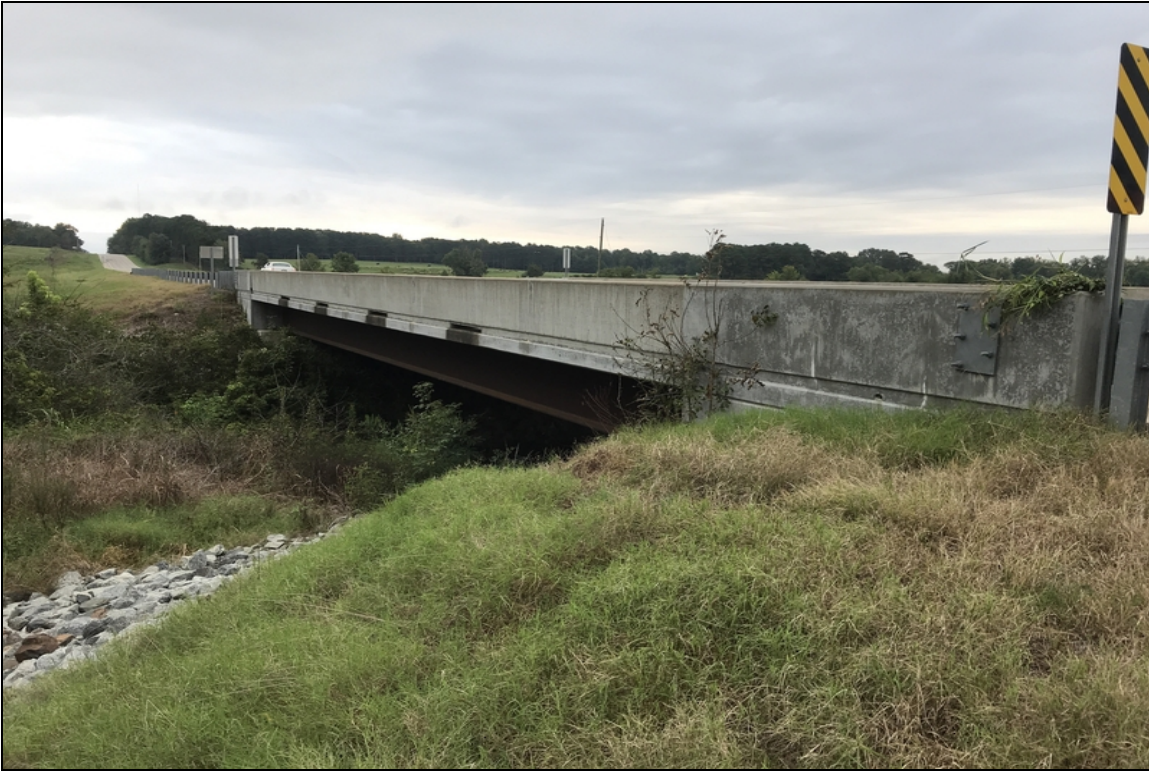
SS

VERY SMALL DECK CRACKS WERE SEALED WHEN BRIDGE WAS BUILT.....9/10/2018...AL, SS, Deck photos taken. Little or no change in condition...

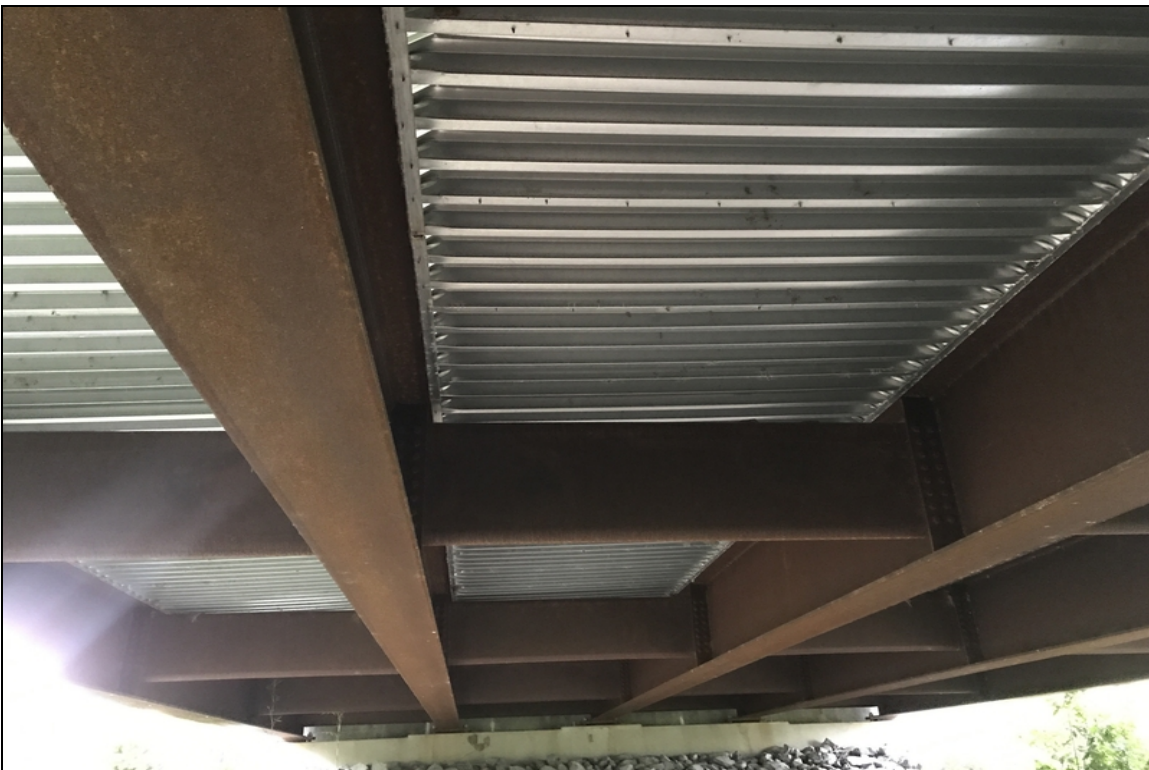
Underside of deck
