Bridge #B6926(Routine)

I-30 WB Log 127.52 over Crooked creek

Team Lead: Keith Harris Inspection Date: September 25, 2019

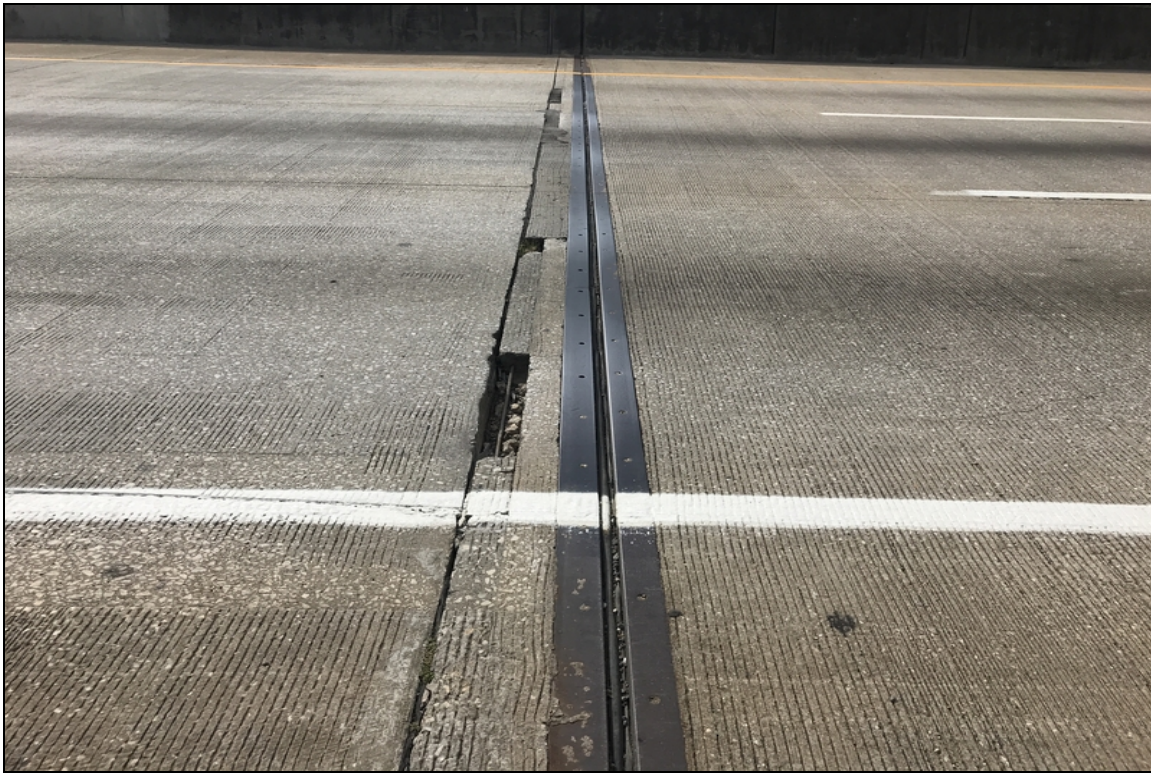
(215)	East abutment spalls with exposed rebar in the top of back wall. Scattered cracks in the back wall of both abutments.						
225	Steel Pile	EA	35	35	0	0	0
515	Steel Protective Coating	SF	2472	2472	0	0	0
234	Reinforced Concrete Pier Cap	LF	285	285	0	0	0
302	Compression Joint Seal	LF	177	155	0	22	0
2310	Leakage	LF	0	0	0	0	0
2320	Seal Adhesion	LF	22	0	0	22	0

Bent 7 east abutment top of backwall spalls with rebar exposed

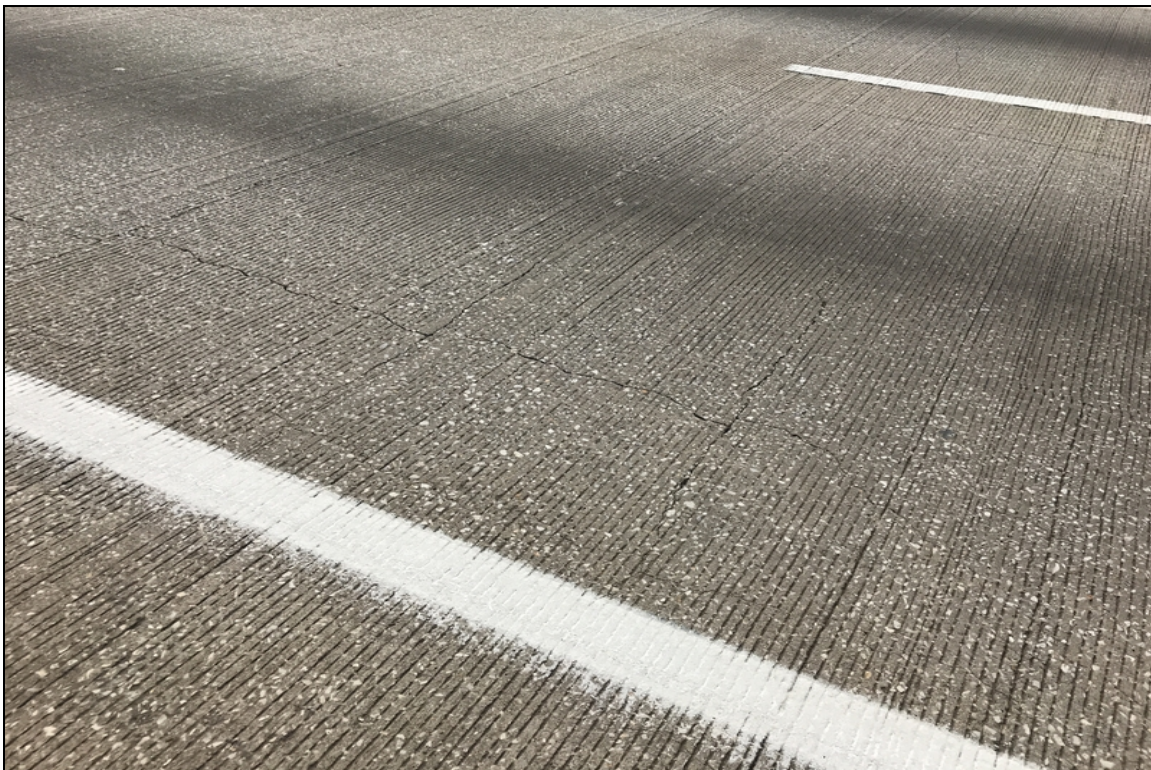
(12)	Deck surface of all spans. Unsealed transverse and longitudinal cracks in all spans up to 0.040 inch						
107	Steel Open Girder/Beam	LF	1260	1260	0	0	0
515	Steel Protective Coating	SF	7182	0	7182	0	0
3430	Oxide Film Degradation Color/Texture Adherence(Steel Protective Coatings)	SF	7182	0	7182	0	0
215	Reinforced Concrete Abutment	LF	141	111	17	13	0
1090	Exposed Rebar	LF	13	0	0	13	0
1130	Cracking (RC and Other)	LF	17	0	17	0	0

Span 5 Unsealed transverse and longitudinal cracks in all spans up to 0.040 inch

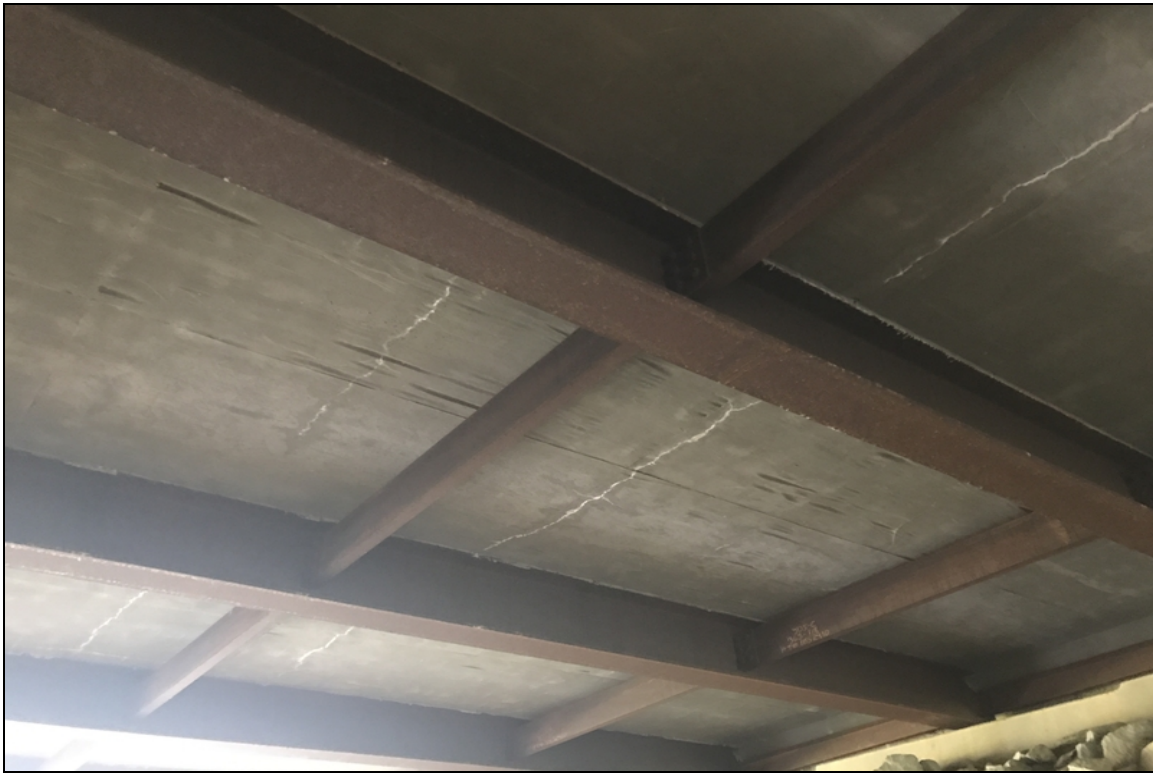
Efflorescence on soffit span 1

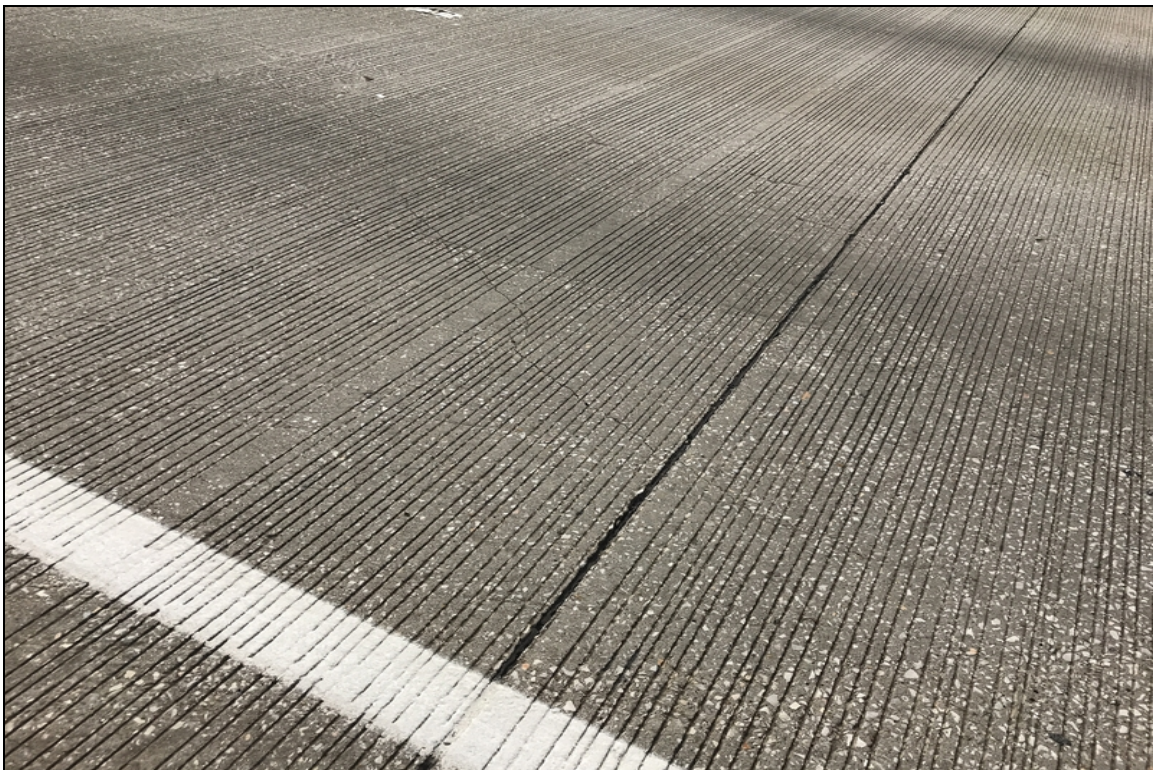
Span 2 Unsealed transverse and longitudinal cracks in all spans up to 0.040 inch
