**Bridge #03011(Routine)**  
**US79 S-7 LM 7.70 over SALINE RIVER**

**Location: 4.89 MI S JCT SH 35**

**Team Lead: Jimmy Reynolds Inspection Date: August 31, 2021**

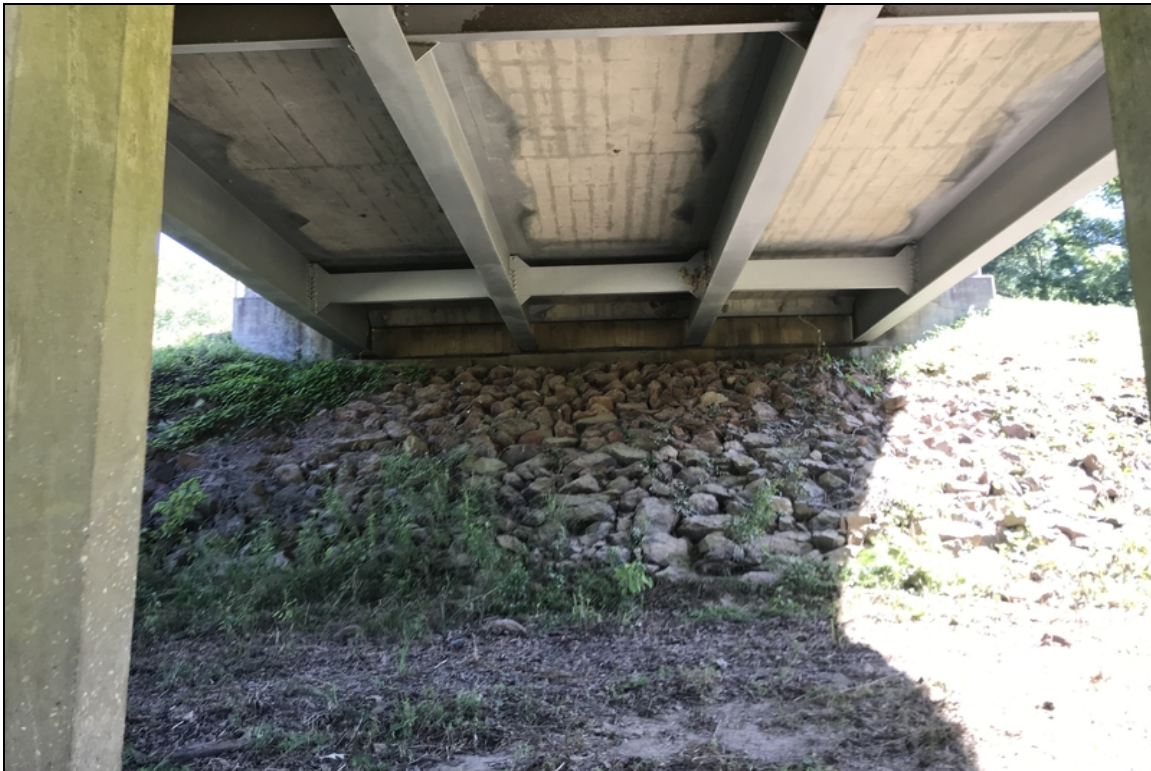
Underside span 49 and abutment 2

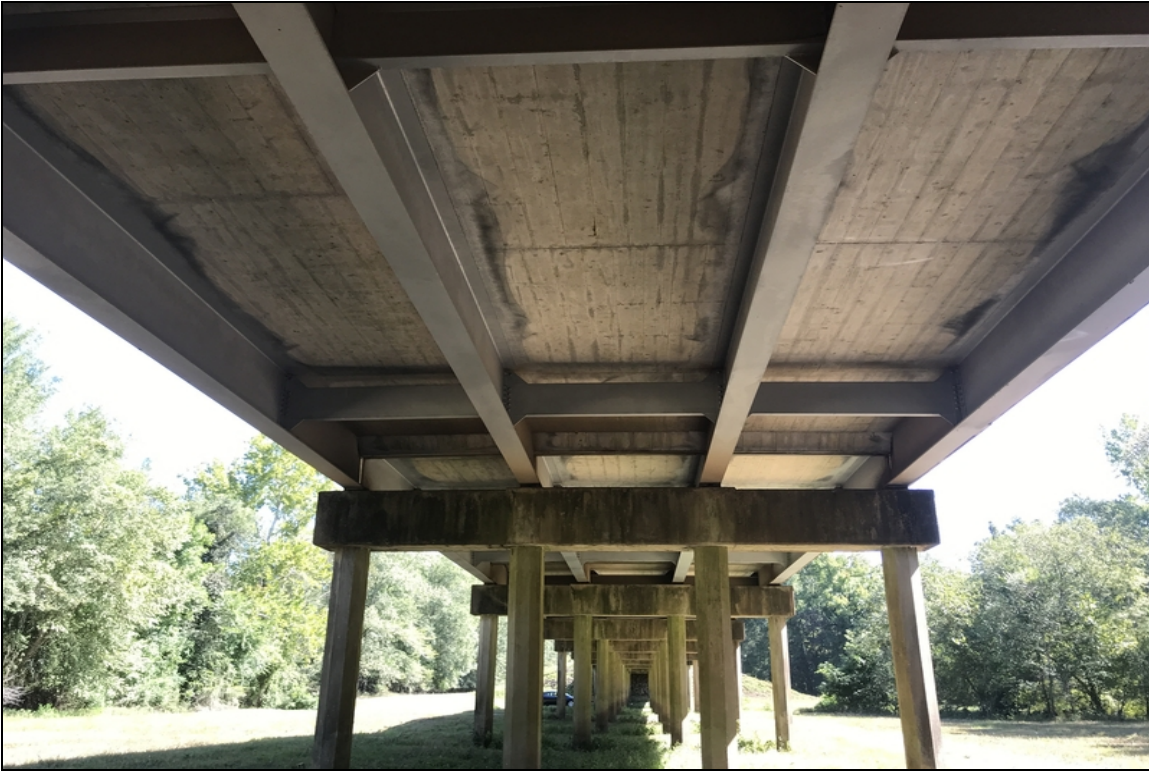
Underside span 40

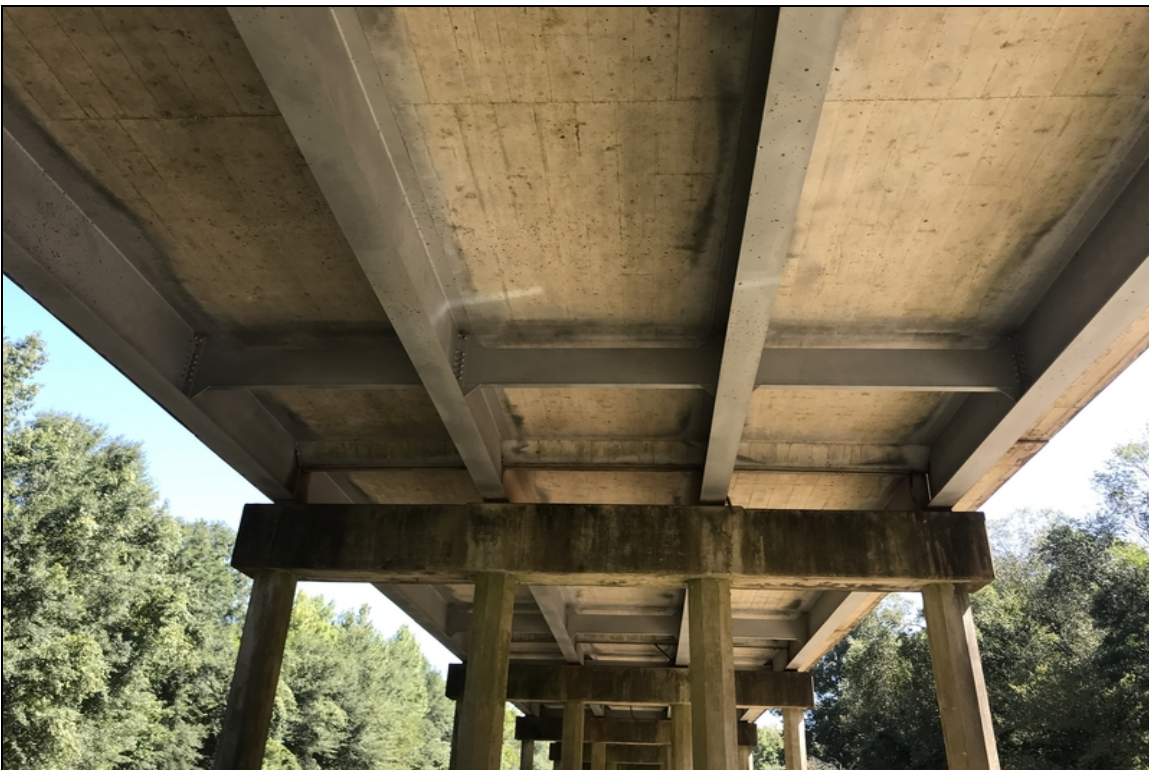
Underside span 30

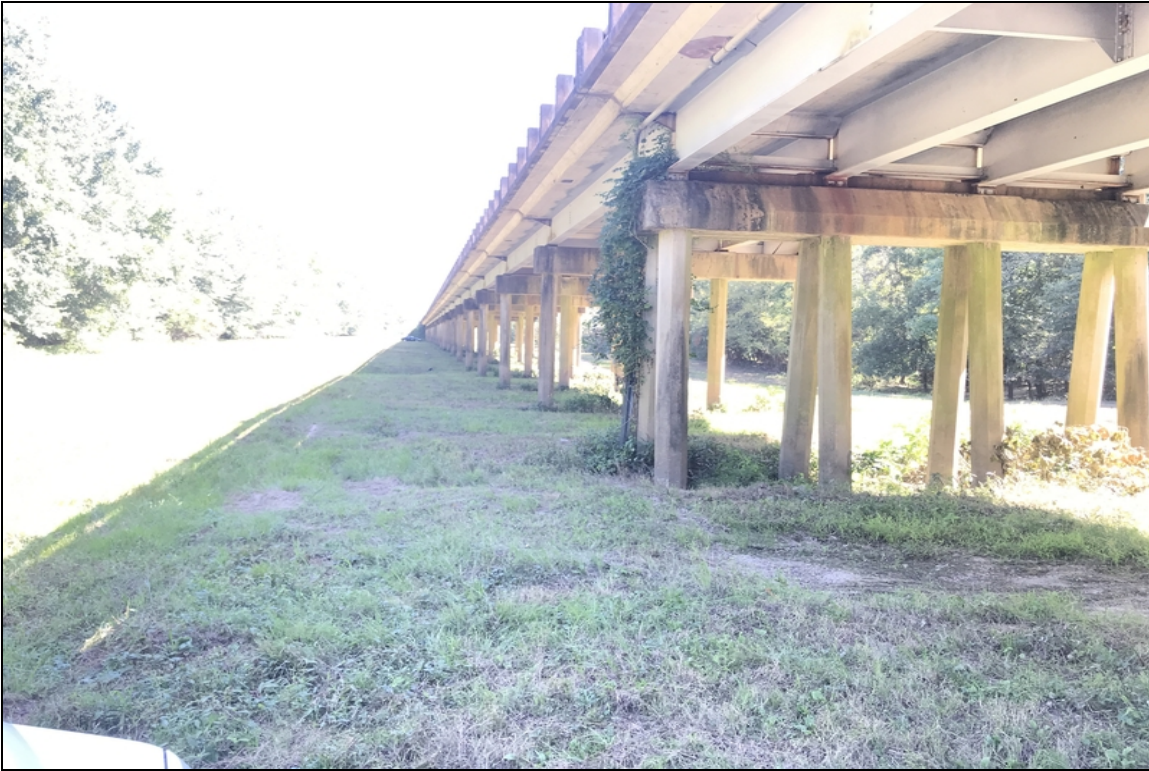
Bent 29 vegetation

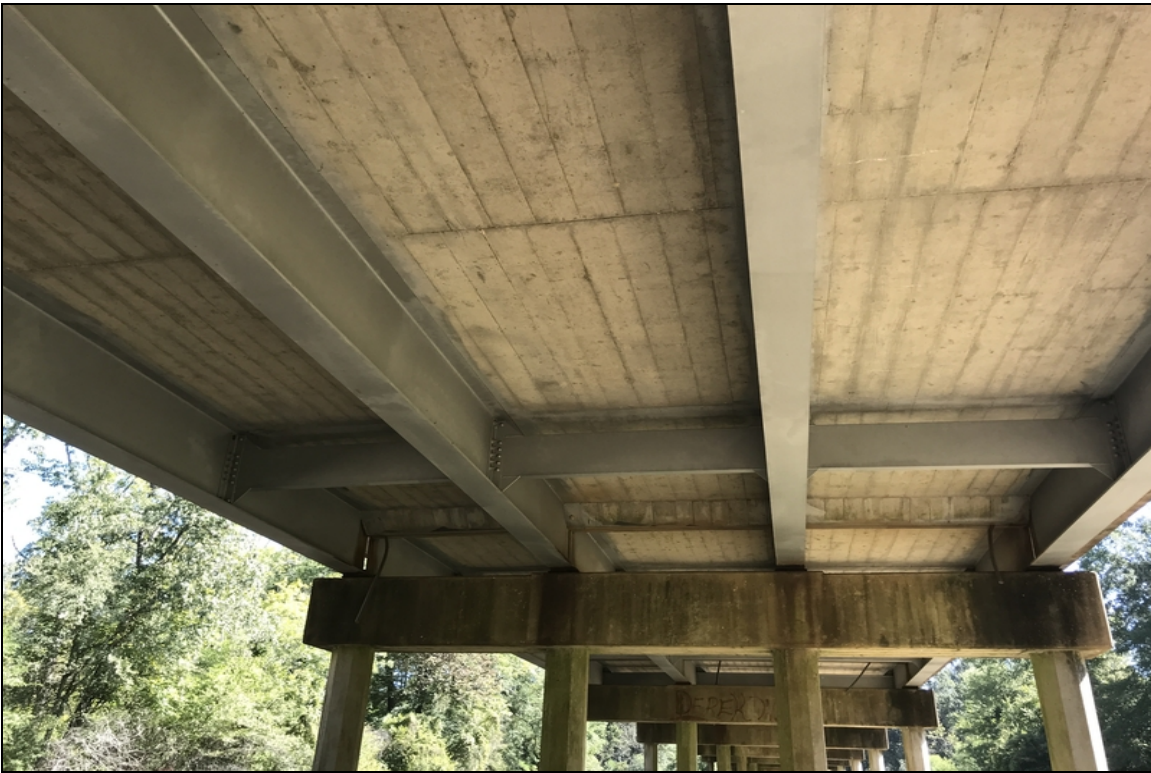
Underside span 15

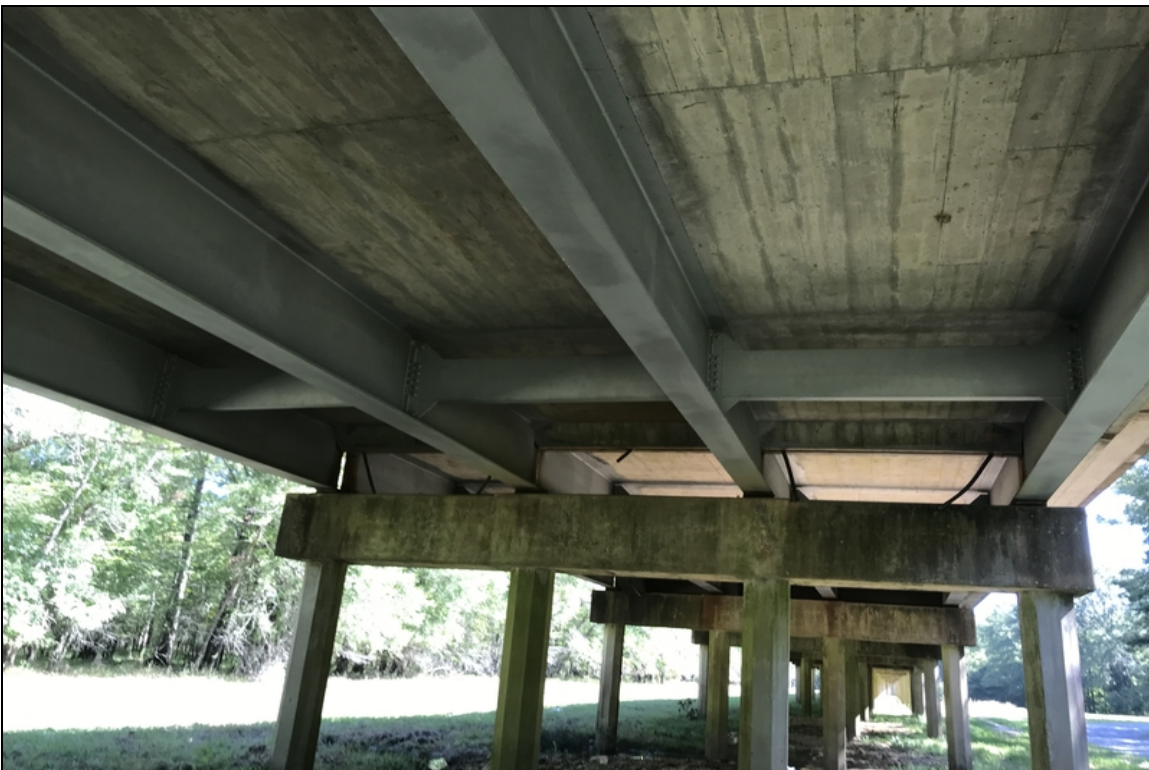
Underside span 4

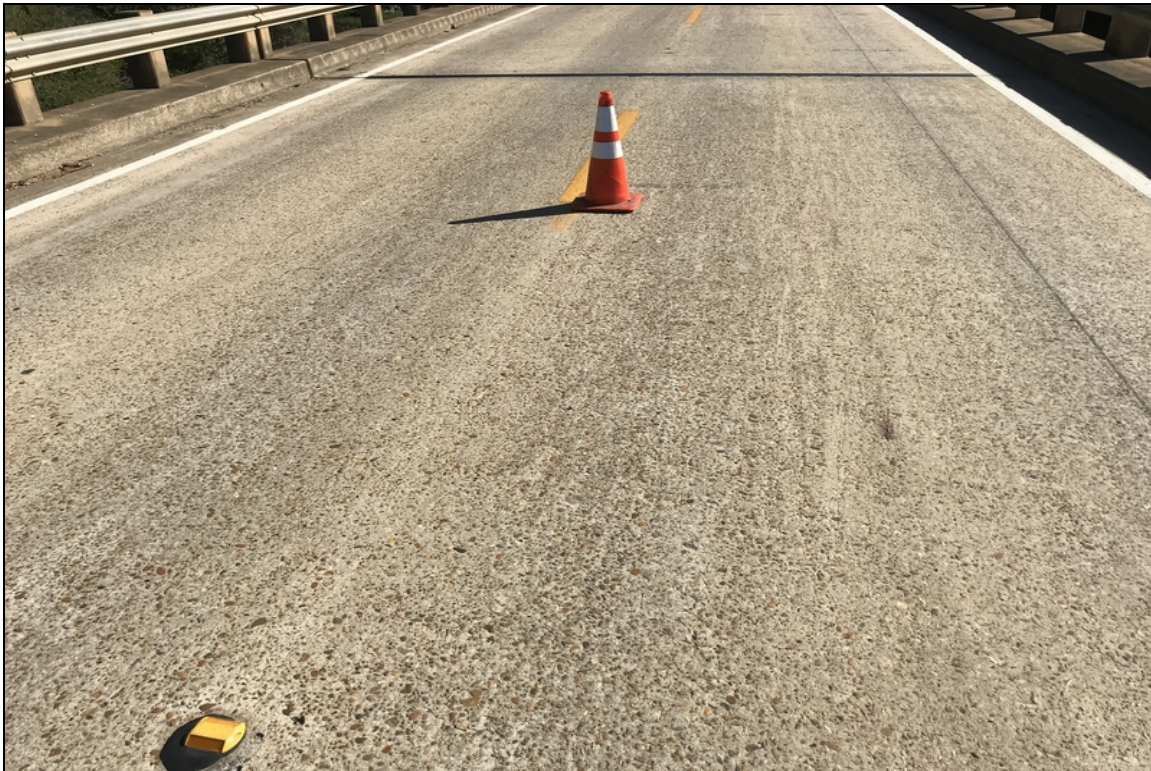
Span 17 looking ahead @ deck overview.

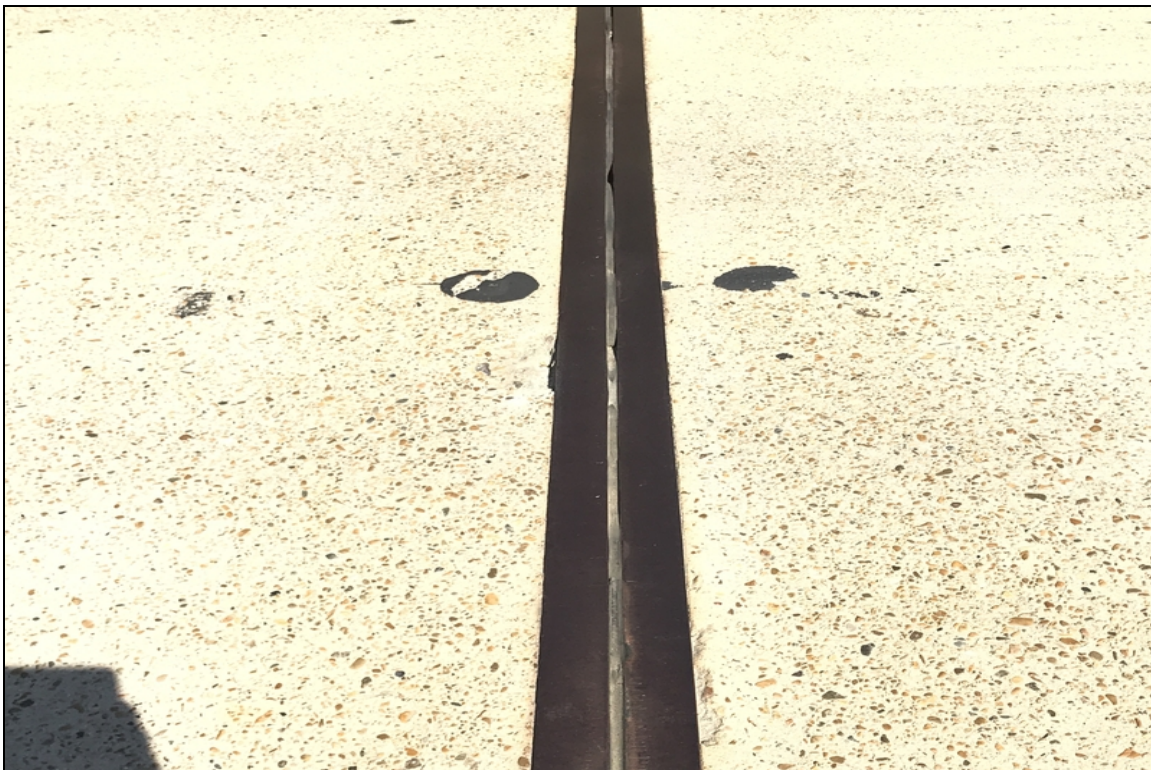
Bent 14 looking across from Rt. to Lt. @ joint material, there is some separation in the poured joint material from C/L Lt. in the SB lanes.

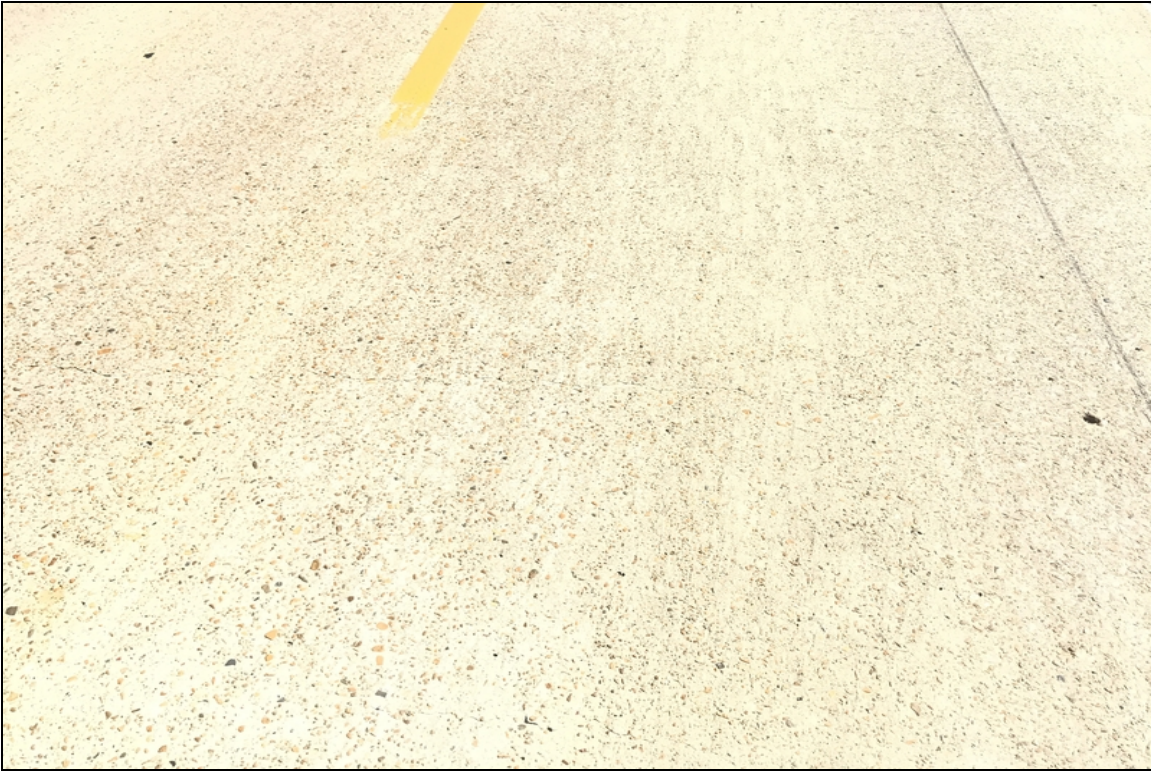
Span 12 looking ahead @ deck

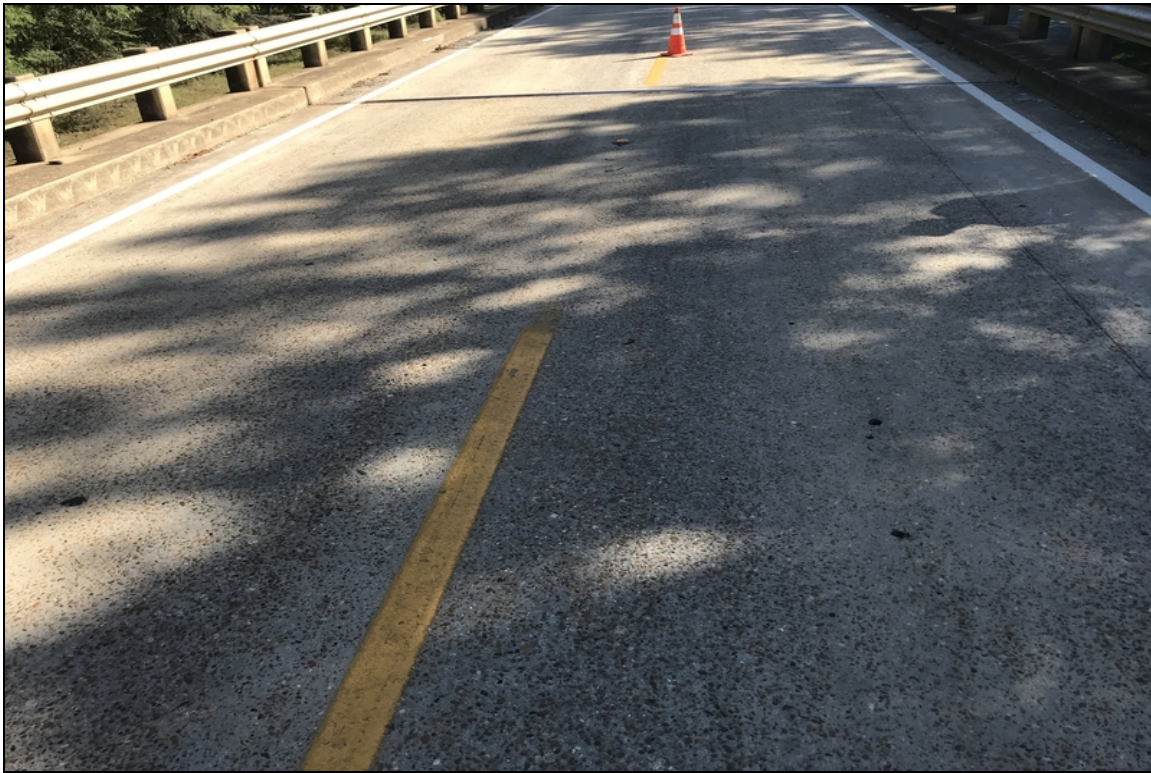
Span 5 looking ahead @ deck.

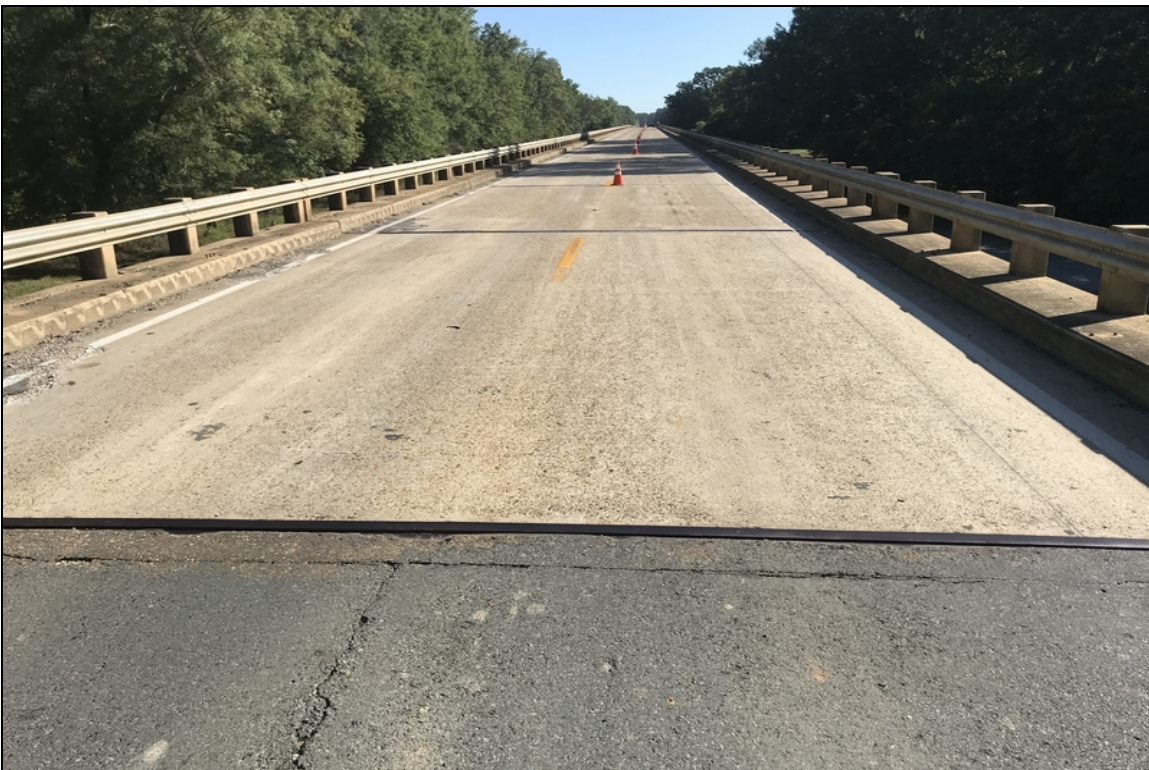
Span 1 deck overview.

Deck spall, Span 1 Lt. lane 4' long x 2' wide x 1" deep about midspan.

Deck spall, Span 1 2' ahead of BR begin, Lt. lane just outside the white line, is 7' long & 2' wide & about 2" deep at the deepest point.

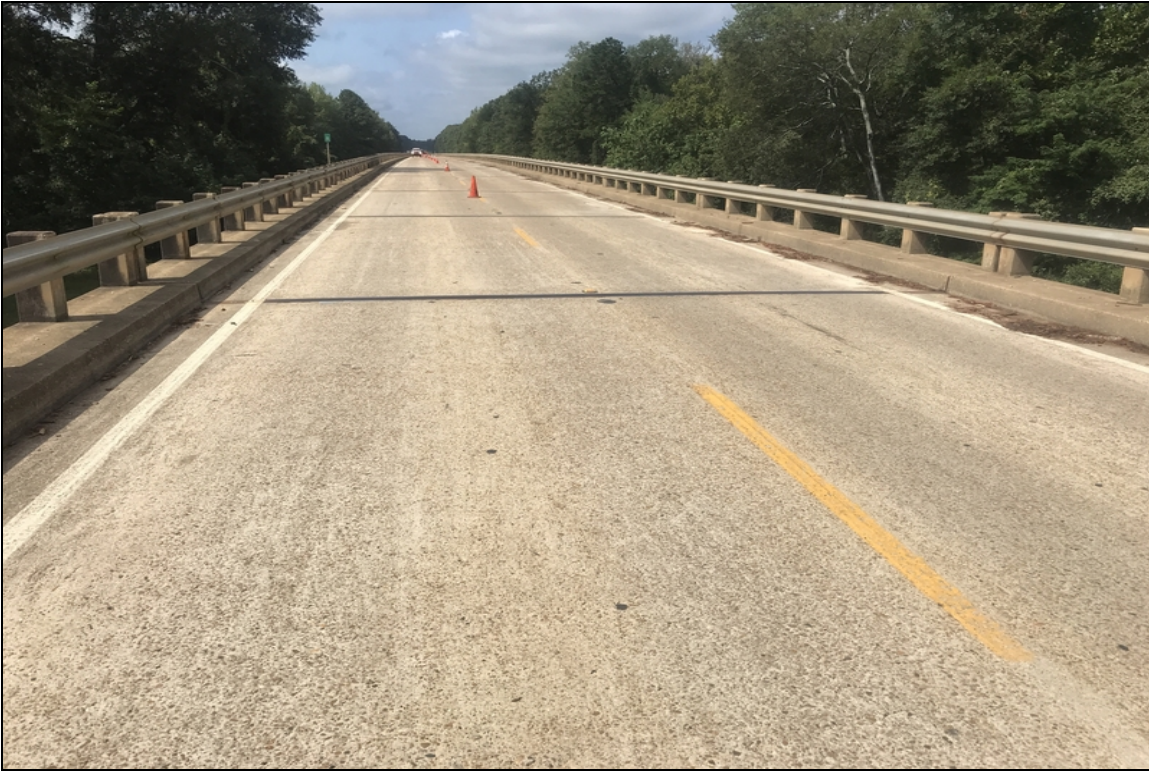
Deck overview.

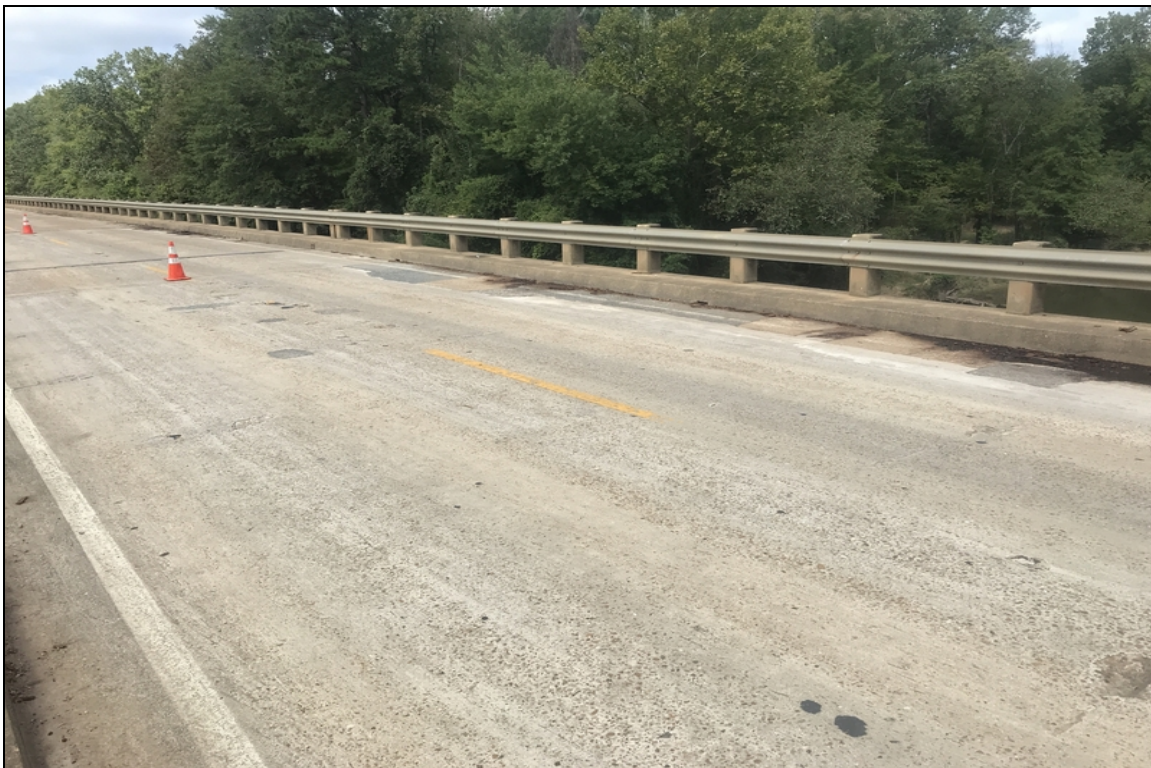
Span 26 overview.

Minor spalls and potholes, some with exposed steel. Spans 25-26-27 are the worst

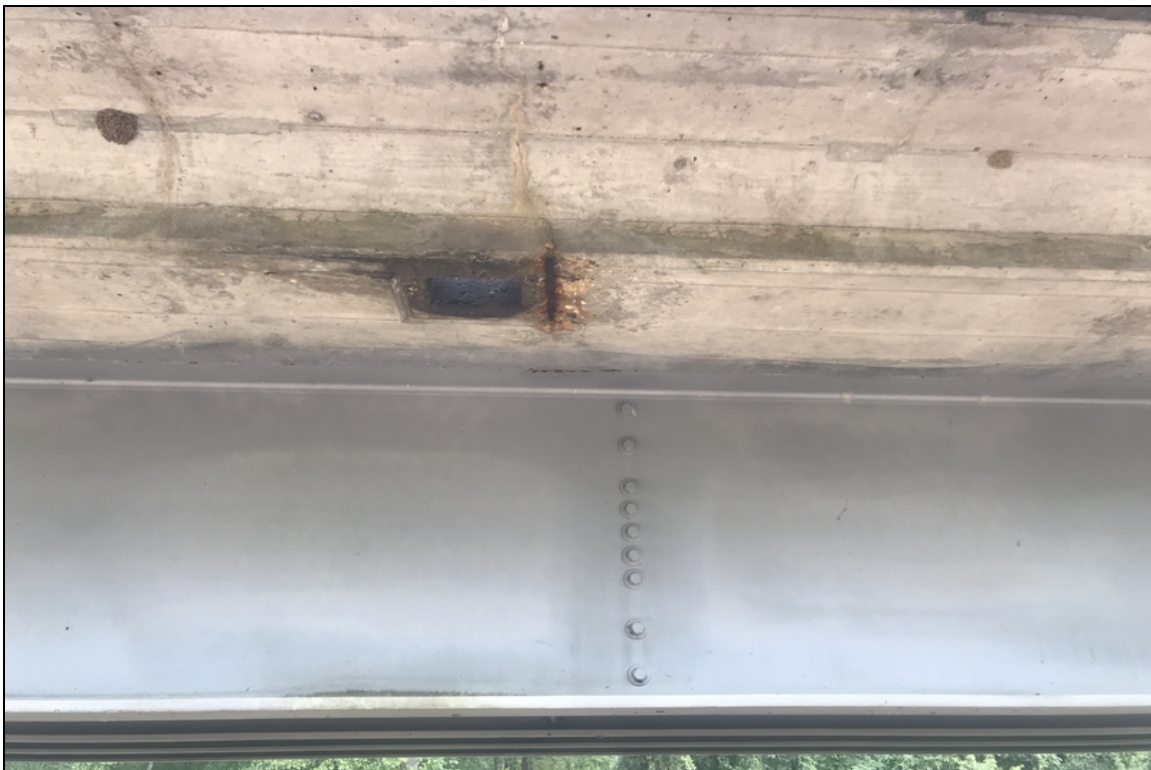
Span 23 drain hole

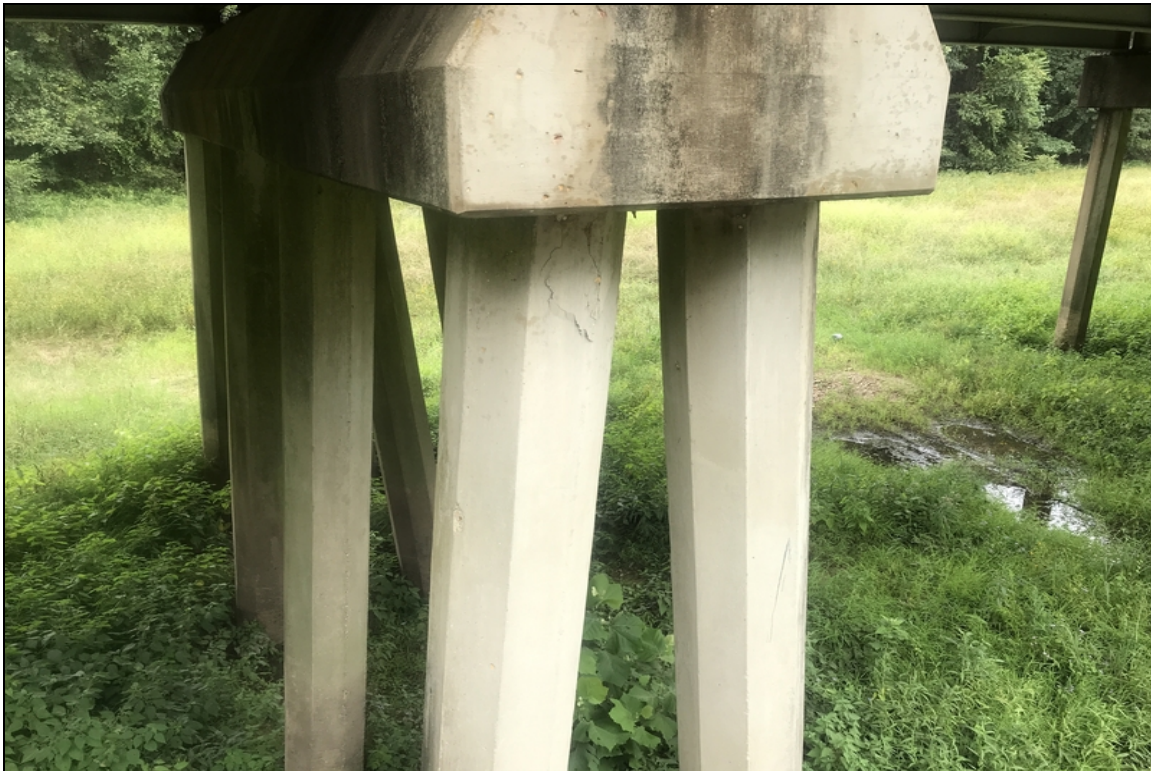
Bent 29 pile 4 back

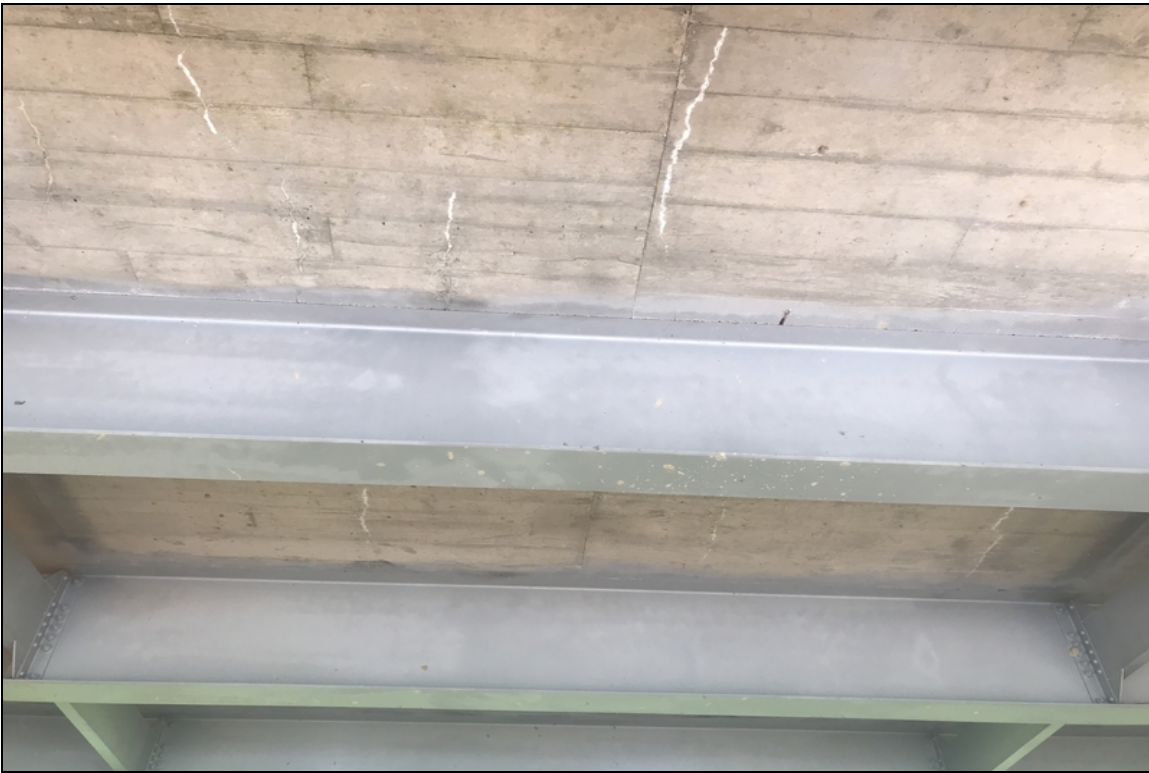
Soffit span 10.

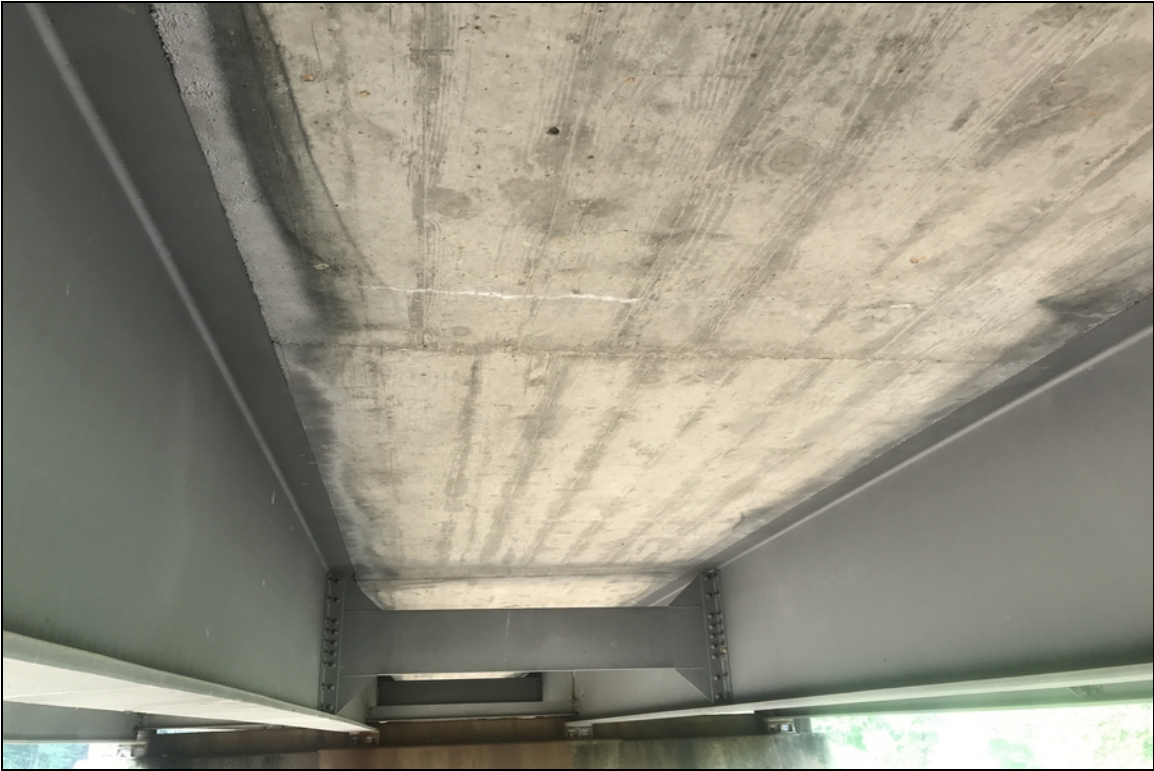
Soffit span 22

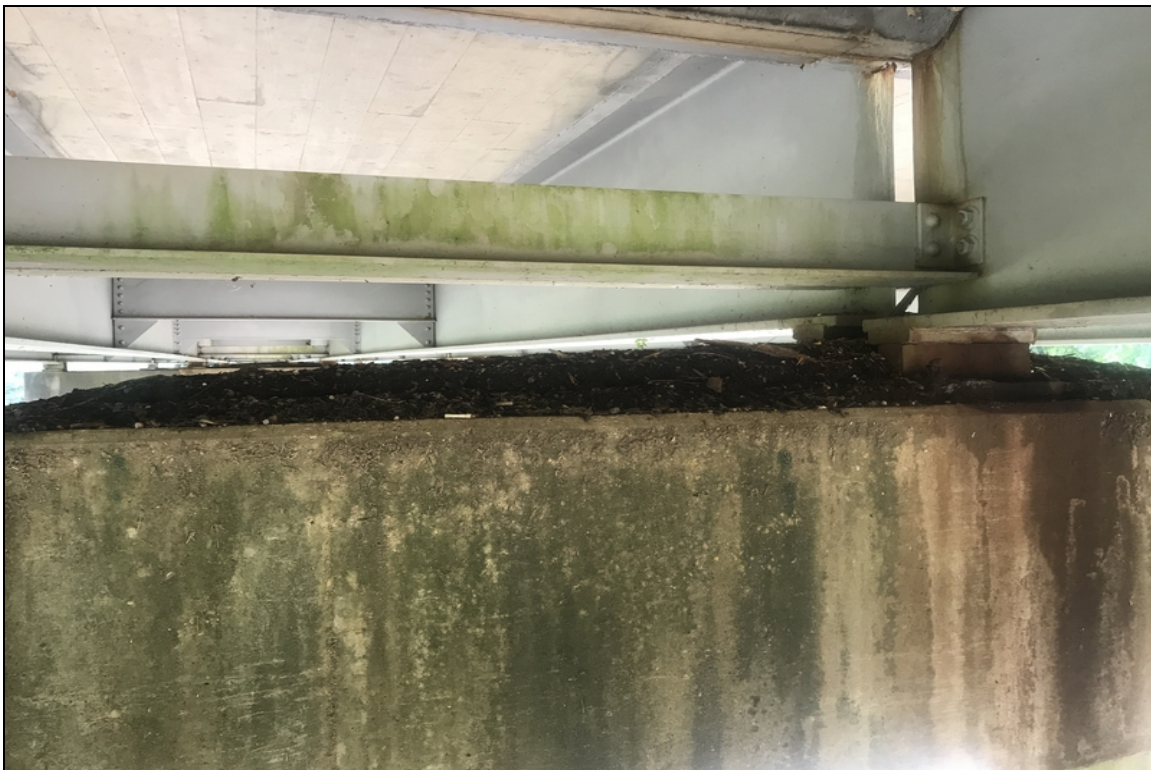
Bent 23 cap debris Also typical of bent 25
