Bridge #05423(Routine, Fracture Critical, Under Record Clearance)

US 65-14B LM 6.46 over Nebraska St, SLSW/UNPAC

Team Lead: Greg Loomis **Inspection Date:** October 06, 2020

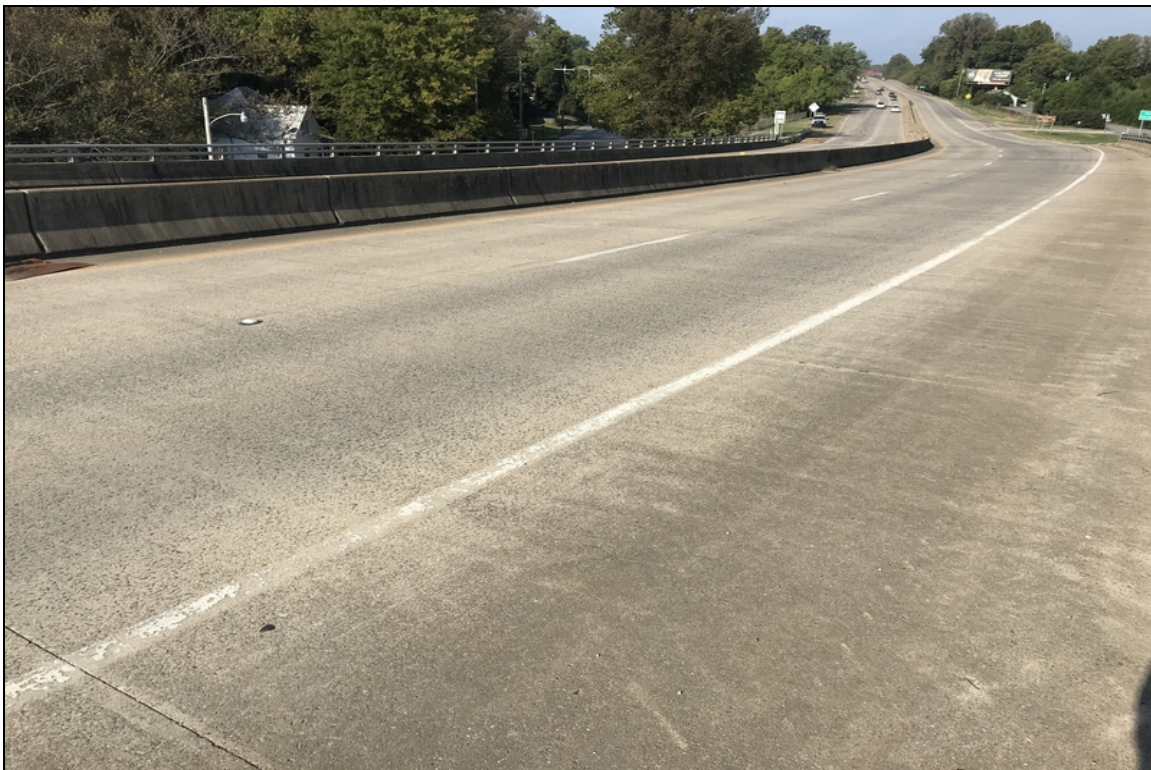
Deck - Span 4 left: Typical

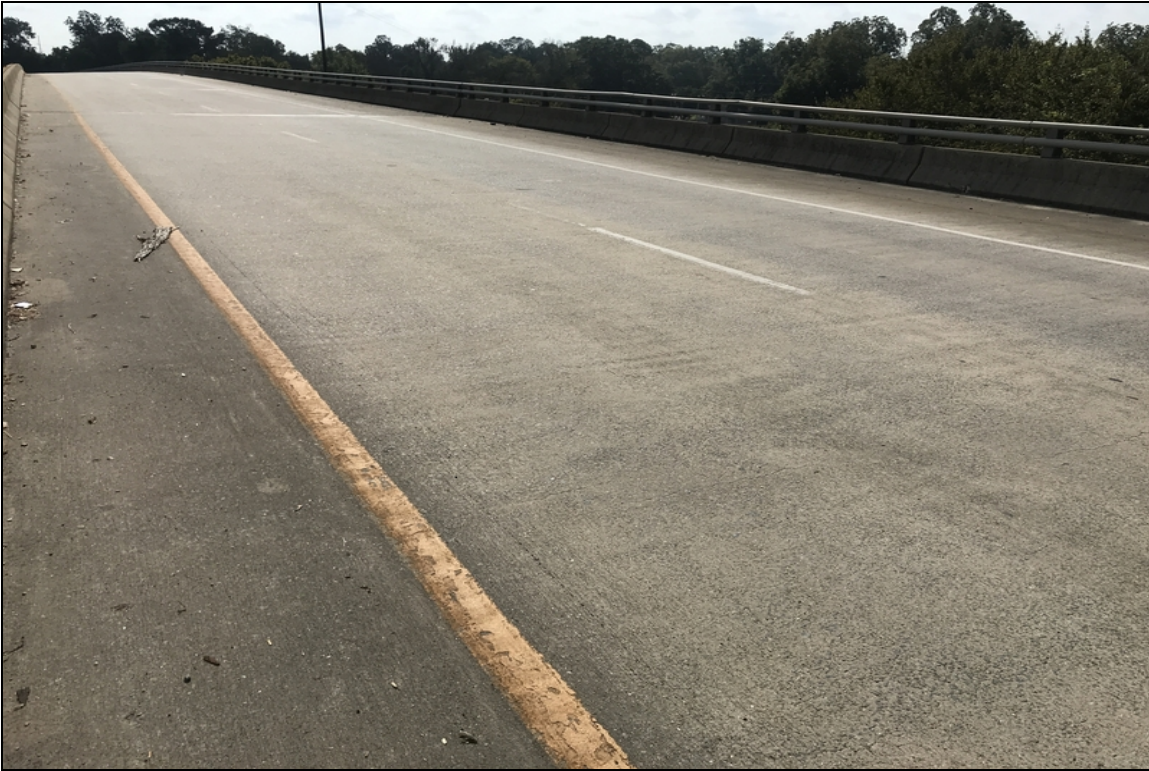
Deck - Span 15 right: Typical

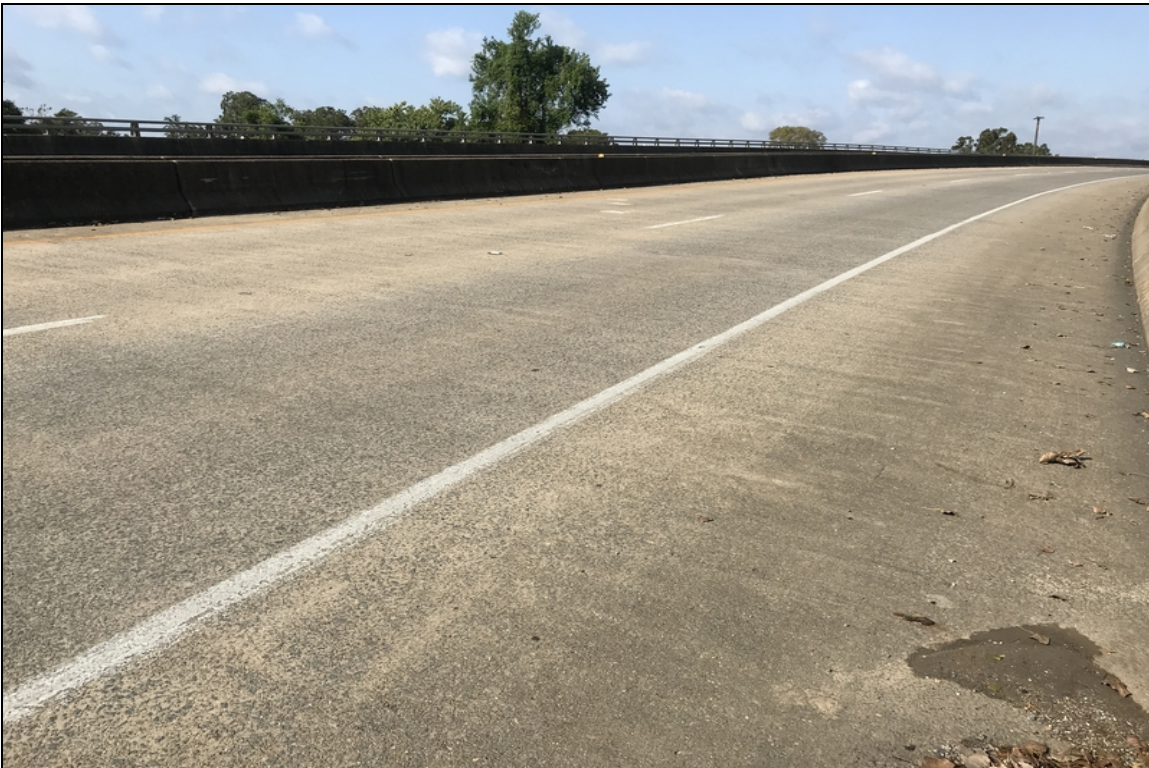
Deck - Span 24 left: Typical

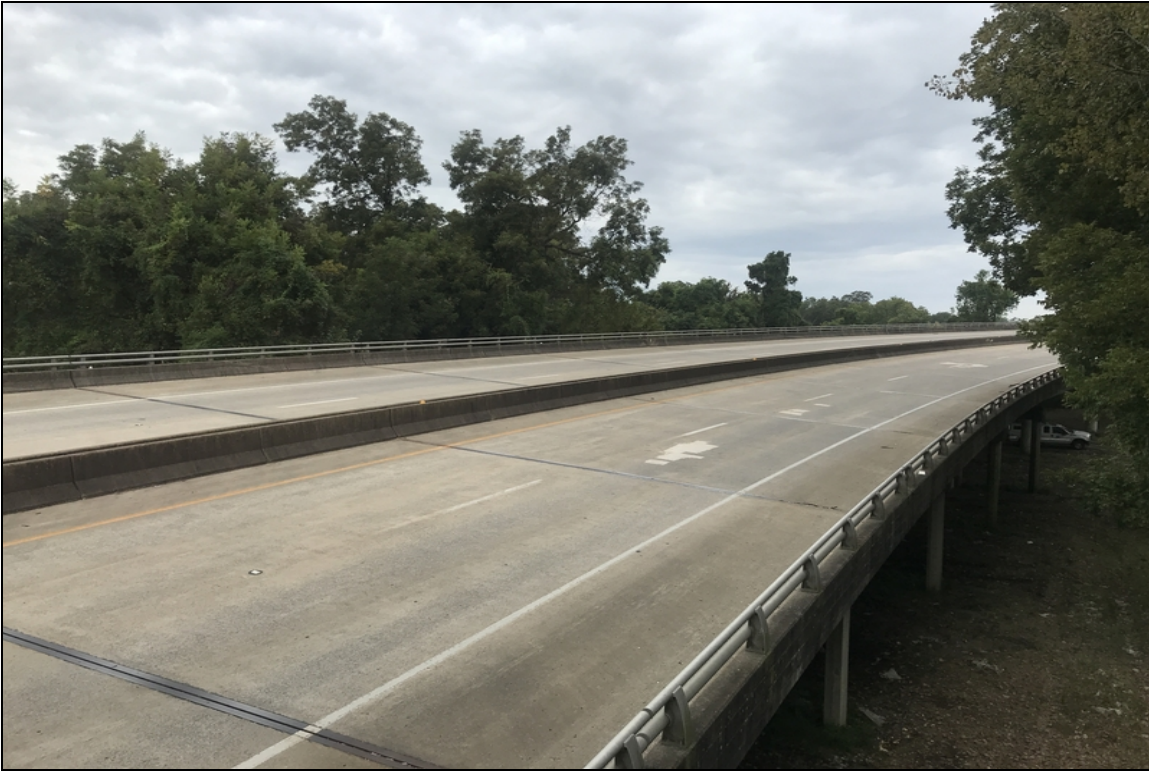
Deck - Spans 26-30: Typical

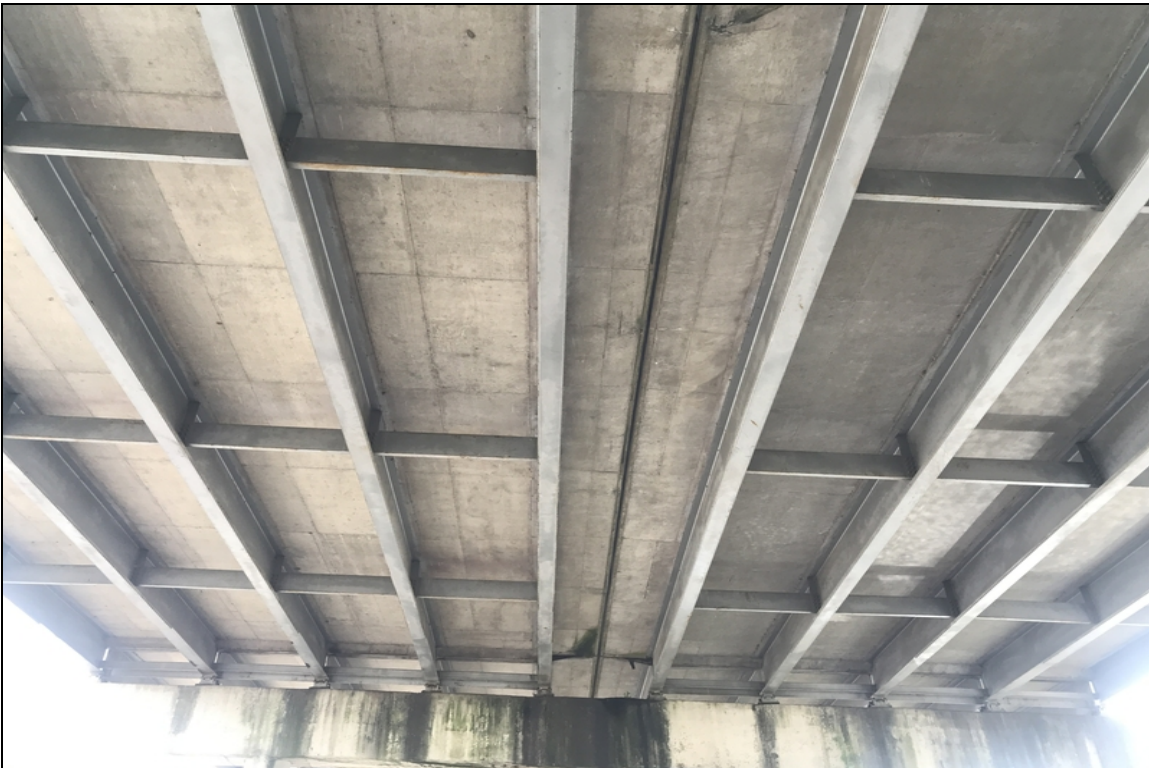
Soffit - Span 6: Typical

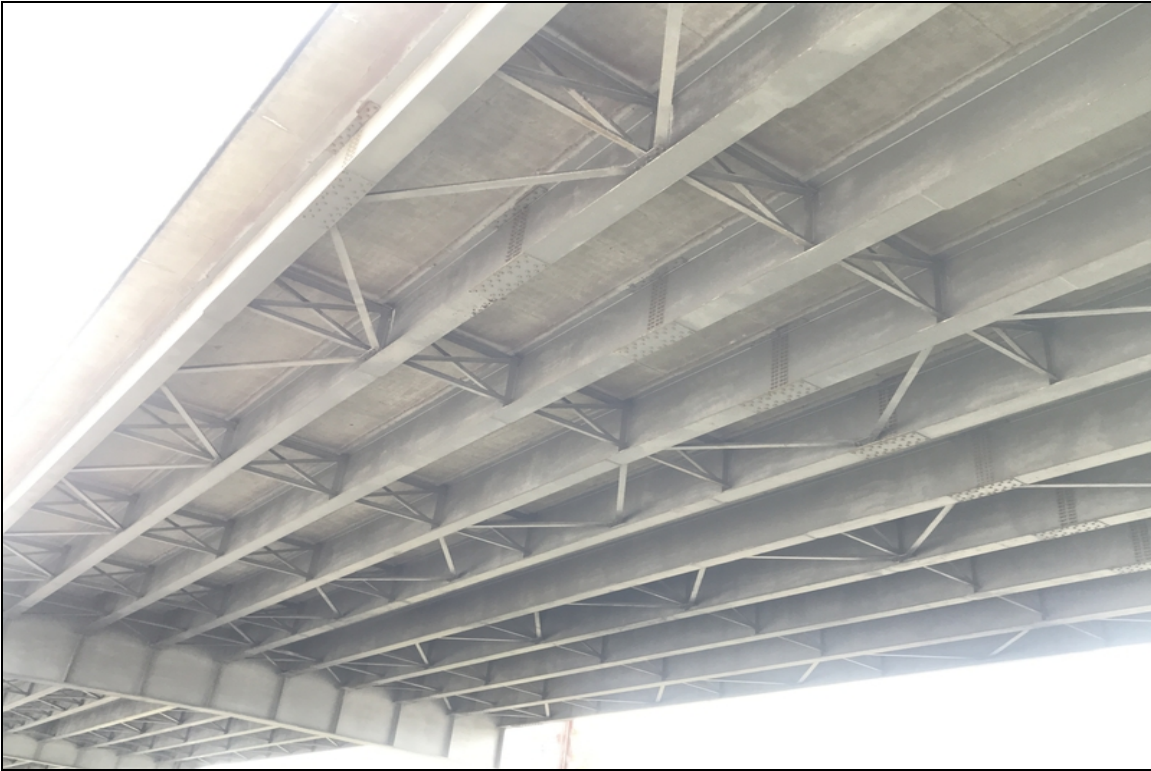
Soffit - Span 13: Typical

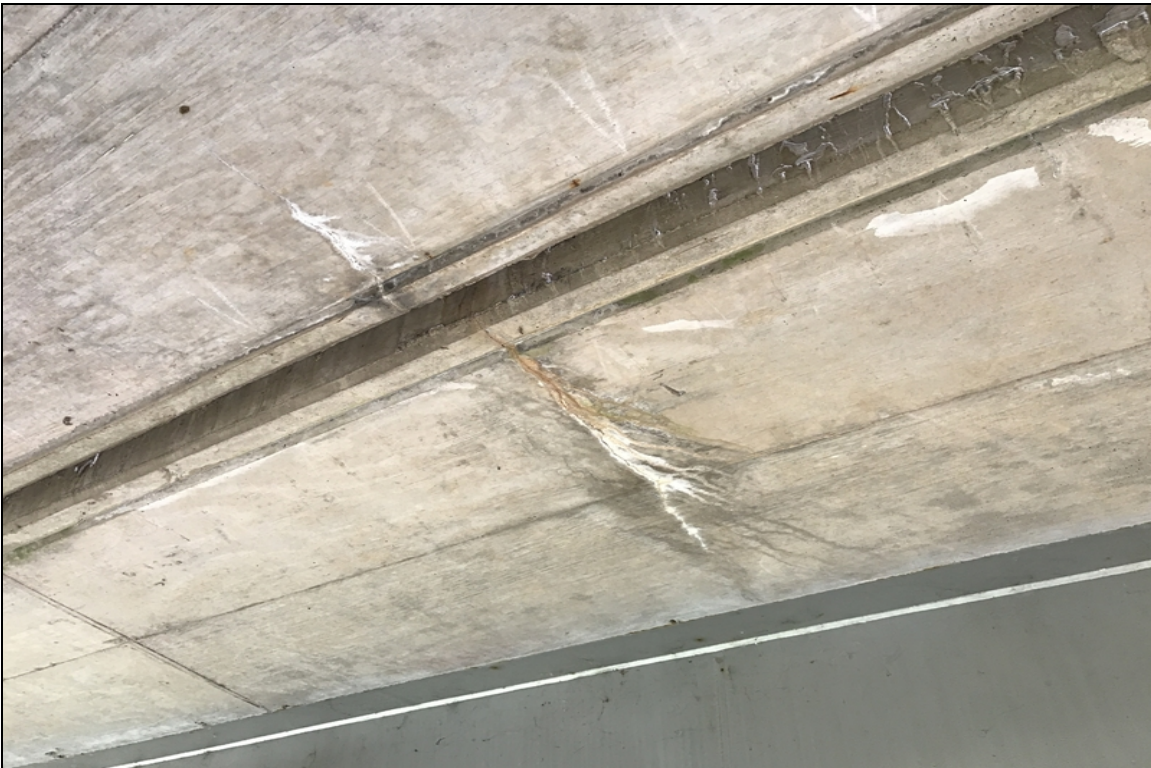
Soffit - Span 22 left: Efflorescence on center overhang

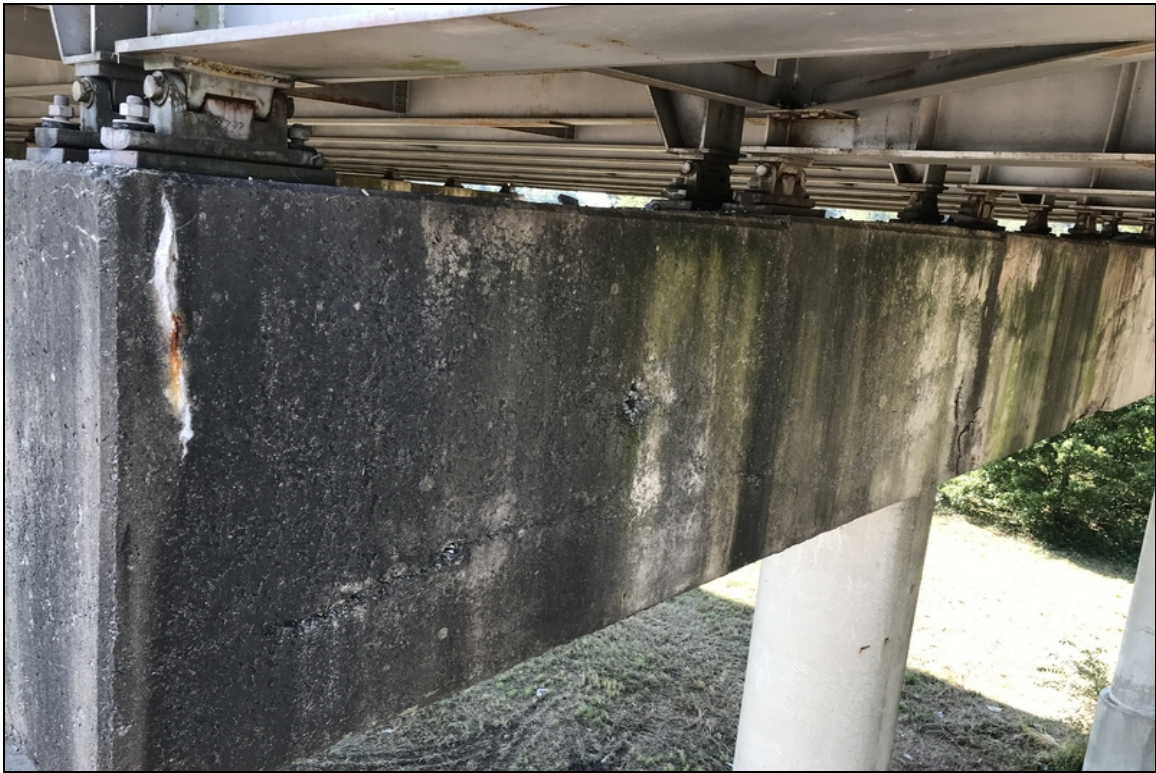
Cap - Bent 16 back left: Efflorescence/rebar exposed

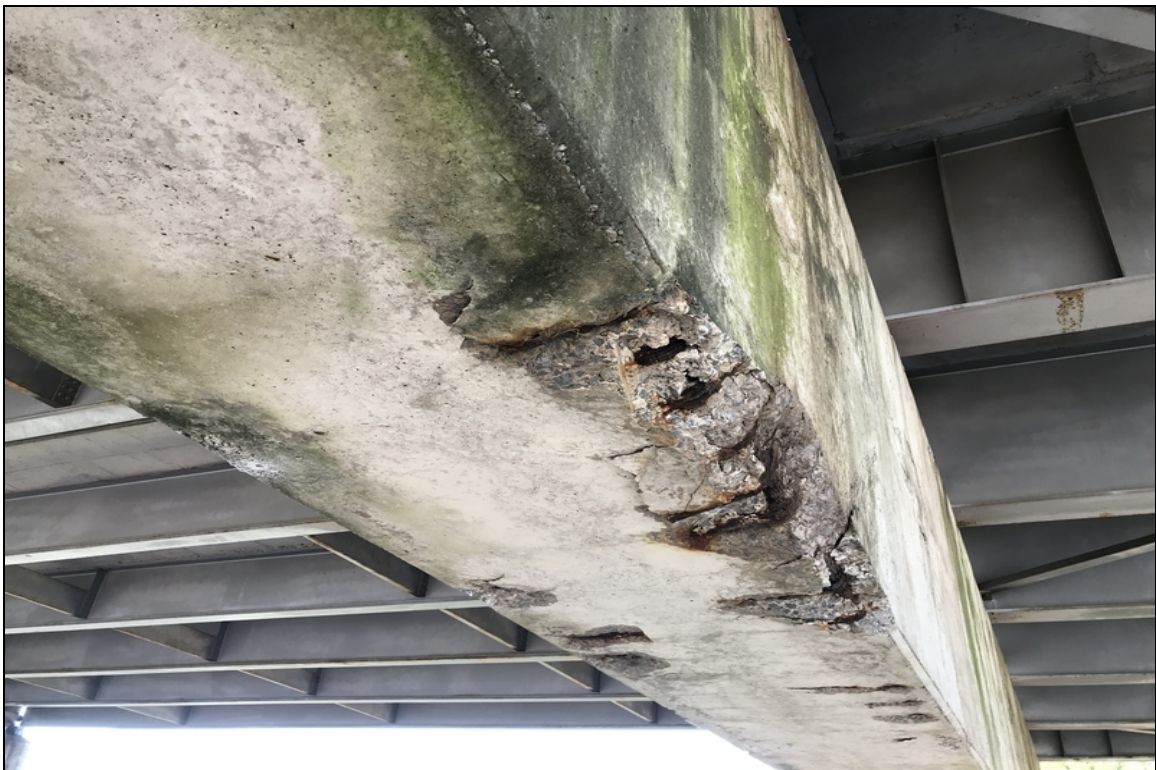
Cap - Bent 16 bottom face: Rebar exposed

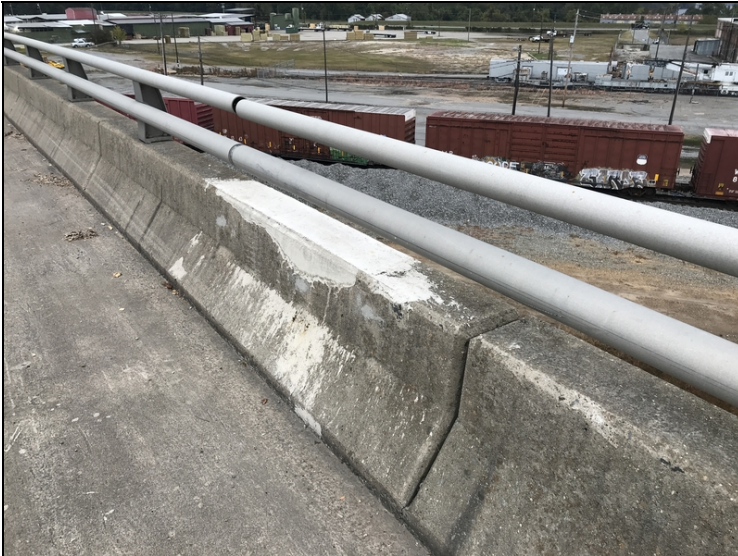
Railing – Span 18 left side: Post missing.
Concrete curb has been repaired, but post for railing is still missing.

Railing – Span 18 left side: Post missing

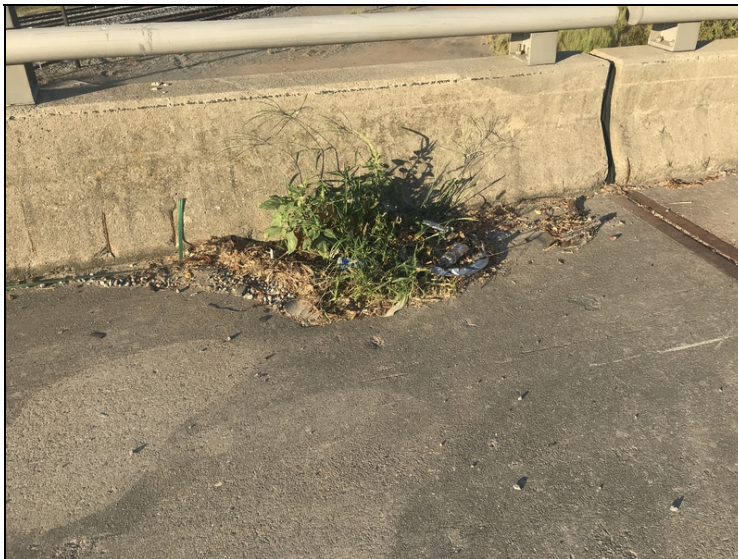
Span 10 south bound lanes drain opening completely stopped up with debris. Common several drains this bridge.

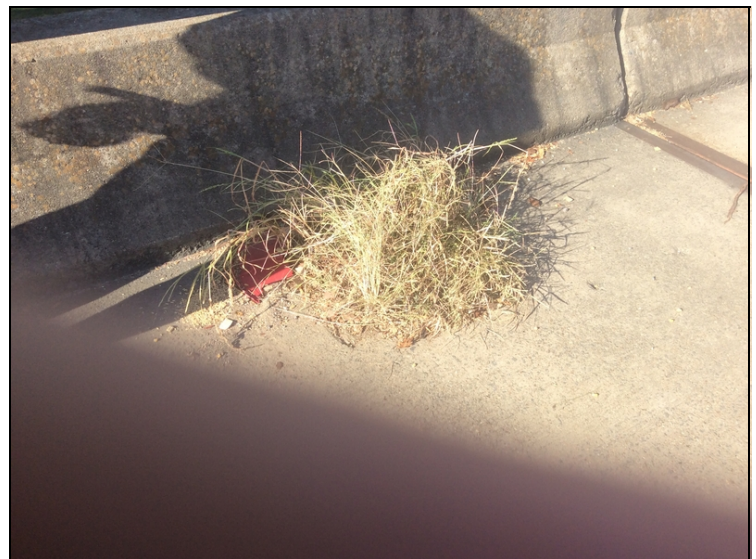
Drain opening near bent 4 right side completely full of debris with no drainage ability.

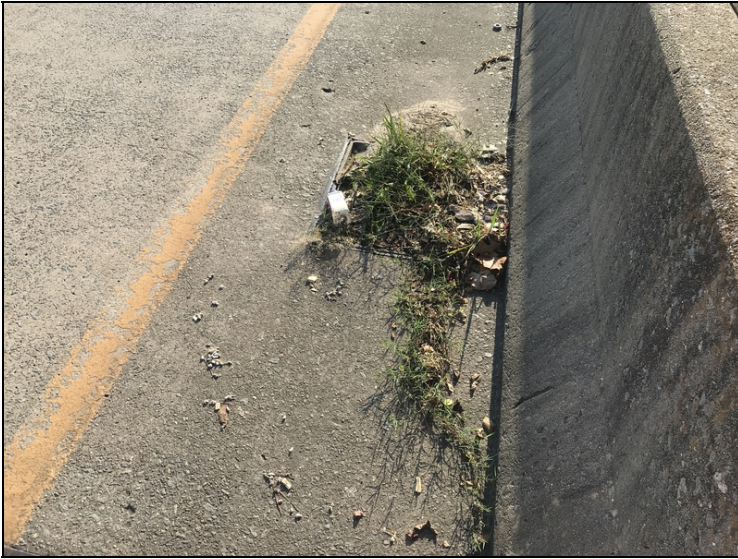
Drain - Span 4 left (inner gutterline): Stopped up

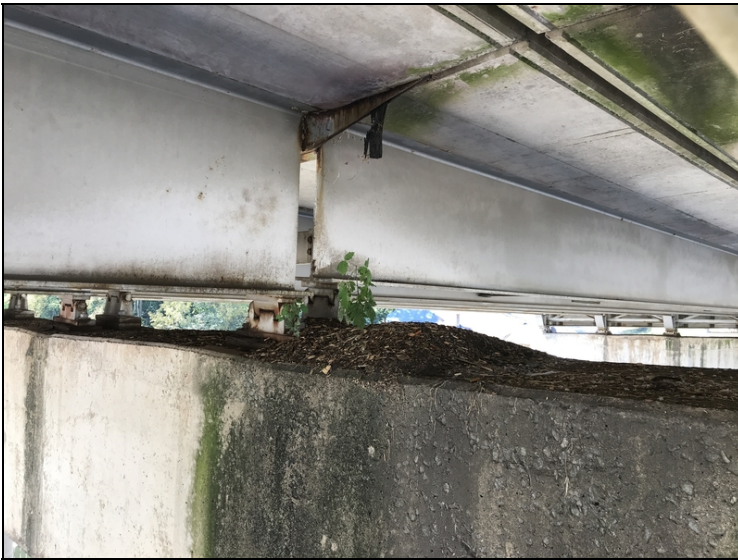
Caps - various bents/locations: Dirt & debris build-up on caps, around bearings, and on end of girders in many locations.

Cap - Bent 7 @ centerline: Debris build-up
