Bridge #05429(Routine)

US 65-14B LM 5.94 over Imbeau Bayou Outlet

Team Lead: Sharon Hooks Inspection Date: September 21, 2020

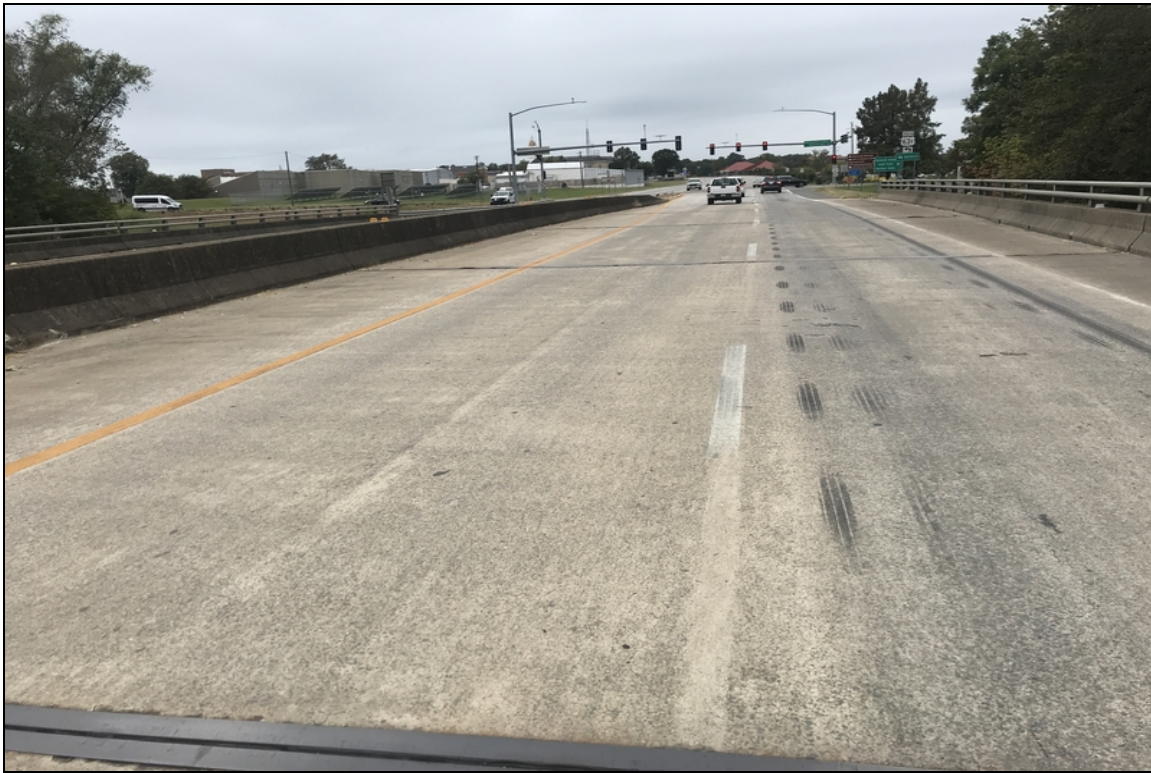
Deck overview spans 1-4 north bound.

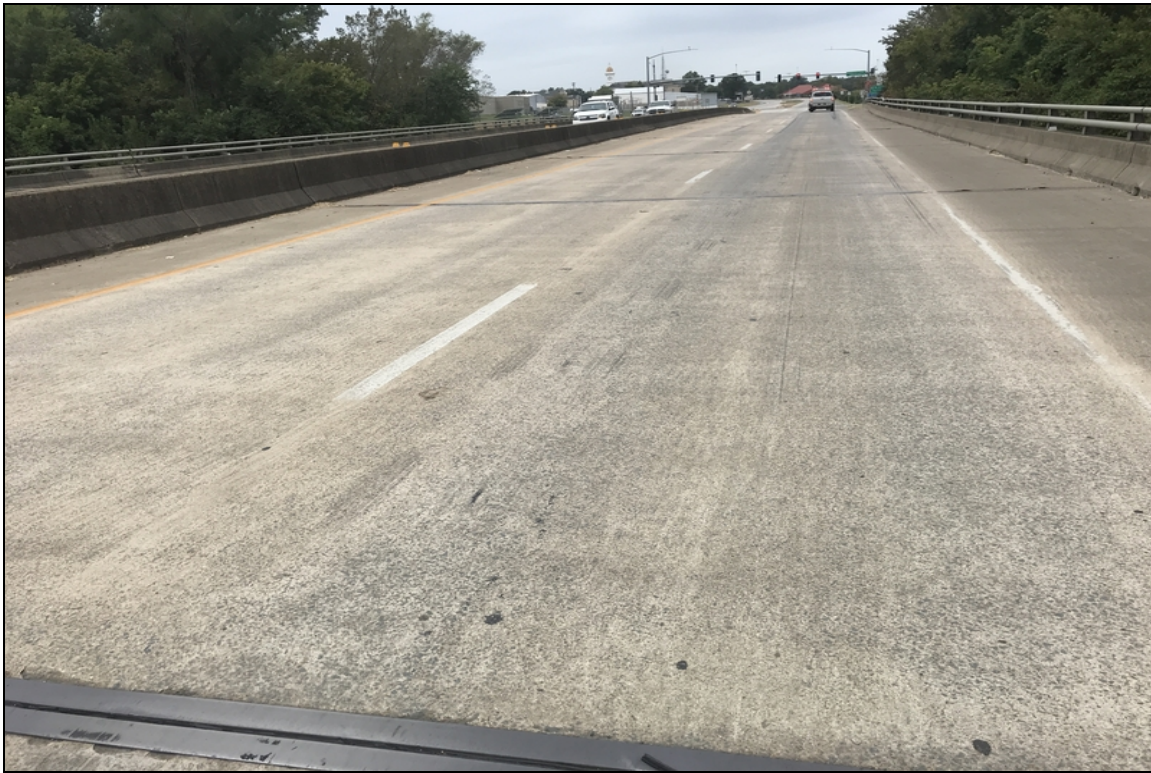
Deck span 5-9 north bound.

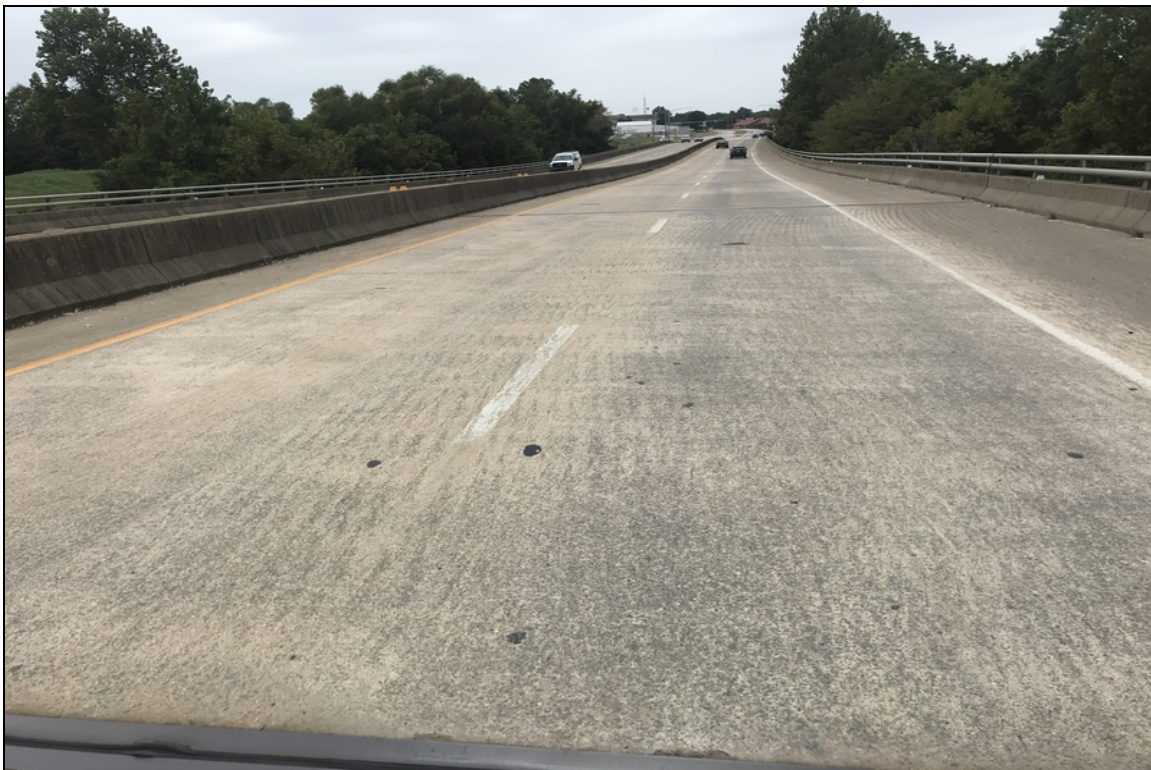
Deck overview span 15-17 north bound.

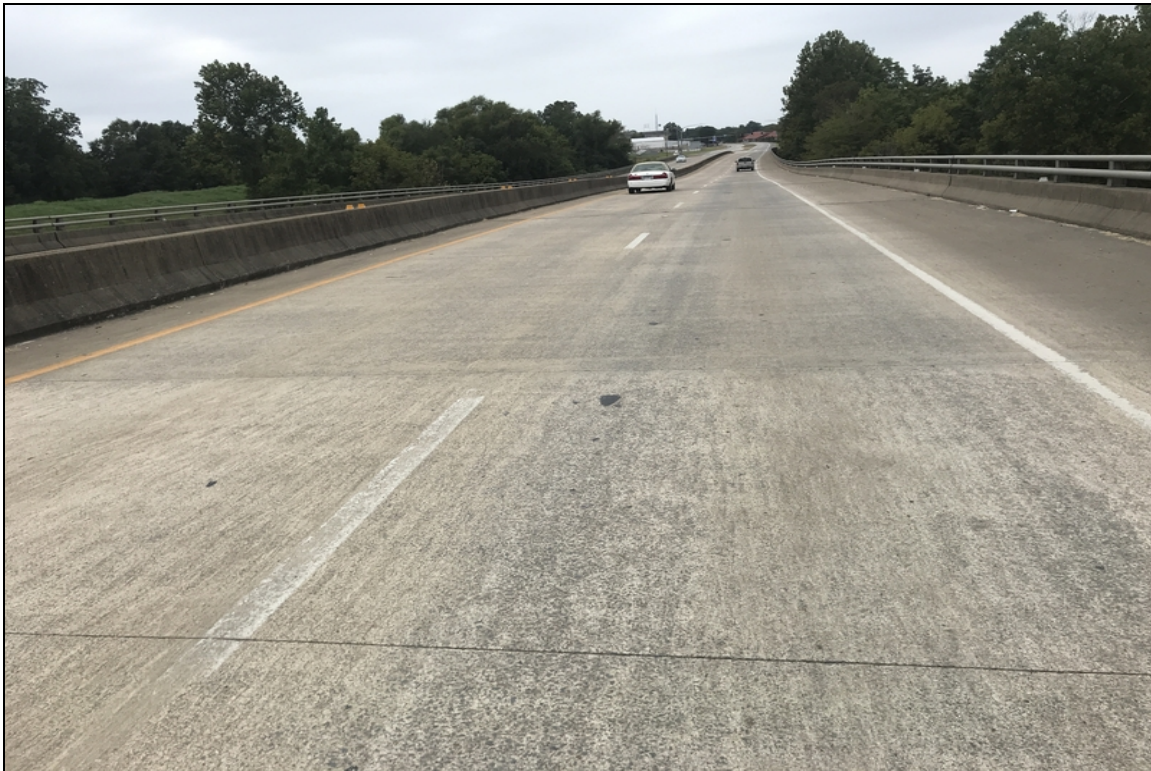
Deck overview span 18 north bound.

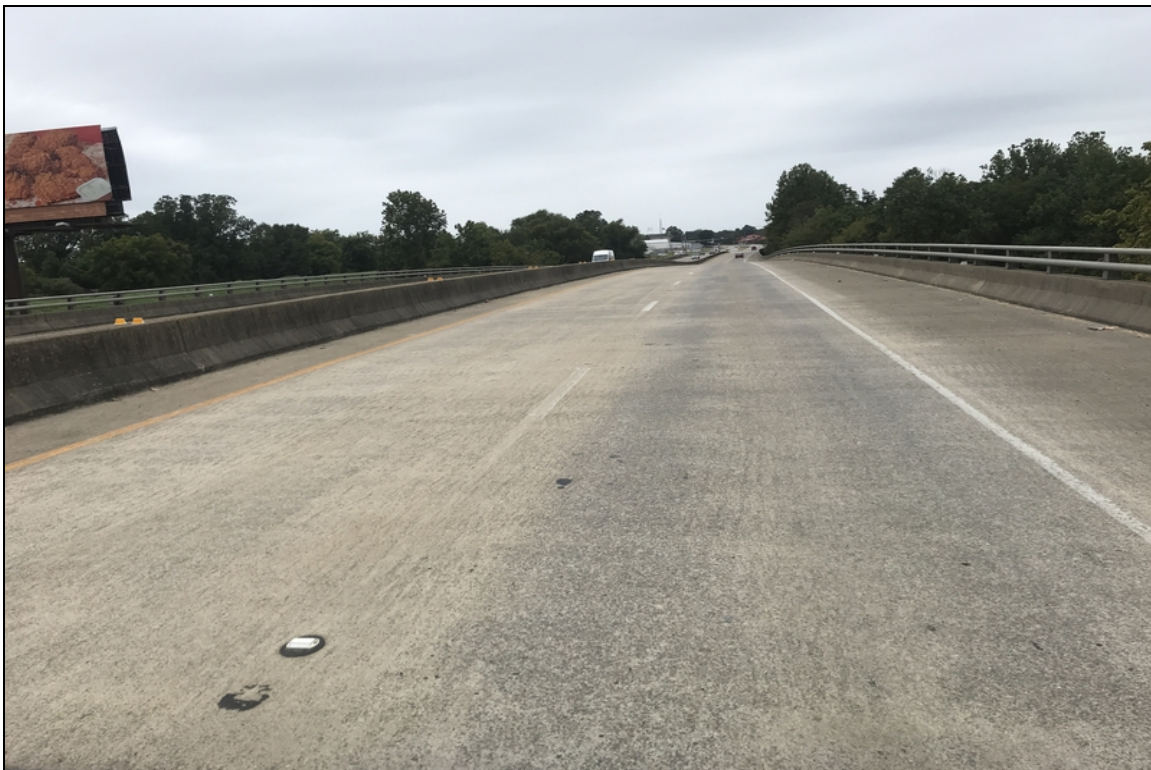
Deck overview span 19-20 north bound.

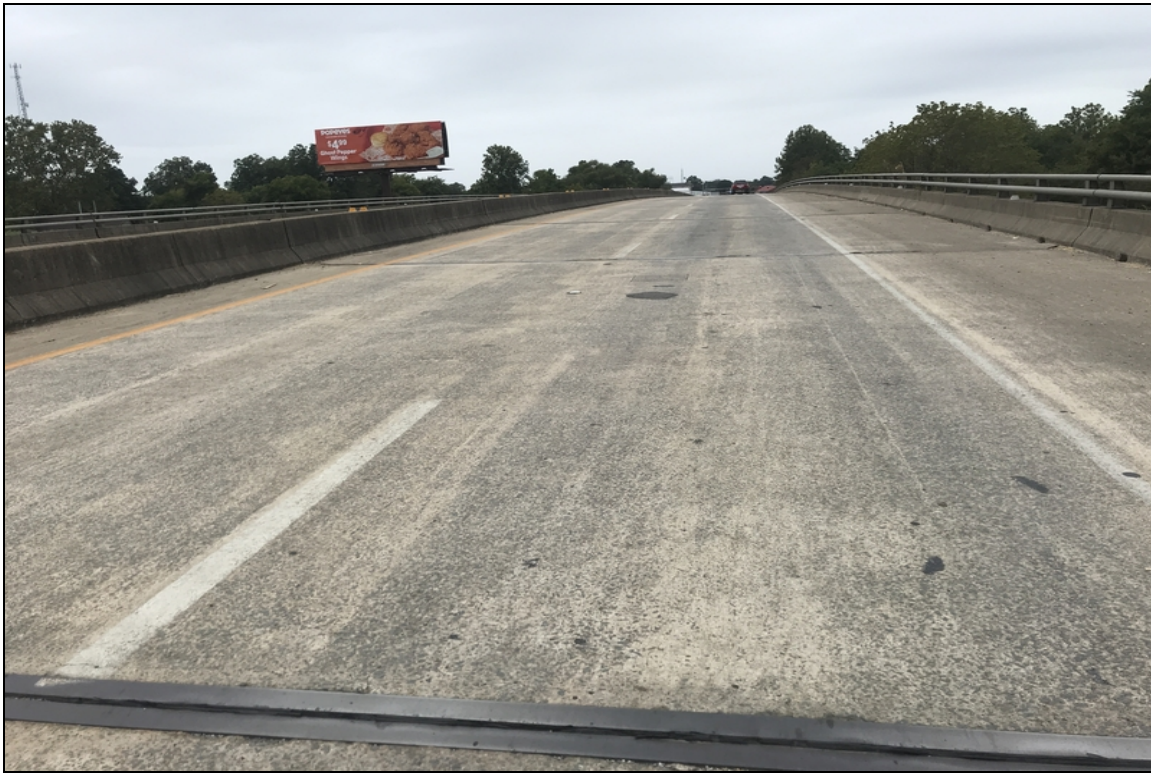
Deck overview span 21-24 north bound.

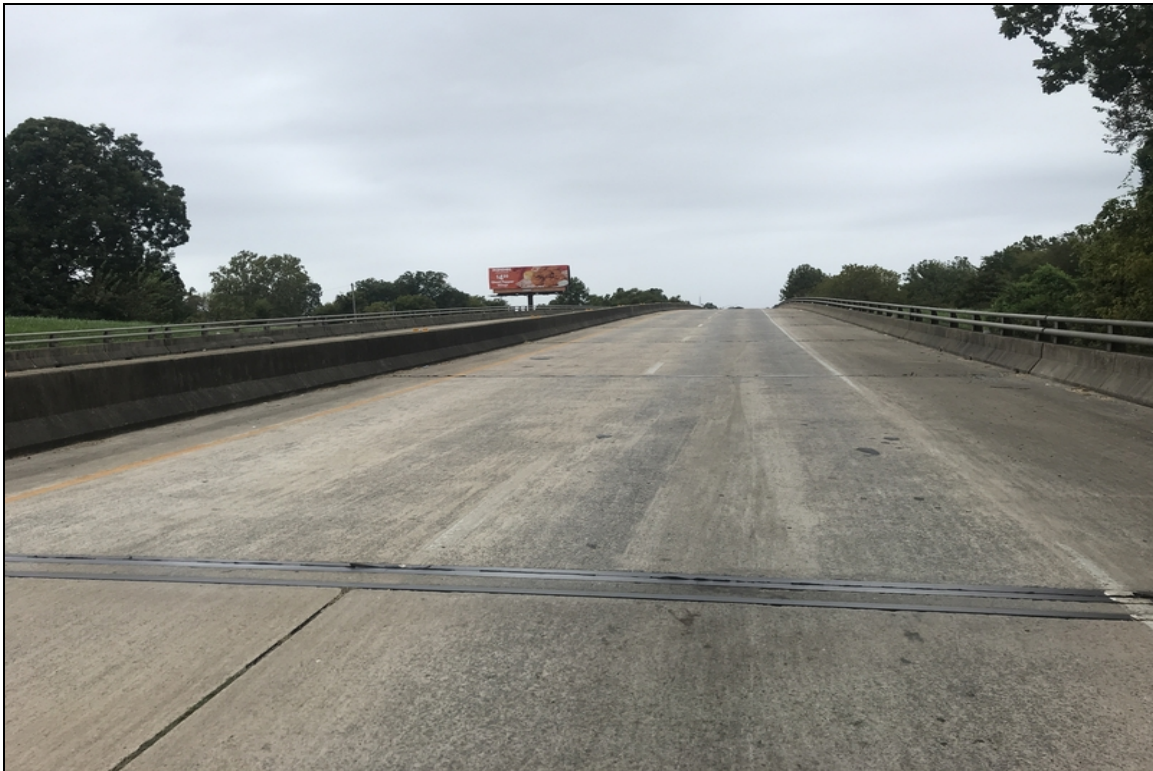
Deck overview 25-29 north bound.

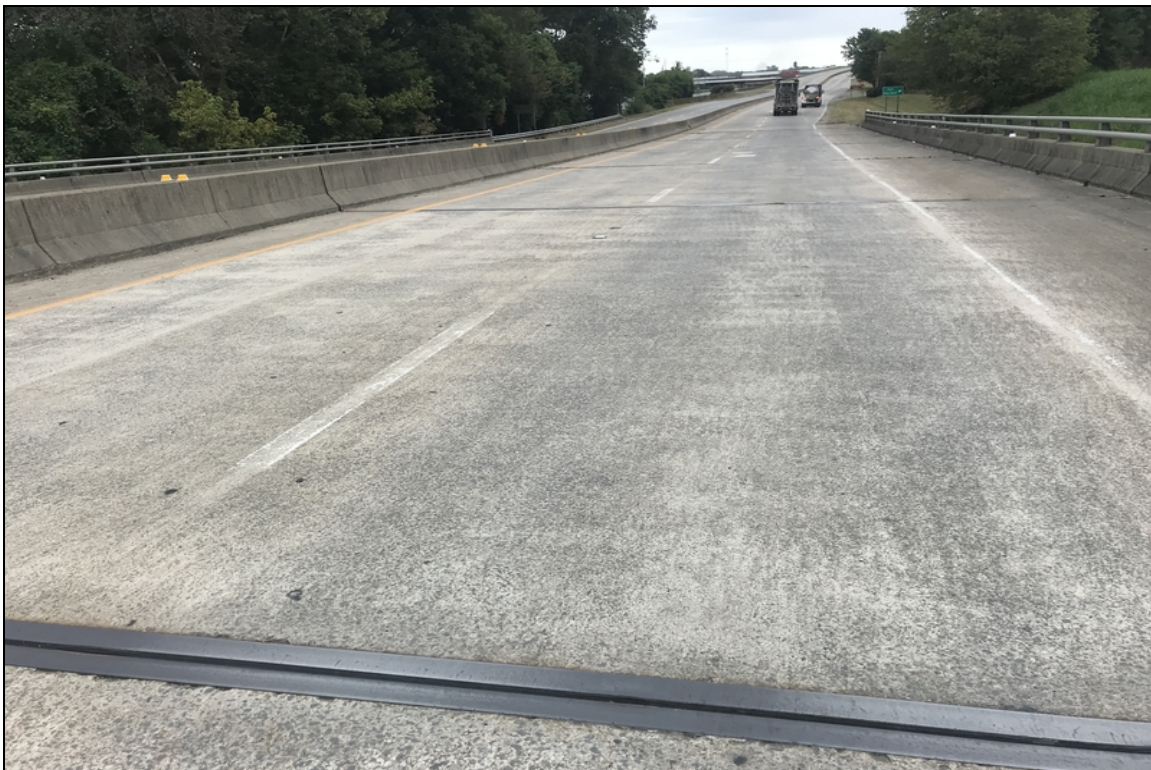
Deck overview of spans 25-29 south bound.

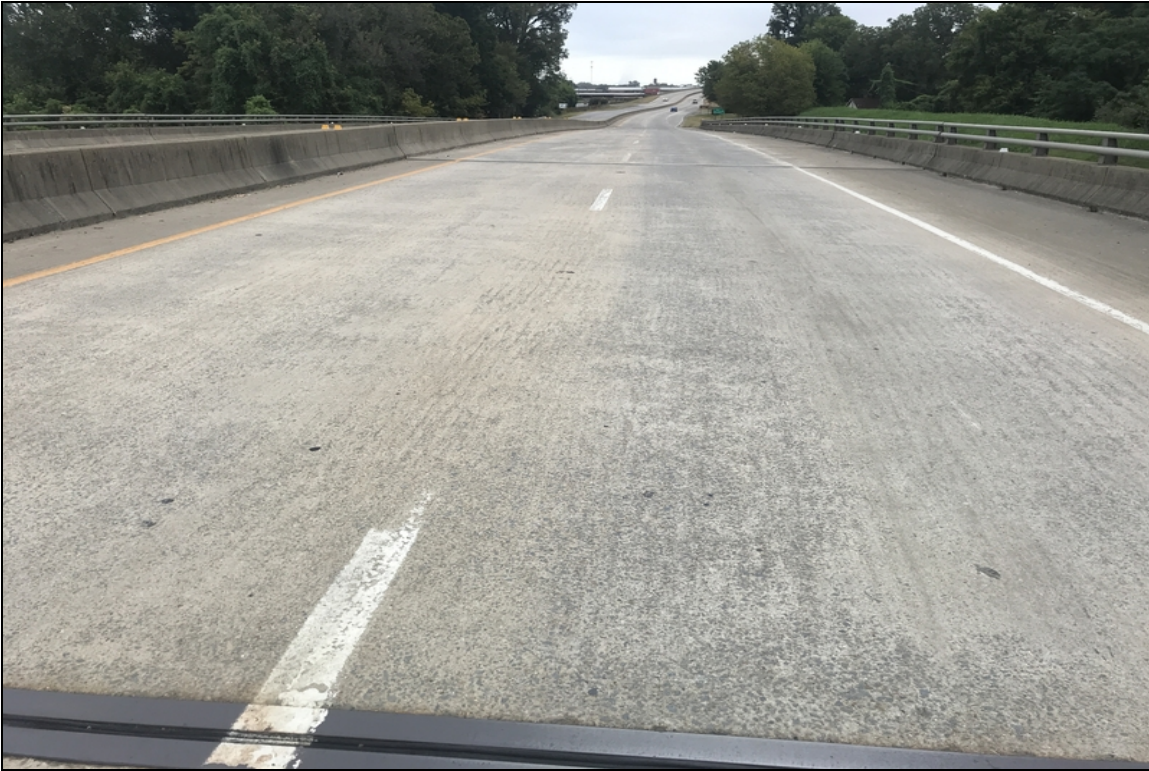
Deck overview span 21-24 south bound.

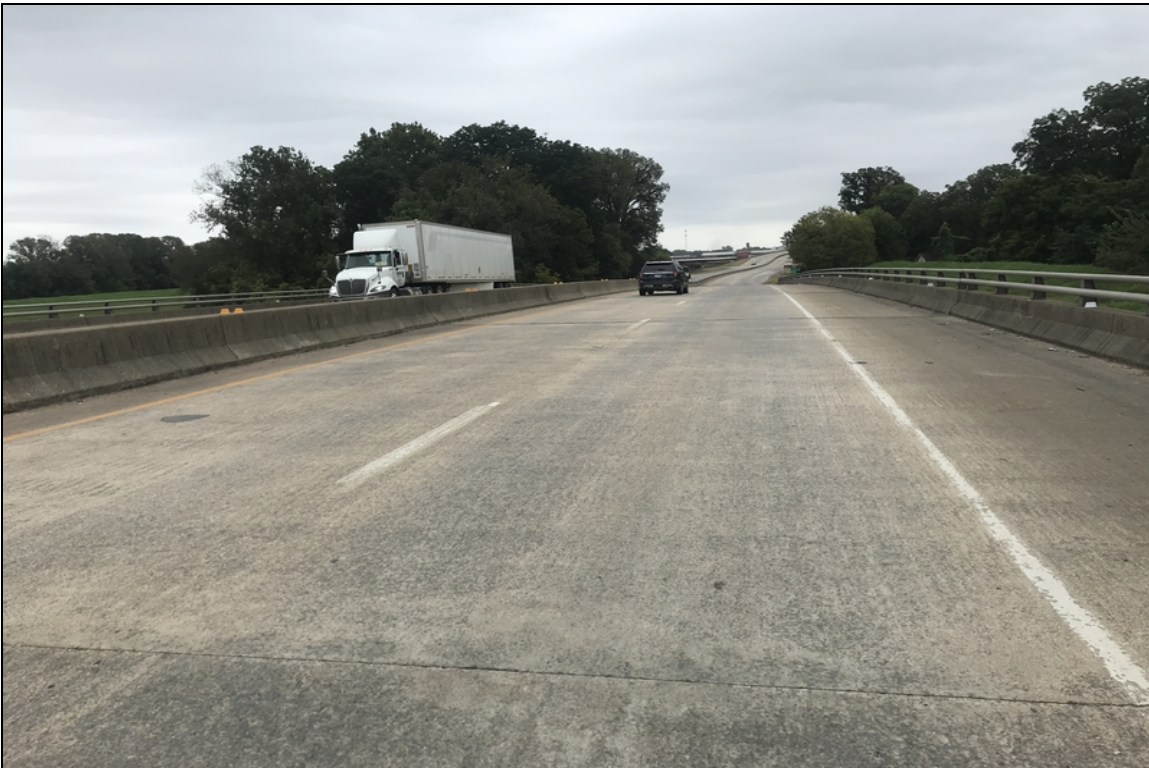
Deck overview span 20 south bound.

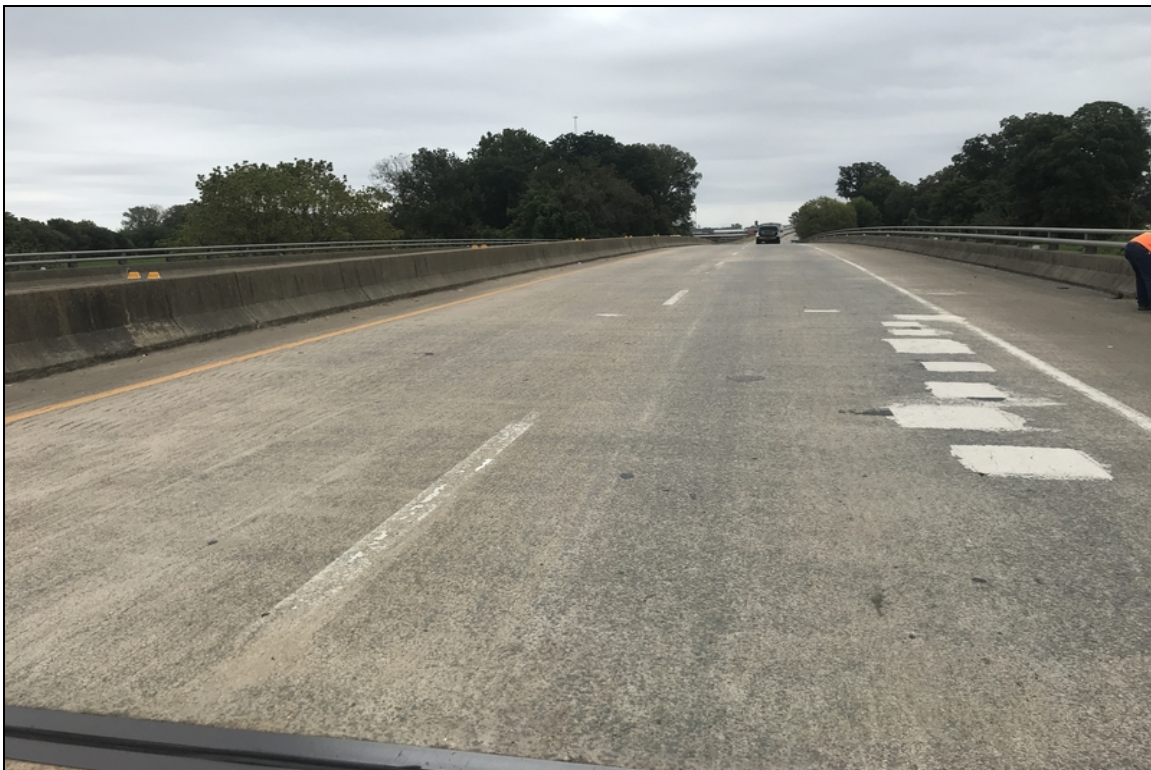
Deck span 18-19 south bound.

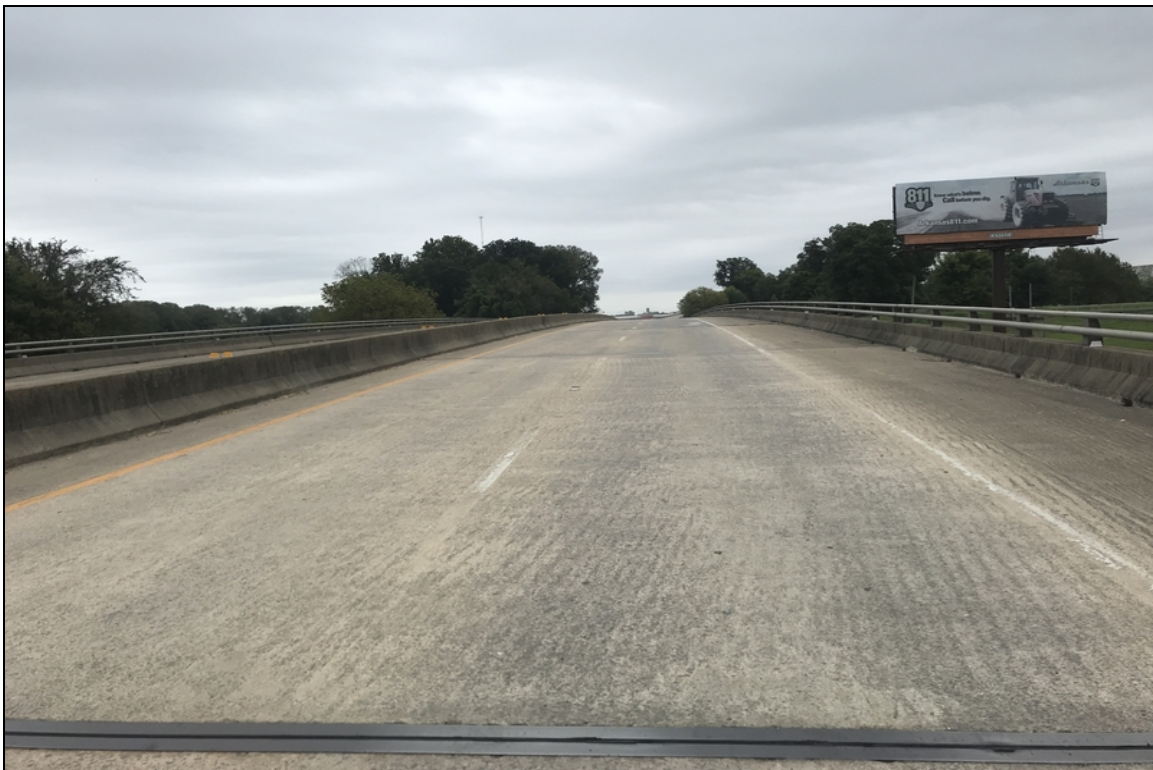
Deck overview span 16-17 south bound.

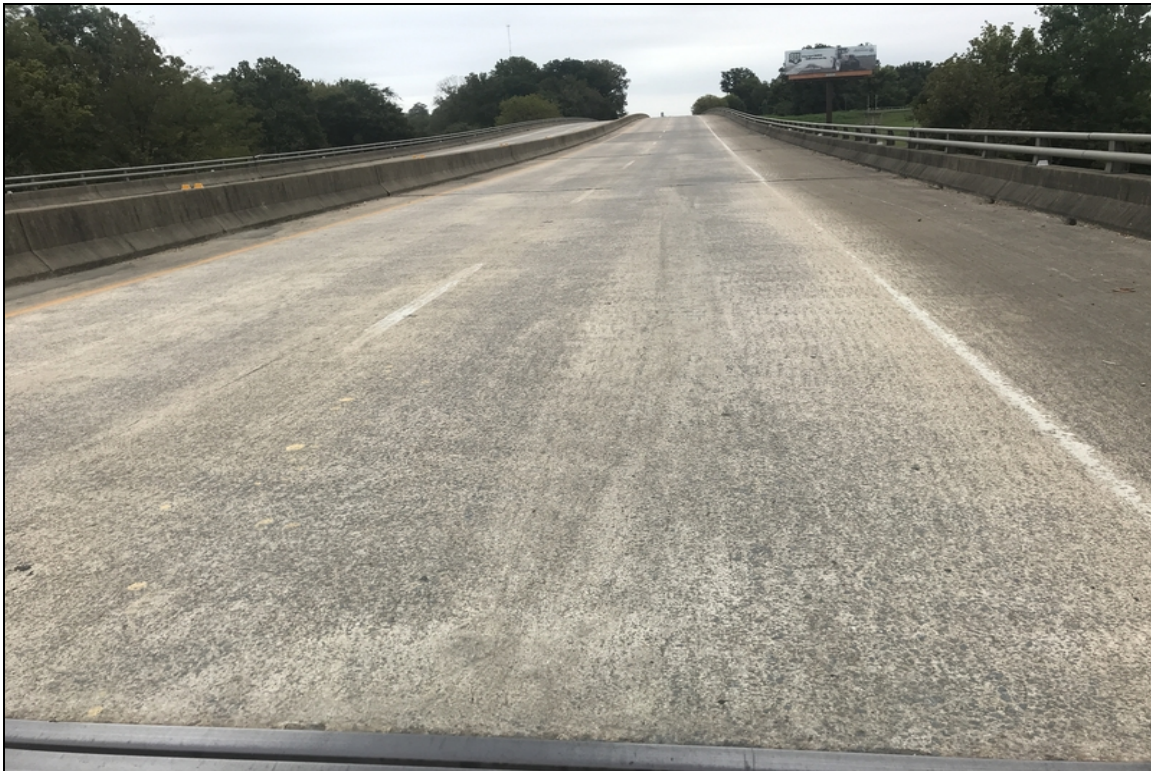
Deck overview span 11-15 south bound.

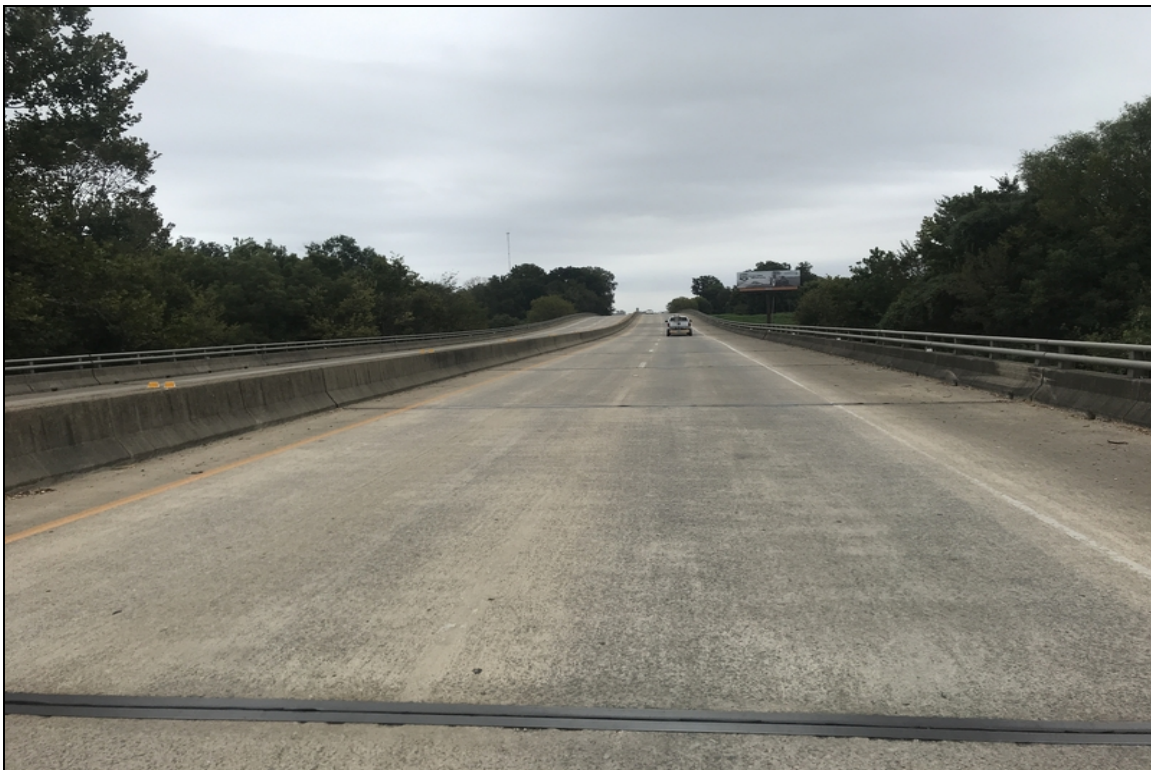
Deck overview span 7-10.south bound.

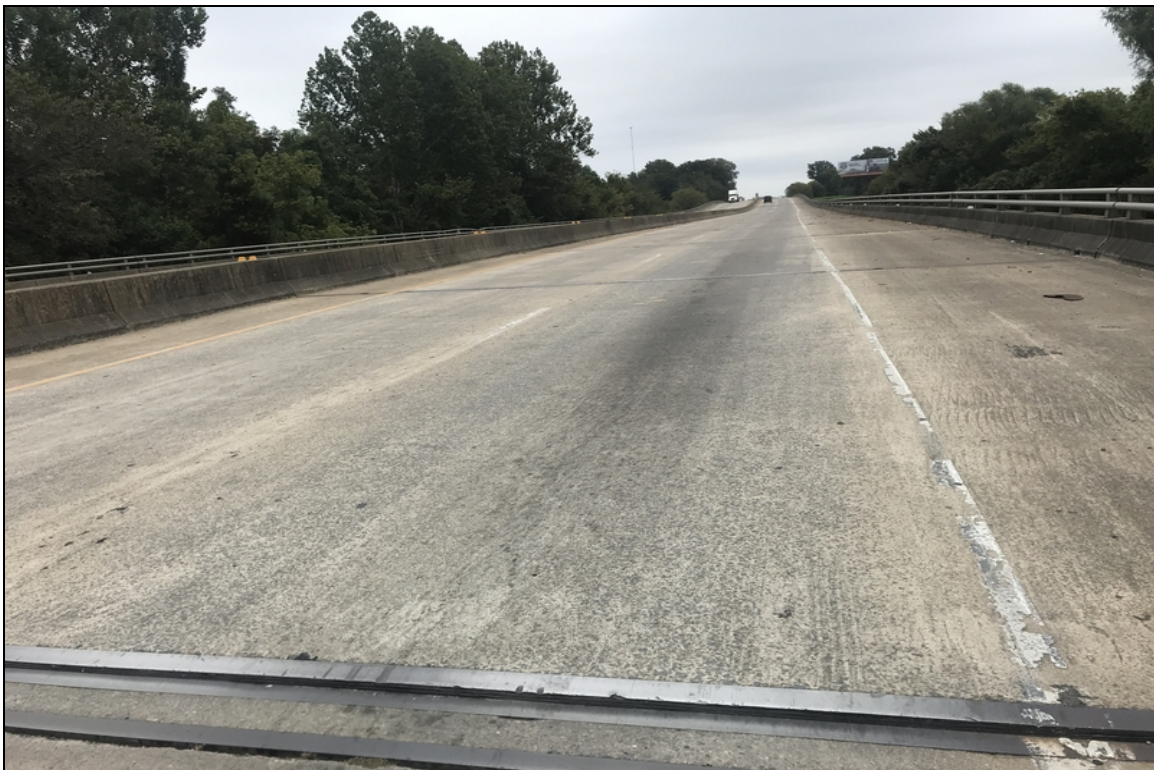
Deck overview spans 1-6 south bound.

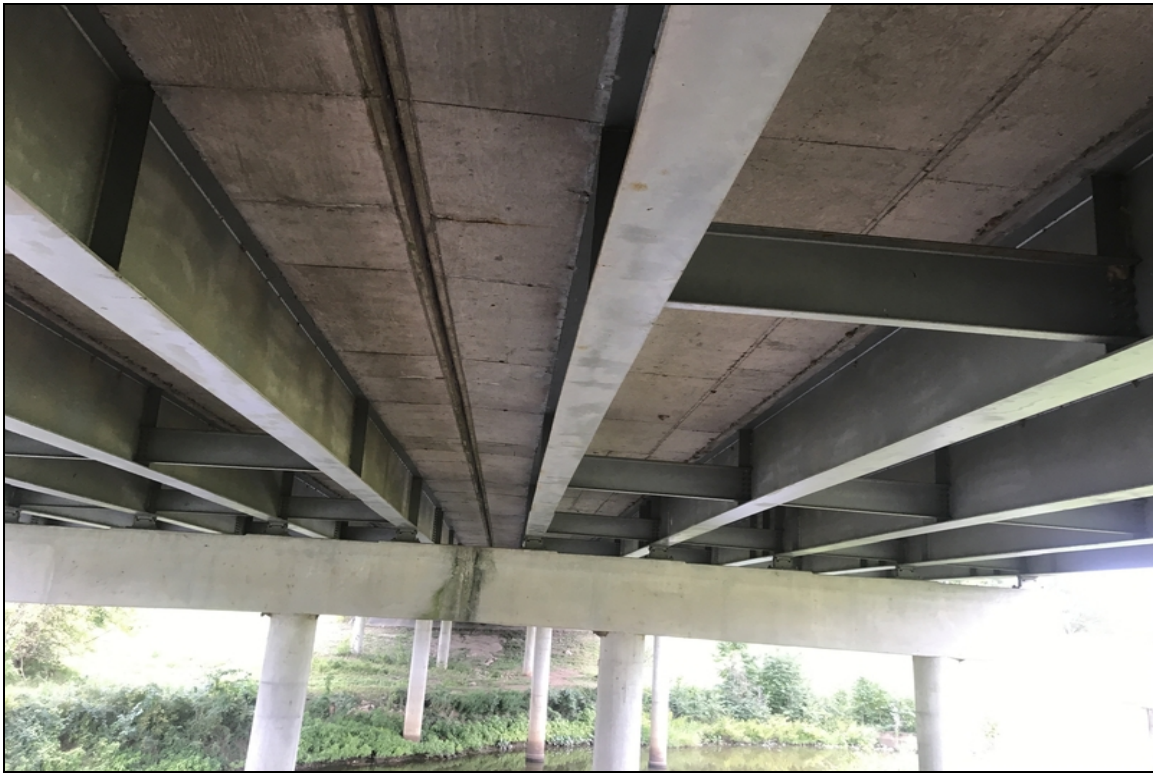
Overview of soffit and girders (Main)

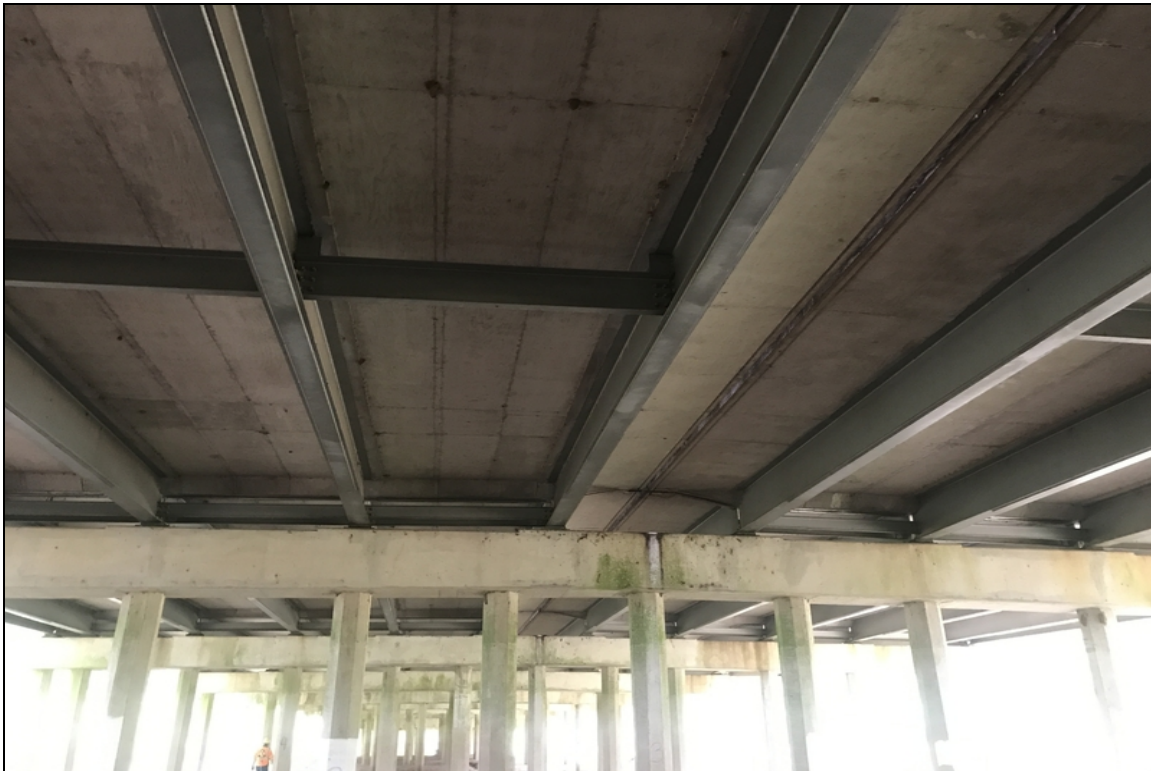
Overview of soffit and girders span 2.

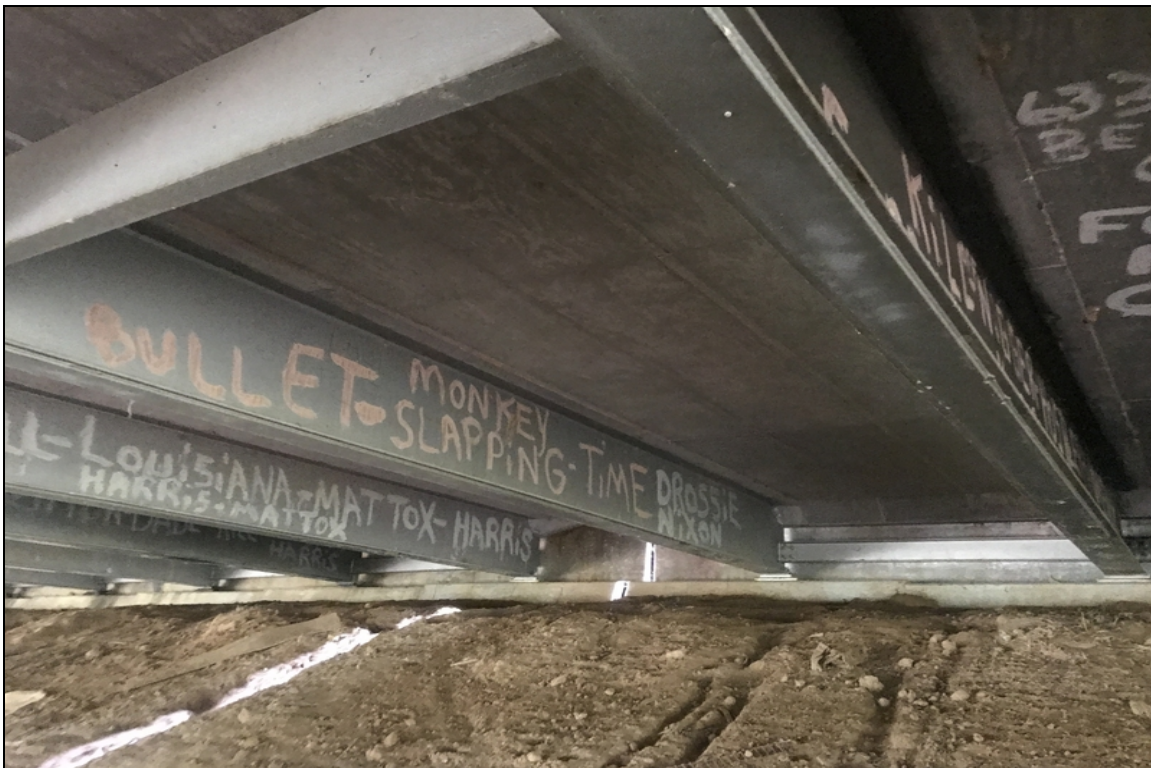
Span 1 graffiti on girders.

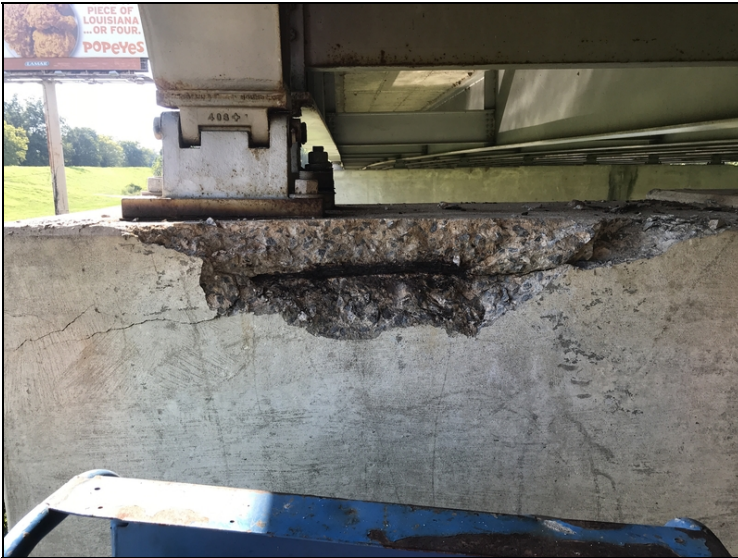
(234)							
Caps: 75' each / Bents 18-21. Bent 19 back face: Diagonal cracks (CS2 cracking - 6'). Bent 21: Spalling with exposed rebar (with some section loss) on back face near Column 2 (CS3 rebar - 4'); spalling with exposed rebar (with some section loss) on top ahead corner near right end under Bearing 10 (CS3 rebar - 6', CS3 cracking - 4').							
302	Compression Joint Seal	LF	2108	0	1233	542	333
2330	Seal Damage	LF	74	0	74	0	0
2360	Adjacent Deck or Header	LF	74	0	74	0	0

Bent 21 - Cap ahead side: Exposed rebar

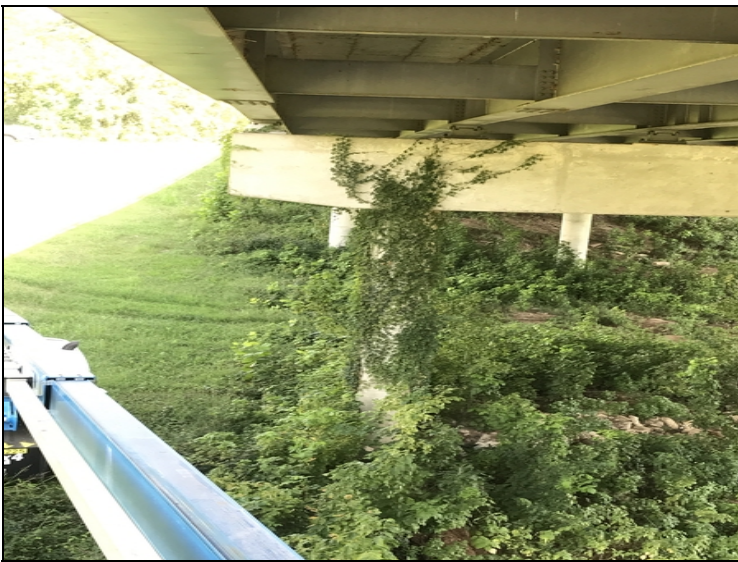
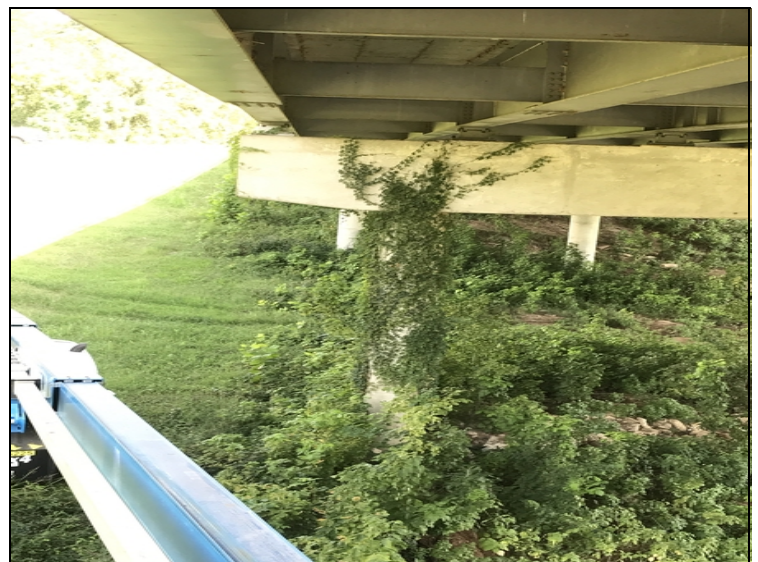
Channel/slope - Bent 20: Vines/vegetation growing up Column 1 - hindering thorough inspection of column.

Bent 20- Vegetation

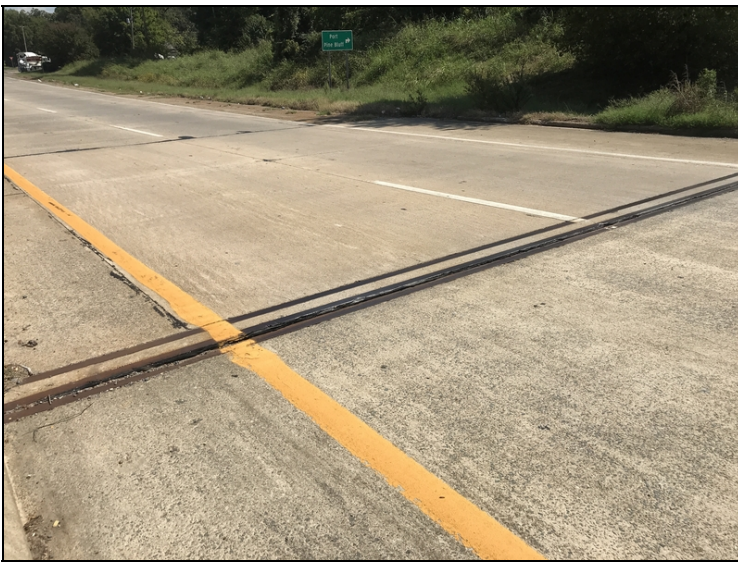
Joint/abutment - Bent 30: Backwall is 1/2-1" higher than adjacent deck, resulting in a slight bump going onto or off of bridge
- largest height difference is in two interior lanes.

Joint - Bent 30 right: Backwall higher than deck

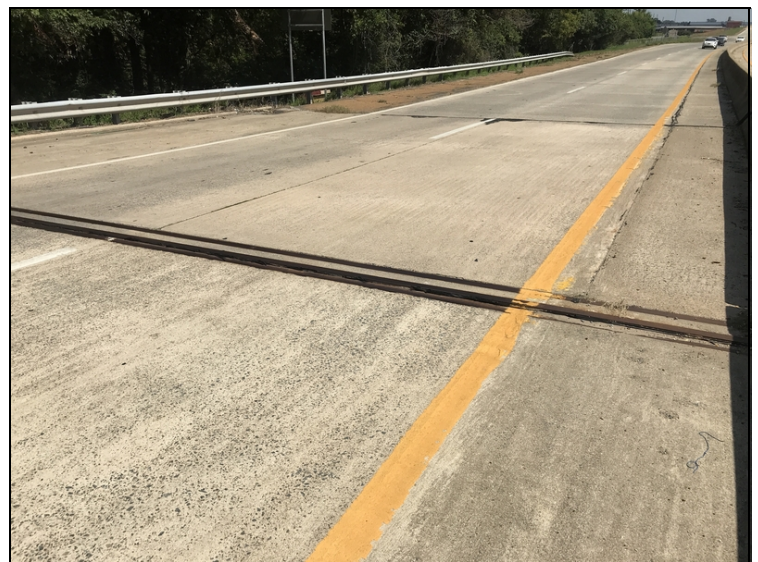
Joint - Bent 30 left: Backwall higher than deck

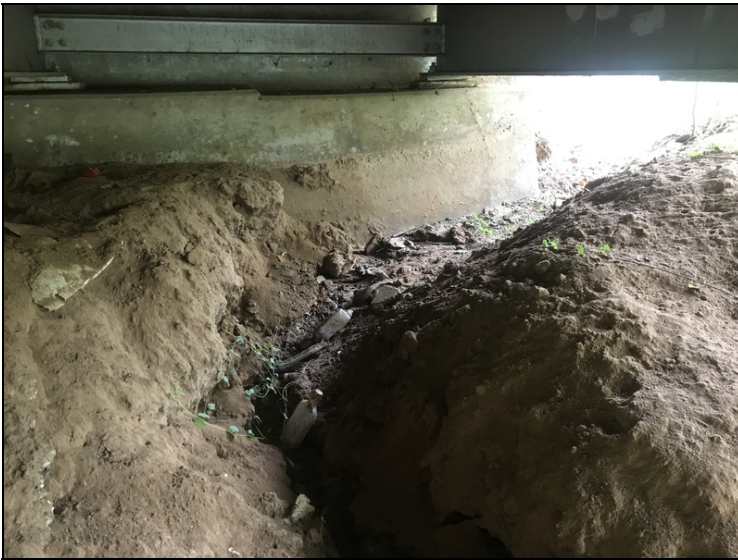
Bent 1 end slope left has some erosion with no undermining of abutment.

Bent 1 left has some erosion to end slope with no undermining of abutment at this time.
