Bridge #02621 (Routine)
State Highway 59 over Huey Creek - Crawford Co

Location: 18.25 N JCT I 40

Team Lead: Jeff Jones Inspection Date: April 30, 2020

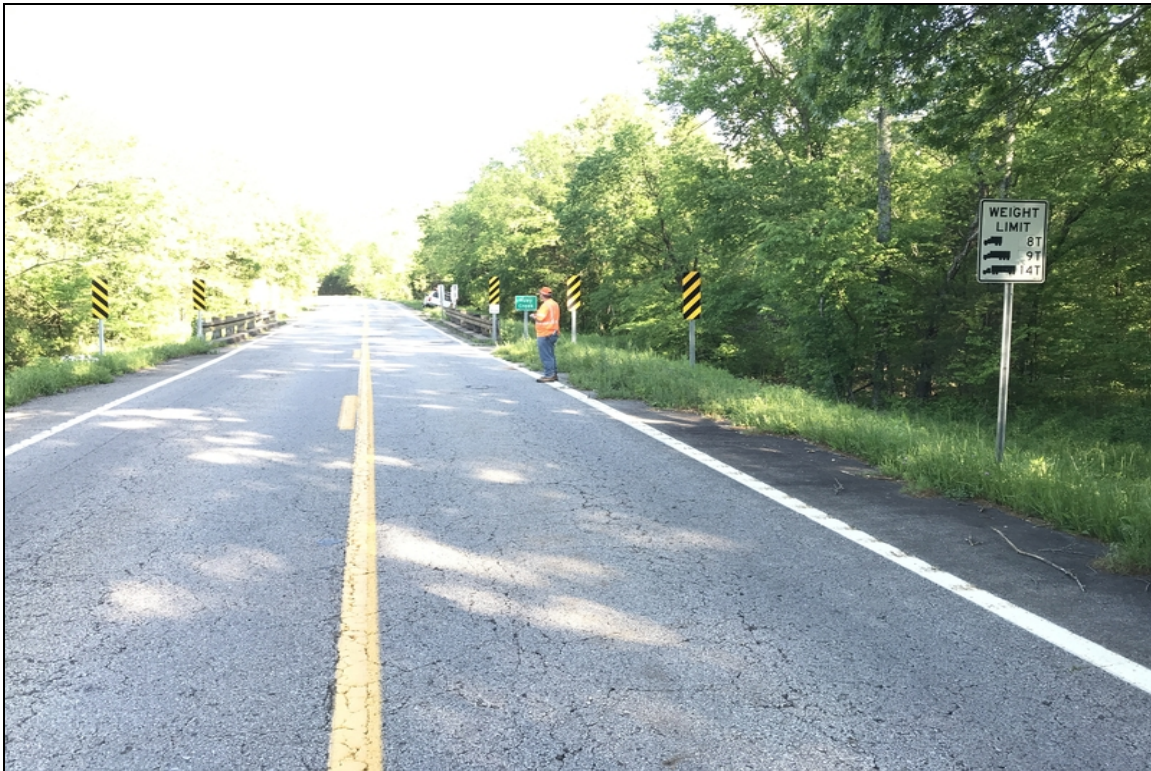
Approach roadway facing North.

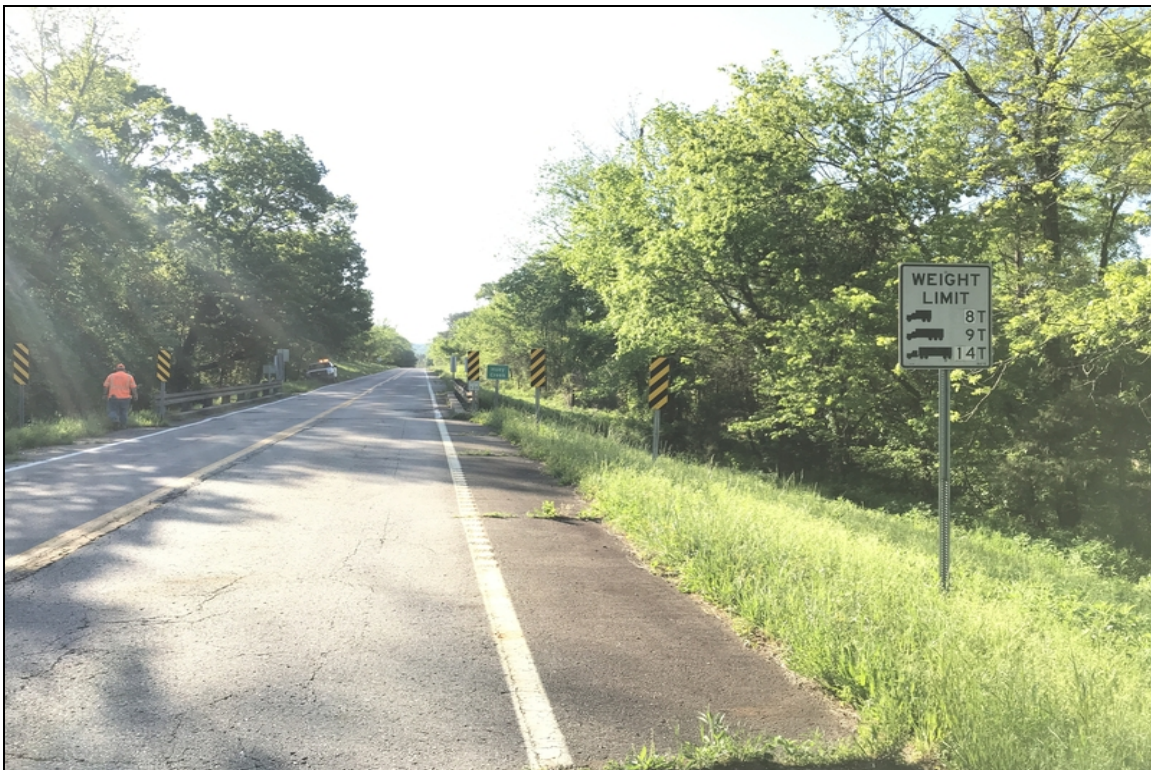
Approach roadway facing South.

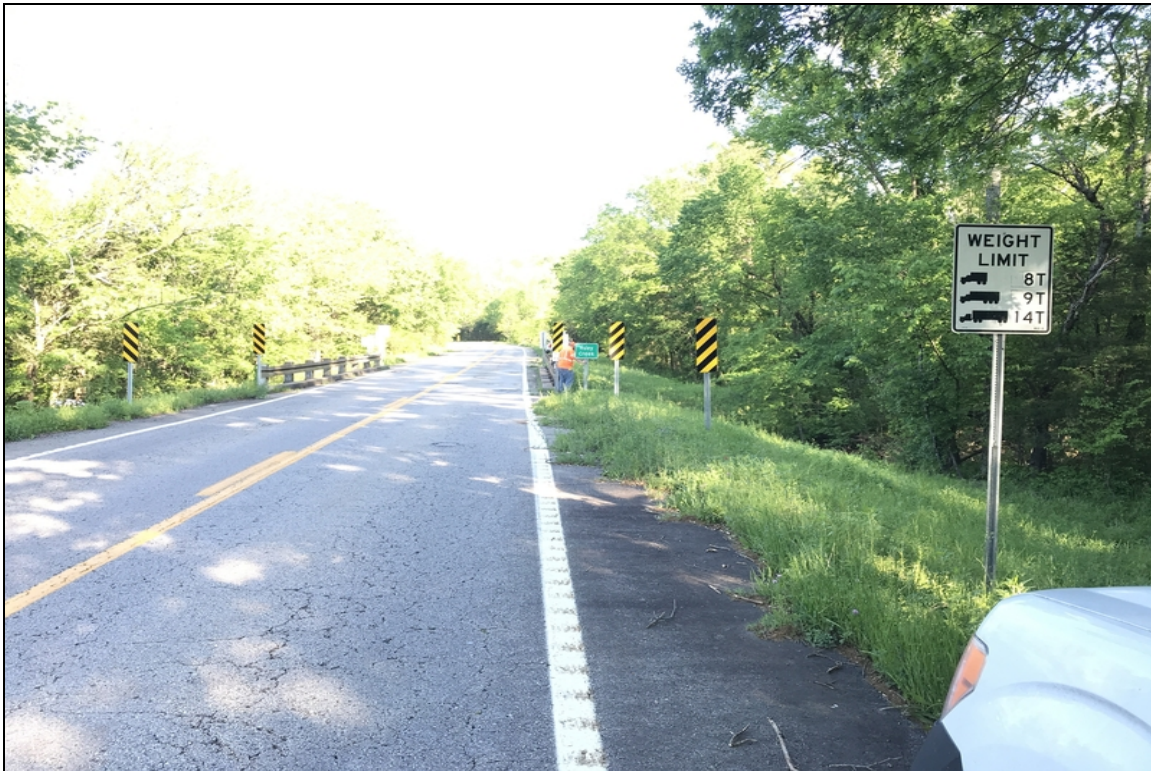
Approach roadway facing North.

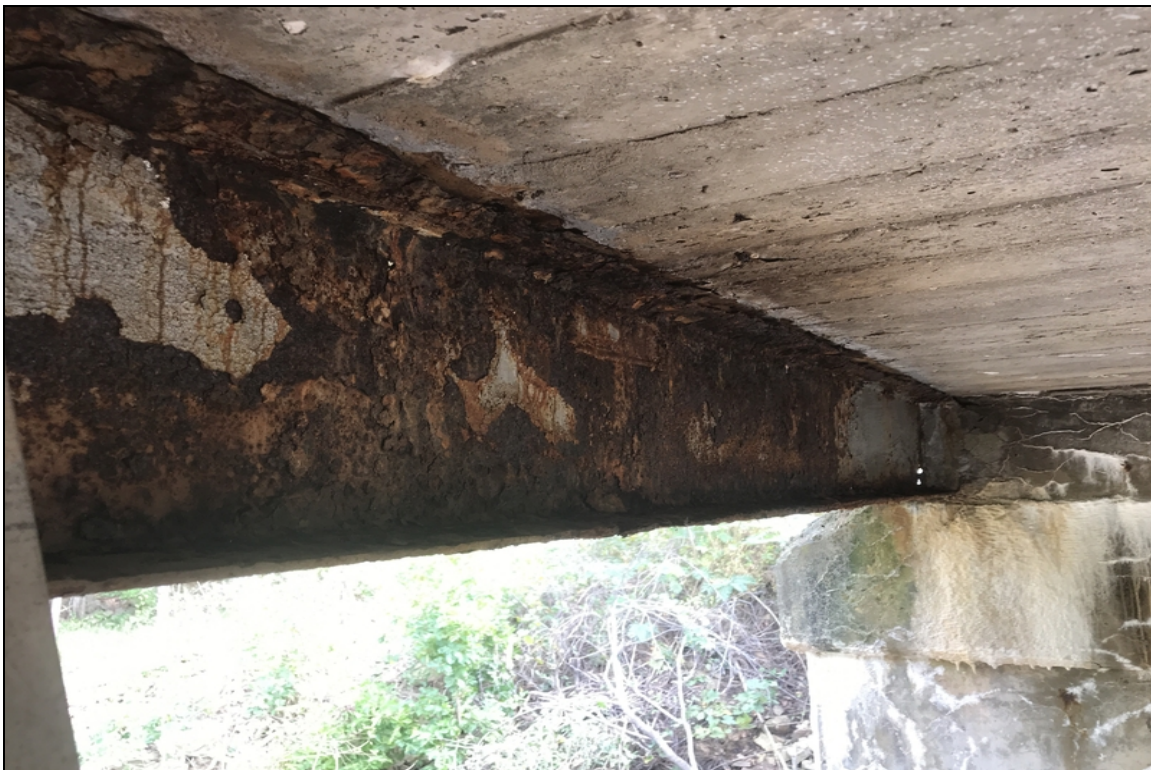
Span 3 Beam 1 Numerous holes in the web.

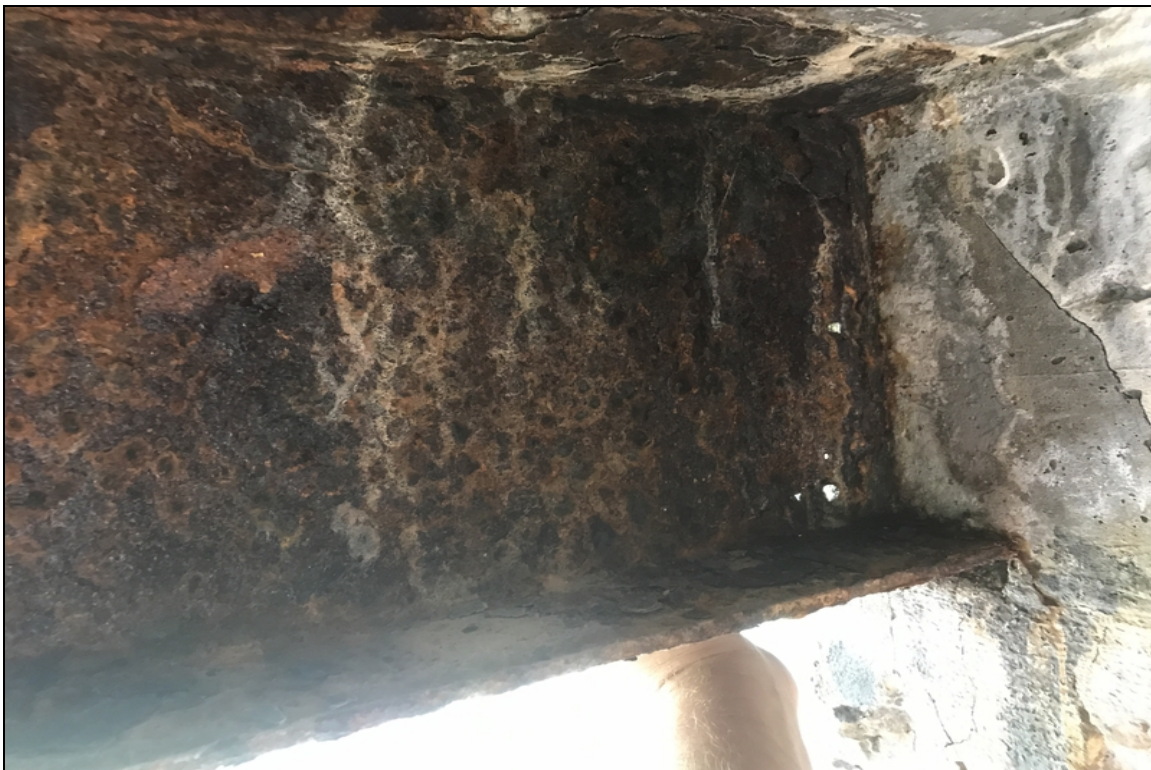
Span 4 Bent 5 Beam 1 holes in the web.

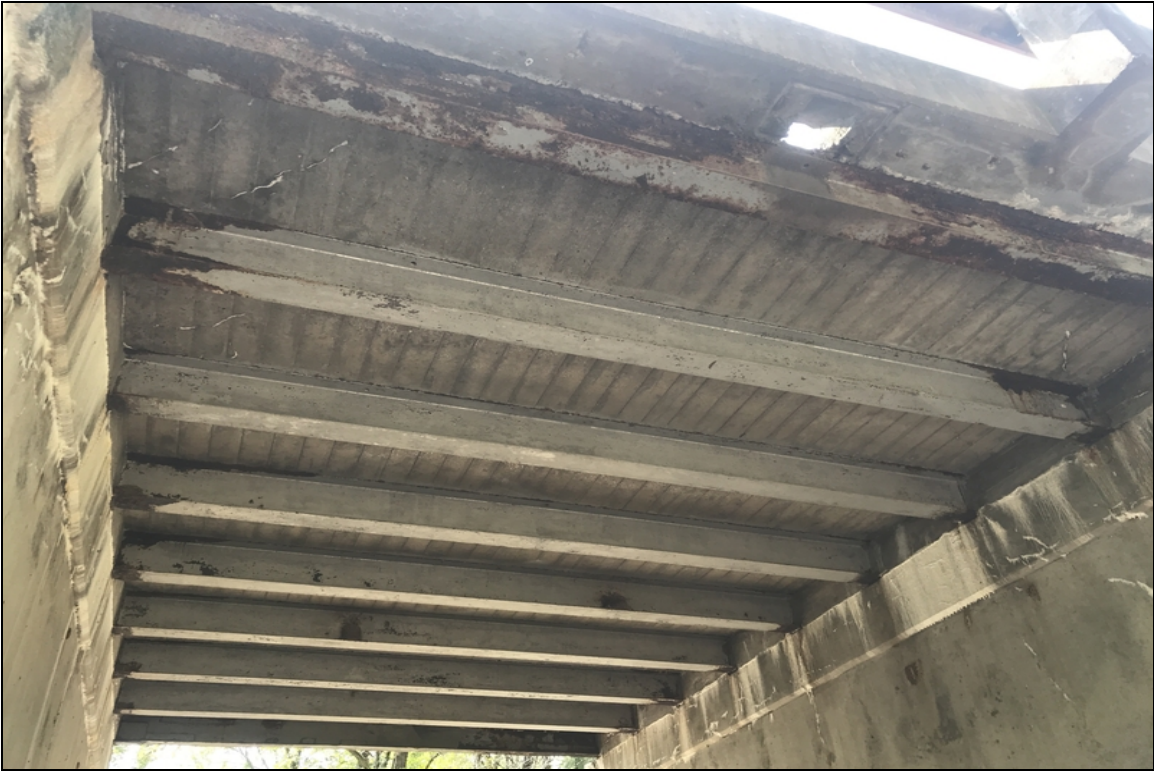
Span 3 typical superstructure.

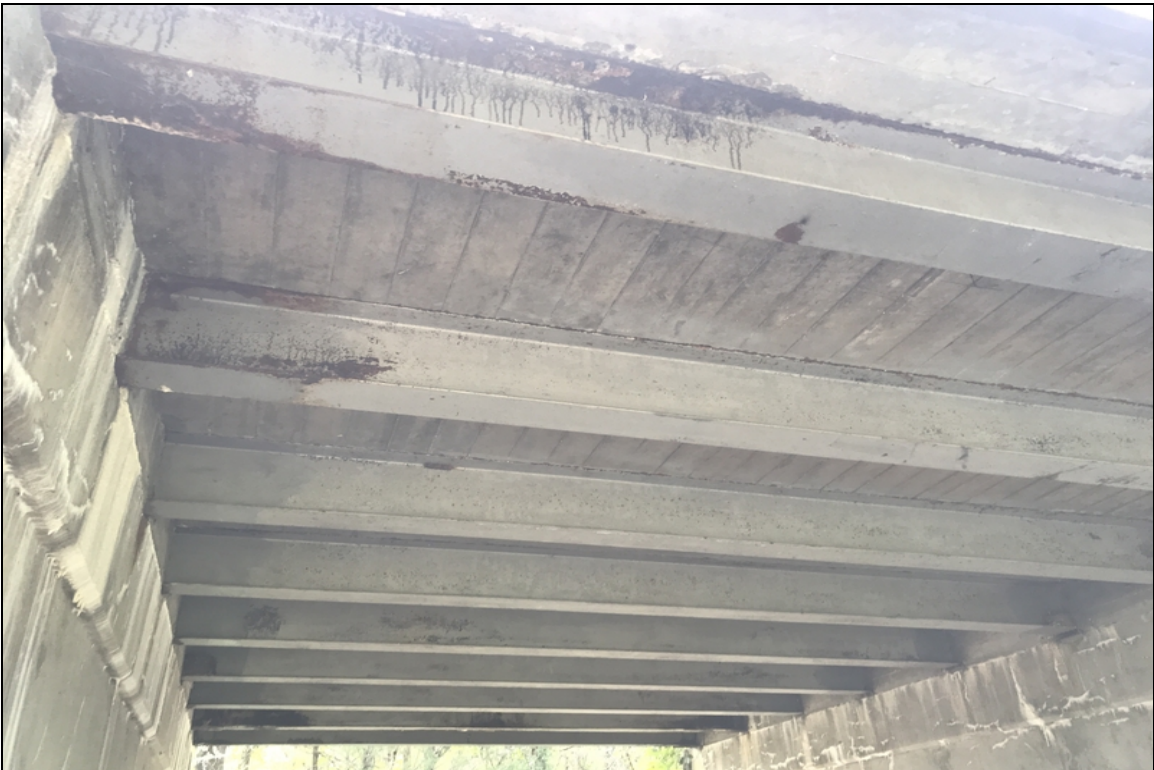
Span 2 typical superstructure.

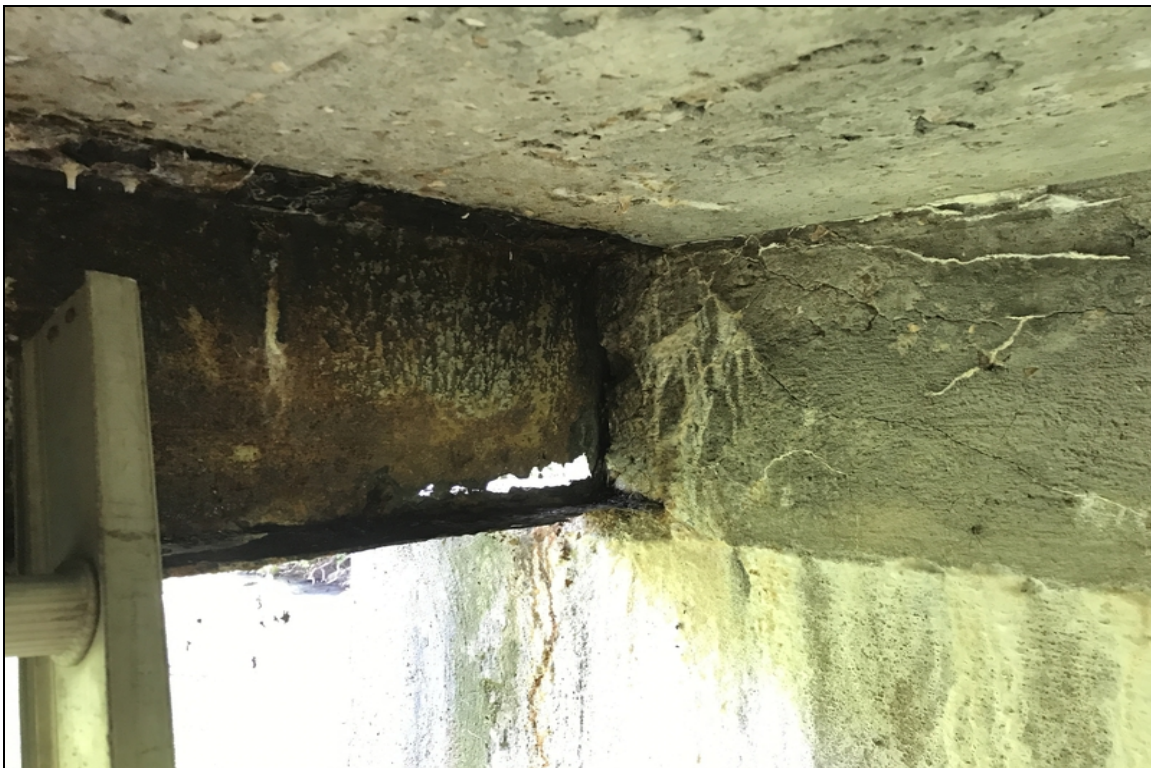
ELEM	DESCRIPTION	UNITS	TOTAL	CS1	CS2	CS3	CS4
	and photographs. Beam 1 Bent 2 face- Large holes in the base of the web with significant section loss to the bottom flange. See field sketch and photos. Beam 2 Bent 2 face- bottom flange has knife edge section loss. Beam 3 Bent 2 face- bottom flange has knife edge section loss and is reduced to 5.25" in width. Beam 4 Bent 2 face- bottom flange has knife edge section loss with a 1" hole rusted through the bottom flange. Beam 5 Bent 2 face- 1/4" hole rusted through the bottom flange. Beam 6 Bent 2 face- bottom flange has knife edge section loss and is reduced to 5.25" in width. Beam 7 Bent 2 face- bottom flange has knife edge section loss and is reduced to 5.25" in width. Beam 8 Bent 2 face- bottom flange has knife edge section loss and is reduced to 5.25" in width. Beam 8 at mid-span bottom flange reduced to 1/8" thick, web has 3/16" section loss. Beam 9 Bent 2 face- web is paper thin with multiple holes and perforations in a 1' area. Beam 9 Top and Bottom flanges are paper thin and reduced in width to 5".

Span # 1, Beam # 1 at the Bent # 2 juncture.

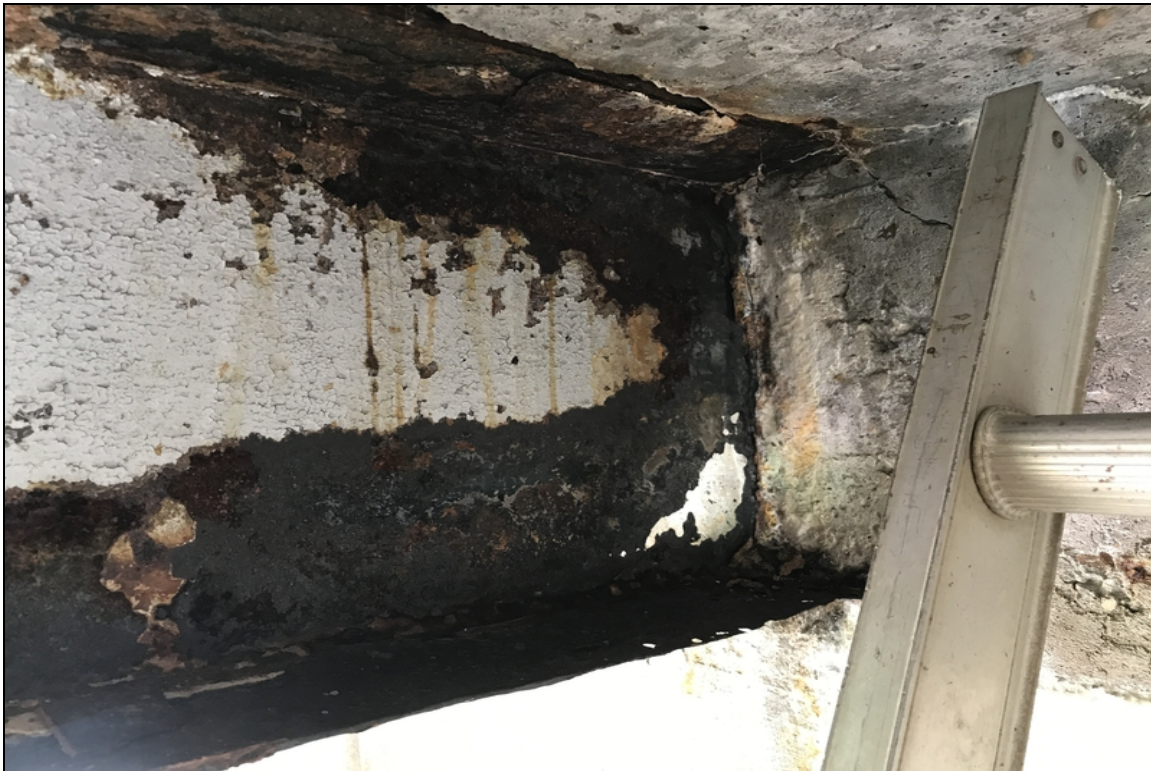
Span # 3 Beam # 2 Bent # 3 - 4" hole in the web at Bent # 3 face.

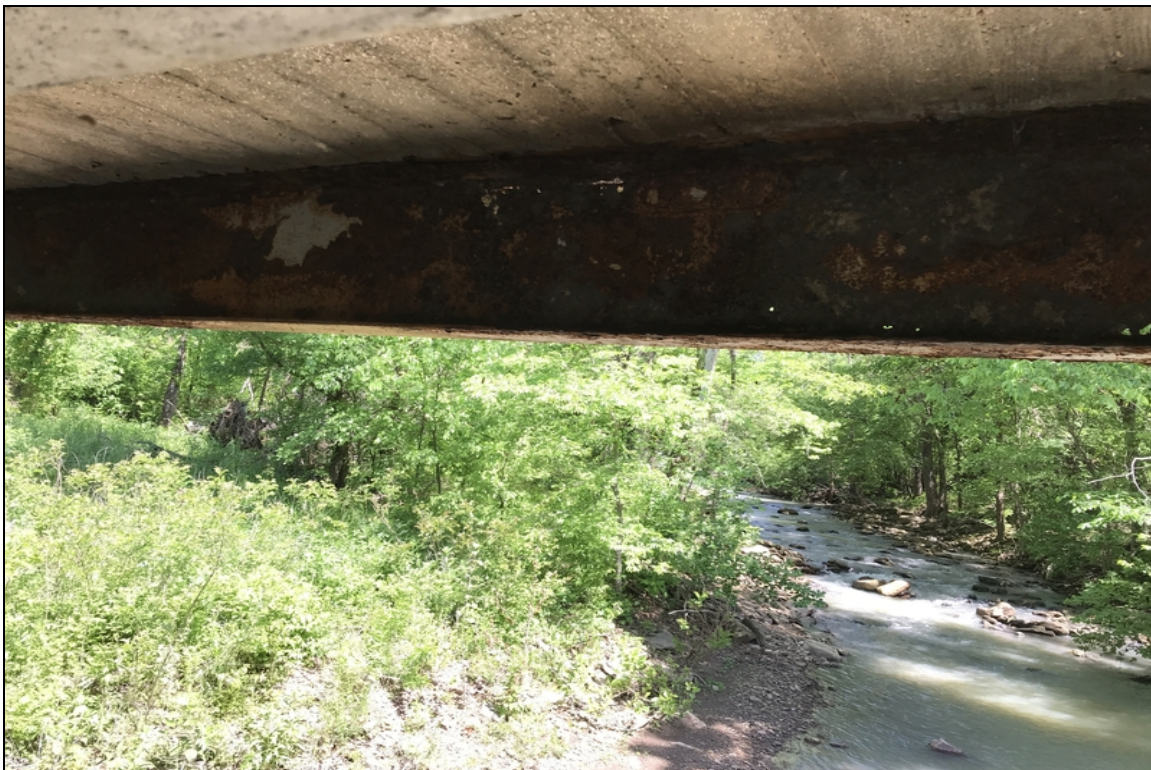
Span # 3 mid-span Beam # 1 - multiple holes in web near mid-span.

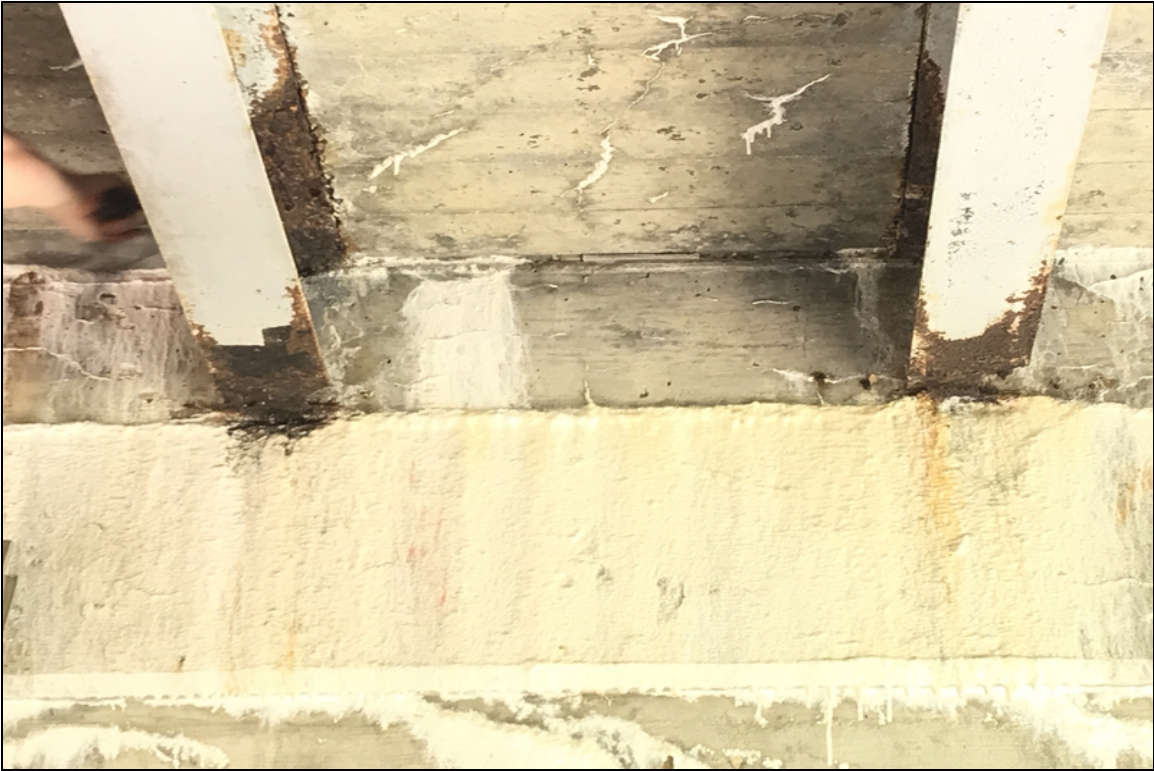
Span # 4 at Bent # 4. Bottom flanges of Beams # 2 & 3.

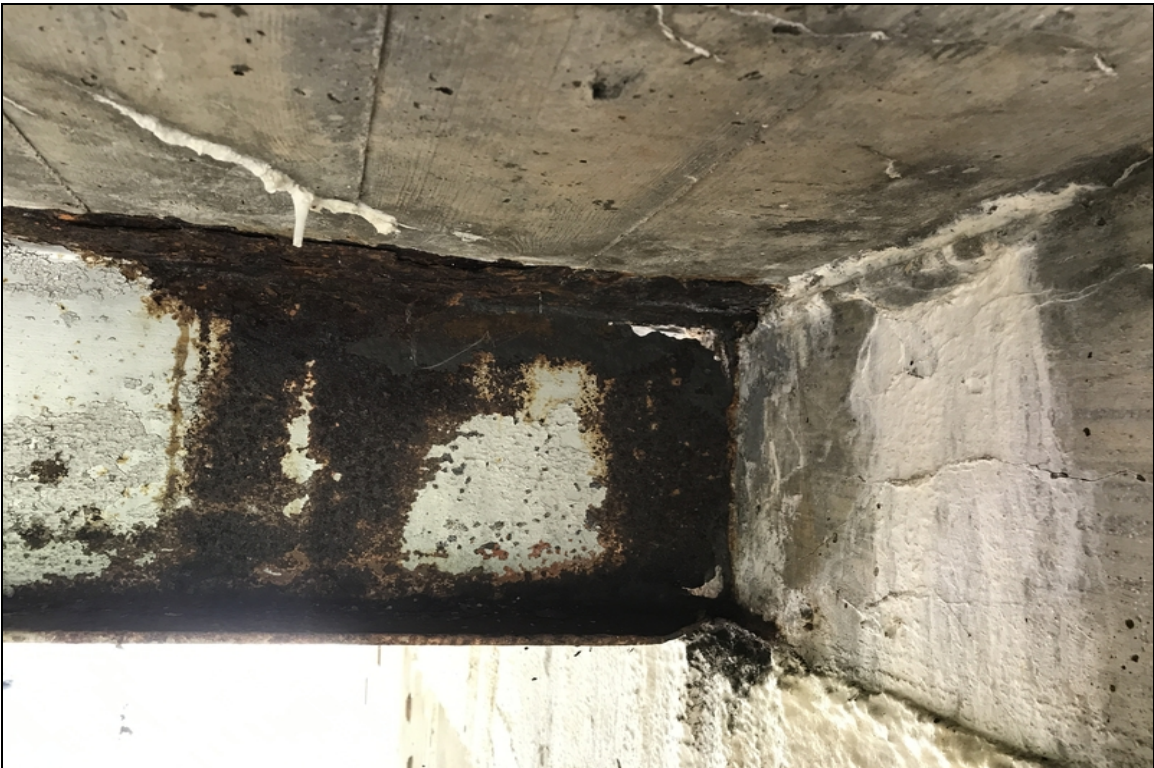
Span 4- Beam 3 Bent 4 face- 4" hole and 1.75" hole, bottom flange is reduced to 2" in width.

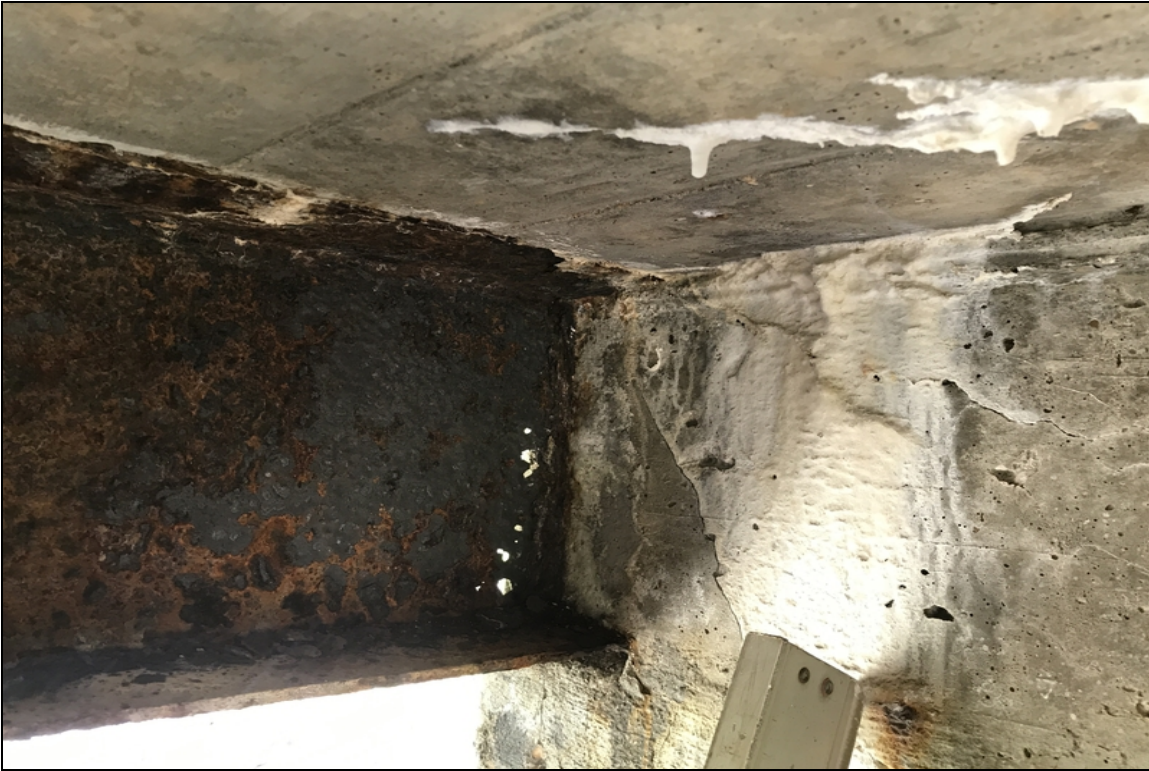
Span # 4- Beam # 1, Bent # 5 face- 2" x 5" area that is paper thin with multiple holes and perforations.

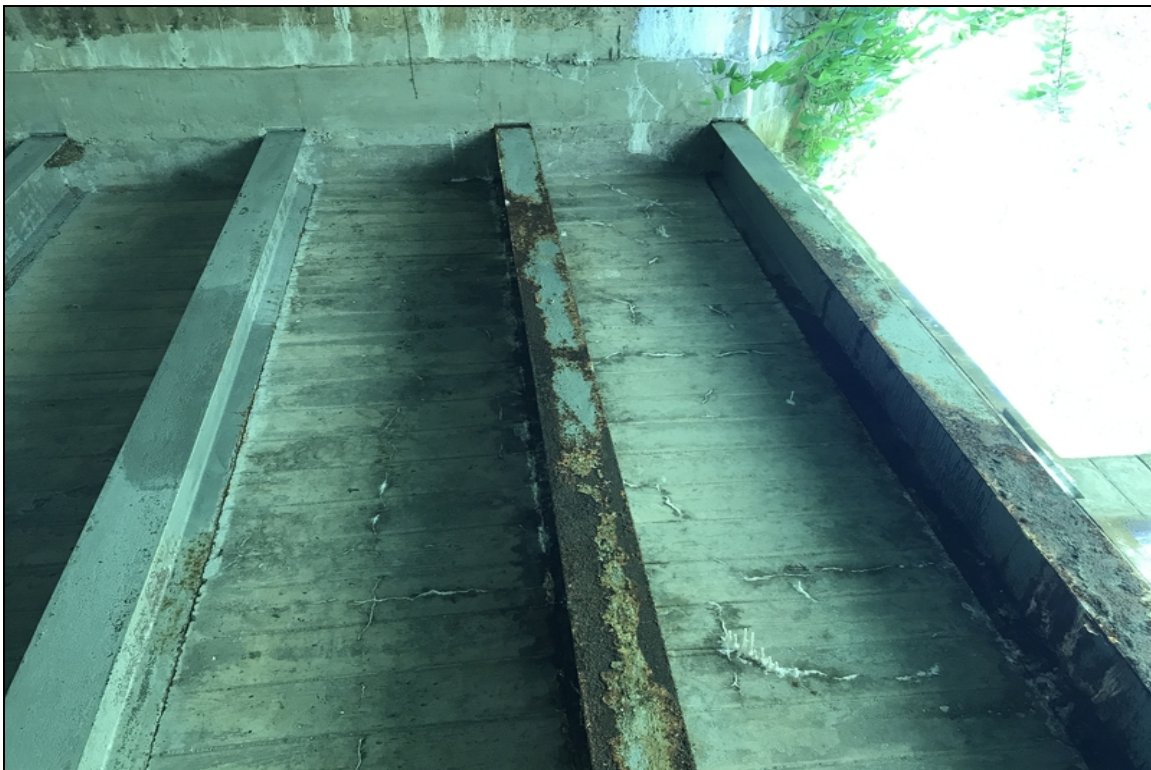
Undersurface of Span # 1. Efflorescence.

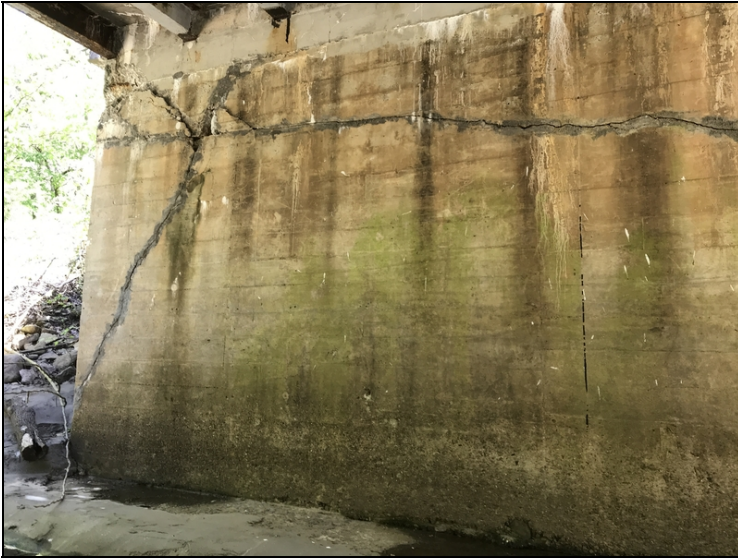
Bent # 5. Typical.

Bent # 5 cracking and concrete deterioration.

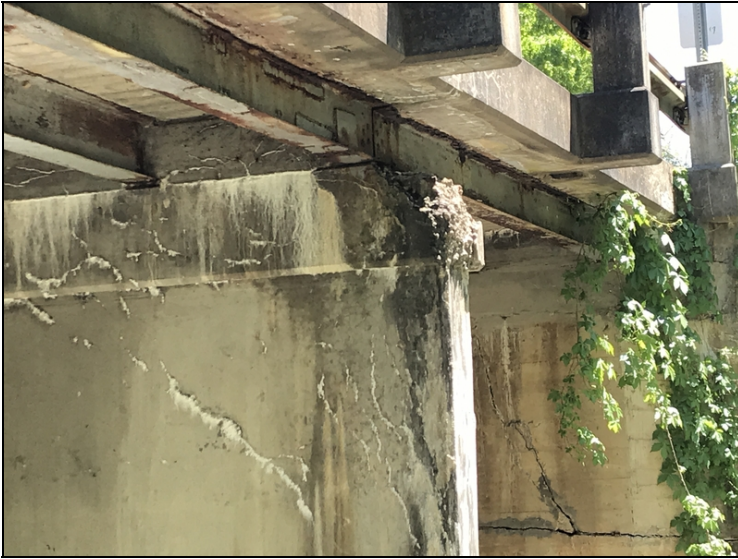
Right end of Bent # 4 cap.

Bent # 4 Rt concrete deterioration and section loss with exposed reinforcing steel.

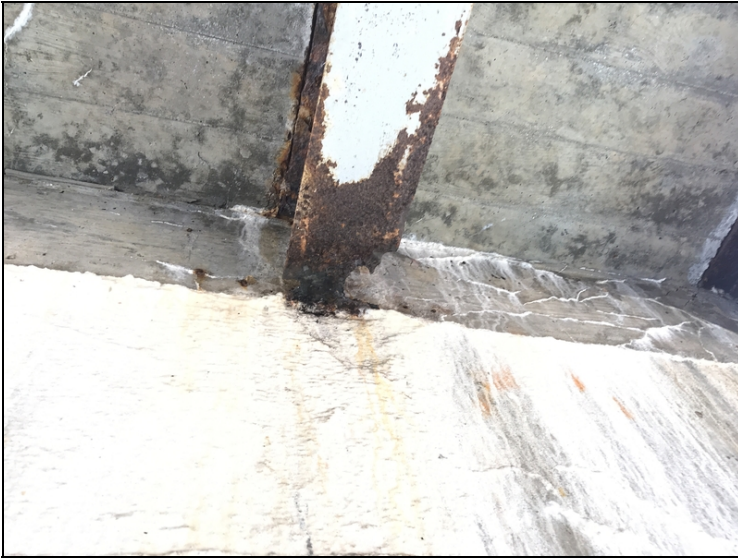
Span # 4, Bent # 4, Beam # 2 has significant section loss to the bottom flange.

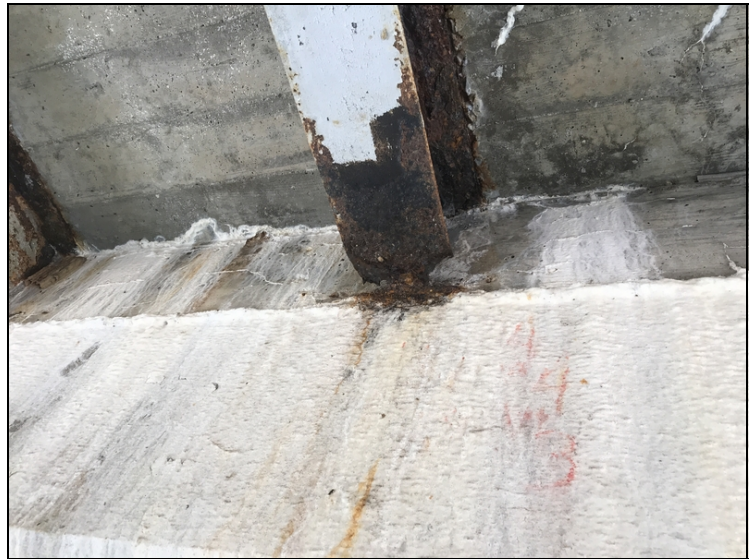
Span # 4, Bent # 4, Beam # 3 has significant section loss to the bottom flange.

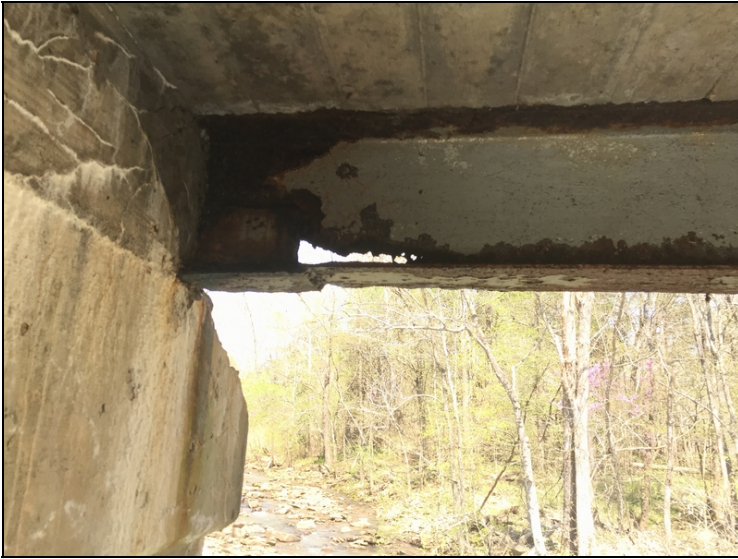
Span # 4, Bent # 4, Beam # 1 has a 3" x 8" hole in the web.

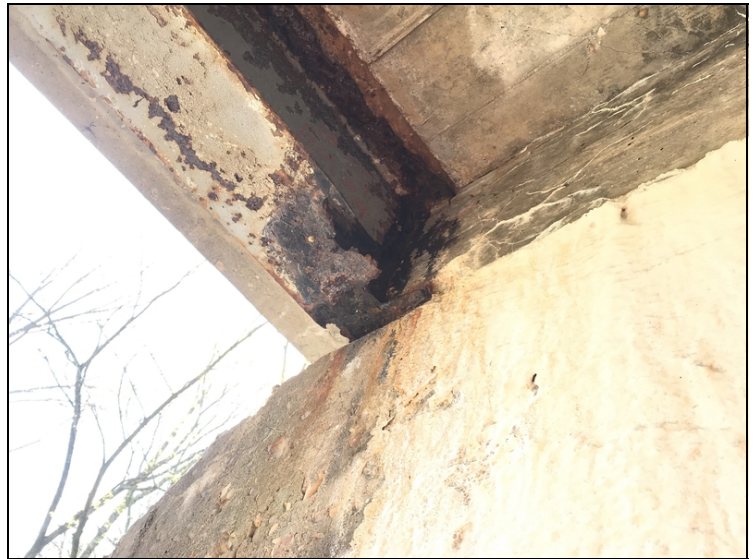
Span # 4, Bent # 4, Beam # 9 has significant section loss to the bottom flange.

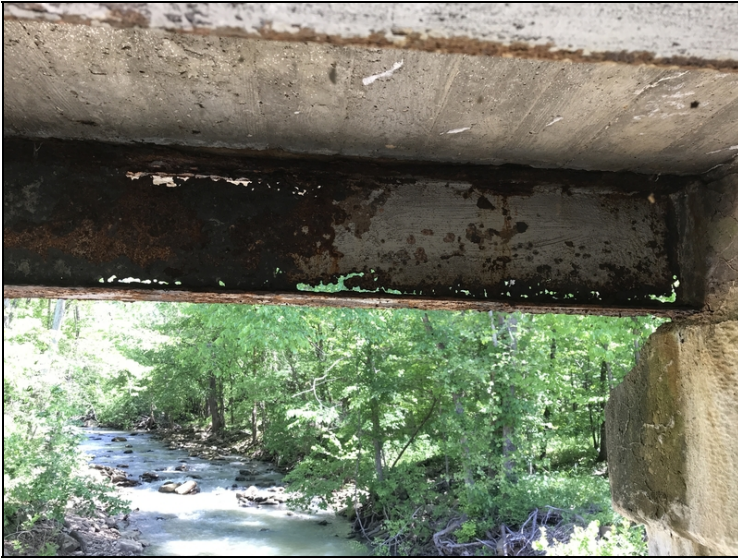
Span # 3 Beam # 1 Bent # 3- multiple holes within 4' of Bent # 3.

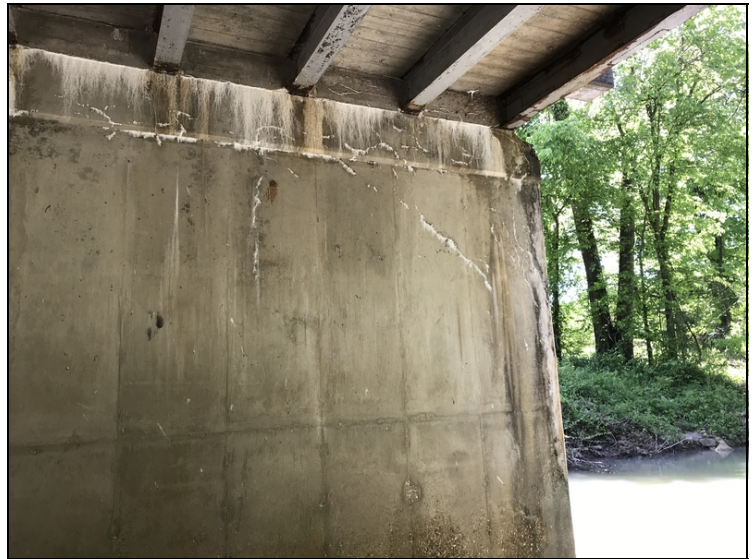
Right side of Bent # 4.

Bent # 4 Rt concrete deterioration and section loss with exposed reinforcing steel.
