Asset #02240(Routine)

US 71 - Seb. Co. over Prairie Creek

Location: 0.1 M N OF SH 252

Team Lead: Jeff Jones, Inspection Date: 08/17/2023

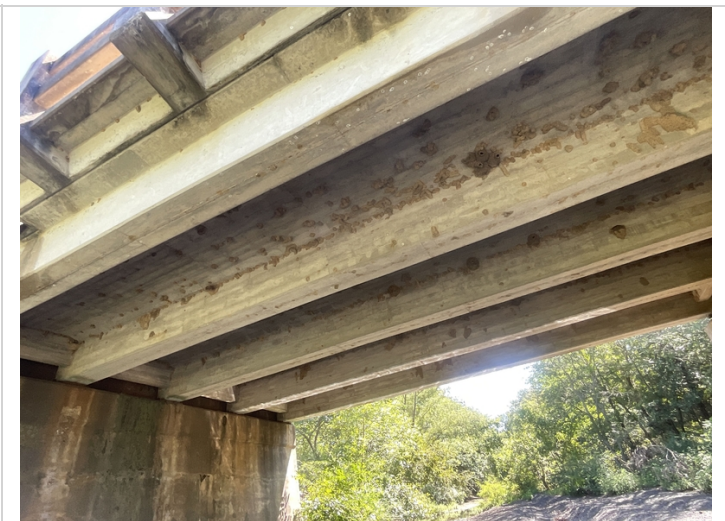
Span # 3 superstructure. Typical.

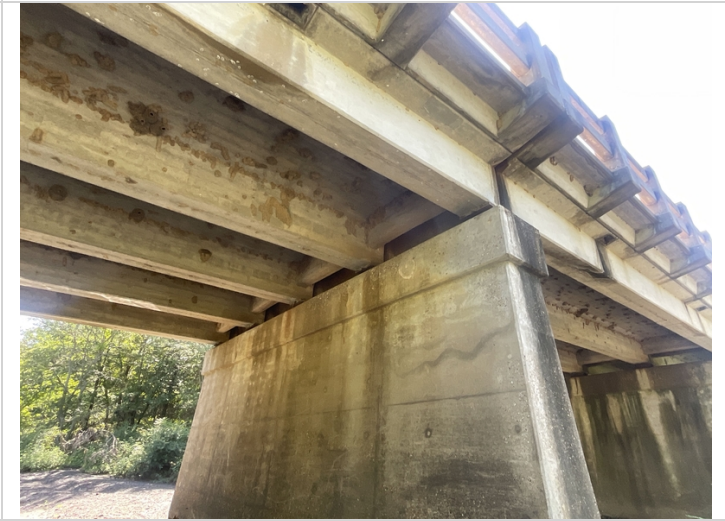
Span # 3 beam ends over Bent # 3.

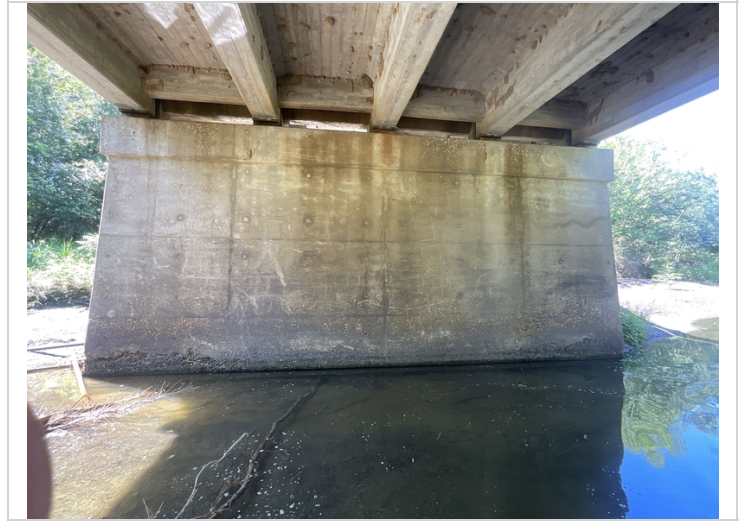
Bent # 3 ahead face. Typical.

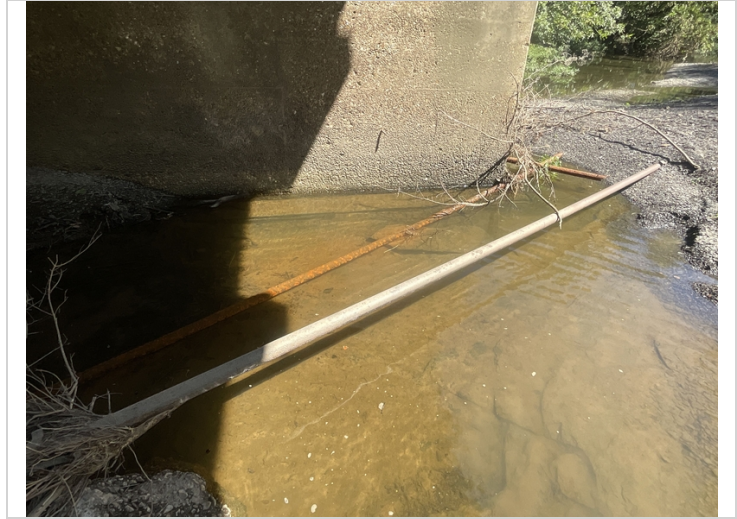
07/13/2017 - JCJ & JML - Type 2 Underwater Inspection - Wading and probing along with visual observation during low water conditions indicate that the top of Bent 3 footing is exposed with no apparent scour problems at this inspection. Bent 3 footing appears to be well keyed into solid shale channel that is exposed in areas.

Bent # 3 footing.

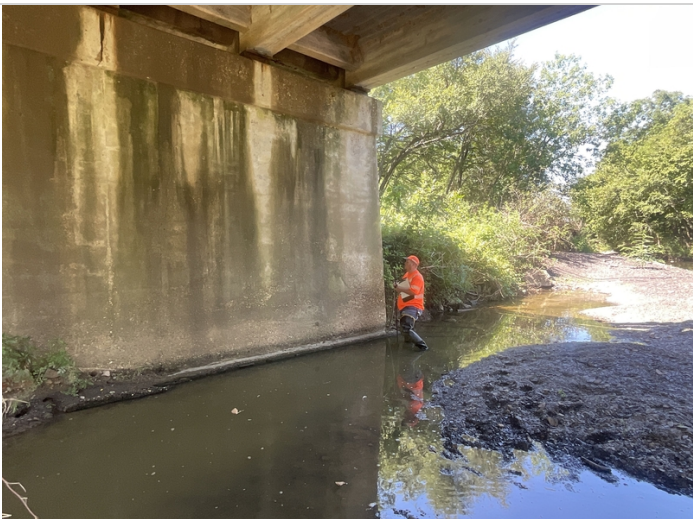
Actual field measurement to document exposed footing elevation.

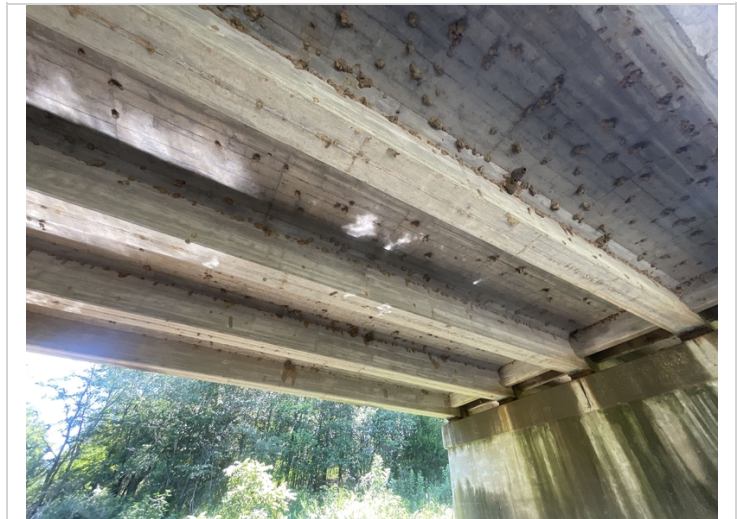
Span # 2 superstructure. Typical.

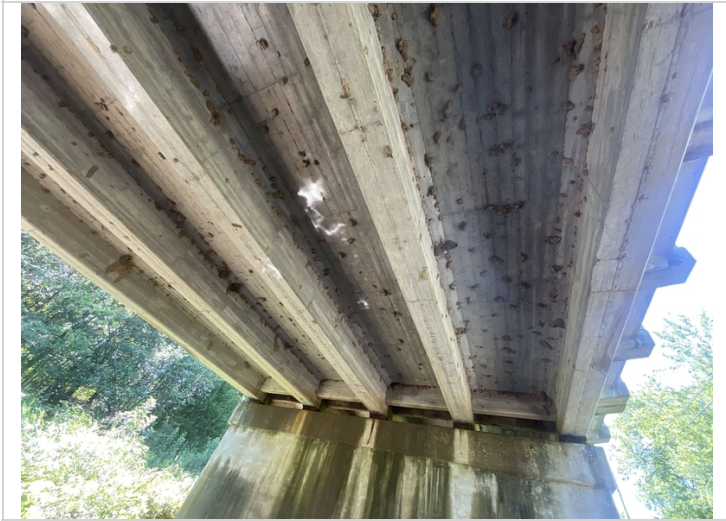
Span # 2 deck soffit. Typical.

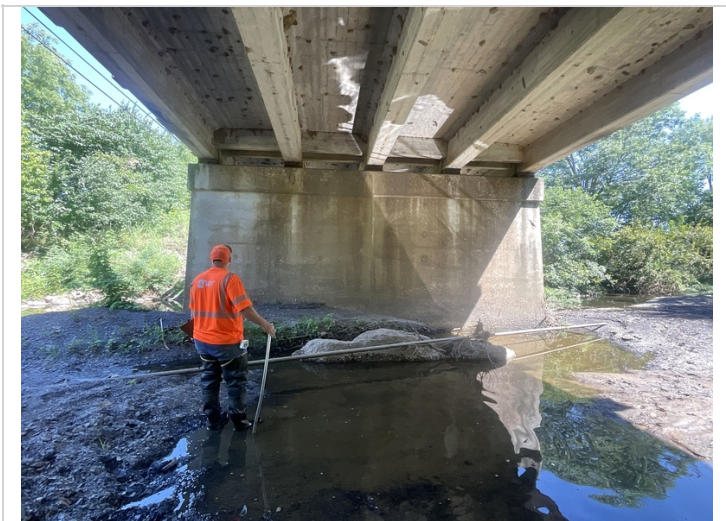
Bent # 3 back face. Typical.

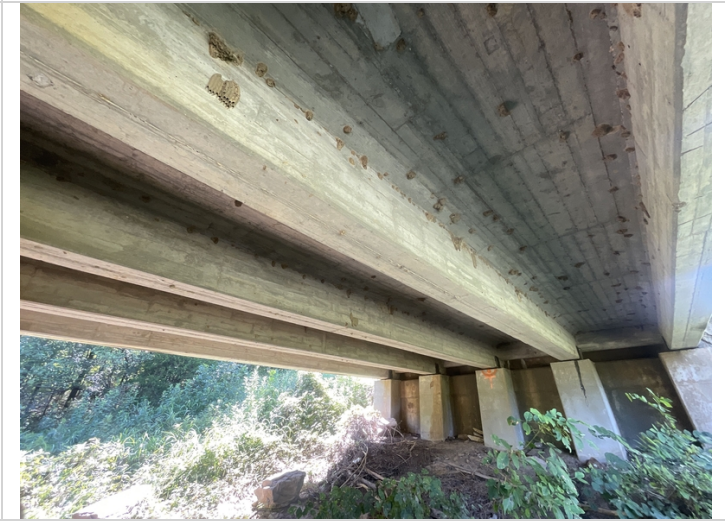
08/17/2023 - JCJ & TJL - Routine Inspection conducted this date. Previous superstructure inspection notes are applicable with additional deterioration to the ends of the girders over Abutment # 1. Actual field measurement indicates that there are no apparent noteworthy changes to Span # 1 since the last inspection. Field measurements are consistent with previous measurements taken over the Past 10 years. There have been no apparent repairs to Span # 1 Girders or Bent # 1 backwall since the 08/30/2016 inspection.

Span # 1 superstructure. Typical.

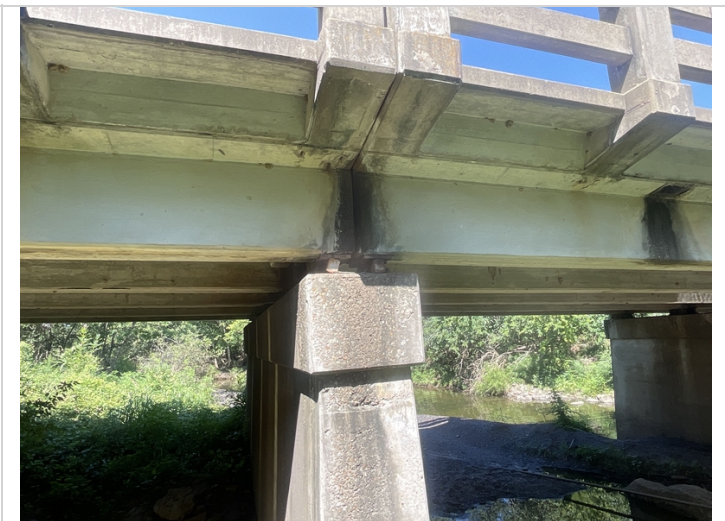
Expansion bearings over Bent # 2. Expanded for Span # 1.

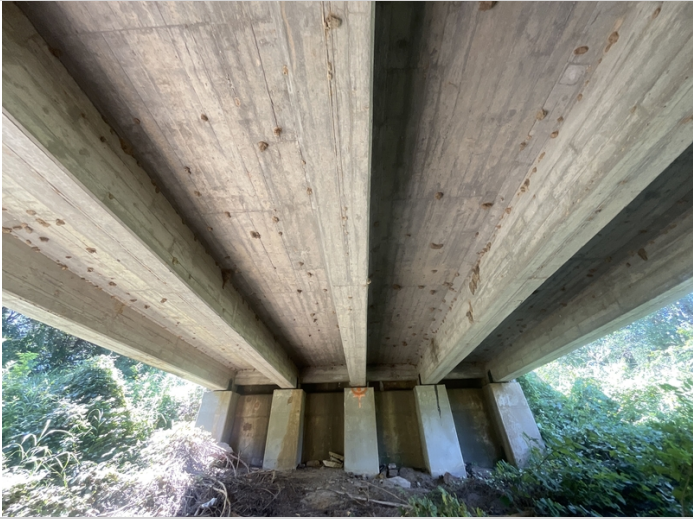
Span # 1 deck soffit. Typical.

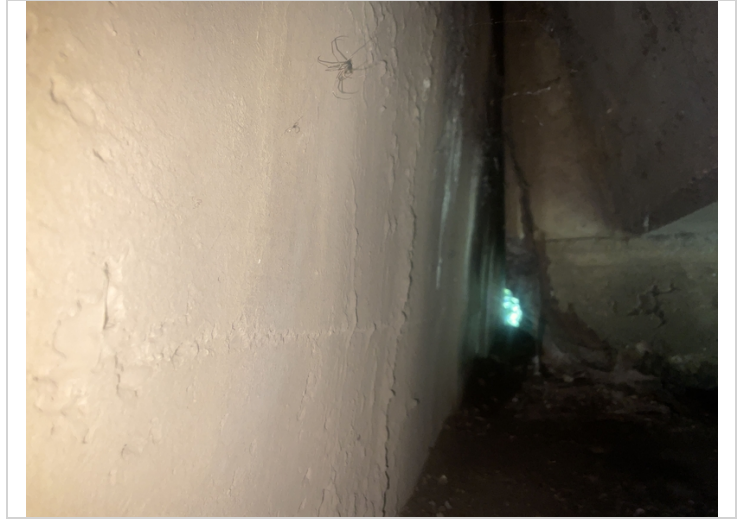
Abutment # 1 backwall makes contact with the ends of the girders at Abutment # 1.

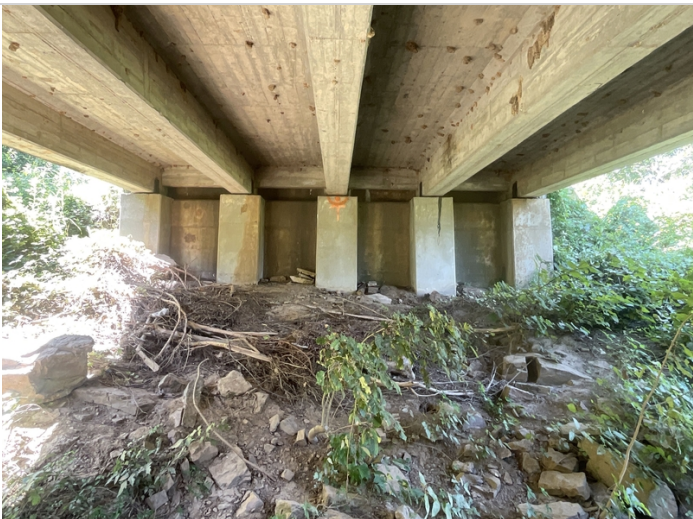
Abutment # 1. Typical.

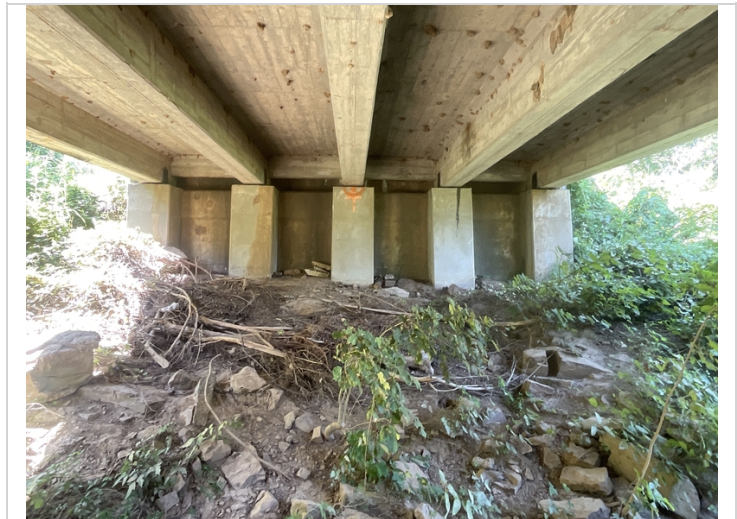
205	Reinforced Concrete Column	EA	5	5	0	0	0
(205) -The cast-in-place columns placed under the girders at Abutment # 1 (for additional support) have no apparent noteworthy deficiencies during this inspection.							
210	Reinforced Concrete Pier Wall	LF	57	0	35	22	0

Columns at Abutment # 1. Typical.

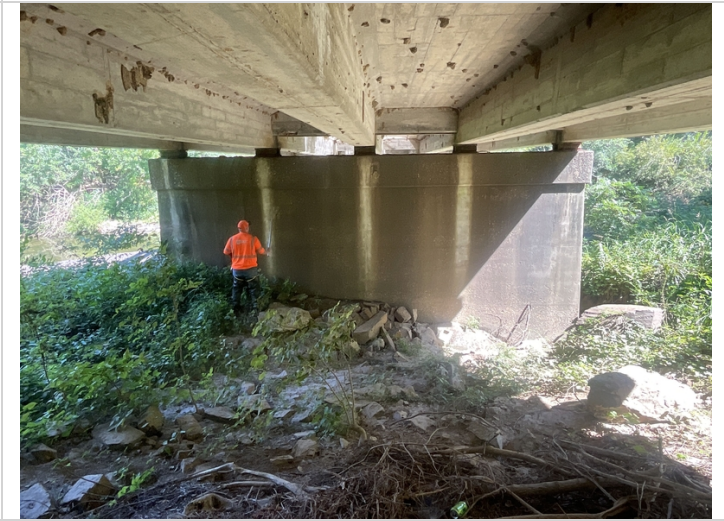
Bent # 2 back face. Typical.

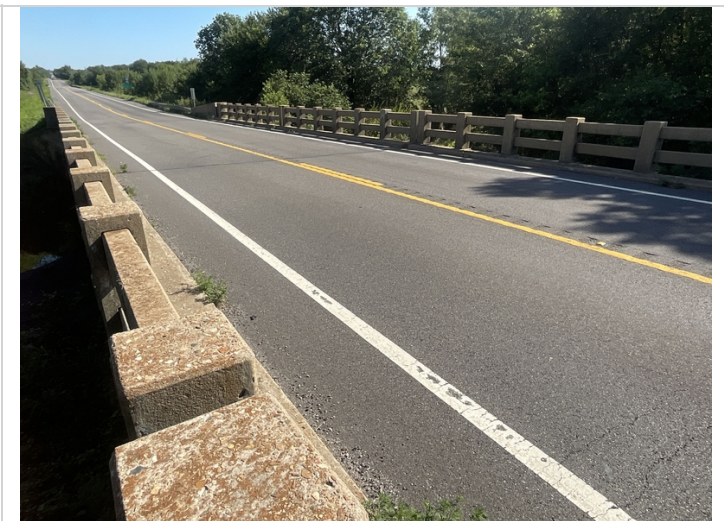
Deck. Typical.

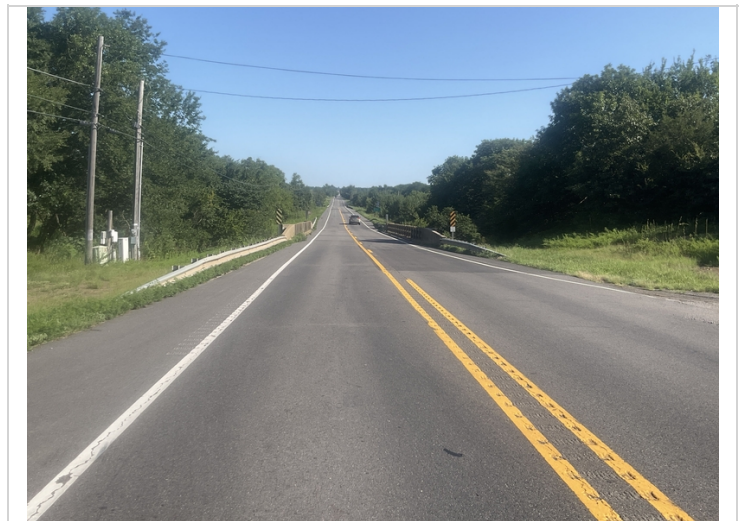
Approach roadway facing South.

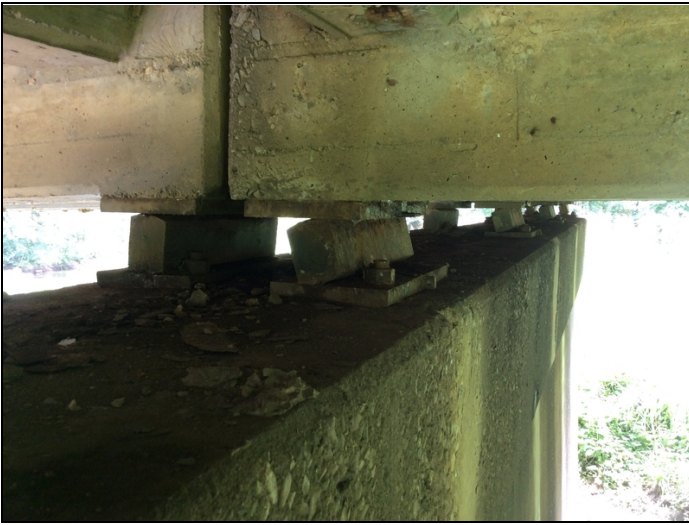
Bent # 2 Span # 1 Bearing movement.

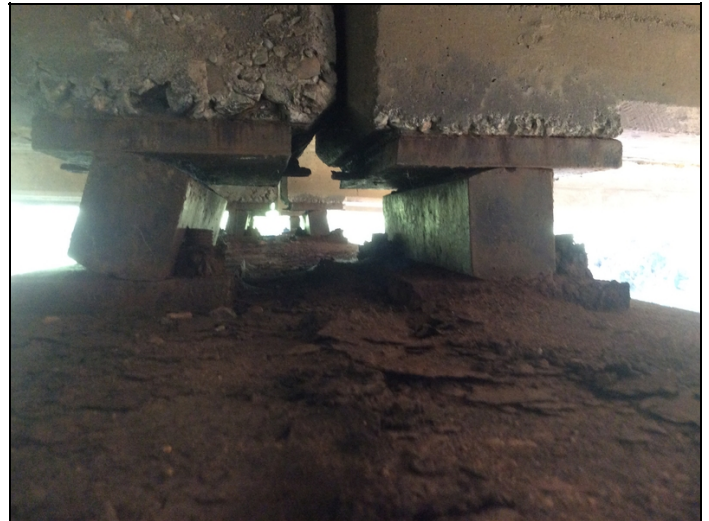
General view of bent # 2 bearing area.
