Bridge #02012(Routine, Underwater type 2)
State Highway 22 over Dry Fork Branch-Franklin
Location: 8.5 E OF JCT SH 96 & 22

Team Lead: Bob McEntyre Inspection Date: May 13, 2020

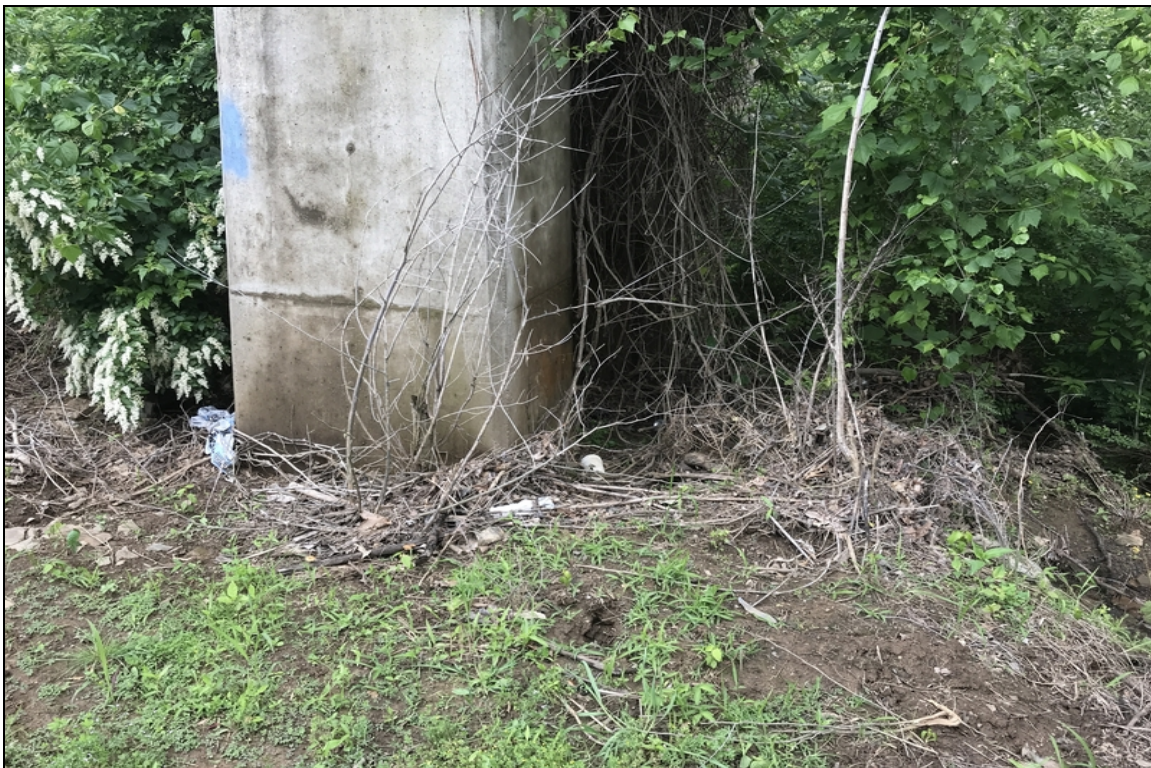
Footings have cover.

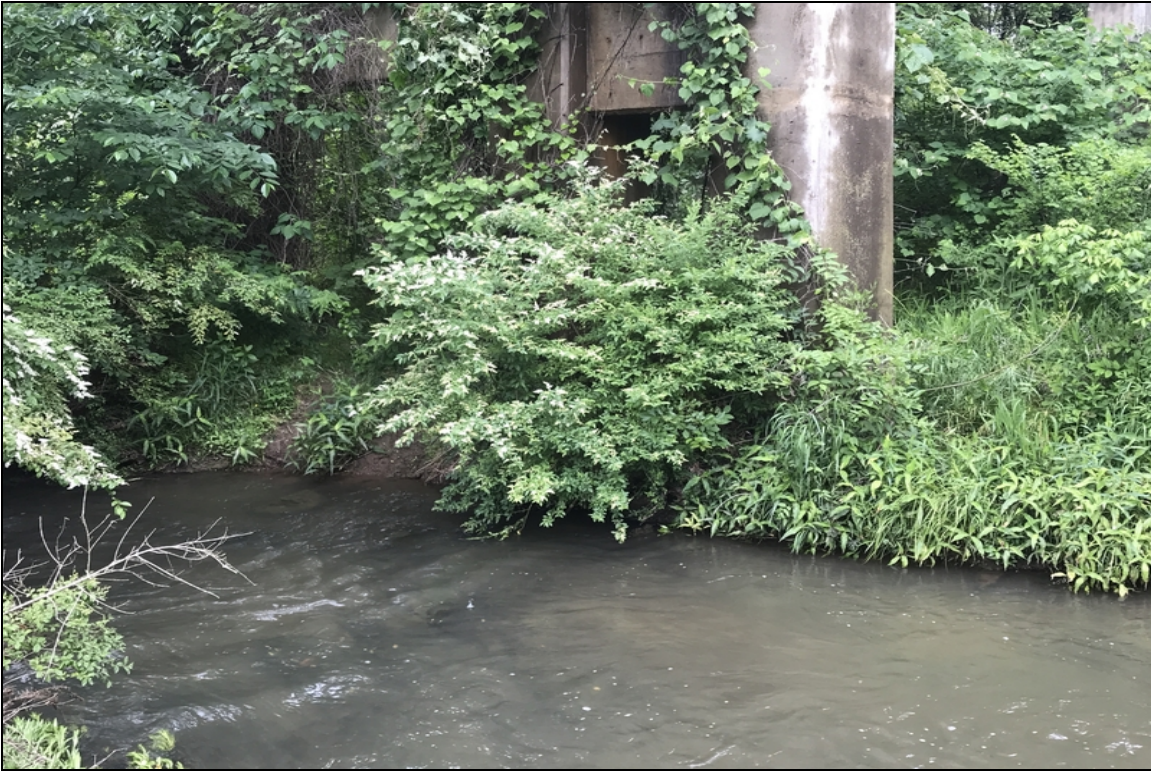
Footings have cover.

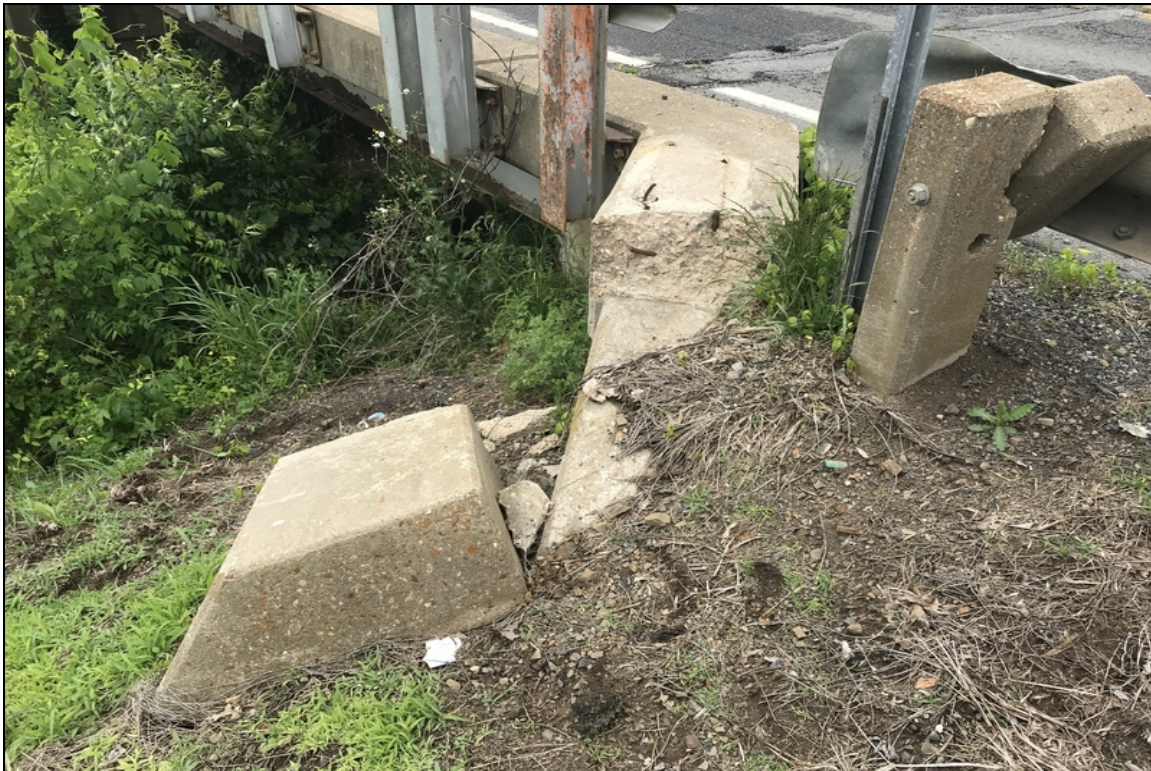
Southeast end post has been displaced.

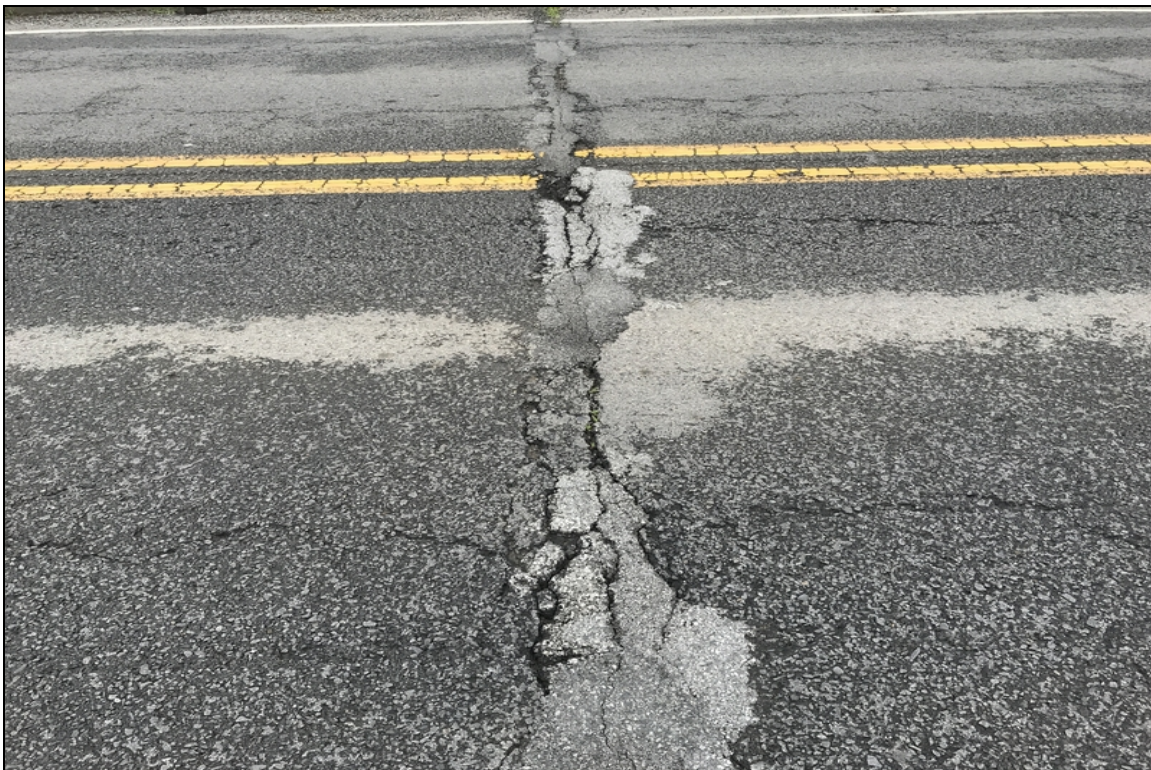
ELEM	DESCRIPTION	UNITS	TOTAL	CS1	CS2	CS3	CS4
305	Assembly Joint without Seal	LF	72	0	0	72	0
2350	Debris Impaction	LF	72	0	0	72	0
(305)							
-Asphalt is still breaking apart over the expansion joints with asphalt patches at both abutments and over Bent # 4. There is spalling and delaminated areas in the expansion joint dams adjacent to the beams visible from the undersurface of the deck.							
311	Movable Bearing	EA	30	0	6	15	9
1000	Corrosion	EA	17	0	6	11	0
1020	Connection	EA	1	0	0	1	0
2210	Movement	EA	12	0	0	3	9
515	Steel Protective Coating	SF	150	0	0	36	114
3440	Effectiveness (Steel Protective Coatings)	SF	150	0	0	36	114

Asphalt breaking apart over intermediate bents.

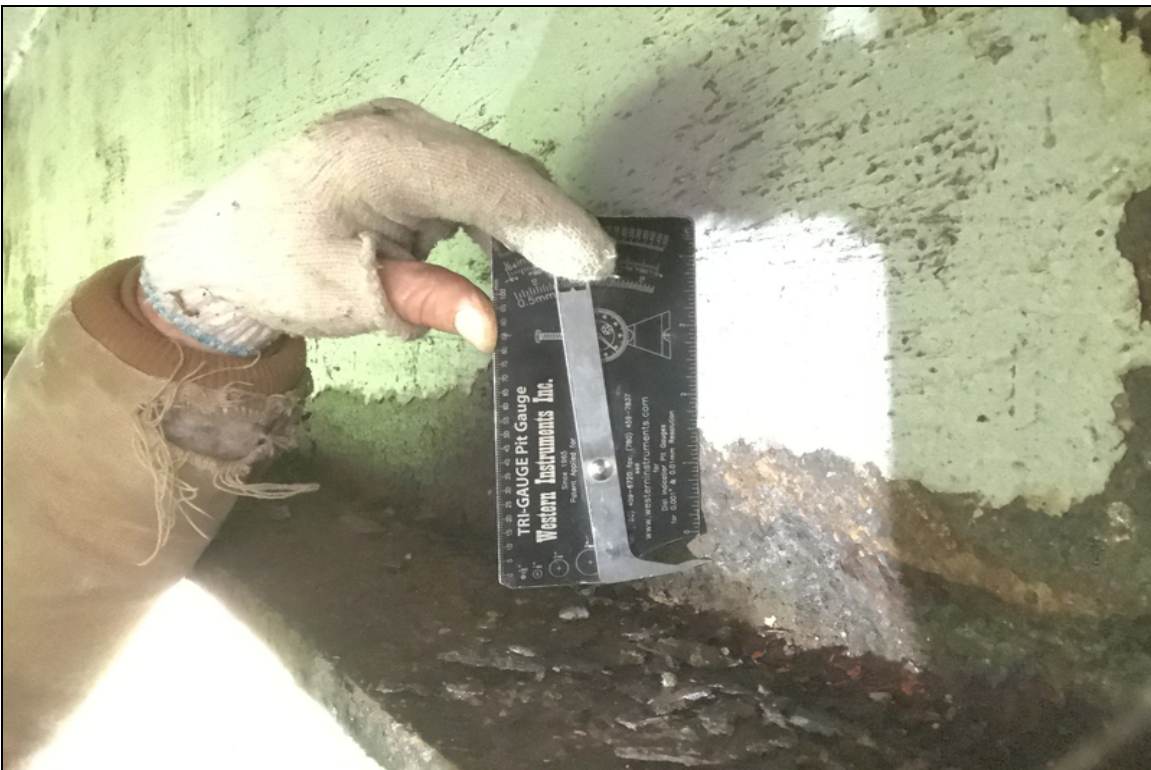
Span # 6, beam 1 over abutment 2-3/16" section loss to base of web.

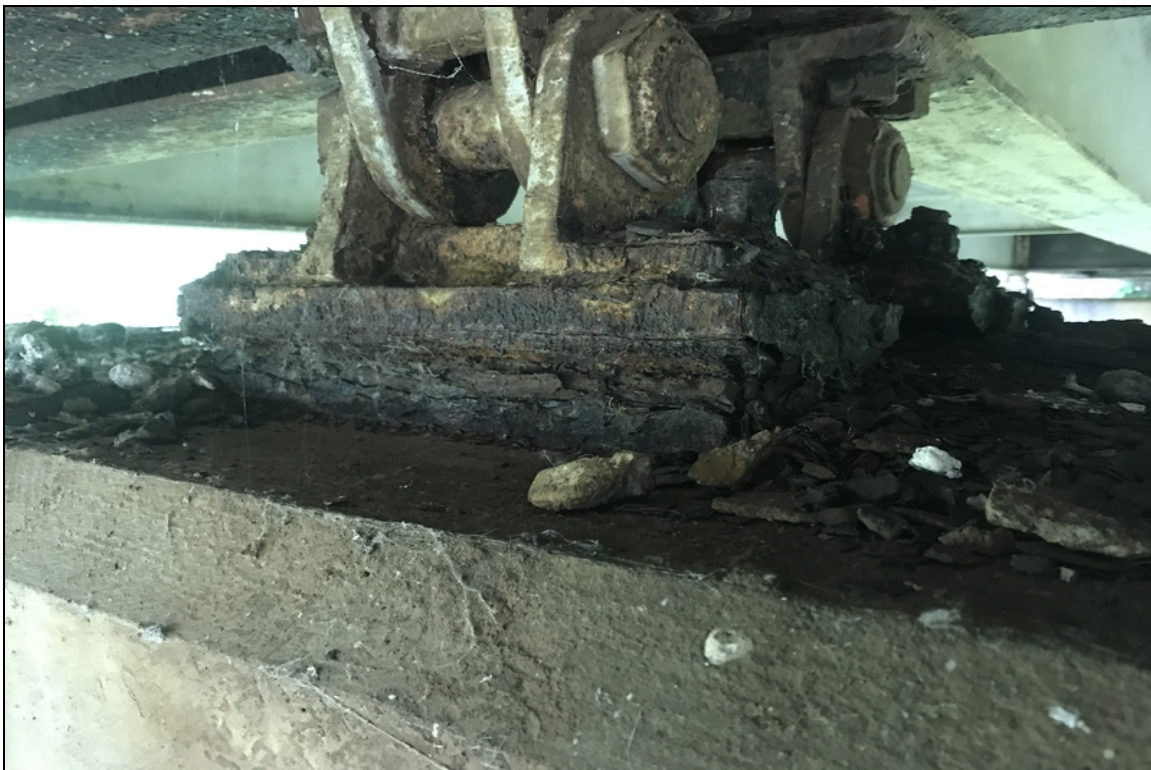
Typical of movable bearings over bent 4.

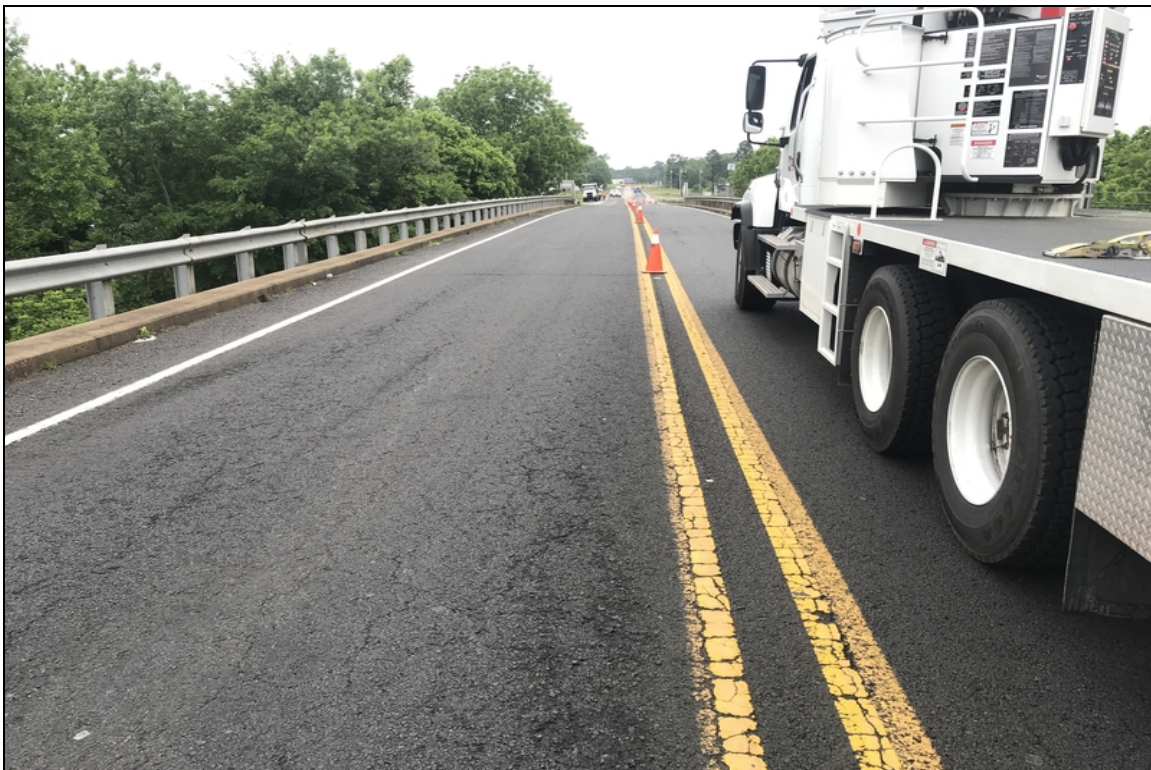
Driving surface.

(12)							
Asphalt measures 5" below the top of the curb.							
Driving surface of the deck: ACHM overlay has mapcracking in the wheel paths and deterioration of asphalt over the expansion joints. -The right lane of span # 2 has an 8" spall in the asphalt driving surface.							
Deck undersurface: -Spalling and delaminated areas in the expansion joint dams visible from the undersurface of the deck. -Span # 2, bay # 4 has a 4" spall with exposed steel near mid-span adjacent to beam # 5. -Transverse cracks with efflorescence and rust staining at variable spacing are typical in all spans. -The undersurface of the deck in span # 3, bay # 4 has a hairline full length longitudinal crack. -Span # 3 has a transverse crack that is spalled with an area of exposed reinforcing steel approximately 8" long. -Concrete spalls with no exposed reinforcing steel over Bent # 1. -The expansion dams have delaminated and spalled areas with wide cracking adjacent to the beams. -The left deck overhang in span # 5 over bent # 5 has a 24" spall with exposed reinforcing steel. The exposed steel has measurable section loss.

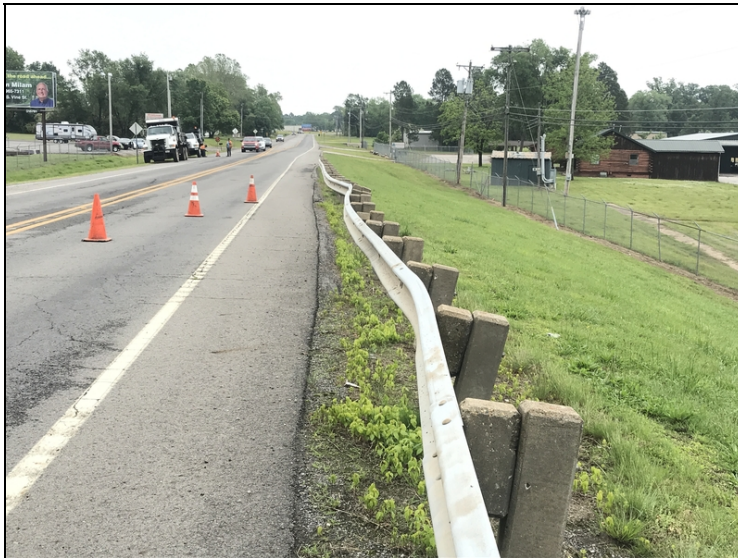
Northwest and Southeast approach guard railing -
The Northwest and Southeast approach guard railing have areas of collision damage.

Collision damage to Southeast approach railing.

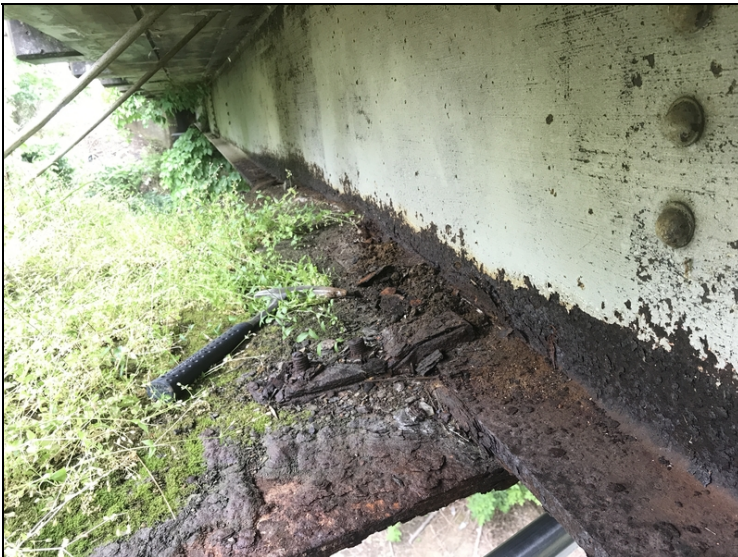
Span 5, beam 1-Heavy corrosion where steel plate is attached To bottom of beams.

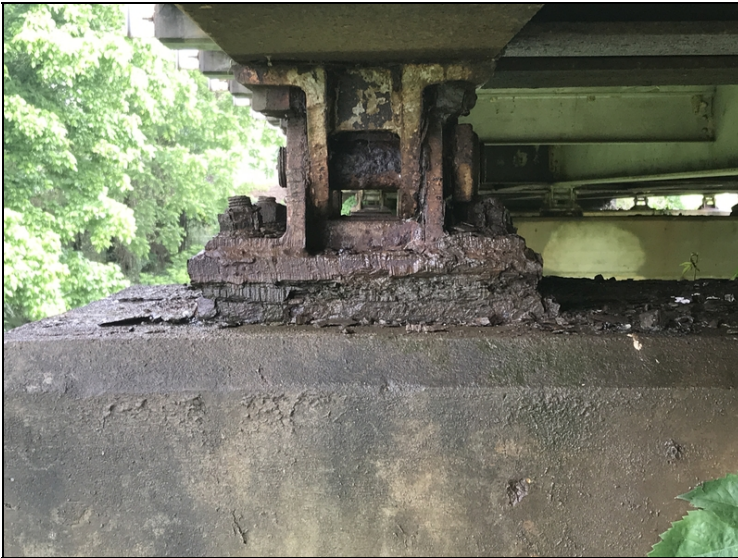
Bearing # 1 of span # 3 over bent # 4 is missing the bearing pin retaining nut.

Span 3, bearing 1 over bent 4-Corrosion.

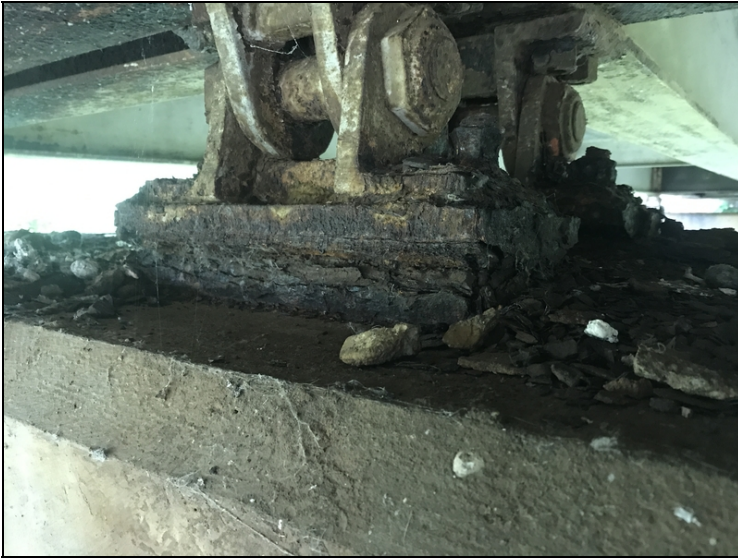
Bearing # 1 of span # 3 over bent # 4 is missing the bearing pin retaining nut.

Typical of movable bearings over bent 4.
