Asset #06115(Routine)

State Highway 96 over Big Creek Relief

Location: 1.94 MI E SH 255

Team Lead: Jeff Jones, Inspection Date: 04/20/2022

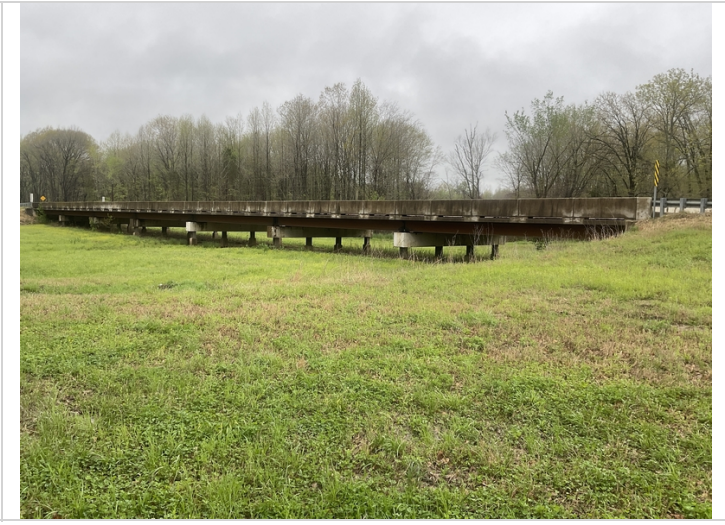
Elevation. Right side of structure.

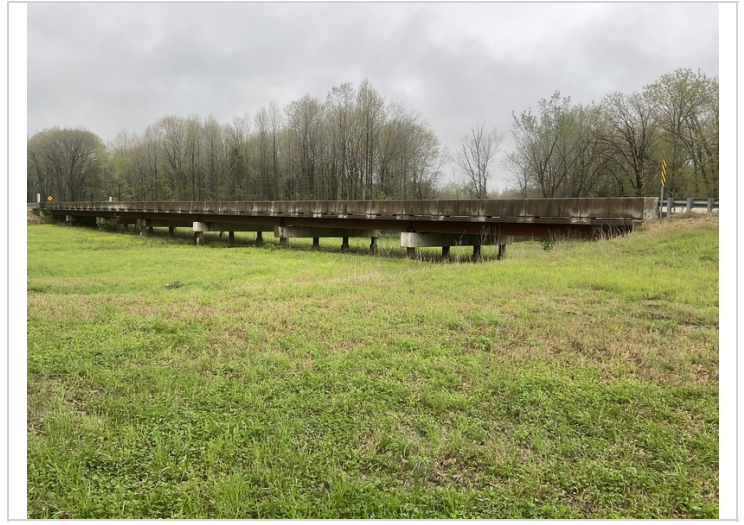
Elevation. Right side of structure.

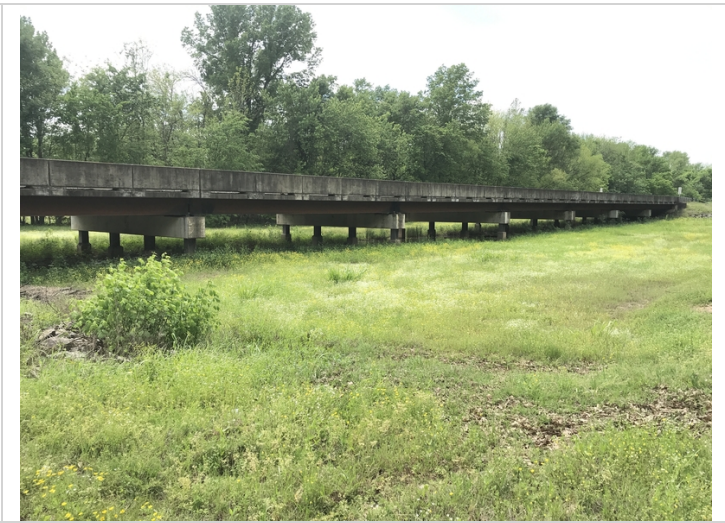
Elevation.

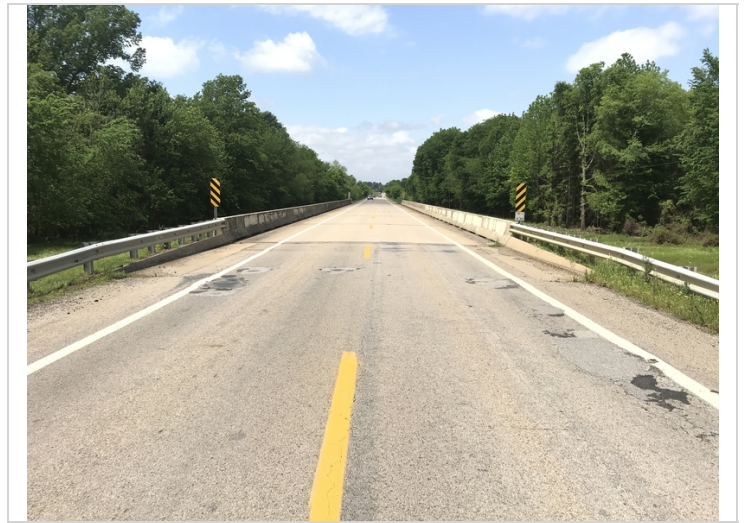
Roadway.

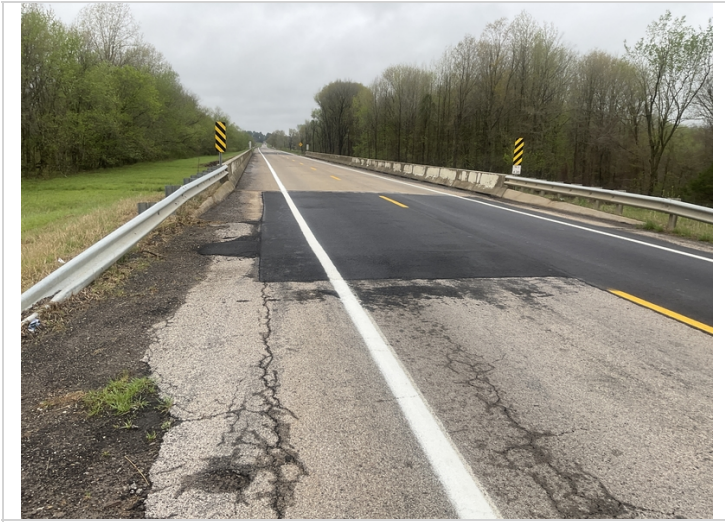
Approach roadway facing west.

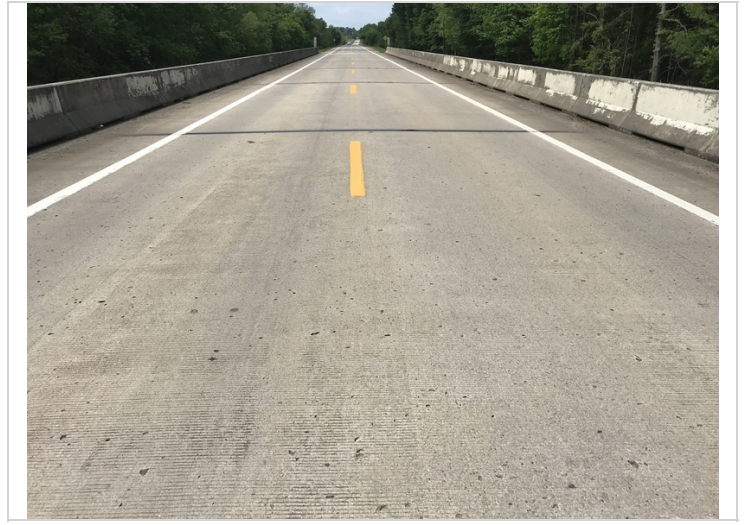
(12) -There are minor transverse cracks at variable spacing on the driving surface of the deck. -Transverse hairline cracks with light efflorescence are visible from the undersurface of the deck overhang that appear to correlate with the parapet wall joints. -There are numerous pop outs visible on the driving surface of the deck in Span # 7. -The driving surface of the deck has a few random hairline longitudinal cracks with no apparent significant changes since the last inspection.							
107	Steel Open Girder/Beam	LF	1400	1120	245	35	0
1000	Corrosion	LF	280	0	245	35	0
515	Steel Protective Coating	SF	8577	1400	6477	350	350
3430	Oxide Film Degradation Color/Texture Adherence(Steel Protective Coatings)	LF	7177	0	6477	350	350

Typical driving surface of the deck.

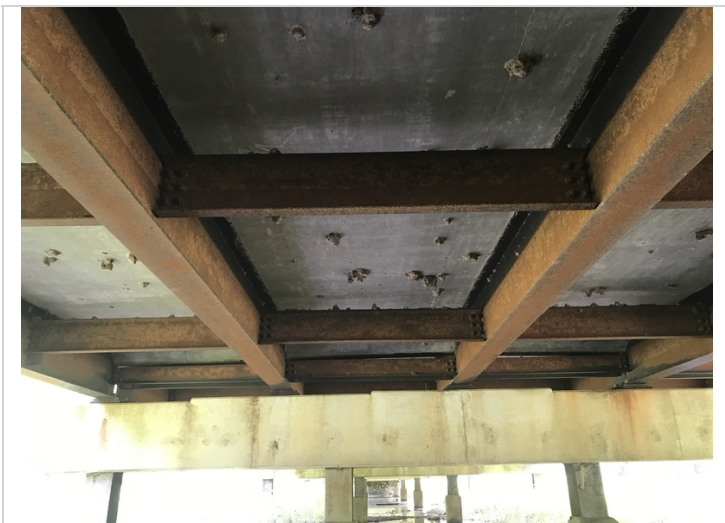
Typical undersurface of the deck.

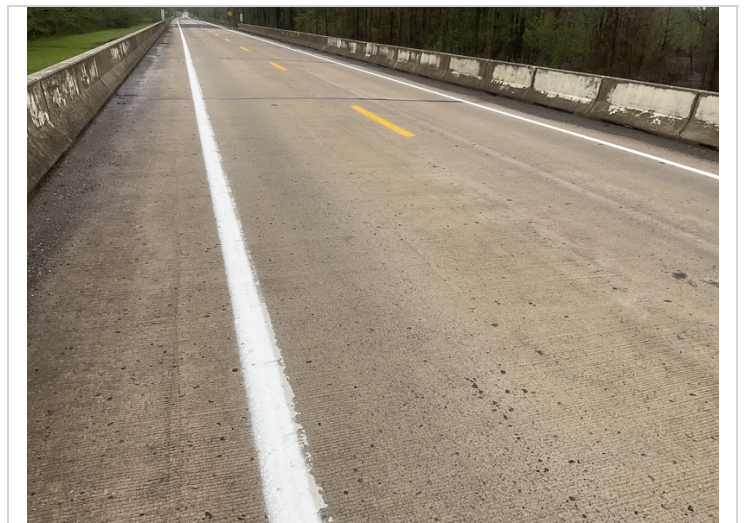
Driving surface of the deck. Typical.

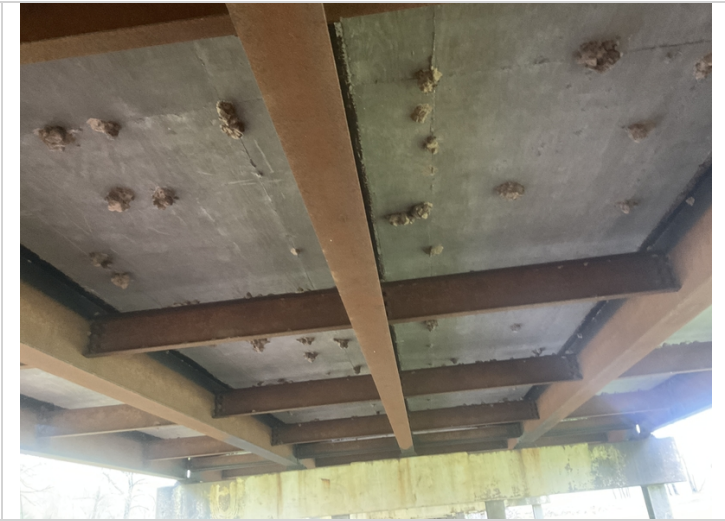
Deck soffit. Typical. Span # 3.

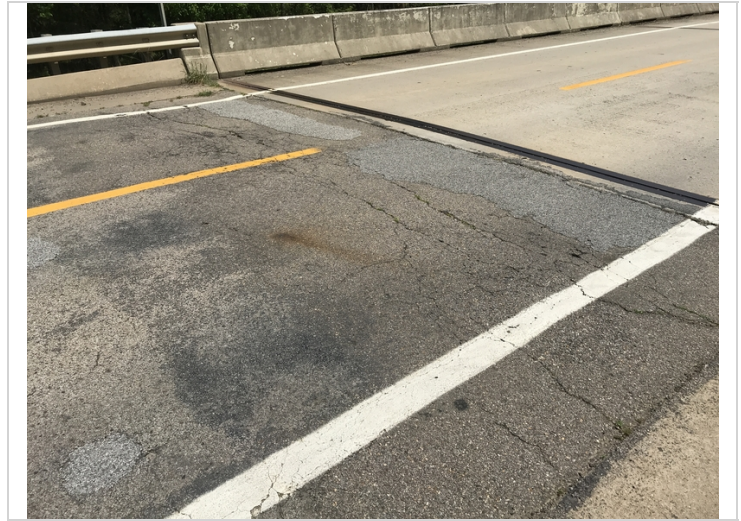
Bent # 1 approach roadway asphalt breaking apart and minor settlement.

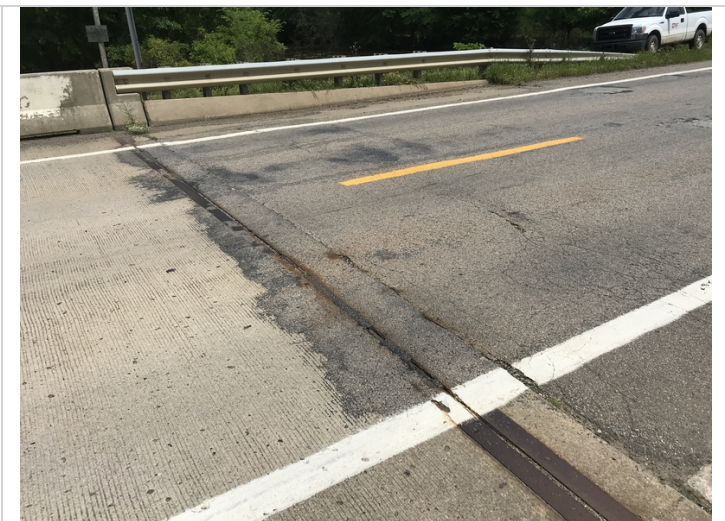
Bent # 8 minor asphalt settlement.

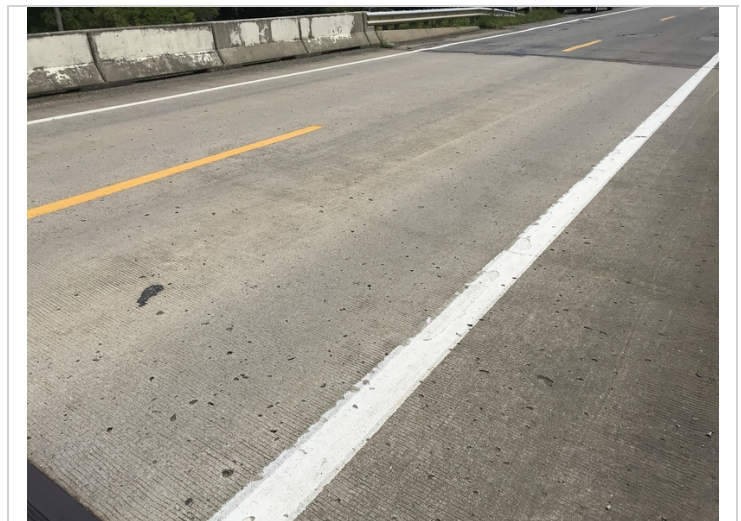
Span # 7 pop outs on the driving surface of the deck.

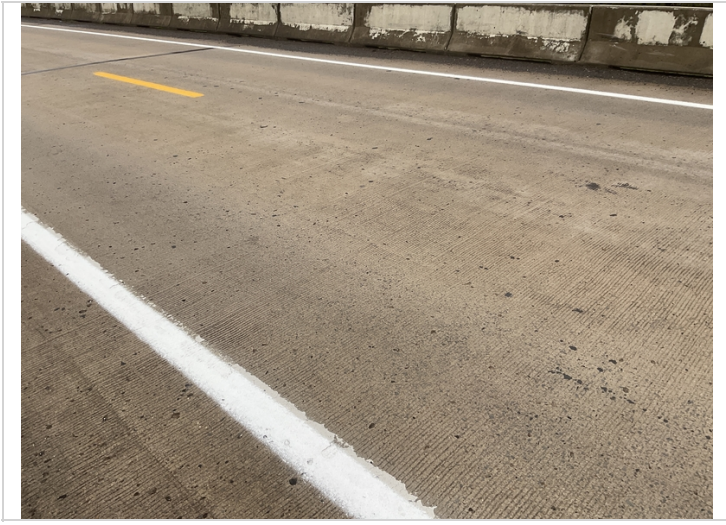
Driving surface of Span # 7. Several pop outs.

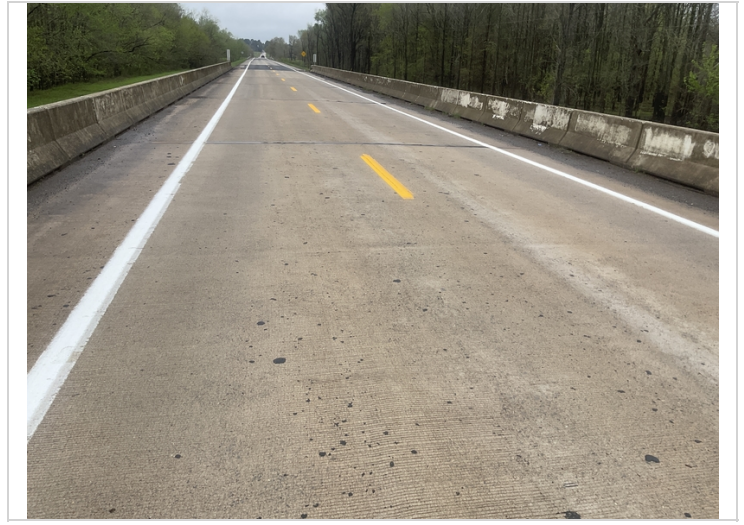
Driving surface of the deck. Typical.

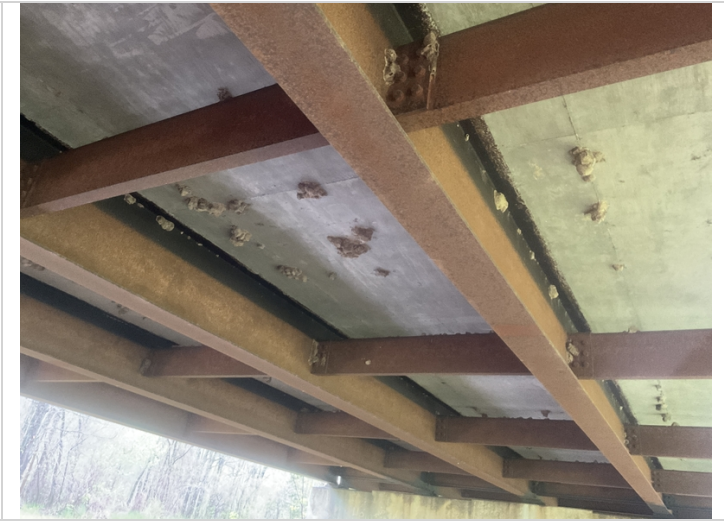
Deck soffit. Span # 2. Typical.

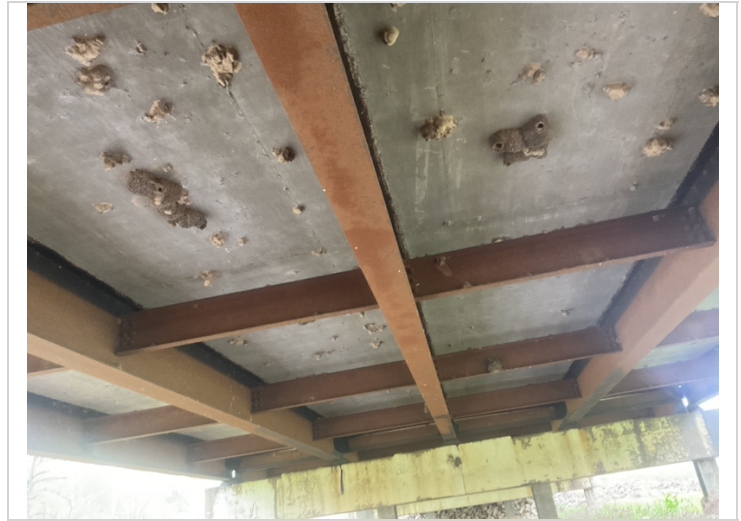
Deck soffit. Span # 5. Typical.

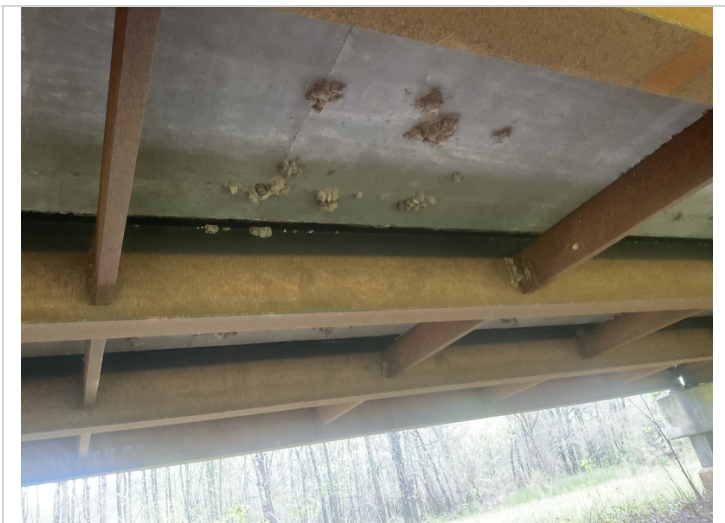
Superstructure. Typical.

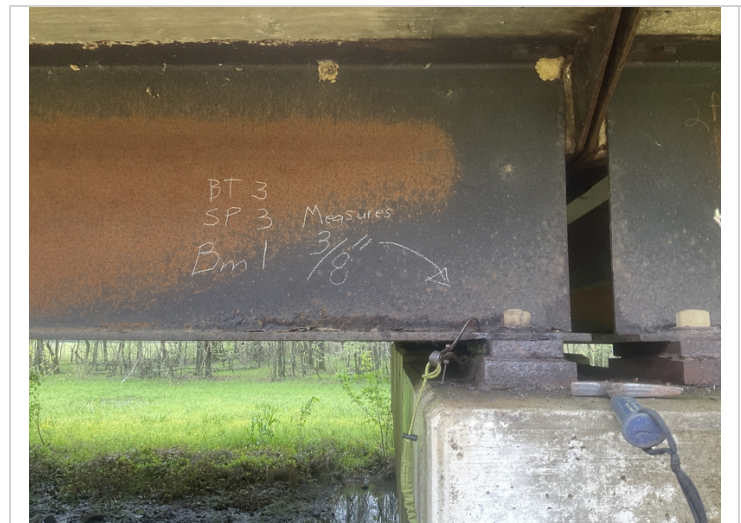
(107) -Superstructure is constructed with A588 weathering steel. -The ends of beams have active corrosion, flaking rust with initial section loss to the bottom flanges and bases of webs where the deck joint seals leak water on the superstructure. -High water has inundated the base of the superstructure leaving a light brown patina on the lower 3/4 portion of the beams. -Several beam ends have 1/8" section loss across the width of the bottom flange at the juncture with the sole plate. Beam 1 at bent 3, span 3 bottom flange has been reduced down to 3/8" thickness remaining. -There is active corrosion with section loss to the web that measured up to 1/8" deep at several of the expansion dam / web junctures. (515-107) -Steel protective coating has abnormal weathering at the beam ends from apparent water leakage through the deck joints. -The protective coating has a light orange patina forming on the lower 3/4 of the beams and diaphragms from being inundated by the recent flooding events.

Span 3. Bent 3. Beam 1. Bottom flange has been reduced down to 3/8" thickness.

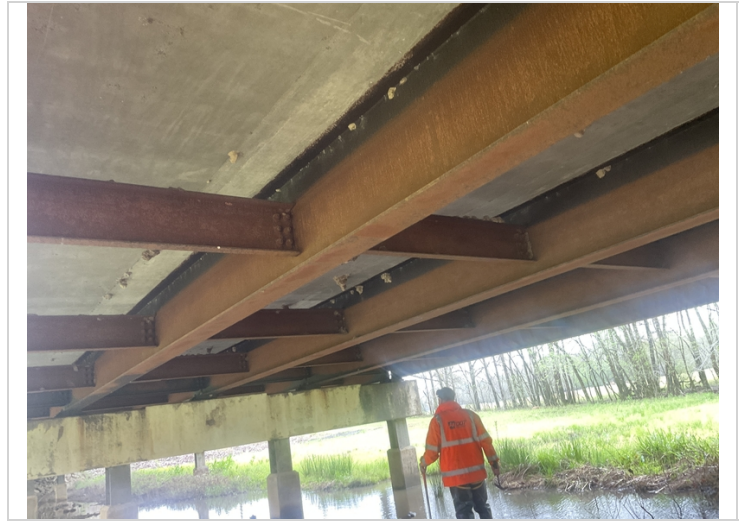
Superstructure. Typical. Span 4.

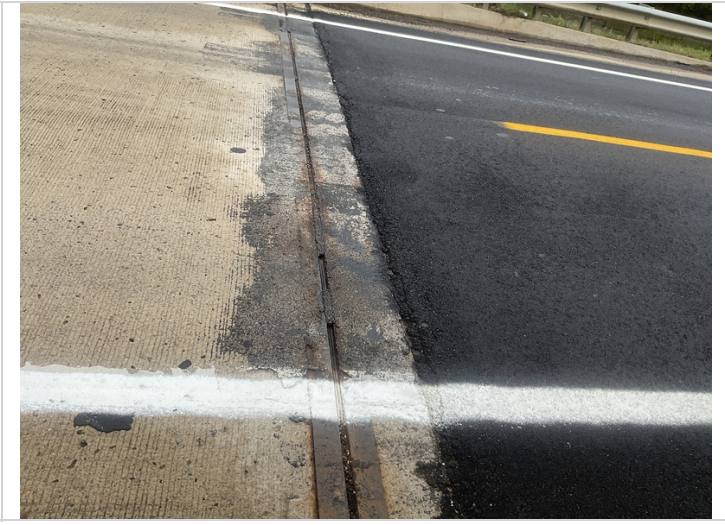
215	Reinforced Concrete Abutment	LF	78	70	8	0	0
1080	Delamination/Spall/Patched Area	LF	1	0	1	0	0
1130	Cracking (RC and Other)	LF	7	0	7	0	0
(215) -The top of the East abutment backwall is covered with a chip seal wearing surface in the driving lanes. -The top of abutment backwalls have hairline transverse cracking at random spacing visible from the driving surface. -There is one shallow delaminated area adjacent to the East abutment.							
225	Steel Pile	EA	24	0	0	24	0
1000	Corrosion	EA	24	0	0	24	0
515	Steel Protective Coating	SF	288	240	0	0	48
3440	Effectiveness (Steel Protective Coatings)	EA	48	0	0	0	48

Top of the East abutment. Typical.

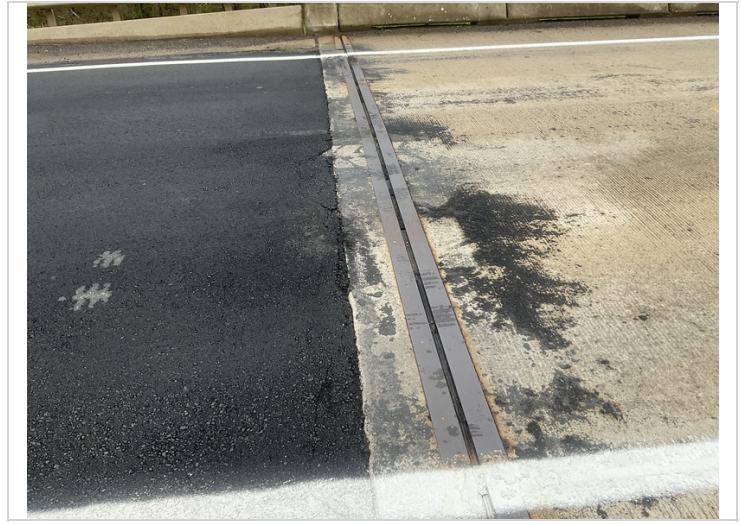
Top of Bent # 1. Abutment backwall.

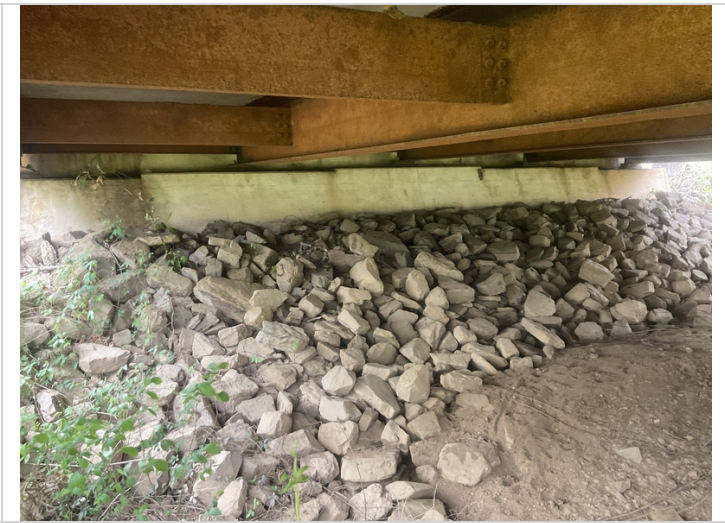
Bent # 1. Typical.

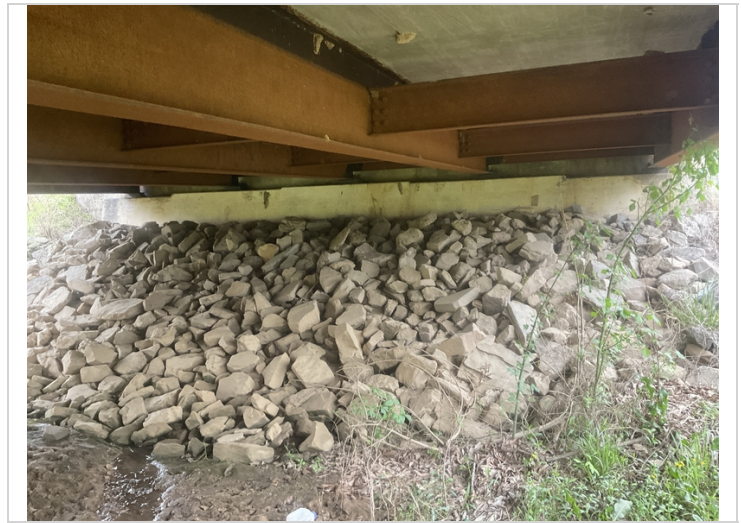
Bent # 8. Typical.

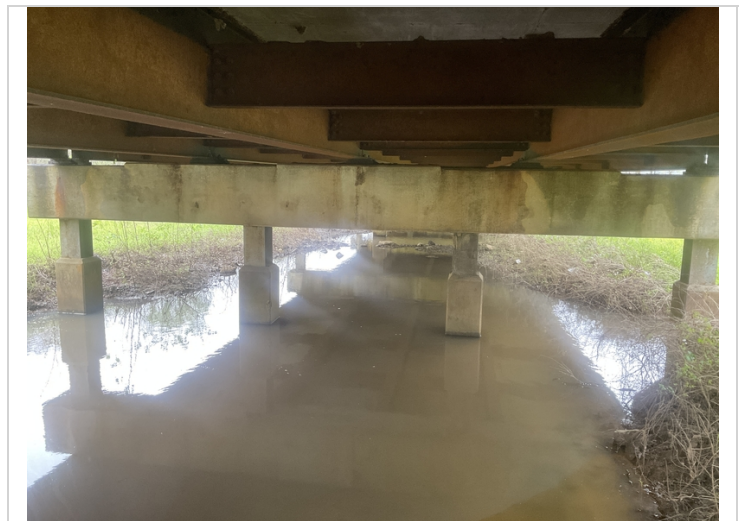
(225) -Steel piles have active corrosion at the juncture of the concrete collars and caps. -Section loss of the flanges range from initial to being reduced down to 1/8" during this inspection. -The tops of some of the concrete collars are delaminated at the steel pile juncture.							
234	Reinforced Concrete Pier Cap	LF	186	138	24	24	0

Steel piles bent # 2. Typical.

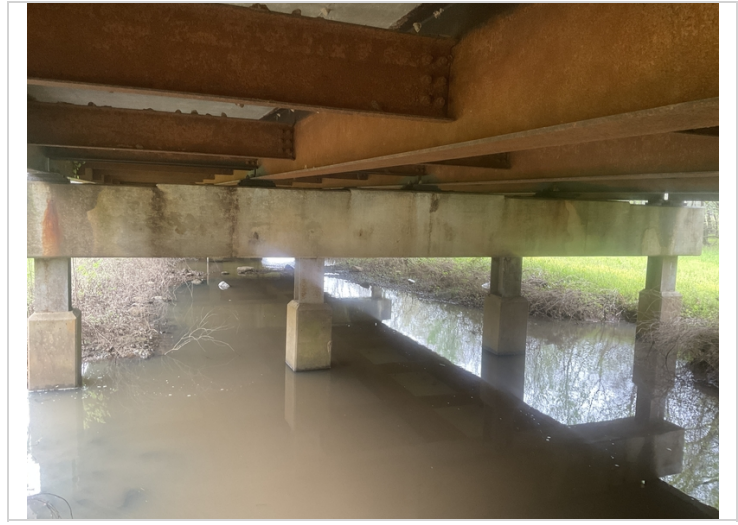
(234) -Intermediate bent caps have delaminated areas, spalls with exposed reinforcing steel and cracks that propagate from the steel pile juncture indicating that there is active corrosion in the top of the steel piles. -The most notable area of spalling is the undersurface of Bent # 7 cap on the Right side which has numerous spalls with exposed reinforcing steel. The exposed reinforcing steel appears to be hoops with insufficient concrete coverage from the construction process. The exposed steel has active corrosion and flaking rust with up to approximately 25% section loss.							
302	Compression Joint Seal	LF	264	24	131	109	0
2310	Leakage	LF	72	0	72	0	0
2320	Seal Adhesion	LF	128	0	40	88	0
2330	Seal Damage	LF	21	0	0	21	0
2340	Seal Cracking	LF	15	0	15	0	0
2360	Adjacent Deck or Header	LF	4	0	4	0	0

Bent # 2. Cap. Typical.

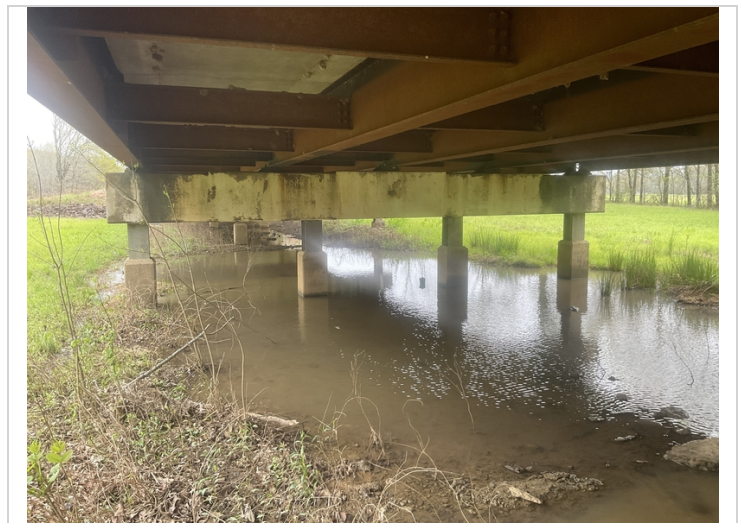
Bent # 5. Typical.

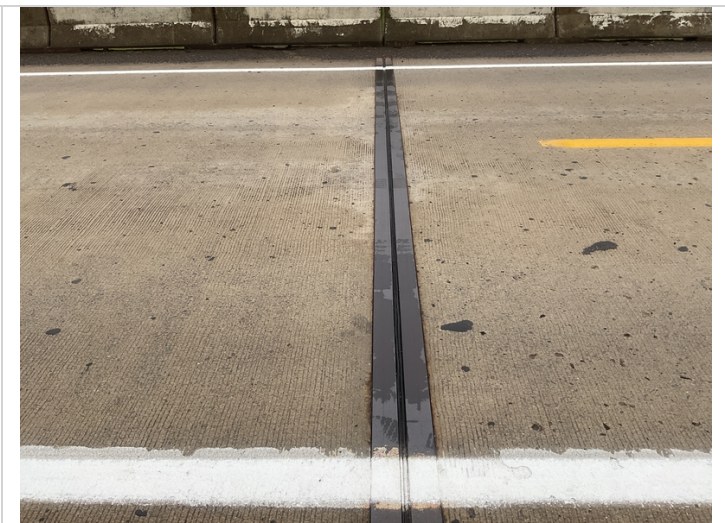
(302) -There are isolated areas with shallow spalls in the adjacent deck. -The compression joint seals are deteriorated with cracking visible in the tops of seals. The assemblies have pack rust throughout that has caused the seals to lose adhesion. -Several of the seals have damaged areas where they stick up above the assemblies. -The substructure caps have staining and the ends of beams have active corrosion where the expansion joints leak water.							
311	Movable Bearing	EA	35	0	12	23	0
1000	Corrosion	EA	35	0	12	23	0
515	Steel Protective Coating	SF	35	0	0	1	34
3430	Oxide Film Degradation Color/Texture Adherence(Steel Protective Coatings)	EA	35	0	0	1	34

Compression joint seal over bent # 7.

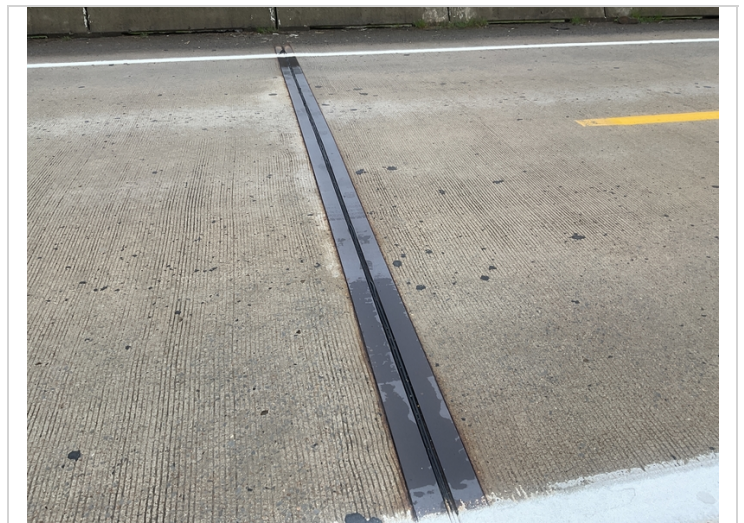
Compression joint seal over bent # 5.

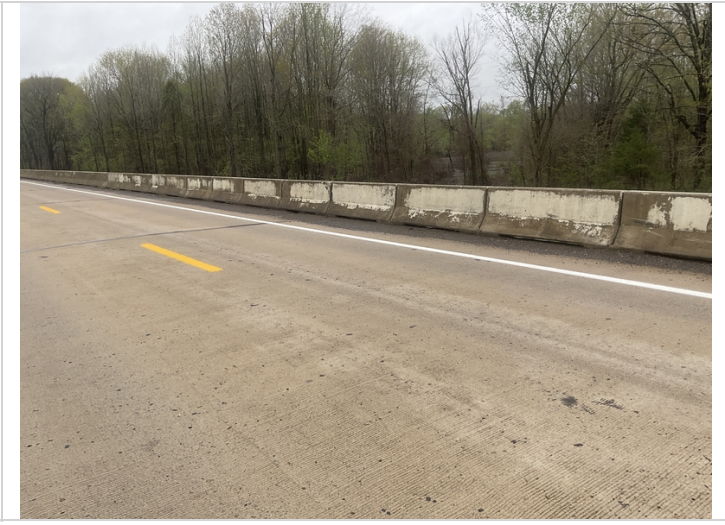
(331) -Cast-in-place concrete New Jersey type parapets with paint coating that is peeling off the interior face of the parapets. -The parapets have vertical cracks that correspond with the joints in parapet and adjacent to the drain openings.

Left parapet. Typical.

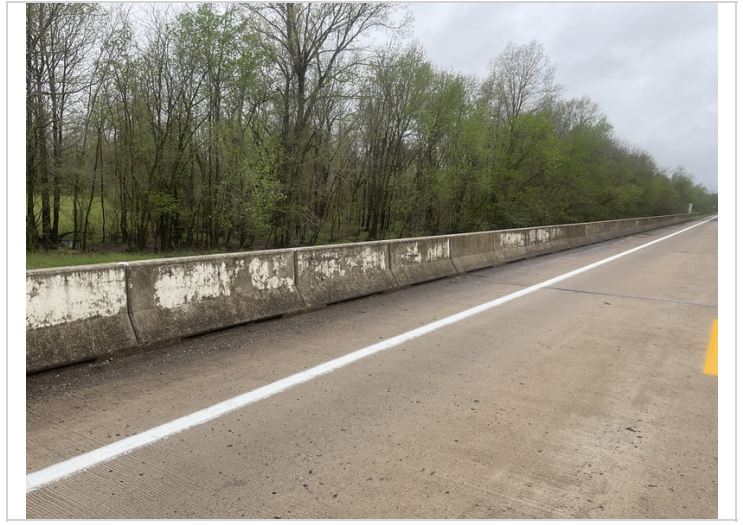
Right parapet. Typical.

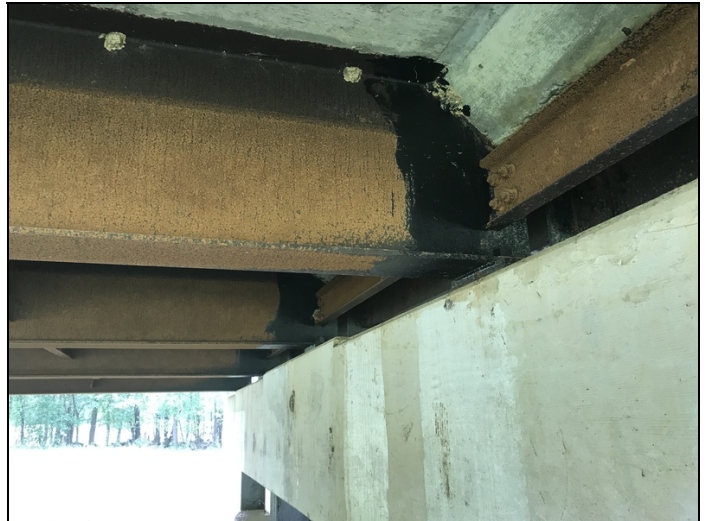
Bridge mate applied to the beam ends in some locations.

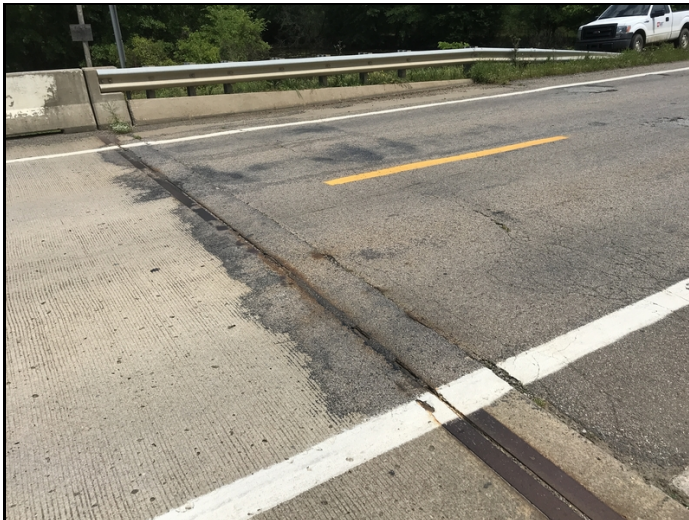
Bent # 8 minor asphalt settlement.

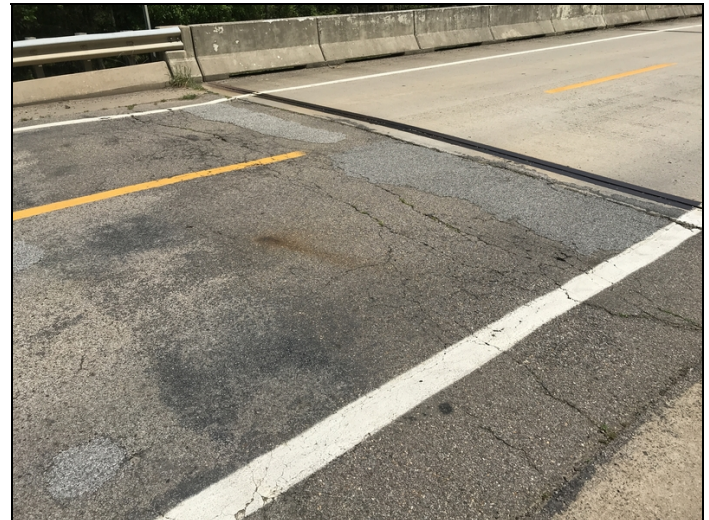
Bent # 1 approach roadway asphalt breaking apart and minor settlement.

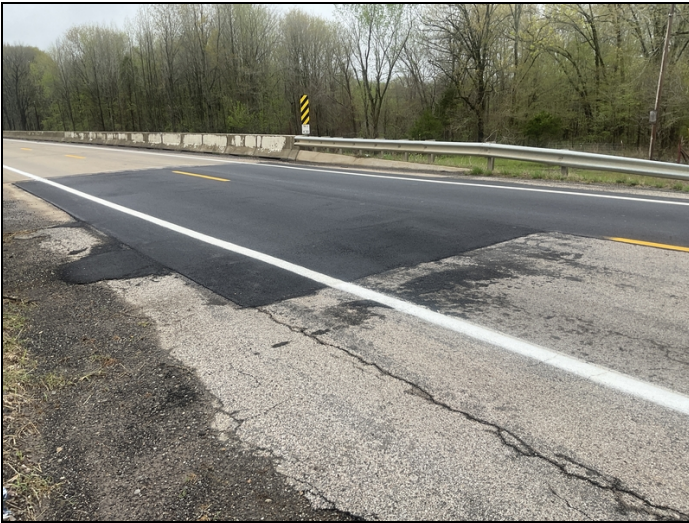
JCJ & TJL - 04/20/2022 - There is new asphalt at both approaches placed since the previous inspection.

East approach. New asphalt roadway.

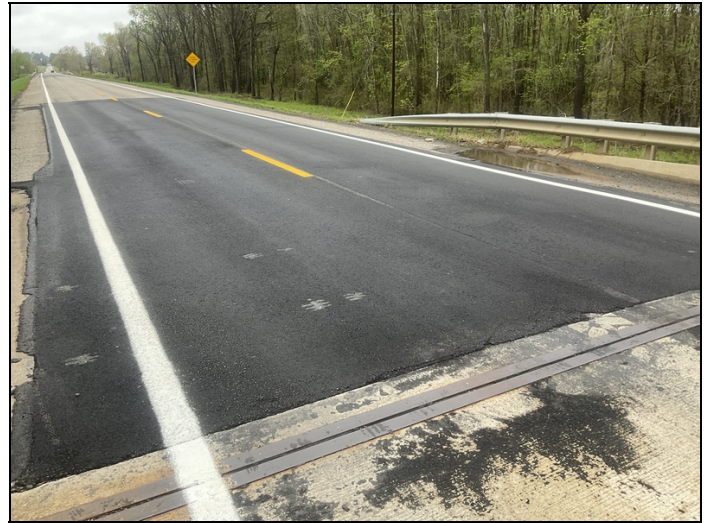
West approach roadway. New asphalt roadway.

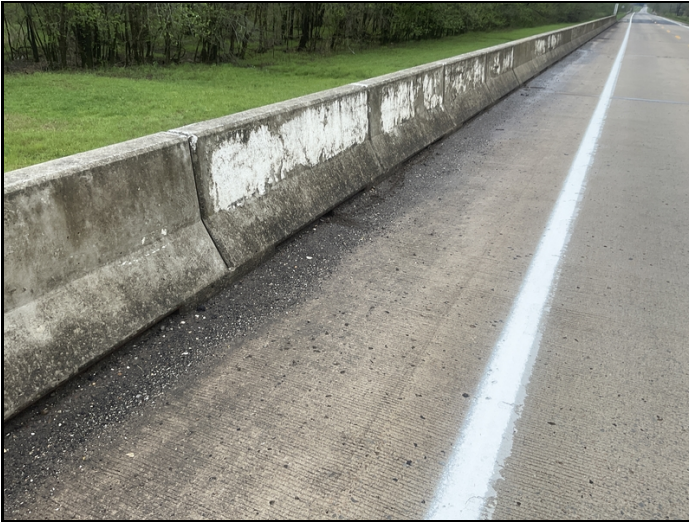
There is debris accumulation in the gutters of the deck.

Right gutter. Debris accumulation.

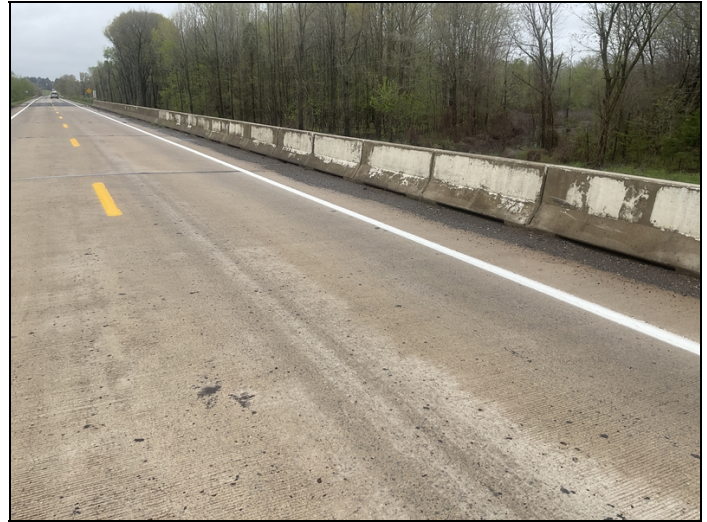
Left gutter. Debris accumulation.
