Asset #03097(Routine, Underwater type 2)  
State Highway 45 over Fly Creek-Washington Co.  
Location: 1.95 MI E JCT OF SH 59  
Team Lead: Jeff Jones Inspection Date: 10/10/2024

(37) Historical Significance	5 - Bridge is not eligible for
CONDITION	
(58) Deck	4
(59) Superstructure	4
(60) Substructure	4
(61) Channel & Channel Protection	5

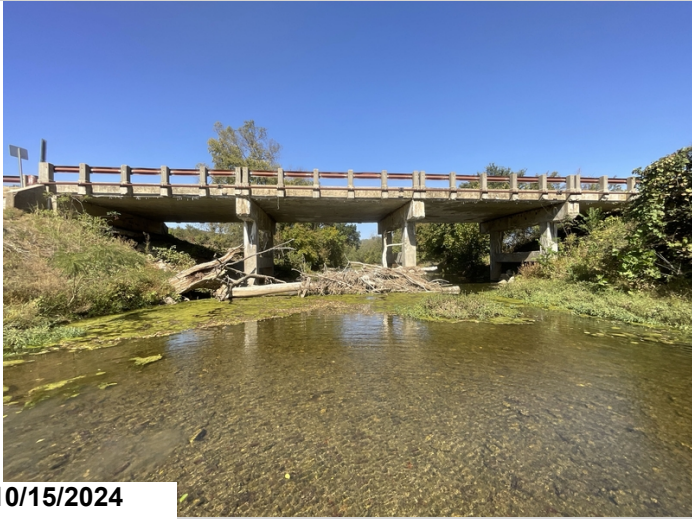
Elevation. Right side of structure.

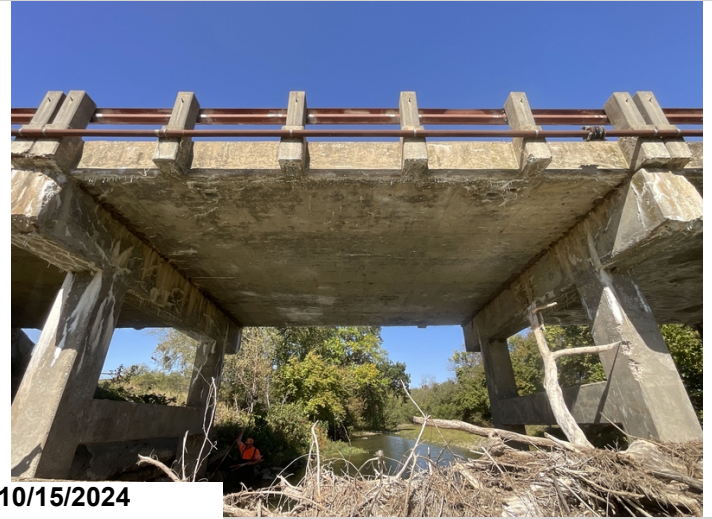
Undersurface of Span 2. Typical.

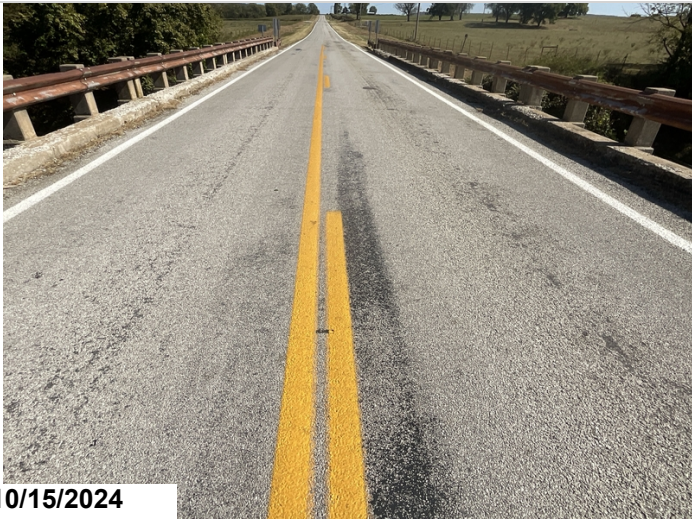
Deck. Typical.

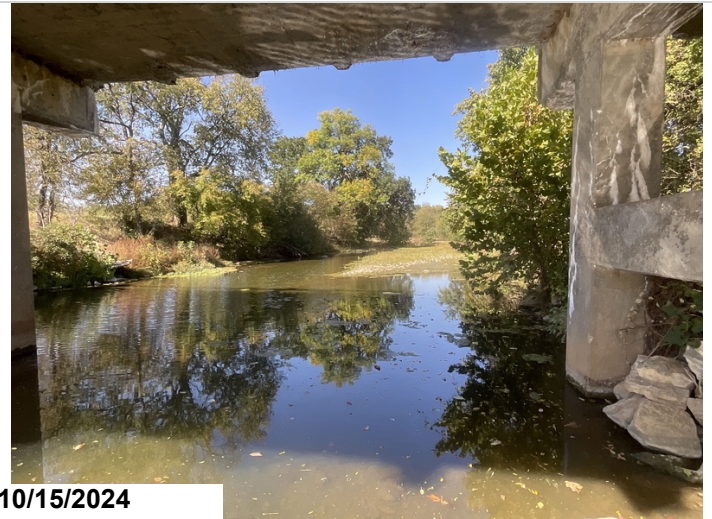
There is some embankment erosion observed on the Left and Right ends of the structure.

Channel, Left side of structure.

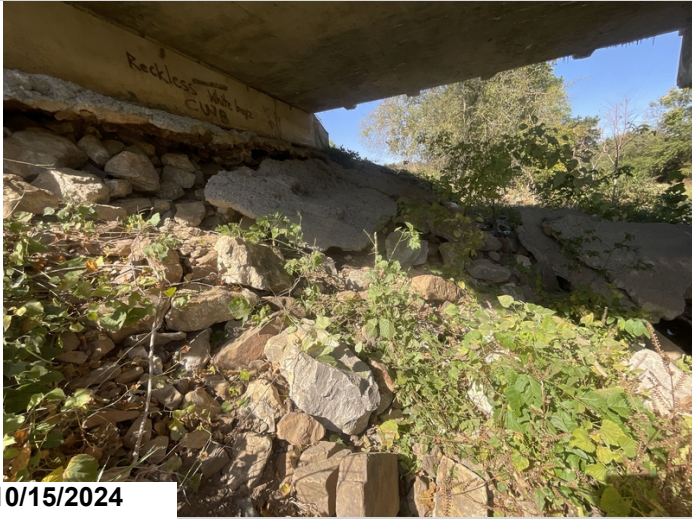
Abutment 1. Left embankment.

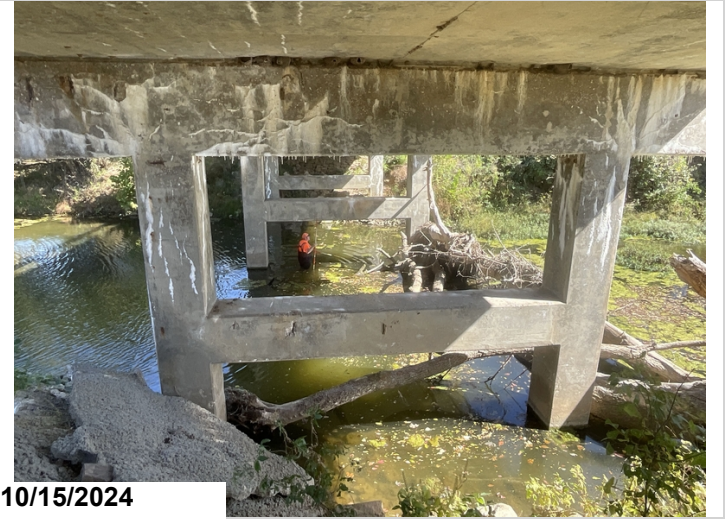
Loose gravel located at the base of all footings approximately 6" below the top of the footings.

Probing substructure footings.

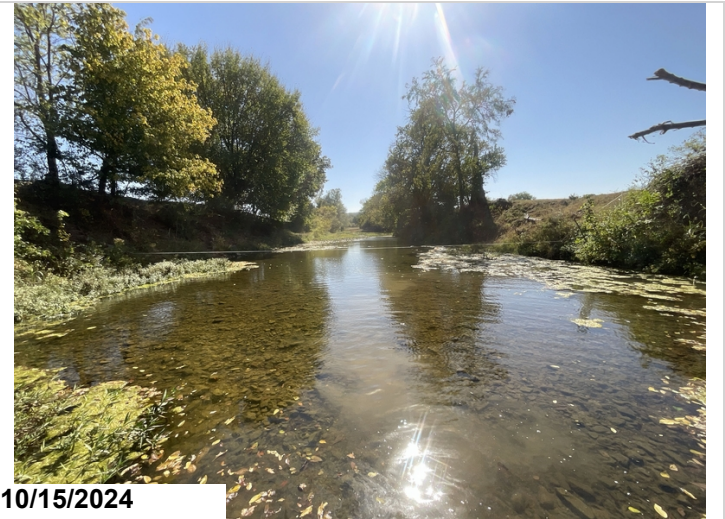
Channel. Right side of structure.

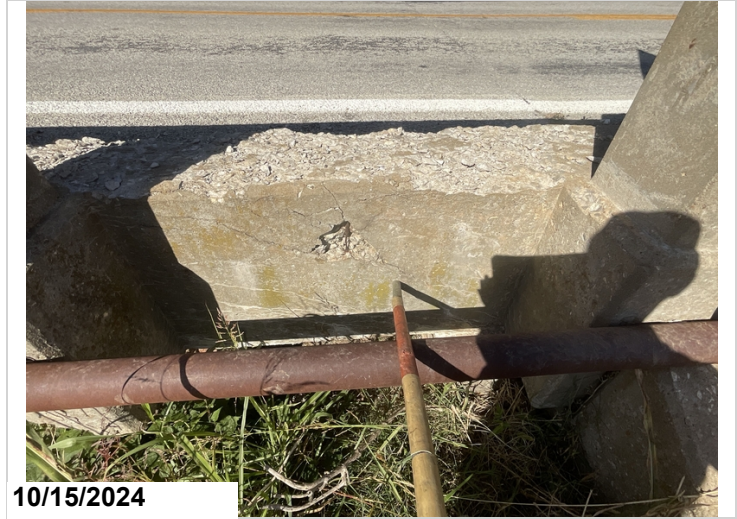
Span 4, Abutment 2, Right side of slab.

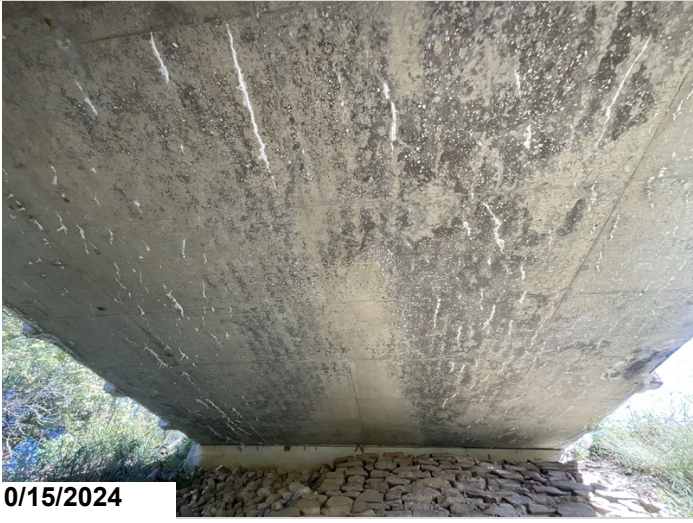
Span 4, Undersurface of the deck. Typical.

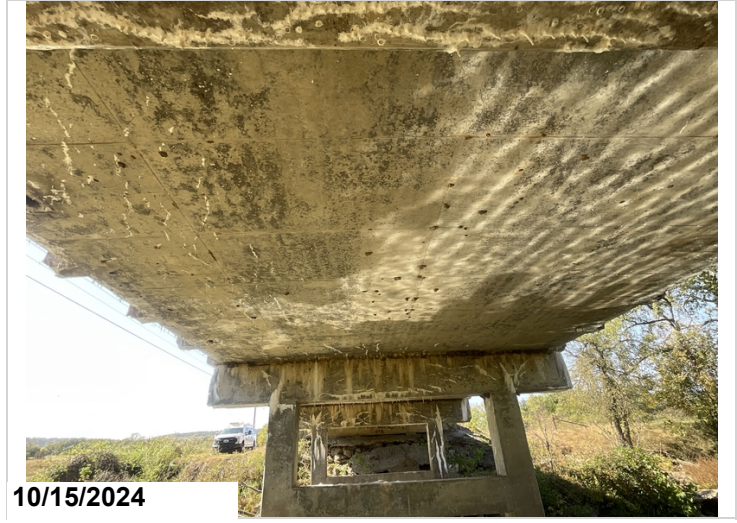
Span 3. Undersurface of the deck. Typical.

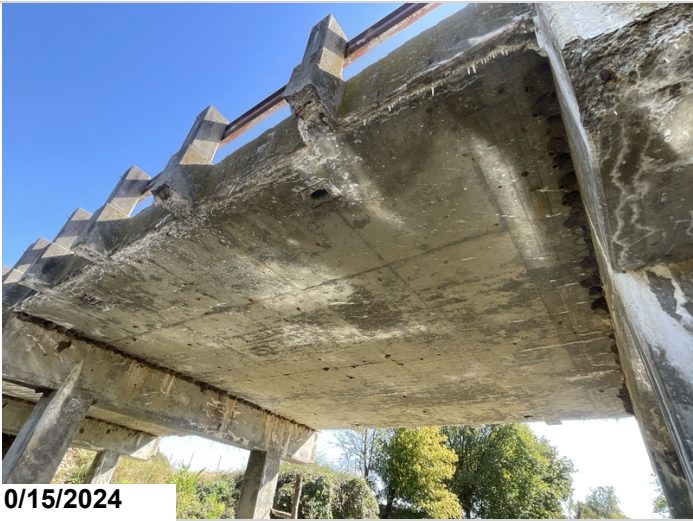
Span 2, Undersurface of the deck. Typical.

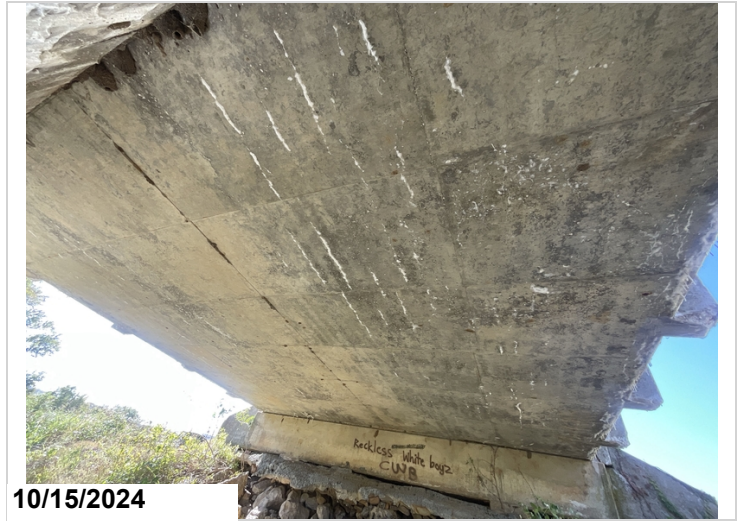
Span 1, Undersurface. Typical.

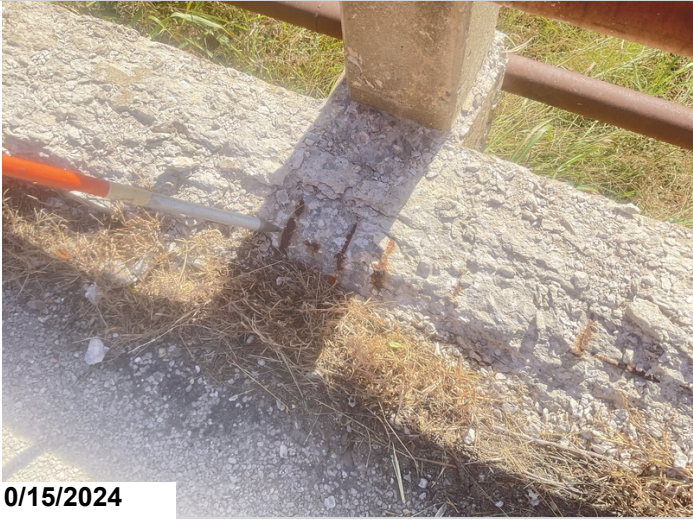
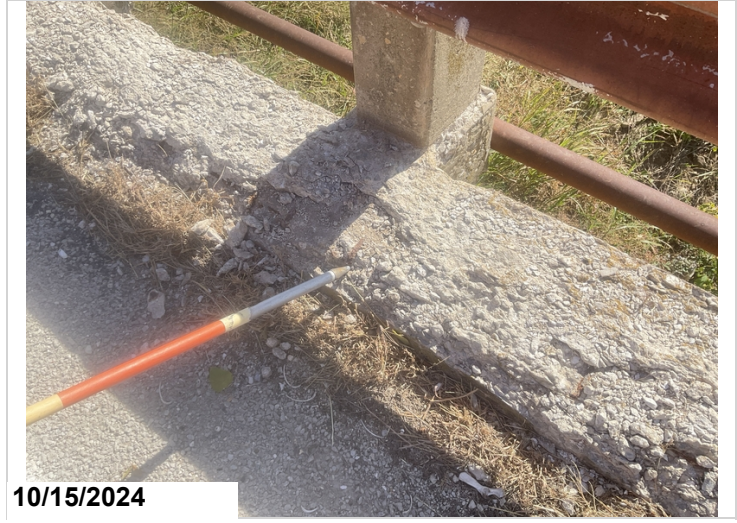
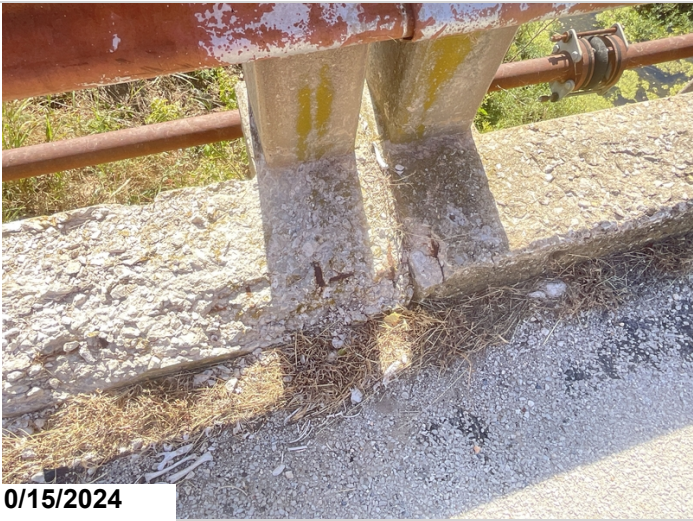
Right curb.

The deck has soft and deteriorated concrete with delaminated areas in the gutters on the left and right sides of structure. The concrete curbs have areas that are soft and deteriorated with heavy scaling. Span 4 right has a large spalled area with exposed reinforcing steel that has initial section loss.

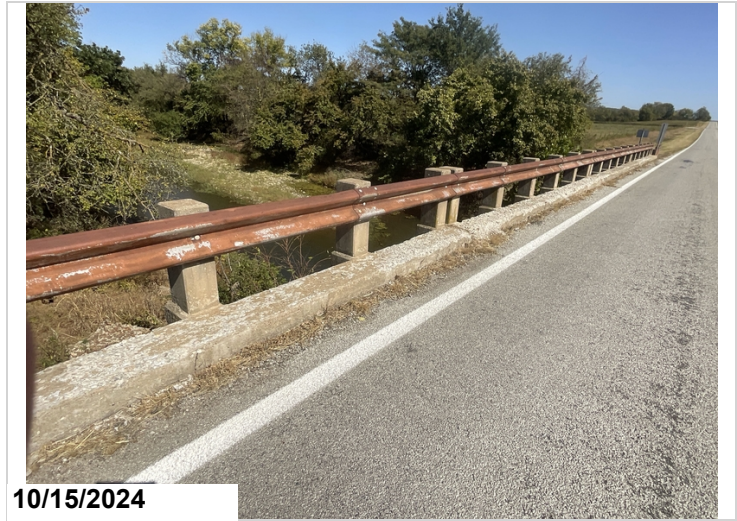
Deck. Left curb. Typical.

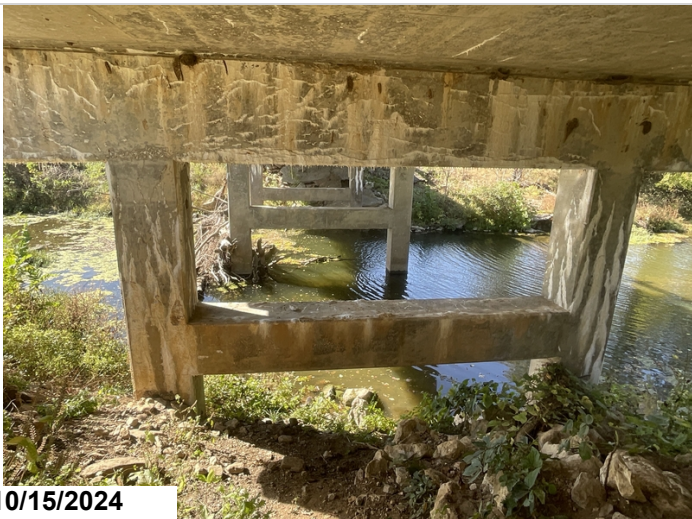
Bent 4 columns. Typical.

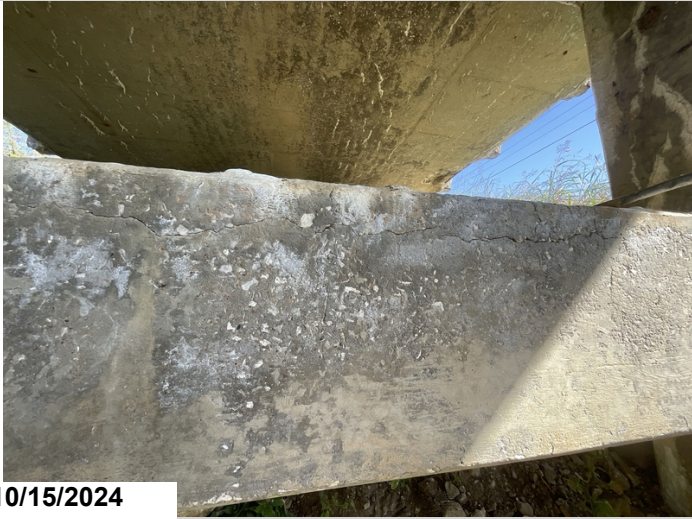
Bent 4 strut. Back face.

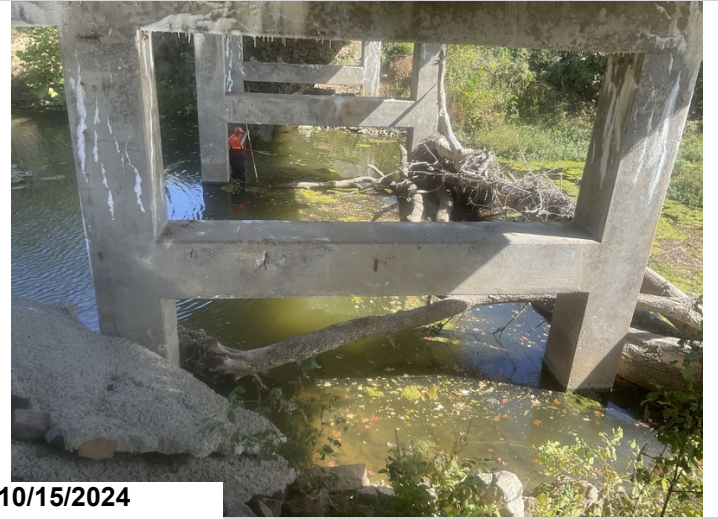
Bent 2, Back Face: Typical.

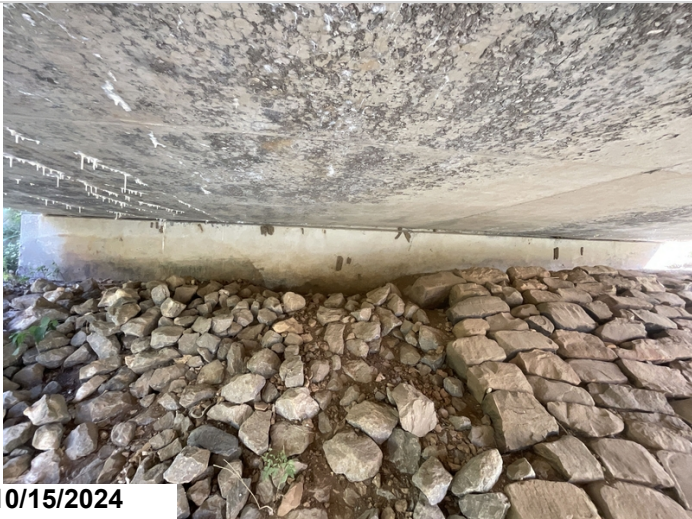
Abutment 2: Typical.

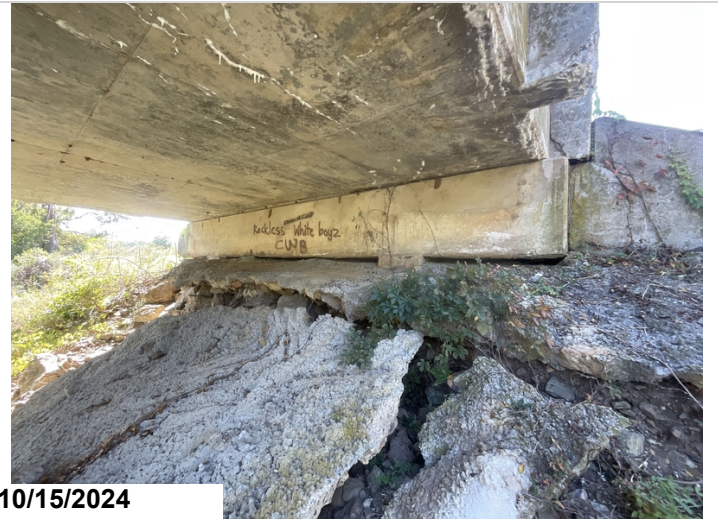
-Abutment # 1 has earth settlement under the cap with failing concrete repairs.

Abutment 1: Typical.

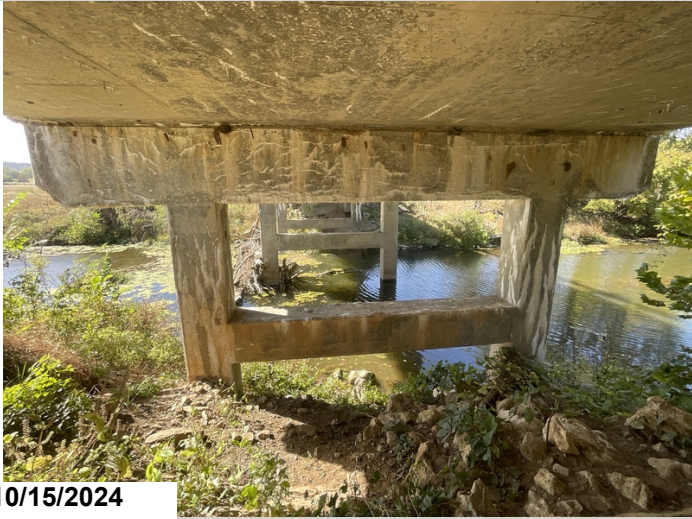
Bent 4, Ahead face.

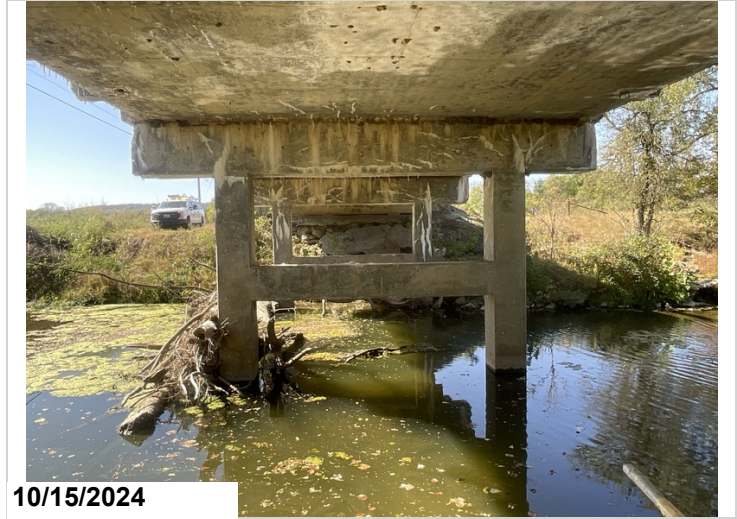
Bent 3, Ahead face. Typical.

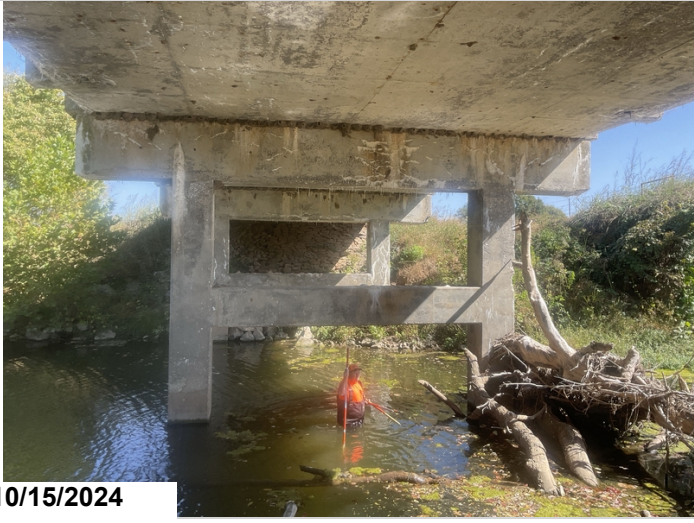
Bent 3, Back face. Typical.

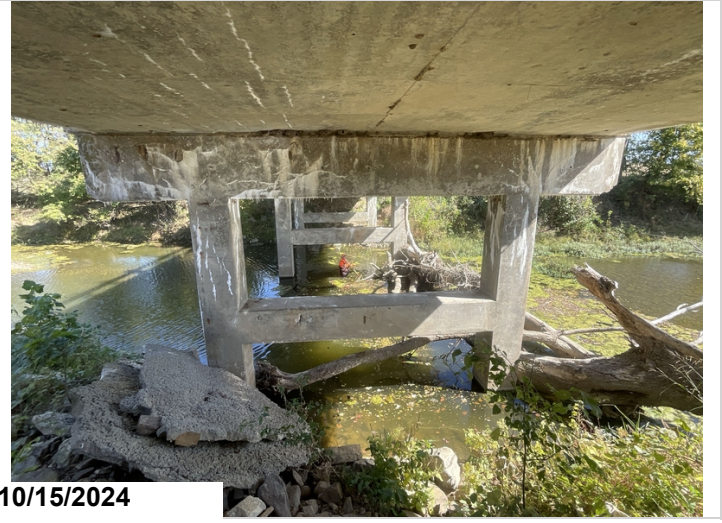
Bent 2, Back face. Typical.

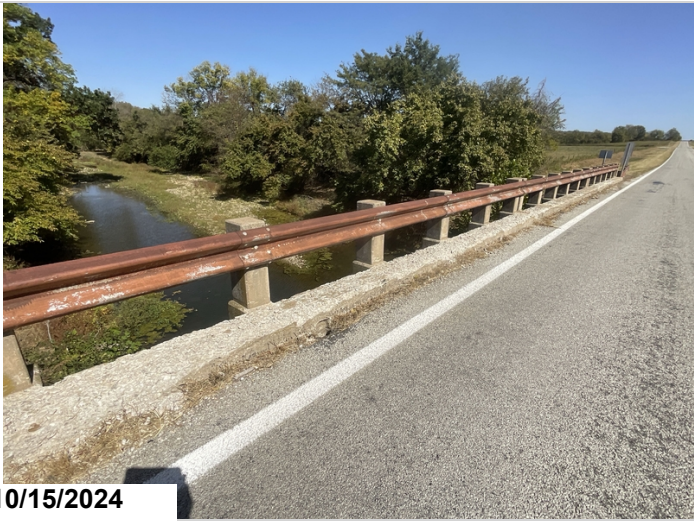
Left bridge railing. Typical.

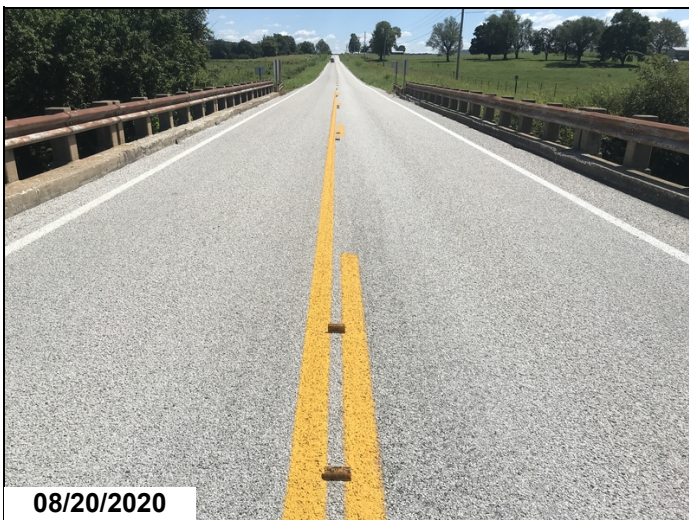
08/19/2020 - RSM - A Routine Inspection revealed that Maintenance Forces have applied a new Chip and Seal Wearing surface since last inspection. Deficiencies in the gutters not visible during this inspection.

New chip and seal wearing surface.

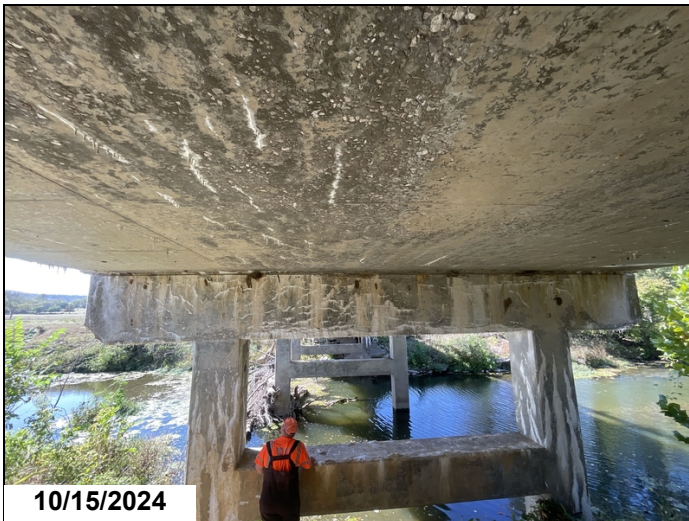
The intermediate bents have heavy map cracking with concrete deterioration and efflorescence throughout. The ends of the intermediate caps have concrete section loss with exposed reinforcing steel and delaminated areas in some locations. Bent 4 is the most extreme case with heavy cracking with efflorescence, delaminated areas, and concrete deterioration that exposes reinforcing steel in the ends of the cap.

Bent 4 cap.

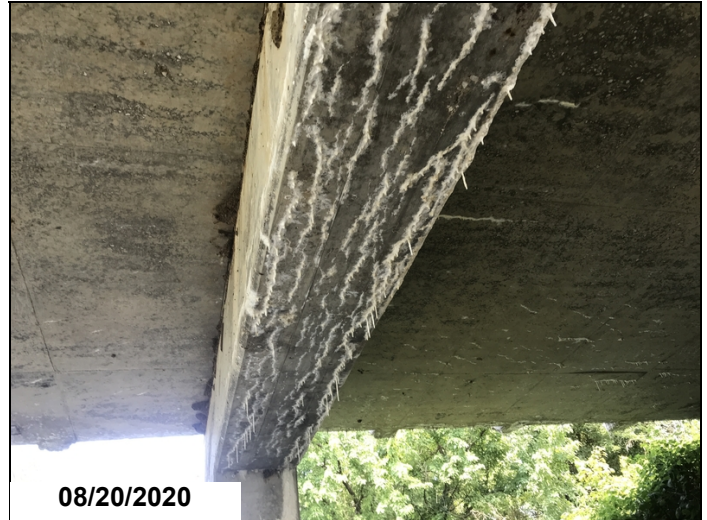
Undersurface of bent 4 cap.

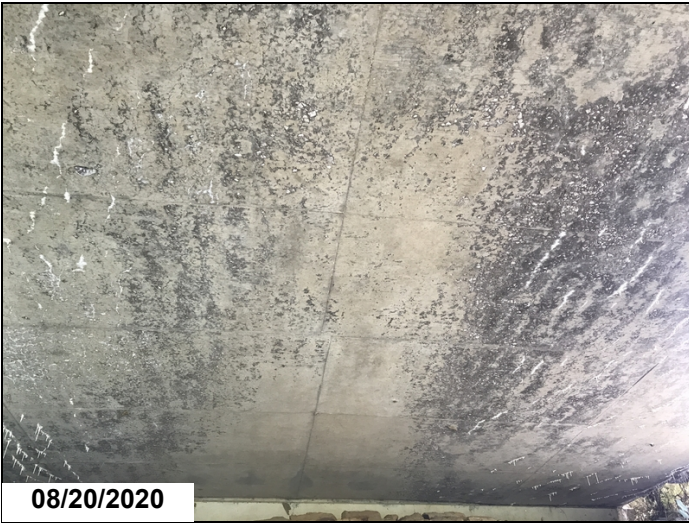
Span 4 undersurface.

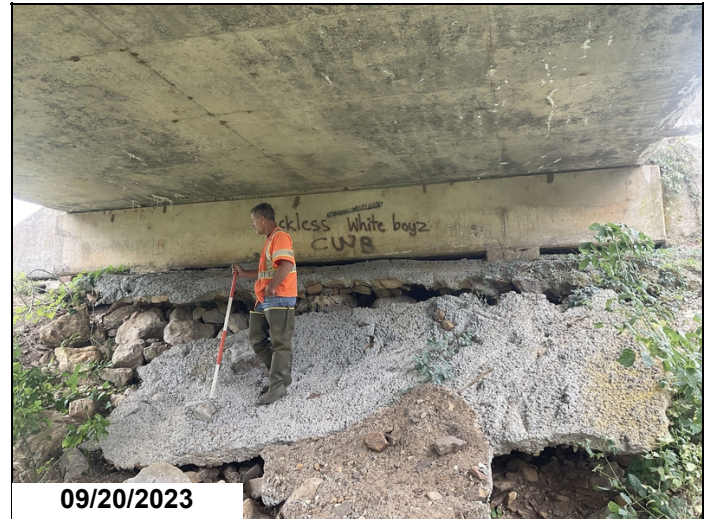
Abutment 1 typical.

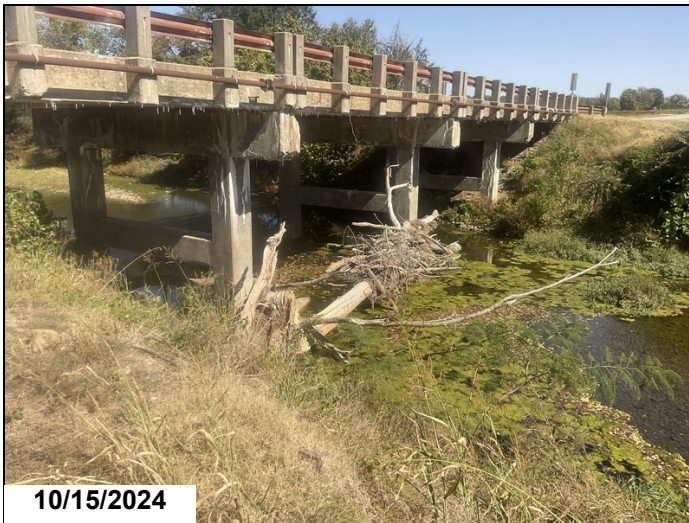
Drift
