Asset #A6237 (Routine, Underwater type 2)
I-49 Southbound over Ravine-Washington Co.

Location: 11.4 MI N. OF WASH.CO.LN

Team Lead: Eric West, Inspection Date: 12/12/2022

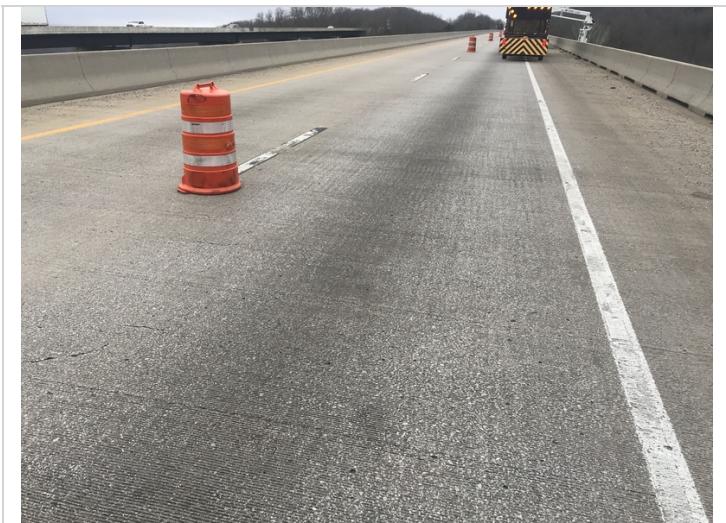
Driving surface of the deck. Typical.

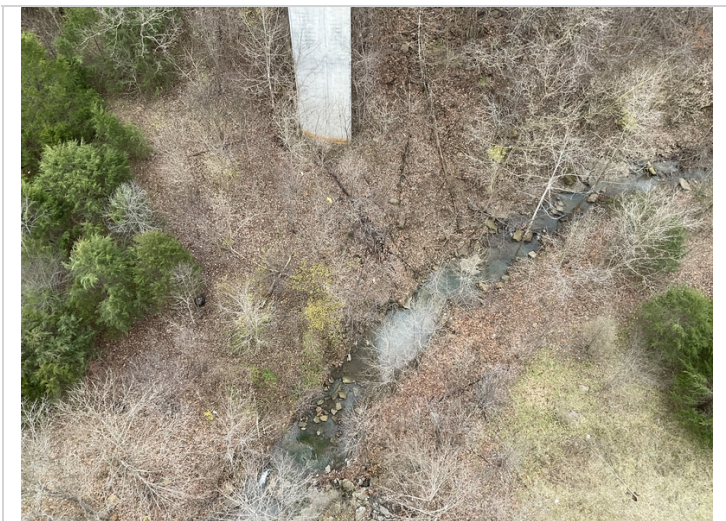
Footing has cover.

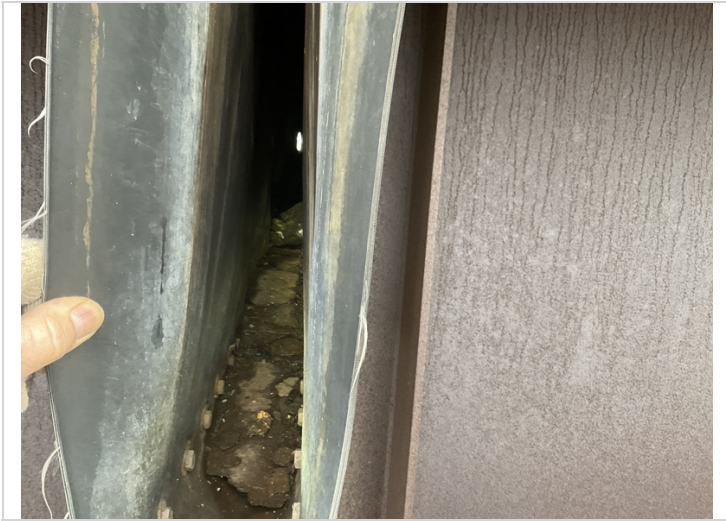
Bent #3 trough with debris accumulation.

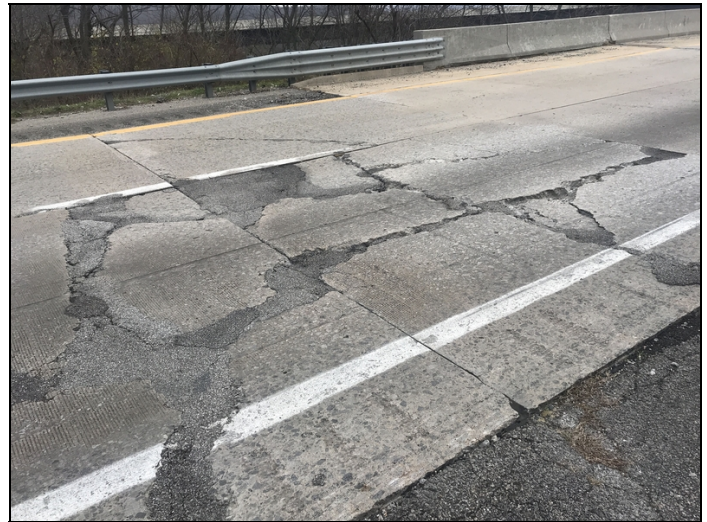
Approach roadway at the north end of structure is settling and breaking apart.

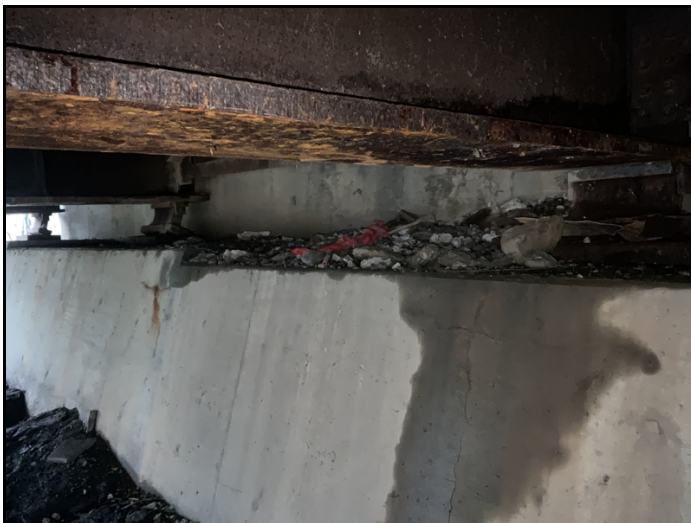
Abutment #1 bearings fully expanded.

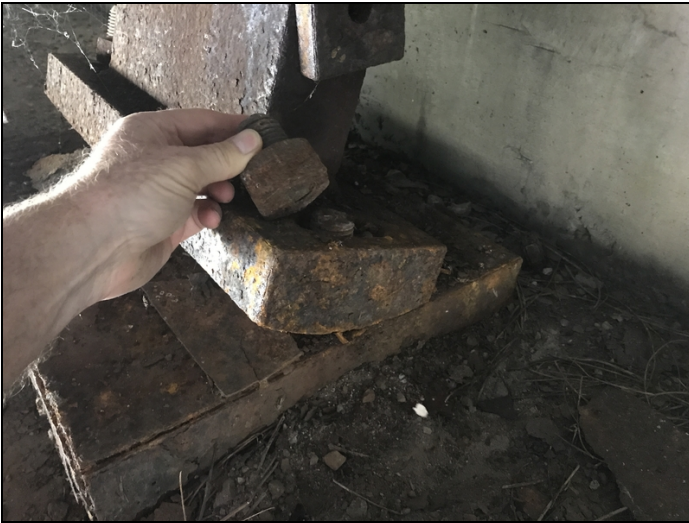
The left anchor bolts for bearings # 2 and # 3 at the South abutment are sheared off. The remaining anchor bolts are leaning out of plumb.

The bearings at abutment # 1 are fully expanded during this inspection with an approximate temperature of 80 degrees Fahrenheit. The left anchor bolts are sheared off at bearings # 2 and # 3 at abutment # 1. The remaining anchor bolts are leaning out of plumb.

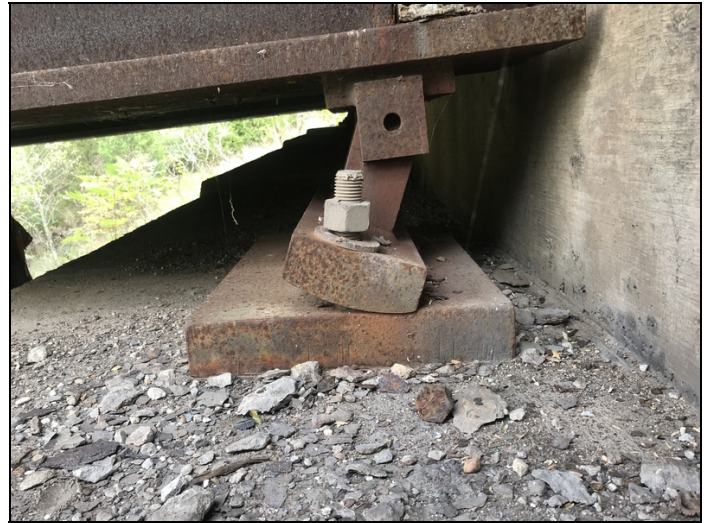
Abutment # 1, bearing 1-Fully expanded with sheared off bolt that attaches girder to bearing device.

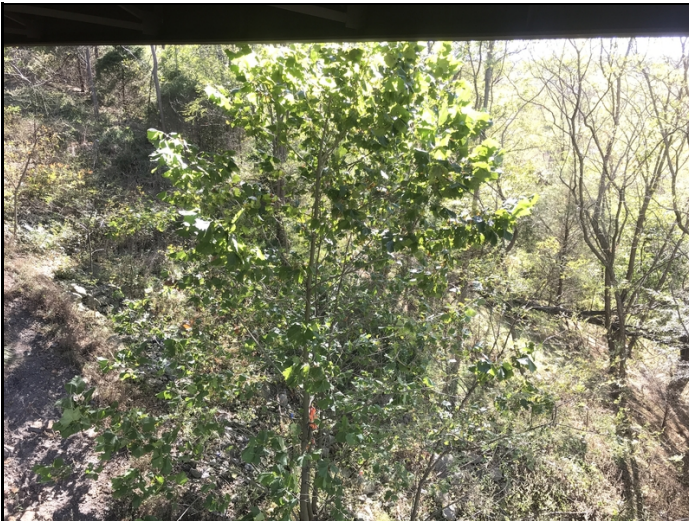
The Southwest embankment (Left side of Span # 1) has a tree growing under the structure that restricts inspection access with the Under Bridge Inspection Vehicle.

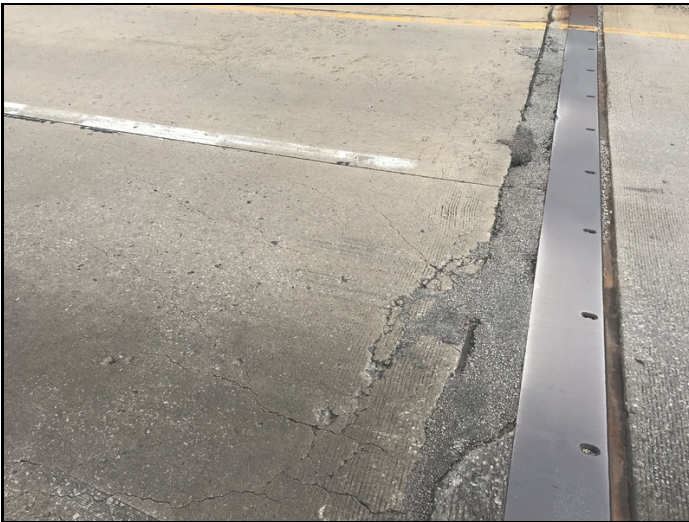
The north approach slab adjacent to the north abutment is beginning to break apart.
