**Asset #B6237** (Routine, Underwater type 2)  
**I-49 Northbound over Ravine-Washington Co.**

**Location: 11.4 N. OF WASH CO LINE**

**Team Lead: Eric West, Inspection Date: 12/12/2022**

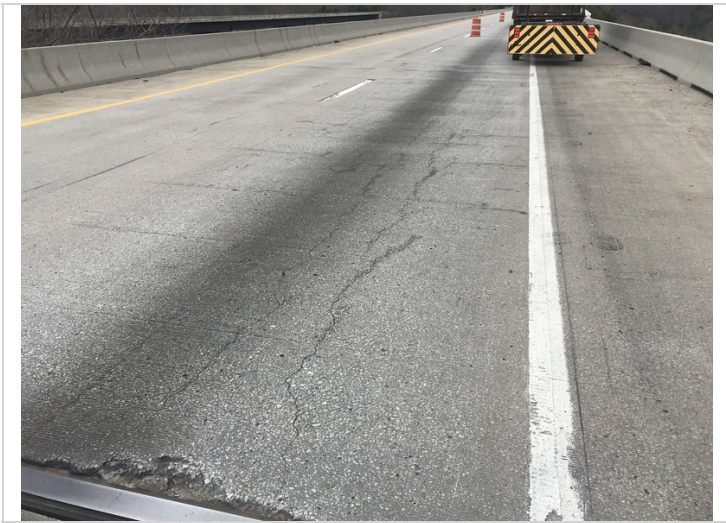
Typical driving surface of the deck. Span # 1

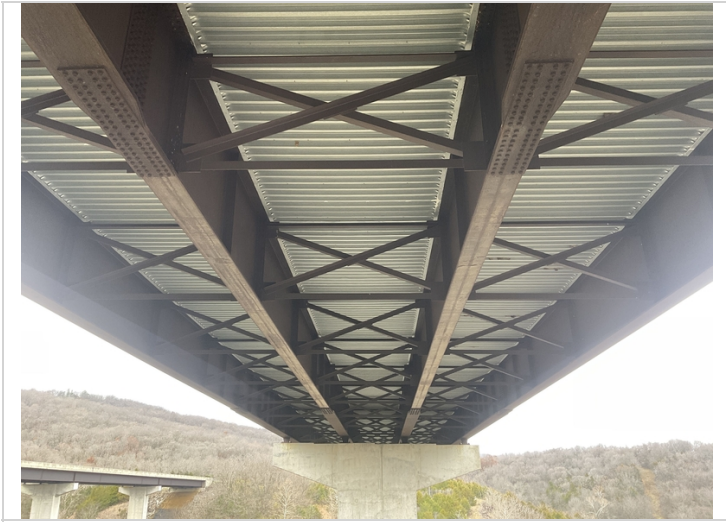
Span # 2 typical undersurface of the deck.

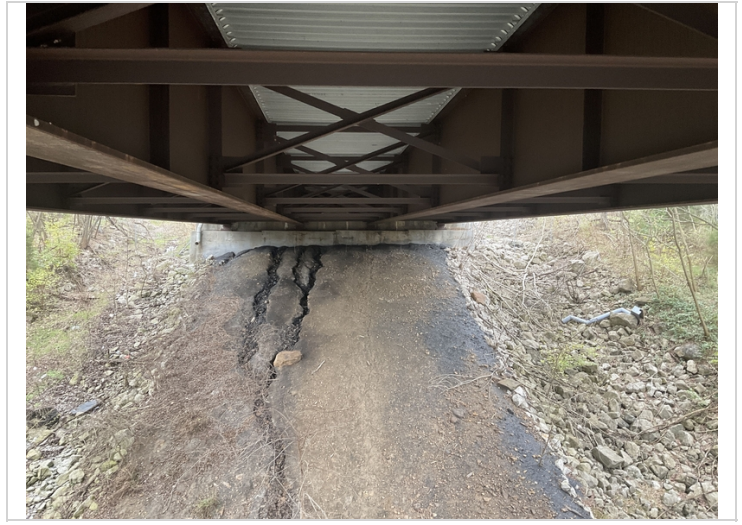
Abutment # 1 typical.

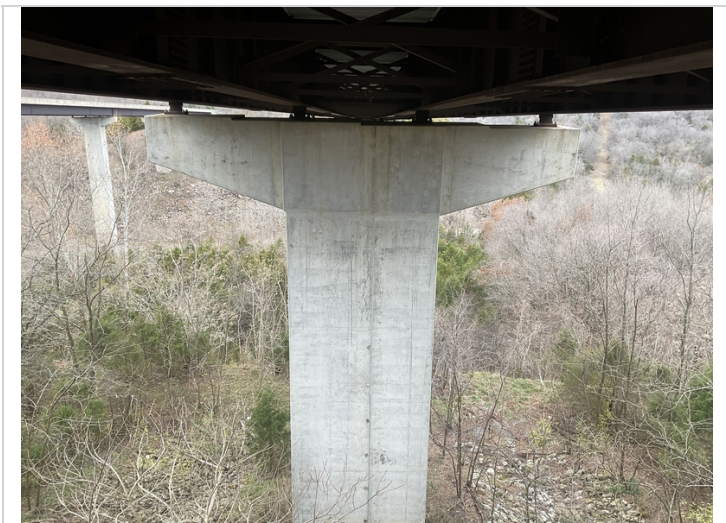
Bent # 2 typical.

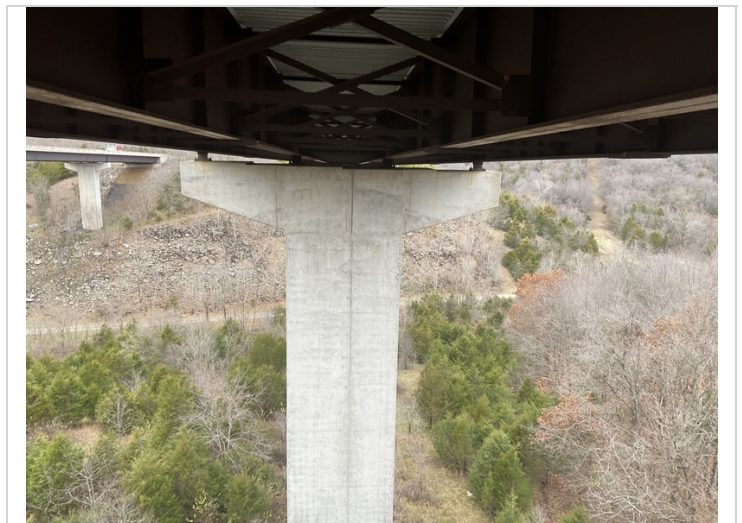
Bent # 3 typical.

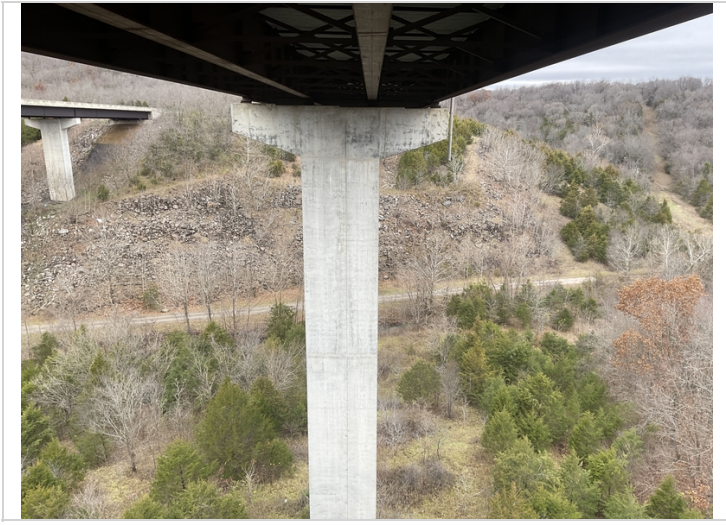
Bent # 4 typical.

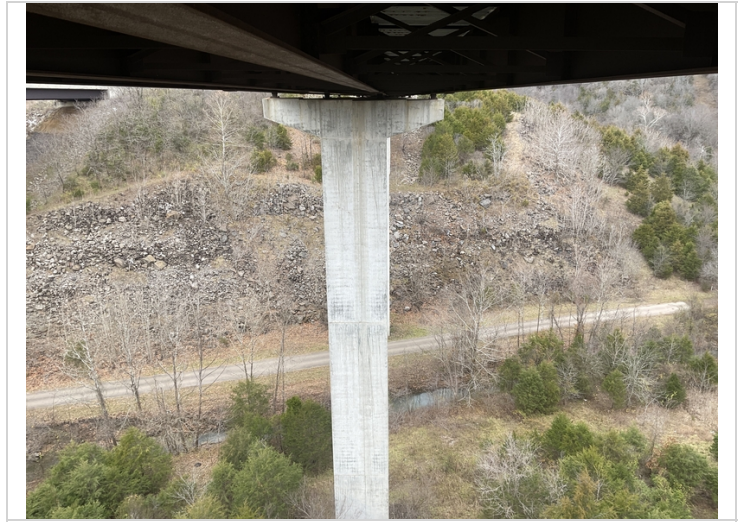
Bent # 5 typical.

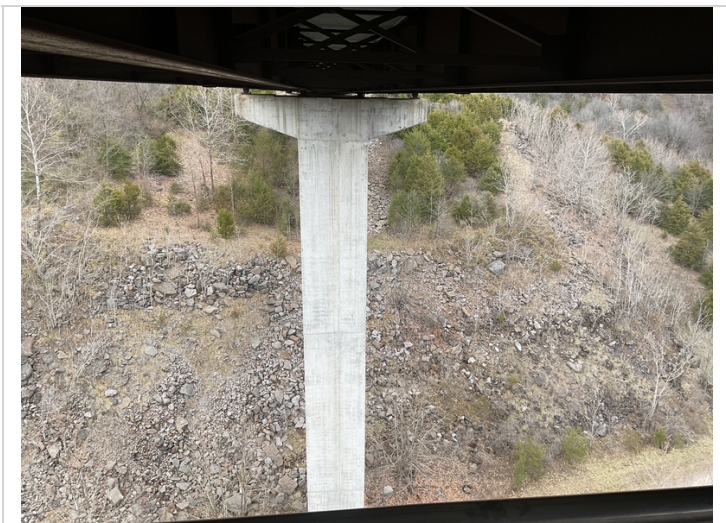
Bent # 6 typical.

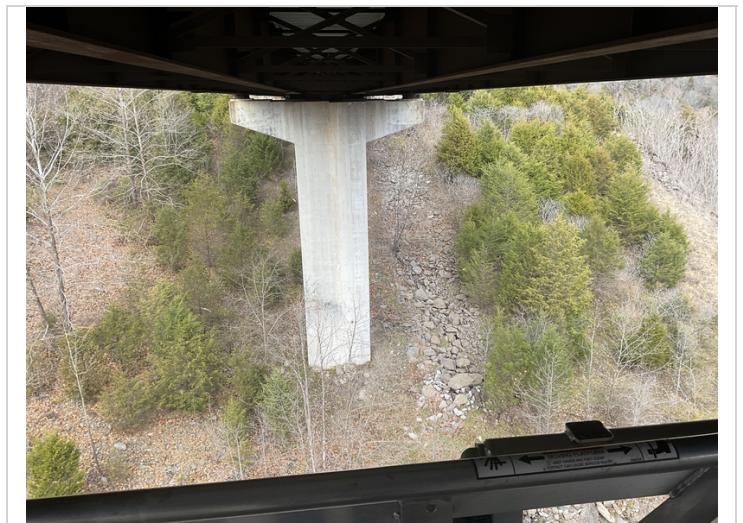
Bent # 7 typical.

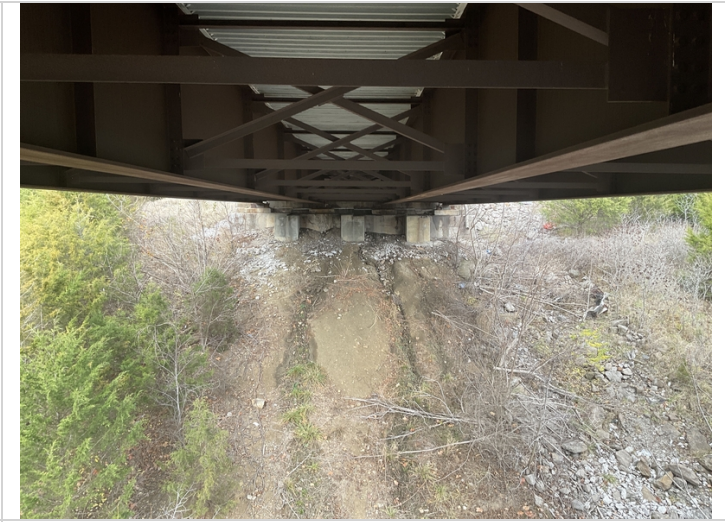
Abutment # 2 typical.

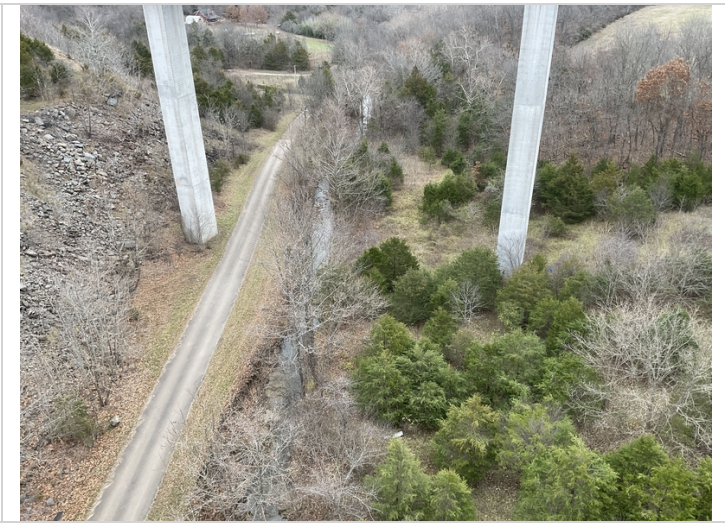
Footing has cover.

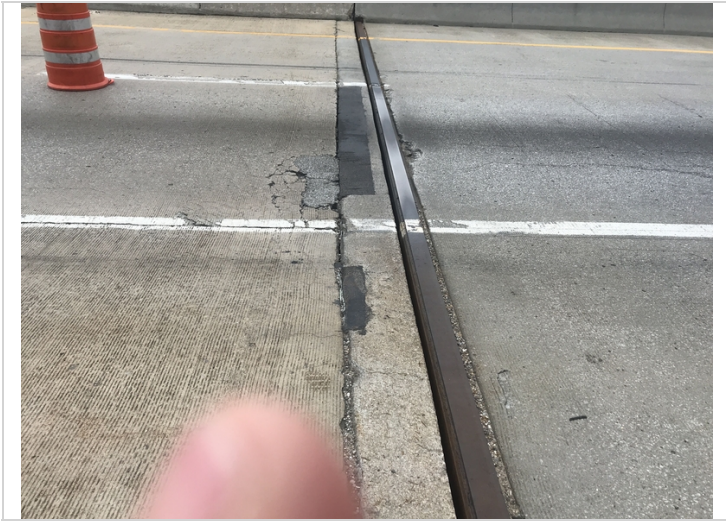
Abutment # 1 top of the backwall typical.

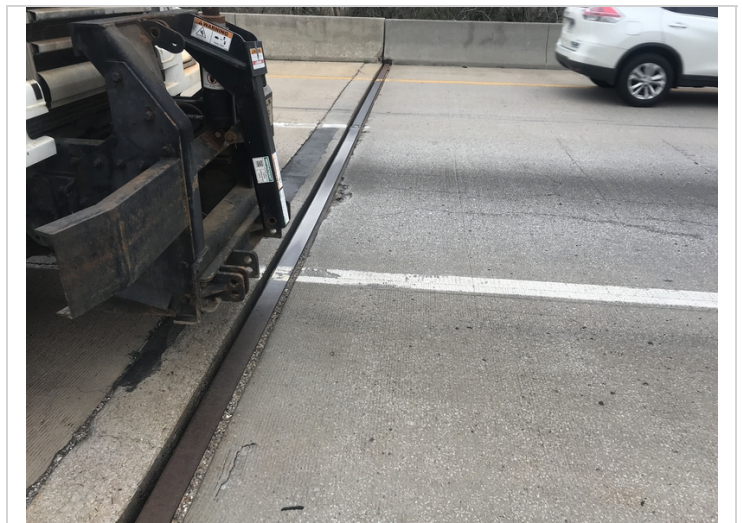
The expansion joints at both bridge ends have no seals allowing water, dirt and debris to leak onto the substructure and superstructure causing abnormal weathering / corrosion to the beam ends and bearing devices.

Abutment # 1 open expansion joint typical.

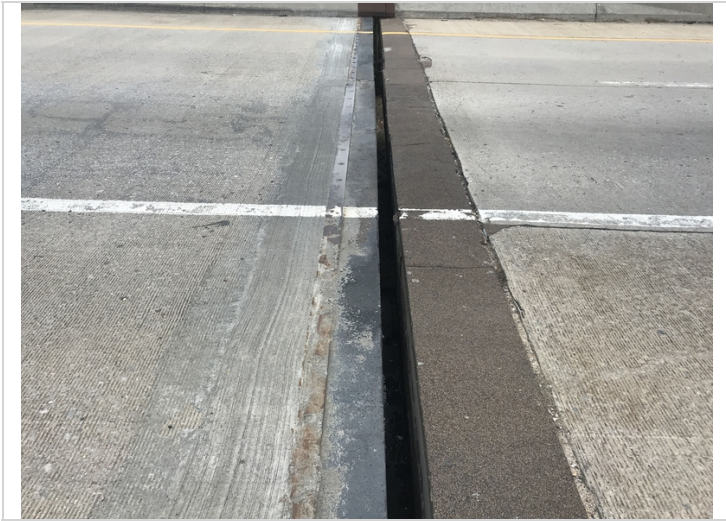
Abutment 2 open expansion joint.

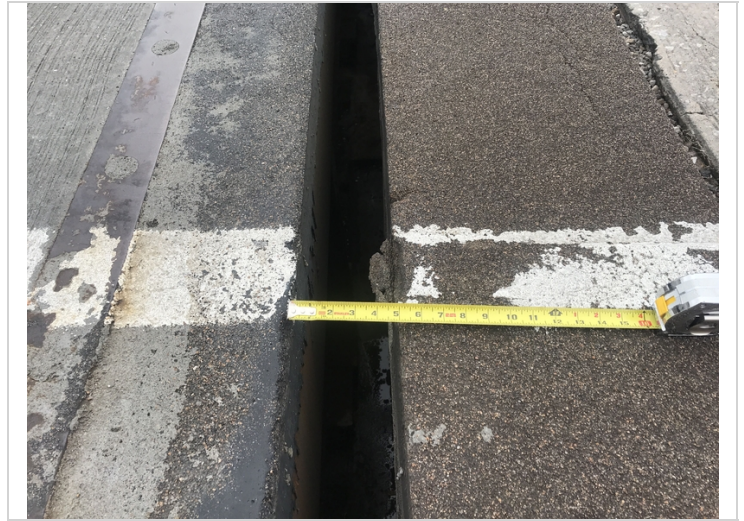
Abutment # 2 with a 5" wide open expansion joint measured at the white line.

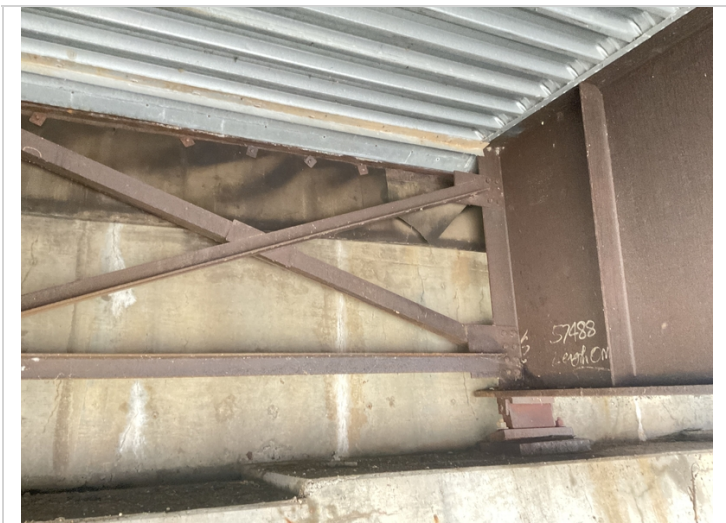
Abutment #1 trough tear adjacent to girder #2.

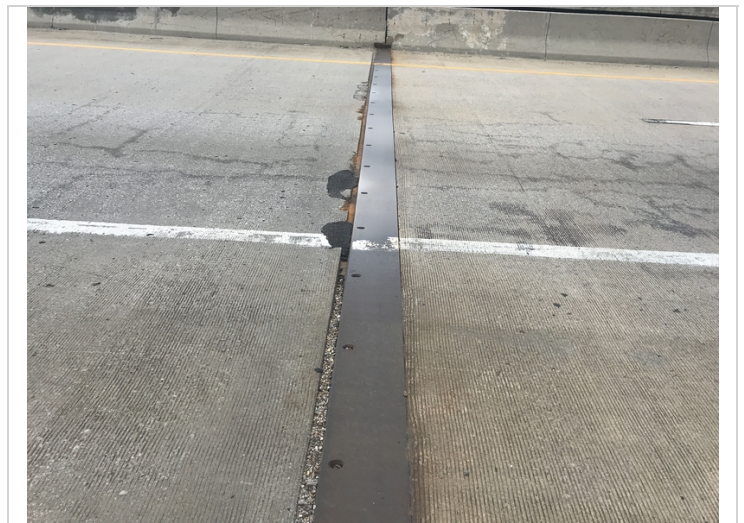
Bent # 4 sliding plate expansion joint typical.

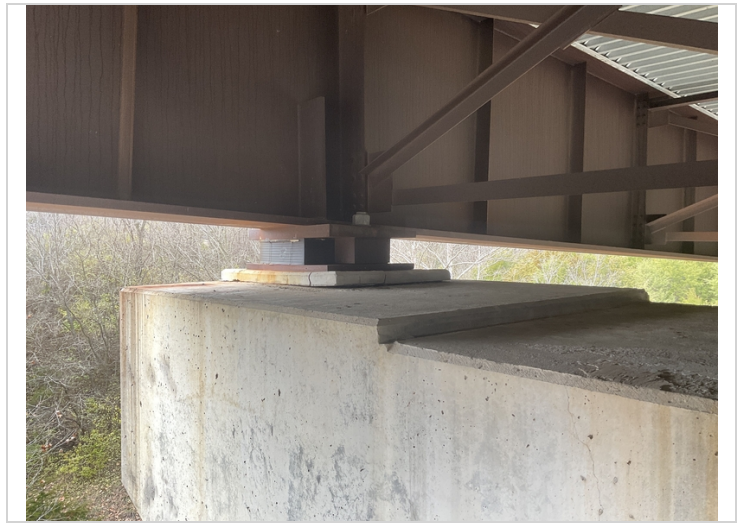
Bent # 7 beam #1 pedestal delaminated from the cap.

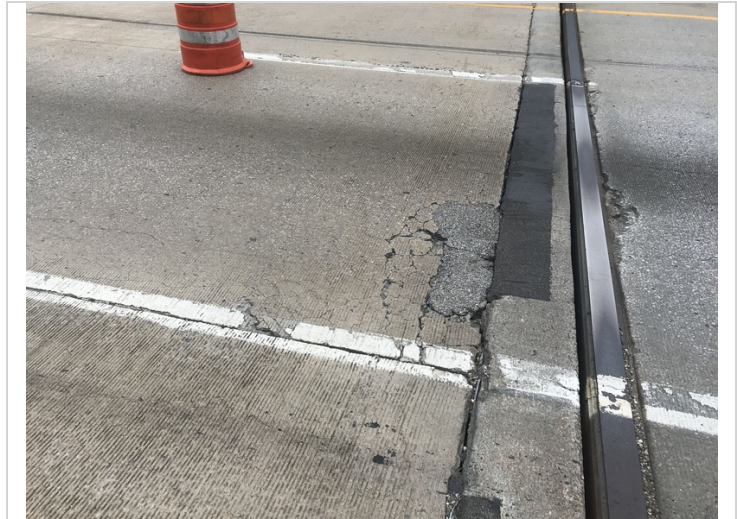
The driving surface of the deck has sealable transverse, longitudinal, and map cracking. The North and South approach slabs have map cracking with areas that are beginning to spall. The overhang portion of the deck on the right side of Span # 6 has a failing repair with exposed reinforcing steel.

The south approach slab is breaking apart adjacent to the abutment # 1 backwall.

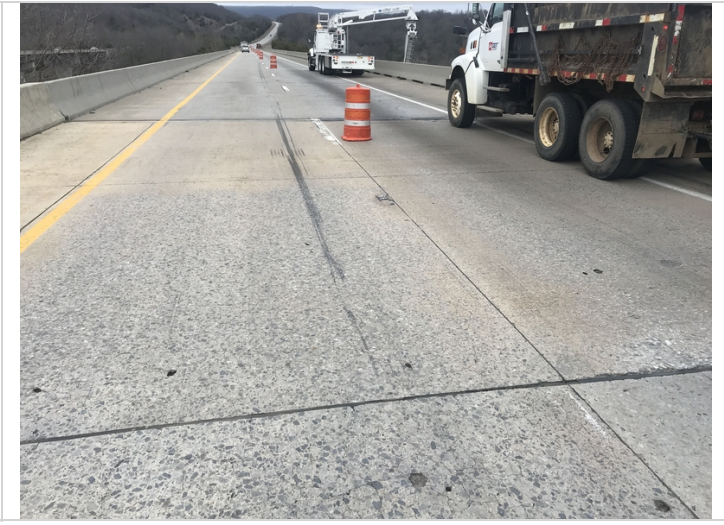
South approach slab. Typical.

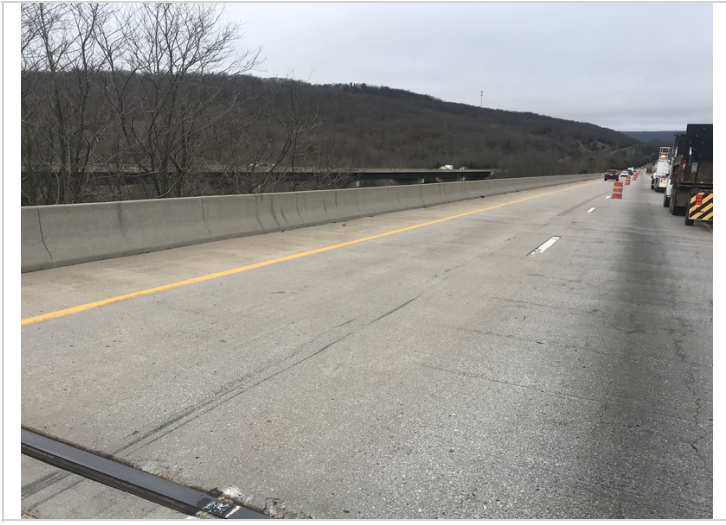
Left parapet. Typical.

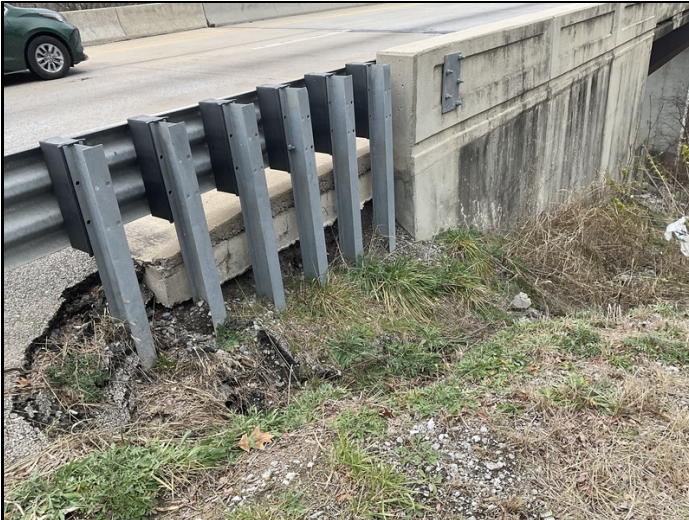
Abutment #1 Rt erosion.

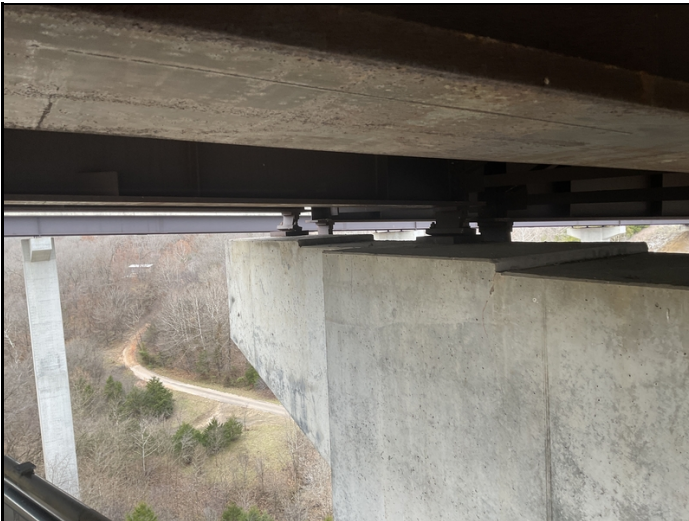
12/12/2022 - EJW- The temperature was approximately 48 degrees at the time of the inspection, bearings were in the expanded position.

Bent # 4 bearings in the expanded position.

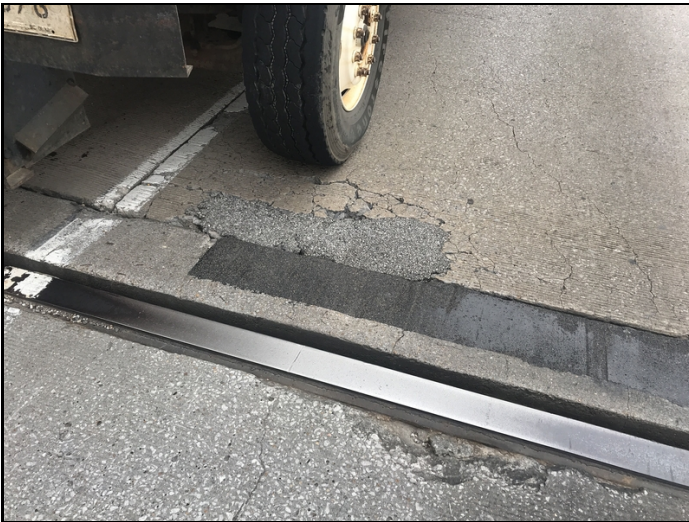
The south approach slab has a 5'X3' area that is breaking apart adjacent to the bent 1 backwall.

-The south approach slab has a 5'X3' area that is breaking apart adjacent to the bent 1 backwall.
