Asset #A6479(Routine)

I 49 SB LNS over BLACKBURN CREEK

Location: .5 MI N OF HOPPER TUNNEL

Team Lead: Lee Swan, Inspection Date: 04/14/2022

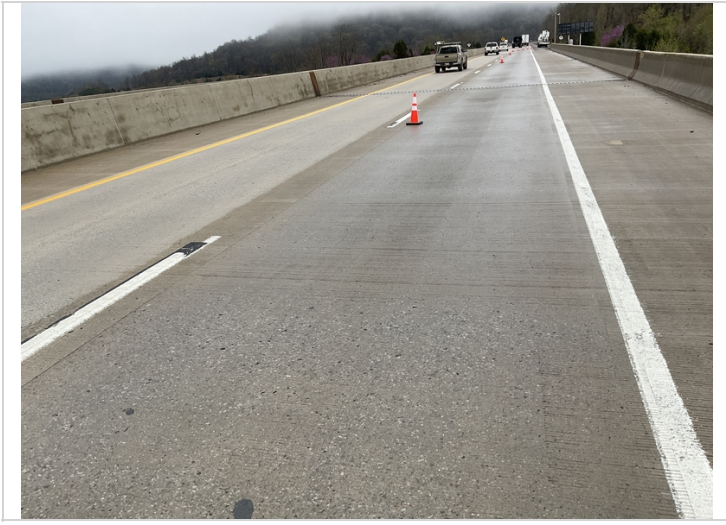
Typical deck

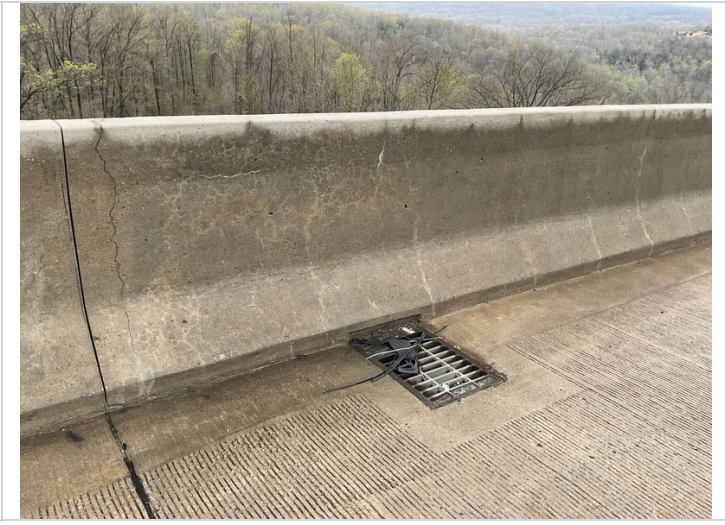
Typical concrete bridge rail.

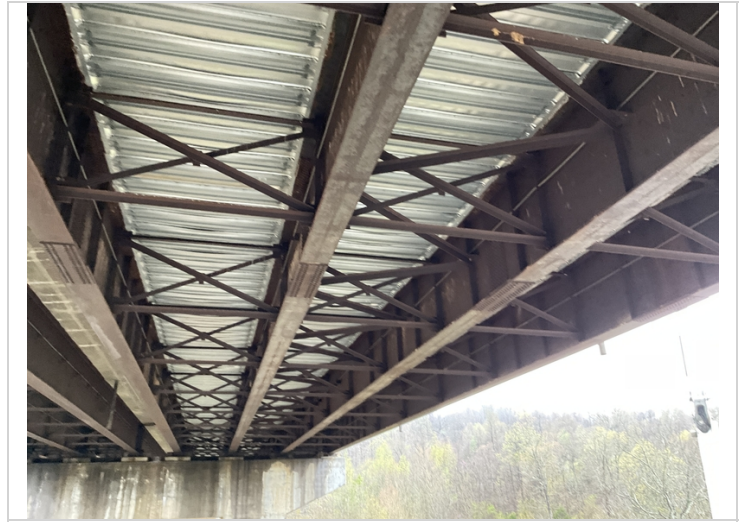
Typical soffit

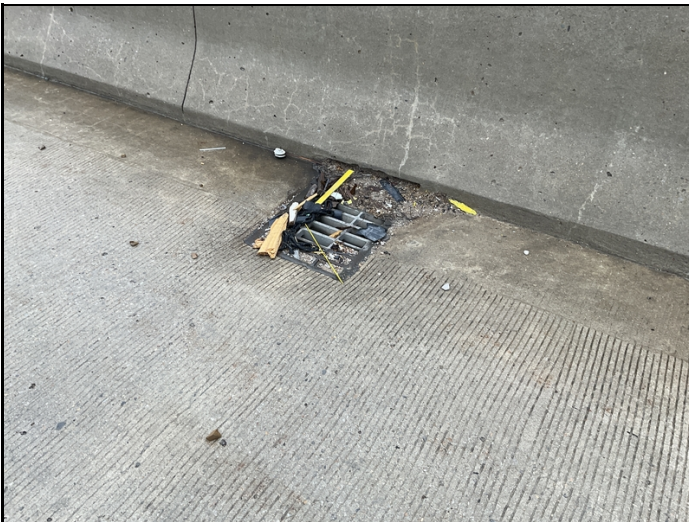
Span 5, typical debris in drains.

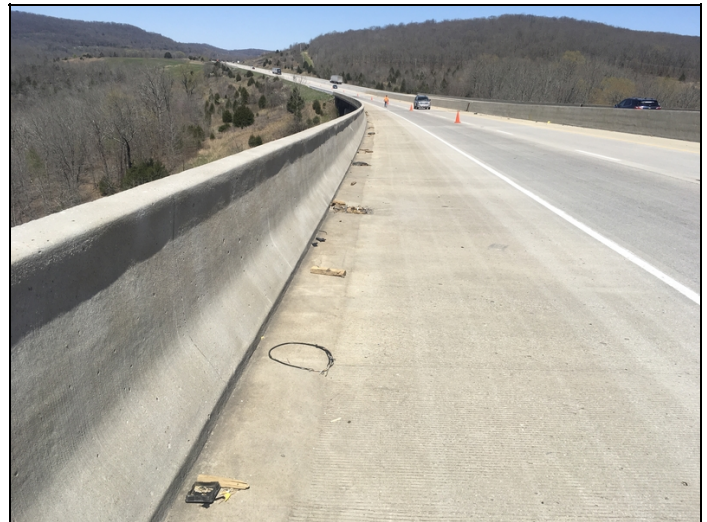
Dirt an debris in gutter.

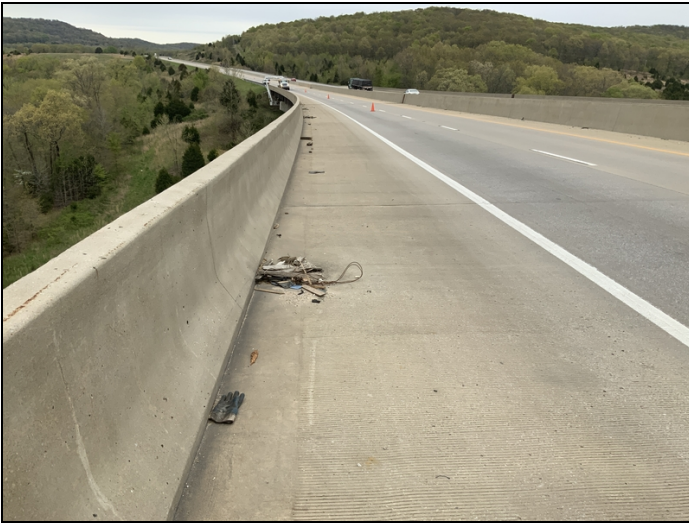
Deck drains full of debris typical throughout structure.

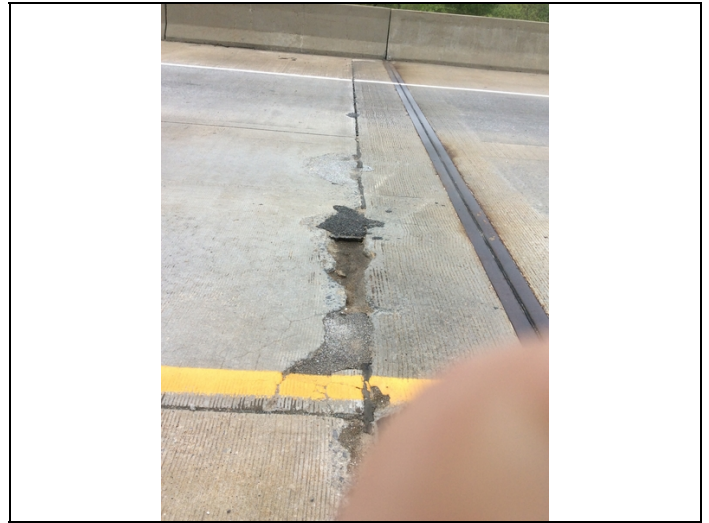
North approach slab sealed cracks.

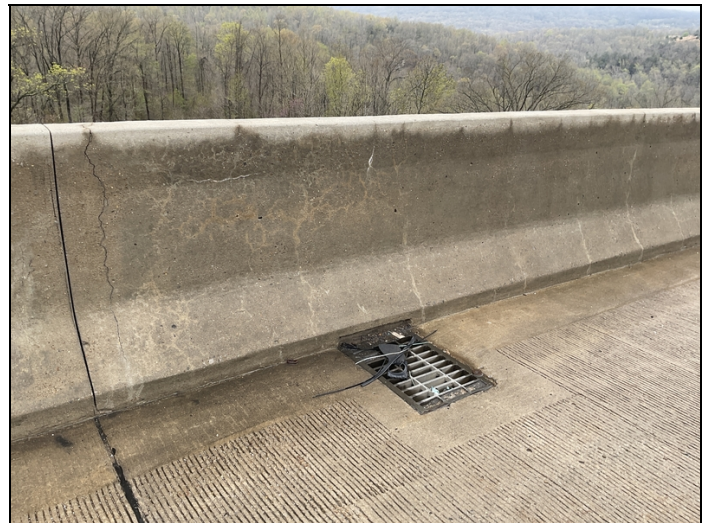
Typical concrete bridge rail.

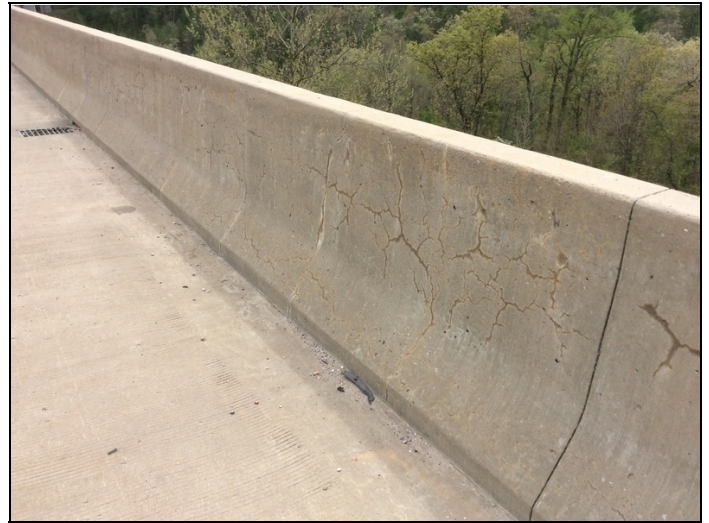
Typical cracking throughout barrier walls.

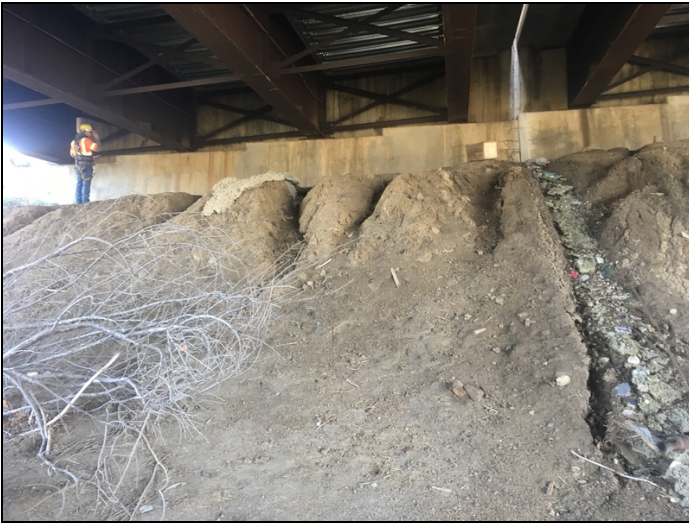
North Abutment embankment erosion.

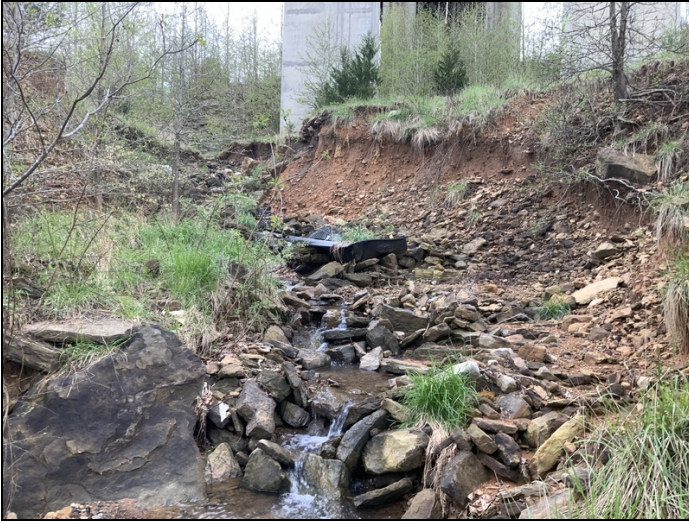
Bent 4 erosion.

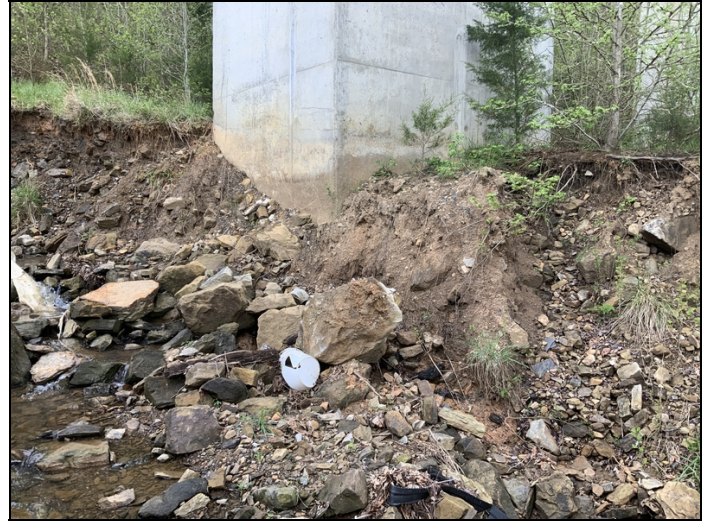
Bent 4 column 2 erosion .
